# Rail Accident Report

## Incident at Llanbadarn Automatic Barrier Crossing (Locally Monitored), near Aberystwyth, 19 June 2011

# **Incident at Llanbadarn Automatic Barrier Crossing (Locally Monitored), near Aberystwyth, 19 June 2011**

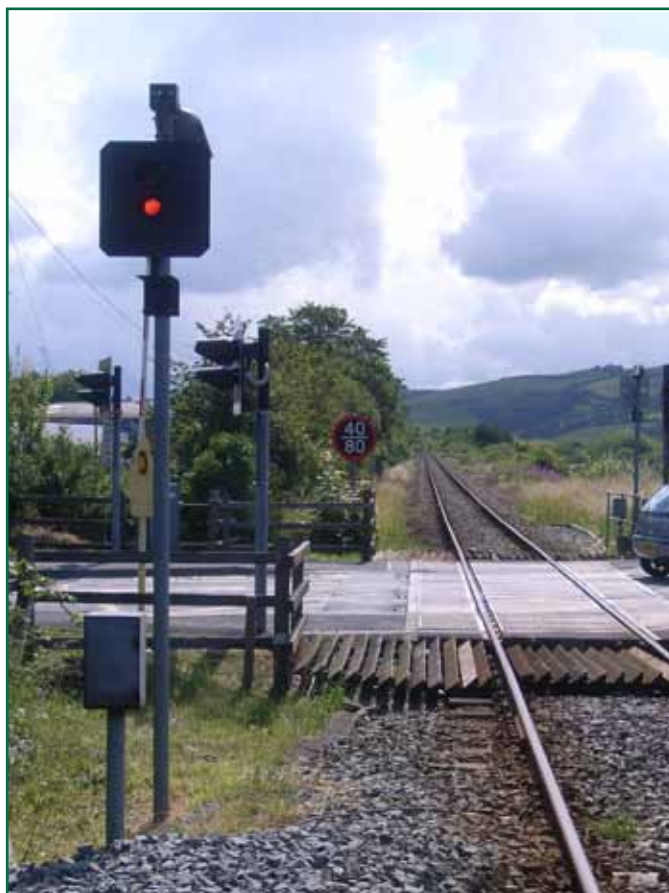
Figure 6: Llanbadarn ABCL showing driver's crossing indicator (DCI) flashing red

## Events following the incident

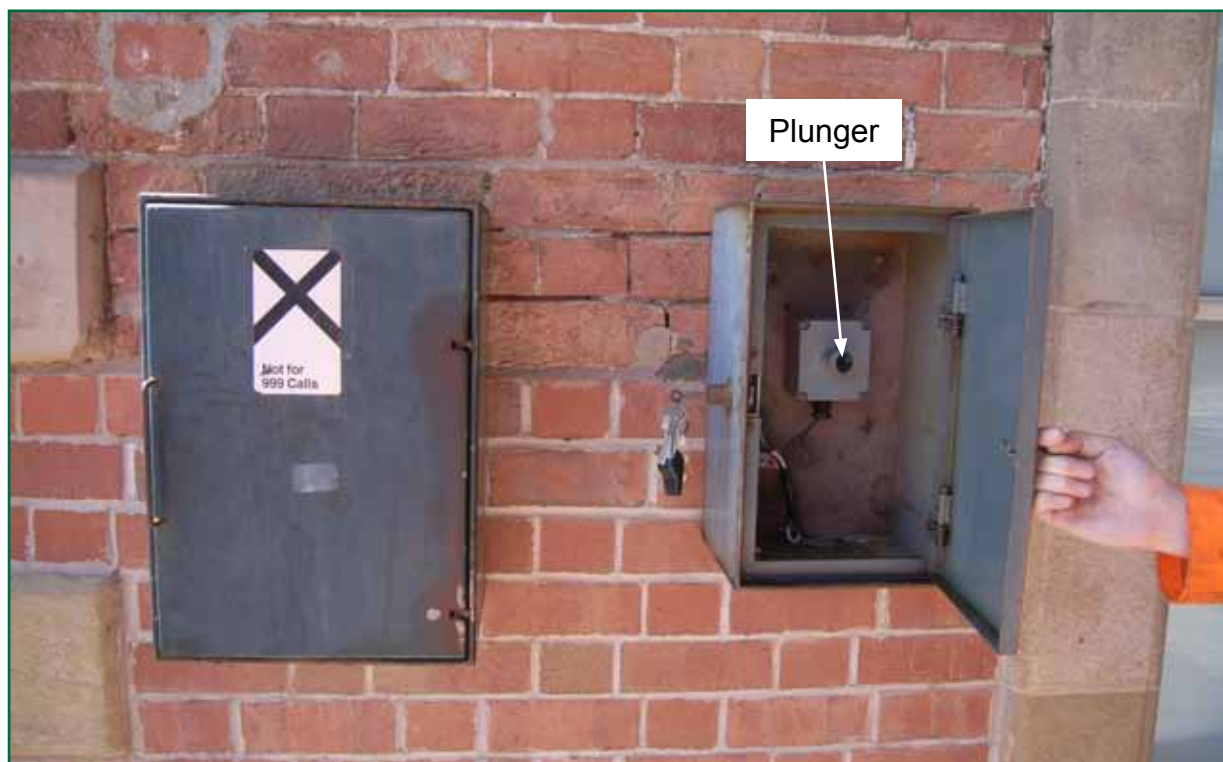
<sup>4</sup> A plunger (push button) that is operated by a member of train crew, when the train is ready to depart. The plunger operates signalling equipment associated with Llanbadarn ABCL and AOCL crossings.

Figure 7: Plunger on platform

- a. The plunger at Aberystwyth will not reset and begin timing again, if pressed again during its 10 minute timing period. The absence of a train driver's awareness of this may lead to potential confusion (**paragraph 170, Recommendation 2**).
- b. The RSSB were unable to provide the RAIB with information concerning why the Control Command and Signalling Standards Committee chose not to follow the RSSB's recommendation (**paragraph 155, Recommendation 6**).

- 2 *The intention of this recommendation is to provide automatic protection at Llanbadarn crossing (similar to that provided at manned barrier crossings) and to remove the plunger at Aberystwyth station.*

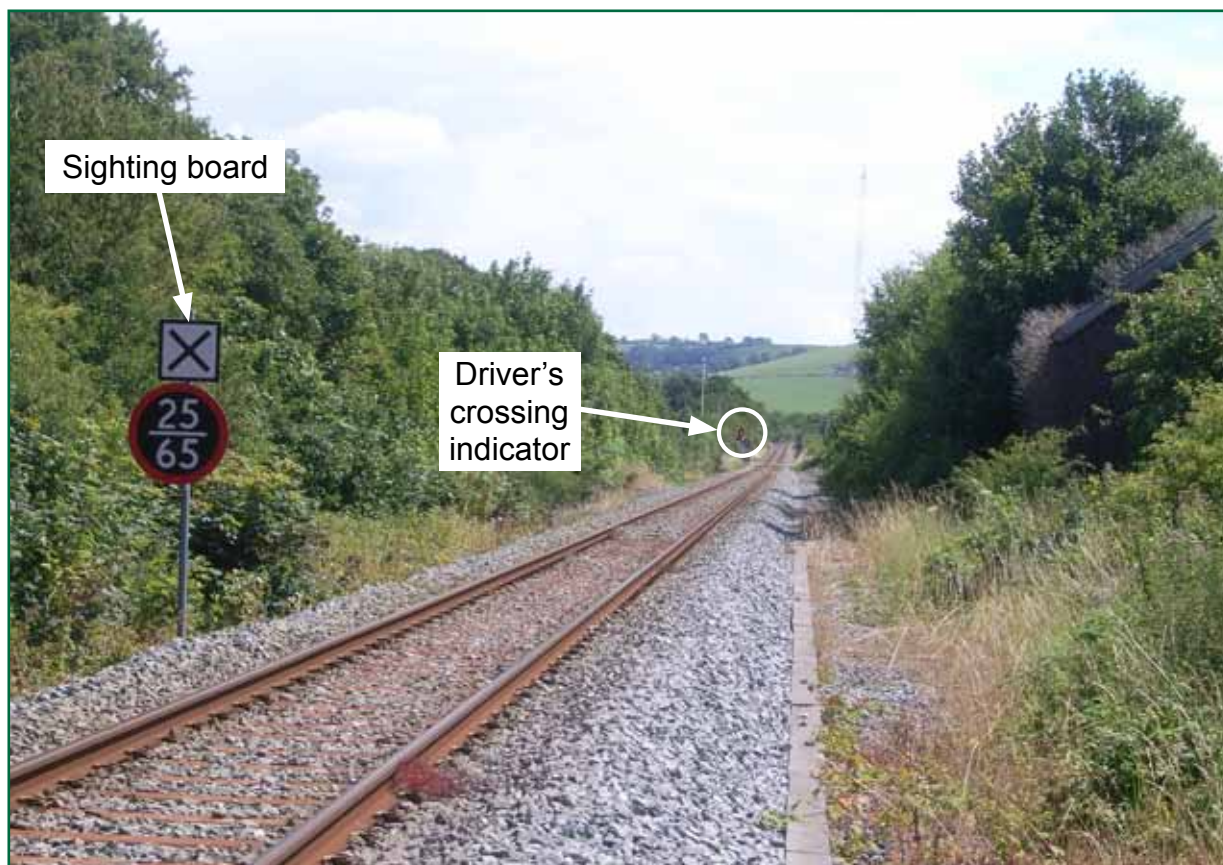
- 36 The sighting board for up direction trains at Llanbadarn ABCL is located 257 metres before the DCI (figures 5 and 8), which, in turn, is located 6.8 metres before the crossing. Thus the board is approximately 264 metres before the crossing. The DCI can be seen by a driver approximately 950 metres before the train reaches it. The warning board is located 778 metres on the approach to the sighting board.

Figure 8: The Sighting board on the up approach to Llanbadarn ABCL (with the driver's crossing indicator displaying a flashing red)

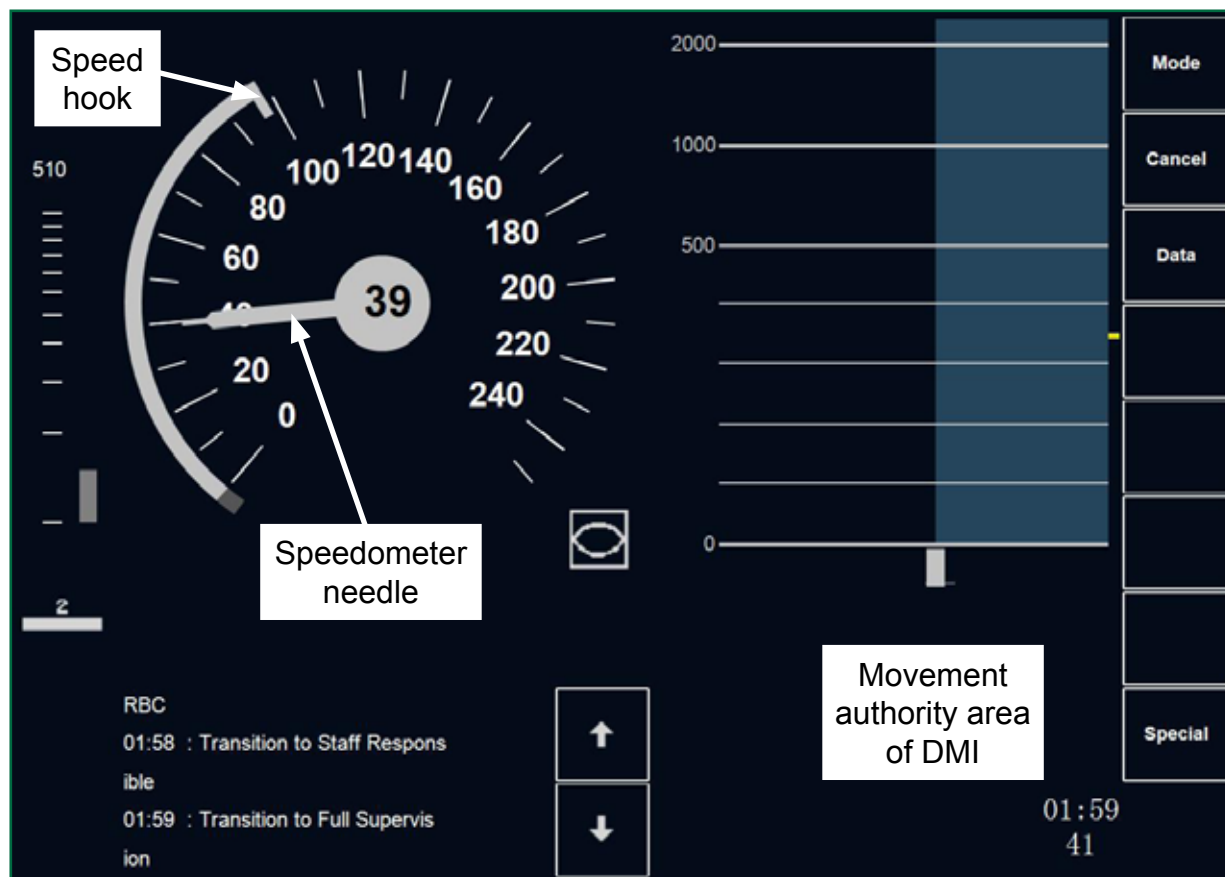
Figure 10: ERTMS DMI screen showing movement authority and speedometer needle and speed hook.  
 Note: The speedometer is showing 39 km/h and the speed hook (maximum speed) is indicating 98 km/h

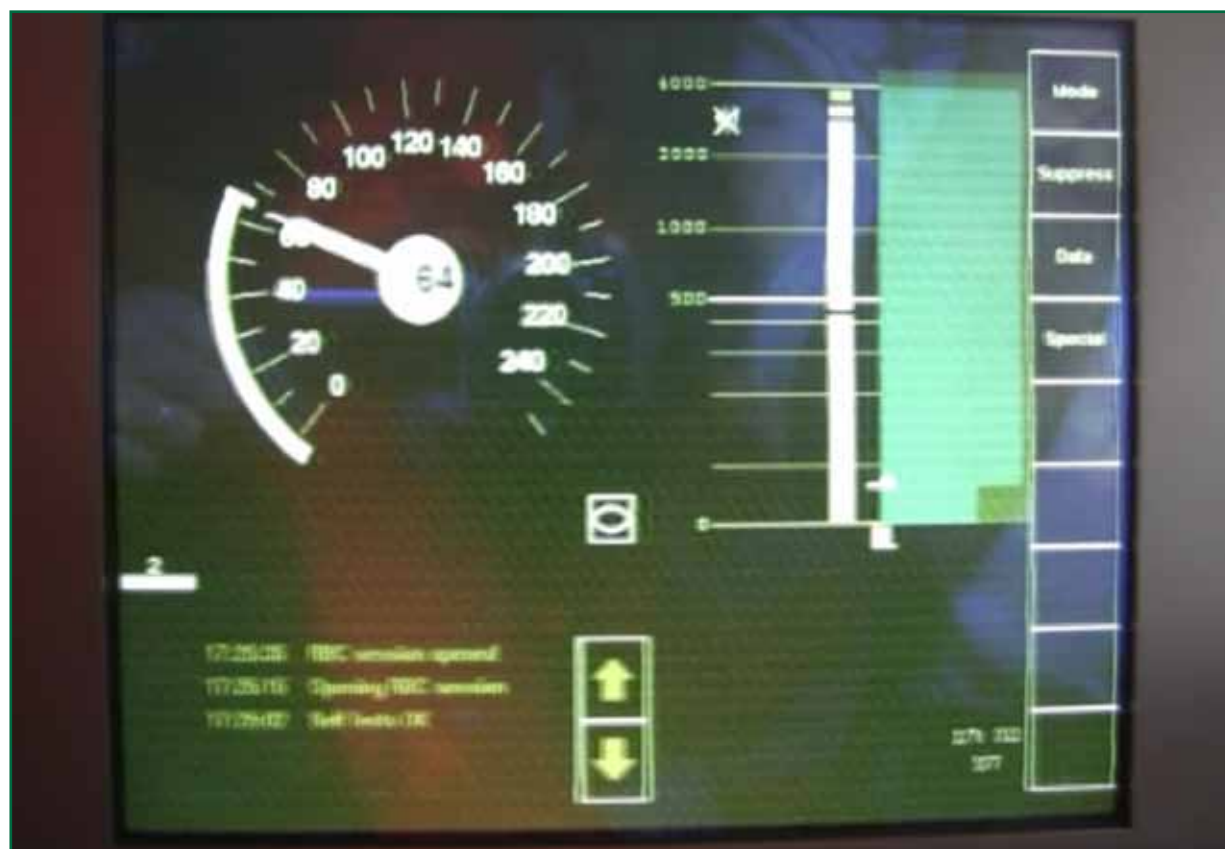
Figure 11: ERTMS DMI screen showing movement authority and speedometer needle and speed hook.  
 Note: the speedometer is showing 64 km/h and the speed hook (maximum speed) is indicating 65 km/h

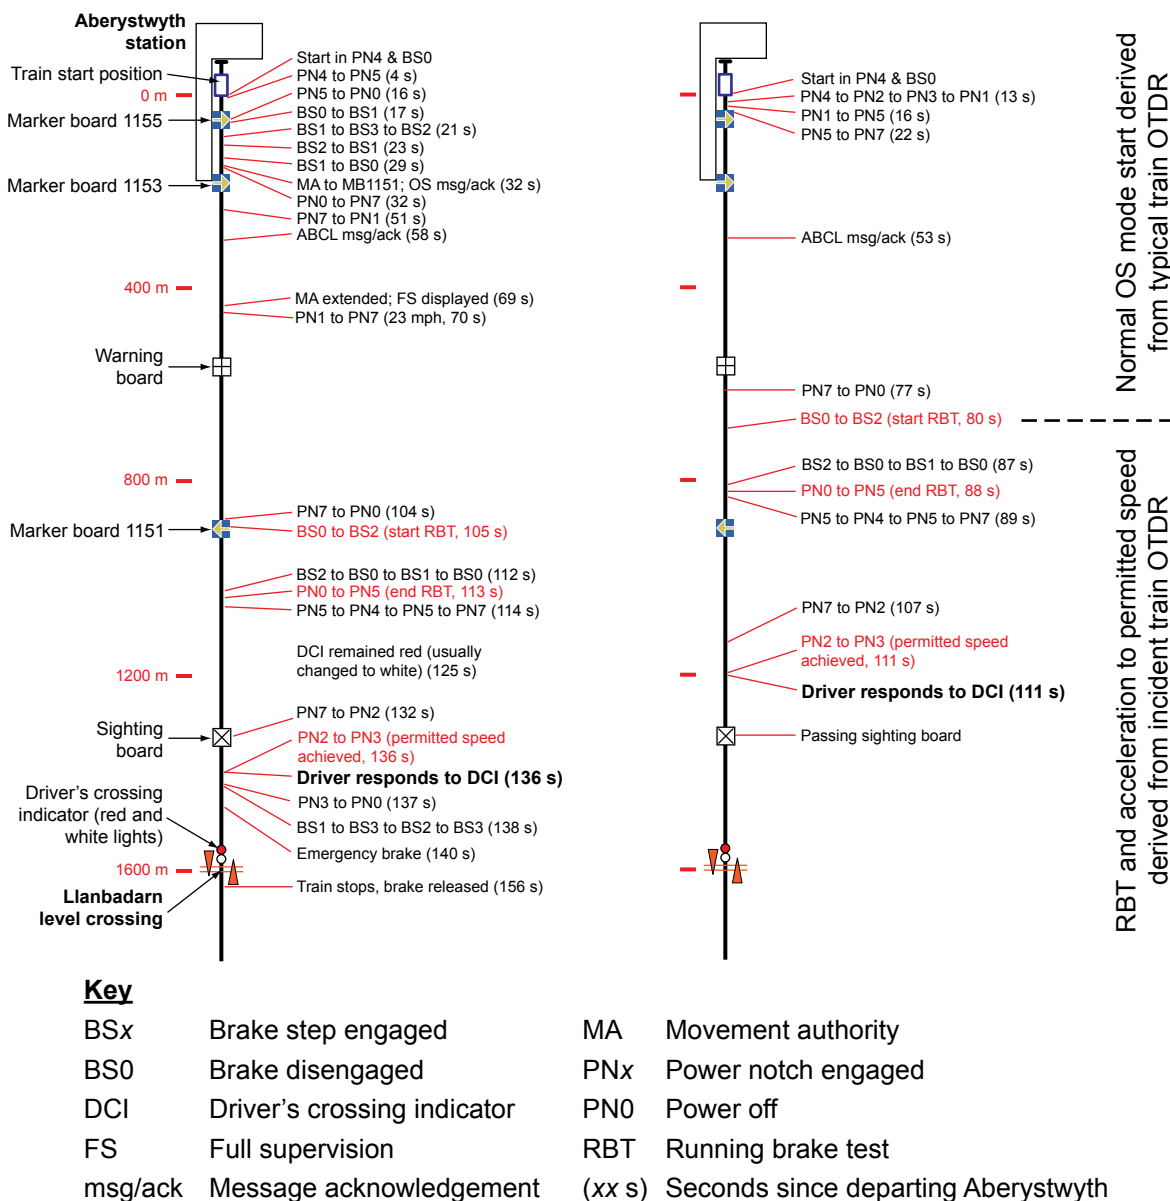
Figure 12: Driver's tasks for incident train (The start and end of the RBT and achieving the permitted speed are highlighted in red)
