Rail Accident Report

Detachment of a cardan shaft at Durham station 10 April 2011

Detachment of a cardan shaft at Durham station

10 April 2011

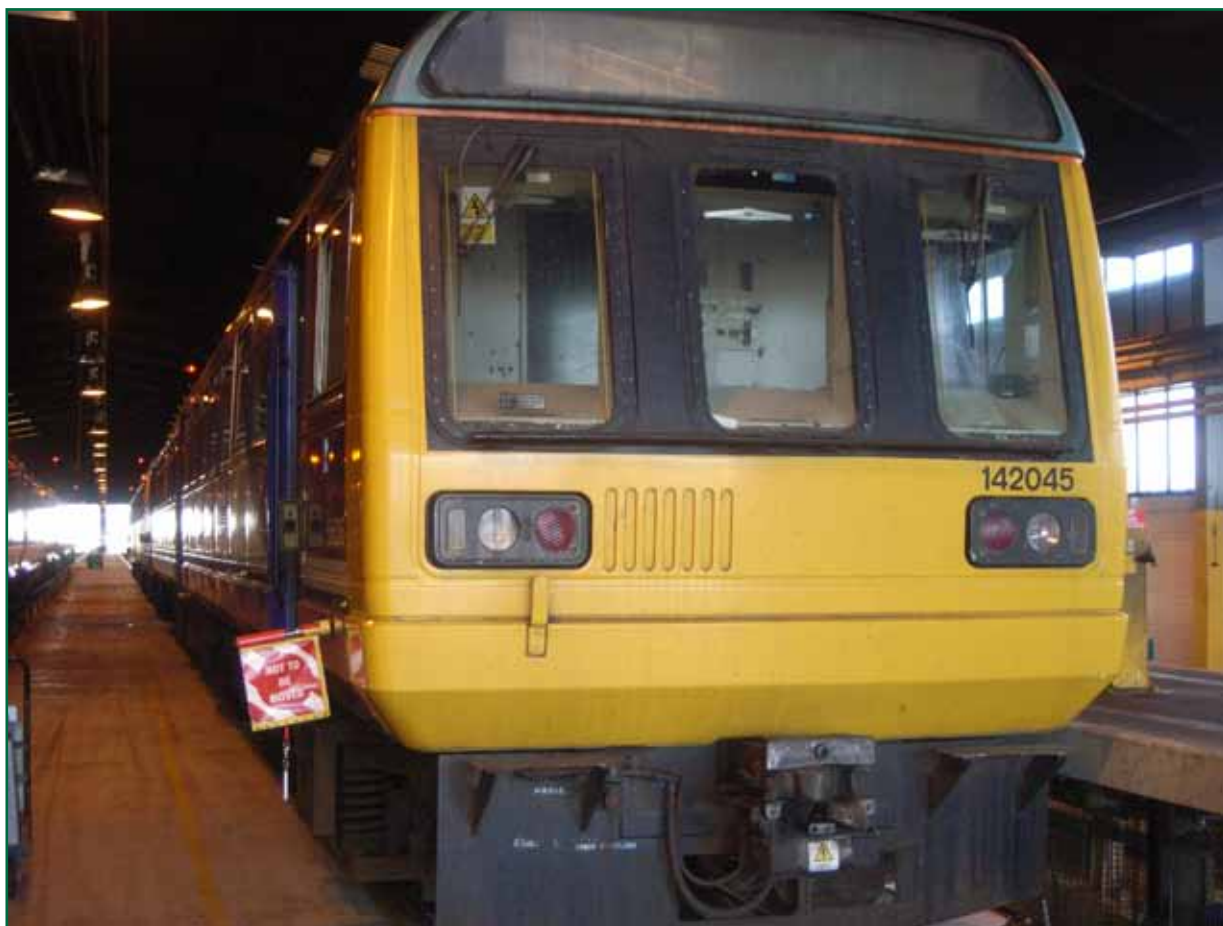
Figure 1: Unit 142045 at Heaton depot on 11 April 2011

- 9 The train involved was formed of two 2-car class 142 units (figure 1). The shaft detached at the trailing end of the third vehicle and was not held up by its *retention devices* (in this case two *safety loops* – figure 3). The detached cardan shaft came to rest between the rails of an adjacent line after damaging the underside of the third and fourth vehicles, piercing the fuel tank on the fourth vehicle and releasing around 500 litres of diesel fuel onto the railway.
- 10 Unaware of what had occurred, but alerted by an un-commanded brake application and the engine warning light illuminating on his cab console, the driver stopped his train on the approach to signal T291, 2 miles (3.2 km) outside Durham station (figure 2).

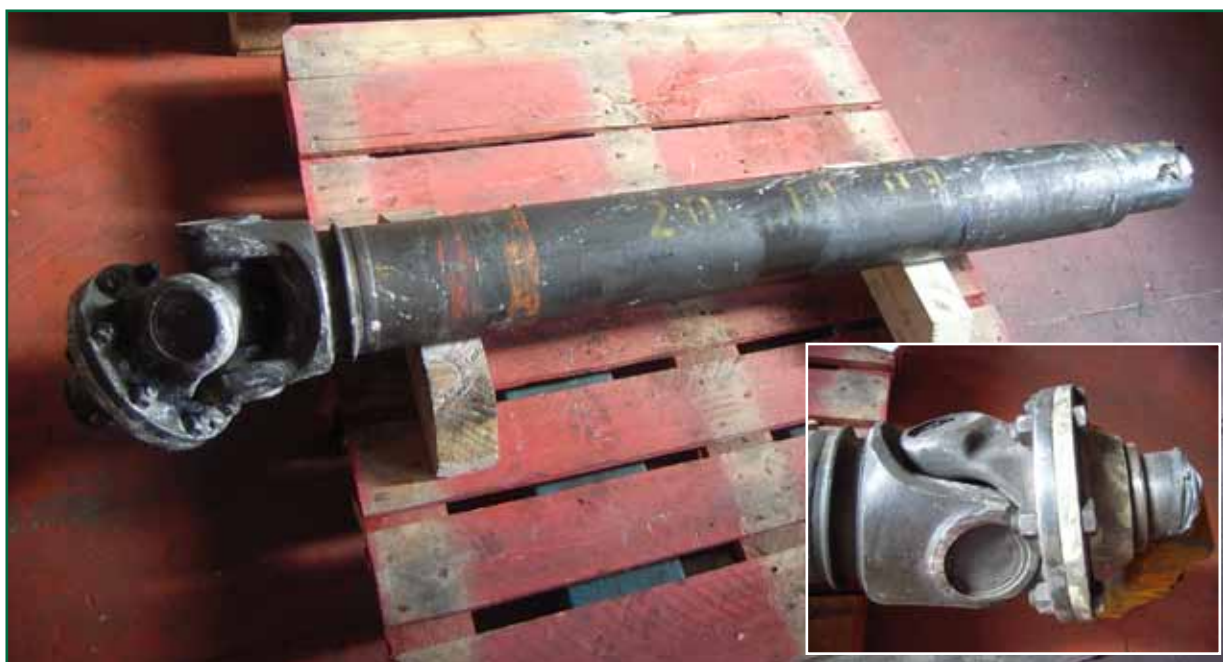
Figure 6: Recovered cardan shaft

- 54 As the driver was examining his train, the station staff contacted the signaller again to report that a large cardan shaft had been found in the four-foot of the up main line (figure 6 shows the recovered shaft). The signaller blocked the up main line to all traffic, the down main line already being blocked by the stationary train 5G01. The signaller then told the driver that a cardan shaft had been found on the track at Durham station.

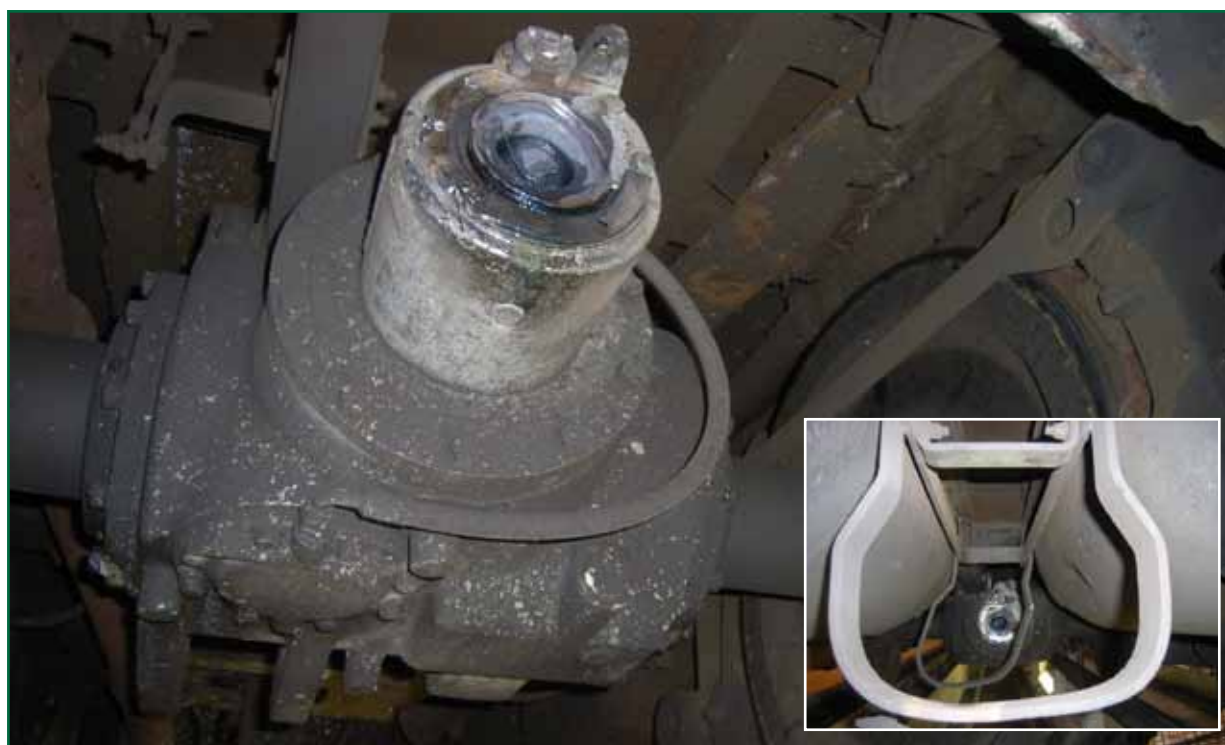
Figure 7: UT1140 as found on 11 April 2011

- 80 The examination of the unit carried out by the RAIB on 11 April 2011 showed that the safety loops had deformed and had been in contact with the cardan shaft. With the deformation of the safety loops, there was sufficient clearance to allow the cardan shaft to fall through (inset at figure 7).

- 120 Examination of the safety loops on 11 April 2011 found that they had deformed during the accident (inset at figure 7).
- 121 A further examination of several undamaged class 142 vehicles showed that a detached cardan shaft could still exit the cradle formed by the safety loops without requiring any deformation. There is enough space available to slide a detached cardan shaft in between the safety loops and the final drive. The arrangement of the safety loops was a possible factor.
- 122 The RAIB considered making a recommendation for the improvement of the design of the safety loops on class 142. However, the RAIB's recommendations in other areas combined with the practical difficulties associated with designing effective safety loops and the limited safety benefits obtained from an improved design led the RAIB to conclude that it would be unlikely to be reasonably practicable.

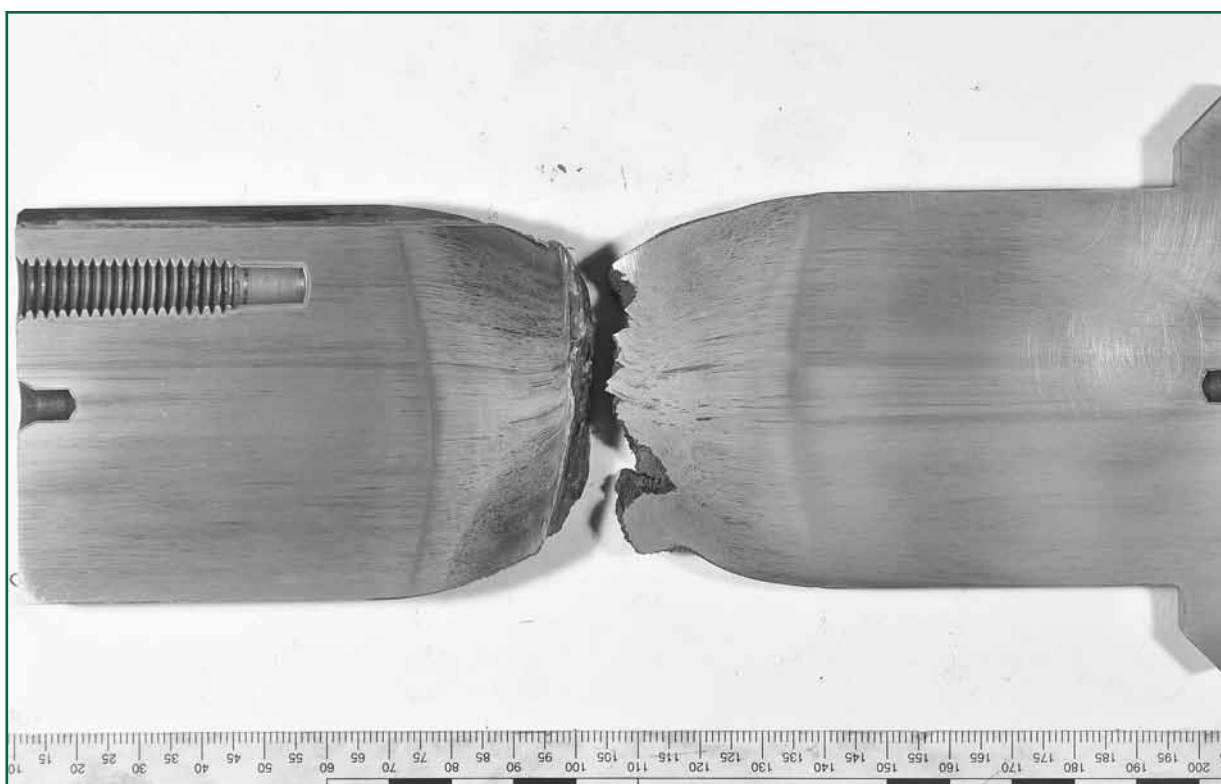
Figure 8: Section through the input shaft

- 81 **The seizure of the outer bearing led to the fracture of the input shaft which ultimately led to the detachment of the cardan shaft. The seizure of the outer bearing was a causal factor.**
- 82 The RAIB commissioned a metallurgical examination of the failed components in the input housing assembly. This examination located the fracture face of the input shaft marginally inboard of the outer bearing and showed evidence of heat input to the shaft with temperatures increasing towards the fracture face. The examination revealed that the input shaft had reached temperatures in excess of 850°C in the vicinity of the fracture. The shaft diameter also decreased steadily towards the fracture face (figure 8).

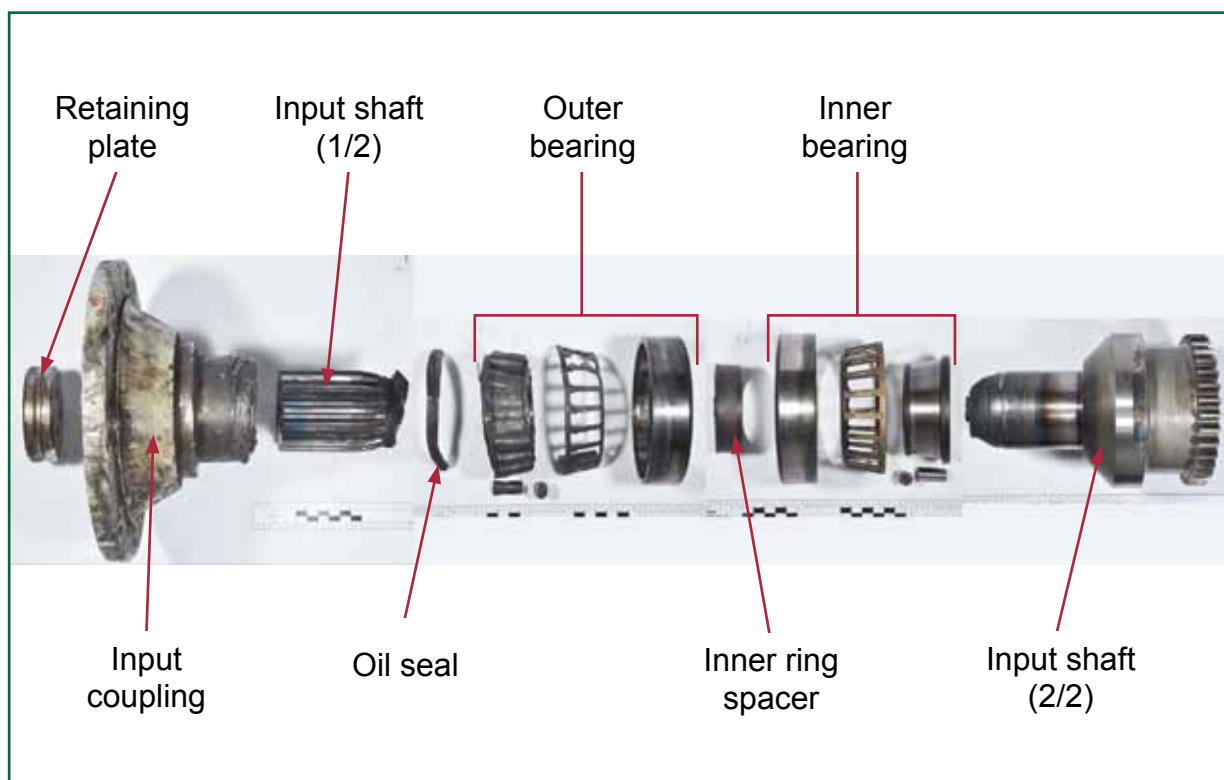
Figure 9: Components of the drive shaft input assembly following failure of the shaft

- 78 The release of the final drive end of the cardan shaft was due to the fracture of the input shaft within the input housing. The input shaft was found in two parts after the accident (figure 9): one part was still inside the final drive and the other was attached to the cardan shaft by the input coupling.

- 85 The input coupling (figure 9) showed significant damage to the surface that had been in contact with the inner ring of the outer bearing. The examination also revealed that this area had been exposed to temperatures in excess of 820°C.

- 86 Analysis of the physical evidence suggests that the input shaft fractured under normal operating loads when at very high temperatures. At 850°C, the material characteristics change significantly and in particular the material strength reduces to less than one tenth of its original value at normal ambient temperature. With such a reduction in material strength, the input shaft was unable to carry the normal operating loads and fractured under a combination of torsional and tensile loads.

- 87 The physical evidence also indicates that the source of heat was the interface between the input shaft and the inner ring of the outer bearing after the seizure of the outer bearing. The seizure of the outer bearing was a causal factor.

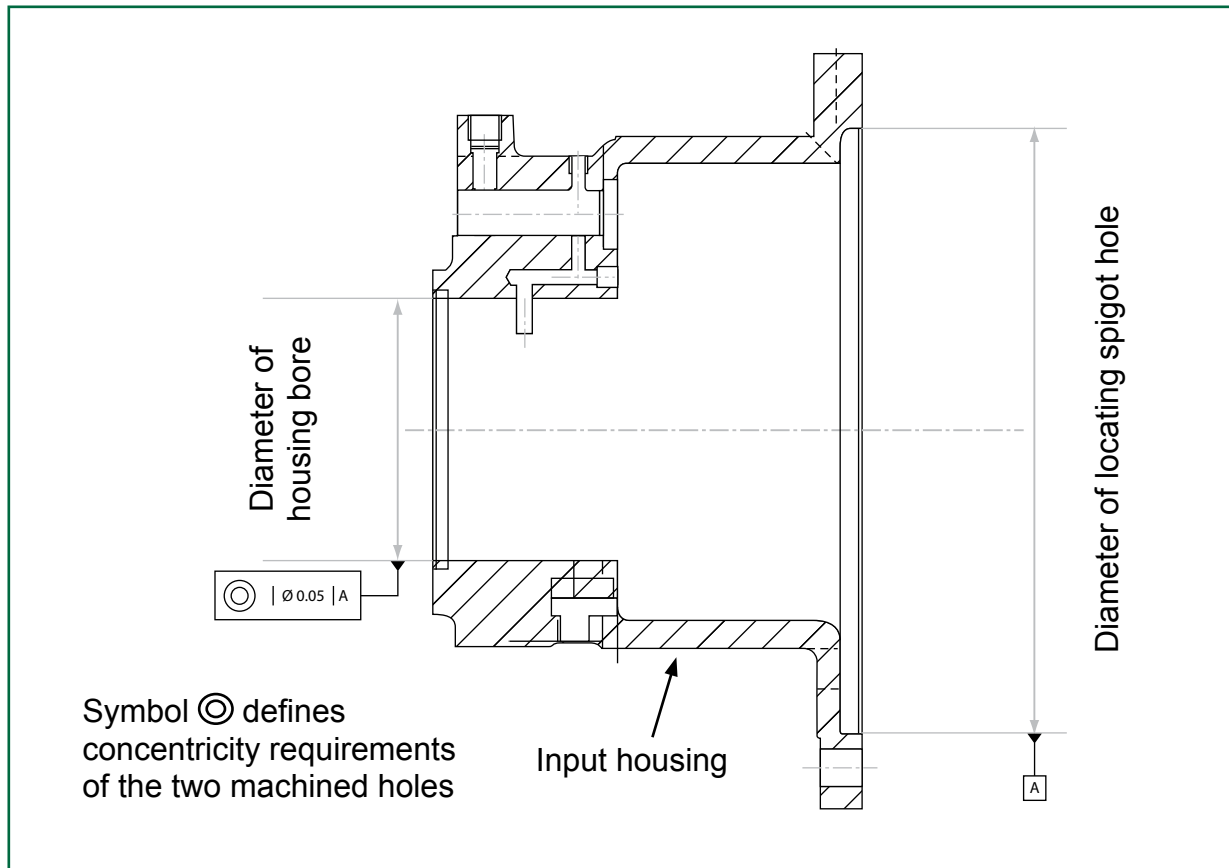
Figure 10: Concentricity of locating spigot hole relative to the housing bore for the bearings

- 95 During the controlled disassembly of UT1140, the *concentricity* of the axis of the spigot hole locating the input housing in relation to the axis of the housing bore for the bearings was measured and found to be approximately 0.5 mm. The original SCG drawing for the input housing shows that this dimension should have been controlled to be no greater than 0.05 mm (figure 10). The concentricity of the two axes was not controlled during the manufacturing of new input housings or when housing bores were re-sleeved due to excessive wear. The larger than expected concentricity resulted in the input shaft and pinion shaft being misaligned. This is confirmed by the inclined wear pattern found on the selector fork on UT1140 which is indicative of the level of permanent misalignment between the input and pinion shafts.

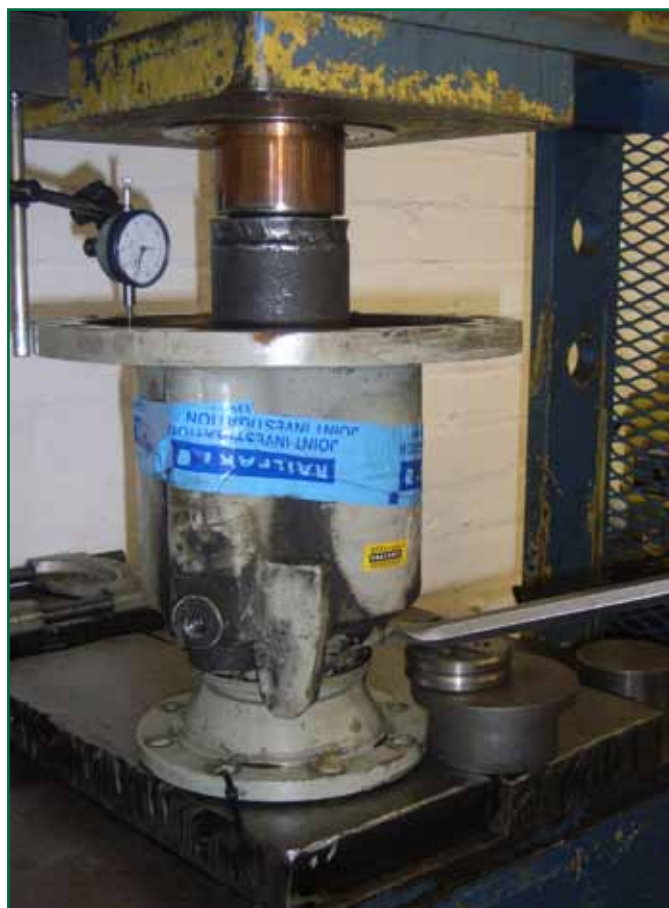
Figure 11: End float measuring technique

- 101 The end float measuring technique described in WI-27 involves the input housing assembly being located under a press (figure 11). The press clamps the input shaft stack and the fitter displaces the input housing using a crowbar wedged in between the support and the housing. The fitter uses a dial gauge to measure the achievable displacement. The gauge has a 0 - 0.1" (0 - 2.5 mm) scale and the fitter measures displacement within the range 0.002" - 0.004" (51 μ m - 102 μ m). The end float measuring technique is a sensitive operation with the output depending on the dexterity of the fitter.

- 102 The RAIB witnessed a series of tests done by the industry to establish whether this method was able to determine the end float accurately. These tests suggest that housing tilt might have been measured by the method instead of true end float. The potential inaccuracy of the measuring method has led the RAIB to conclude that it is possible that this technique contributed to the under provision of end float.
