# Rail Accident Report

**Train departed with doors open, Warren Street,  
Victoria Line, London Underground  
11 July 2011**

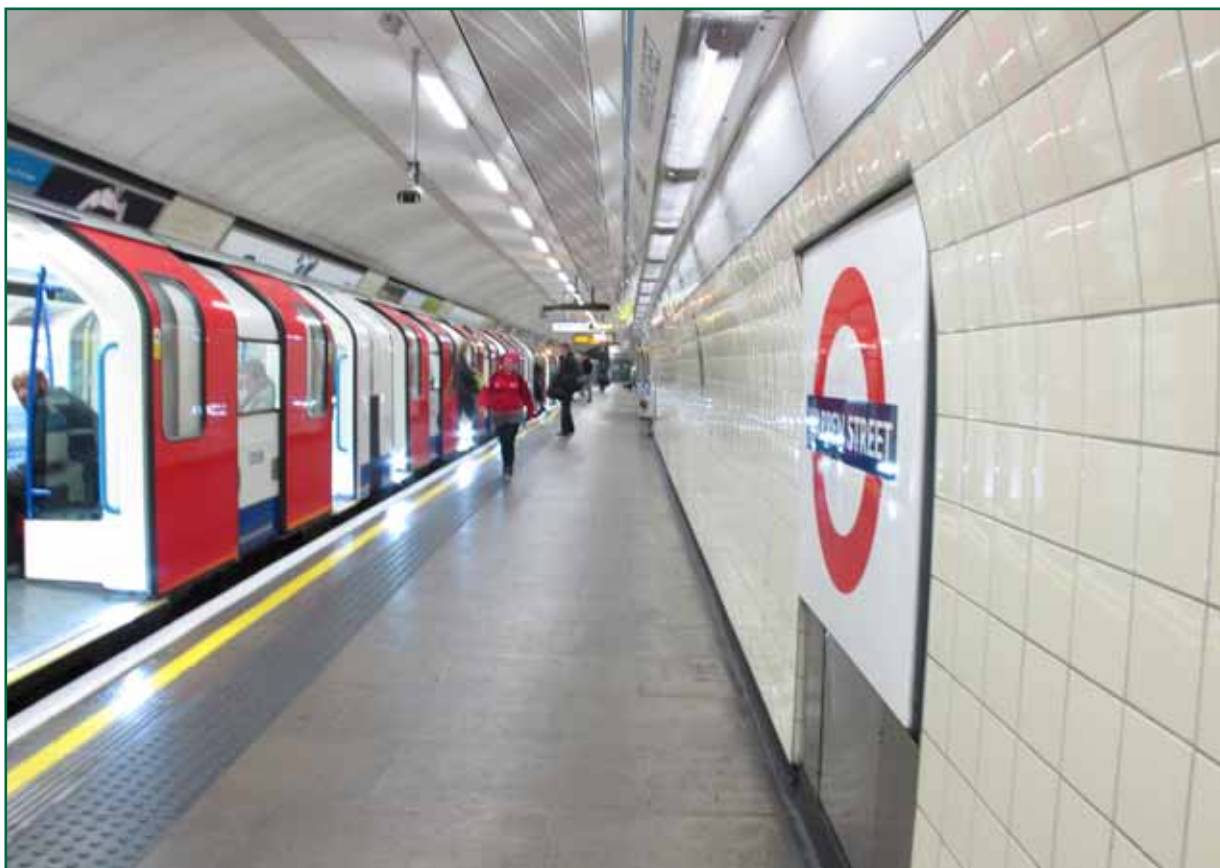
Figure 2: Northbound platform at Warren Street, Victoria Line (by courtesy of London Underground)

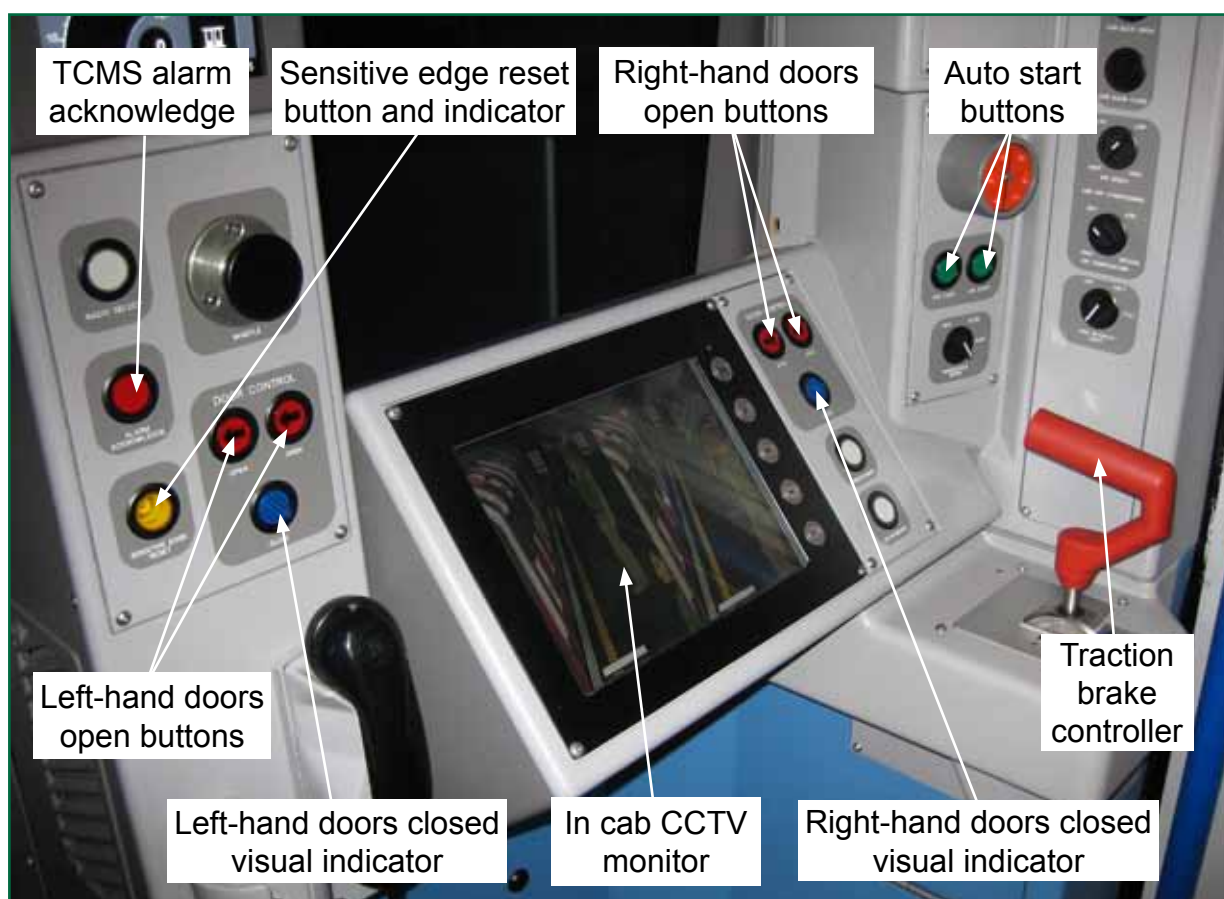
- 17 On each car there is a set of double sliding doors at a third and two thirds of the way along each side. In addition, the cars without a driving cab have single leaf sliding doors giving access to the passenger saloon at each end; cars with a driving cab have single leaf sliding doors giving access to the saloon at the non-cab end. The layout of the doors is shown later in the report in figure 5.
- 18 The trains normally operate in *automatic mode* and only require the train operator to open the doors on arrival at a station, and then close the doors and press the *start buttons* (figure 3) if it is safe for the train to depart.

Figure 3: Layout of relevant cab controls in the driving cab of 2009 tube stock

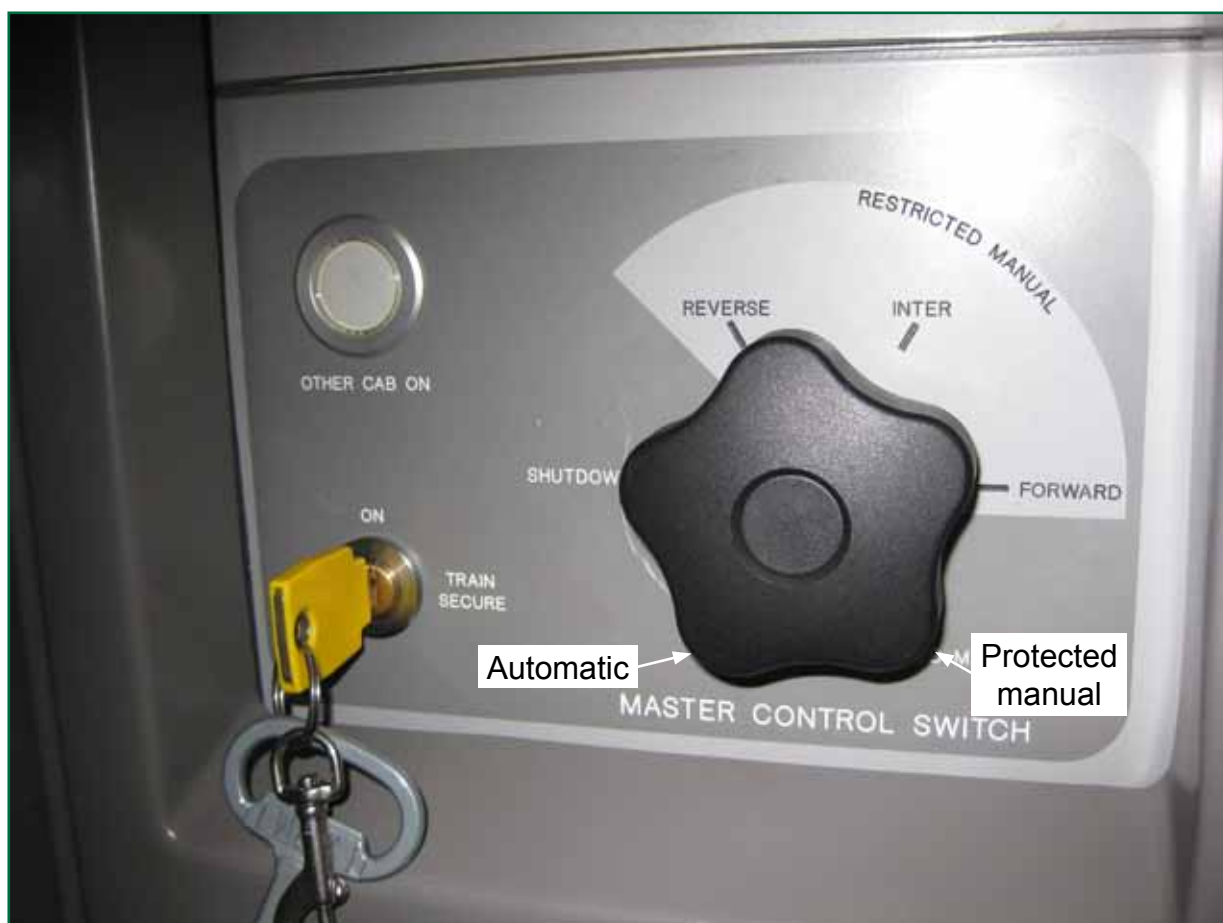
Figure 4: Master control switch 2009 tube stock

- 128 While between Oxford Circus and Warren Street, the train operator turned the master control switch to shutdown and then back to protected manual (paragraph 52). This action caused the door close relays to de-energise causing the sensitive edge override and sensitive edge cut out switches to be ineffective. Train operators had not been briefed on this and it made it more difficult for the train operator to resolve the activated sensitive edge at Warren Street.

- 136 The circuitry is to be modified so that turning the master control switch to shutdown does not de-energise the door closed relays, or cause the sensitive edge override to be no longer available. The implementation of this change has been allocated to Bombardier to carry out (paragraph 132a).

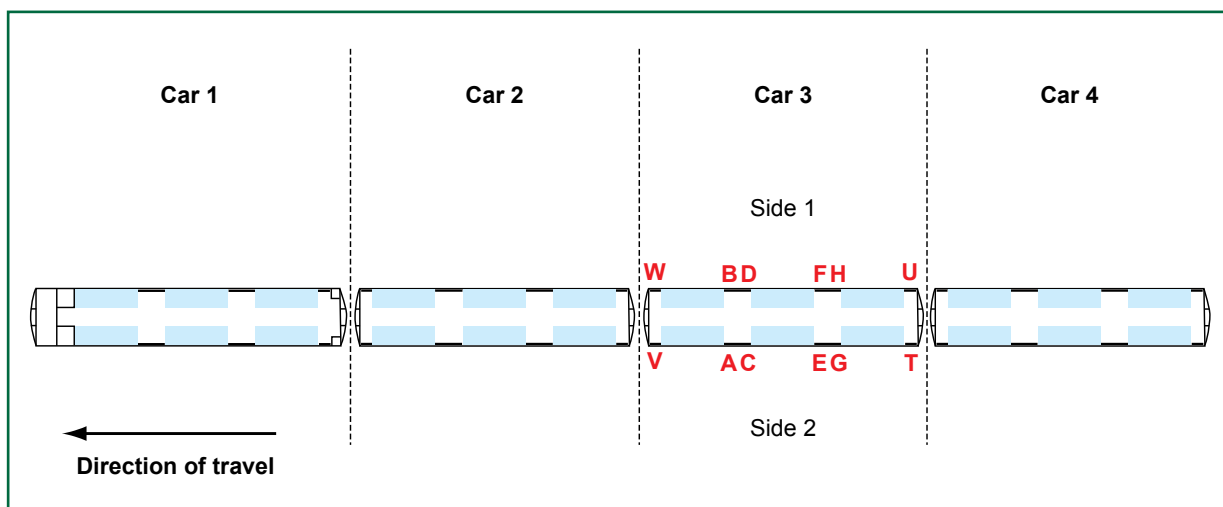
- 47 The message displayed related to the third car of the train, car number 13066, and advised 'SE door DBW side 1'. Doors D, B and W are located as shown in figure 5. The message further advised: 'Emergency brake applied, once cause of activation is known press Sensitive Edge push button for brake release'.

Figure 5: Layout and designation of train doors 2009 tube stock
