# Rail Accident Report

**Incident involving a runaway track maintenance  
trolley near Haslemere, Surrey  
10 September 2011**

# Incident involving a runaway track maintenance trolley near Haslemere, Surrey, 10 September 2011

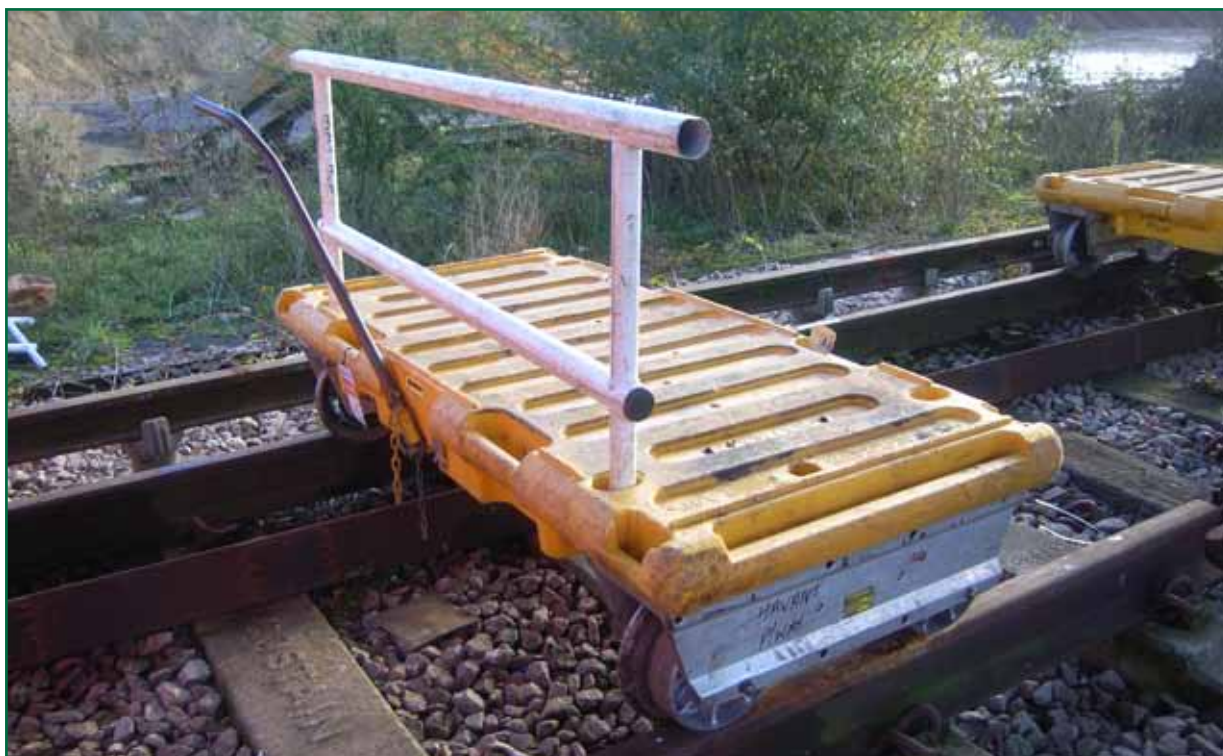
- 18 The trolley was a Wolfe Designs 'trakrat'<sup>1</sup> LT1000P (figure 3). Two of these trolleys were based at Havant track maintenance depot; it is likely that the trolley involved in the incident was No. E0007515 (refer to paragraph 46) although it has not been possible to confirm this as trolley use is not recorded. Network Rail had taken delivery of thirteen LT1000P trolleys in August 2009, following product acceptance of the 'trakrat' family of trolleys by Network Rail during 2008. The LT1000P was the smallest product in the range, which included the LT1250A, LT1500A and LT1500A welders' trolleys.

Figure 3: LT1000P 'trakrat' trolley

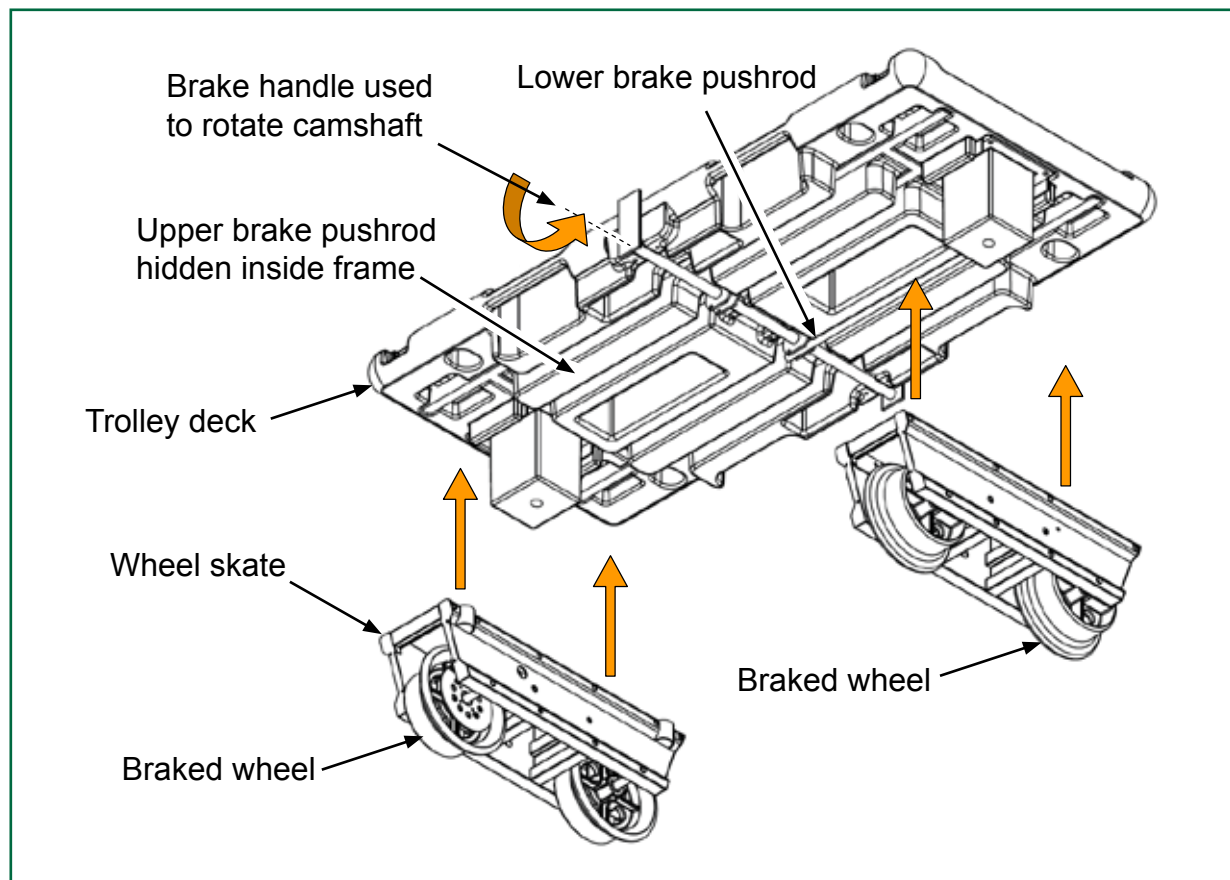
- D1 The two 'trakrat' trolleys which had been in use at Havant track maintenance depot on 10 September 2011 were examined at Woking by the RAIB and Network Rail on 4 October 2011. Testing demonstrated that the brake handle could jam with the brakes released, and the trolley could then run un-braked without further intervention from the operator.
- D2 The wheels on the 'trakrat' family of trolleys are carried in demountable wheel skates or bogies, figure D1. There are two braked wheels, on diagonally opposite corners of the trolley. The brakes are normally held in the applied position by means of springs, and are released by a brake handle which is attached to either end of the trolley, figure D2.

Figure D1: Underside of 'trakrat' LT1000P, showing location of wheel skates and brake linkage (Courtesy of Norlec Sheet Metal)

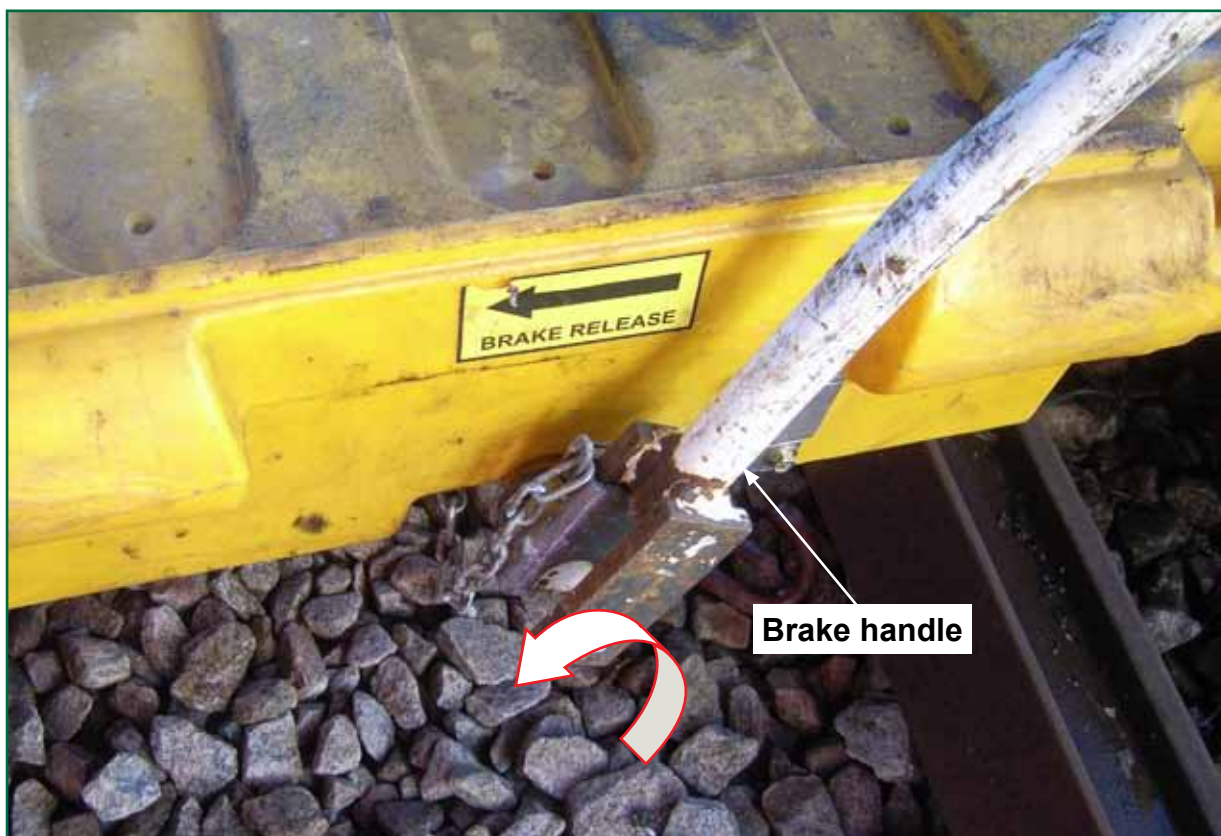
Figure D2: One end of 'trakrat' LT1000P, showing use of brake handle to release brakes

- D4 One of the features of the linkage arrangement is that the longitudinal camshaft is rotated in opposite directions depending on which end of the trolley the operator is standing. On one end (eg figures D1 & D2) the shaft is rotated anti-clockwise to release the brake, ie the operator must push the handle to the left, and on the other (figures D3 & D4) it is rotated clockwise and the operator must push the handle to the right. The indication to the operator as to which direction he should push the handle is given by a label on the end of the trolley, figure D2.

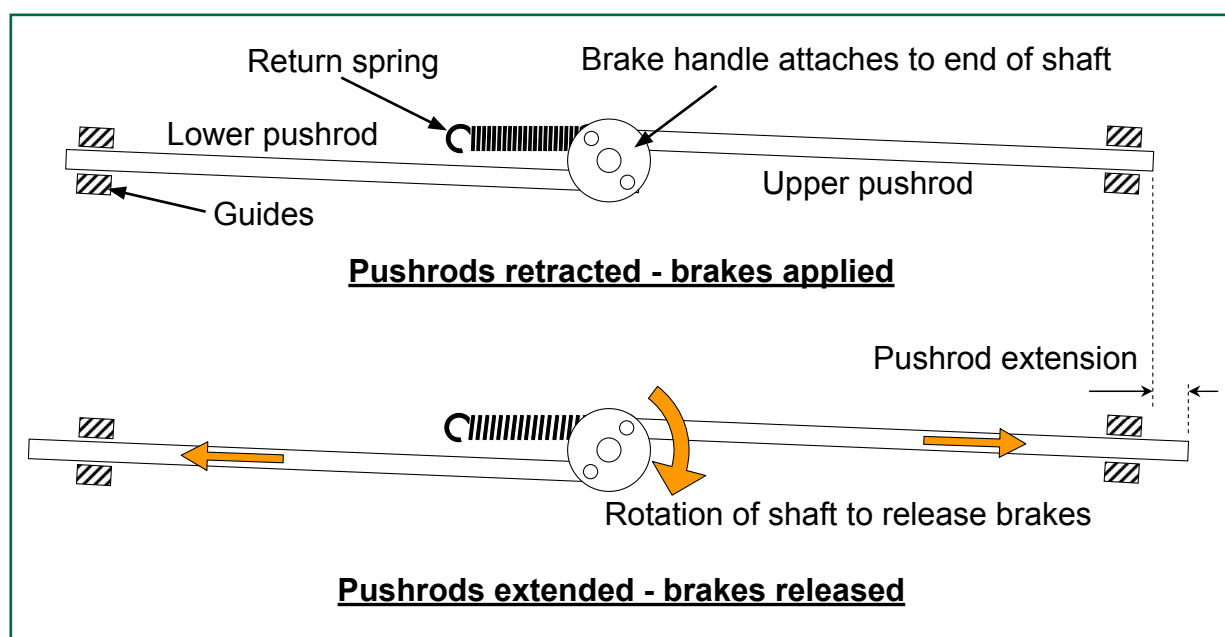
- D3 The brake handle is used to rotate a longitudinal camshaft, which drives one pushrod per braked wheel, figures D3 & D4. When extended, the pushrods overcome the force of the springs holding the brakes on. Because the pushrods are connected eccentrically to the longitudinal shaft, they are offset from each other. The upper pushrod has a return spring to keep the pushrods normally in the retracted position. In this state, the wheel skates can be detached from the trolley deck for transporting to and from site.

Figure D3: Two views of the brake linkage as designed, showing extension of the pushrods to release the brakes

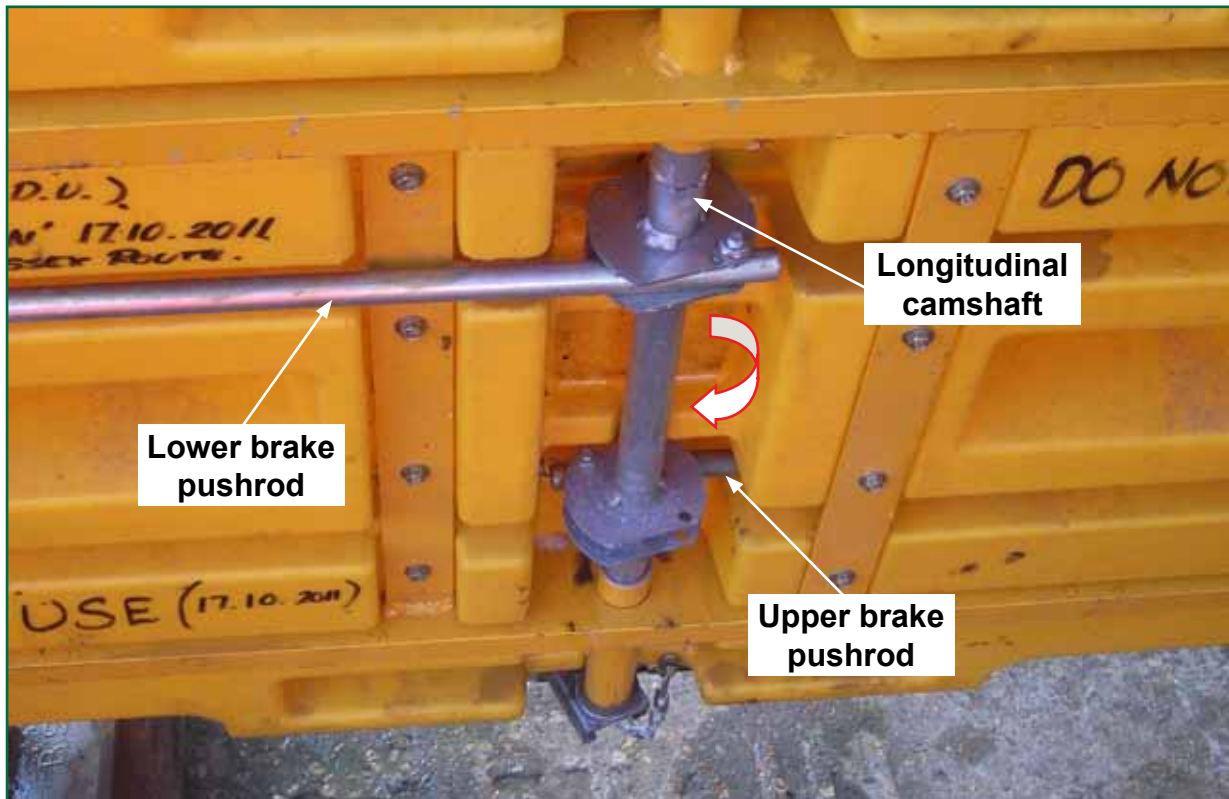
Figure D4: Underside of the trolley from Reading depot, showing brake pushrod linkage as designed

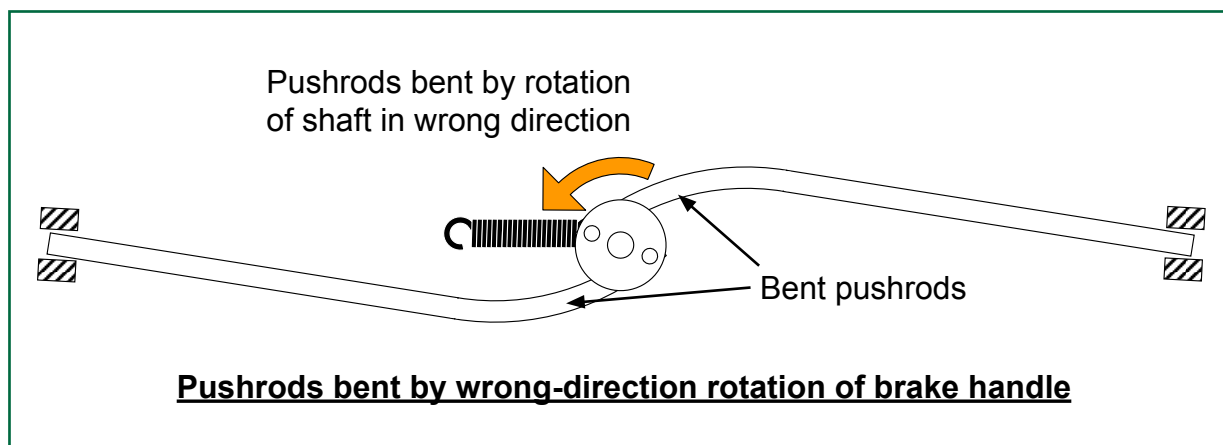
- 65 The damage to the brake mechanism had two effects. Firstly, the bent pushrods could rub on the trolley frame (refer to appendix D, paragraphs D5 to D7) and jam in the 'off' position (paragraph 45). Secondly, it probably made the trolley more difficult to push because of the angle of the brake handle when the brakes were in the 'off' position (paragraph 49).

- D5 If the handle is pushed in the wrong direction, the brakes remain applied. If the handle is forced further in this direction, the pushrods, which are made from steel tubing, can start to bend and wrap themselves around the camshaft (figure D5). Damage consistent with this mechanism was observed on six of the seven LT1000P trolleys examined after the incident, figure D6. Bending of the pushrods in this way probably occurred incrementally due to trolley operators mistakenly applying too much force to the brake handle in an initial attempt to release the brakes, before realising that the handle should be pushed in the opposite direction. If the damage had occurred over a short period, it is likely that the operators would have noticed the sudden changes in the positions of the brake handle and put the trolleys into quarantine.

Figure D5: View of the brake linkage showing bending of brake pushrods

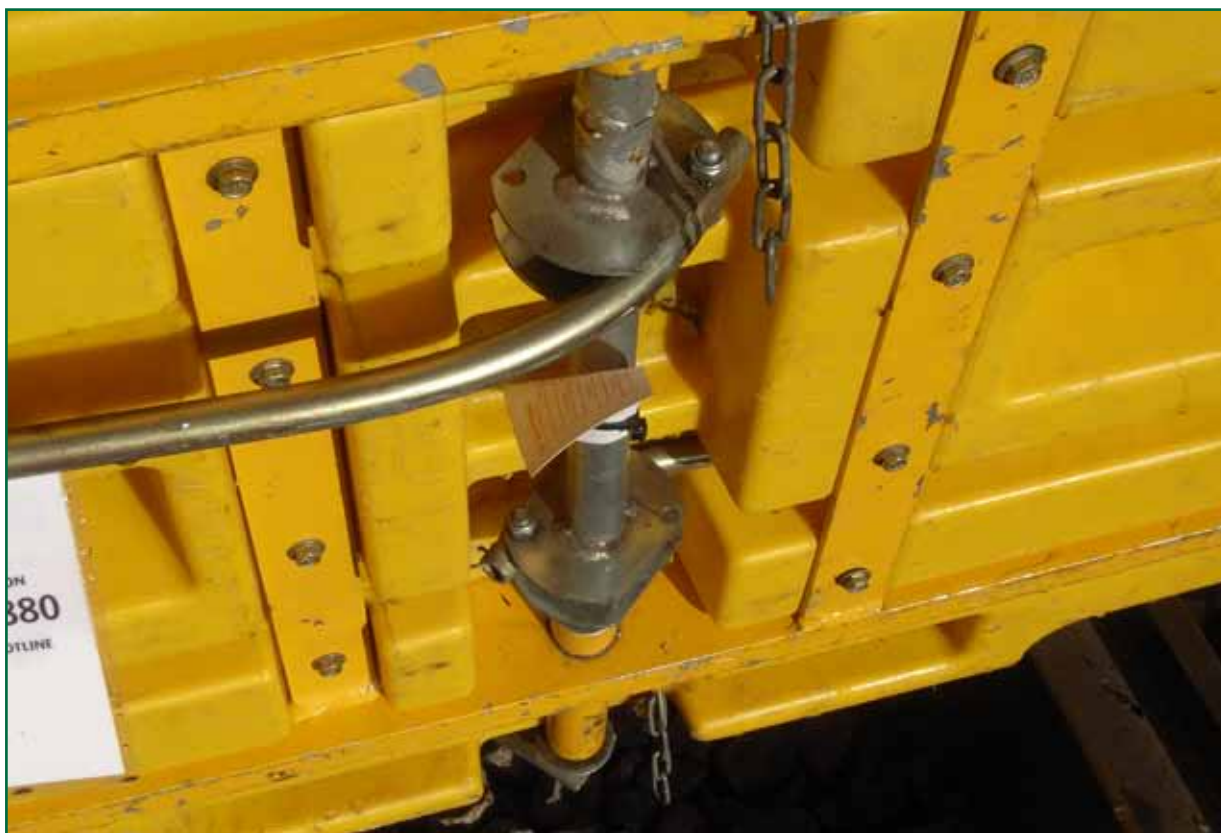
Figure D6: Brake linkage of a trolley from Havant depot, as examined after the incident

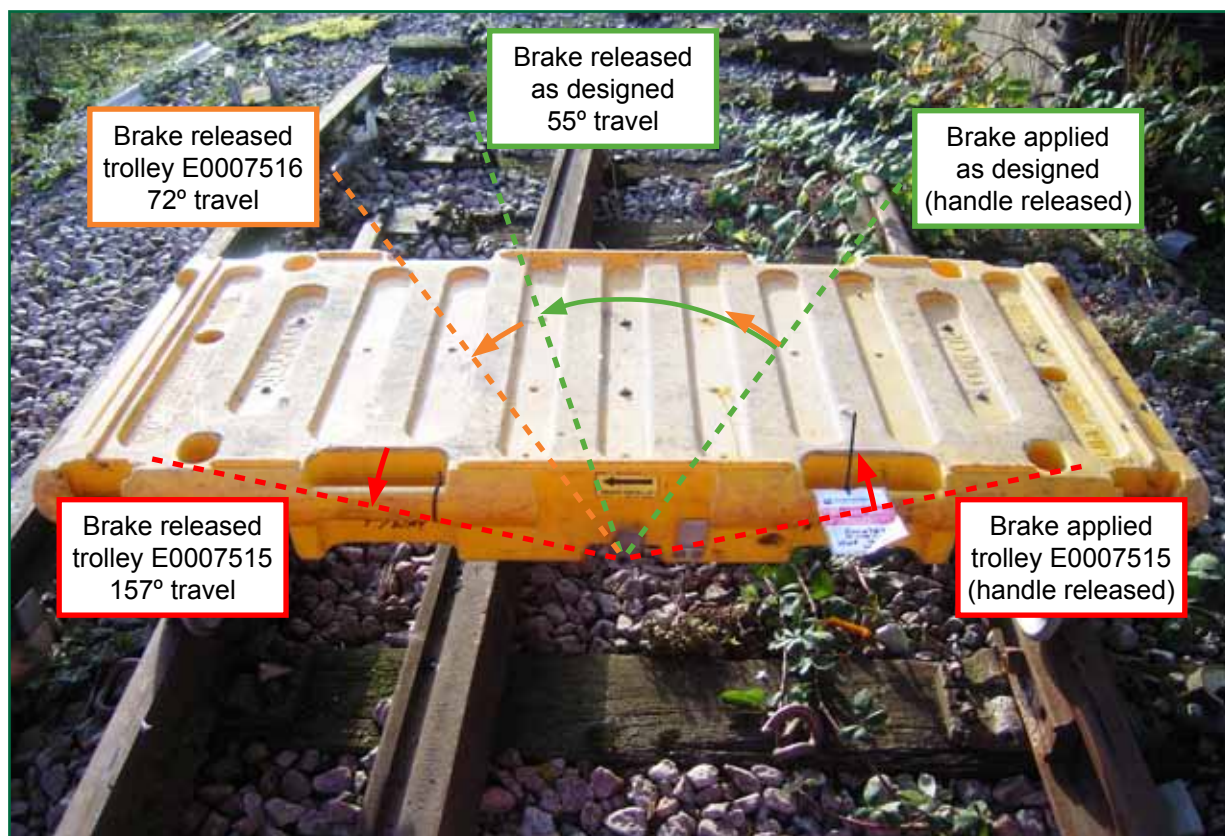
D6 As the pushrods start to bend around the camshaft, the angle through which the handle must then be turned in the correct direction to release the brakes is increased; this probably makes it harder to use the trolley. Testing by the RAIB established that the total angle through which the brake handle had to be rotated to release the brakes (figure D7), including slack in the mechanism, was approximately:

- 72° for the trolley from Reading depot; and
- 125° and 157° respectively for the two trolleys from Havant depot.

Figure D7: Rotation of brake handle required to release the brake

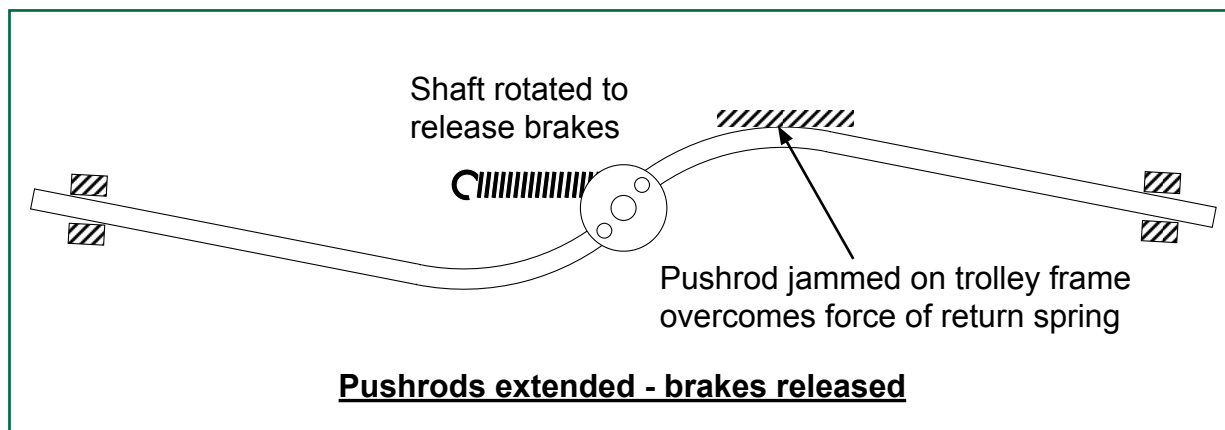
- D7 Where the bending of the pushrods has become extreme, the upper pushrod can rub on the trolley frame. During testing, the RAIB observed that the friction was sometimes sufficient to cause the pushrod to jam and prevent the brakes from applying, figures D8 & D9.
- D8 When the trolleys were examined by the RAIB and Network Rail after the incident it was also found that two of the four securing bolts were missing from one of the brake discs on trolley E0007515, and that a lubricant or release agent had been applied to the surface of the discs. Although these conditions each had the potential to prevent the brakes from applying, neither of them was sufficiently advanced to have done so at the time of the incident. The RAIB did not therefore consider them further in this investigation.

Figure D8: View of the brake linkage showing bent upper pushrod jammed on trolley frame

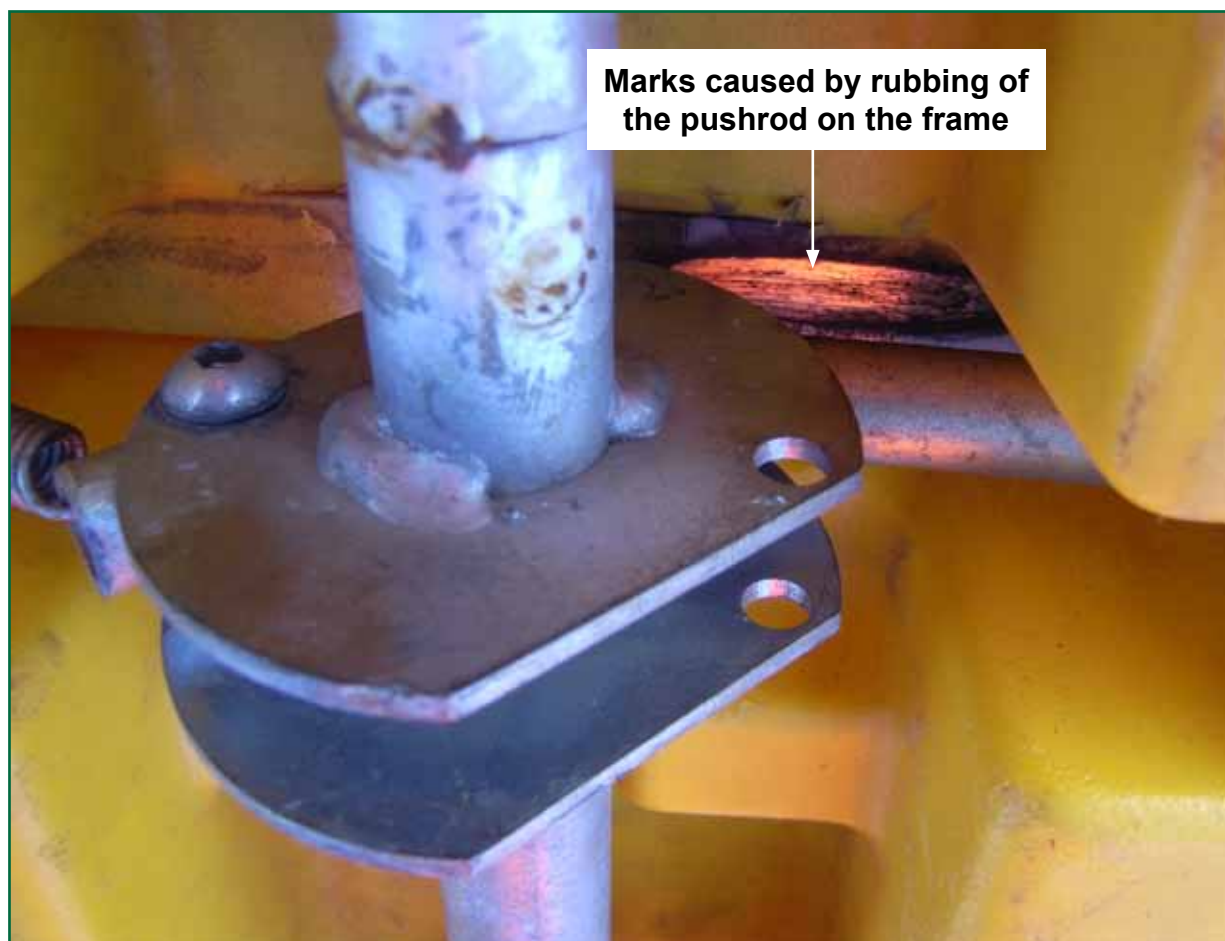
*Figure D9: Close-up of the upper brake pushrod, showing evidence of rubbing on the frame*
