Rail Accident Report

**Fatal accident at Gipsy Lane footpath crossing,
Needham Market, Suffolk
24 August 2011**

Fatal accident at Gipsy Lane footpath crossing, Needham Market, Suffolk, 24 August 2011

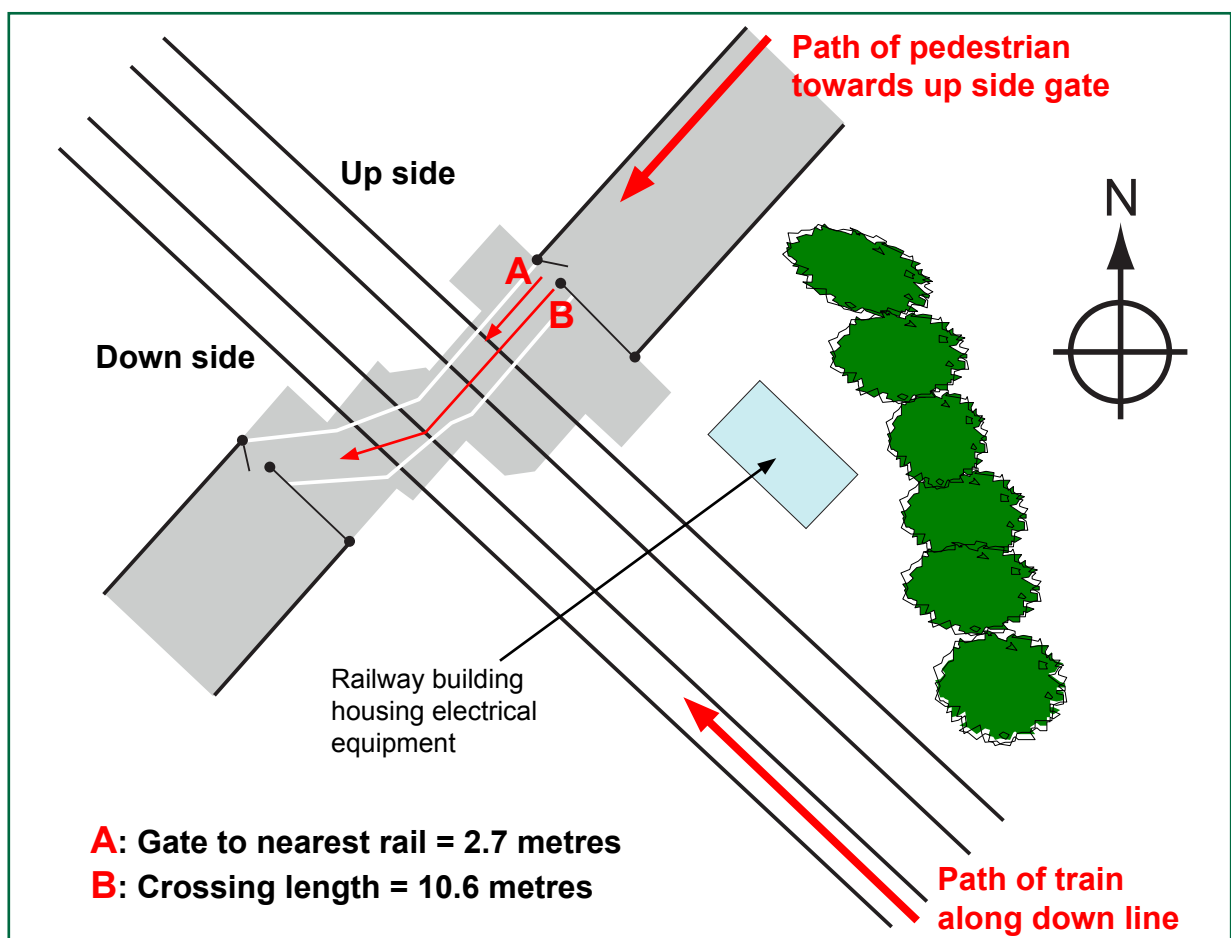
Figure 3: Layout of Gipsy Lane footpath crossing

- 10 Pedestrians have a restricted view of trains approaching along the down line (ie from the London direction) due to line curvature and seasonal vegetation growth. For this reason, a *whistle board* is provided to warn pedestrians of an approaching down train. This is located 396 metres from the crossing.

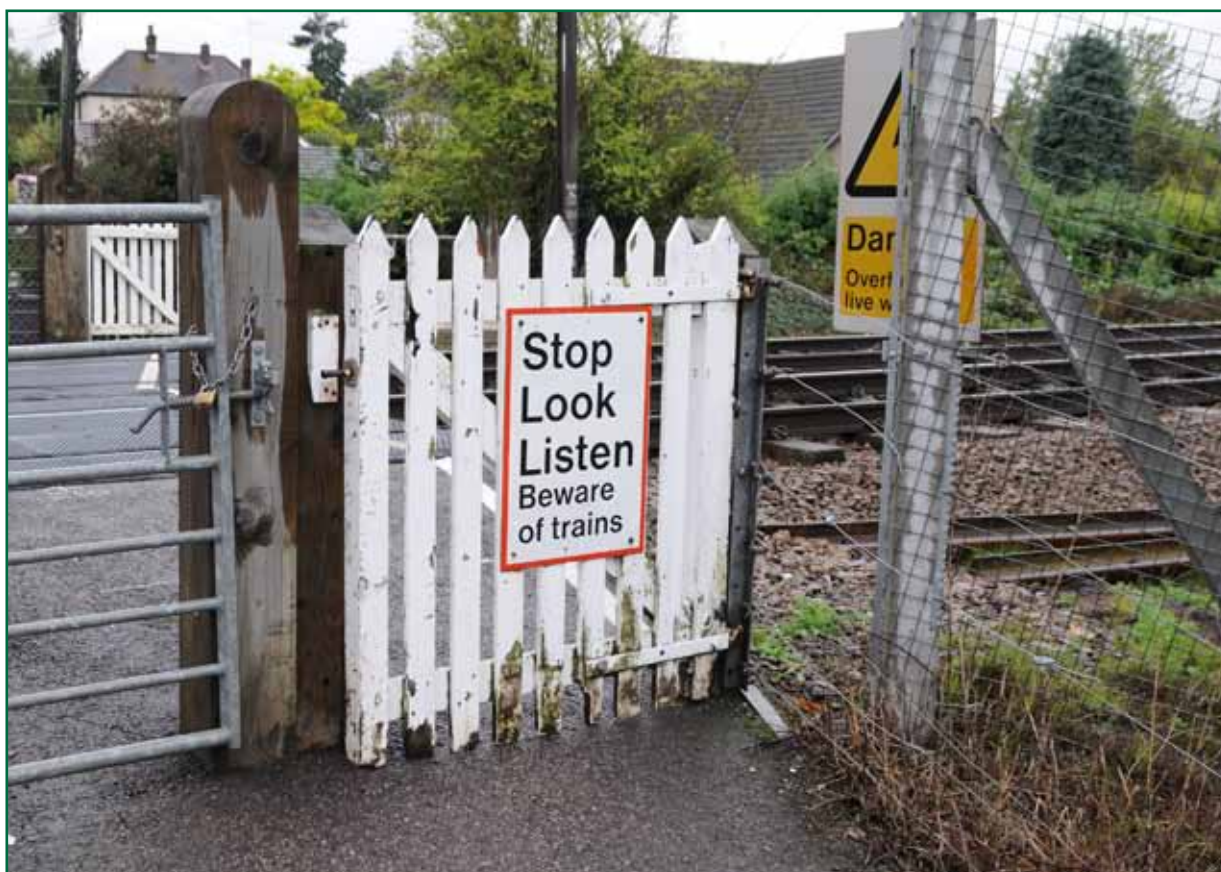
Figure 5: Sign at the crossing gate (view taken from the up side of the crossing - the side from which the pedestrian approached)

- 16 The crossing was fitted with wooden gates on both approaches which opened outwards (ie away from the railway). Signs instructing pedestrians to stop, look, listen and beware of approaching trains were attached to each gate (figure 5).
- 17 The crossing surface comprised rubber panels and asphalt strips. The condition of the crossing surface was not a factor in the accident.

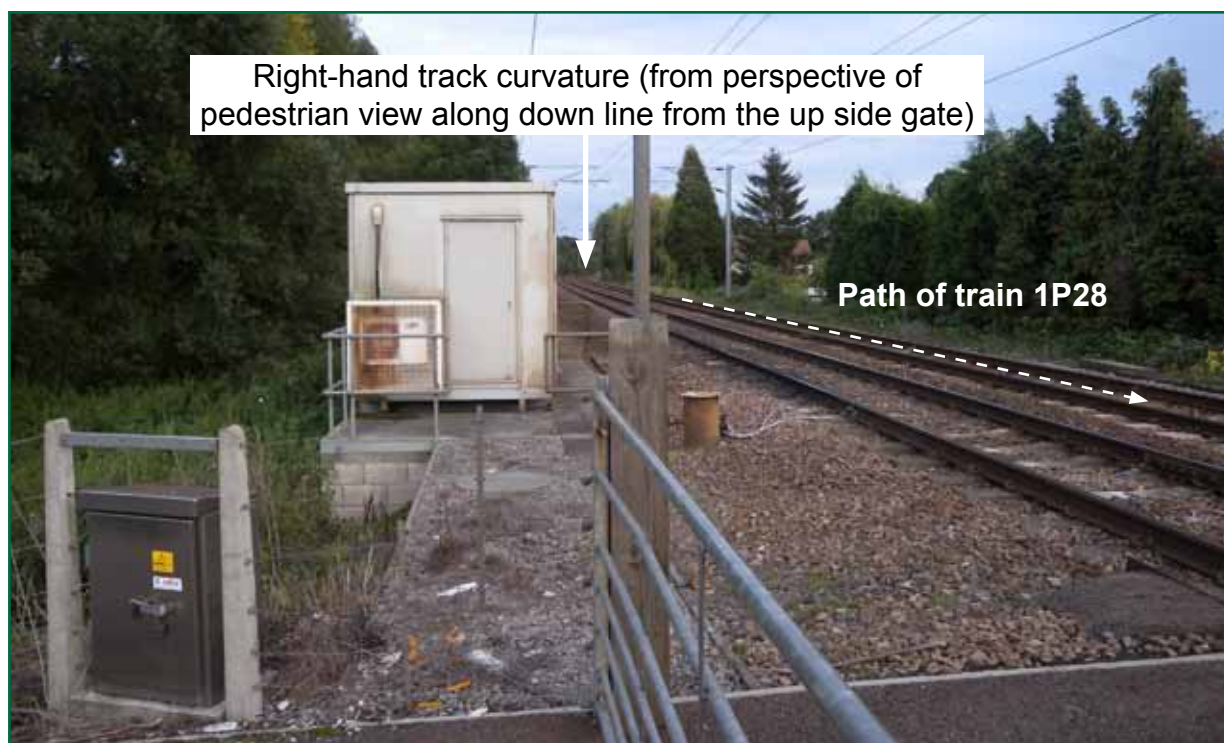
Figure 6: Sighting of down line trains from the up side gate

- 42 The view from the up side gate towards trains approaching on the down line is restricted by line curvature and vegetation. On the day of the accident the *sighting distance*⁹ was recorded as 348 metres using the up side gate as the decision point - see figure 6. In June 2011, Network Rail had assessed that the required sighting distance needed to be a minimum of 448 metres if users were to rely on sighting alone when judging whether it was safe to cross (at this time vulnerable crossing users (see footnote 7) had not been identified and no additional traverse time had been allowed for).

- Required sighting distance on the down line, based on the traverse time and line speed: 448 metres. The available sighting distance at Gipsy Lane footpath crossing was therefore deficient by 58 metres.

- 1 *The intent of this recommendation is for Network Rail to improve the safety of pedestrians at Gipsy Lane crossing.*

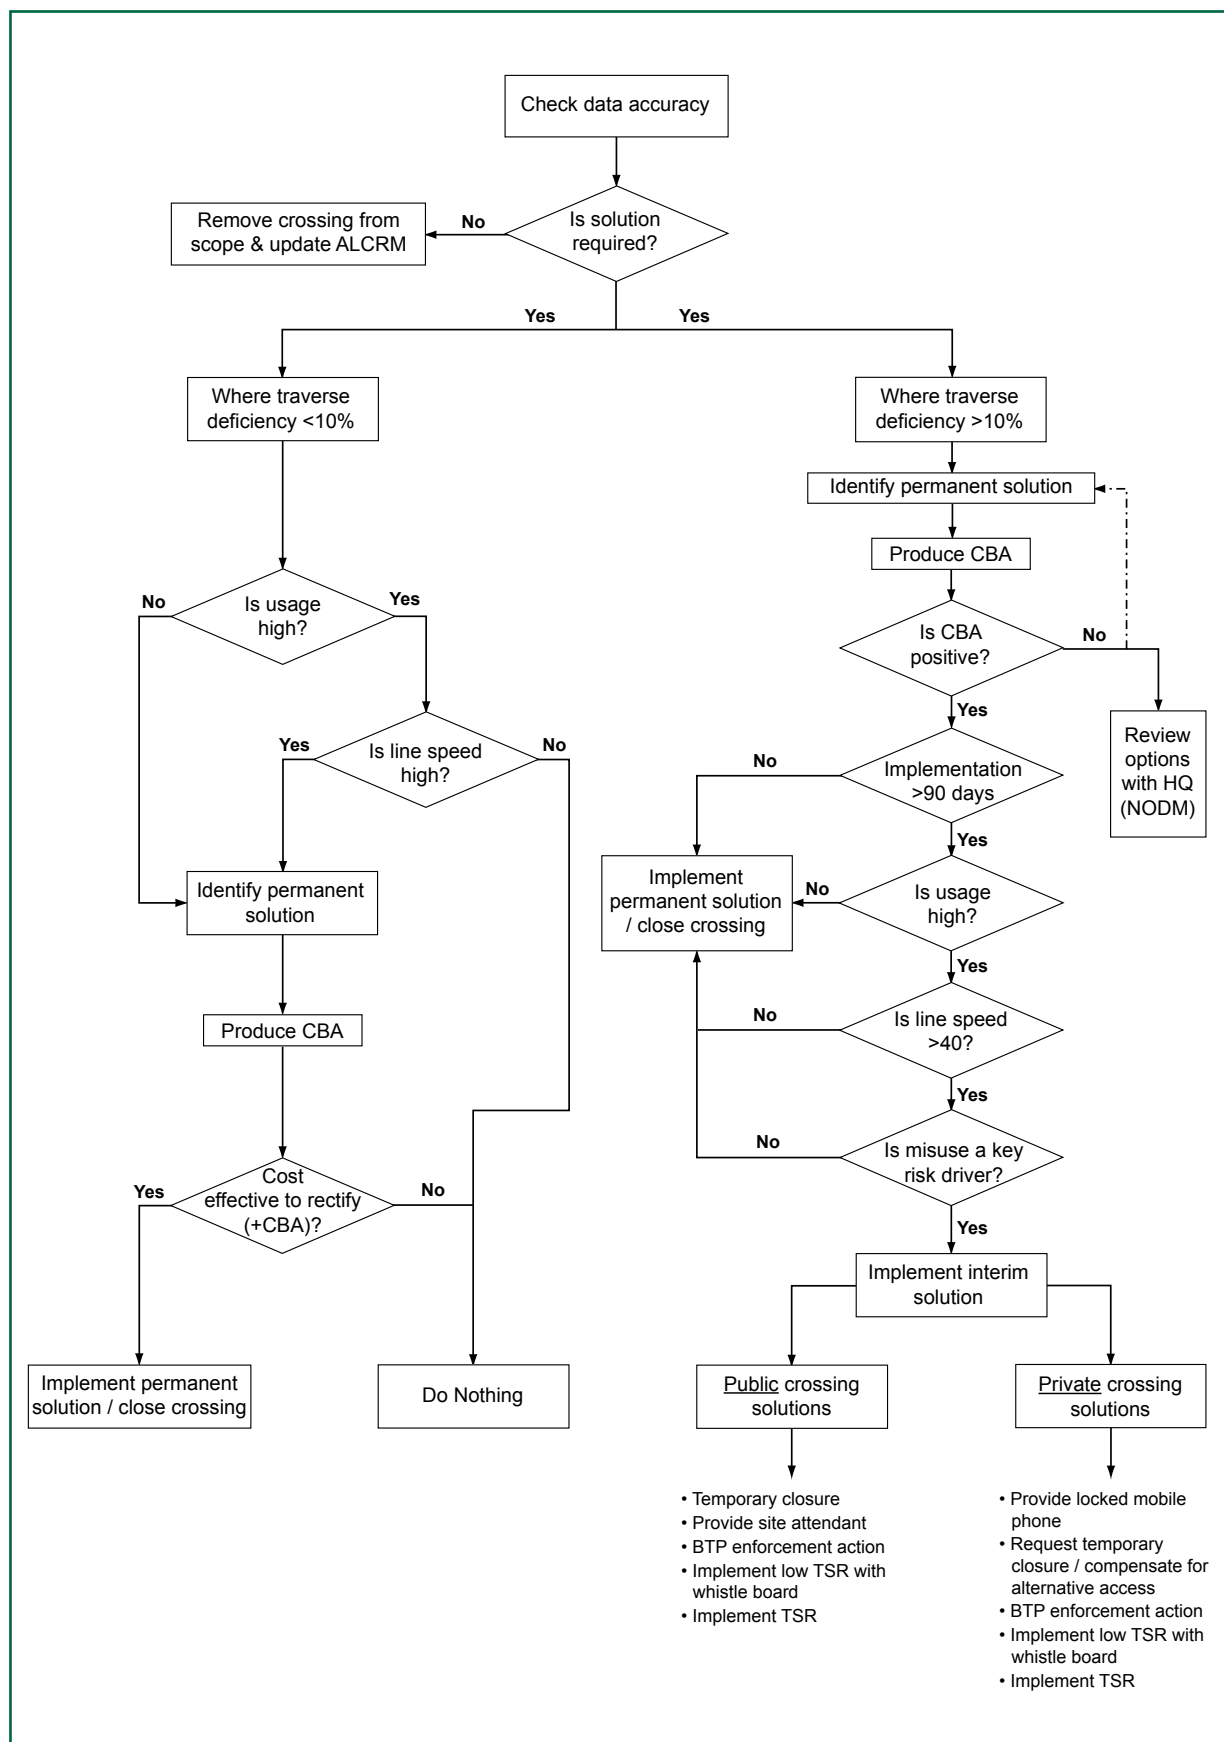
Figure 7: Level crossing decision flowchart devised by the national level crossings team

- 104 The RGM recalled that when the decision flowchart was applied to Gipsy Lane, it did not merit interim mitigation. The crossing had not met the criterion on high usage (figure 6) because the team considered that the June census had shown usage to be low. The quick census at the crossing identified 6 adult users. Using a standard conversion factor the ALCRM calculated that over a 24-hour period 122 pedestrians would use the crossing and that this level of usage was 'large'. However, when the decision flowchart was applied to Gipsy Lane the team defined usage at the crossing as 'low'. Rather than discount interim mitigation at that stage, the assessment was continued, but it was still not possible to reach the 'implement interim decision' box because there was no recent history of misuse at the crossing. For this reason, and for the reasons described at paragraph 96, the RGM stated he did not impose a speed restriction on the down line on the approach to Gipsy Lane footpath crossing.

- 105 The construction of the flowchart made it difficult for users to justify applying short-term mitigation measures. By asking a qualitative question about usage ('is usage high?') there was a risk that the flowchart would be applied inconsistently throughout the nine routes.

- 118 Guidance, in the form of a decision flowchart provided by Network Rail's national level crossings team, sometimes discouraged those involved in level crossing risk management from making short-term changes to reduce risk at crossings such as Gipsy Lane (**paragraph 97, Recommendation 3**).

- 3 *The intent of this recommendation is for Network Rail to develop guidance for use by the level crossing teams on the circumstances under which short-term mitigation measures are to be implemented at level crossings that have insufficient sighting or warning of approaching trains (paragraphs 117d, 117f, 118 and 119d).*

- a clear definition of what constitutes a 'higher than usual' number of vulnerable users;
- implementing risk-reduction measures at crossings that have deficient sighting or warning times; and
- when speed restrictions must be imposed, what type of speed restriction is to be used (emergency, temporary or permanent) and the timescales for imposing speed restrictions.
