Rail Accident Investigation Branch

Rail Accident Report

Track worker struck by a train at Stoats Nest Junction 12 June 2011

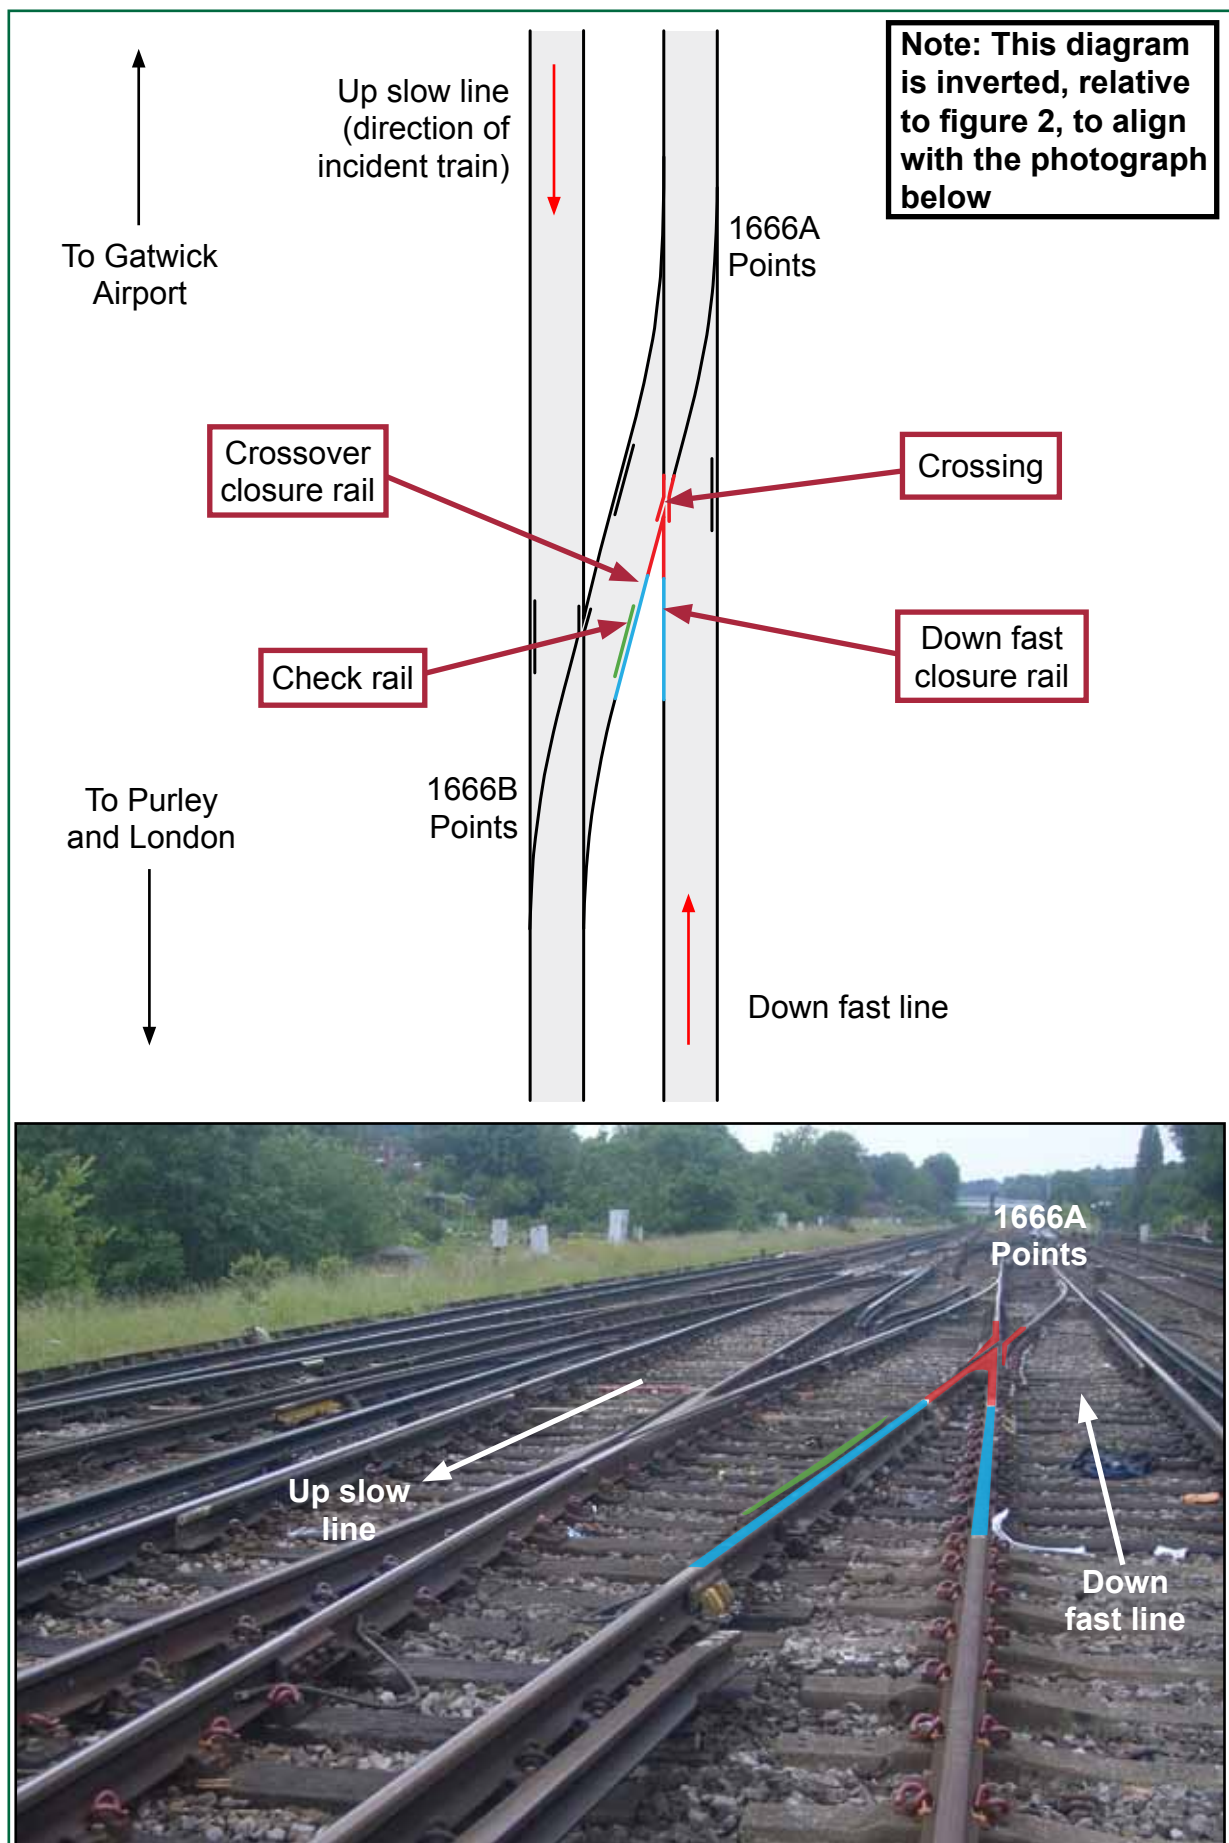
Figure 3: Crossover detail at Stoats Nest Junction

- 39 Initially, the gang removed the rail fixings and cut out the cracked crossing section, in preparation for lifting out and replacement.
- 40 Two RRVs were used to bring the replacement crossing piece to site, from near Purley, along with two lengths of *closure rail* that had been cut to length to accommodate the new crossing assembly (figure 3).

- 85 By this time the welds on the down fast line closure rail (figure 3) were under way, and the track workers were preparing to clamp the crossover closure rail into position so that the up slow line could be handed back on schedule. Although this meant that the crossover would only be able to be used at low speed, the fact that it normally had a 25 mph (40 km/h) speed restriction meant that this would cause no disruption.
