# Rail Accident Report

## Container train accident near Althorpe Park, Northamptonshire 18 July 2011

# Container train accident near Althorpe Park, Northamptonshire, 18 July 2011

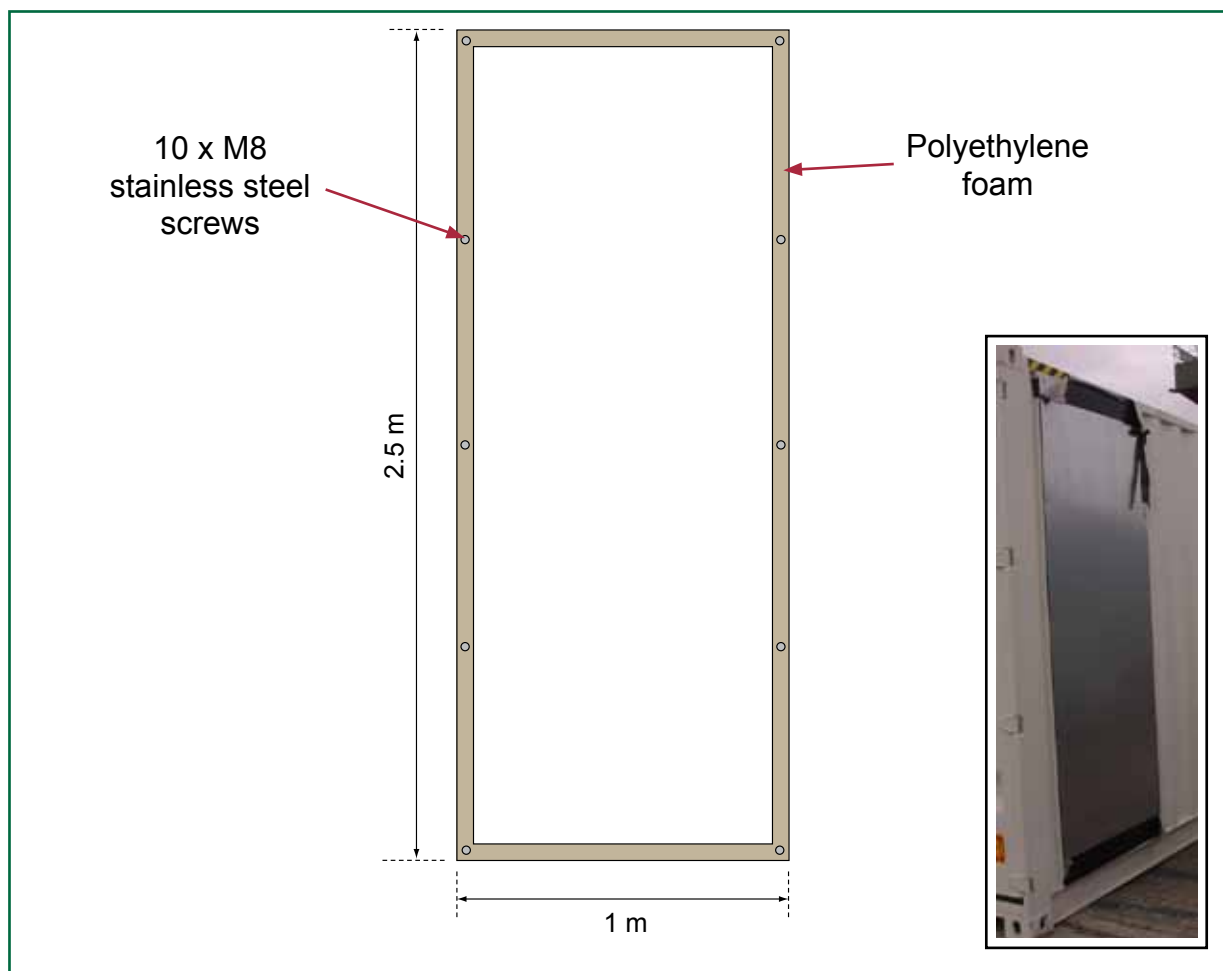
- 23 The transit plates were fixed to the container side by two vertical columns of five near-equally-spaced bolted joints<sup>2</sup>, each comprising an *M8* stainless steel screw screwed into a *threaded insert*. Figure 5 shows a diagram of the arrangement, and also a photograph of a plate that remained attached. The threaded inserts, essentially threaded metal tubes, were secured into holes in the container sidewall by a special tool. This tool was used to pull the far end of the tube and *cold form* it tight against the rear surface of the container sidewall (figure 6). The screws had a button head with a special hexagonal socket to make them resistant to tampering (figure 6 inset). To improve sealing, a 50 mm wide strip of 6 mm thick polyethylene foam was fixed around the perimeter of the plate. Tightening the screws made the transit plates compress the foam against the container side.

Figure 5: Transit plate attachment arrangement. Inset shows the transit plate that remained attached to container CPIU 9006609 (the black adhesive tape was applied after the accident)

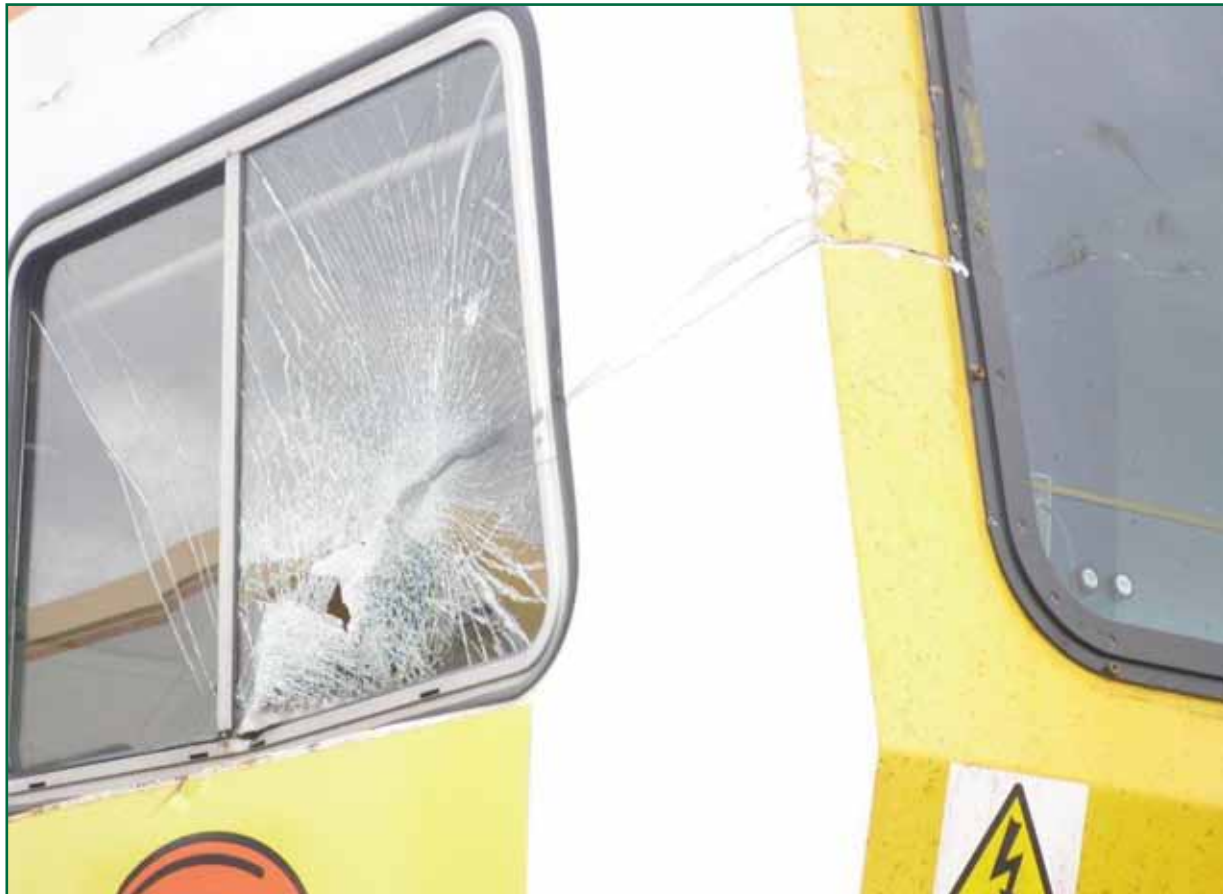
- 35 The tamper driver was uninjured, but his cab was damaged by the impact and the side window was smashed (figure 9). The impact also caused some damage to other parts of the tamper. After starting to drive the tamper forward to Rugby, he stopped again to report that there was debris in the up Northampton cess that looked similar to the metal that had earlier struck his machine.

Figure 9: Damage done to the driving cab of the tamper (photograph courtesy of Colas Rail)

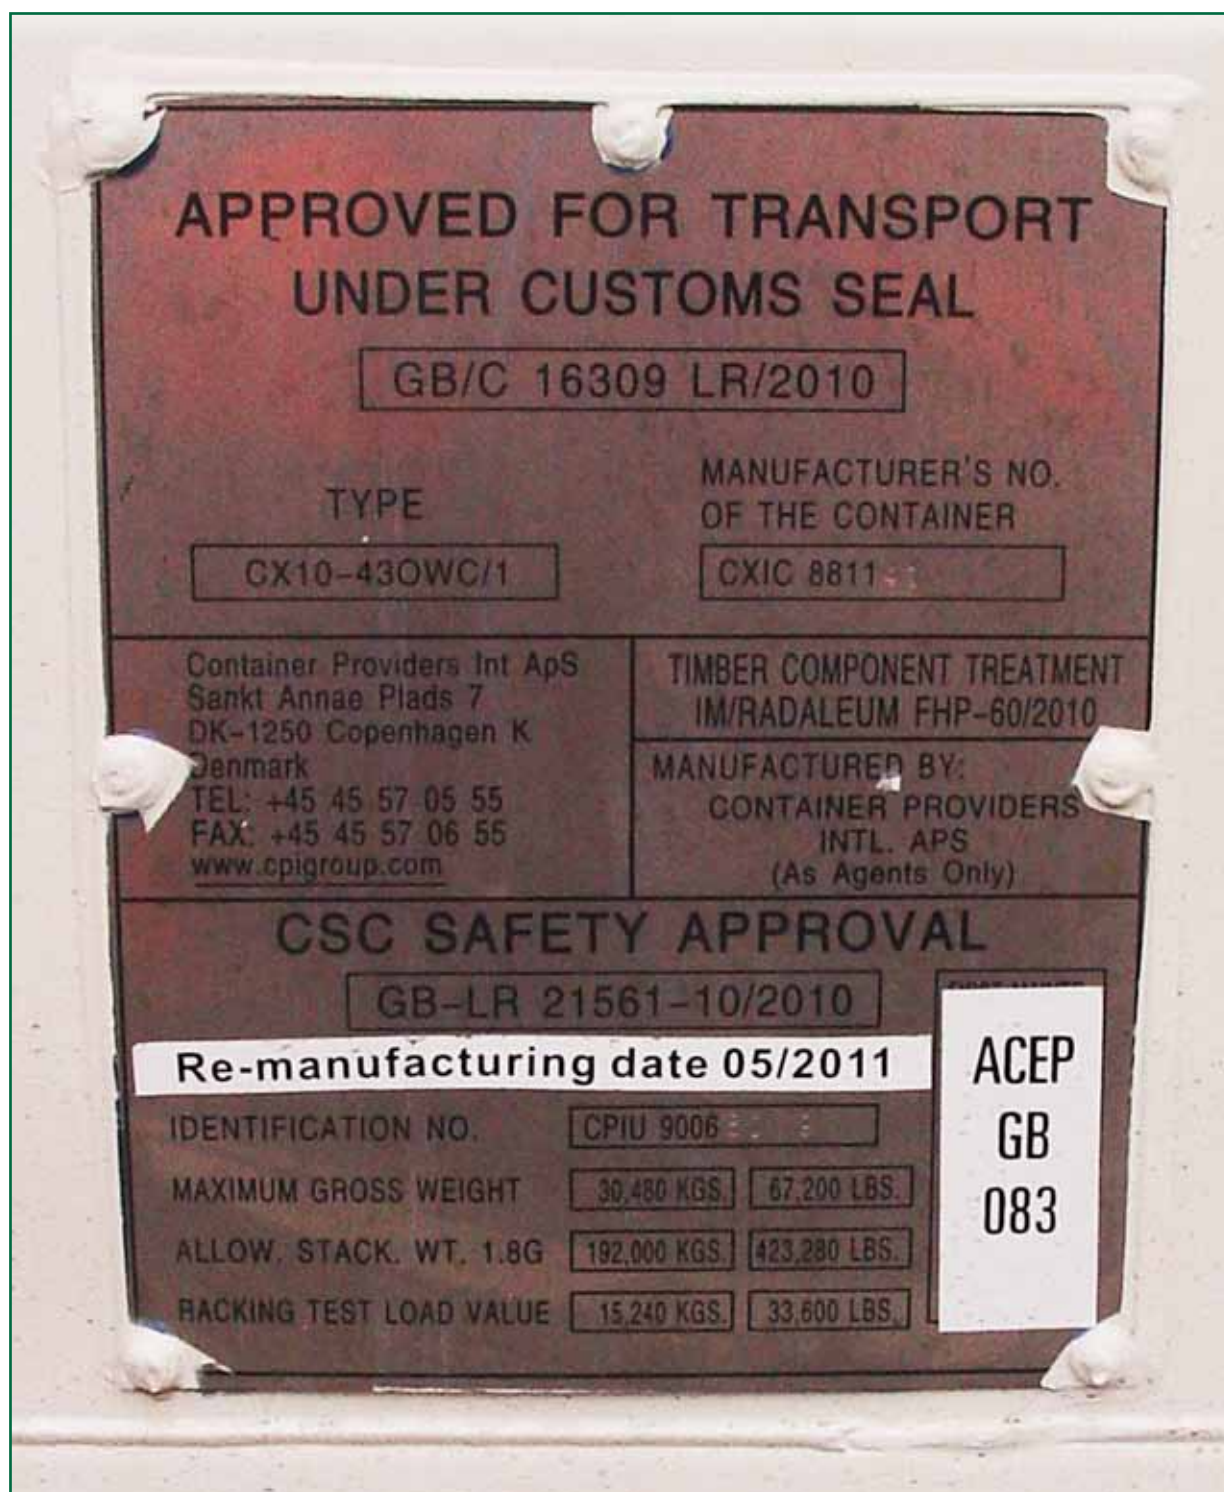
Figure 10: Safety approval plate fixed to container CPU 9006609. The RAIB understand that the white decal, entitled 'Re-manufacturing date 05/2011', was affixed when the container was modified (paragraph 20). Note: Recognised by the CSC as acceptable practice, the safety approval plate has been grouped with other official plates on one base plate

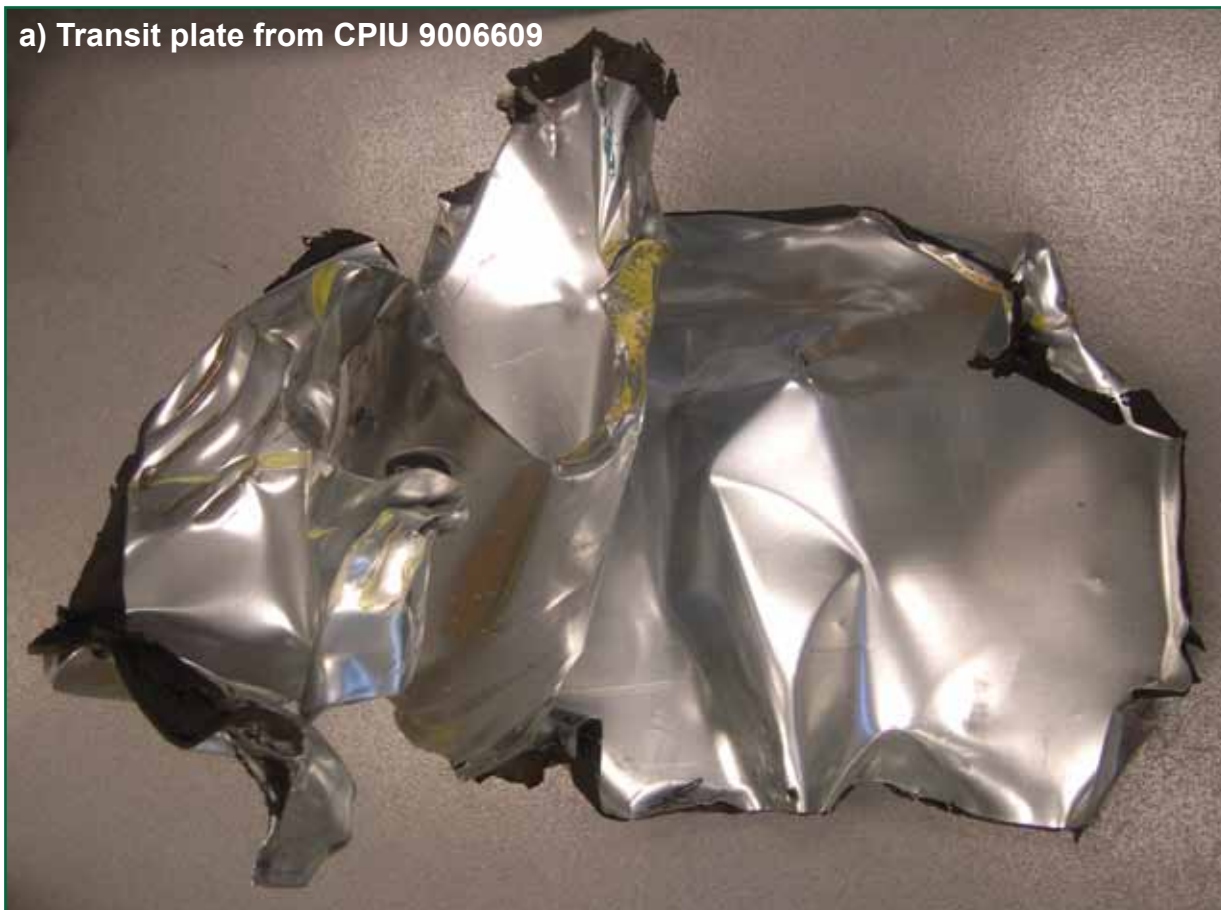
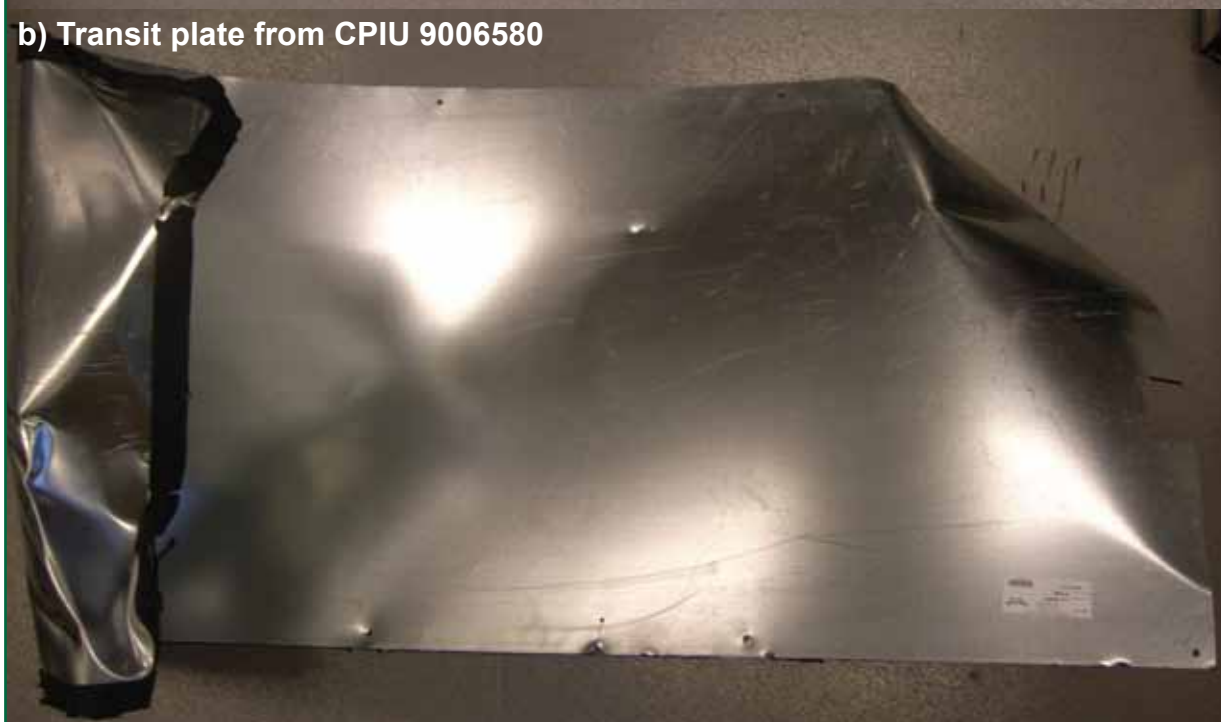
- 60 **The immediate cause of the accident was that screws, which were securing the transit plate on the right-hand side of container CPIU 9006609, came loose enabling the upper part of the transit plate to detach and, because of its flexibility, infringe the path of the approaching tamper.**

- 61 The following evidence supports this:
- the six uppermost screws used to secure the transit plate were missing when the RAIB examined the container after the accident;
  - the six uppermost threaded inserts remained in place and in good condition; there were no broken screw parts in any of them; and
  - the distressed state of the lower screws, and their threaded inserts, and the evidence of pull-through distortion around the lower holes on the transit plate.
- 62 The above evidence is consistent with the tamper driver's account of the upper part of the transit plate 'flapping' as he approached train 4L68 (paragraph 33). It was then torn from the lower screws in the impact.

Figure 11: The transit plates that detached from containers CPIU 9006580 and 9006609 on train 4L68

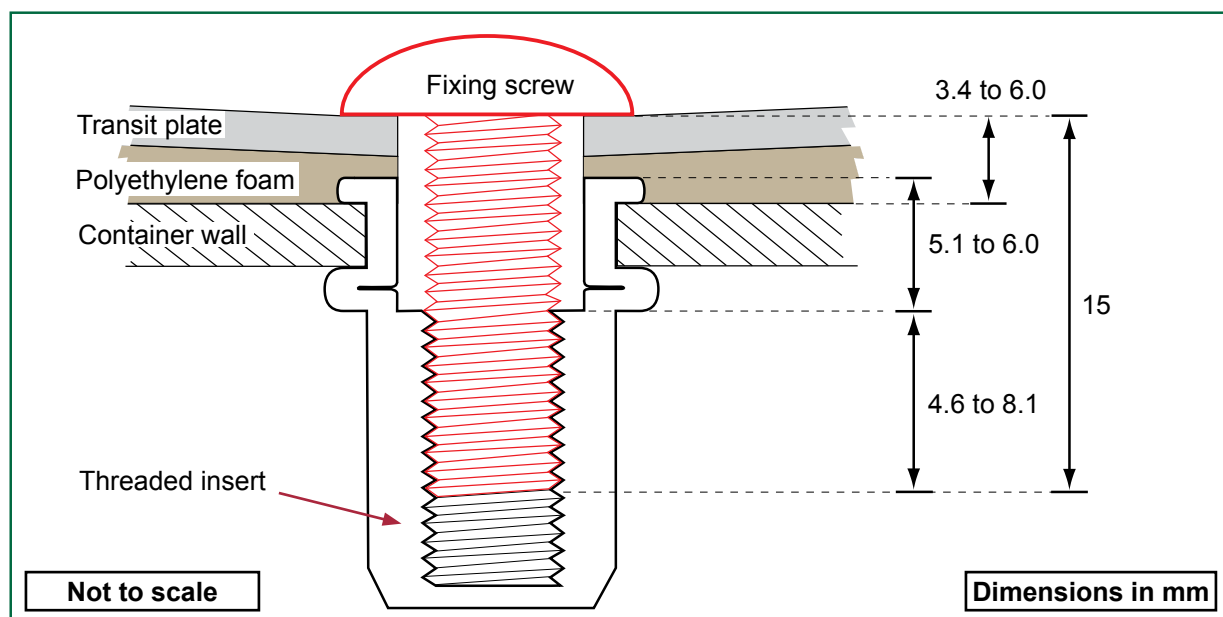
- 58 As there were no design drawings (paragraph 54), the dimensions shown in figure 12 have been derived from measurements and component datasheets.
- 59 Figure 12 represents the condition just after screw tightening. The RAIB found evidence of light score marks around some of the fixing holes on the transit plates to indicate that the screws had been tightened. However, it is not possible to be certain of the extent of tightening since torque values were neither prescribed nor measured. The range of the dimensions shown and the degree of compression of the polyethylene foam, which ultimately affect the degree of screw engagement in the threaded insert, are due to this lack of certainty.

Figure 12: Cross-section through a typical bolted joint used on CPIU 9006609

- 63 **The loosening of the screws securing the transit plate was initiated by a loss of *preload* in the bolted joints as a result of continued compression of the polyethylene foam after tightening. This was a causal factor.**

The Health and Safety Executive should issue a safety bulletin to make manufacturers and users of converted freight containers aware of the need for a competent assessment of the adequacy of bolted joints, which are used to secure exterior attachments, when designing, modifying or repairing containers. It should also ask the organisations authorised to approve containers to cascade this information to their clients (paragraphs 102a and 102b).
