Rail Accident Report

**Derailment at Princes Street Gardens,
Edinburgh
27 July 2011**

Derailment at Princes Street Gardens, Edinburgh, 27 July 2011

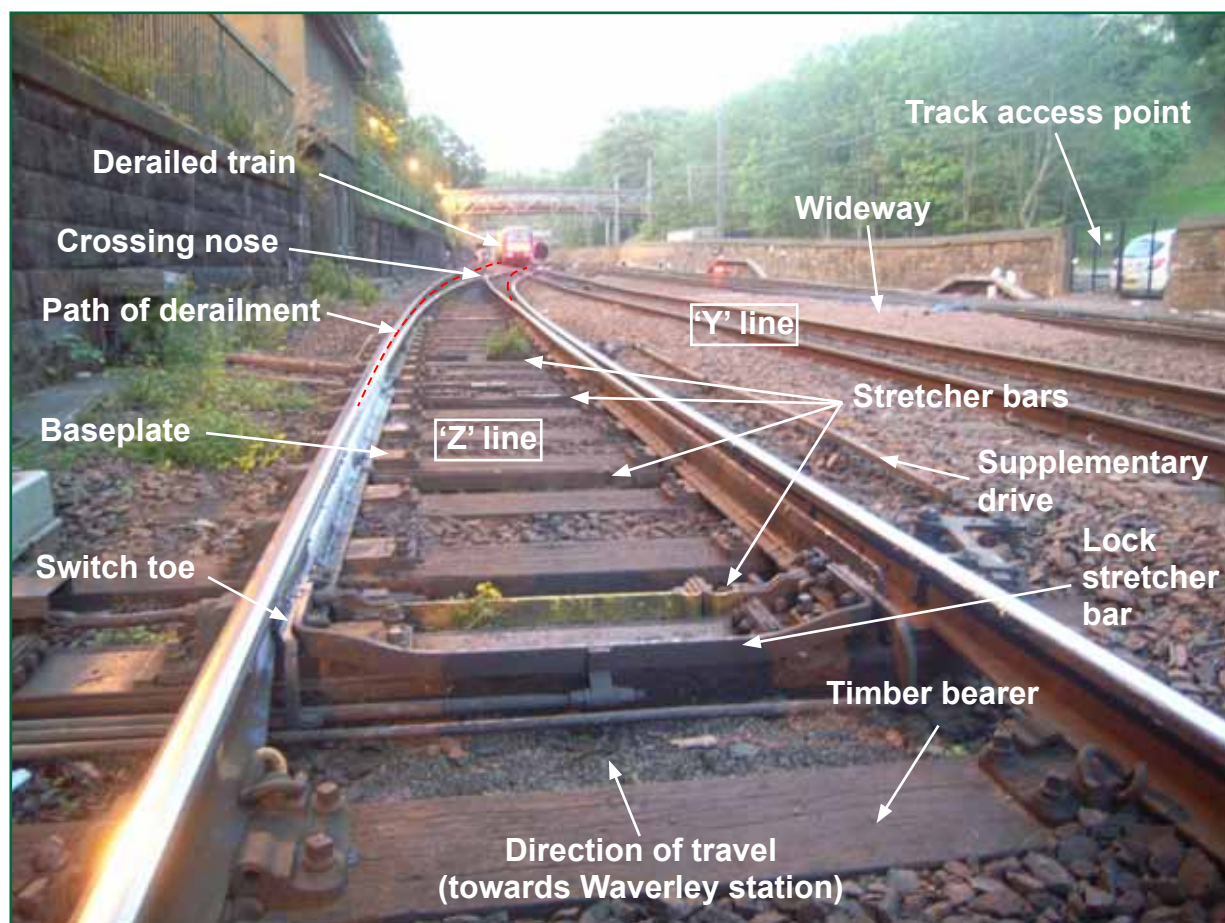
Figure 3: Points 167B

- 6 The driver and conductor, who were the only occupants of the train, were uninjured. The derailment caused damage to points 167B and to two further sets of points beyond, which were in the path of the derailed wheels. The track was pulled out of alignment where the derailed *bogie* was drawn across it and there was damage to track fixings and *bearers*, signalling cables and to a drainage pit. The train also suffered significant damage to the bogie and underframe equipment, and to the connecting corridor between the second and third cars. A significant spillage of oil from the final drive gearbox, which is situated on the trailing axle, occurred at the *crossing nose* (figure 3).

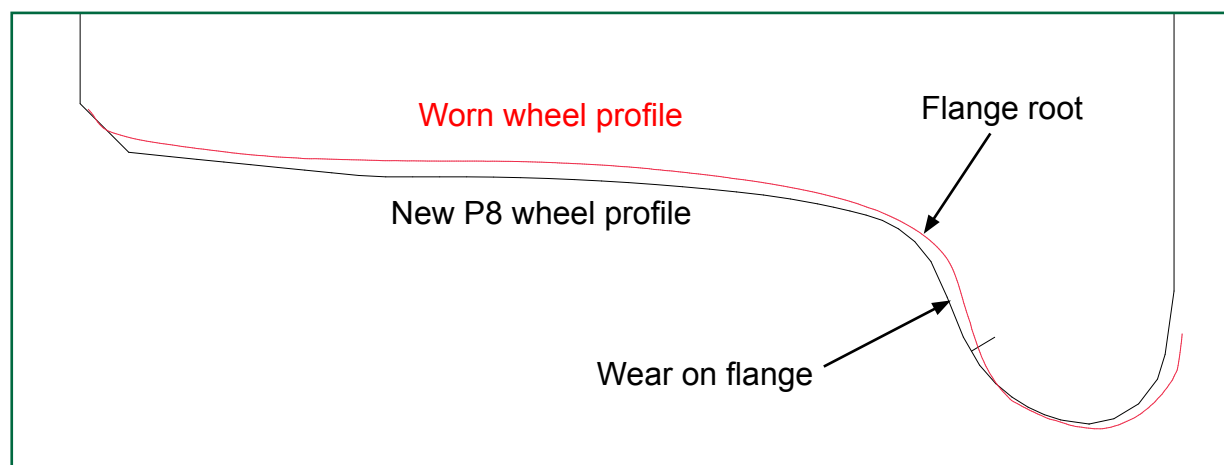
Figure 6: Wear to the flange thickness on first wheel to derail compared with new P8 wheel

- 49 Measurements taken by Network Rail of the train's wheel dimensions showed that the first wheel to derail, the leading left-hand wheel on the leading bogie of the third coach, had around 2 mm of wear to the wheel flange thickness, with minimal wear to the wheel *tread*. All other wheels on the train showed a similar pattern of wear, although the first wheel to derail had marginally the thinnest flange. The flange thickness of this wheel was, however, well within the limits provided by the Railway Group Standard (paragraph 16) measuring 26.1 mm compared with the minimum limit of 24 mm.
- 50 The wear to the flange occurred in the flange root area (figure 6).

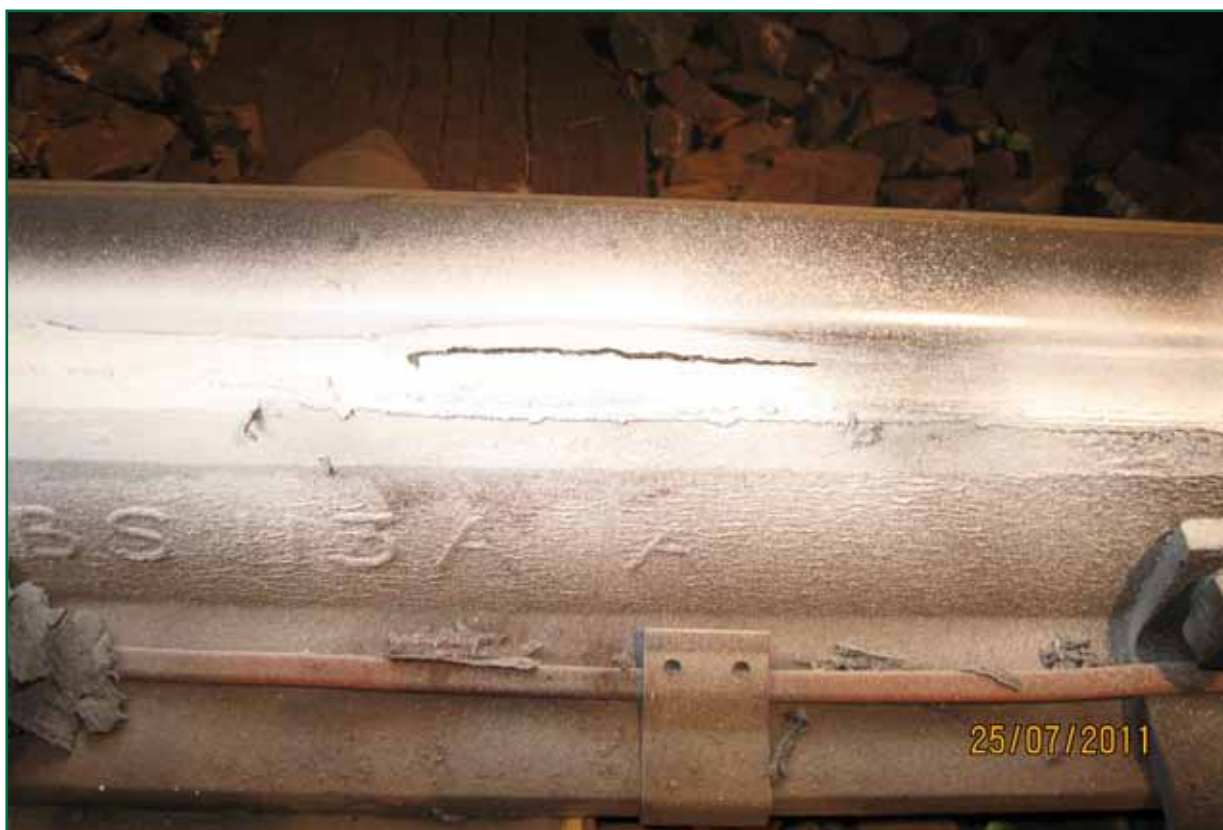
- 86 The former GSM and the grinding technician reported to the RAIB that they were shocked by the condition of the left-hand switch rail. The grinding technician described it as one of the worst switches he had seen on a main line. He noted that it was very low relative to the stock rail in the first metre but with no damage in this area. When he stripped the lubrication from the switch rail he also noticed a previously unidentified crack about 140 mm long, starting approximately 1.5 metres from the toe and running close to the top of the switch rail (figure 7). Although the grinding technician was unsure about whether the switch was repairable by grinding, work proceeded to attempt to restore a profile that would pass the TGP8 gauge and to remove the crack.

Figure 7: Crack in left-hand switch rail of points 167B at 1.5 metres from switch toe

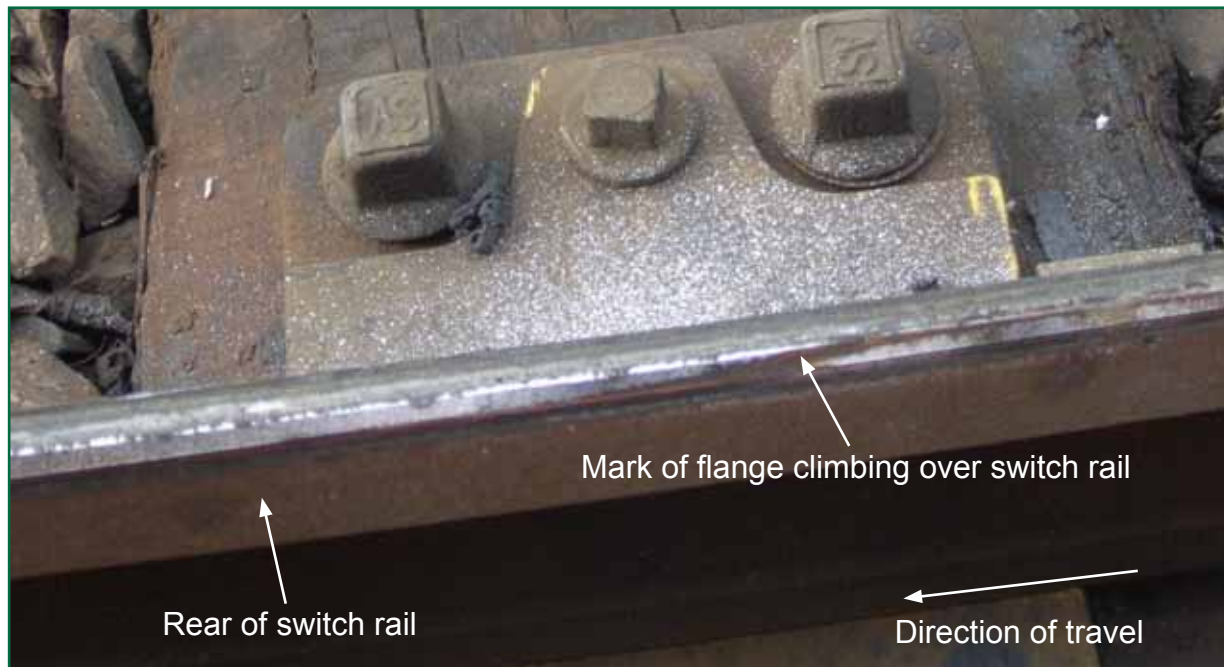
- 94 Marks on the switch rail and damage to switch components and bearers were consistent with the leading left-hand wheel of the third coach climbing over the switch rail at a point 2.8 metres from the switch toe (figure 8), deflecting the switch rail towards the four-foot and dropping down between the switch and stock rails. This pulled the corresponding right-hand wheel into contact with the open right-hand switch rail and squeezed the switch rails together, damaging the third and fourth stretcher bars. The right-hand wheel of the leading axle was subsequently pulled into derailment, dropping between the right-hand stock and switch rails, approximately 14 metres from the switch toes.

Figure 8: Witness mark of wheel flange climbing over switch rail at 2.8 metres from switch toe

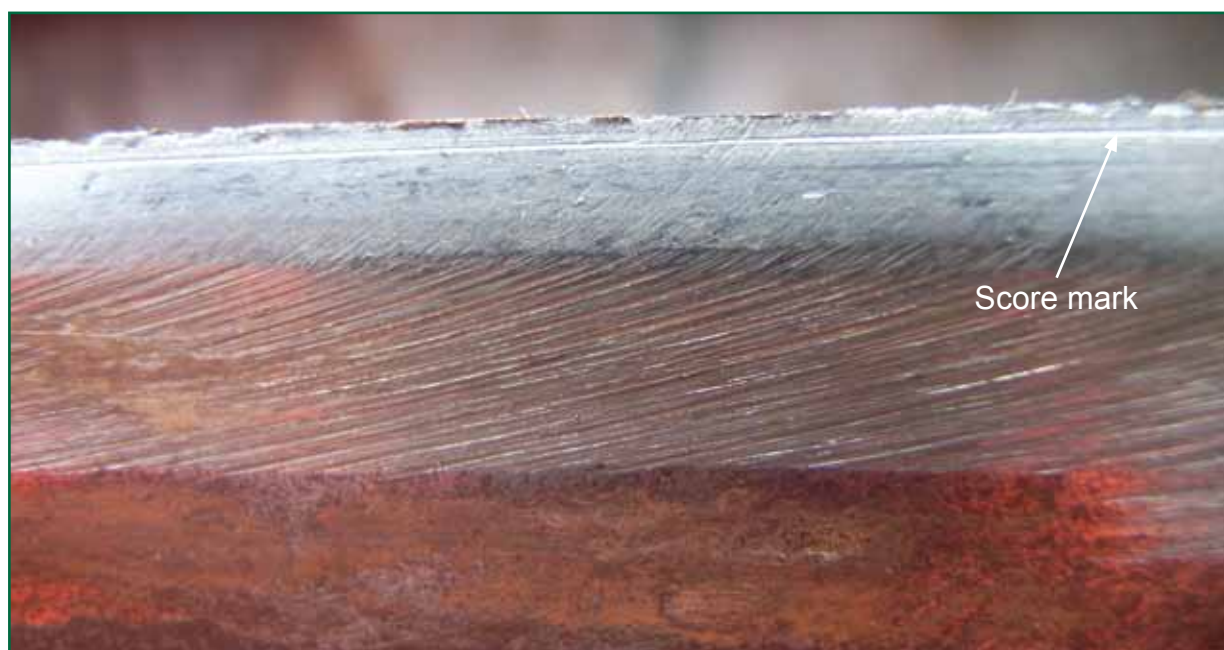
Figure 9: Score mark close to top of switch rail and marks left by grinding

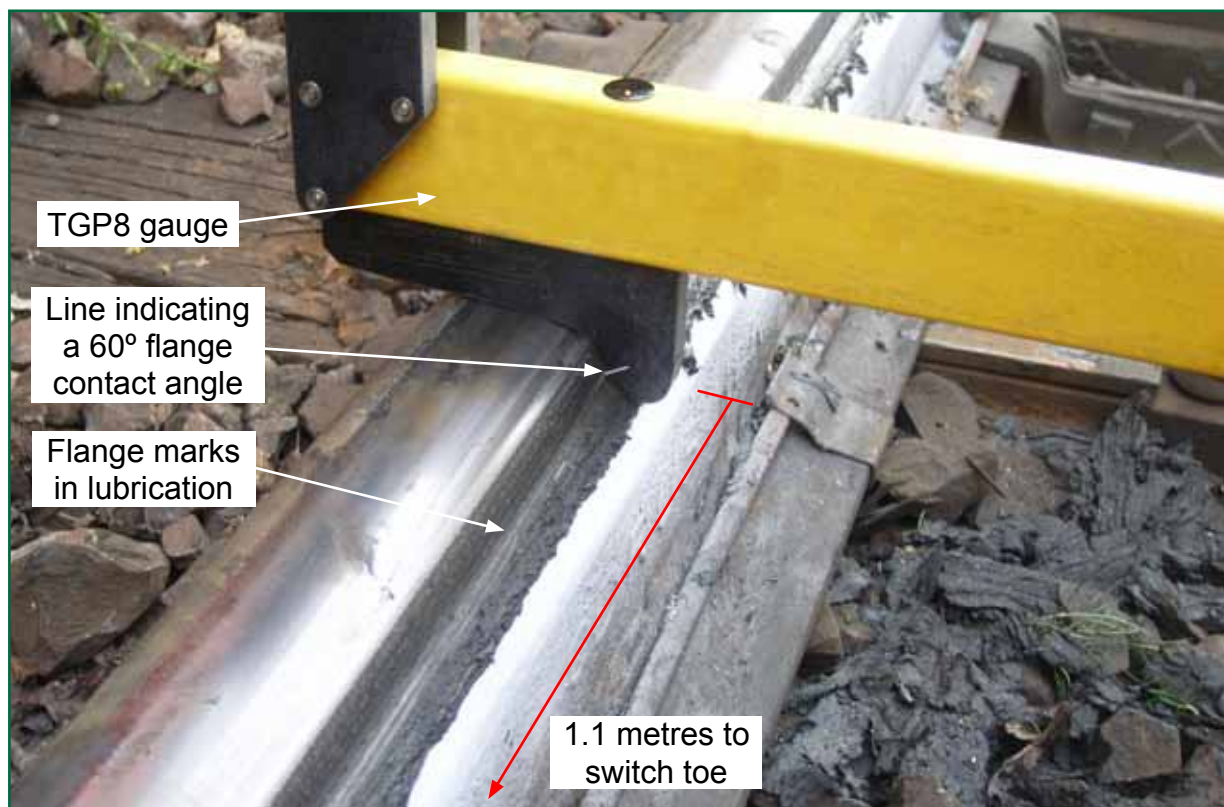
- There were marks observed at the top of the switch rail starting around 1.1 metres from the switch toe, in the area where the switch rail was found to be non-compliant with the TGP8 gauge (figure 10), and becoming more prominent around 1.7 metres from the switch toe. Figure 11 shows a TGP8 gauge placed on markings on the switch rail to replicate the likely position of wheel flanges when they made these marks. There were also at least two running bands on the switch rail starting in this area.

Figure 10: TGP8 gauge applied to left-hand switch rail of points 167B 1.1 metres from the switch toe

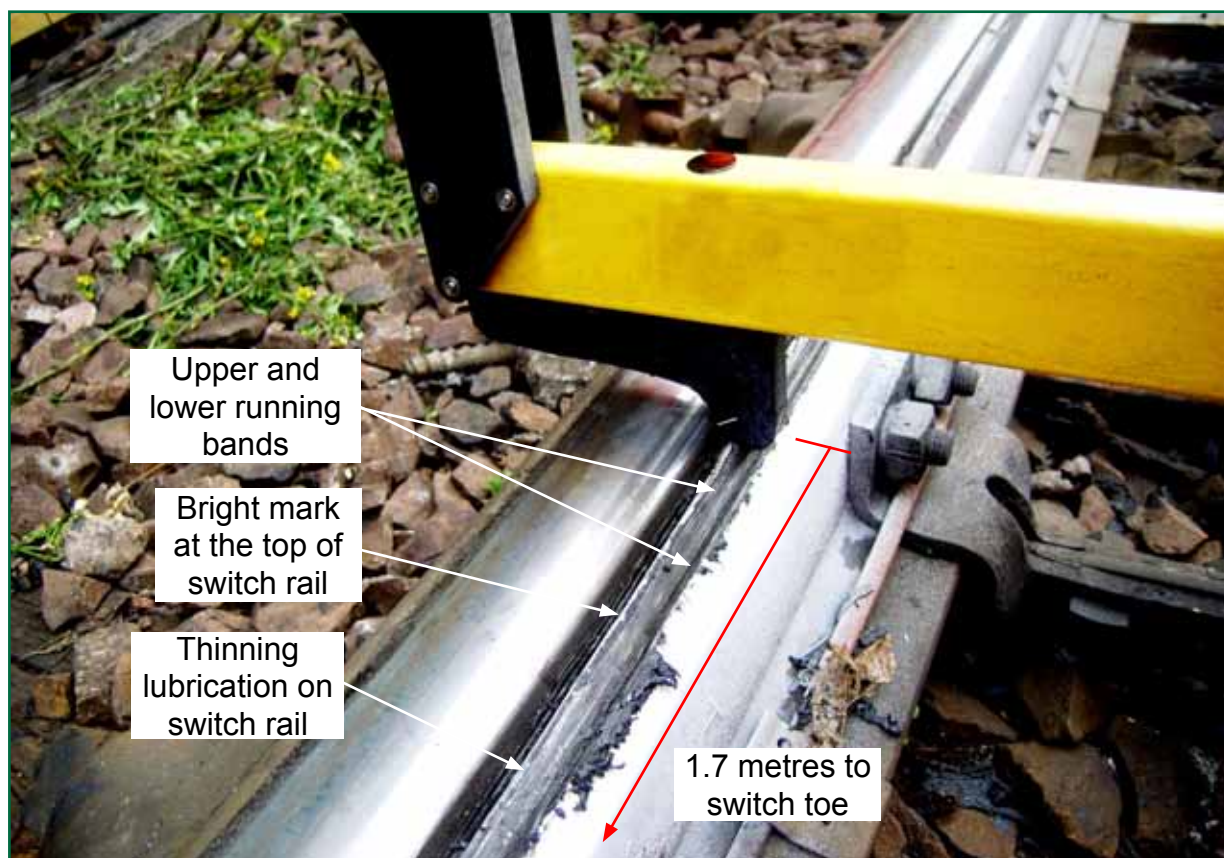
Figure 11: TGP8 gauge applied on markings on left-hand switch rail of points 167B 1.7 metres from the switch toe

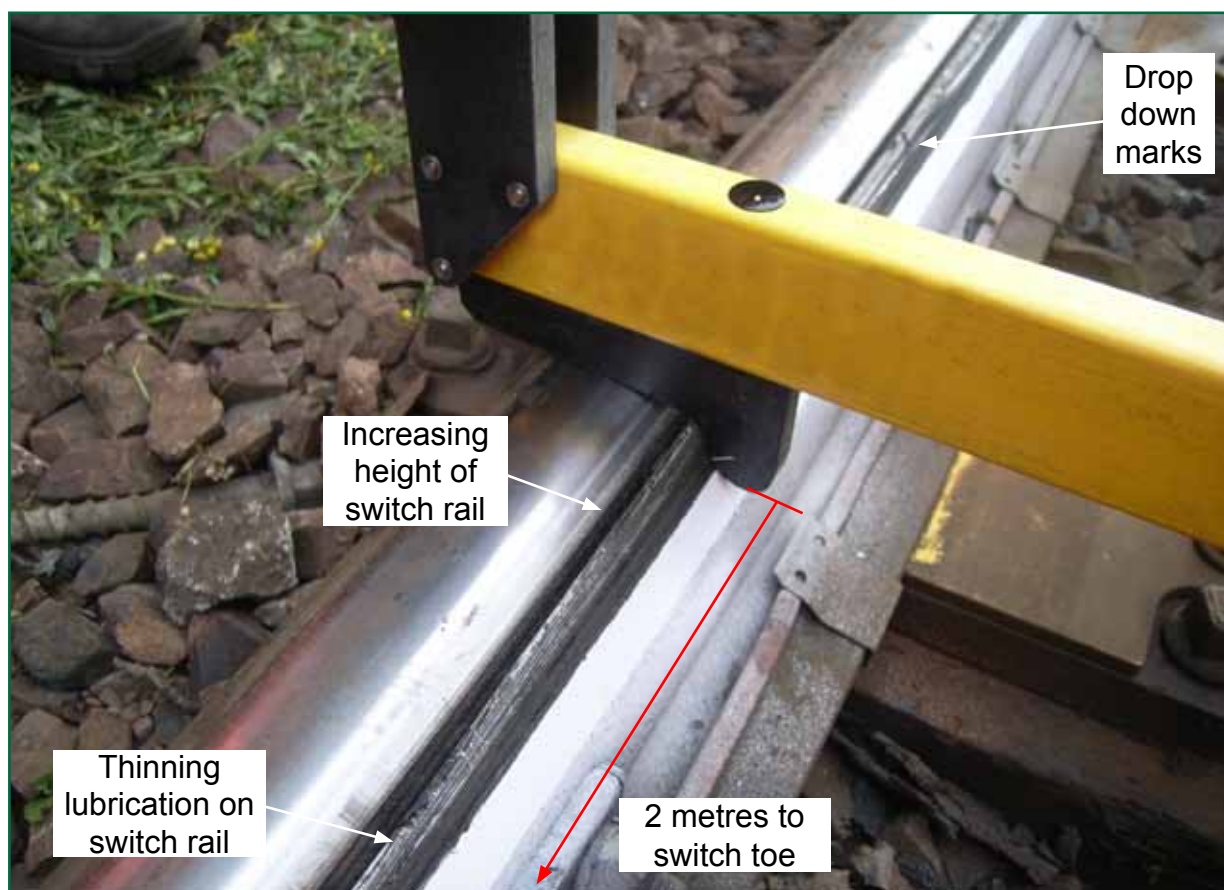
- From around 2 metres from the switch toe there was an emerging pattern of flange markings left by wheels taking a rising path on the switch rail, coincident with the increasing height of the switch rail. There were also distinct marks of flanges having dropped down the gauge face from the higher to lower running bands. At least six 'drop down' marks were observed on the switch rail, indicating that other wheels had tried to climb the switch rail (figure 12).

Figure 12: TGP8 gauge applied to left-hand switch rail of points 167B 2 metres from the switch toe

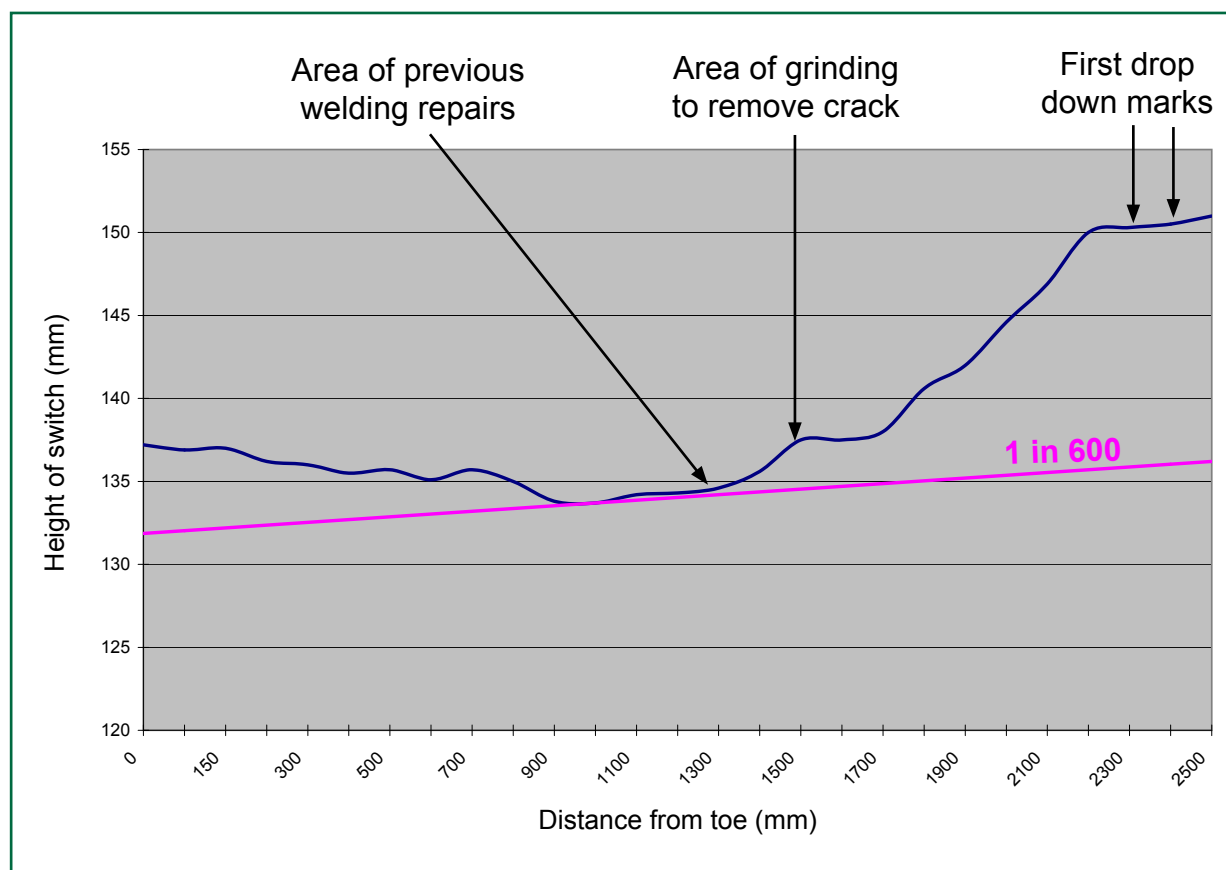
Figure 13: Points 167B - profile of top of switch rail

108 Grinding the toe of the left-hand rail of points 167B so that it was 2 mm below the bottom of the sidewear scar on the stock rail and blending out at a gradient of 1:600 was not, in any event, realistically achievable. Figure 13 shows the height profile of the switch rail after the derailment. The height, which was measured at 137.2 mm at the toe, dipped down to 133.7 mm at one metre from the toe. If a line representing a 1:600 gradient is drawn so that it passes through this lowest point, the switch rail would need to be reduced to a height of 131.8 mm at the toe. This would entail the removal of an unrealistic amount of metal and leave the switch rail so low that it would be unable to engage with the wheel flange to steer the train for a considerable distance from the toe.

109 The grinding repair to remove the crack was also not blended into the unaffected part of the switch rail at a gradient of 1:600 as required by the 053 standard (figure 13). Instead the technician used a straight edge to get a line to grind to. This was stated by the grinding technician to be partly because of the lack of time but mainly because he felt it was not practicable to blend out at the required rate without taking the switch toe too low. The switch was ground from the area of the crack towards the switch heel for as far as could be achieved in the time available.
