Rail Accident Report

Derailment at Bordesley Junction, Birmingham **26 August 2011**

This report is published by the Rail Accident Investigation Branch, Department for Transport.

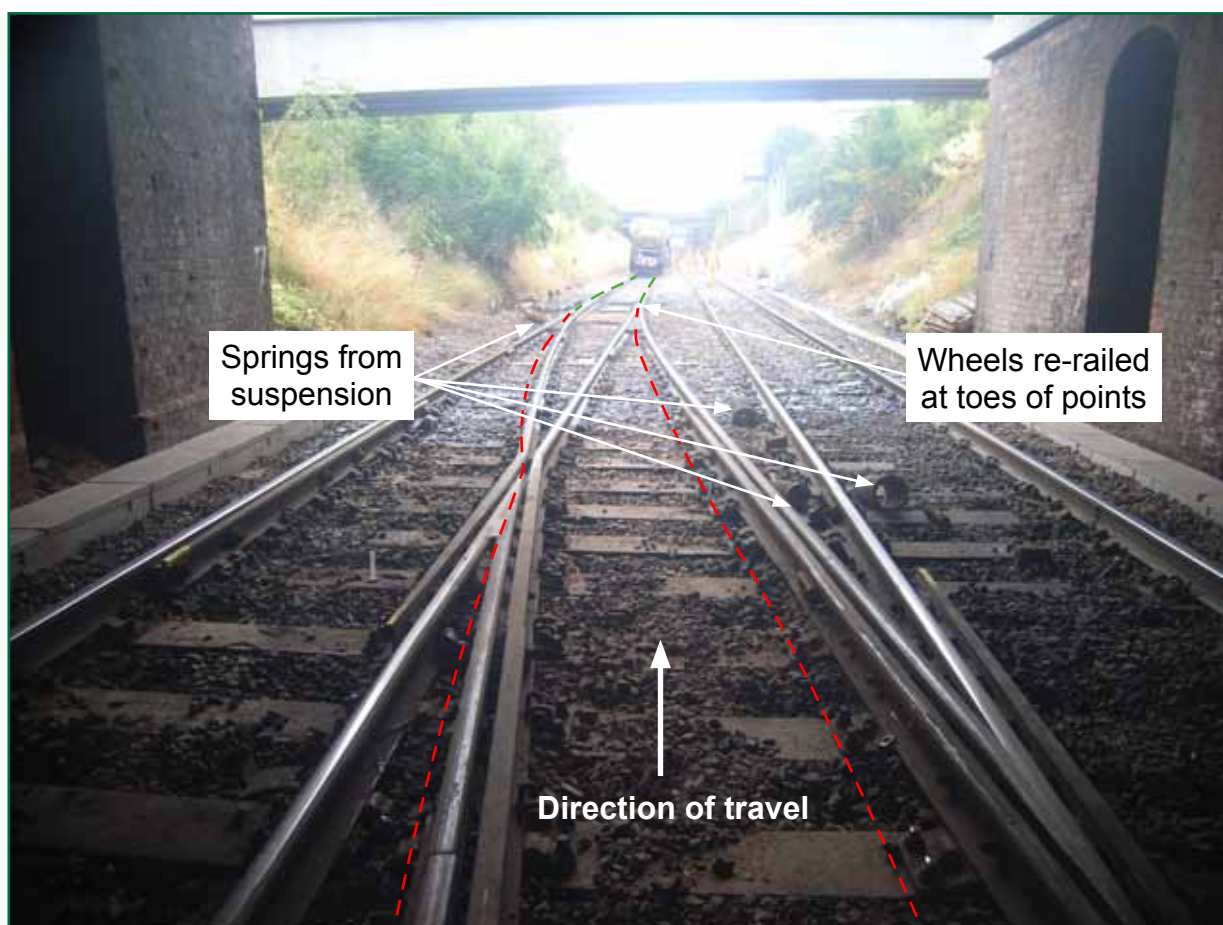
- 30 After about 100 metres, the derailed wheels were guided back towards the Up Camp Hill line by the rails that form crossover number 633 (figure 4). All of the derailed wheels then re-railed on the Up Camp Hill line at the *toes* of 633A points (figure 6). While these wheels ran derailed, ten sets of coil springs were dislodged from suspensions and found between the fixed crossing and 633A points. The springs were found at places where the derailed wheels were subjected to large vertical movements, such as where they had struck rails and been dragged over them.

Figure 6: Crossing for 633A points where the wheels re-railed

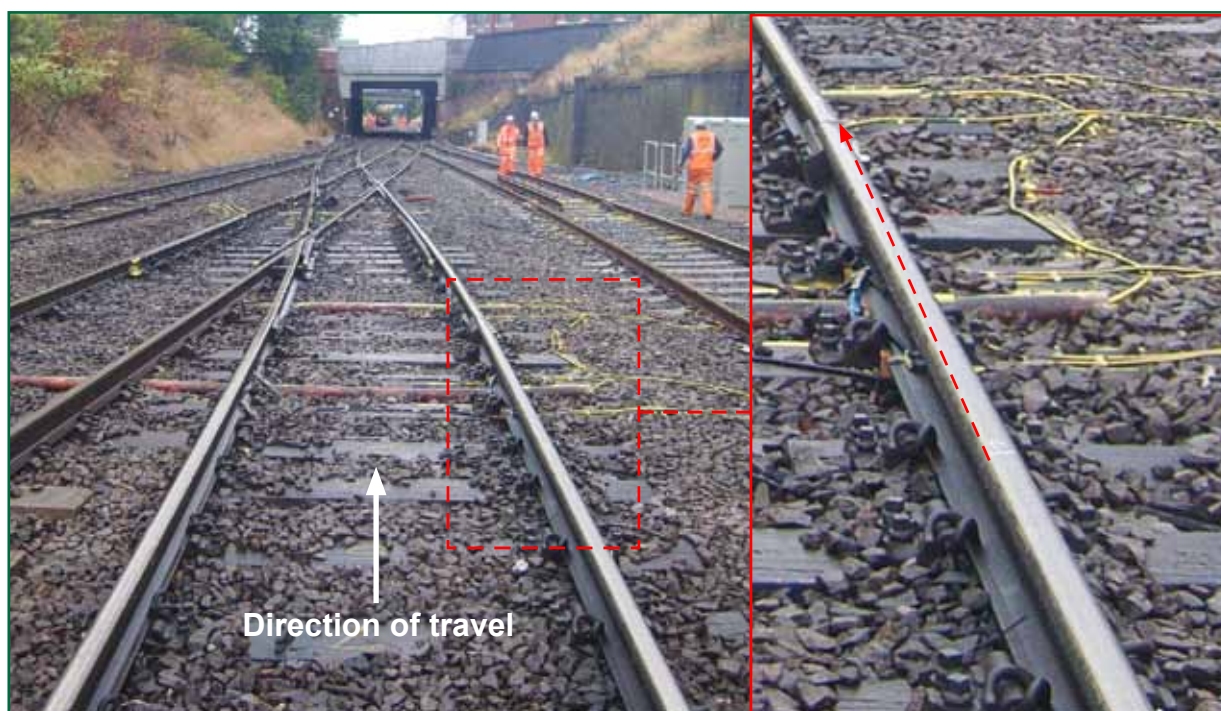
- 53 **The leading right-hand wheel flange on wagon REDA 16066 climbed onto the rail head and then derailed to the right. This was due to a combination of factors related to the suspension on wagon REDA 16066 and the track geometry at Bordesley Junction.**
- 54 The RAIB found marks on the right-hand running rail that showed a wheel flange had climbed and run along the top of the rail for 3.6 metres before derailing to the right (figure 8). The RAIB did not find any other derailment marks on the track before this point.
- 55 The RAIB found no evidence or damage to the preceding wagons to indicate that they had run derailed; none of the wagons before REDA 16066 had scuff marks on their wheels caused by running on ballast. Only the rear four wagons had damage to their suspension.

Figure 8: Point of derailment on the approach to the junction

- 56 The track where the leading right-hand wheel of REDA 16066 derailed was on a left-hand curve, and also canted with the right-hand rail higher than the left-hand rail. Both of these factors alter the angle at which the wheel flange makes contact with the running rail and make the leading right-hand wheel more prone to a *flange climb* derailment. These same factors also make it very unlikely that the trailing right-hand wheel on this wagon was the first wheel to derail.
- 57 The RAIB examined the marks on the track after the initial point of derailment and the couplings on the wagons. This evidence indicates that the following wagons were pulled into derailment at the fixed crossing where the Down Main (Bordesley) intersects the Down Camp Hill line. There is no evidence that the wagons behind REDA 16066 pulled it into derailment.

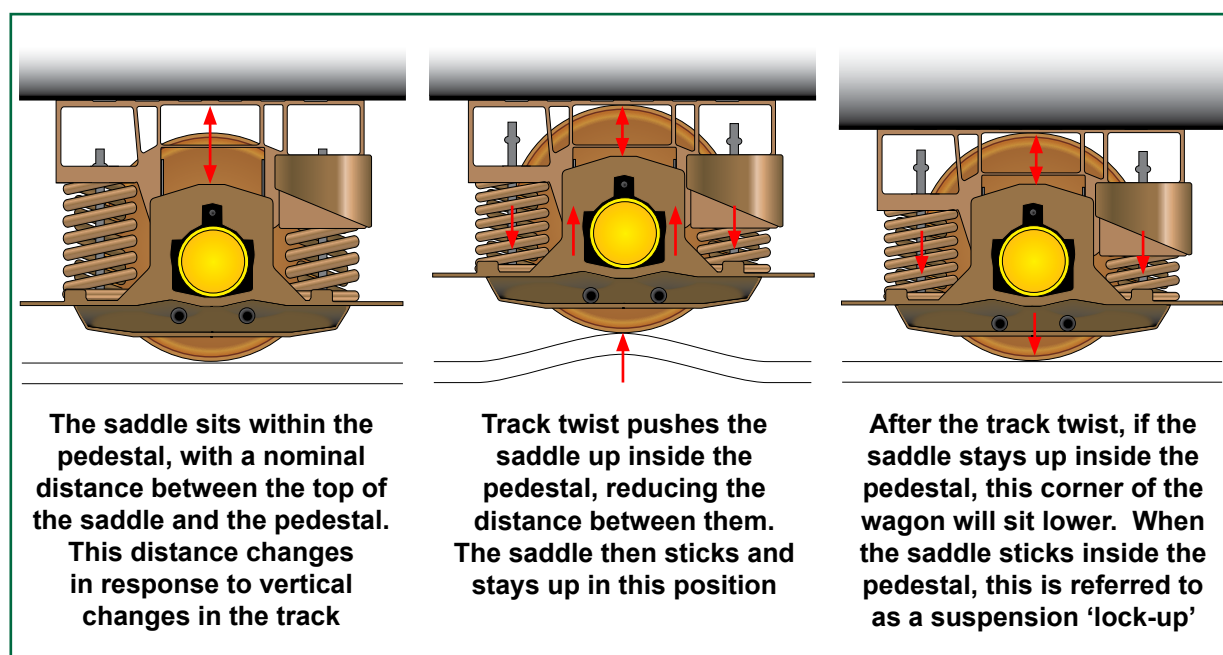
- 60 Before the point where it derailed, REDA 16066 passed over track geometry that would have caused its trailing left-hand wheel to carry increased dynamic load. It is probable that this occurred at a track twist that the RAIB found about 8 metres before the point of derailment. At this location, the RAIB measured a 3 metre dynamic track twist of 1 in 193 (cant difference of 16 mm) and a dynamic twist of 1 in 212 (cant difference of 23 mm) over the wheelbase of the wagon (which is 4.775 metres).
- 61 When a wheel is loaded, the suspension on a PHA wagon reacts by allowing the saddle that sits on the end of the axle bearing to be pushed up inside the pedestal (figure 10). This meant that the track twist measured 8 metres before the point of derailment would have pushed the saddle on this corner up inside the pedestal by 23 mm relative to the other corners.

Figure 9: No vertical movement of the saddle within the suspension - a lock-up

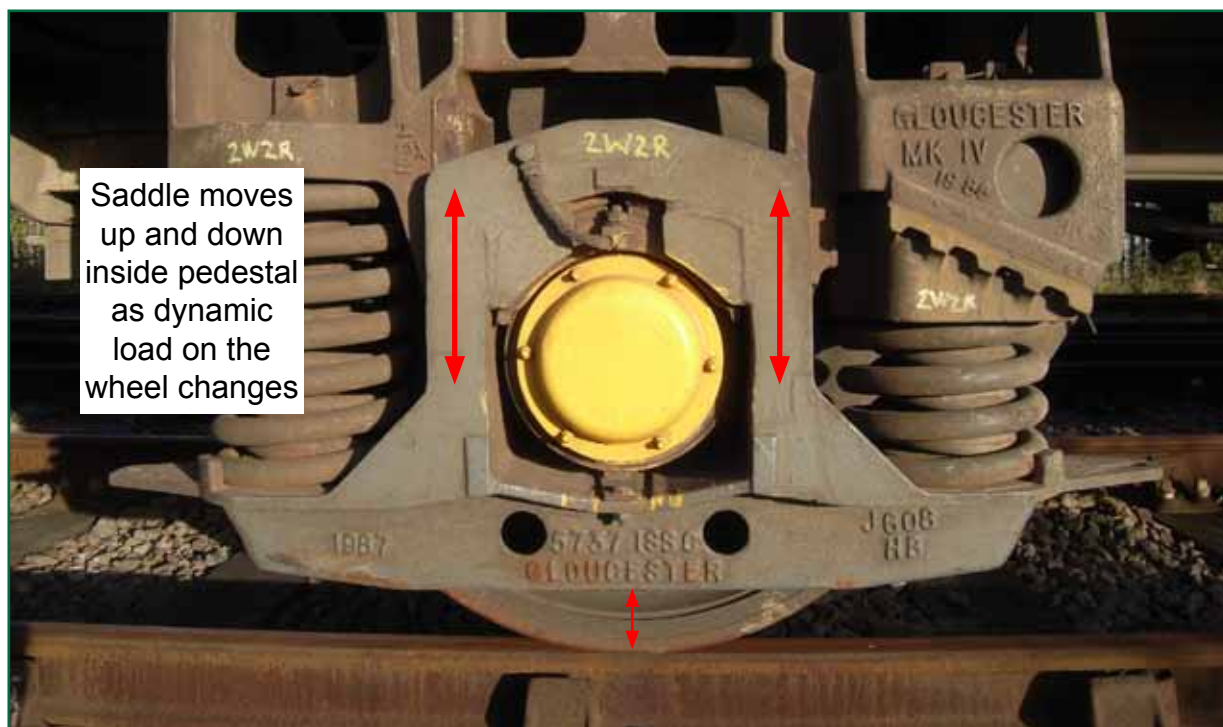
- 62 When operating as designed, the saddle will move back down inside the pedestal as the dynamic wheel load reduces after the track twist. However, if the saddle sticks and stops moving inside the pedestal, this is commonly referred to as a suspension 'lock-up' (figure 9). All types of suspension which rely on friction to provide their damping have the potential to lock-up but the PWRAMG had investigated the specific problem of suspension lock-ups on PHA wagons after an accident at Ely Dock Junction (paragraph 147). The PWRAMG had identified a mechanism where a lock-up could occur on this type of suspension when the outer edge of the damper pad makes contact with a groove created by hollow wear on the saddle friction liner plate (figure 11). The damper pad could become wedged against the saddle friction liner plate, stopping the saddle from moving up or down.

Figure 10: Vertical movement of the saddle within the suspension

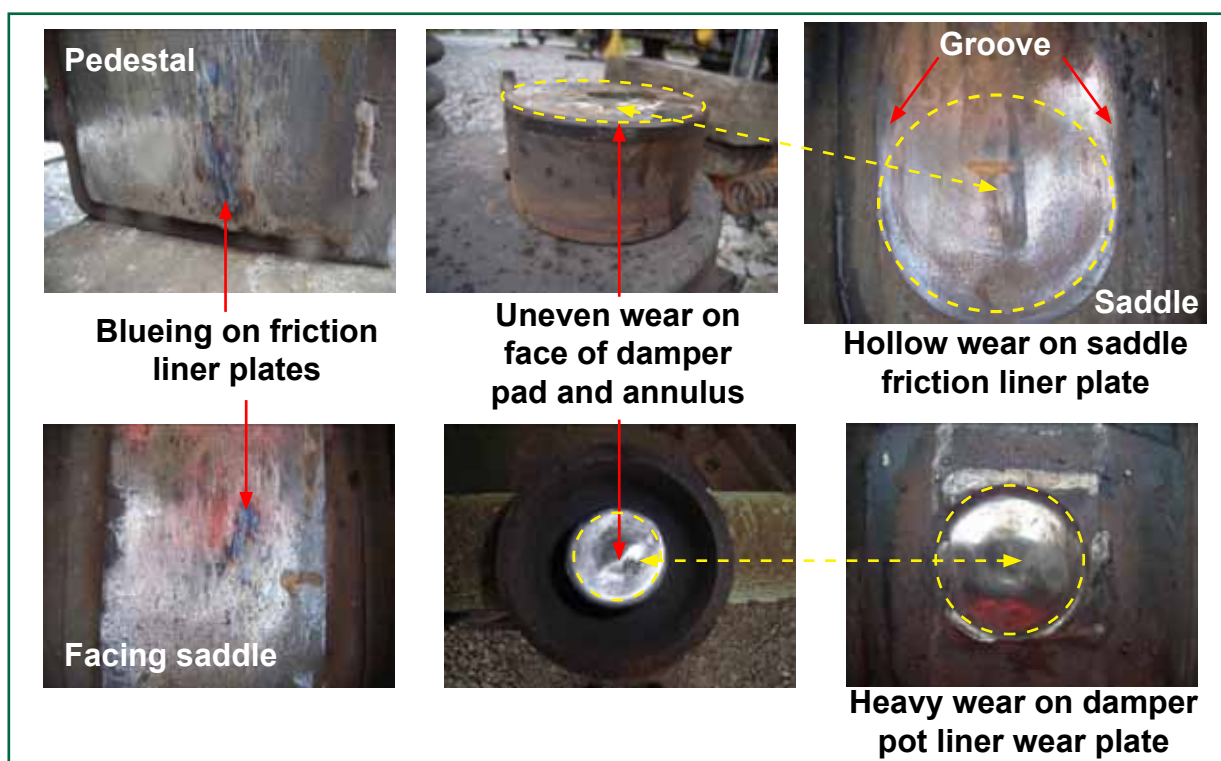
- 63 The RAIB's examination of the suspension components on the trailing left-hand corner of REDA 16066 found a groove worn into the saddle friction liner plate to a depth of 1.8 mm, uneven wear on the damper pad's face and also wear on the damper pot liner wear plate that was beyond the permitted maintenance limit (figure 11). The wear found on these components was consistent with the previous findings of the PWRAMG, which showed that such wear patterns would probably have caused the saddle to stick inside the pedestal in the loaded position.

Figure 11: Components found on REDA 16066's trailing left-hand corner suspension

- 64 The RAIB also found blueing on the pedestal friction liner plate and facing saddle friction liner plate (figure 11). This occurs when the material becomes heated to a temperature of about 300°C. Friction heating can occur when the two surfaces are pushed hard against each other and rub under load. It is a sign that the suspension had not been working normally and is often found after a wheel has run derailed.

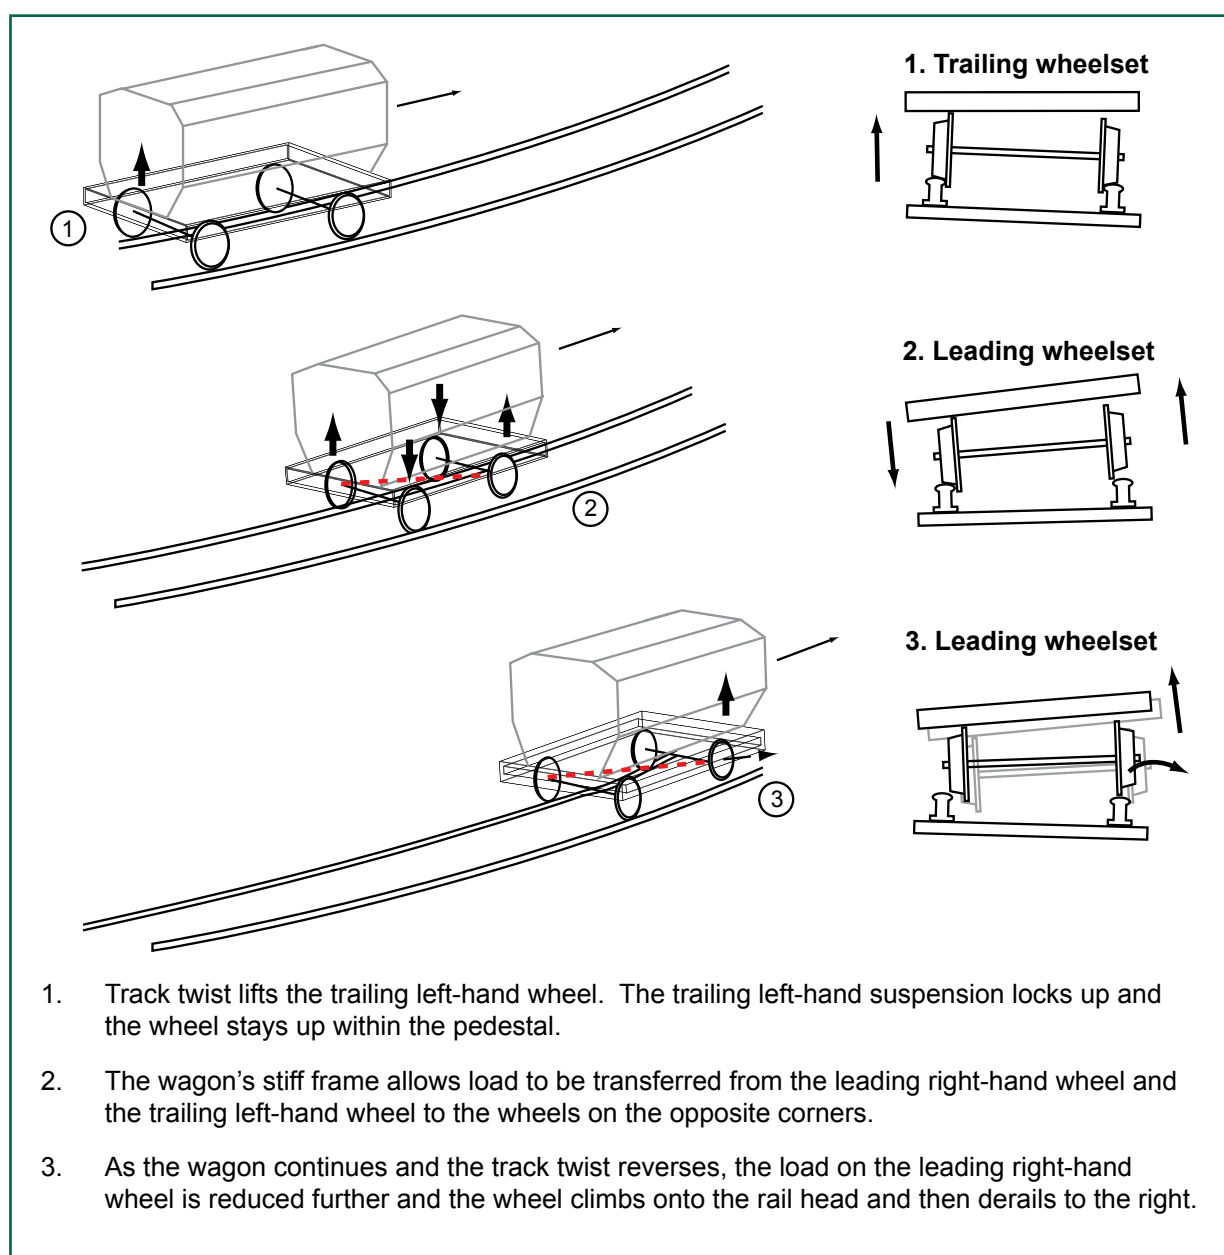
- 65 Calculations showed that when a suspension lock-up occurs, the stiffness of the PHA wagon's frame allows wheel load to be transferred from the locked-up and diagonally opposite corner to the other two corners. As a consequence, if the suspension on the trailing left-hand corner of REDA 16066 locked-up in a loaded state, load will be transferred away from it and also the wagon's leading right-hand wheel (figure 12). With a reduced load on the leading right-hand wheel of REDA 16066, this wheel is then much more susceptible to derauling when a track twist is encountered that further reduces the load on it.

Figure 12: Transfer of wheel load on REDA 16066

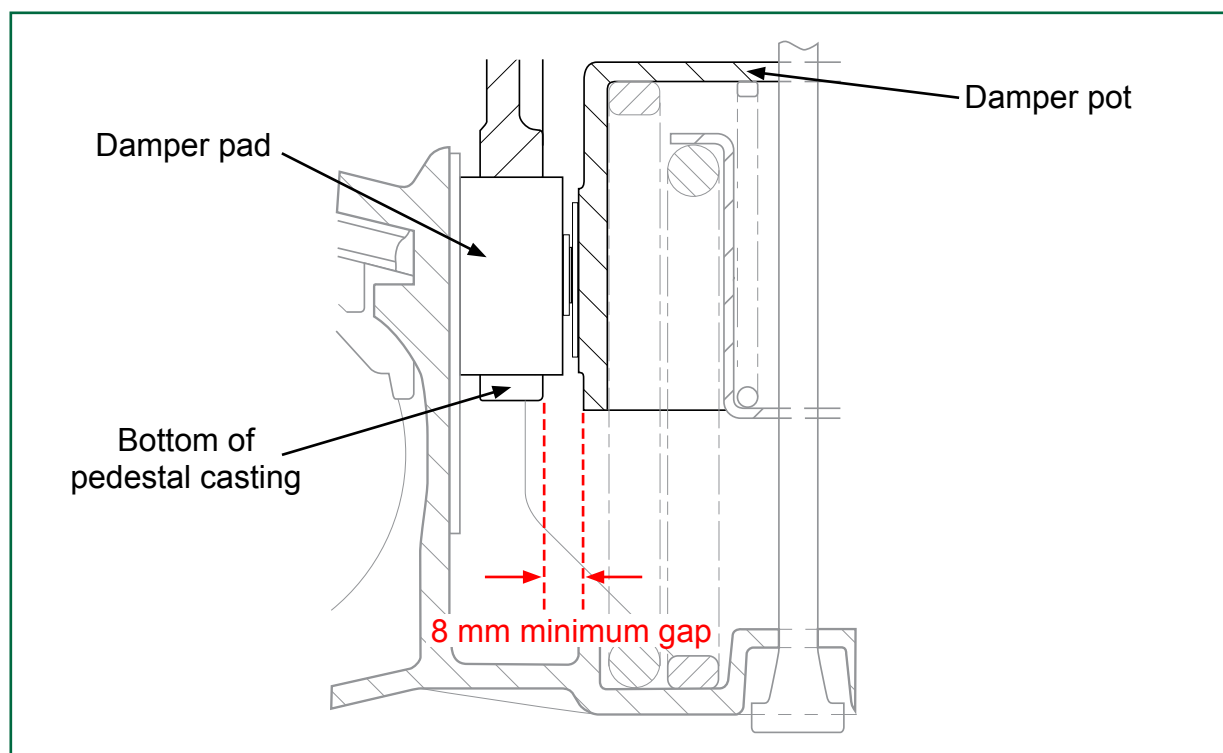
- 72 When the wagon is not lifted, staff assess the overall amount of wear within the suspension by taking a single measurement between the pedestal casting and the damper pot (figure 13). This distance is referred to as the damper pad clearance and the instructions allow a minimum distance of 8 mm. In February 2010 the clearance was 16 mm, and marked as a pass when the last VIBT and PPM examination took place. After the accident, the clearance was measured as 15 mm. However, post-accident repairs to the suspension to allow the wagon to be moved, meant this measurement was not representative of the condition before the derailment.

Figure 13: Damper pot clearance measurement

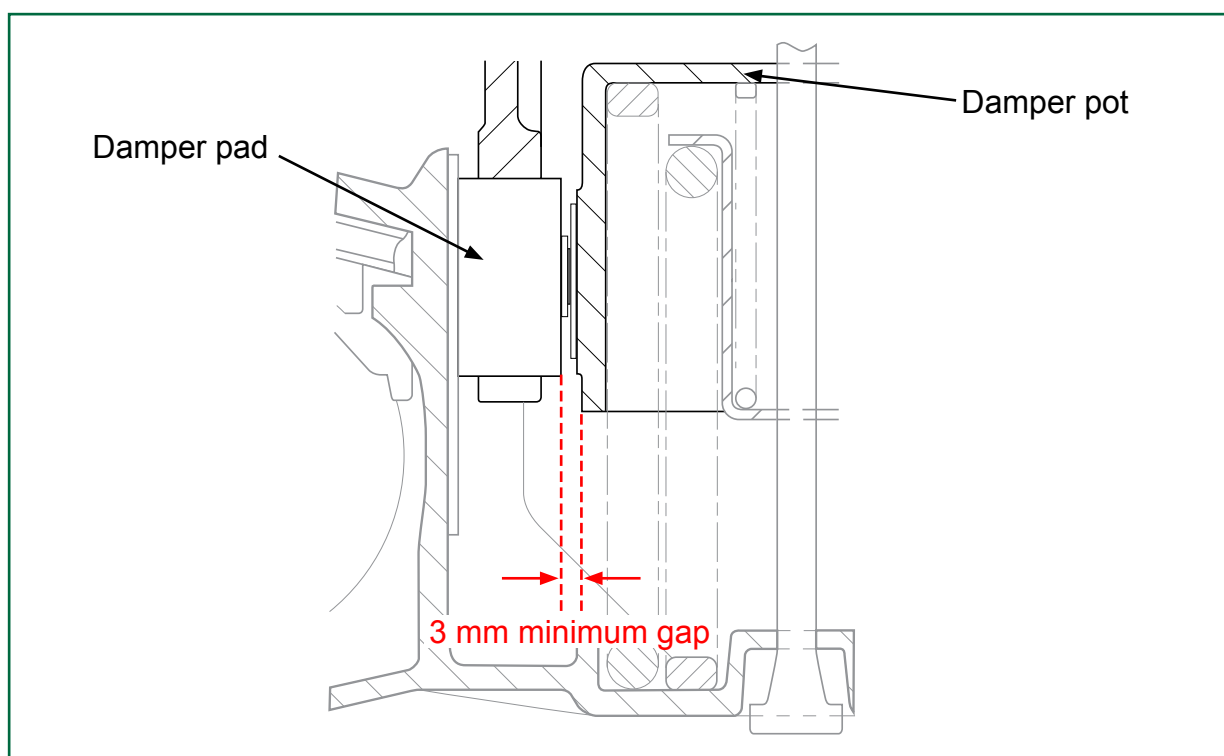
Figure 15: Additional check of the gap between the back of the damper pad and the damper pot

93 In late 2009, as part of the work to address the RAIB recommendation from Ely Dock Junction (paragraph 76), Network Rail's PWRAMG also identified two new maintenance checks that could be carried out to identify worn components which it believed were the likely cause of suspension lock-ups. One check was to look for a minimum gap of 3 mm between the back of the damper pad and the damper pot (figure 15). The second check called for hollow wear on the saddle friction liner plate to be measured. If the hollow wear was deeper than 1.5 mm the friction liner plate was to be replaced.

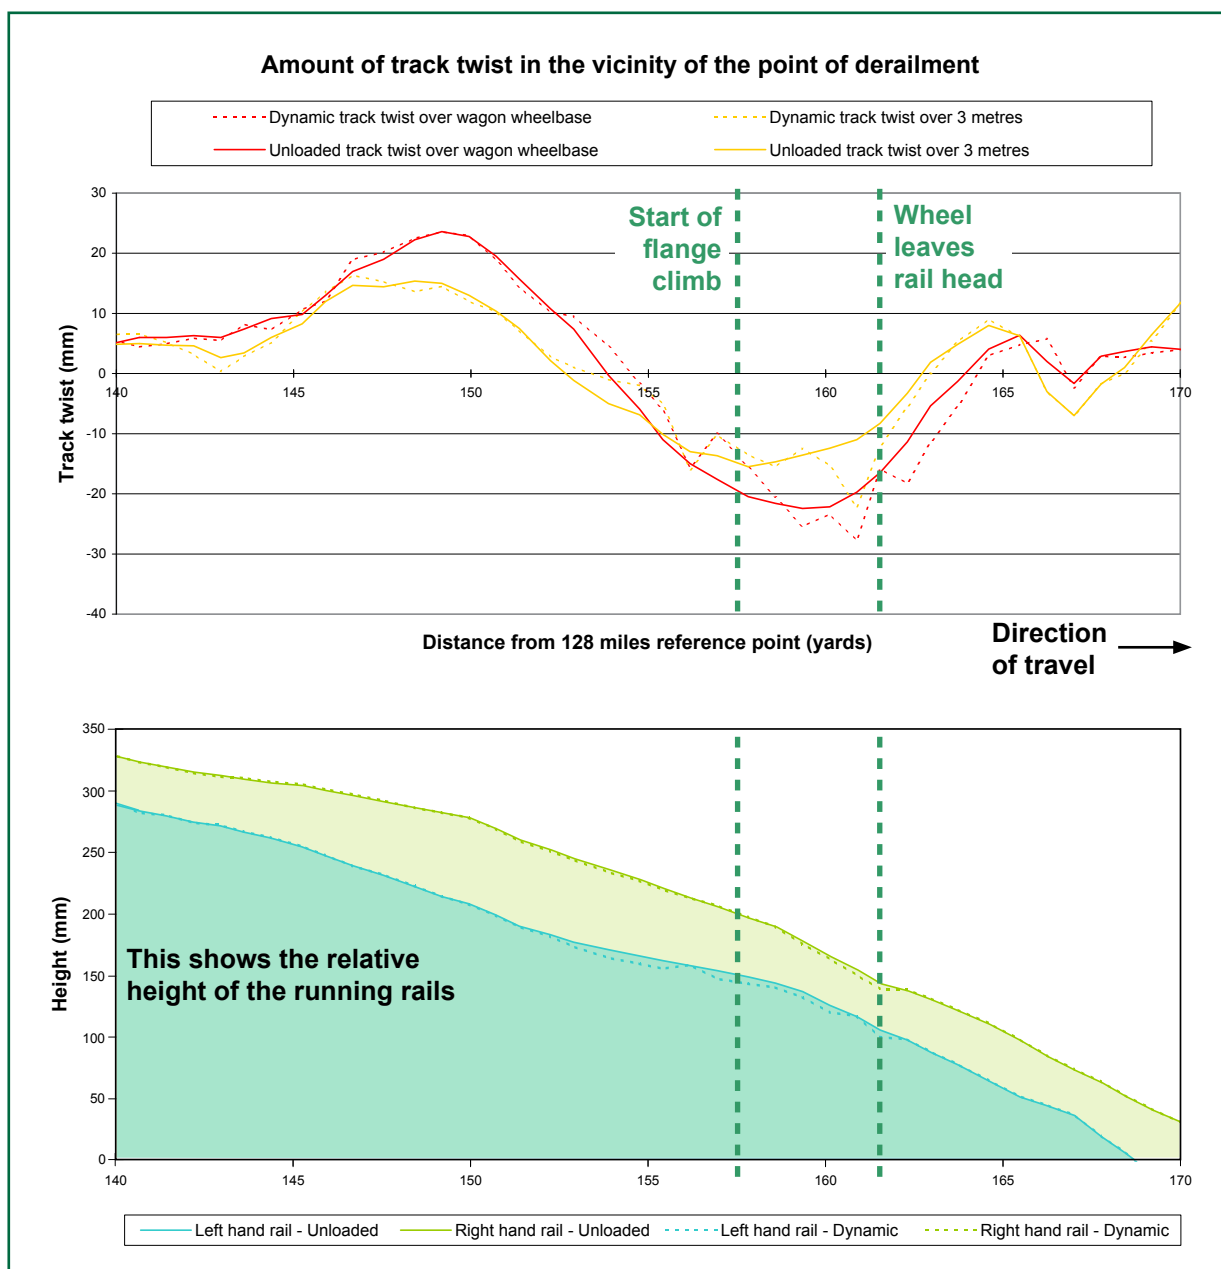
Figure 16: Graph showing the amount of track twist and relative change in height of the running rails

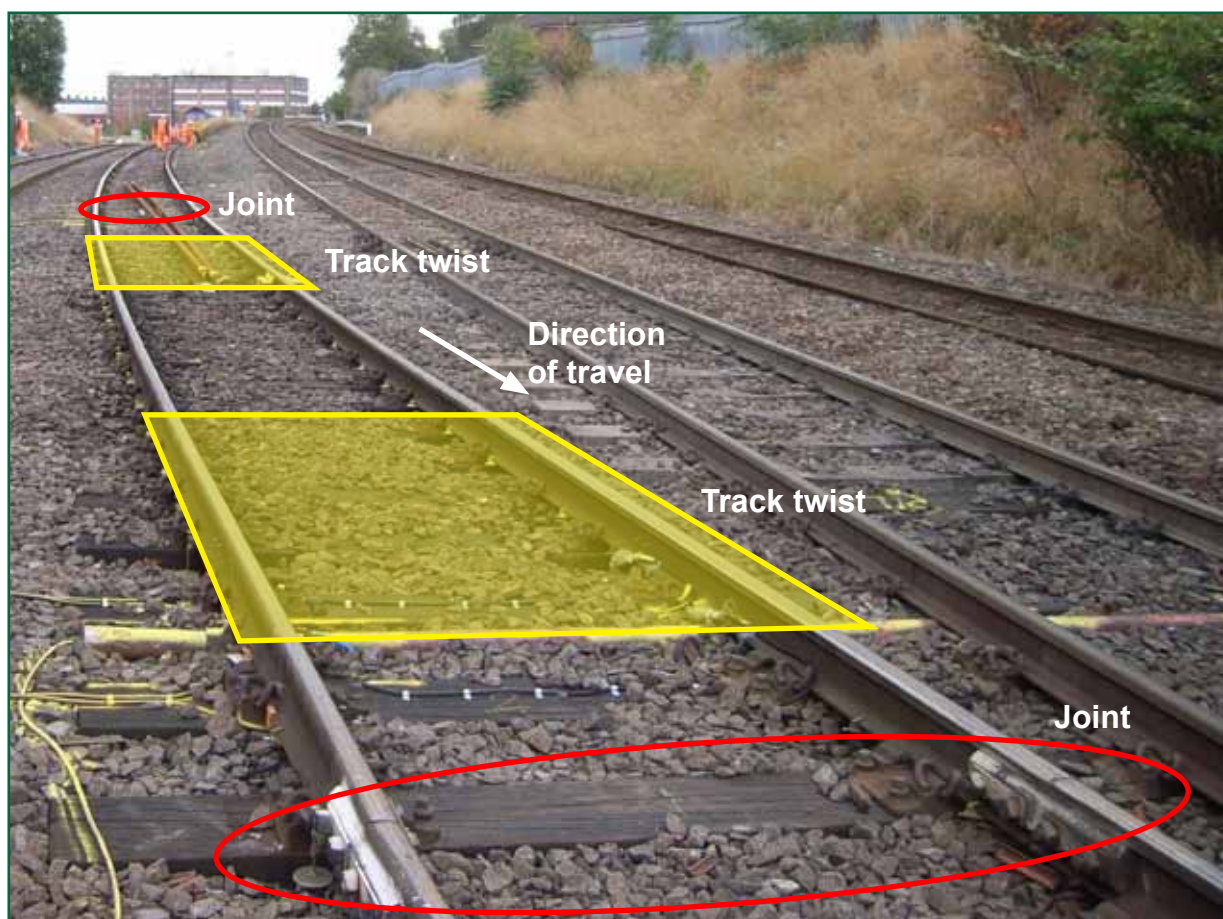
- 115 From witness evidence and analysis of the track geometry data, the RAIB concluded that the repair work was being carried out in the wrong place, either side of the track twists. The maintenance team were carrying out measured shovel packing repairs at a track joint before the first track twist and at the joints within the switches and crossing for the junction after the second track twist (figure 18). Figure 17 shows the cant waveforms measured by the track geometry recording trains in 2011. The cant reaches a peak of about 70 mm, with it changing at a rate of about 1 in 200 either side of this peak, which is just on the threshold for a reportable track twist (paragraph 112). The aligned cant waveforms for the section of track with the track twists did not change throughout 2011, but it did change over time in the vicinity of the joints which was as a result of the work done by the maintenance team.

- 116 The maintenance team had carried out similar repairs at these joints several times in the past. When the team had gone out to do the repairs, they had measured and found changes in the cant at these joints, so that was where they did the work to lift and pack the track. They did not measure the cant in the section of plain line between the joints, so they did not find the reported track twists. Therefore the track twists went unrepaired.

Figure 18: Locations of track twists and where repair work took place at track joints

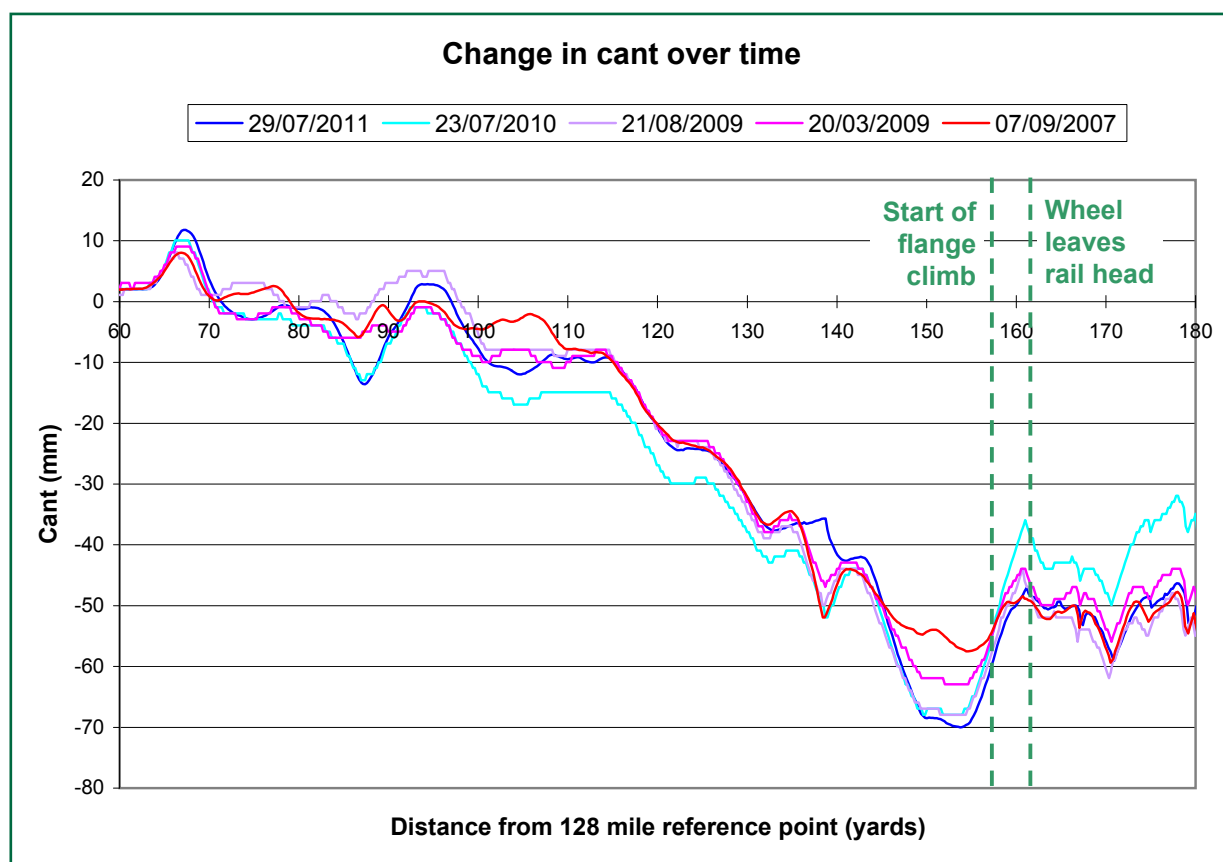
- 120 Similarly, the review meetings checked whether the faults had been signed off within the required time but no one took any action to look at why repeat faults were happening at Bordesley Junction. There was a general acceptance that the track formation in the vicinity of Bordesley Junction was poor which led to track geometry faults regularly being recorded there. The meeting attendees also knew that *tamping* work was planned to take place at the junction in August 2011 (paragraph 123).
- 121 The RAIB analysed the available track geometry data for the Down Main (Bordesley) line back to 2005. This showed that the track geometry where the track twists were found had deteriorated to the condition in which it had been at the time of the derailment by August 2009, but had not worsened since then (figure 19).

Figure 19: Change in cant over time at Bordesley junction

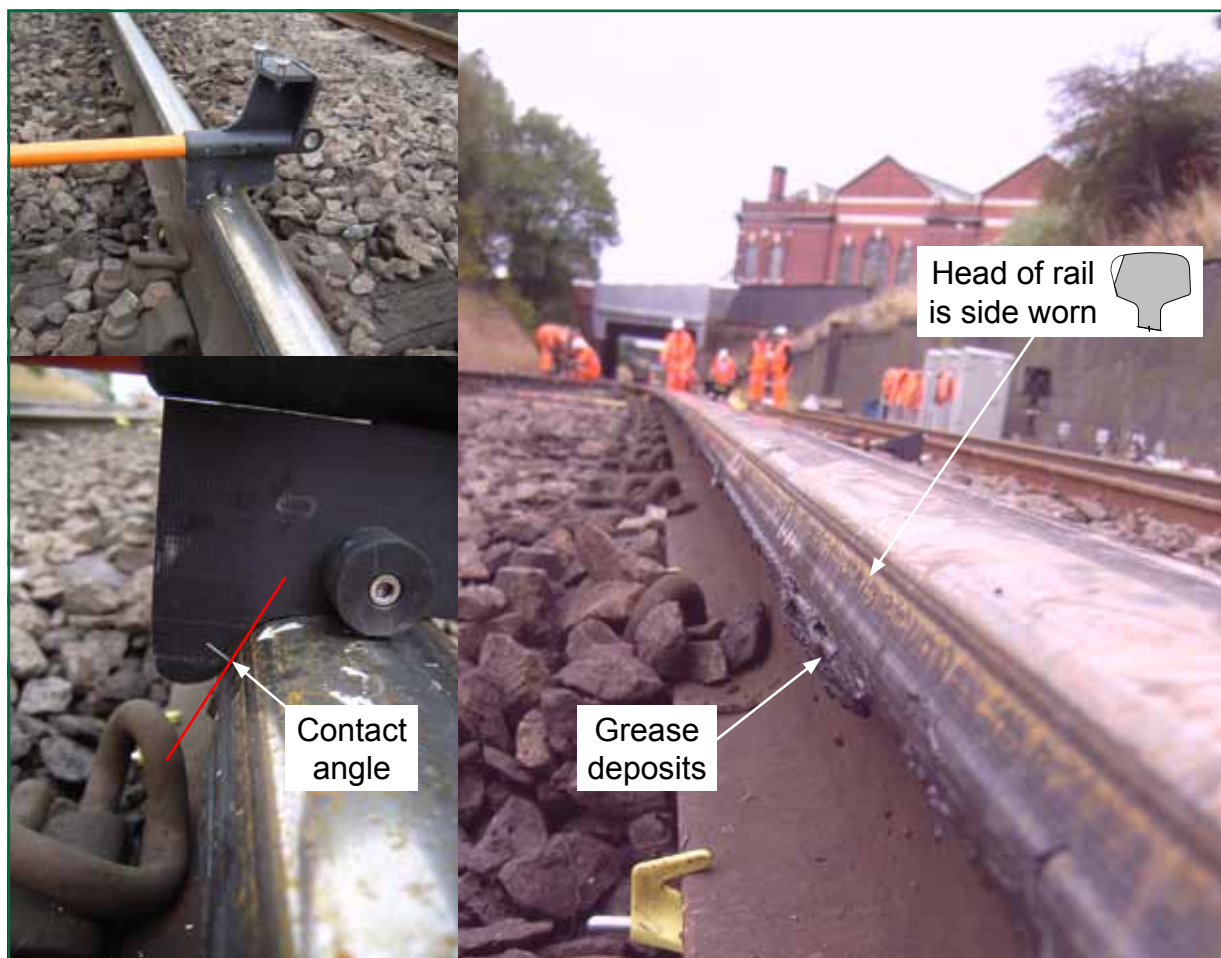
- 135 A reduction in the level of friction between the wheel flange and rail can also reduce the likelihood of a wheel flange climbing onto the rail head. A *flange lubricator* is located on the right-hand rail of the Down Main (Bordesley) line on Bordesley curve (figure 2) which applies grease to the wheels of passing trains in order to reduce wear on both the wheels and rails on curved track. There were some grease deposits from this lubricator found on the inside face of the right-hand running rail (figure 20). However, the effectiveness of this grease in reducing the level of friction between the wheel flange and the rail was limited by its position low down on the inside face. It was also the case that at the time of derailment the rails were dry, and therefore the level of friction was higher than it would have been if they were wet.

Figure 20: Side worn rail and contact angle between the rail and the wheel

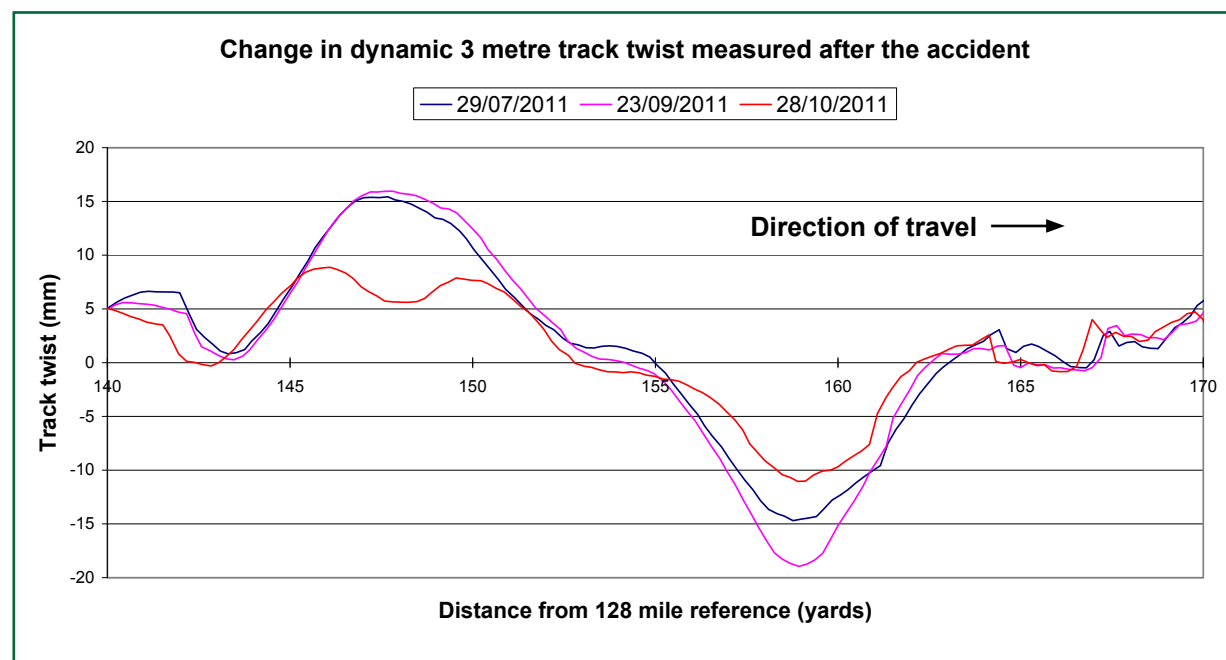
- 143 On 23 September 2011, the track geometry recording train measured a track twist of 1 in 158 on the Down Main (Bordesley) line, just where train 6Z31 had derailed (figure 21). This was the first track geometry recording run after the accident.

Figure 21: Changes in the measured track twist after the accident at Bordesley junction

- 144 A fault report was issued which required Network Rail maintenance to repair this fault within 14 days. Maintenance records show that measured shovel packing repair work took place over this mileage on 29 September. The next track geometry recording train run took place on 28 October and the amount of track twist that was recorded was reduced (figure 21). This indicates that on this occasion the repair work had been carried out in the correct place, as the track geometry had been improved, and it did not require further maintenance intervention after four weeks of traffic passing over it. Since Network Rail has carried out work to reduce the track twists on the Down Main (Bordesley) line, there is no need for the RAIB to make a recommendation about this.

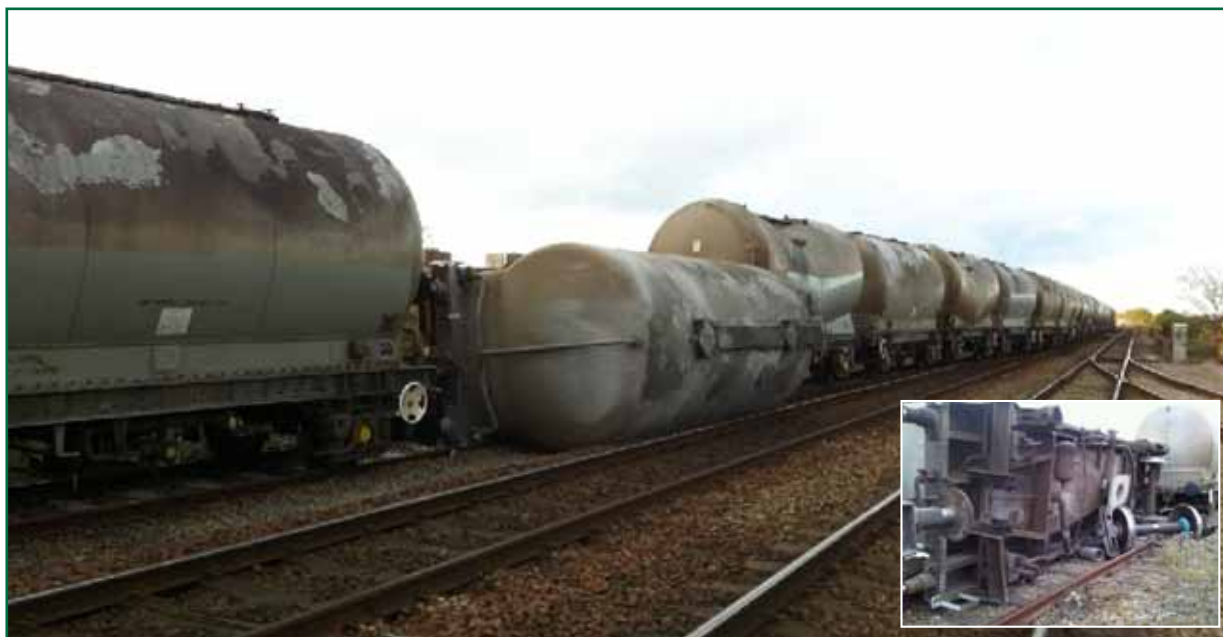
- 151 While this investigation was in progress, a further derailment of PCA tank wagons happened at Craiginches yard, Aberdeen on 9 May 2012. The train involved was train 6B32, the 16:52 hrs Craiginches Yard to Oxwellmains service, operated by Freightliner. As the train of 25 empty PCA wagons was leaving the sidings, the flange of the leading left-hand wheel on the 19th wagon climbed onto the rail head on plain line within the yard. The derailed wagon was dragged for about 200-metres, overturning onto its side, before stopping foul of the running line the train was joining (figure 22).

Figure 22: Train 6B32 derailed on exit to Craiginches Yard, Aberdeen (images courtesy of Network Rail)

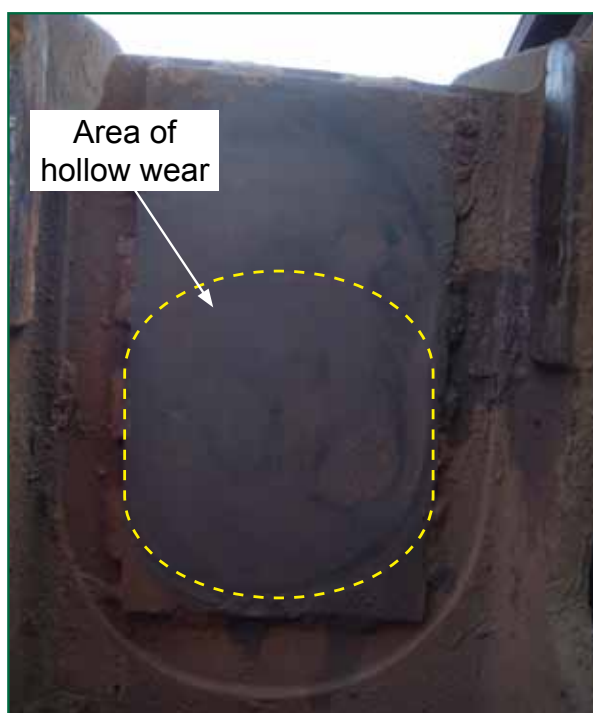
152 Network Rail surveyed the track, and voiding was measured before and at the point of derailment. This revealed a large dynamic 3 metre track twist of 1 in 96 just before the point of derailment. The RAIB examined the wagon after it was recovered and found hollow wear on the saddle friction liner plate in excess of 2 mm on the leading left-hand corner (figure 23). This pattern of wear was consistent with that found on REDA 16066 and the previous findings of the PWRAMG. Although the industry investigation of this accident is in progress, so its cause has not yet been formally confirmed, the wear patterns found indicate that the saddle on this corner would be susceptible to sticking inside the pedestal (paragraph 63).

Figure 23: Hollow wear on the saddle friction liner plate on the leading left-hand corner
