Rail Accident Investigation Branch

Rail Accident Report

**Collision between a train and a lorry and trailer
on Llanboidy automatic half barrier level
crossing
19 December 2011**

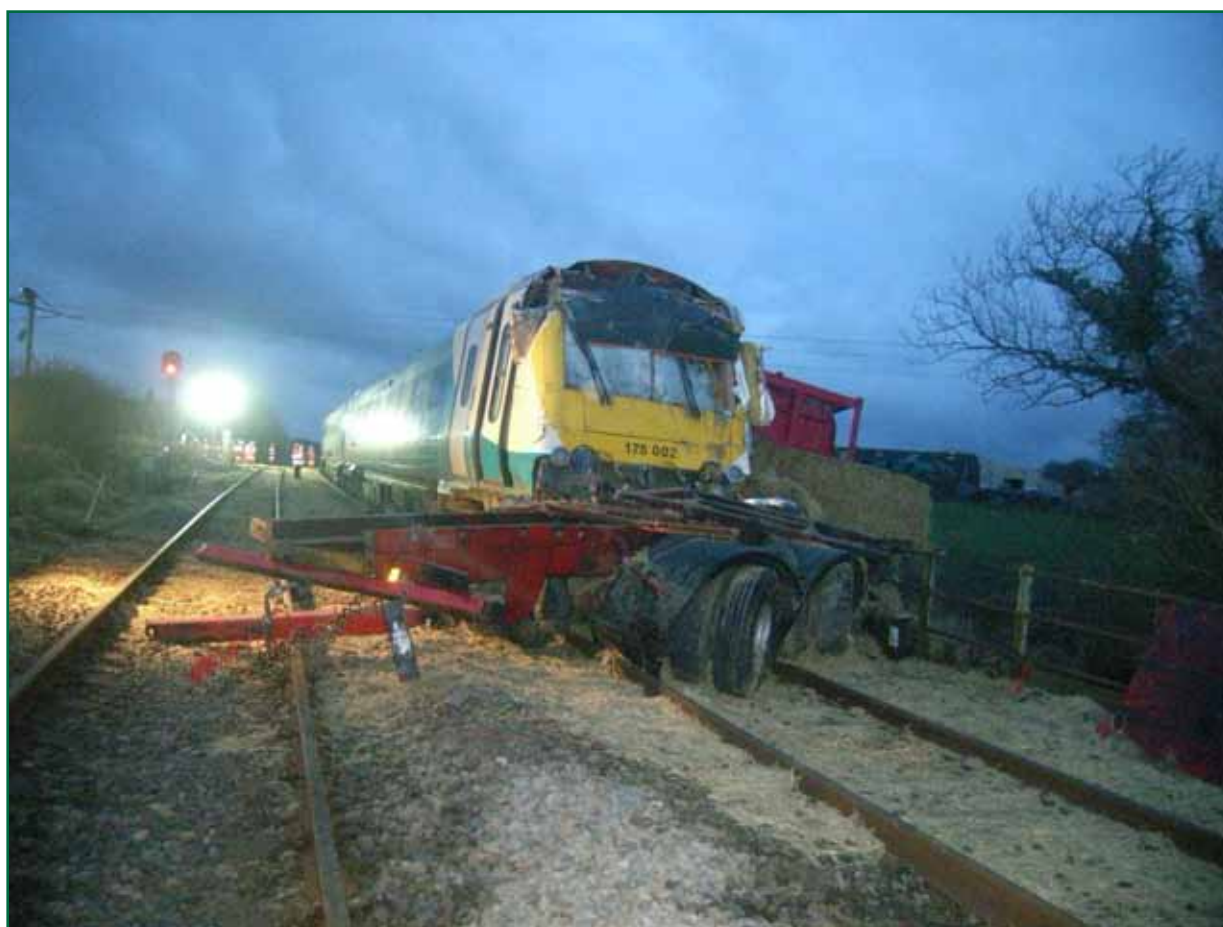
- 4 The impact between the train and the lorry caused the lorry to be separated from its trailer and pushed 78 metres along the track (figure 1). The lorry driver left his cab prior to the collision and was beside the trailer when the impact occurred. He was struck a glancing blow by the trailer and was slightly injured.

Figure 1: The train and lorry where they came to rest after the accident (most of the straw has been removed)

- 14 The train speed had reduced to 38 mph (61 km/h) by the time it reached the crossing and struck the lorry at 09:44 hrs. The impact broke the drawbar from the lorry trailer and the lorry was pushed by the train 78 metres along the line before coming to rest.

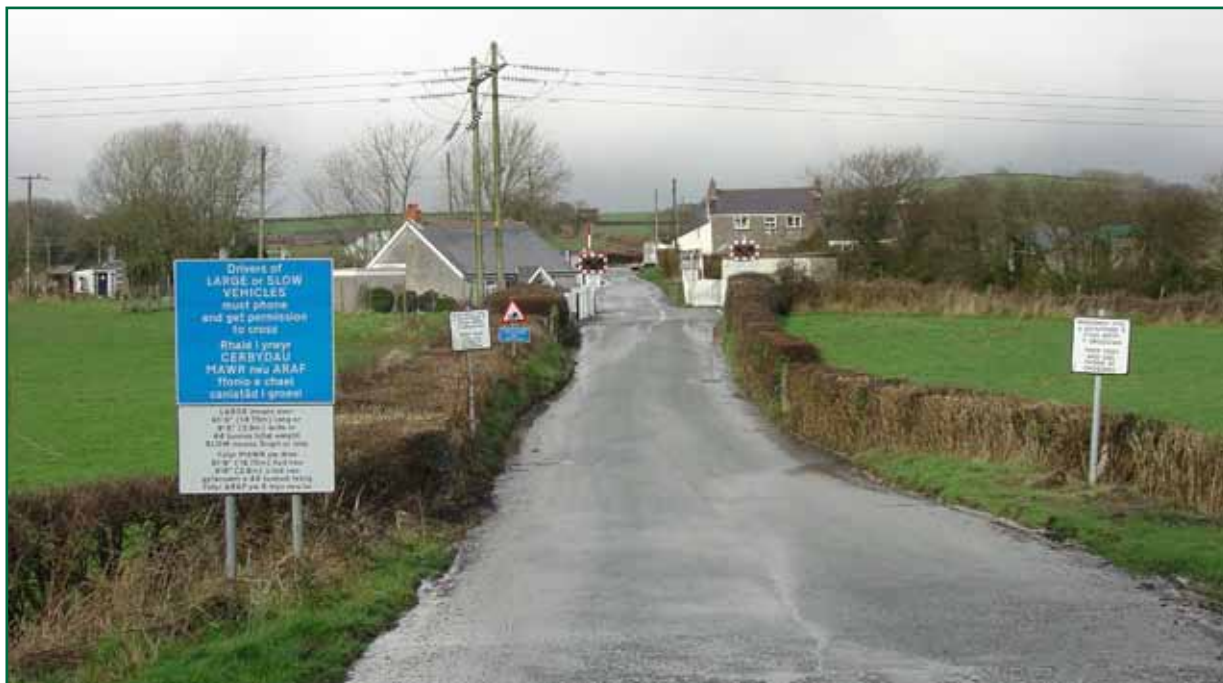
Figure 3: South approach to Llanboidy AHB crossing

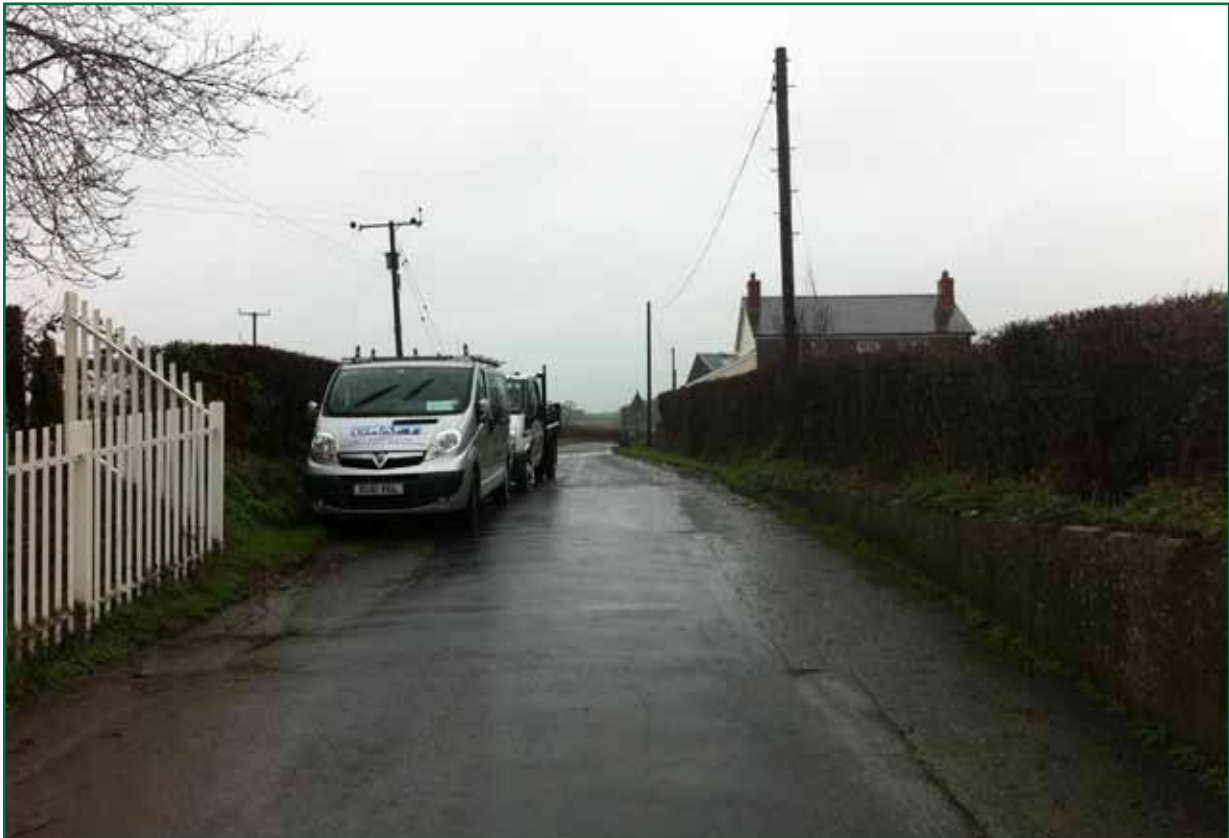
Figure 4: Road on the north side of Llanboidy AHB crossing showing parked vehicles (courtesy of BTP)

40 The contractors working on the line side parked their vehicles close to the crossing, partly obstructing the road on the exit from the crossing.

- 41 The road exit from the crossing at the north side narrows from 5 m at the crossing to 3.8 m, which is the width of the road on this side of the crossing. The narrowing of the road is all on the left-hand side, so that vehicles travelling northwards must move to the right-hand side as they leave the crossing. The position of the parked vans on the left forced vehicles to move to the right earlier than they would otherwise have done, bringing them closer to the half barrier on the exit side of the crossing (paragraph 33).

- 4 *The purpose of this recommendation is to prevent parked staff vehicles causing traffic to block back onto a level crossing, in particular vehicles of maximum legal dimensions.*

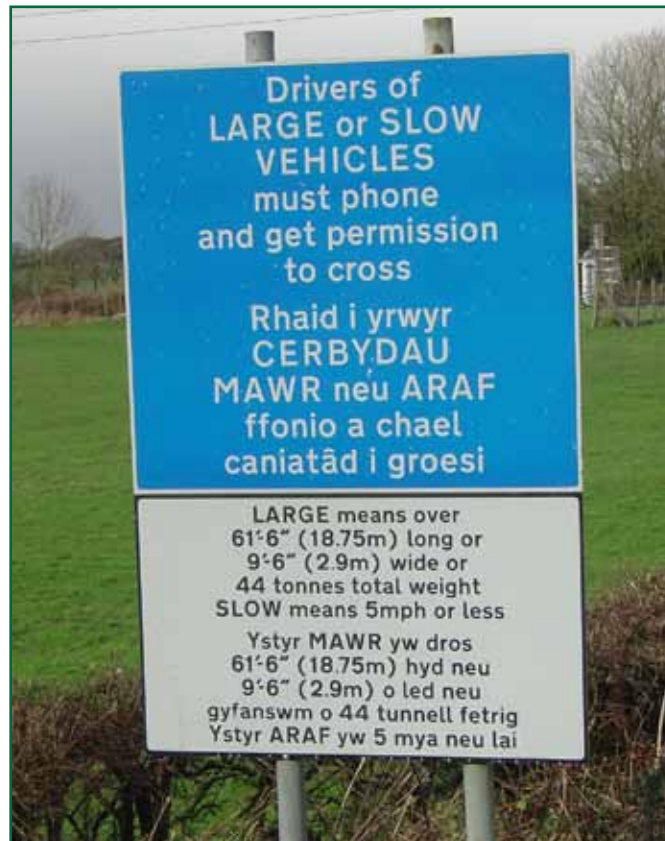
- 20 The road signs on the approach to the crossing are standard signs defined in the Traffic Signs Manual⁷ and are the same as those provided at all AHBs in Great Britain (with the exception of the Welsh translation). They include one which states '*Drivers of LARGE or SLOW VEHICLES must phone and get permission to cross*'. Beneath the sign the terms 'large' and 'slow' are defined: '*LARGE means over 61'-6" (18.75m) long or 9'-6" (2.9m) wide or 44 tonnes total weight SLOW means 5 mph or less*' (figure 5). The length of the lorry was recorded in the Vehicle and Operator Services Agency (VOSA) vehicles database as 11.61 m and this dimension was broadly consistent with measurements made after the accident (the damage to the lorry made it impossible to measure its length accurately). The length of the trailer was recorded in the VOSA database as 9.81 m from coupling pin to the end of the trailer. However, the trailer was fitted with drop down flaps at the front and rear which extended its length and were in use at the time of the accident. The manufacturer's drawing of the trailer showed that it was 11.07 m long with the flaps extended. The combined length of lorry and trailer, when coupled together, was calculated as 21.48 m at the time of the accident. As this was longer than the length defined as 'large' on the sign (over 18.75 m), the driver should therefore have phoned for permission to cross the line.

Figure 5: Sign reminding drivers of large or slow vehicles to call signaller

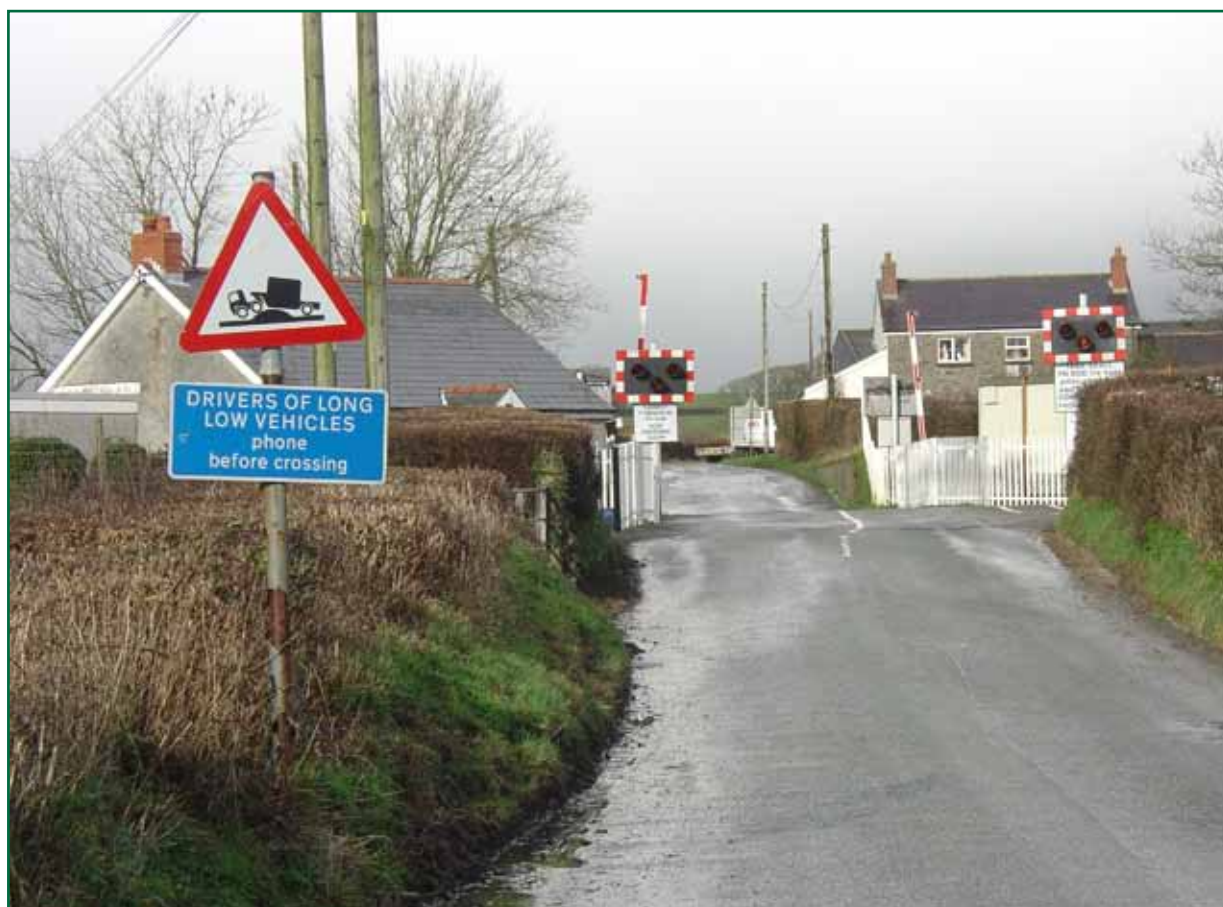
Figure 6: Uneven road warning sign on approach to crossing

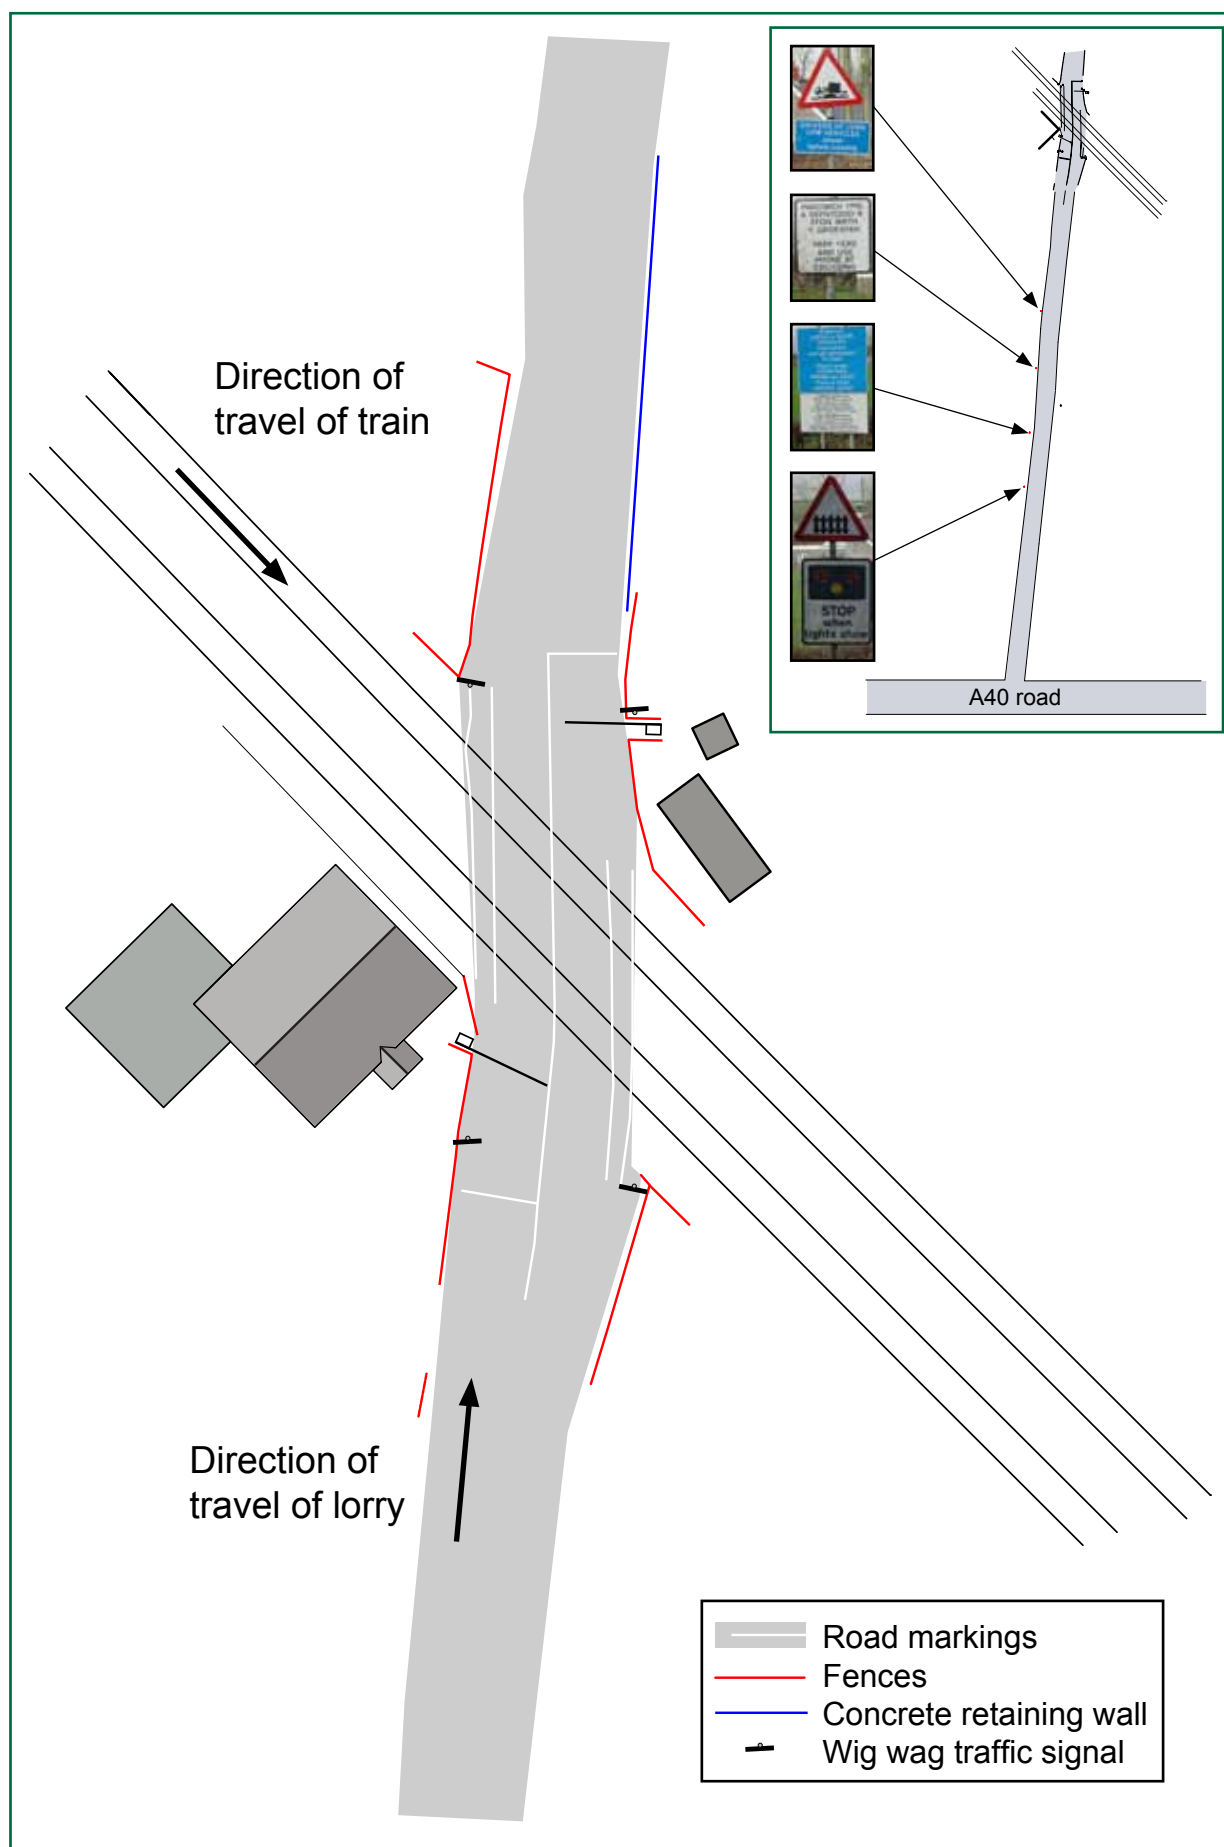
- 27 The centreline of the road over the crossing was at an angle of 6 degrees to the left of the line of the road approaches. The effect of this misalignment was to make the half barriers jut out into the path of a vehicle taking a straight line over the crossing (figure 7). The misalignment first arose when the crossing was converted from manually controlled gates to an AOCR. The road over the crossing was widened to comply with the minimum width of 5 m for an AOCR crossing specified in the Department of Transport publication '*Railway Construction and Operation Requirements – Level Crossings*'. Physical constraints meant that the road was widened on opposite sides of the road on each side of the crossing (on each side of the crossing the road was widened on its right-hand side). This caused the widened road over the crossing not to be parallel with the rest of the road.

Figure 7: Plan of the crossing (to scale)

- 1 *The purpose of this recommendation is to make the crossing, as viewed by a road user, more closely parallel to the rest of the road and hence provide a clear exit if the user is on the crossing when the barriers start to lower.*

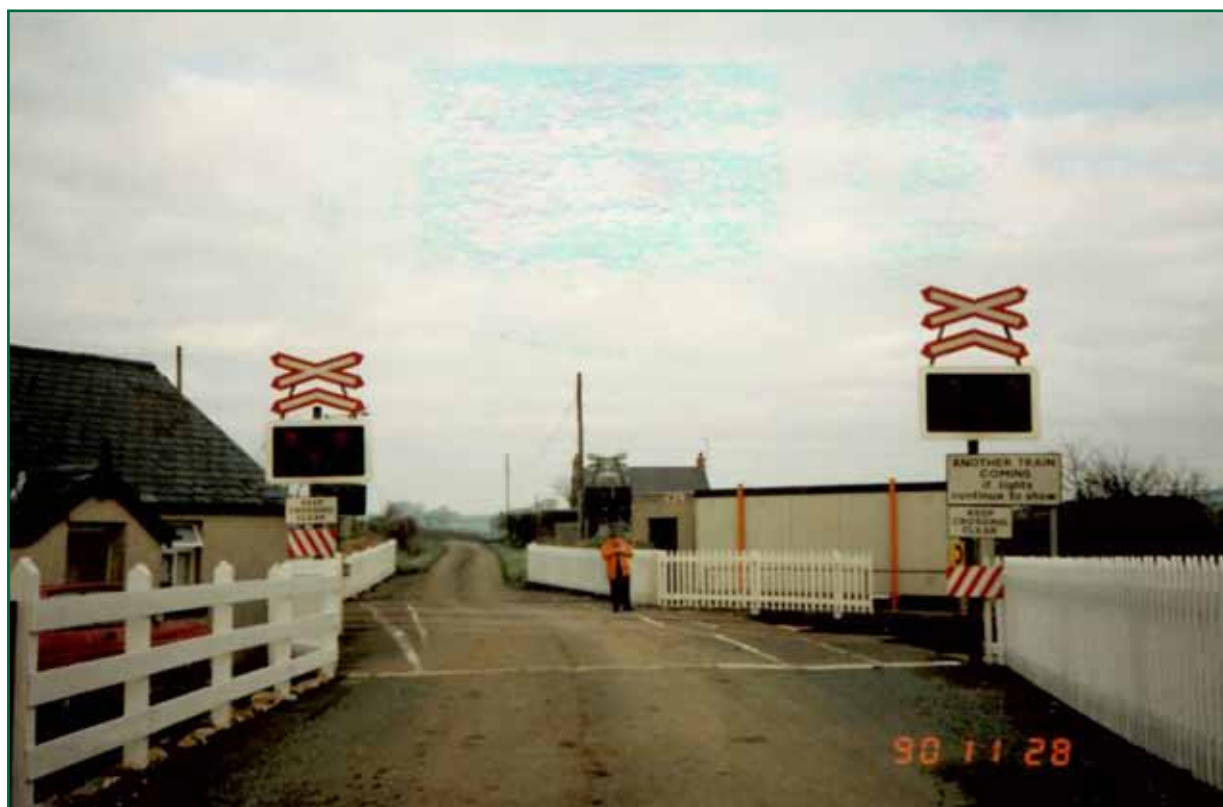
Figure 8: Llanboidy crossing as an AOCR in 1990 (photo courtesy of Network Rail)

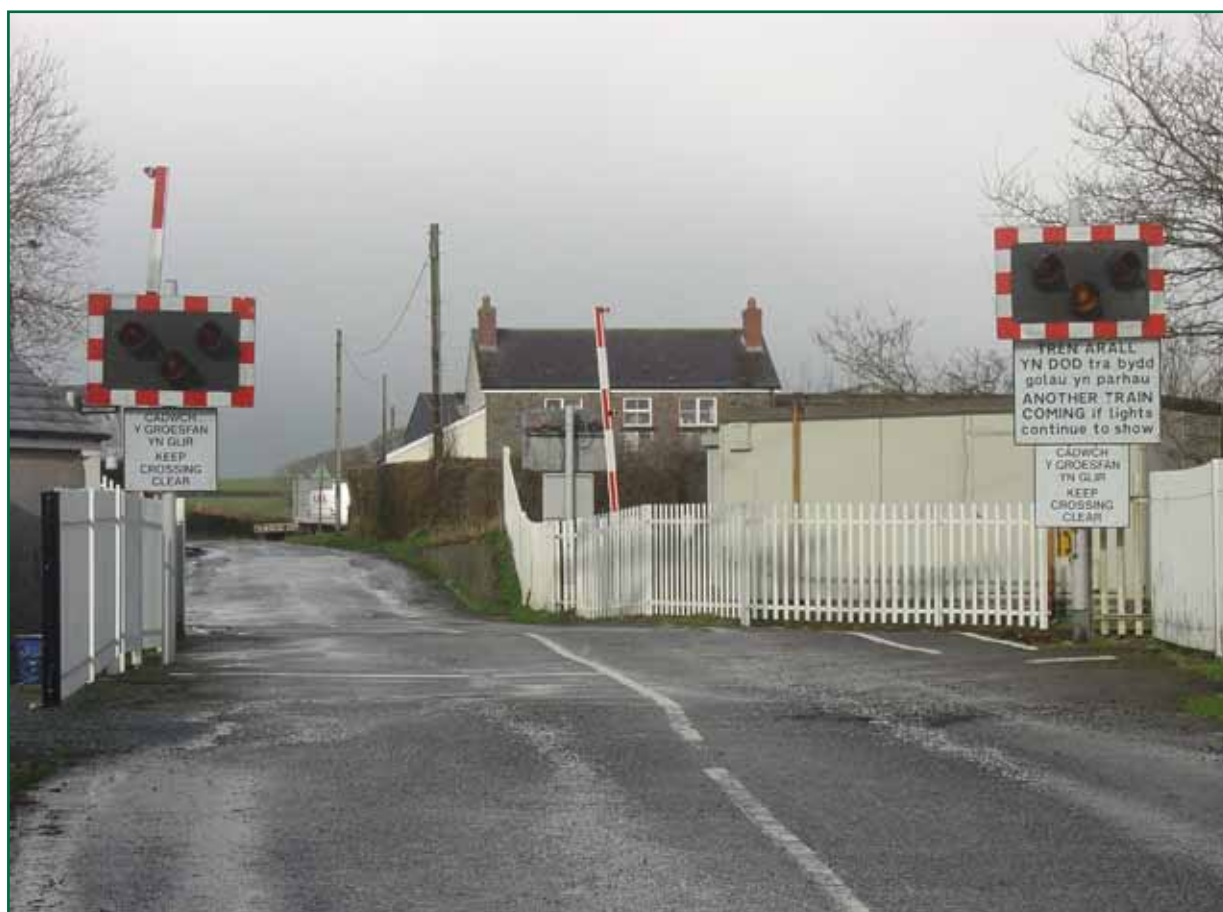
Figure 9: Wig wag signals at the south side of the crossing

- 34 The position of the wig wag light signals was shown on the crossing ground plan dated 25 June 1993 associated with the level crossing order¹⁰. The position was also specified in the Department of Transport's *Railway Construction and Operation Requirements – Level Crossings*; the same requirement is included in the current ORR guidance document *Railway Safety Publication 7 'Level crossings: A guide for managers, designers and operators'*. The position is defined as the distance between the nearest red light lens and the edge of the carriageway. This distance is defined as not less than 810 mm and not more than 1500 mm, meaning that the light unit backboard is clear of the carriageway. The position of the nearside wig wag unit on the south side of Llanboidy crossing did not comply with this requirement. The light unit was positioned at the edge of the carriageway and projected out into the carriageway by 1072 mm, meaning that the red lamp was 700 mm into the road rather than a minimum of 810 mm back from it (figure 9).

- 35 The combined effect of the wig wag signal being positioned too far out into the carriageway, the misalignment of the road over the crossing with the rest of the road and the position of parked vehicles on the far side (paragraph 40) would have been to encourage a lorry driver to take a line towards the right-hand side of the road. This line was obstructed by the half barrier on the far side lowering for the passage of the train.

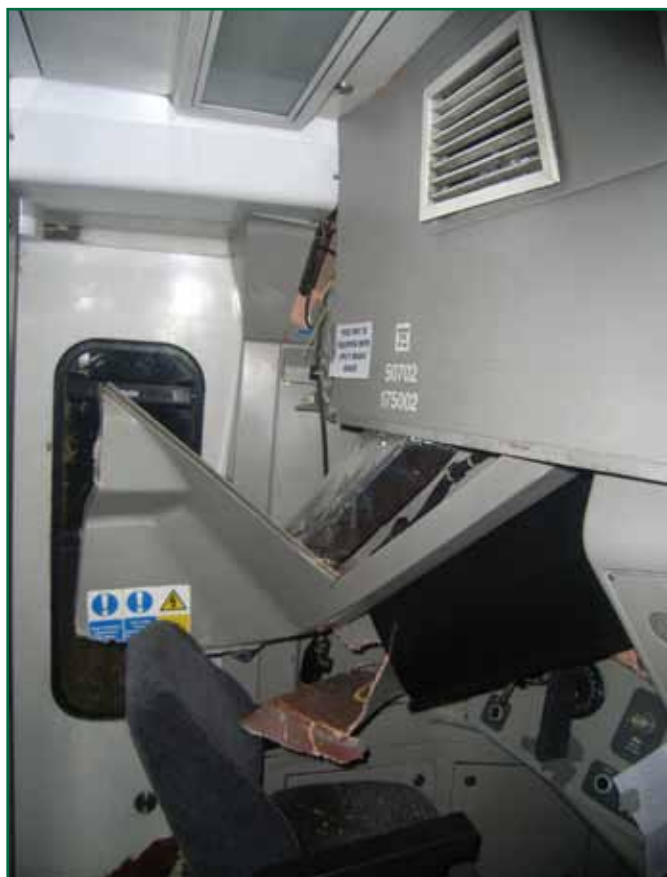
- 56 In the collision, the steel structure remained undamaged as the collision forces were not high enough to deform it. However the GRP skins became detached from the steel structure as they were hit by the lorry's load which pushed the skins towards the inside of the cab. Parts of the inner GRP skin intruded into the area around the driver's seat and compromised his survival space. It is likely that he would have sustained injury, had he not left the cab before the collision (figure 10). It should be noted that GM/RT2100 Issue 5 and the TSI, by reference to European Standard EN15227 '*Railway Applications – crashworthiness requirements for railway vehicle bodies*', now includes a specific definition of, and requirement for, a driver's survival space. This requires that deformation of the structure does not cause any vehicle equipment or parts to encroach into the designated survival space during the specified collision scenarios. RAIB calculations accounting for deformation of the obstacle showed that the collision scenario at Llanboidy was less severe than any of the EN 15227 scenarios for level crossing collision at a comparable speed.

Figure 10: Driver's seat showing position of GRP panels after collision

- 5 *The purpose of this recommendation is to find a means of mitigating the risk to the driver from detachment of the cab GRP structure during a collision.*
