Rail Accident Report

Collapse of the overhead line near to Jewellery Quarter Tram Stop, Midland Metro 20 April 2011

This report is published by the Rail Accident Investigation Branch, Department for Transport.

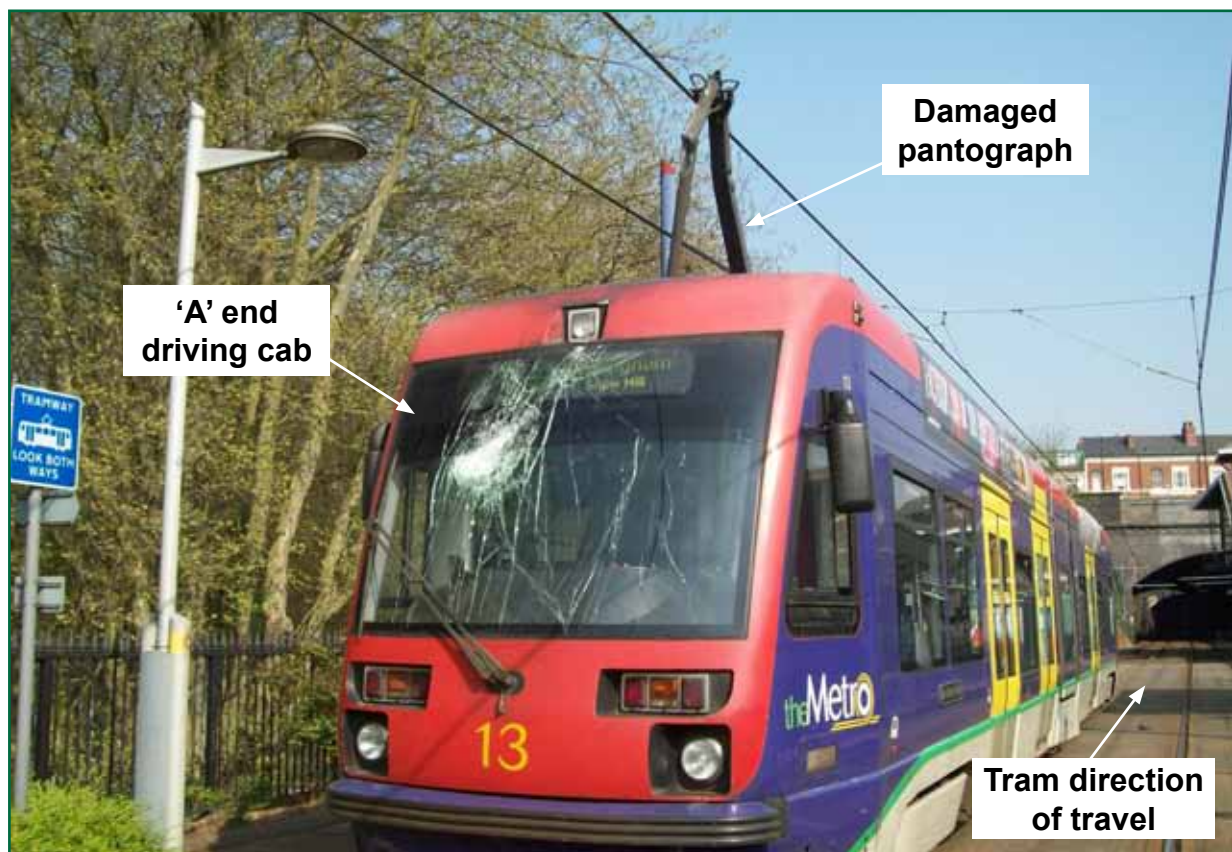
Figure 3: Damage to the trailing end of tram 13 (image courtesy of National Express Midland Metro)

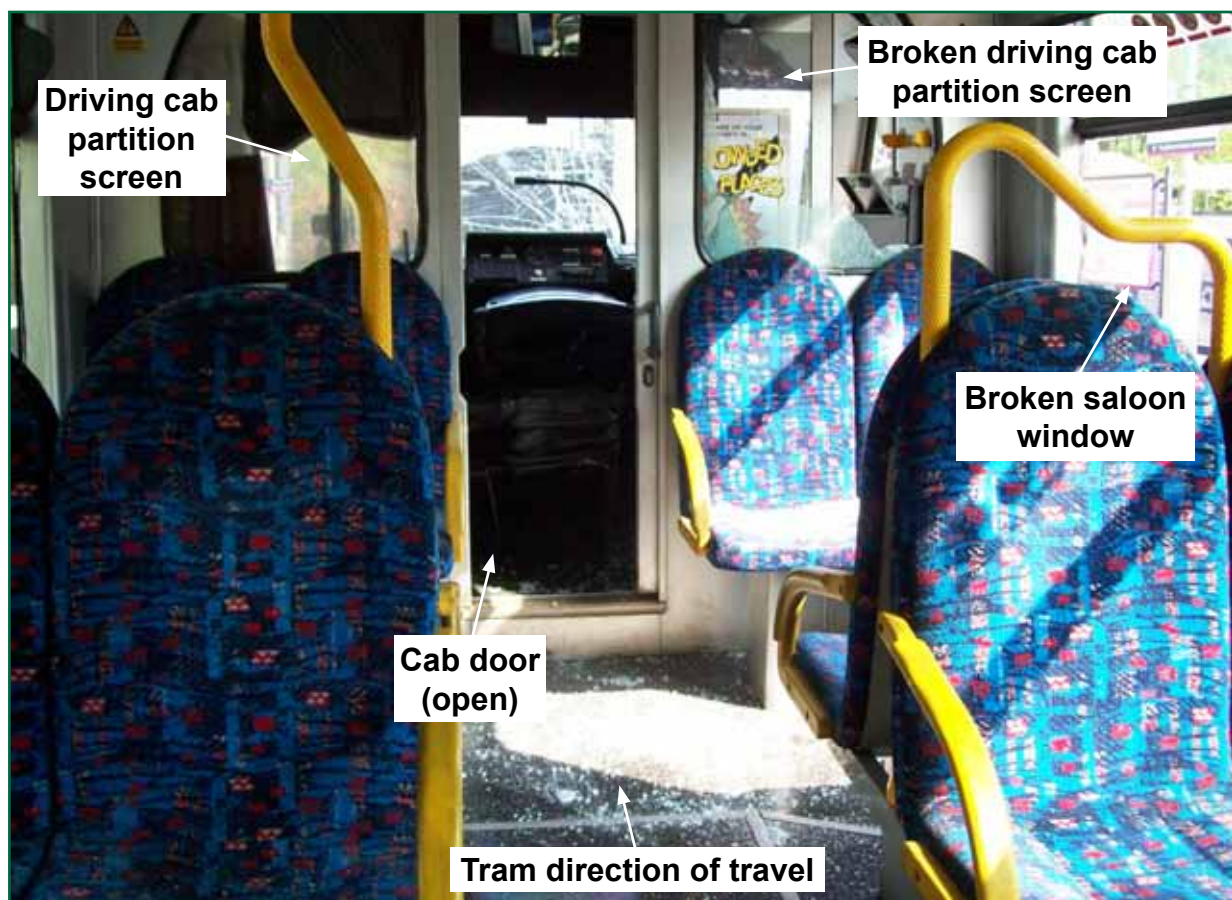
Figure 4: Damage to the saloon interior at the leading end of Tram 13 - the cab door is shown in the open position (image courtesy of National Express Midland Metro)

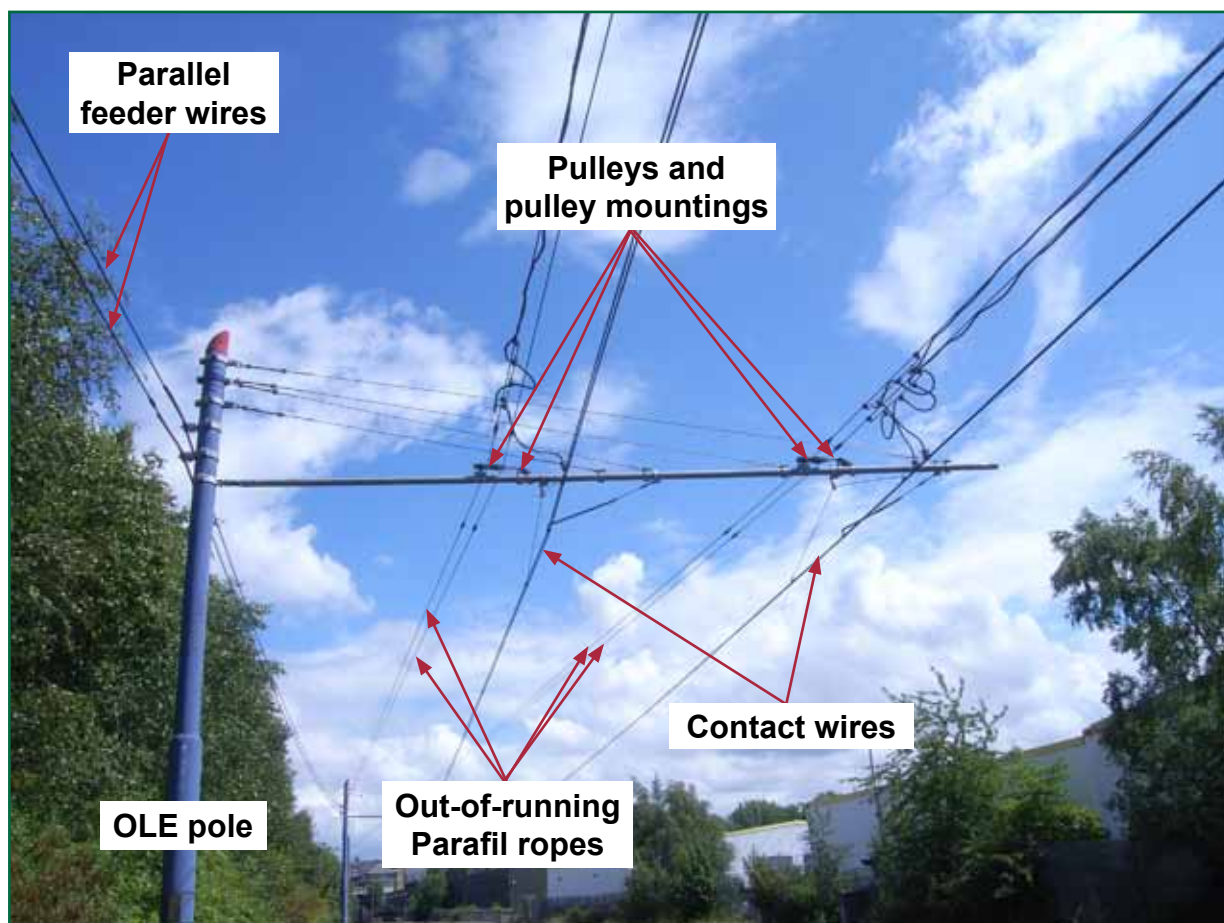
Figure 11: Post-incident photograph of overlap equipment at 18512 pole

- 42 At 13:24:57 hrs the tram CCTV system (which has cameras facing forwards and rearwards through cab windscreens and also throughout the saloon) shows Tram 13 approaching 18512 pole. The detached cantilever was not seen by the driver and was also out of view of the CCTV. The tram’s onboard *data recorder* registered its speed as being 70 km/h at this point.

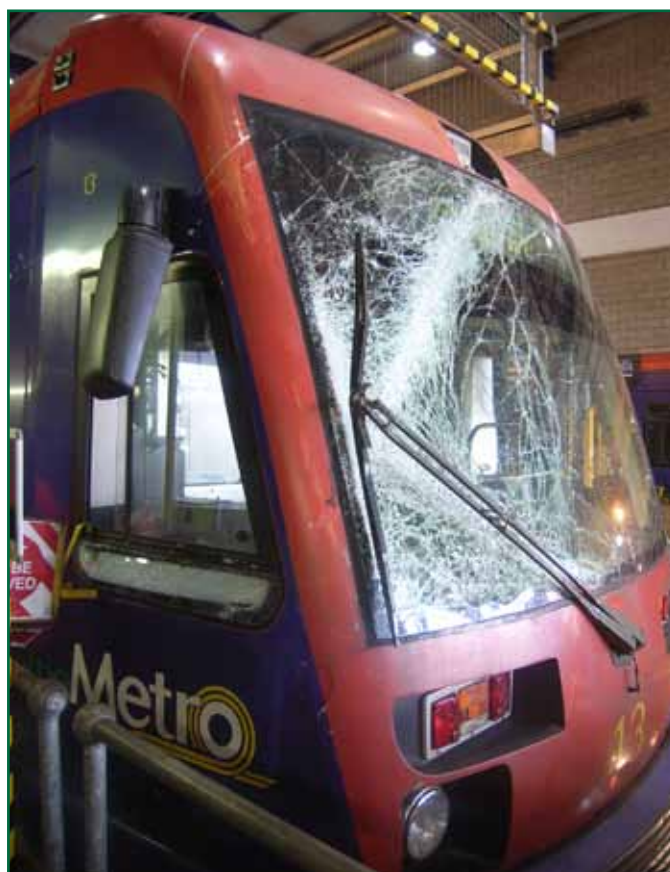
- 44 By 13:25:02 hrs the tram CCTV system recorded the right-hand side saloon doors sustaining damage. It also shows that the OLE collapse had now overtaken the tram, with the cantilever at 18606 pole having detached and dropped in front of the windscreen of the tram’s leading cab, which it then struck. Immediately afterwards the front-most right-hand side saloon window and the right-hand side driving cab partition screen both shattered, showering the passenger saloon with glass.

Figure 12: Damage to front windscreen and cab side window of Tram 13

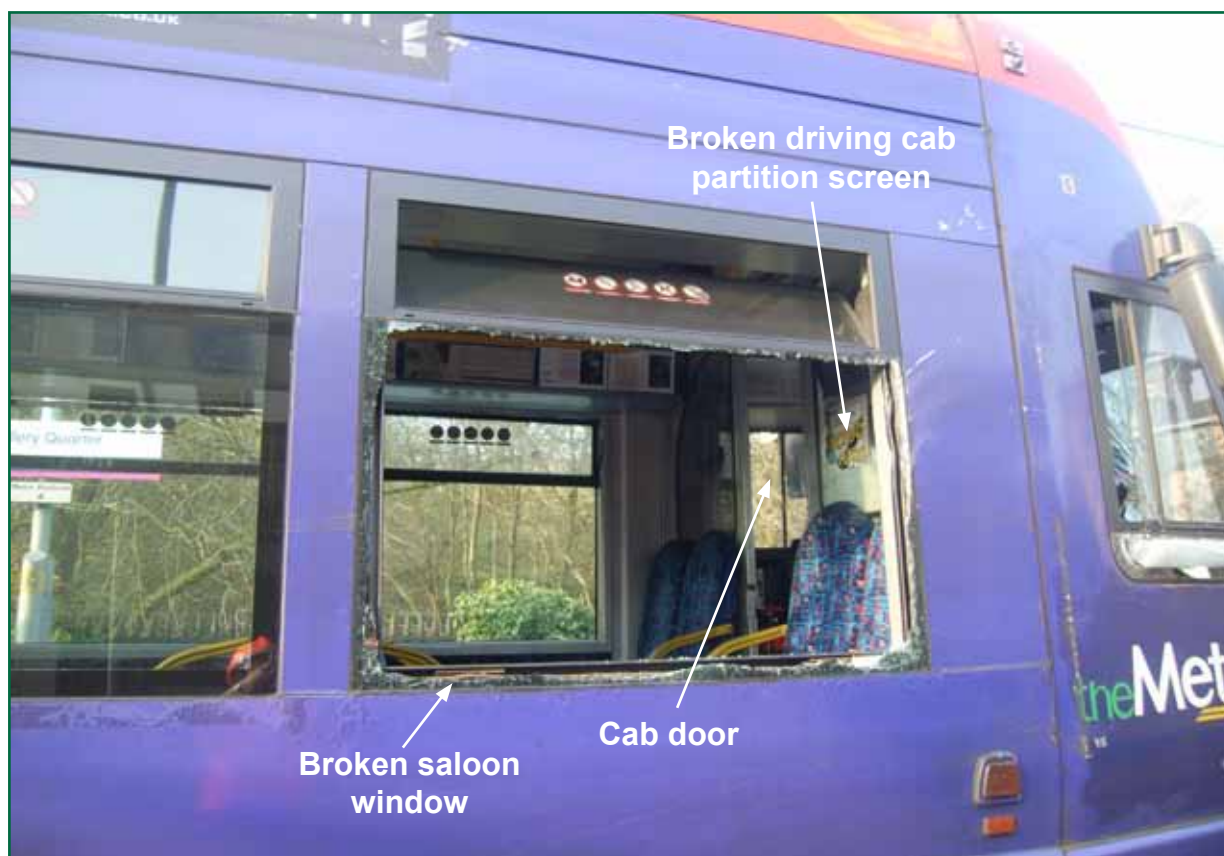
Figure 13: Damage to saloon window and driver's screen glass on the right-hand side leading end of Tram 13

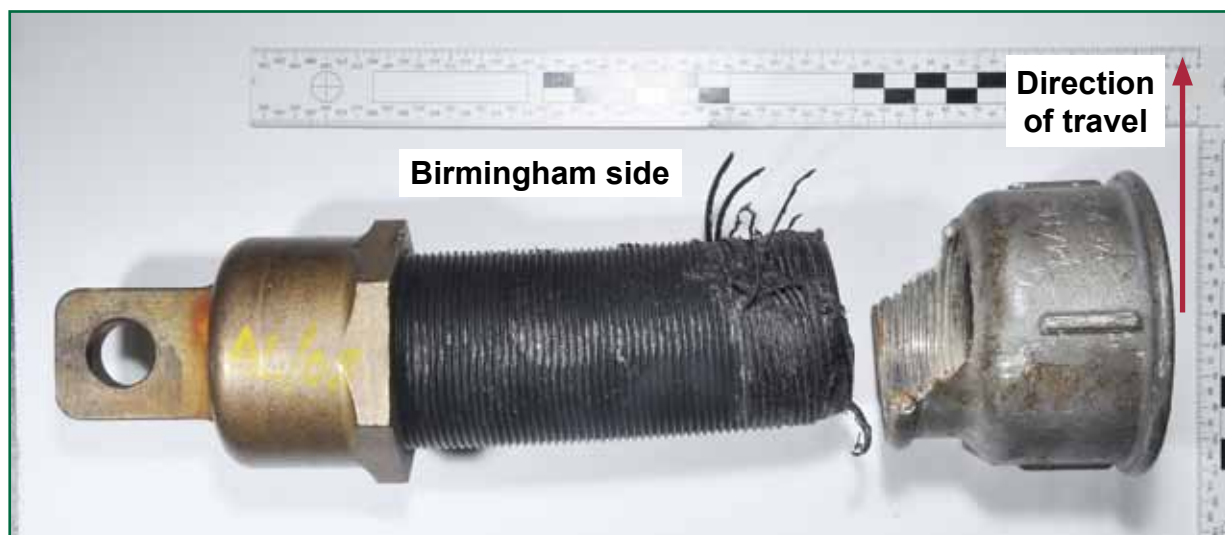
- 61 **The partial detachment of the cantilever at 18512 pole was due to the fracturing of the reducing sleeve.**
- 62 Examination of the bracket arm showed that the bracket foot assembly (figure 14) had parted at the point where the nylon insulator threads into the reducing sleeve, leaving both items damaged. The clevis cover and insulator remained attached to the pole bracket by the clevis pin, with the main body of the reducing sleeve remaining with the cantilever. The examination also found that the delta suspension connecting to the contact wire on the Wolverhampton line had been ripped from the clamp connecting it to the cantilever (figure 15) and that the register arm on this line was also disconnected. The Wolverhampton out-of-running pulleys had become separated from the cantilever at 18512 pole, although the out-of-running ropes and contact wires remained intact.

Figure 14: Damage to the bracket foot assembly of 18512 pole

- 67 The nylon insulator was deformed in the direction of Birmingham and slightly upwards (figure 14). The thread at the reducing sleeve end of the insulator was damaged, with many threads being deformed or stripped on both sides. Taken together with the distortion of the reducing sleeve segments this clearly indicates that the overload force was applied in the direction of Birmingham.
- 68 There are two credible sources of this overload, namely;
- the way in which *operating loads* were able to act (the less likely cause - see paragraph 69); and
 - the introduction of an *abnormal load* following the parting of a Parafil rope (the most likely cause - see paragraph 103).

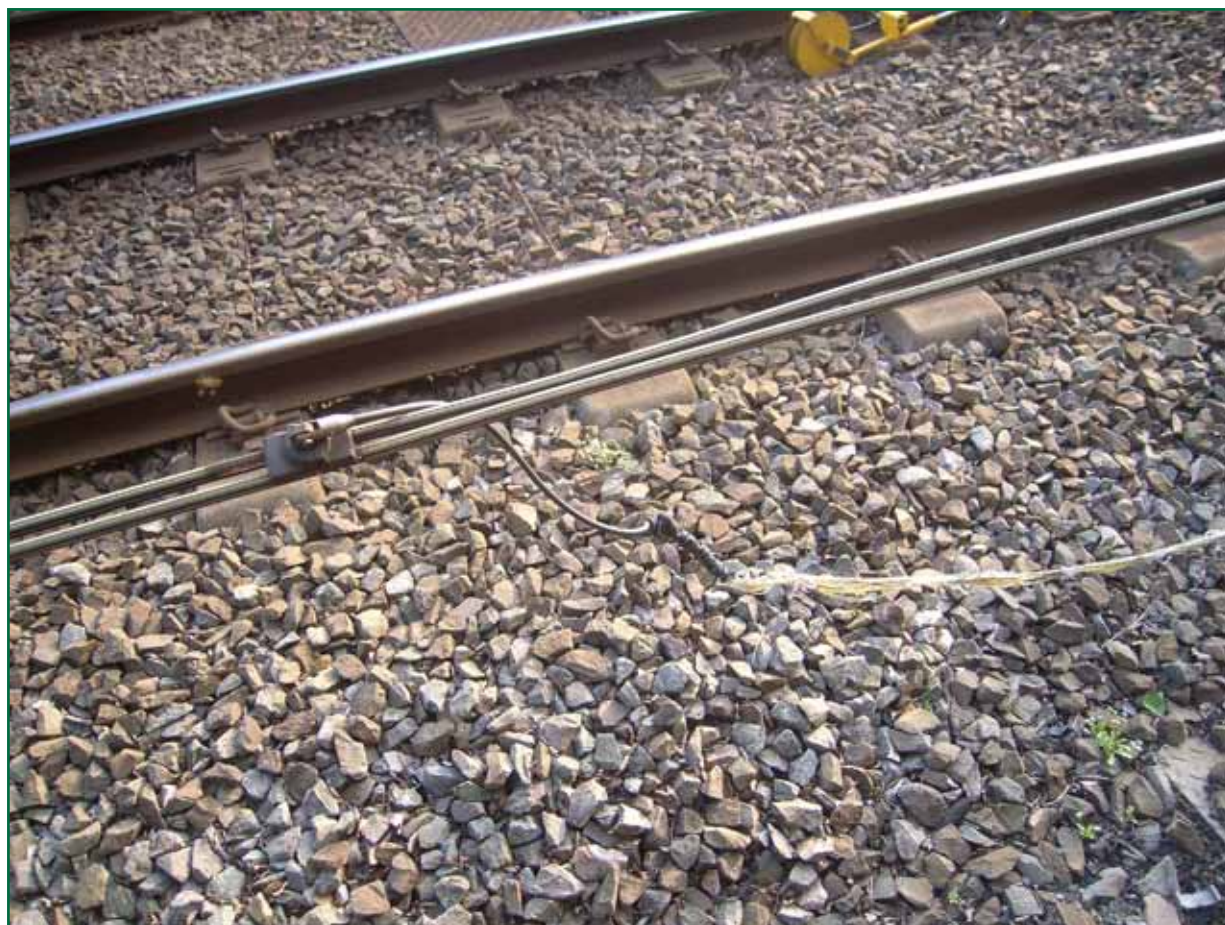
Figure 15: Damage to the delta suspension of the Wolverhampton contact wire

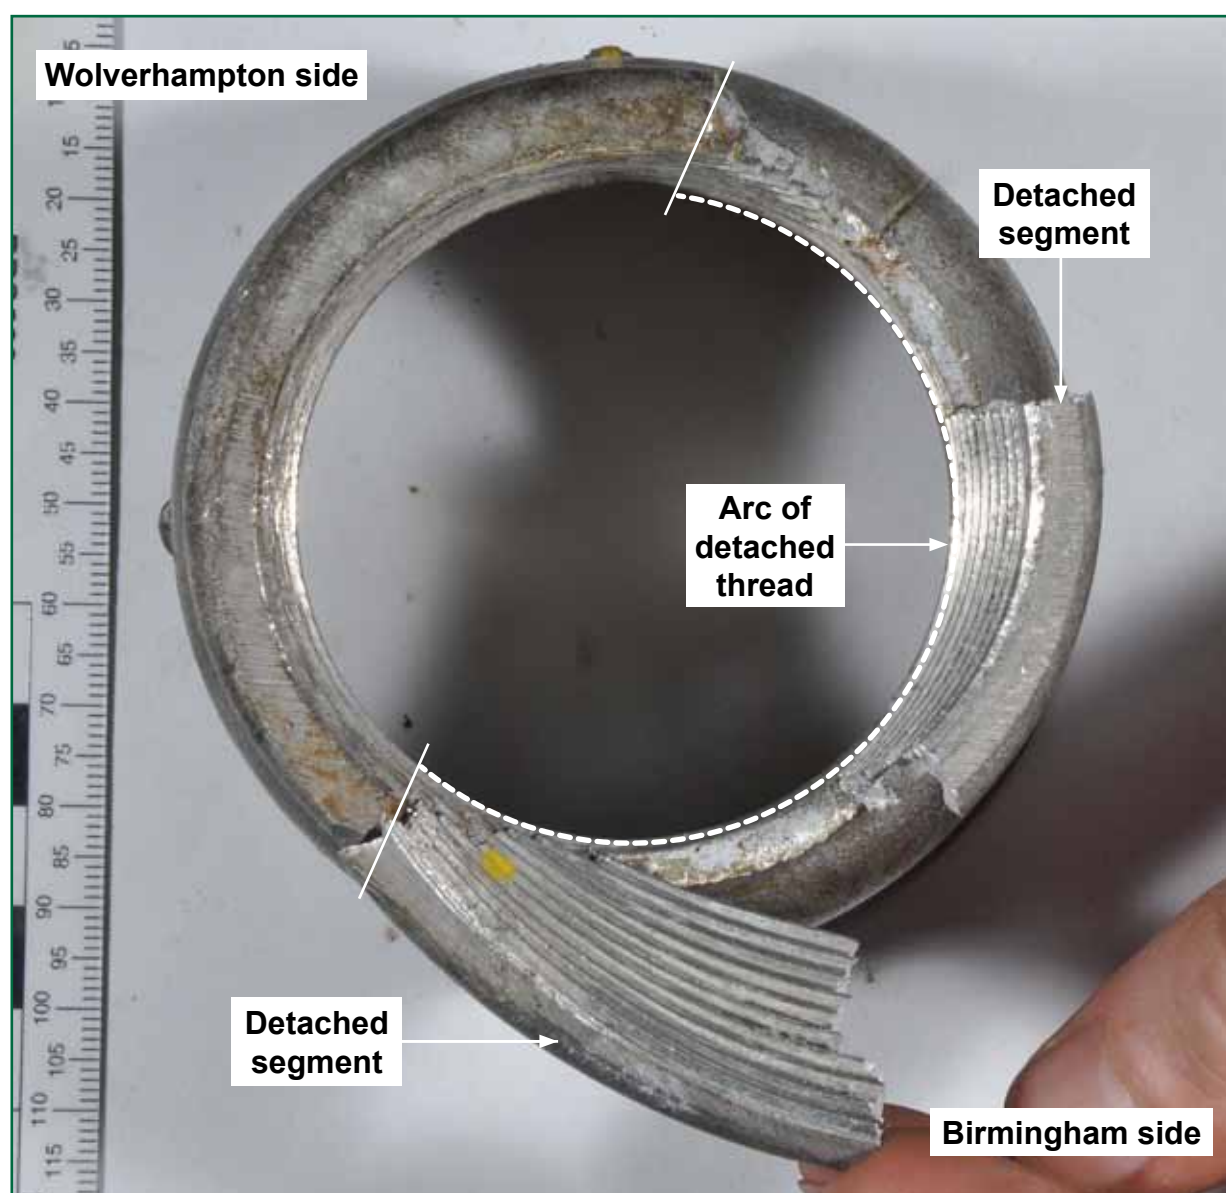
- 65 Metallurgical examination indicated that the reducing sleeve failed in a brittle manner due to mechanical overload. There was no evidence of significant impact damage, fatigue or significant casting defects. Although there was evidence of superficial corrosion, this had not caused significant material loss.

- 66 The reducing sleeve was cracked around the thread run out of the smaller diameter thread (ie where it meets the insulator), with the crack extending approximately 180° around the thickness of the sleeve and then longitudinally through this thread (figure 16). This caused the detachment of segments on the Birmingham side, from approximately the 1 to 7 o'clock positions. These segments were distorted in the direction of Birmingham as they separated from the sleeve.

Figure 16: Damage to the reducing sleeve - two of the detached pieces of the smaller diameter thread have been re-positioned for photographic purposes

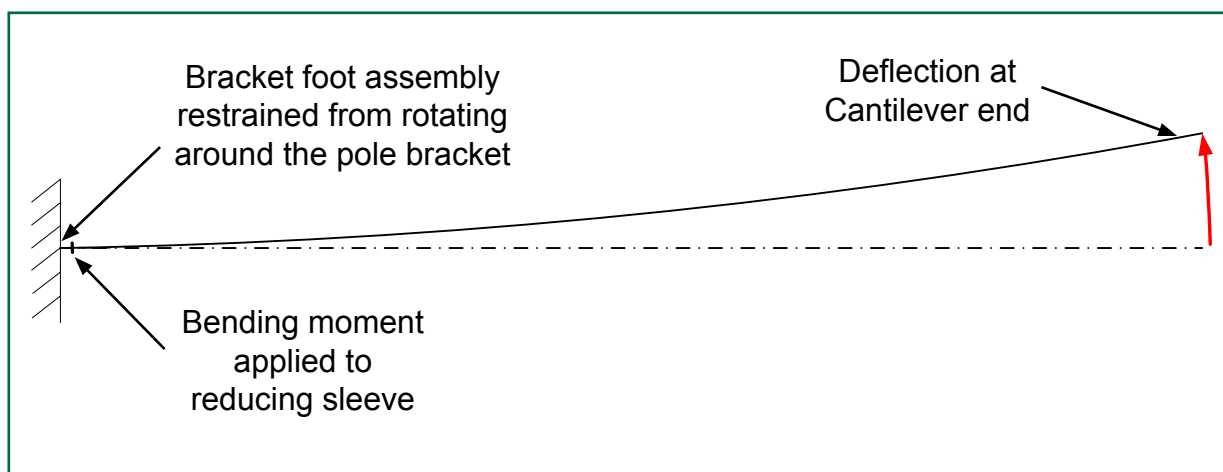
- the bracket foot assembly became restrained from rotating around the pole bracket pin and the cantilever end was deflected by 400 mm (figure 17); or
 - the cantilever became fixed at some point along its length such that a cantilever deflection could apply a bending moment on the reducing sleeve. For example, if the Birmingham contact wire delta was able to act as a pinned joint, then deflecting the cantilever end by 400 mm would also result in the reducing sleeve entering yield (figure 18).

Figure 17: Diagrammatic representation of the bracket foot assembly becoming restrained from rotating around the pole bracket and the cantilever end being deflected

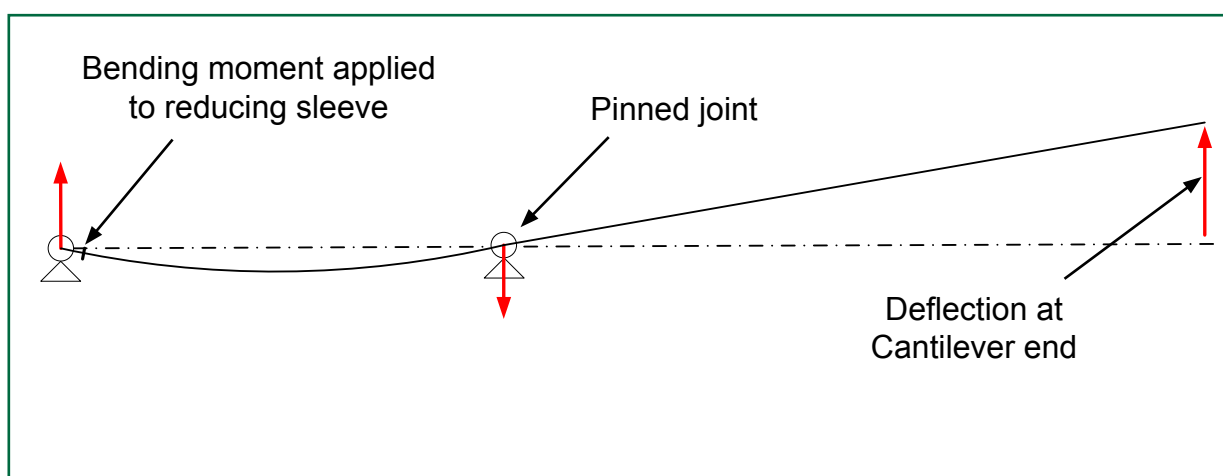
Figure 18: Diagrammatic representation of the cantilever becoming fixed at some point along its length and the cantilever end being deflected

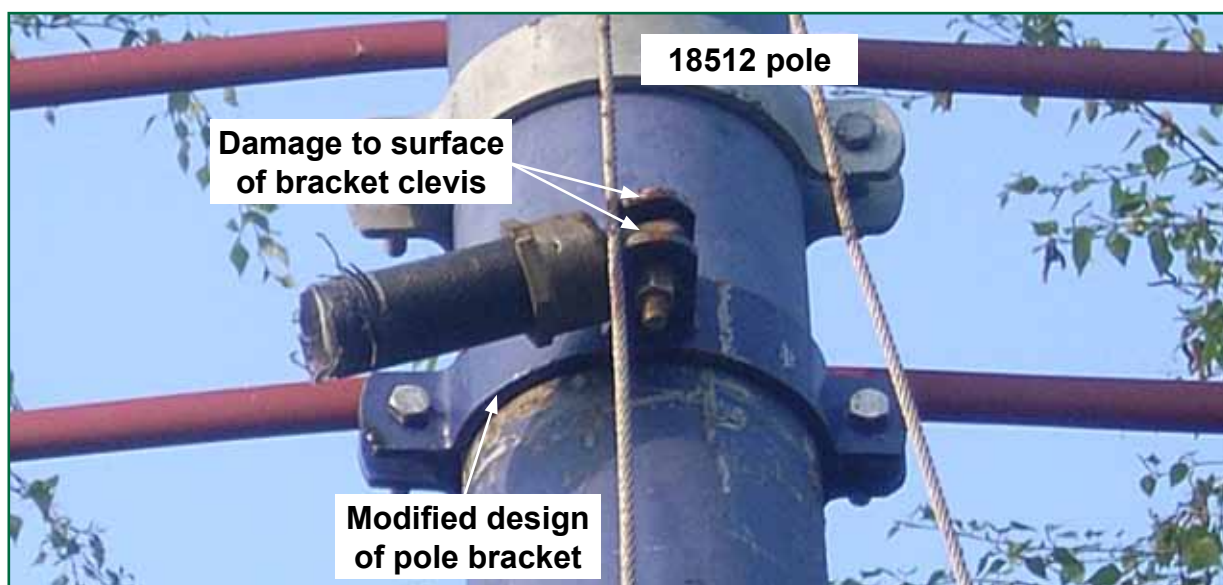
Figure 21: Modified design of pole bracket in-situ at 18512 pole following the accident

- 91 It is also of note that, during recovery operations following the accident, there was a comparable failure of a reducing sleeve on another pole whilst the contact wires were being connected. In this second failure, the bracket foot was unable to rotate because it had been fitted in error to a tie rope pole bracket (figure 23) which had a square-faced profile.
- 92 Despite there being evidence of contact between the bracket clevis and clevis cover at 18512 pole, analysis showed that, whilst this may have caused some restriction of movement, the friction created would have been insufficient to react the magnitude of bending moment required to yield the reducing sleeve ie the clevis cover would slip across the face of the bracket clevis before the reducing sleeve started to yield.

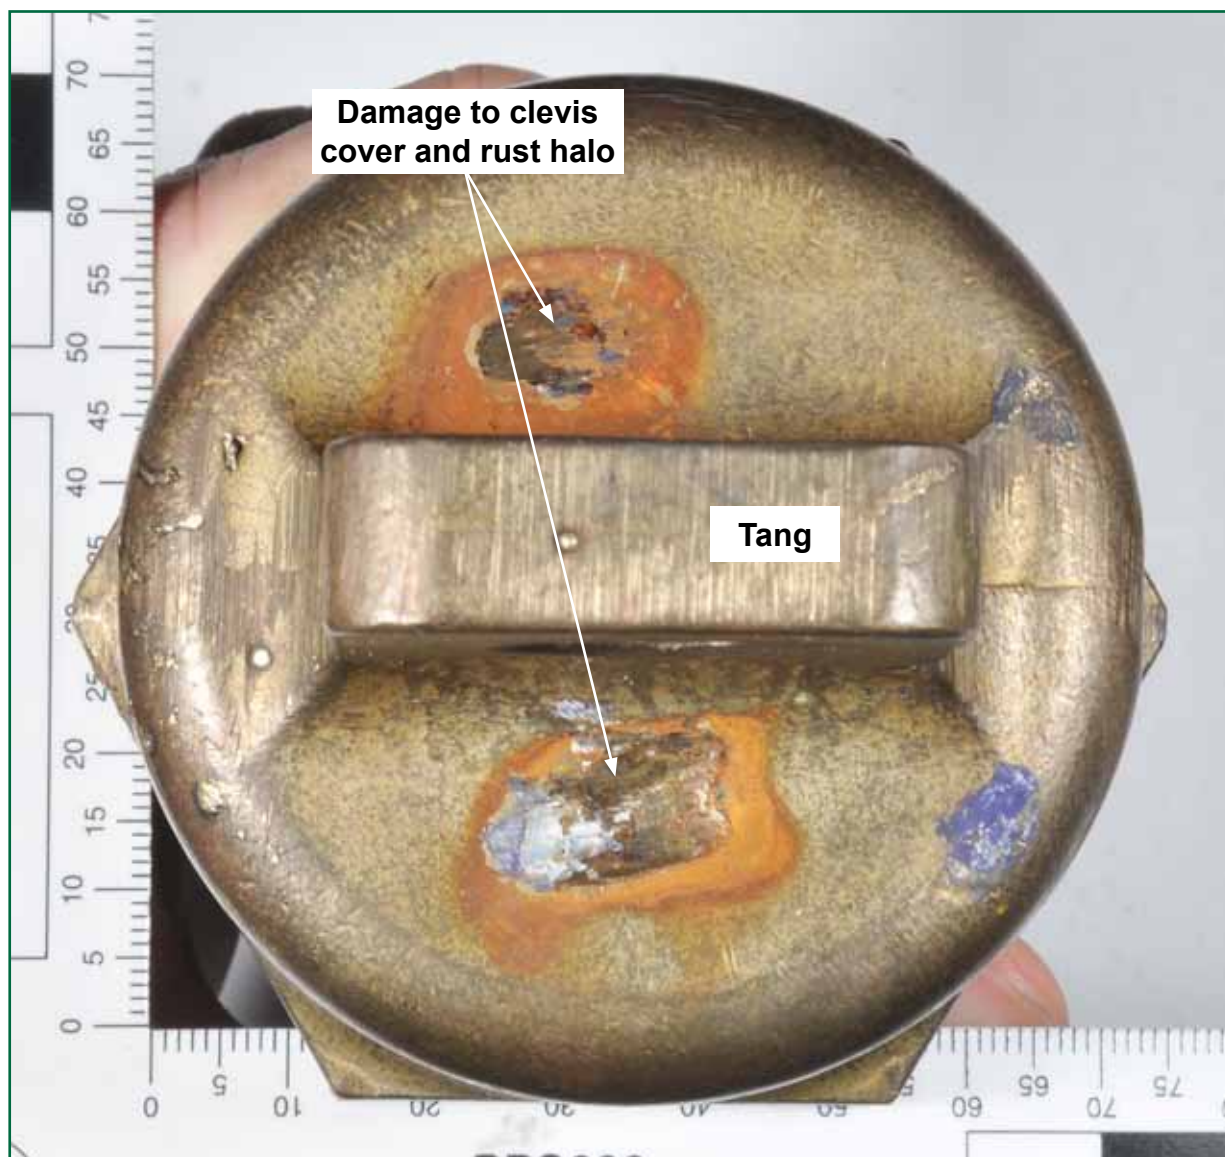
- 90 Post-incident inspection showed evidence of contact between the bracket clevis and the clevis cover of the bracket foot assembly recovered from 18512 pole. The bracket clevis had either a rough or damaged face (figure 21) whilst the clevis cover showed both wear marks and evidence of rust (figure 22). This rust could only have resulted from contact with a steel item, such as the pole bracket (the clevis cover is made from aluminium bronze and would not produce rust).

Figure 22: Marks on the clevis cover of the bracket foot assembly taken from 18512 pole

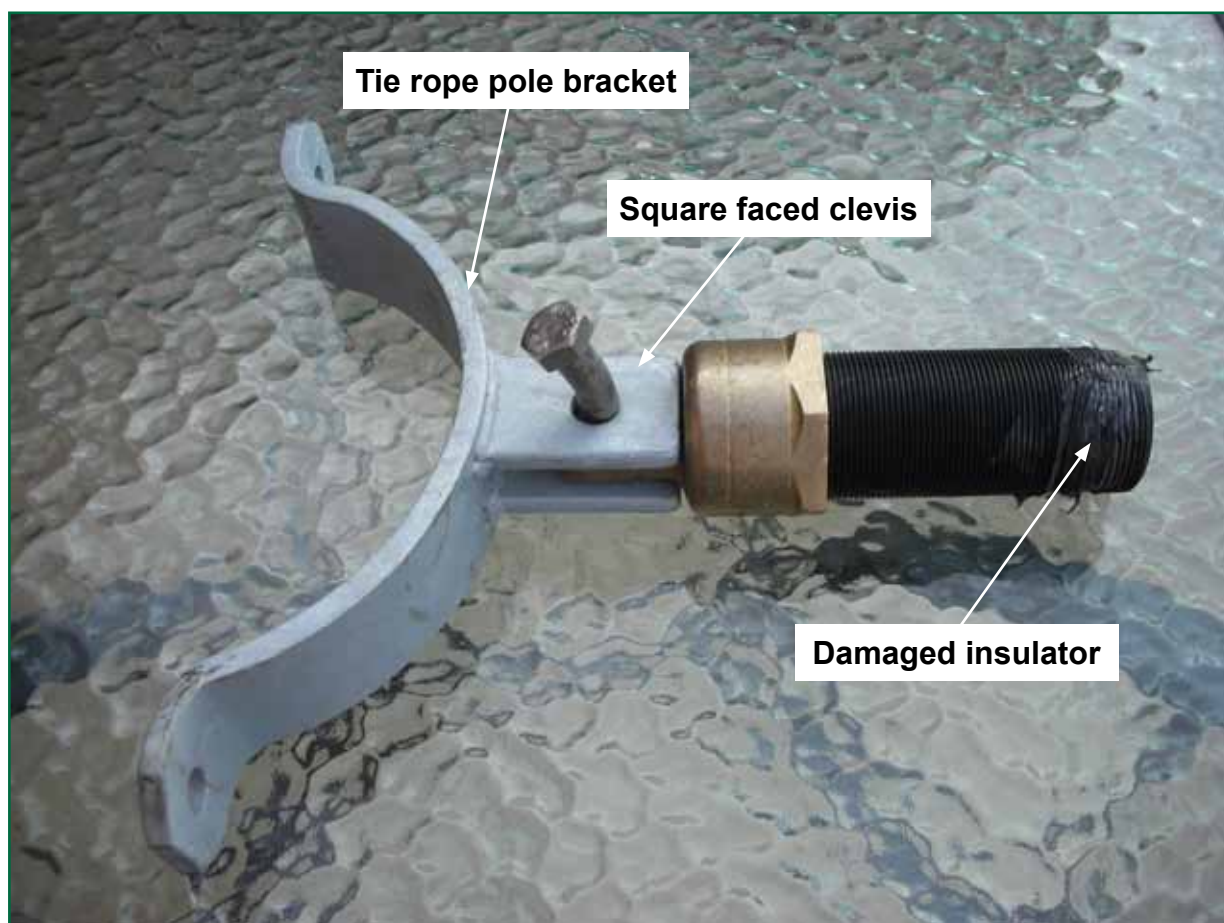
Figure 23: Bracket foot assembly which failed post incident, connected to a tie rope pole bracket featuring a square faced clevis (image courtesy of National Express Midland Metro)

- 93 Testing and analysis indicated that the presence of a small flat profile of 10 mm on the bracket clevis would react the bending moment necessary to yield the reducing sleeve through the clevis pin and the tang of the clevis cover. However, this reaction load would also be expected to distort the tang of the clevis and/or the clevis pin (in a similar manner to that shown in figure 23). Although the clevis pin fitted at the time of the accident was not available for examination by the RAIB, the inspection of the tang of the clevis cover showed no obvious evidence of such distortion, nor was there any evidence of a flat being present on the bracket clevis.

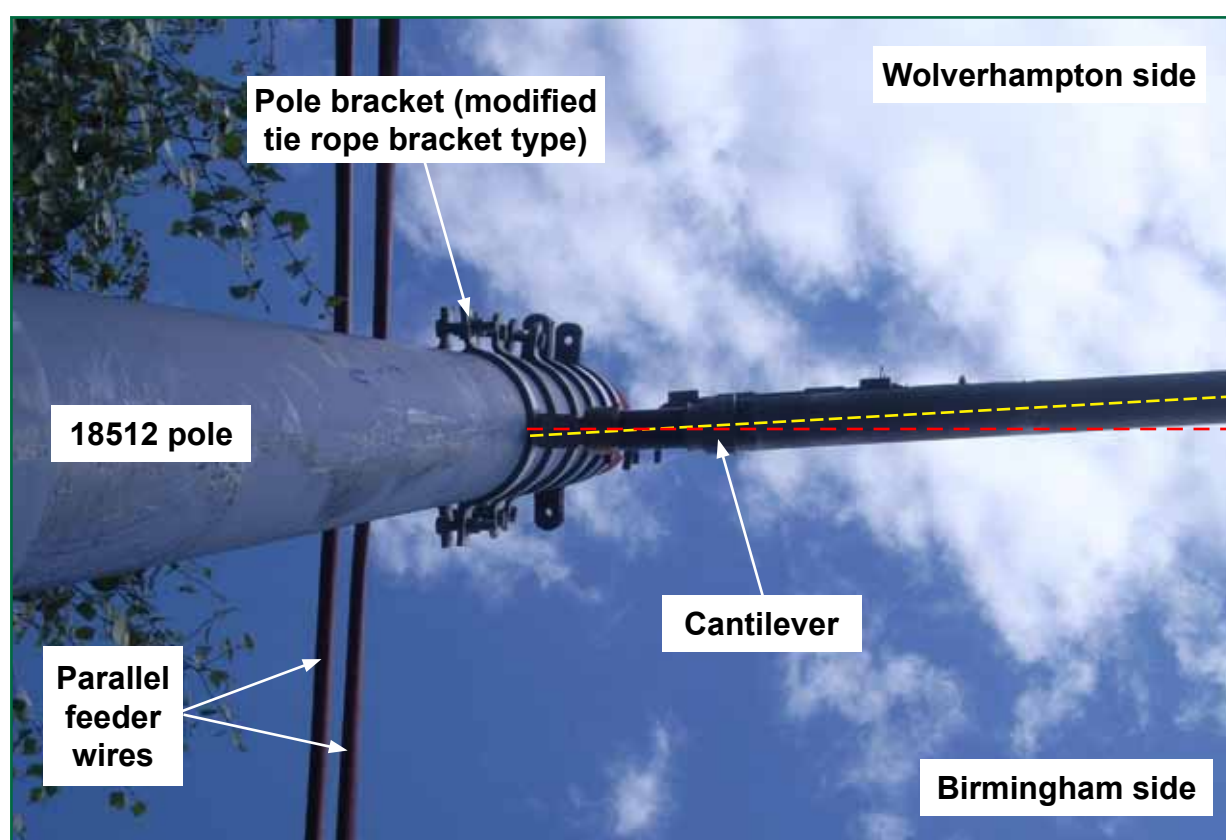
- 76 The distortion of the reducing sleeve segments and the deformation of the nylon insulator indicate that the cantilever was deflected towards Birmingham prior to the sleeve failing. Measuring the angle of deformation of the insulator (some of which may have been caused as a result of the dewirement) and extrapolating it over the typical cantilever length (7.97 metres) indicates that the end of the cantilever at 18512 pole was deflected by no more than approximately 550 mm from its position when perpendicular to the centre line of the track.

Figure 24: Photograph of 18512 pole taken in July 2011 showing insulator deformation

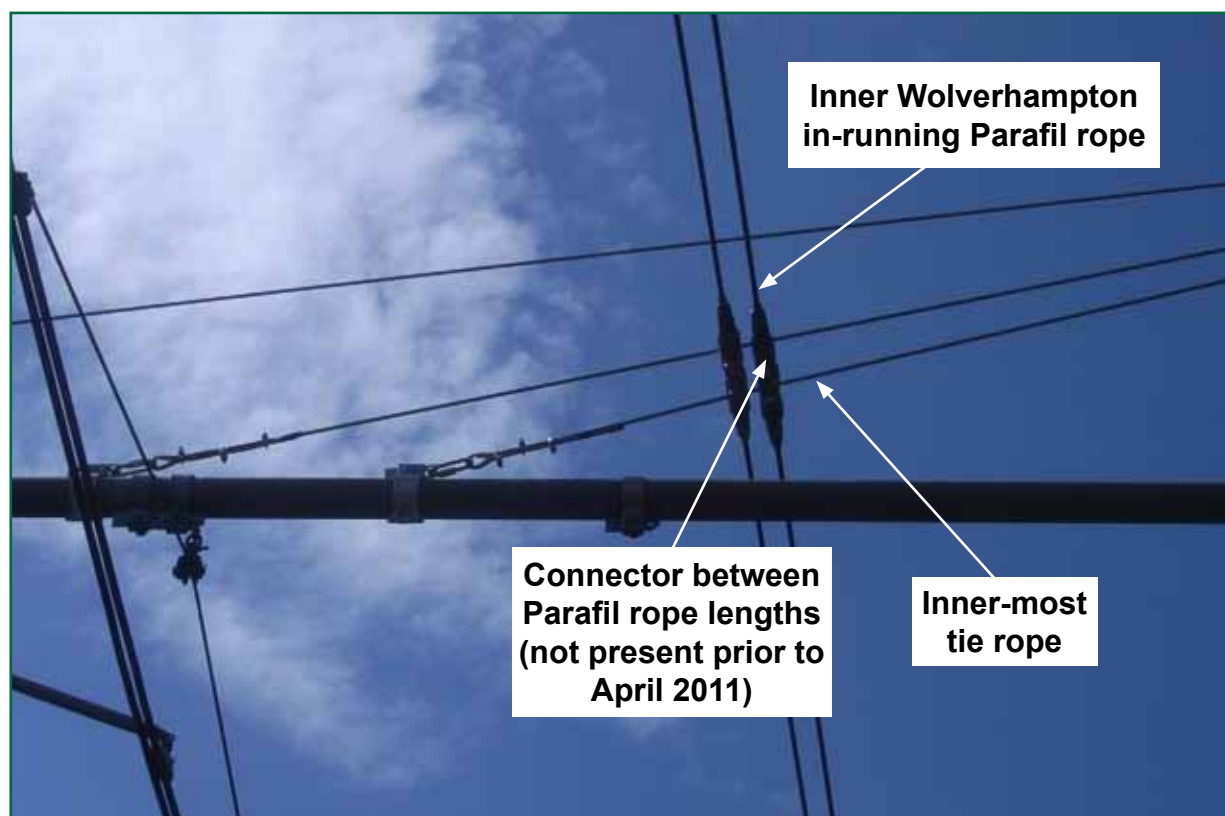
110 The damage to this rope could have occurred either prior to the accident or as part of the collapse of the OLE which followed it, although it is significant that the Parafil seems to have parted where it ran in close proximity to the tie ropes supporting the cantilever at 18432 pole. The evidence available to the RAIB is that the parted tie rope ran between the inner-most and middle tie ropes, although it is inconclusive as to whether the Parafil rope was able to touch these tie ropes prior to April 2011. However a post-incident inspection of 18432 pole in July 2011 showed that the inner of the two Wolverhampton in-running Parafil ropes was touching the inner-most steel tie rope as it passed over the cantilever (figure 25).

Figure 25: Inner Wolverhampton in-running Parafil rope touching a tie rope at 18432 pole – photograph taken in July 2011
