# Rail Accident Report

**Fatal accident at Grosmont, North Yorkshire  
Moors Railway  
21 May 2012**

Report 23/2012  
October 2012

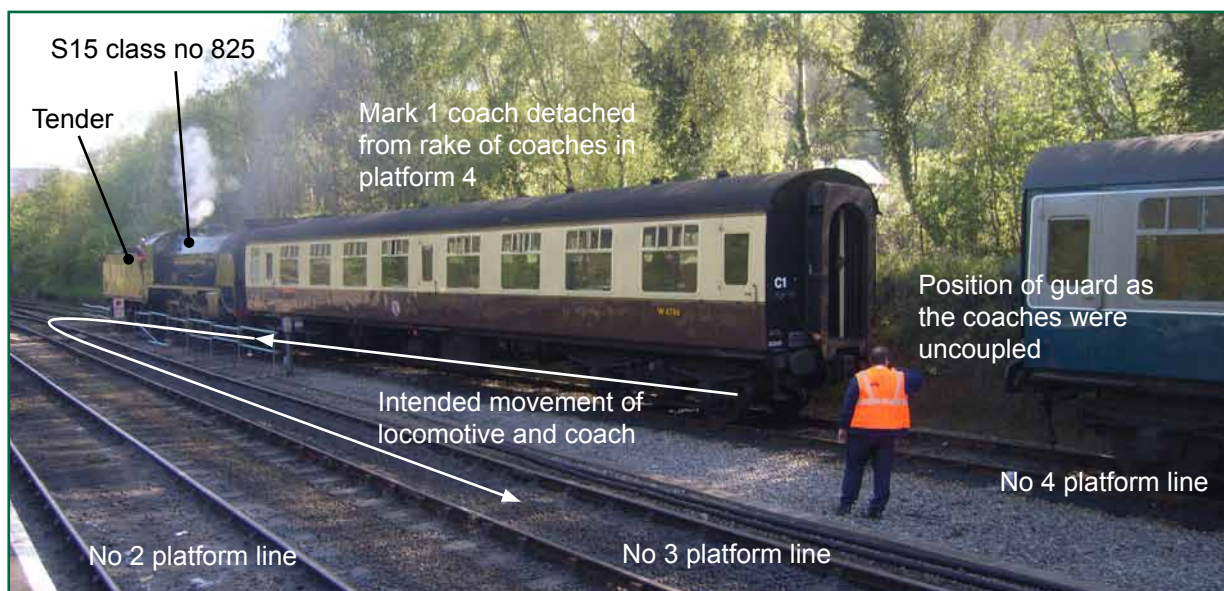
- 5 As one of the coaches was being drawn away by a steam locomotive, to be coupled to another rake of coaches, the locomotive changed direction and pushed the coach back towards where the uncoupling had just taken place. Meanwhile, the guard had gone between the coaches to complete the work arising from the uncoupling. The guard was trapped between the coaches and was fatally injured. Figure 2 shows the site of the accident.

Figure 2: The accident site at Grosmont station showing a reconstruction by the RAIB of the accident circumstances

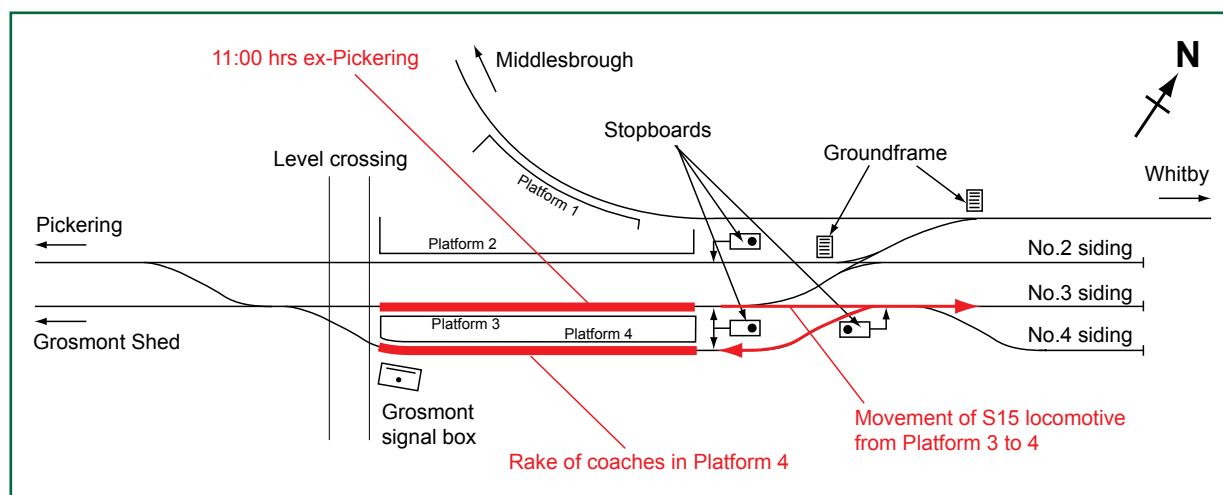
- 7 The station track layout at Grosmont (figure 3) consists of one platform to serve the Esk Valley line and three platforms to serve the NYMR. At the north end there are three NYMR sidings and a connection between the NYMR and the national network. Immediately south of the station there is a level crossing, followed by a short tunnel, and then the locomotive shed. Through the station, the gradient falls away at 1 in 126 towards Whitby.

Figure 3: The track layout at Grosmont station

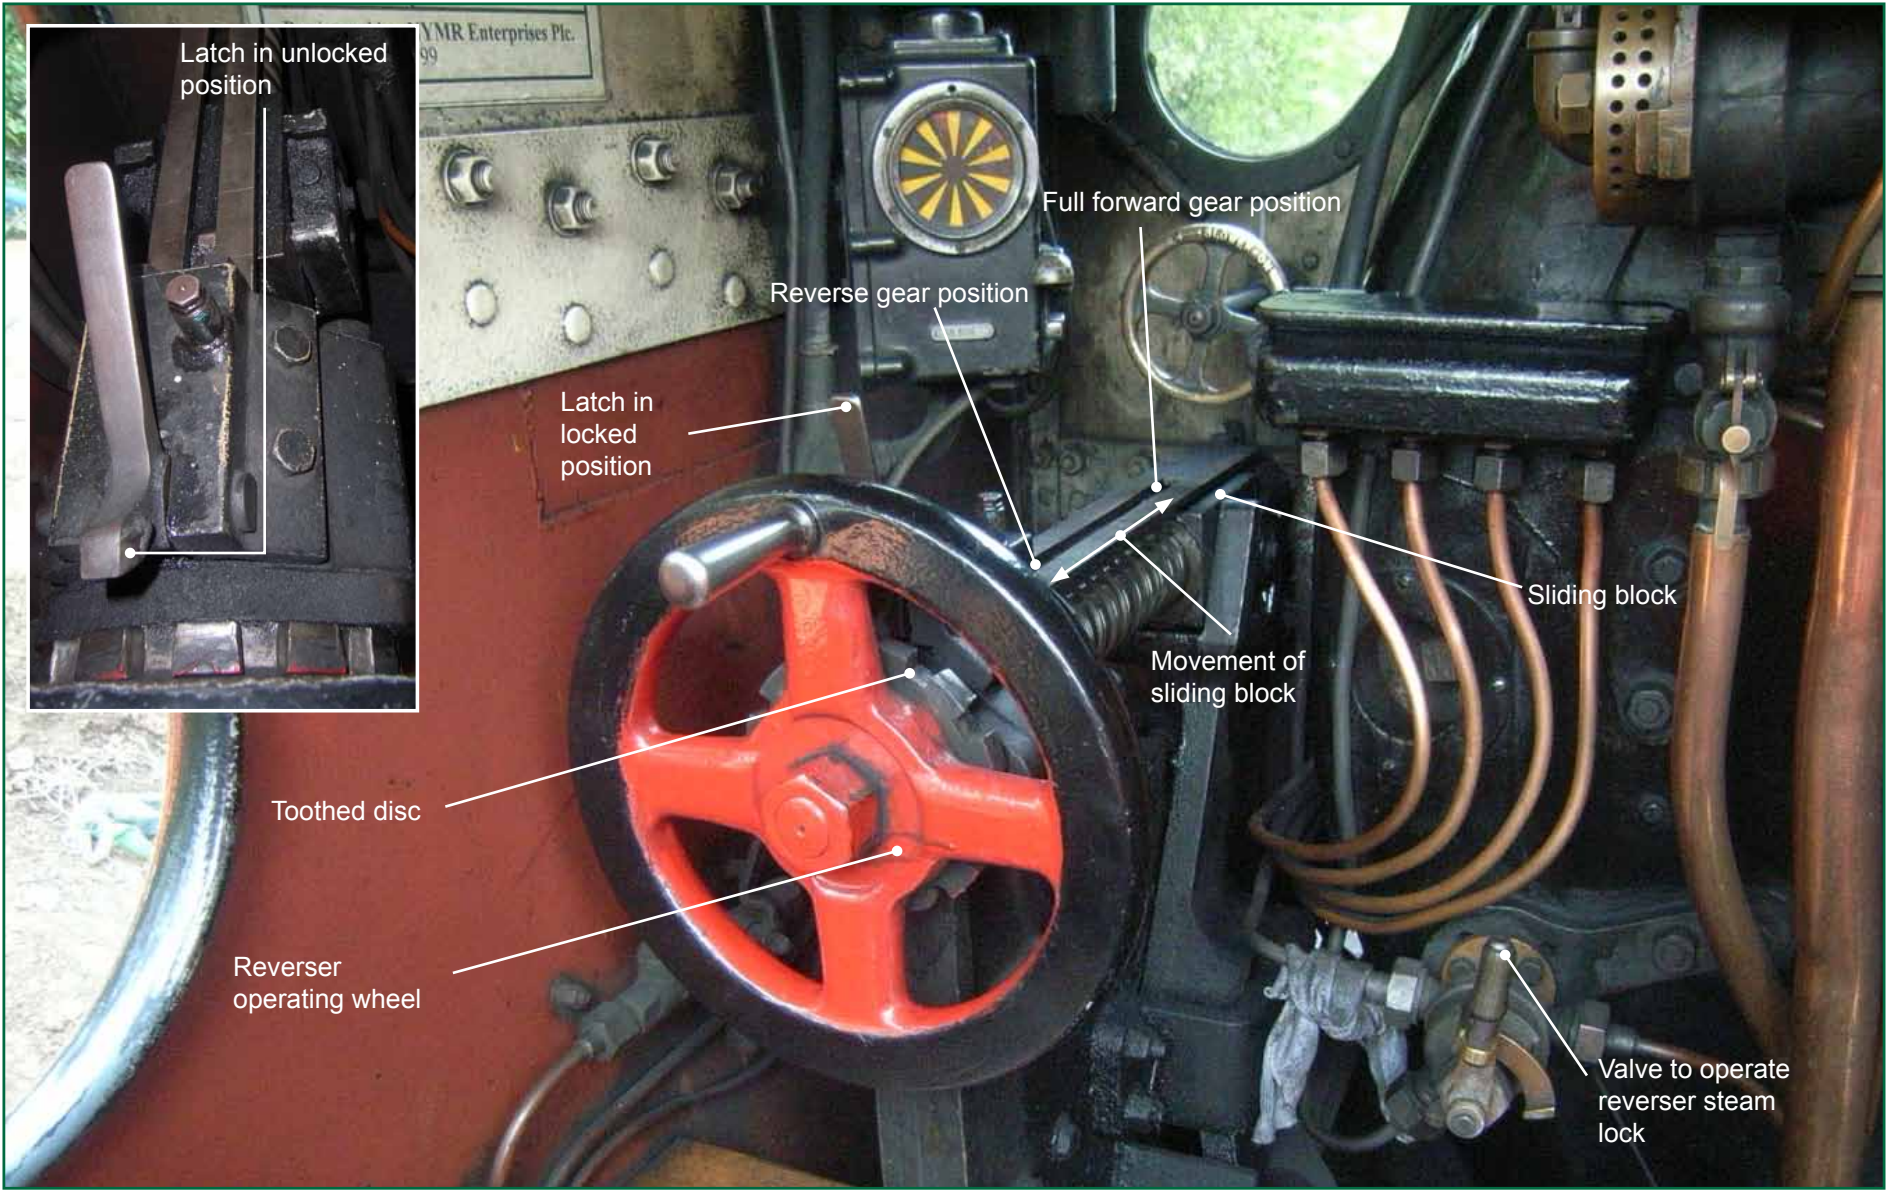
- 11 In common with many other types of steam locomotive, the S15 locomotive is fitted with a *screw reverser* (figure 4) which the driver operates to alter the setting of the *valve gear*. The valve gear consists of a set of rods and links moved by the rotation of the locomotive's driving wheels, which in turn controls the admission and exhaust of steam to and from the locomotive's cylinders by opening and closing valves. Changing the setting of the valve gear can alter the direction of the locomotive from forwards to reverse (or vice versa) and alter the quantity of steam being admitted to the cylinders during each piston stroke. The S15 locomotive has two sets of valve gear; one on each side of the locomotive; the valve gear fitted to the right-hand side of the S15 is shown in figure 5.

- 13 Two locking devices are fitted to the S15 locomotive to prevent the reverser changing position when the locomotive is moving. These are a mechanical latch (figure 4), which is spring loaded with an over centre spring and, when operated, engages with a toothed disc fixed to the reverser shaft; and a steam operated lock. It is only necessary to use the mechanical latch during shunting movements, whereas during service running both locking devices should be used. Use of the mechanical latch alone in these circumstances would cause it to rattle resulting in wear and a noise distraction to the driver as a result of the higher forces when the locomotive is working at higher loads.

Figure 4: The screw reverser and its locking mechanism in the cab of S15 class locomotive no.825

- 47 The RAIB has concluded that the reverser was able to move because the driver had not used the mechanical latch to prevent it, even though the evidence was that he fully understood the purpose of the latch and when it should be used. This almost certainly resulted from a lapse, the reasons for which the RAIB has been unable to determine. The examination which qualifies drivers as competent when converting from fireman to driver (paragraph 15) includes questions on the valve gear, which he answered competently. The driver's practical driving assessments provided no evidence of any issues concerning his use of the screw reverser locking devices.

- 51 The RAIB examined the latch mechanism, and the condition of the toothed disc with which it engages, and found no apparent deficiencies in its operation. The records show that the reverser, including the latch mechanism, was last examined as part of the routine annual examination of the locomotive on 20 March 2012. The latch is also used daily by maintenance staff as part of the safety precautions associated with the daily examinations; any defect in the operation of the latch should be identified from these examinations. There are no records of any defects having been found.

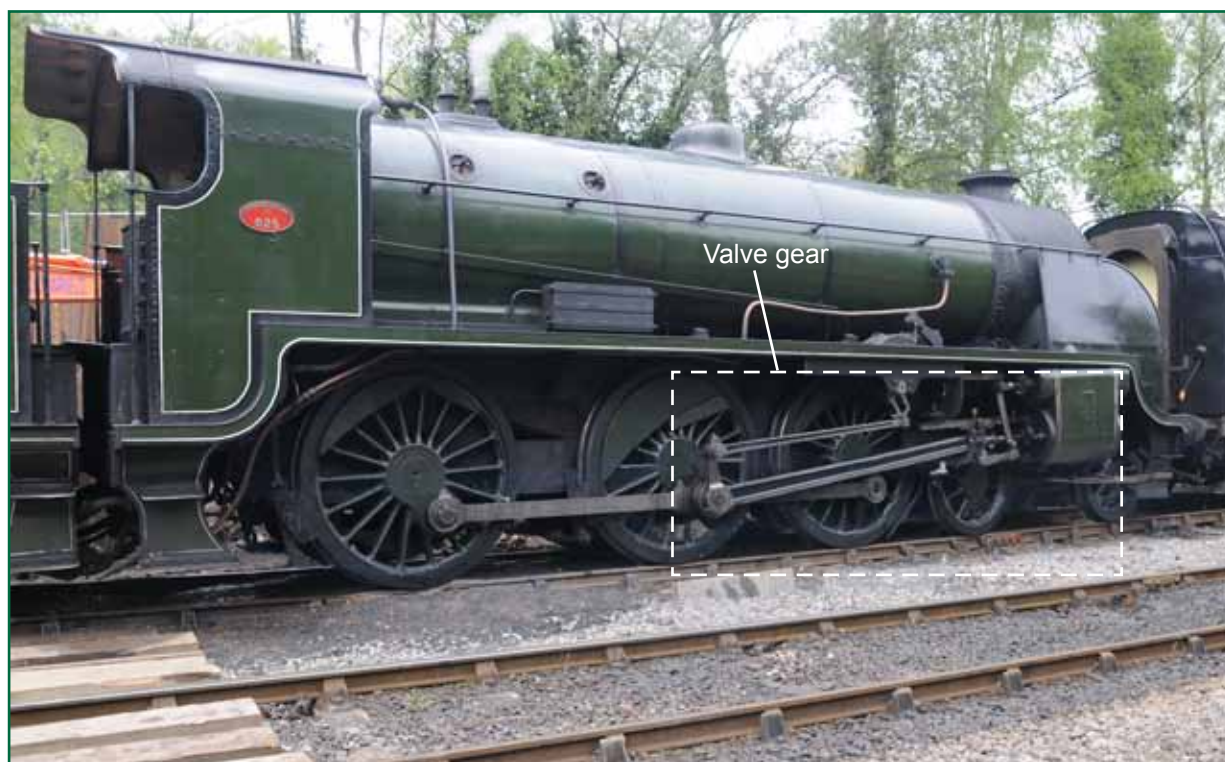
- 12 When the reverser is operated to alter the position of the valve gear from full forward gear towards mid-gear and then (if the locomotive is required to go backwards) into reverse (back) gear, its mechanism lifts one end of both radius rods, each of which is able to slide in its associated expansion link (figure 6). If the reverser is not restrained, the weight of the radius rods then acts to try and pull the valve gear to full forward gear, altering the position of the reverser. To prevent this movement, screw reversers are fitted with locking devices.

Figure 5: Valve gear fitted to S15 class locomotive no.825 with the locomotive in reverse gear
