Rail Accident Report

**Road vehicle incursion and subsequent
collision with a train at Stowmarket Road,
30 November 2011**

Report 25/2012
November 2012

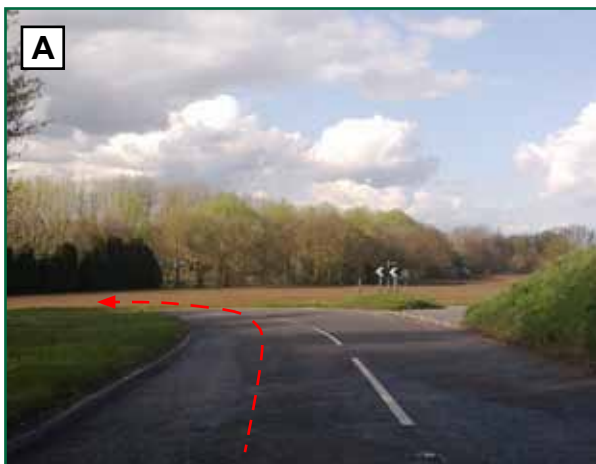
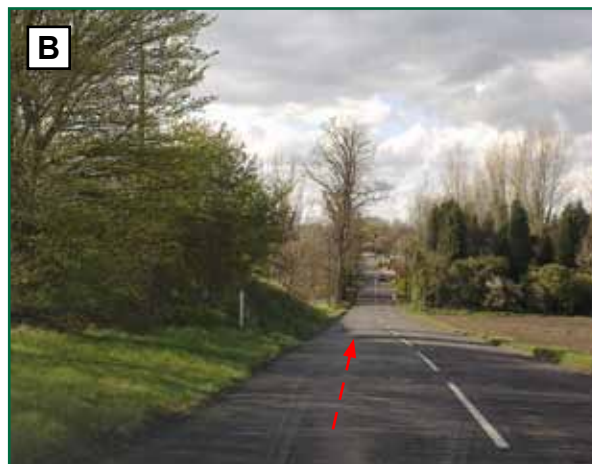
- 14 The highway at the location where the vehicle left the road has a soft verge to the left with a rising one metre high earth *bund* towards the boundary fence. The land then descends relatively steeply towards the cess and railway track.

Figures 3a and 3b: (left) Image showing left-hand bend on the Stowmarket Road leading to the downward gradient shown in figure 3b (right)

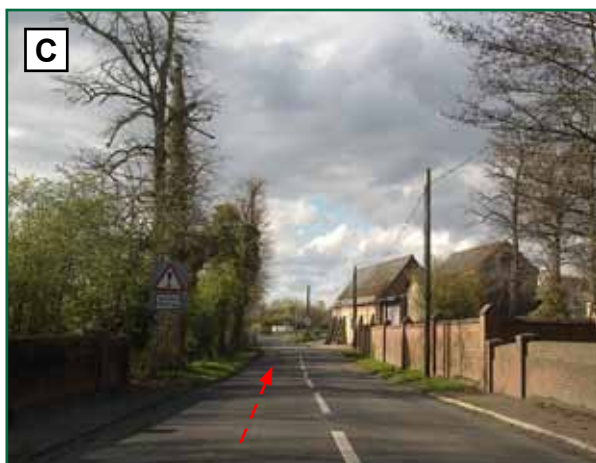
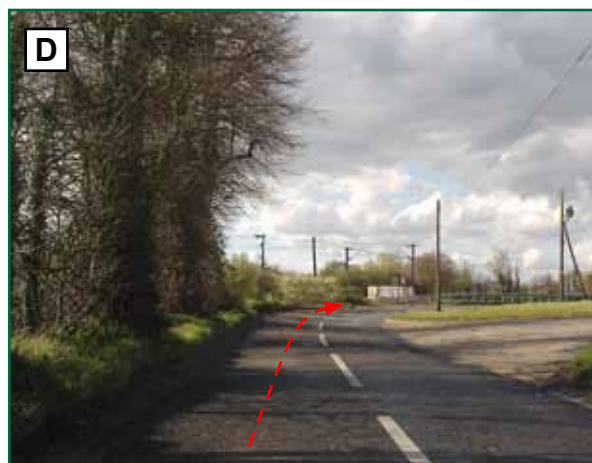
Figures 3c and 3d: (left) Image showing right-hand bend on the Stowmarket Road (LGV park entrance on right) leading to right-hand 'kiss bend' shown in figure 3d (right) where the road runs parallel to the railway

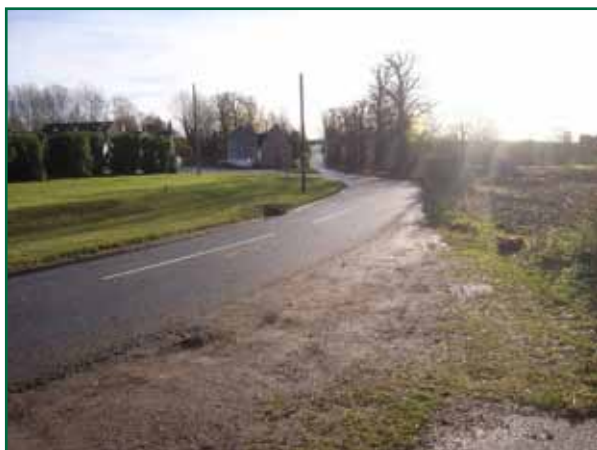
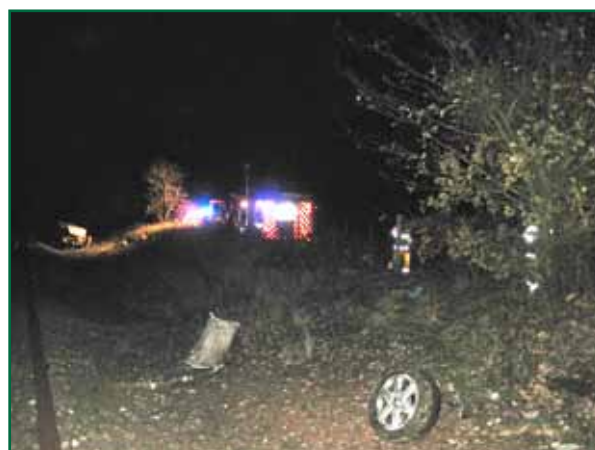
- 30 The motorist left his home south of Stowmarket at approximately 19:15 hrs to travel to Old Newton. At approximately 19:34 hrs, as he negotiated the right-hand bend adjacent to the railway, he felt the front and then rear of the car slide towards the left of the road. He attempted to rectify the skid and bring the car under control but was unable to do so. The vehicle hit the nearside verge and rolled over, turning lengthwise through 180 degrees, becoming airborne as it travelled backwards through the boundary fence, coming to rest upright with the rear of the vehicle foul of the railway line (figures 4a and 4b).

Figure 4a: (left) Image showing the direction of travel of the vehicle and image 4b (right) showing the accident scene from the railway side with motor vehicle in the background and associated debris in the foreground.

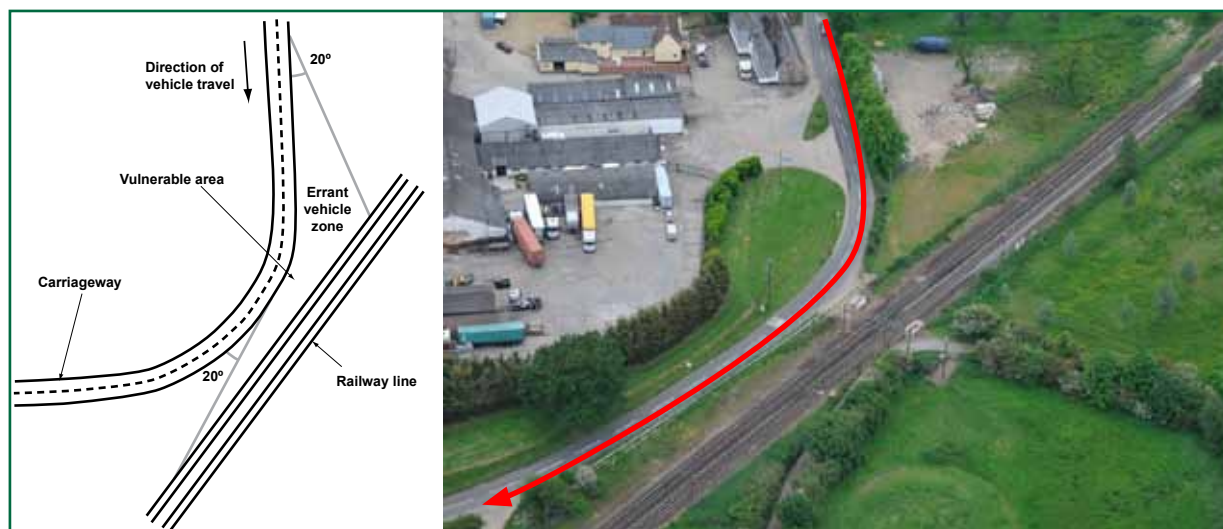
- 39 The RVI process requires an engineer undertaking an initial risk assessment and data gathering exercise at possible road vehicle incursion sites to consider 14 factors, including road alignment, volume of traffic, data on any previous accidents and the speeds and types of trains. Each factor is then given a score to produce a combined total. The scoring system is used as a tool to identify high risk sites, to provide input to a cost benefit analysis for possible risk mitigation measures and to apportion budgets for mitigation works. The DfT protocol requires assessment of sites where the highway passes over or runs parallel to the railway. This includes locations where the highway approaches close to the railway for only a short distance (known as a '*kiss bend*' (figures 6a and 6b)).

Figures 6a and 6b: Diagram of typical '*kiss*' bend (left) and aerial view of the B1113 Stowmarket Road '*kiss*' bend location (right) (image courtesy of Suffolk Police air support unit)

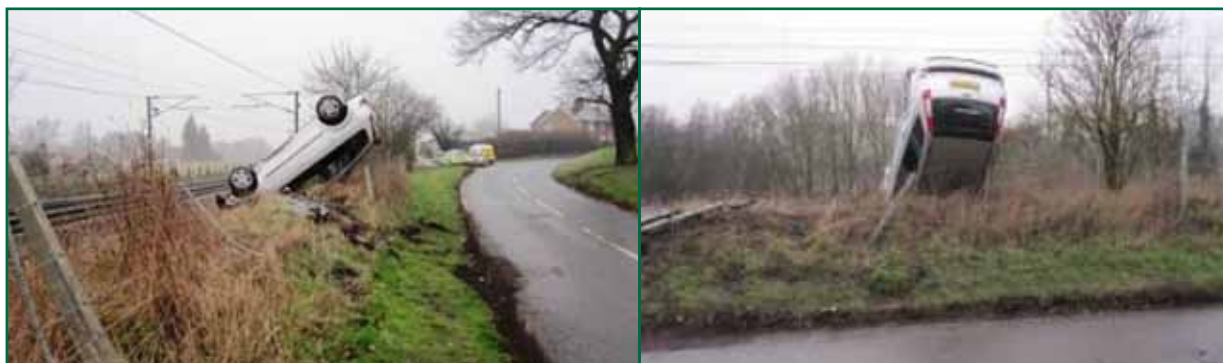
- 46 In addition, on 27 January 2010, a motorist travelling from Stowmarket to Old Newton failed to negotiate the right-hand bend and crashed through the railway fence in circumstances that were nearly identical to the accident on 30 November 2011 (figures 7a and 7b). However, on this occasion the car did not foul the railway line. The motorist did not require hospital treatment and the police took no further action. The BTP was not made aware of the accident. As there were no injuries, the data was neither passed to the police road safety management unit nor discussed with engineers within SCC's road safety team (paragraphs 85 to 89).

Figures 7a and 7b: Images of the accident on 27 January 2010, at the same location as the accident on 30 November 2011

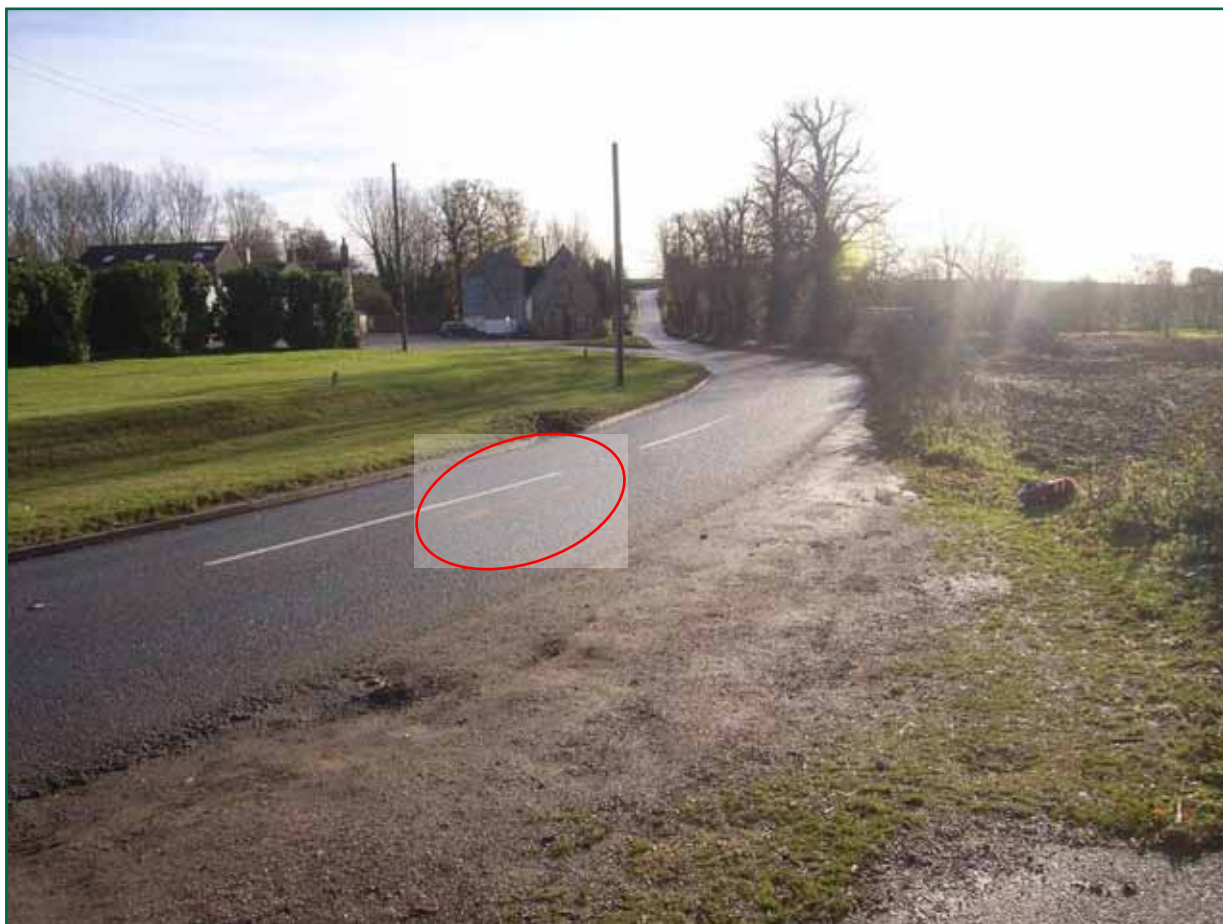
- 51 The police officer attending the accident reported that road conditions were damp from the rain that had fallen during the day, and there was evidence of contamination (fuel/oil/mud) on the surface of the road in the vicinity of the centre of the carriageway just beyond the bend (figure 8). The RAIB has not investigated the cause of this road traffic accident and no accident investigation or survey was undertaken by Suffolk police. The source of the contamination is unknown, but it was treated with sand by Network Rail staff after the accident. No police action was taken in respect of the motorist.

Figure 8: Image of the accident scene the following day (01/12/11) showing area of contamination (circled in red) on the road

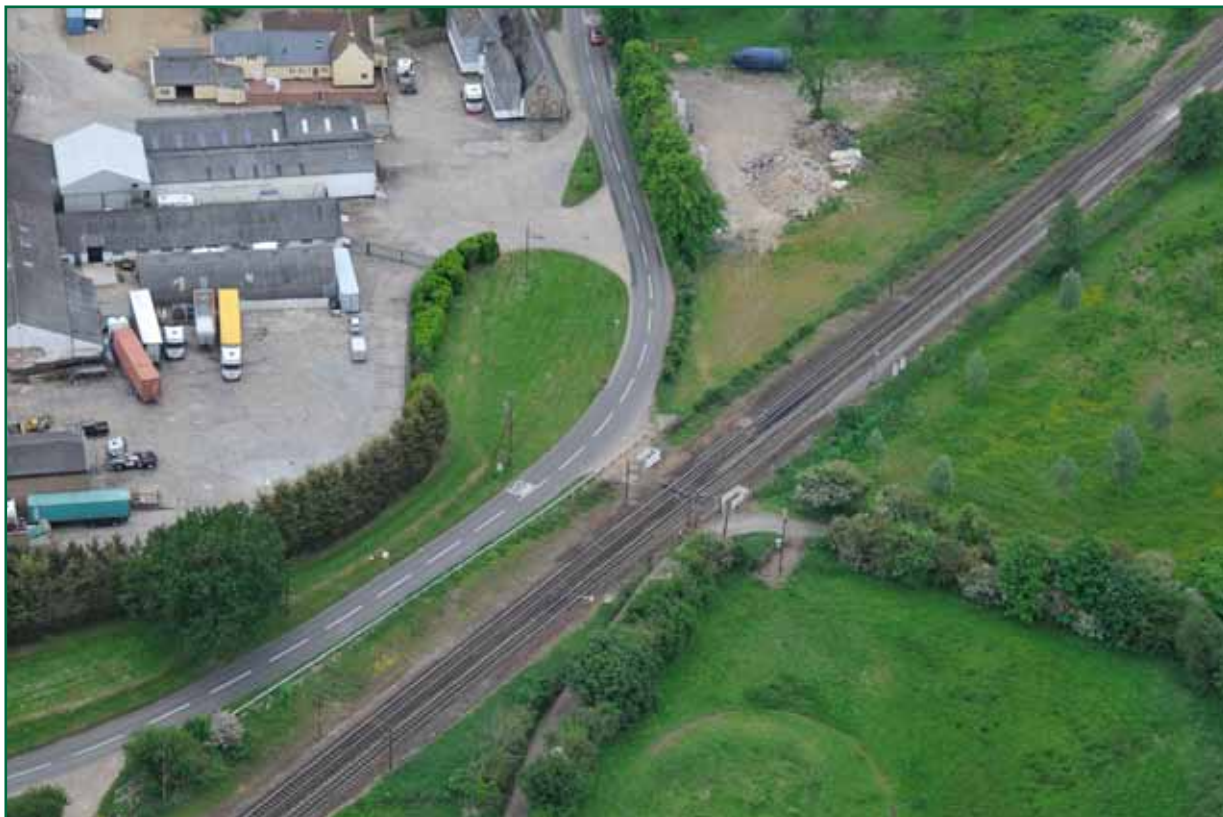
Figure 9: Aerial view of the B1113 Stowmarket Road 'kiss bend' location showing the business park (top left of the image) (image courtesy of Suffolk Police Constabulary air support unit)

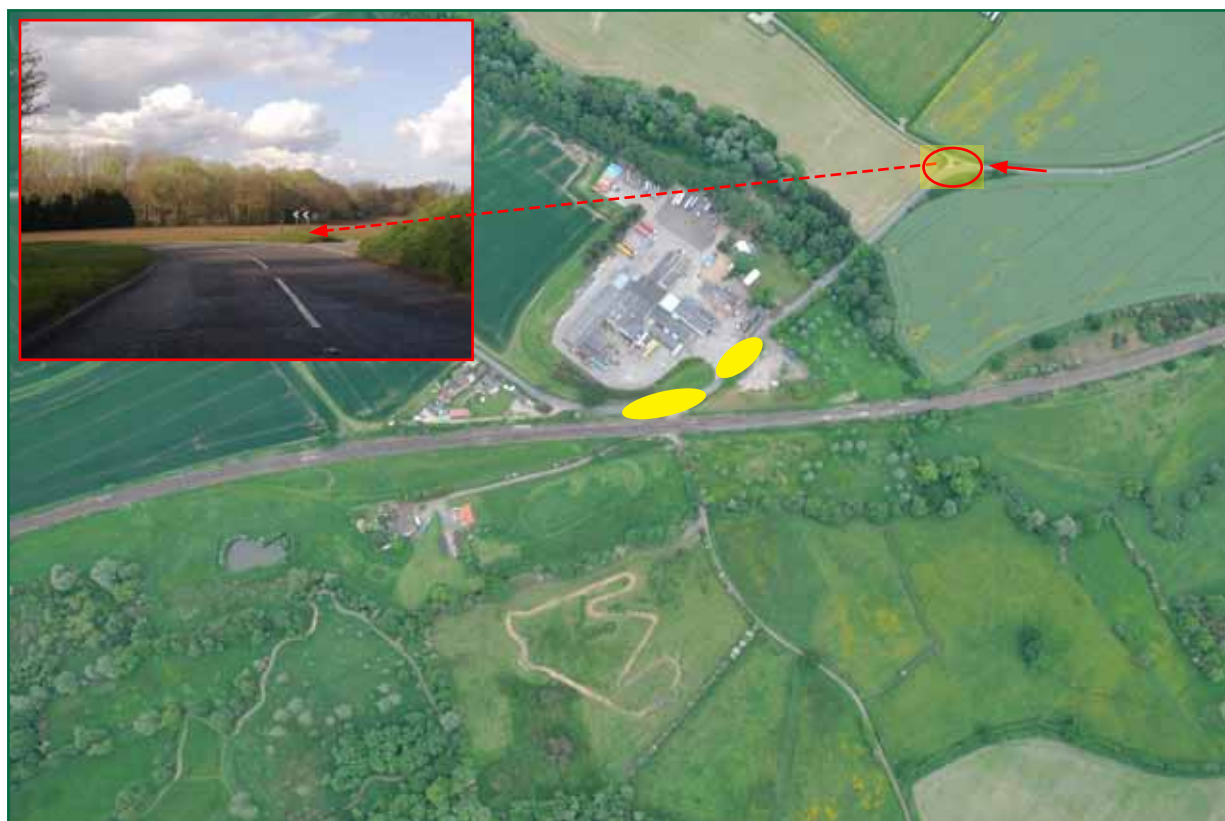
- 66 Engineer 2 received this intelligence and completed a road sign and surface assessment. However, for reasons the RAIB has not been able to establish, this assessment was not undertaken at the location reported by the residents, but at a nearby location on the same stretch of road where there had also been known reports of vehicles leaving the road (figures 10a and 10b). Chevron markers were installed and road markings were improved at this other location but no work was undertaken at the location originally reported by the local residents.

Figures 10a and 10b (inset): Image of location where road vehicle incursions were reported (bottom yellow areas) and inset image showing the incorrect location (red circled area)

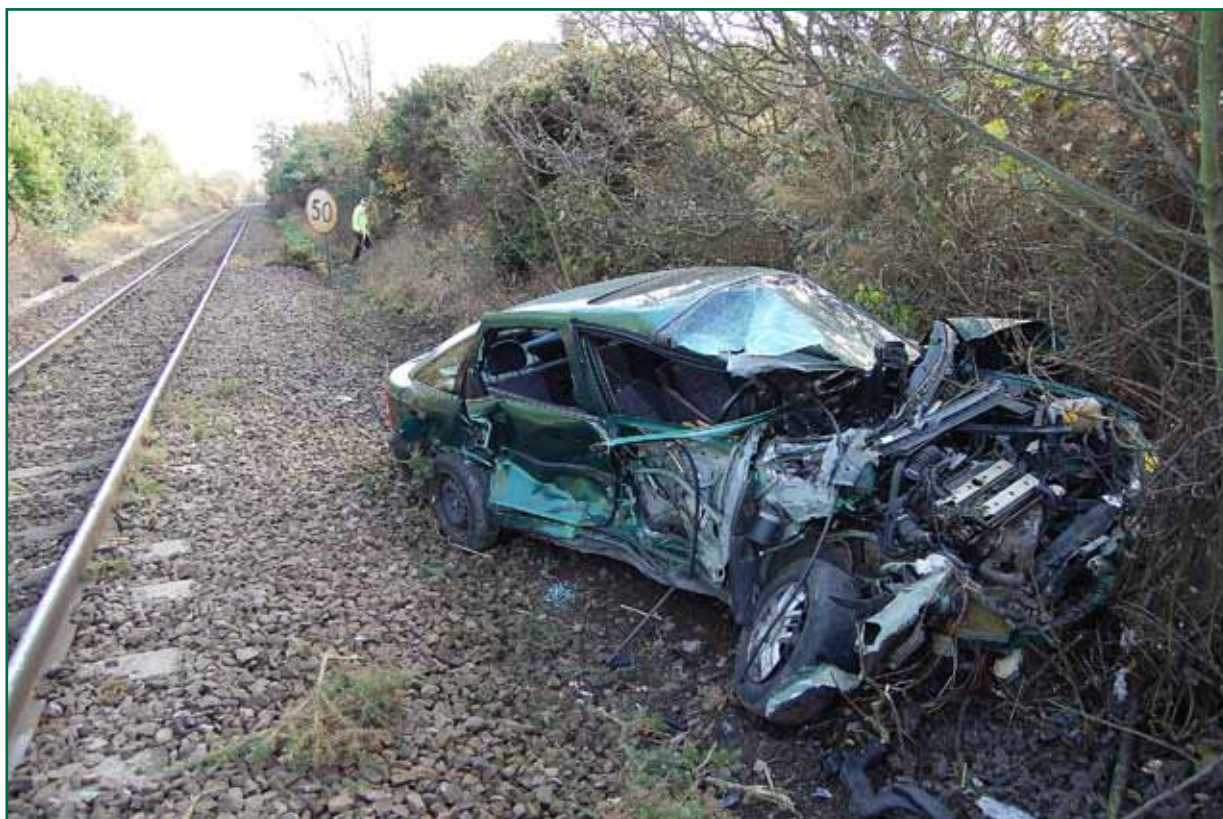
125 During the investigation the RAIB identified three other incidents where a vehicle incursion had occurred, but the location had not been assessed (figure 11) or recorded on the Network Rail database for known RVI sites. The RAIB considers that potential problems at some of these locations could not have been foreseen. However new mapping technology (eg Google Earth / Street View / DfT / ACPO crash database) is available, which may allow Network Rail or the local highway authorities to identify locations which pose a risk to the railway (paragraph 143).

Figure 11: Image showing a road vehicle incursion incident at a previously unidentified RVI location that occurred in Ipswich in November 2010
