Rail Accident Report

Fatal accident at James Street station, Liverpool 22 October 2011

Report 22/2012
October 2012

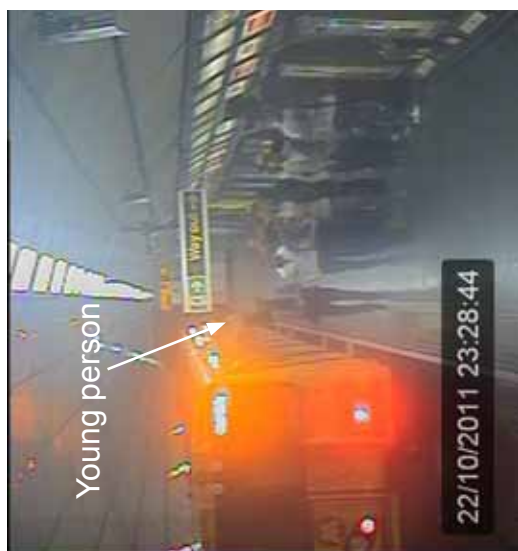
(c) Young person leans against the train

- 14 The young person turned to look in the direction of the guard as the last person in the large group left the platform through the exit opposite the guard's door. The guard stated that he warned the young person to stand back and platform video camera footage shows that he gestured with his arm for her to move away from the train (figure 5d) but she continued to lean against it.

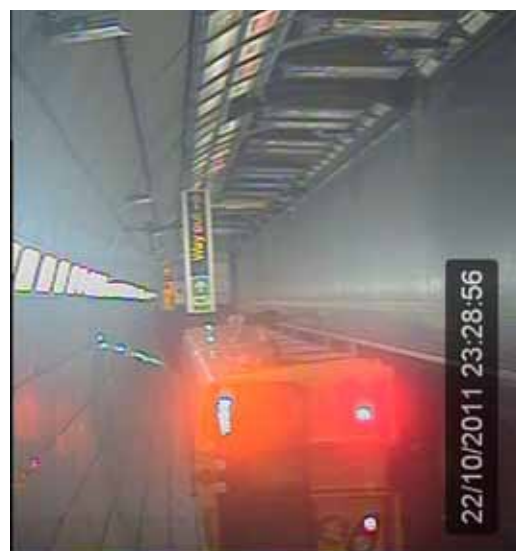
(d) Guard warns the young person to stand back

- d. By the time the guard warned the young person to stand back she had been leaning against the train for approximately eleven seconds. It is not known when the guard saw her during this time or, if he saw her, whether he delayed taking action in the expectation that she would move away. Platform video camera footage shows him warning her to stand back in the moments before the train departs and it is likely he did this because he thought that it would be immediately effective and because he had no direct and immediate way to stop the train (**paragraph 39, Recommendation 1b**).

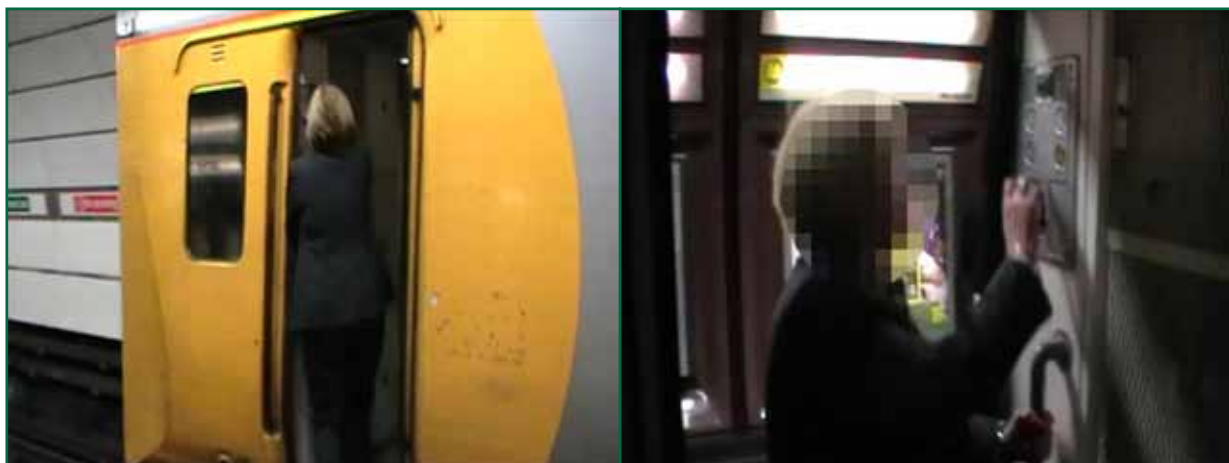
Figure 9: A guard looking away from the platform to use the door control panel

- 33 The third possibility, that the guard had looked briefly in the young person's direction but did not see her, cannot be completely discounted because 'looked but failed to see' is a known phenomenon in routine, repetitive tasks. A study into road traffic accidents published in 2006⁹ stated that 'looked but failed to see' was a contributory factor in almost 21% of accidents at road junctions and in over 8% of accidents away from junctions. 'Looked but failed to see' was recorded most frequently at private drives or entrances, and almost as frequently at mini-roundabouts. Dispatching a train is a routine, repetitive task that the guard would have carried out several hundred thousand times in his career before the dispatch that caused the accident.

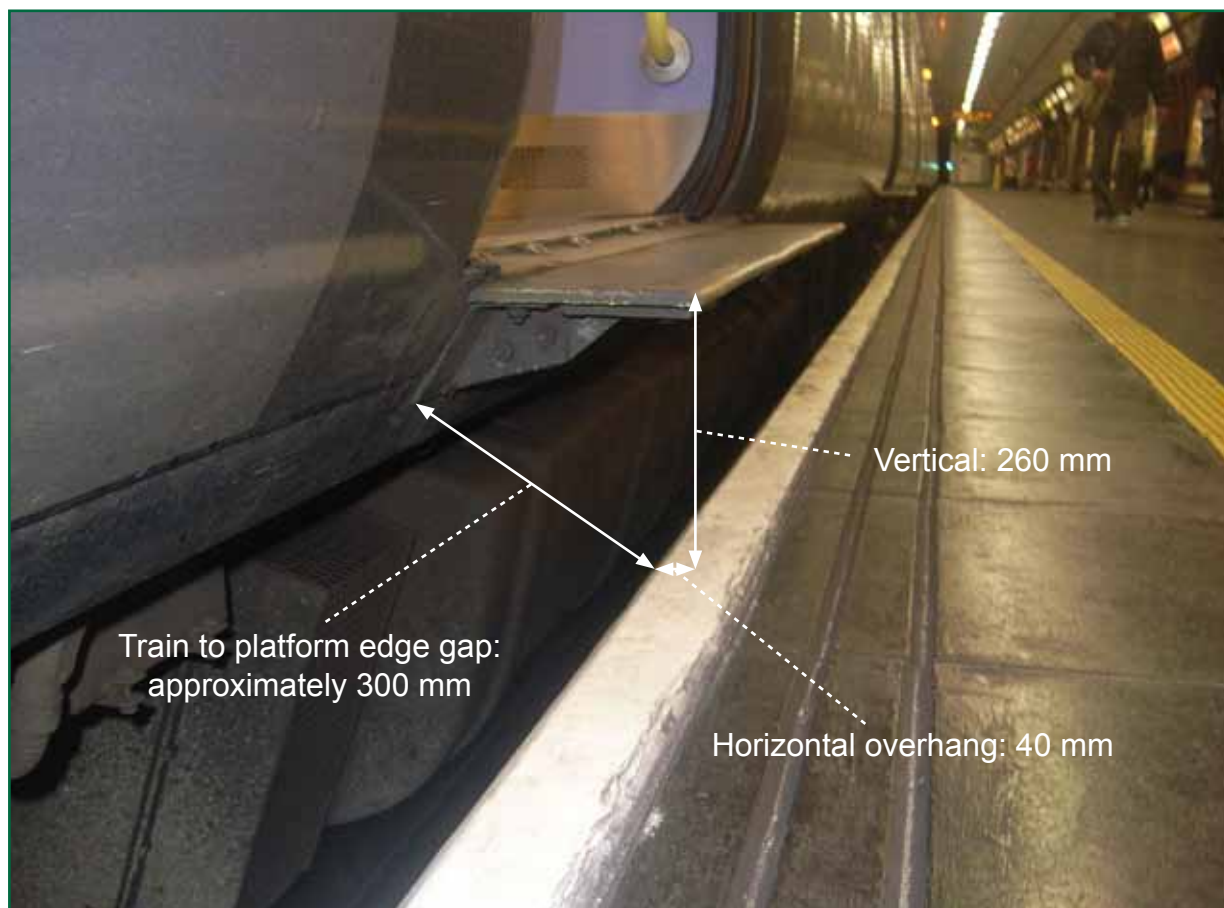
Figure 10: The train to platform edge gap and measurements to the footstep

The platform edge gap was wide enough for her to fall through and onto the track

The gap can be made much smaller on platforms with straight, level track served by trains of uniform size and suspension that do not pass through at speed. All these conditions prevail at James Street station platform 1.

FOOTSTEP TO PLATFORM EDGE	James Street platform 1 measurements (mm)	Industry maximum dimensions (mm)	Comparison with requirements
Platform edge to footstep: vertical	260	250	Does not comply but reducing the dimension to 250 mm would have little effect on the platform edge gap
Platform edge to footstep: horizontal	40 (overhang)	275 (gap)	Complies
Platform edge to footstep: diagonal	Not applicable due to overhang	350	Not applicable
Platform edge gap	Approximately 300	No requirement	No requirement

Merseyrail, in consultation with Merseytravel, Network Rail and other relevant industry bodies, should evaluate equipment and methods that reduce the likelihood of a person falling through the platform edge gap. Platform edge gap fillers and vehicle body side panels should be included in the evaluation, the outcome of which should be a plan to implement measures when appropriate to do so, for example when trains or the infrastructure are changed, improved or replaced.

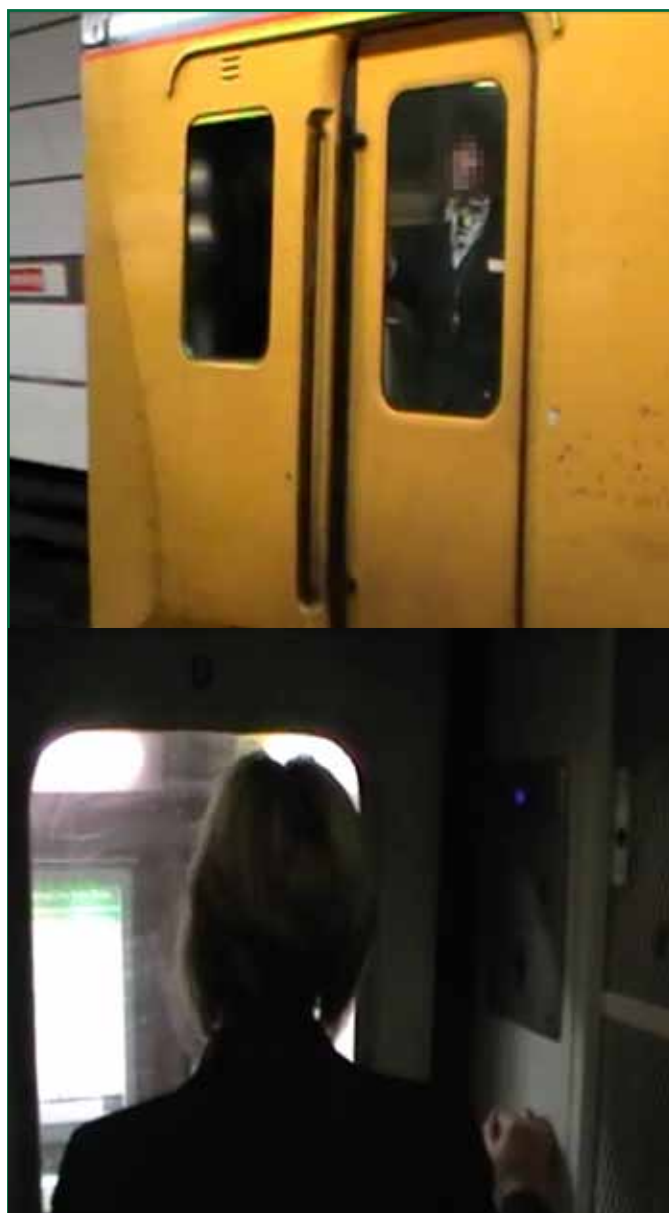
Figure 12: A guard viewing James Street station platform 1 from behind a closed door

- 24 The RAIB used Merseyrail's video of best practice train dispatch to the published procedure to calculate that approximately 12 seconds passes between the guard boarding the train, waiting for the adjacent door to close, sending and receiving the 'ready to start' code and the train moving out of the station. This is a period of time during which serious accidents may occur because a guard may not be able to see and react to events at the platform/train interface because of the narrow field of view through the door's fixed window (see figure 12).

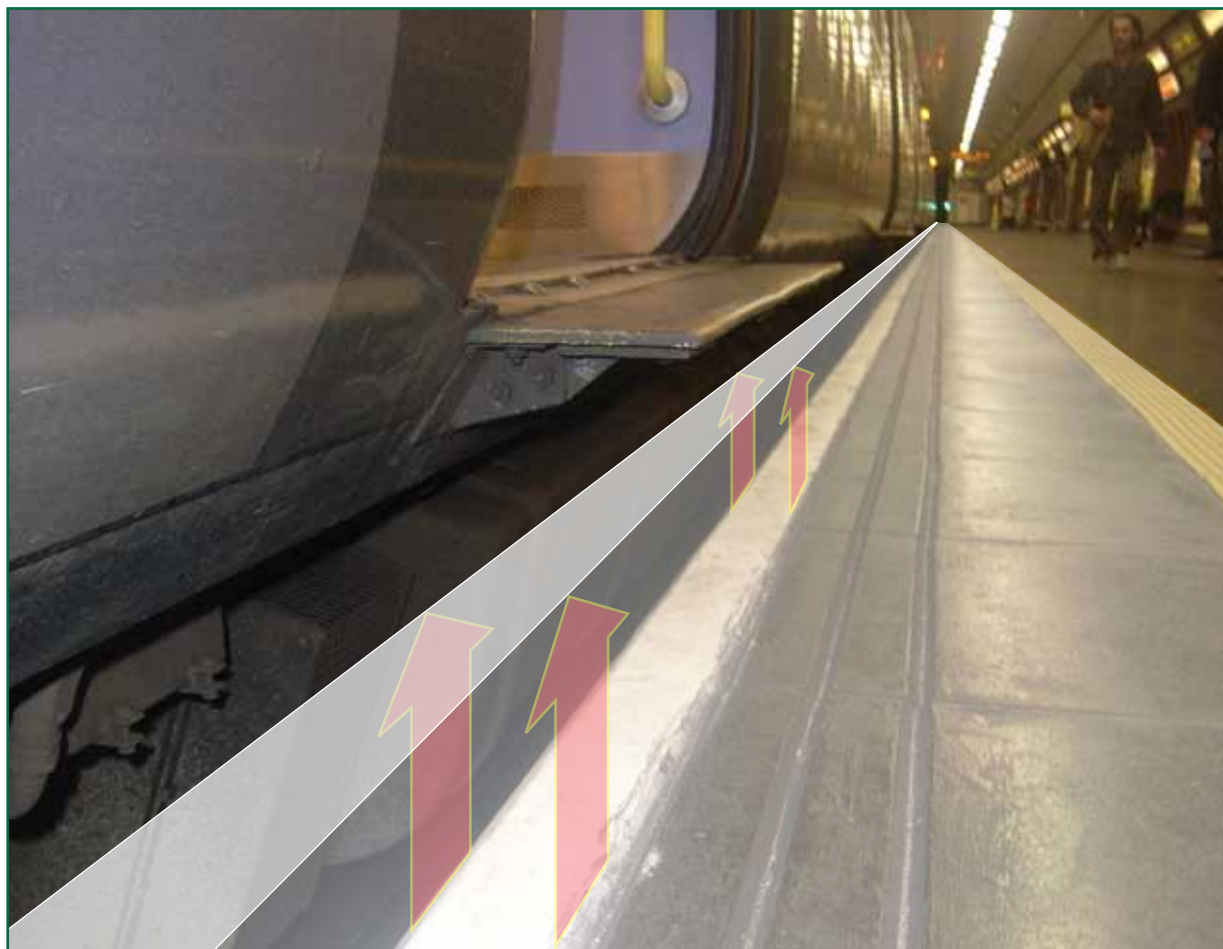
Figure 25: The James Street platform edge gap, shown reduced by raising the platform

- iii. Adapting the infrastructure. Figure 25 shows a platform edge gap reduced by raising the platform edge. Figures 26 to 28 show the gap reduced by fitting gap fillers to the platform face. The gap fillers are made from blocks with rubber prongs: the prongs are able to support a person's weight vertically and deflect horizontally without damaging themselves or the trains that pass and contact them. The gap can also be reduced by moving the track closer to the platform, moving the platform coping stones closer to the track or both.
