# Rail Accident Report

**Person trapped in a train door and dragged at  
Jarrow station, Tyne and Wear Metro  
12 April 2012**

# **Person trapped in a train door and dragged at Jarrow station, Tyne and Wear Metro**

## **12 April 2012**

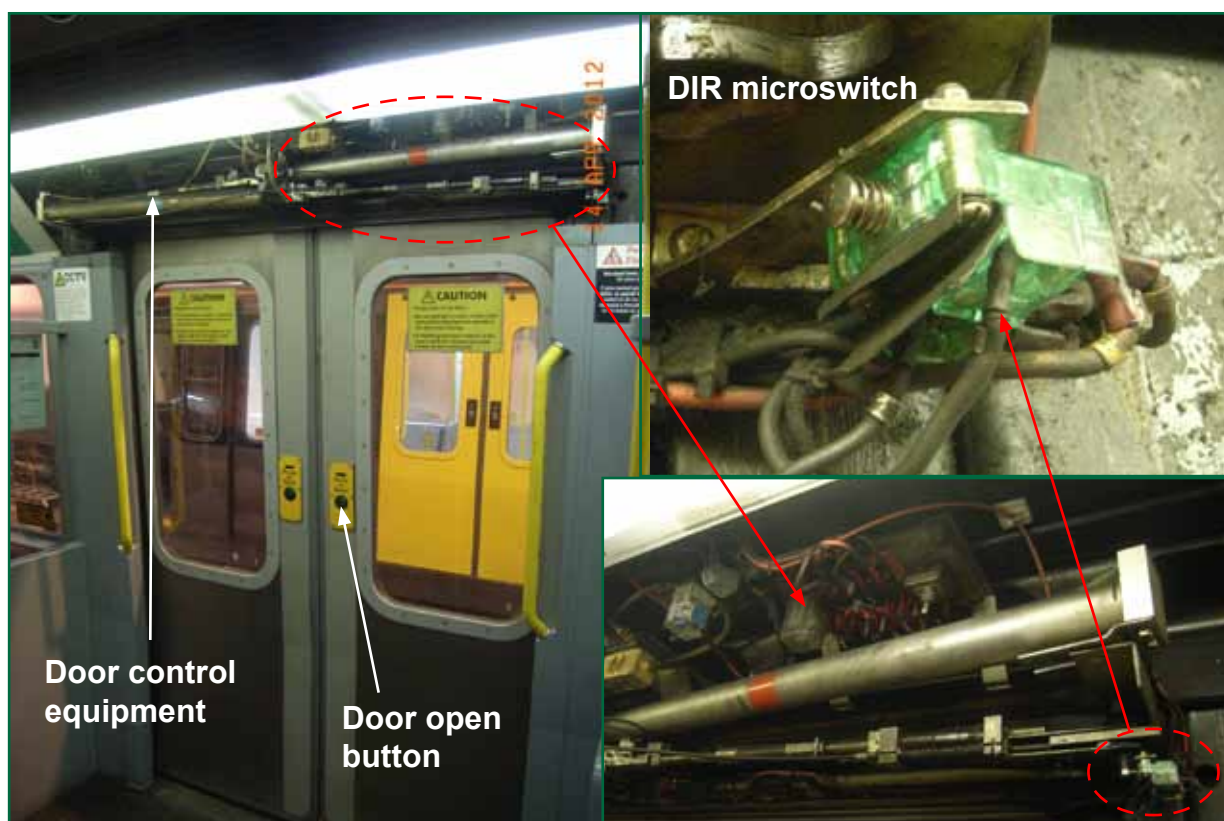
Figure 5: Door control equipment and position of DIR microswitch above door 7

- The faults that occurred during the incident could only be replicated by holding the traction interlock switch for the right-hand door leaf, called the 'DIR' switch (figure 5), in the depressed position as the door was opened and then closed with an obstruction held in the door. This simulated what would have happened at Jarrow if the DIR switch had stuck in the depressed position. Holding down any of the other microswitches on door 7 and operating the door in the same way did not reproduce the observed faults.

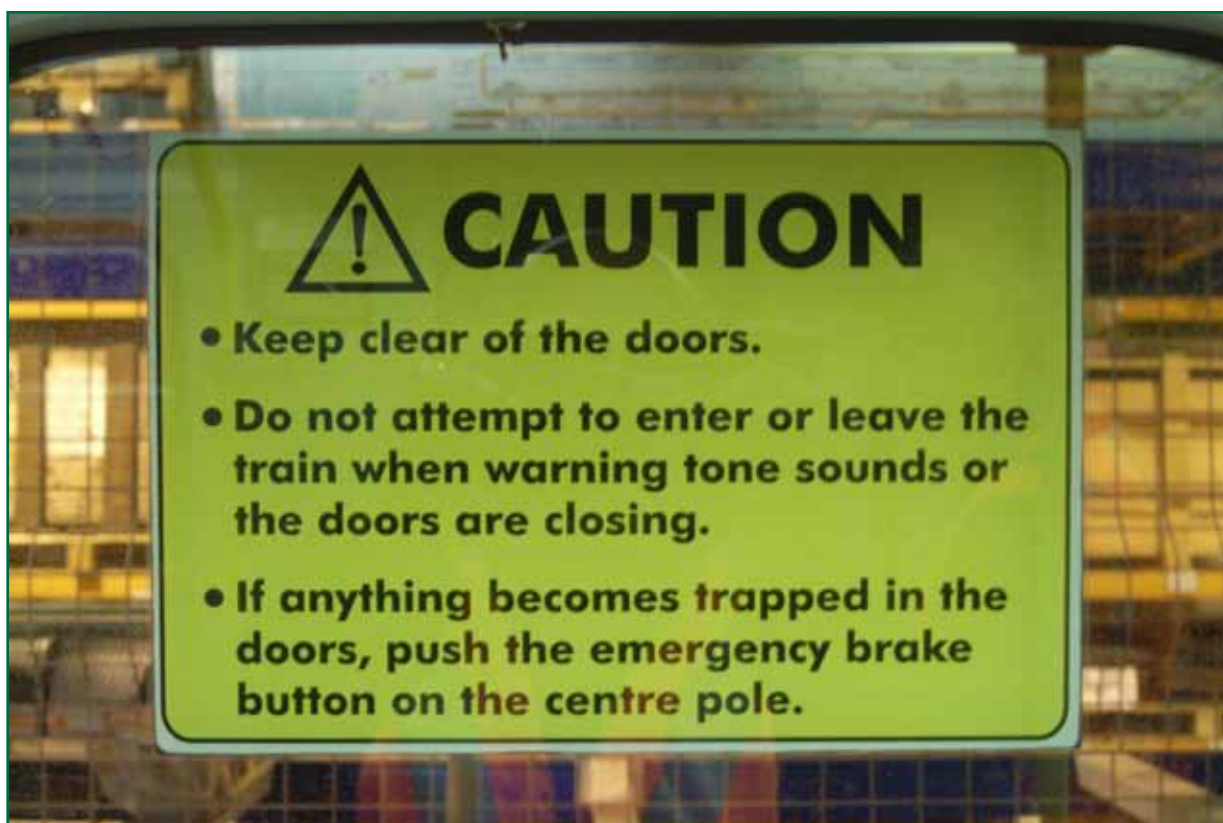
Figure 7: Warning notice posted on both sides of each door leaf

- 26 The passenger attempted to board the train as the doors were closing by obstructing one of the doors. This was a causal factor.
- 27 On TWM trains there are yellow caution notices on both the inside and outside of the doors (figure 7) warning passengers not to leave or enter the train when the warning tone is sounding or when the doors are closing.

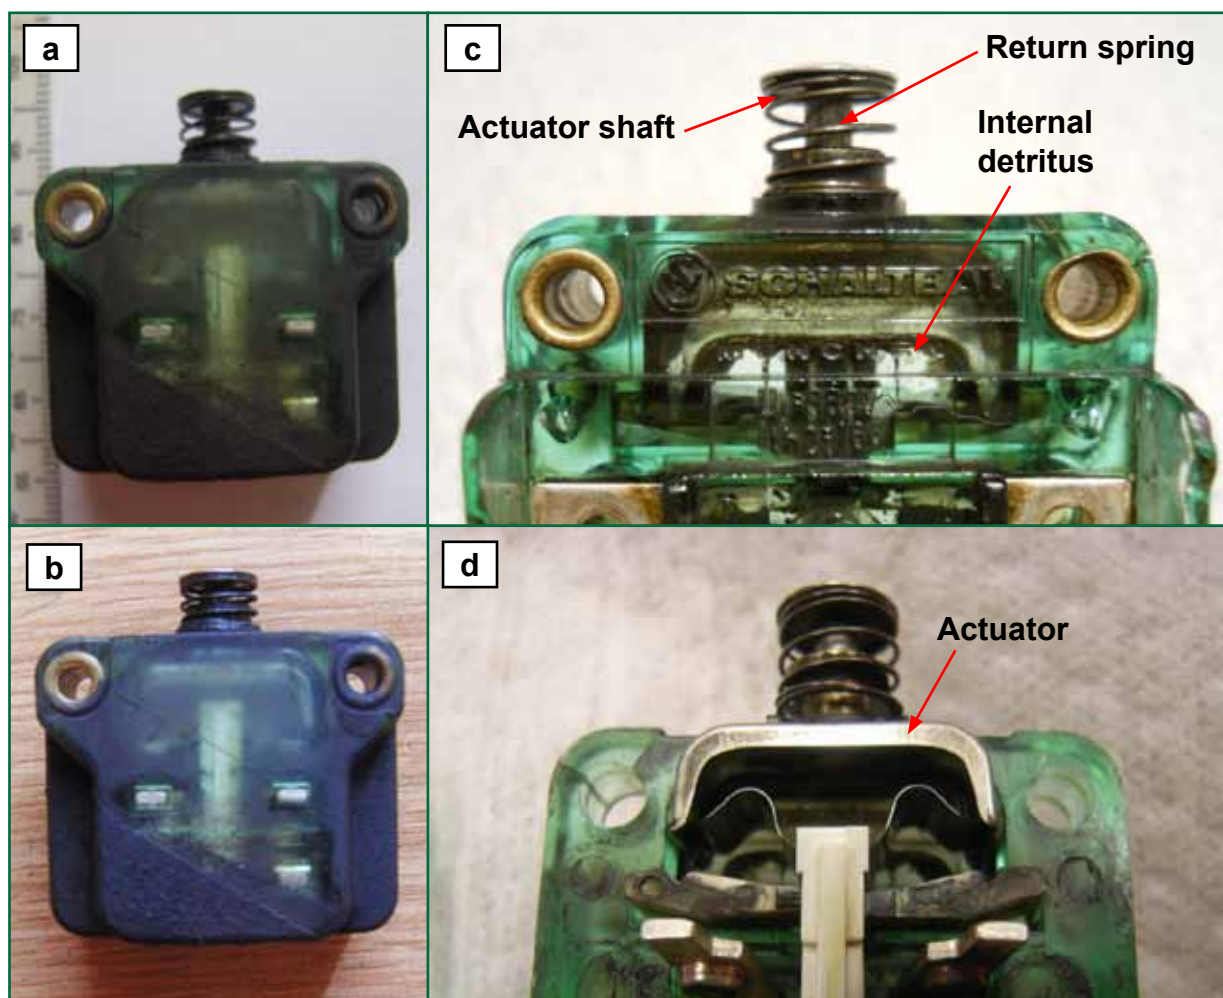
Figure 8: DIR microswitch showing (a) normal actuator position, (b) actuator stuck down, (c) accumulated internal detritus and (d) switch with cover removed

- 35 Since it was only a malfunction of the DIR switch from door 7 that could replicate the condition which occurred during the incident, it was decided to examine this switch more closely. After multiple manual operations of the switch, it was found that it remained stuck down in the depressed position on one occasion (figure 8). This should never happen with a correctly functioning switch. However, after pressing the plunger again, it released and despite further operations of the switch, this fault could not be repeated. The investigation concluded that this switch was capable of intermittent failure and that this fault would explain exactly what was seen to happen in the CCTV footage and post incident testing.

- 38 When the DIR switch was stripped down and examined with the assistance of Schaltbau, a significant amount of *detritus* was found to have accumulated inside the switch (figure 8) together with an oily residue. It is almost certain that the detritus did not get into the switch during manufacture. Further, had it done so, it would almost certainly have been picked up in Schaltbau's quality control process or during installation by the train manufacturer, Metro-Cammell. Additionally, there was no evidence of other switches having similar internal contamination. The oily residue was probably from the light proprietary penetrating oil used by DBTW to clean the switches, once removed from the train, during periodic maintenance. Schaltbau do not use any lubrication when the switches are manufactured.

- 39 It is not known when this switch was fitted. Even if it had been in service since car 4005 was originally built, the switch would have operated for less than 1.2 million cycles, well within its design life of 10 million cycles. The actuation and return forces of the switch were tested and found to be within design tolerance. The general condition of the switch did not indicate excessive wear which could explain a malfunction.

- 40 The contamination in the switch was abnormal and is the most likely cause of the switch sticking down. There are two possible paths for the contamination to enter the switch:

- the clearance between the actuator shaft and switch body into which the shaft can pull in contaminants from outside as it slides; and
  - the joint between the actuator shaft and actuator, which was noted to be slightly loose and around which a ring of detritus had accumulated.

DB Regio Tyne and Wear should identify ways to improve the reliability of the door obstruction detection and traction interlock systems, including consideration of improvements in:

- design of the control circuitry;
- ingress protection of the microswitches;
- switch cleaning method;
- replacement procedures;

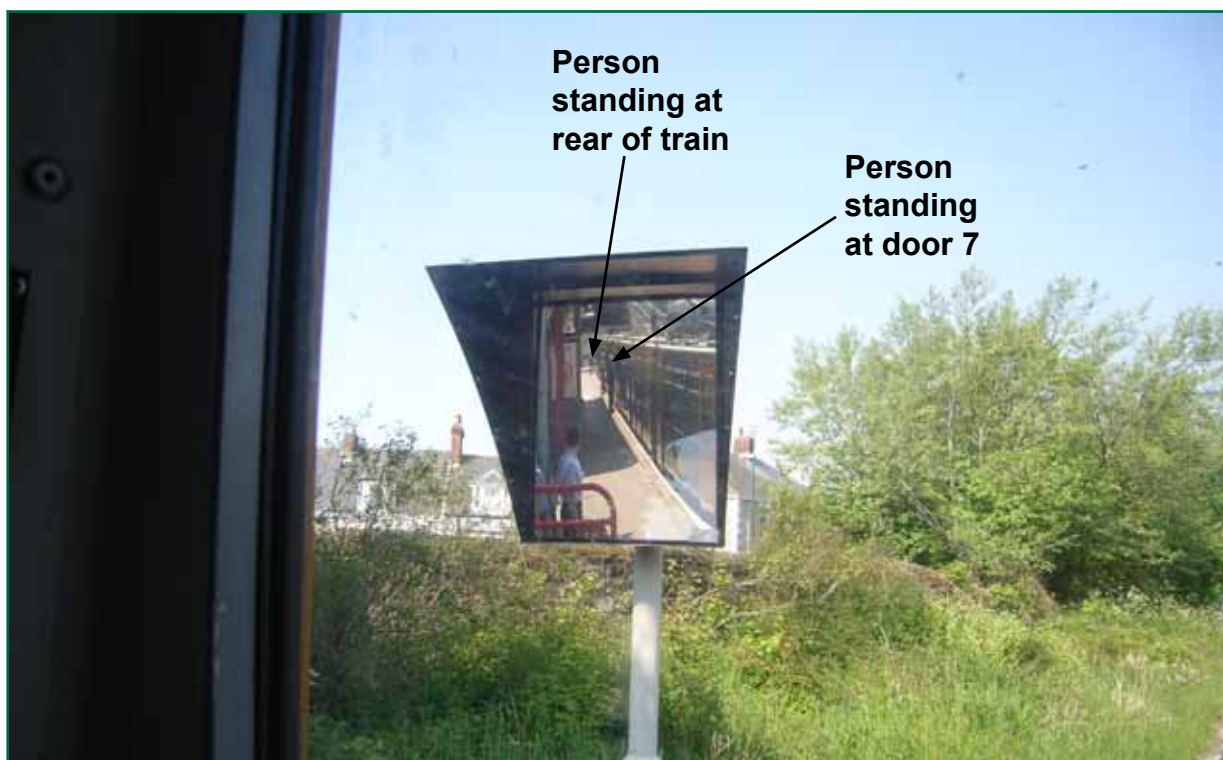
- 53 A reconstruction was carried out, using a test train, to check the visibility of the platform/train interface from the driver's cab at the stopping position of train T135. This stopping position could be determined from CCTV images of the incident train. The reconstruction confirmed that the view from the platform mirror included the whole of the platform/train interface (figures 9 and 10). However, the platform mirror is angled relative to the platform and so the side of the train forms the background to any person standing next to it. It is therefore not a true view along the side of the train.

- 54 There was a period of around 6 seconds between the passenger first arriving on the platform and the train departing, and around 4.5 seconds between the passenger becoming trapped and the train departing. During this latter period she should have been visible in the platform mirror but the driver cannot explain why he did not see her.

Figure 9: Typical view of the platform/train interface from the driver's cab through the mirror on platform 2 at Jarrow station (Note that the station canopy shadow at the time of the incident would not have been so pronounced)

- 3 *The intent of this recommendation is that the visibility of the platform/train interface at stations on the TWM is as clear as reasonably practicable and consistent with the dispatch arrangements for each station.*

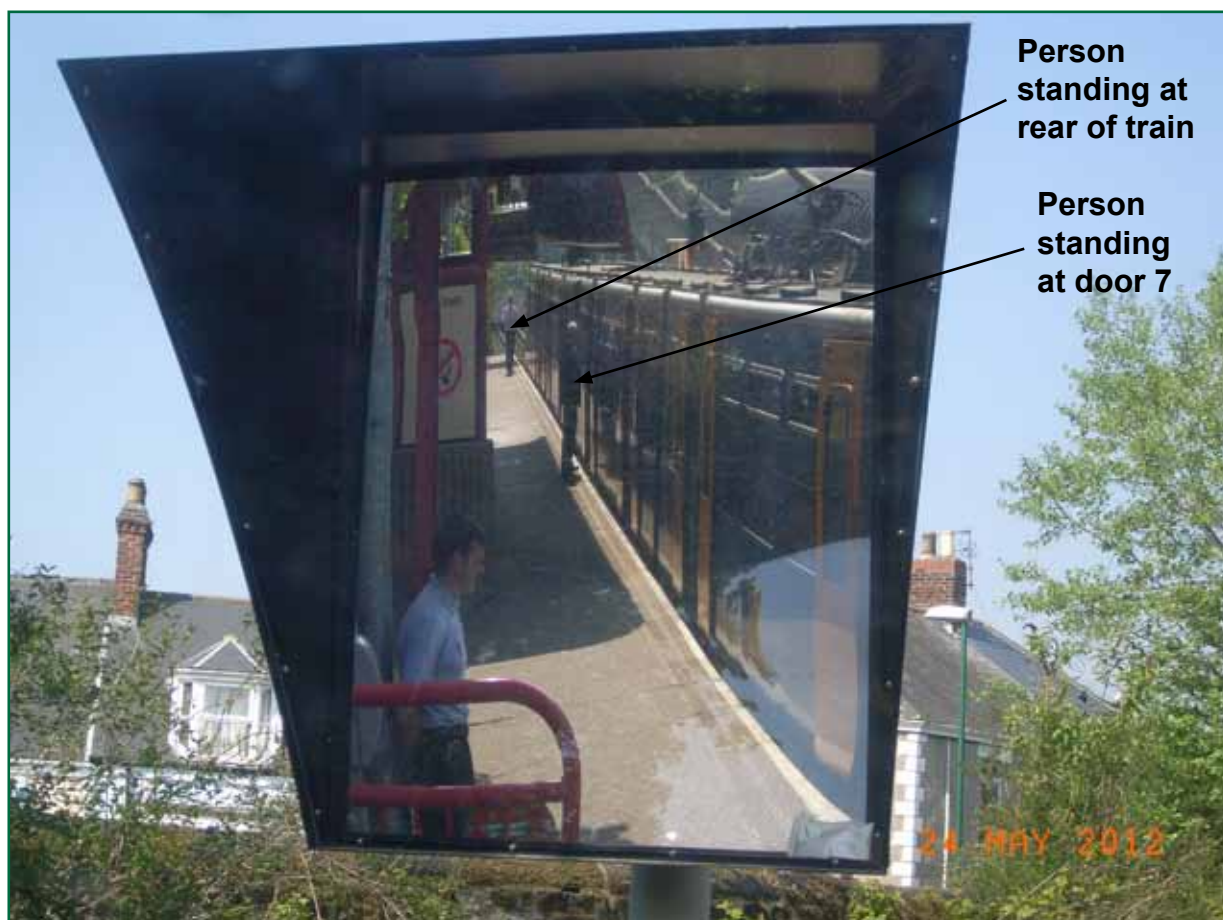
Figure 10: Zoomed in view of figure 9. Note difficulty in distinguishing person in dark clothing at door 7
