# Rail Accident Report

## **Near miss incident at Ufton Automatic Half Barrier Crossing, Berkshire 4 September 2011**

Report 28/2012  
December 2012

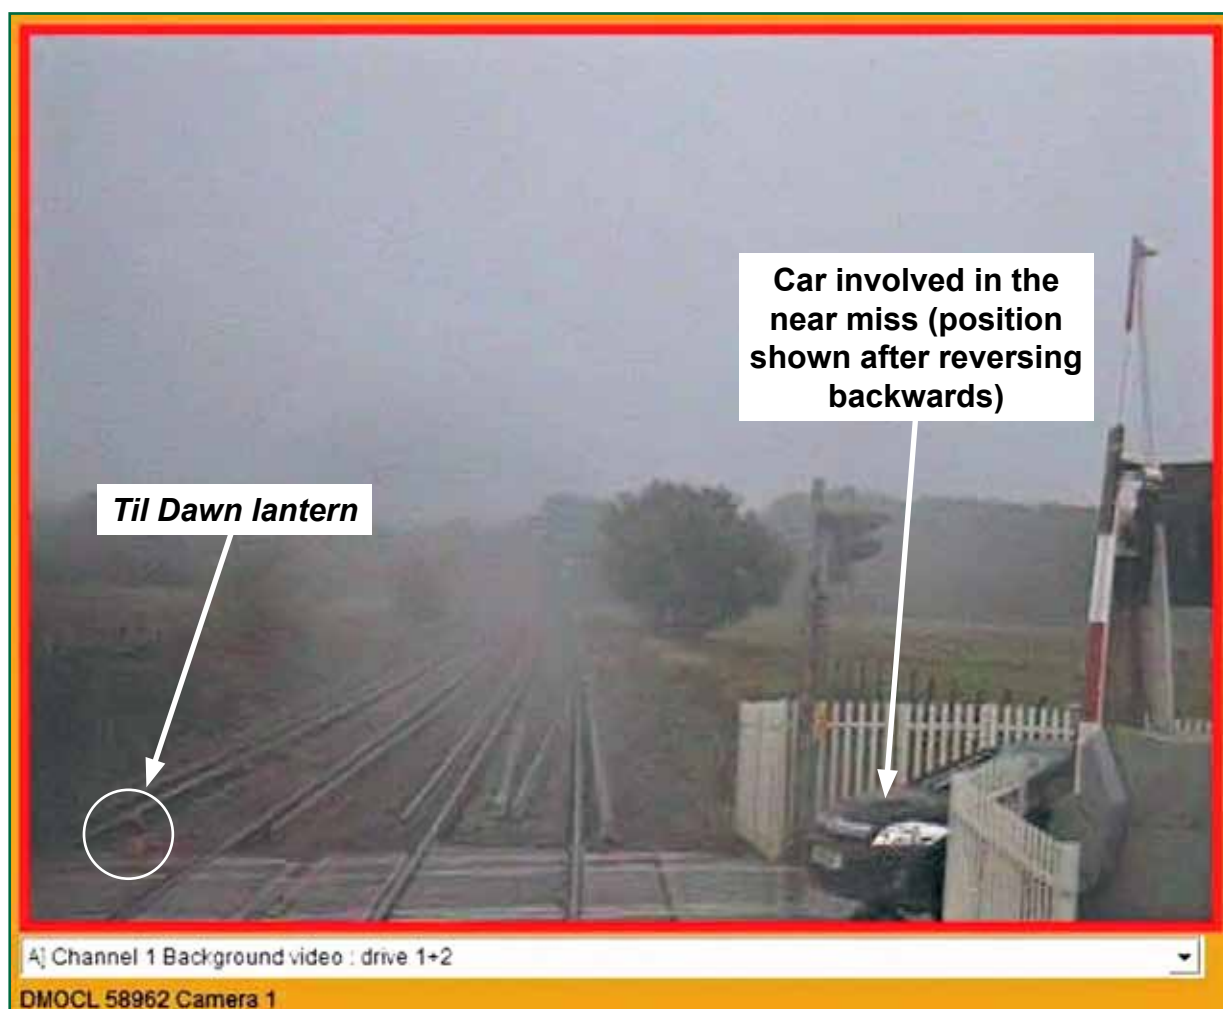
- 69 As soon as the train had passed over the crossing the level crossing attendant rang the pilotman who then contacted the signaller to report the near miss. Witness evidence suggests that the level crossing attendant phoned the pilotman because this was the last person the attendant had spoken with concerning train movements over the crossing, a conversation which had taken place less than 15 minutes before the incident.

Figure 10: Rear facing CCTV image from train 1K54 showing Ufton Crossing and the car involved in the near miss

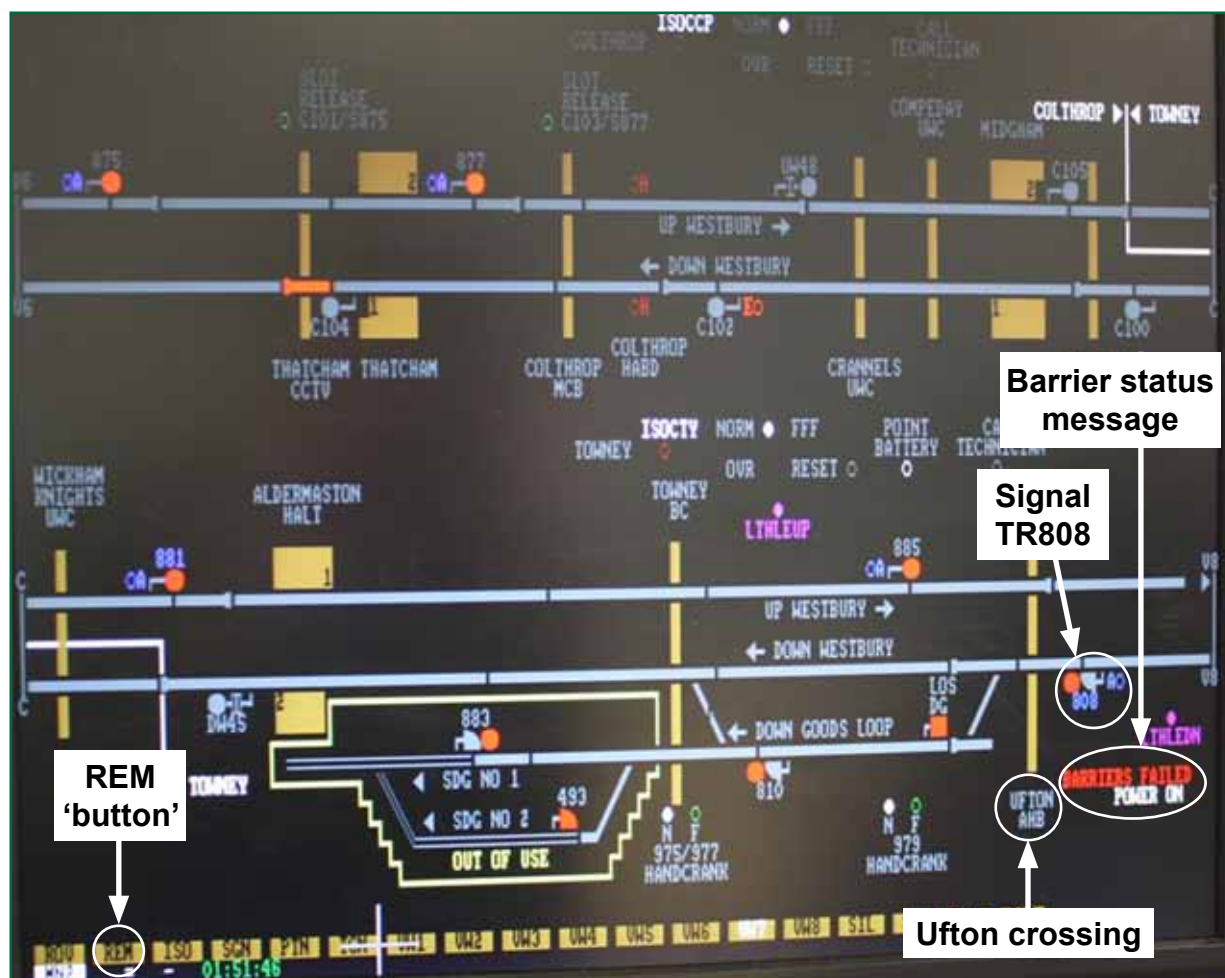
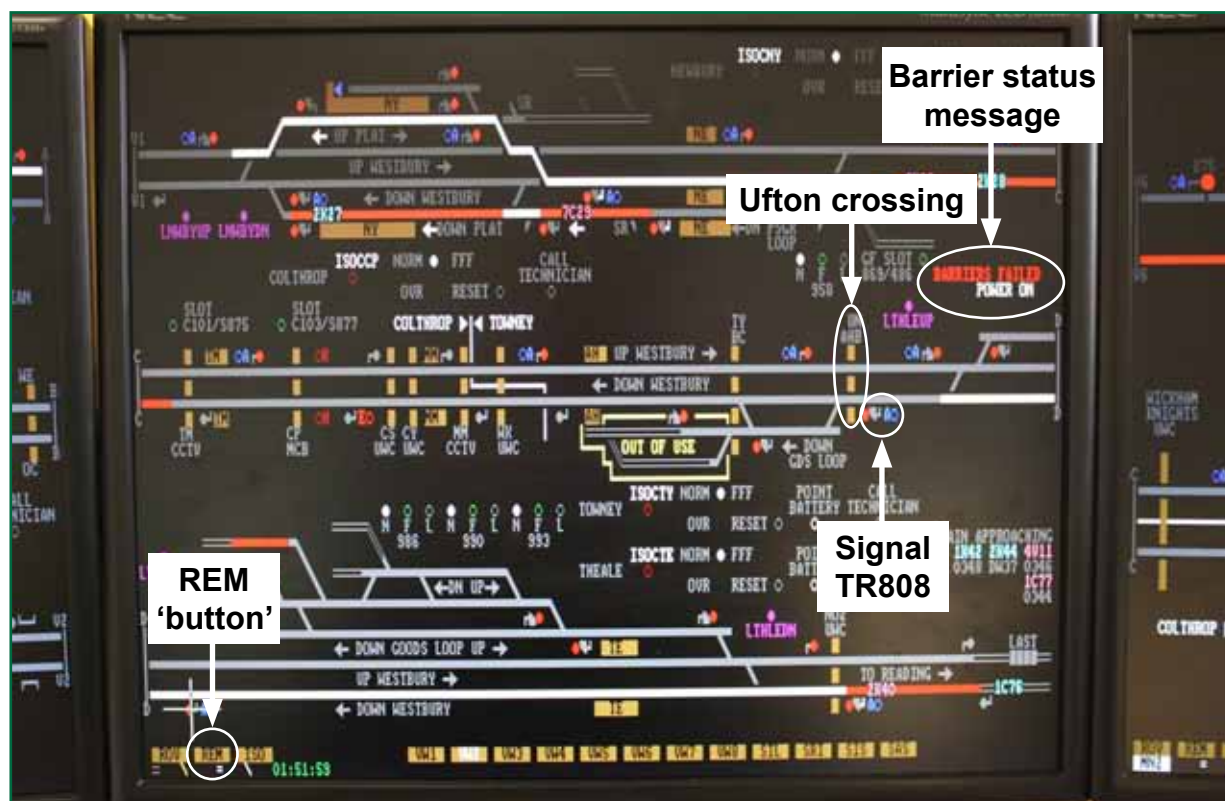
112 The status message ('barrier failed') displayed on detailed view 7 and overview 2 when Ufton crossing is under local control are shown on figures 11 and 12 although the exact display detail (train locations, signal status etc) do not exactly match what would have been displayed at the time of the incident. The barrier status message is the only indication given to the signaller that the crossing is under local control excepting a warning which is acknowledged when local control is first implemented (an event which, in this incident, took place before signaller B started his shift).

- 132 When Ufton AHB was under local control, the Newbury workstation VDUs did not show 'FAILED/ LOCAL CONTROL' as required by the operating specification. Instead, the displays read, 'BARRIERS FAILED'. The term 'local control' has the advantage of reminding the signaller of the presence of a level crossing attendant.

- 3 *The intent of this recommendation is to ensure that, when automatic half barrier level crossings are under local control, IECC displays provide conspicuous warnings compatible with Network Rail's IECC control and indication specification.*

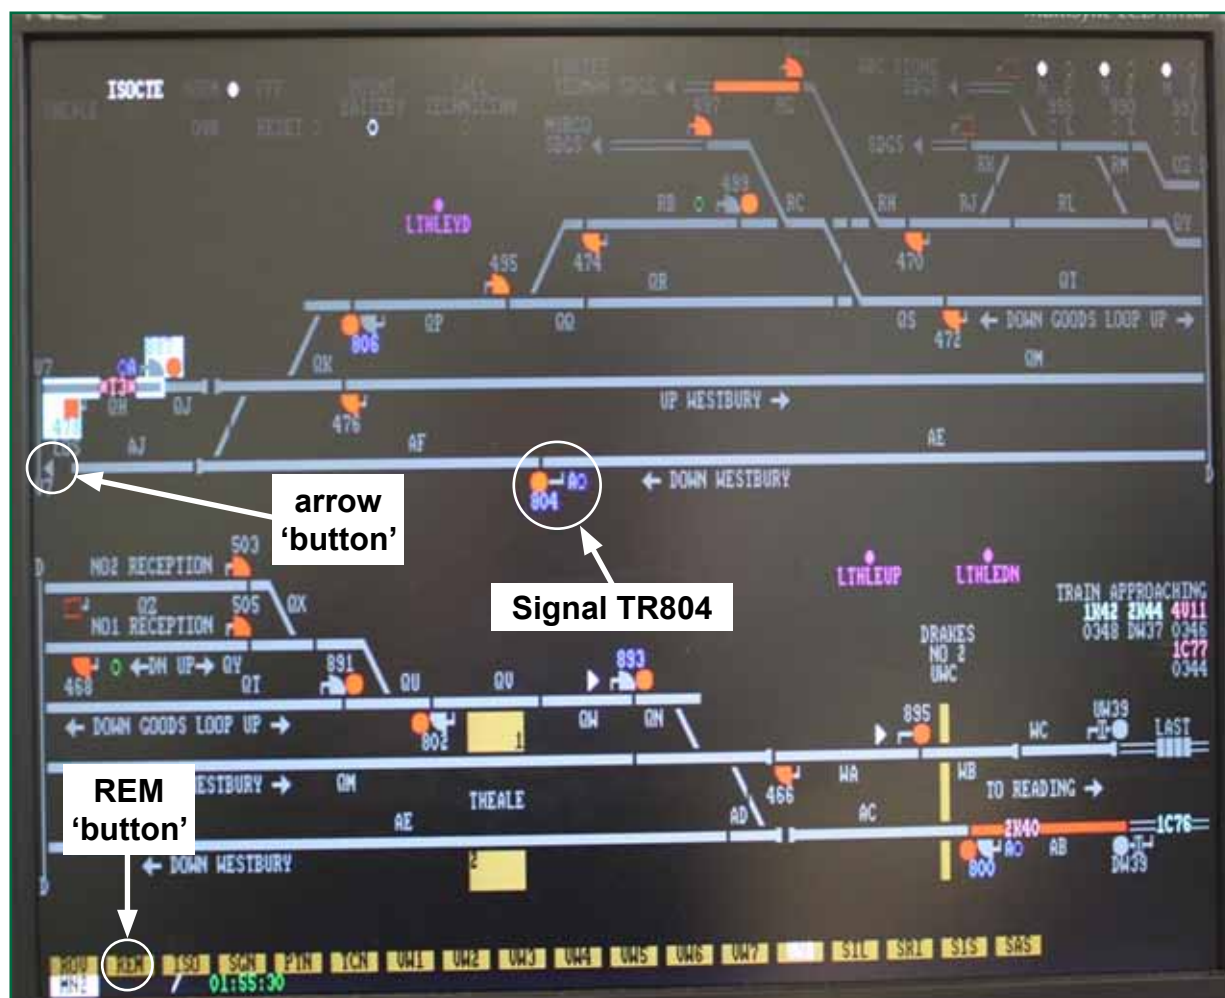
Figure 13: VDU screen 'detailed view 8'

- 108 It is possible that the signaller removed the reminder using the 'arrow' button on detailed view 8 (figure 13). Neither Ufton level crossing, nor an indication of the crossing's status (eg barriers failed) is visible when the reminder is removed using the arrow on detailed view 8. The barrier status is shown on overview 2 and (although probably not displayed when the reminder was removed) detailed view 7. Even if one of these views was displayed on an adjacent screen, the status would not be adjacent to the arrow on detailed view 8.

- 109 The ability to remove the reminder using the arrow on detailed view 8 is an error trap because the signaller could remove a safety critical reminder when the associated crossing status message was not visible.

- 1 *The intent of this recommendation is to ensure that signallers can see appropriate information on the VDU screen when considering whether to remove reminders from signals and points using controls on IECC workstation VDUs. These include reminders on signals that are used to protect an automatic crossing under local control.*

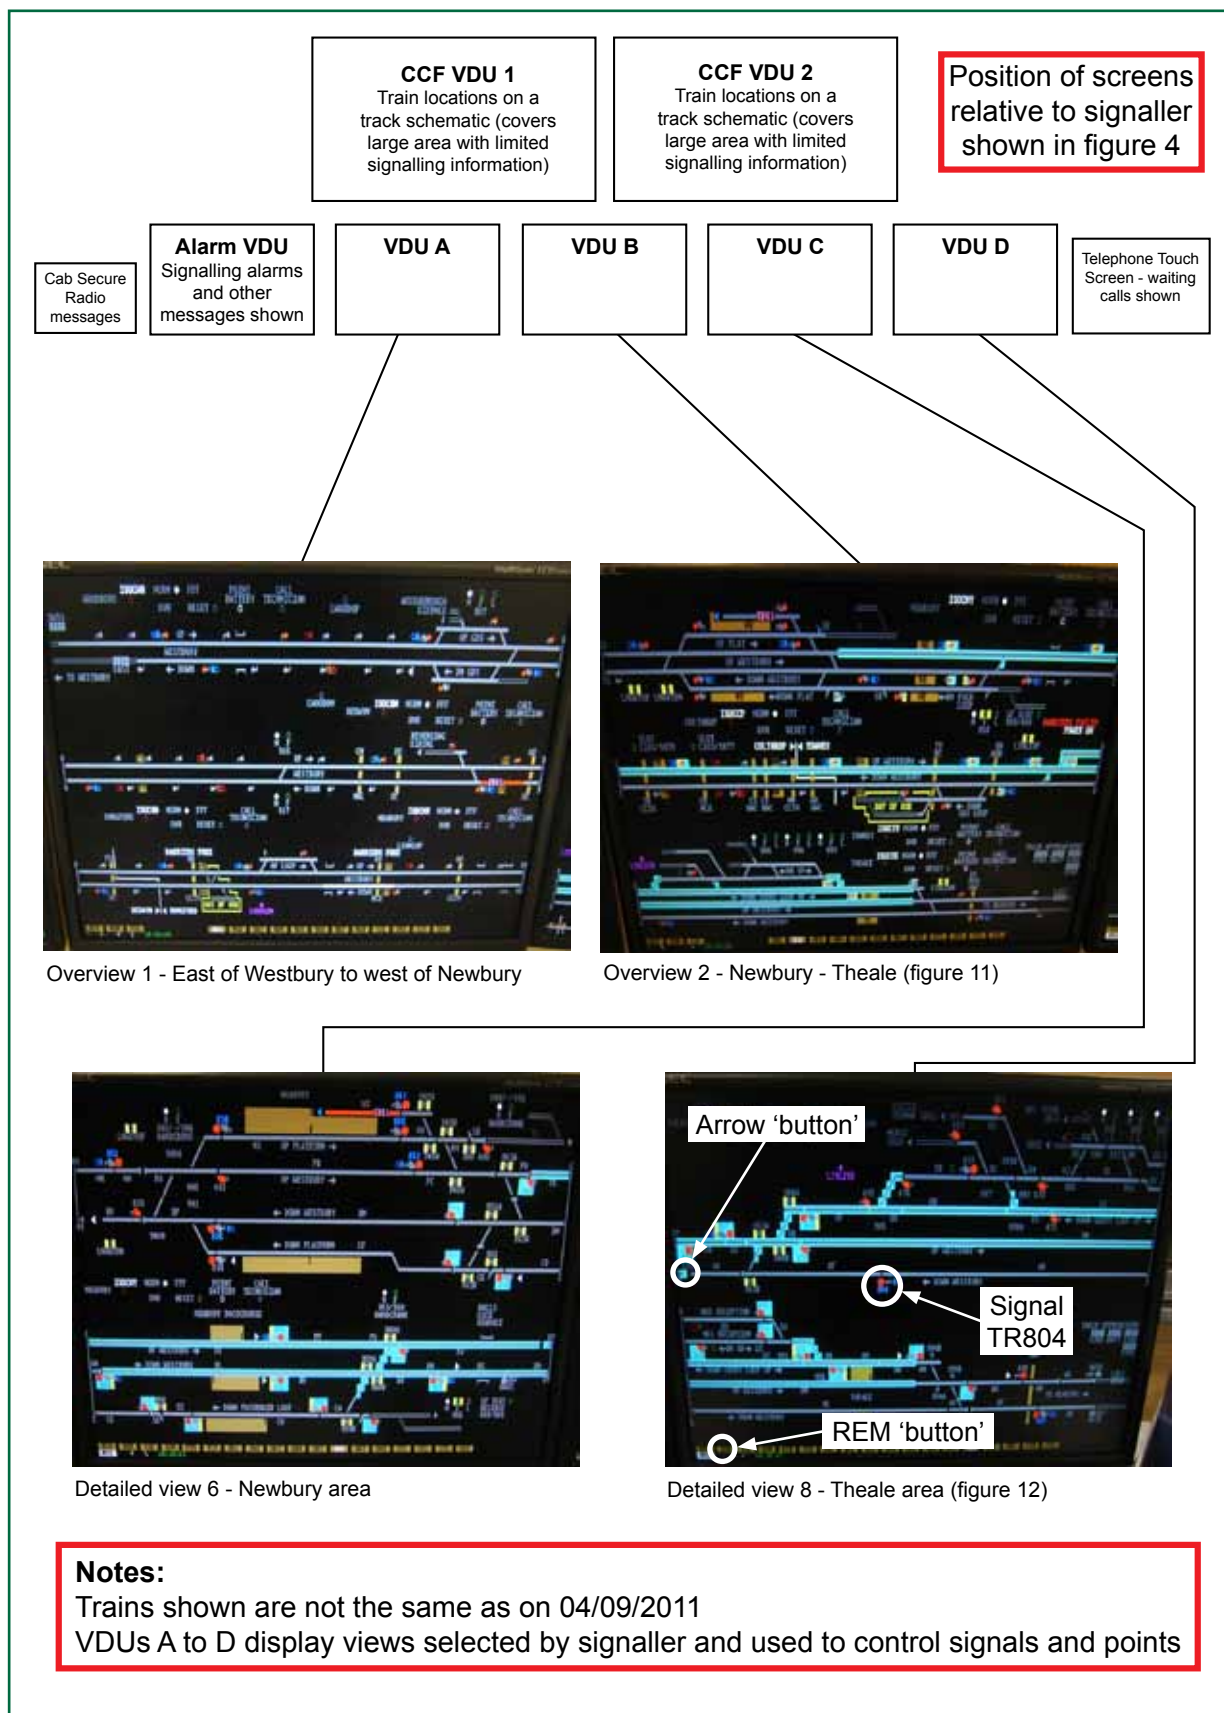
- 82 It is probable that the signaller erroneously removed the reminder from signal TR808 because his attention was diverted by his conversation with the PICOP while operating the signal controls. An unintended error of this type is known as a lapse. It is possible that the signaller recognised that he had incorrectly removed the reminder from signal TR808 and believed that he had corrected this when, shortly afterwards, he replaced the reminder on signal TR804 (paragraph 52).

Figure 14: VDU views probably displayed when reminder removed

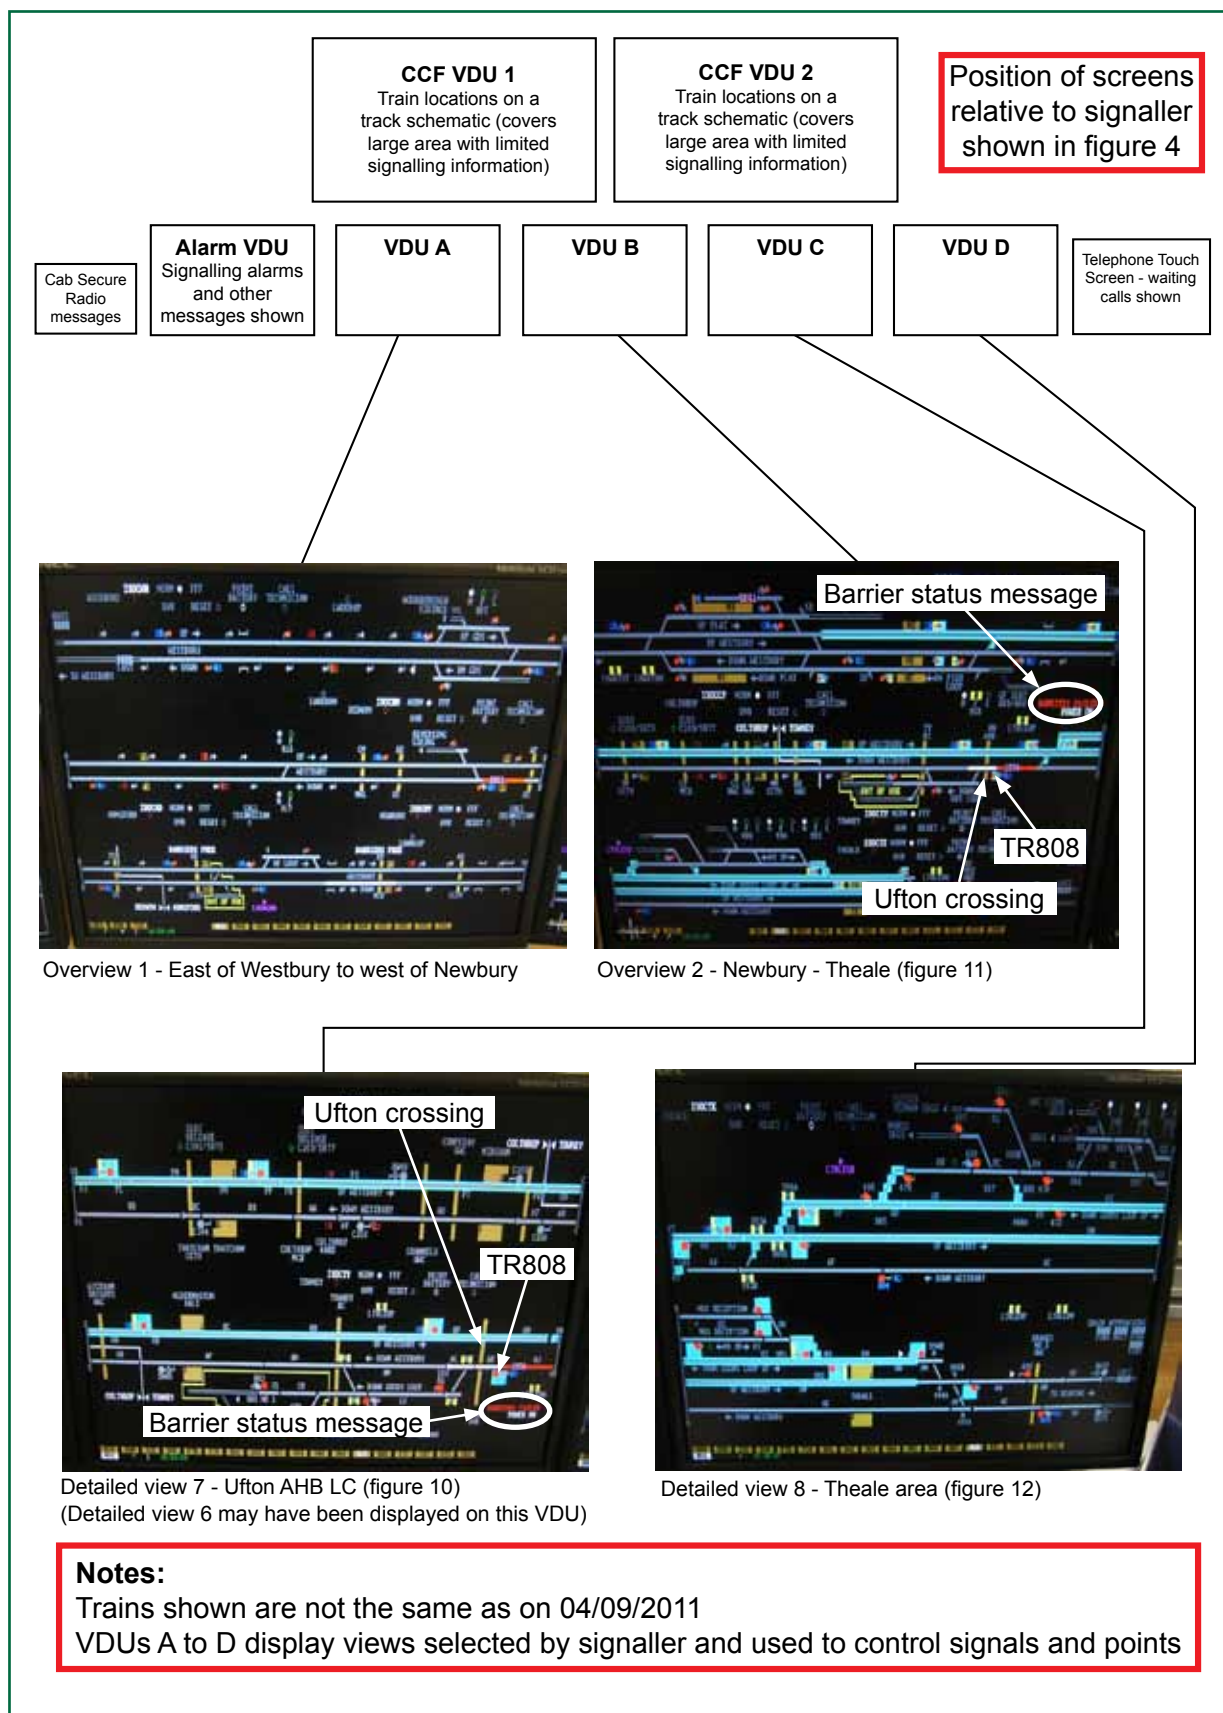
Figure 15: VDU views probably displayed when the route was set from signal TR808 and over Ufton crossing

**110 The level crossing barrier status message was positioned at a location where it could be overlooked by a signaller setting a route over the crossing. This was a possible causal factor.**

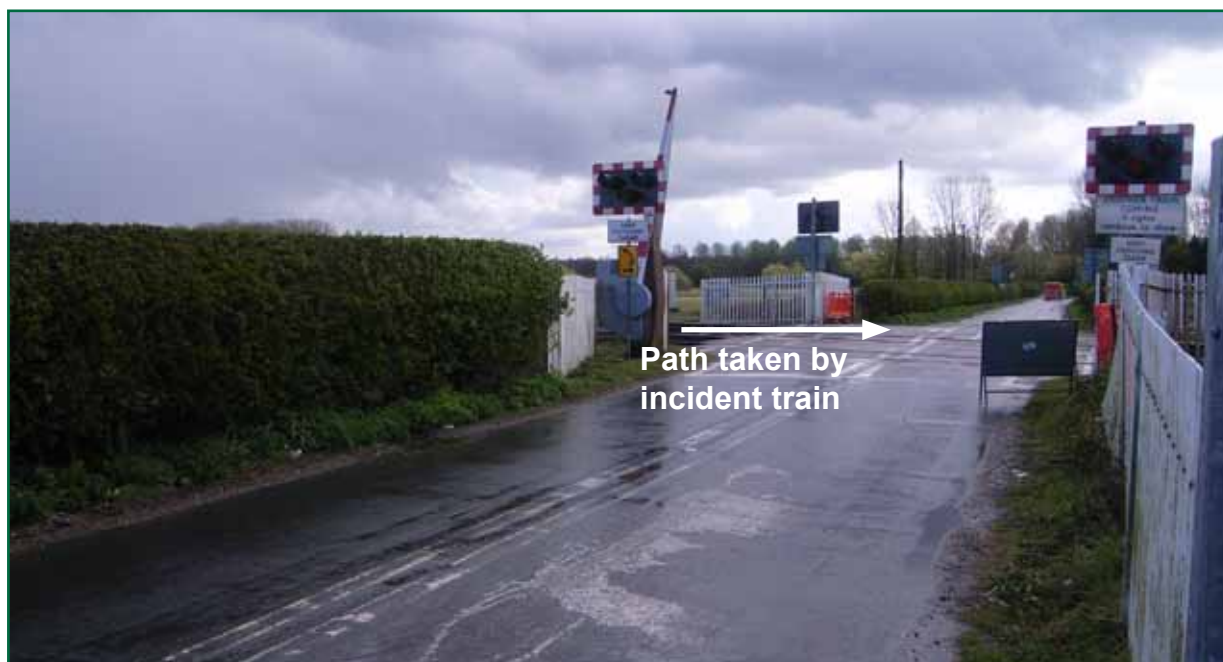
117 When the signaller made his unsuccessful attempt to check that the barriers were lowered by using the level crossing phone to contact the level crossing attendant about a minute before the incident (paragraph 62), the attendant was standing approximately 17 metres north west of the crossing, adjacent to gates on the west side of Ufton Lane (figure 16). He was speaking with a colleague who was sitting in a car and was responsible for controlling access to a railway yard served by these gates. The attendant remained at this location until after the incident train passed over the crossing.

Figure 16: Level crossing attendant's view when standing near gates

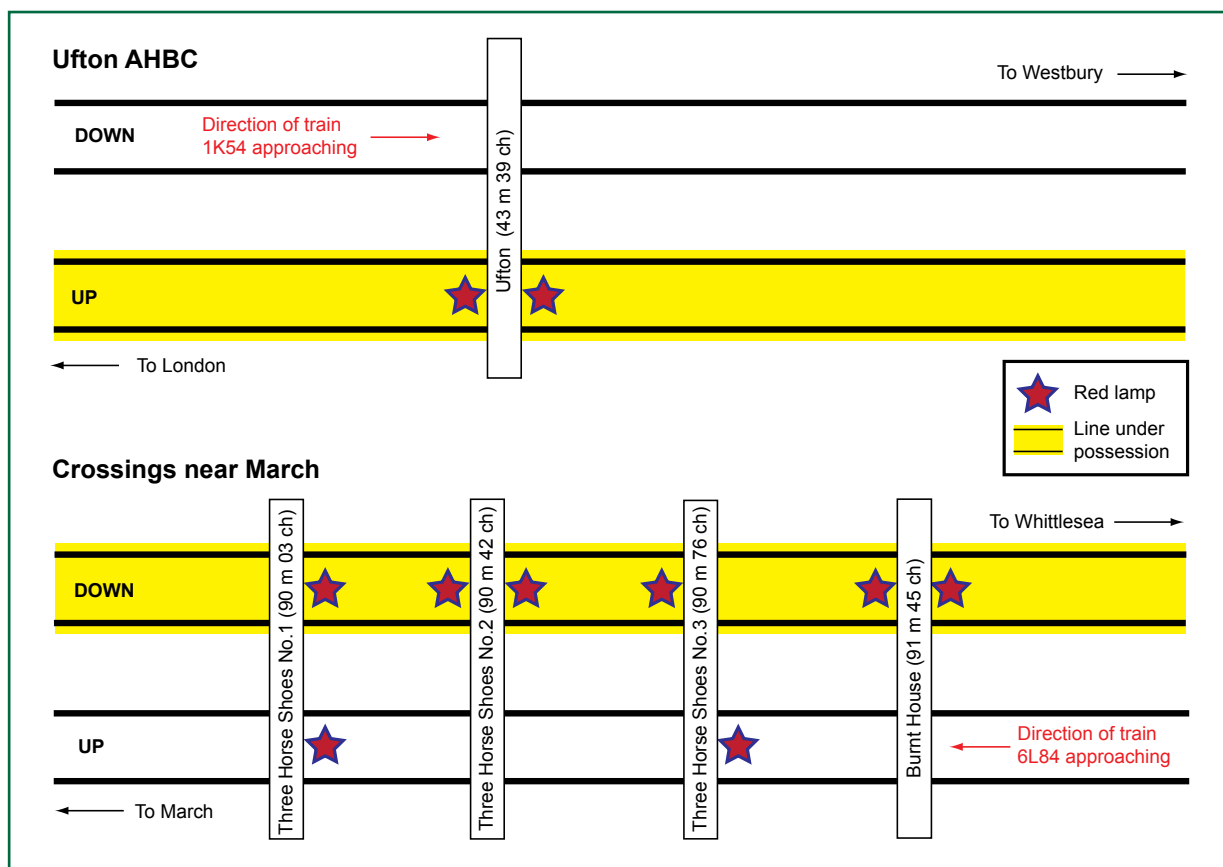
- 143 The rules, keypoint cards and training are inconsistent in respect of the number of red lights to be placed on each side of a level crossing when trains can approach a side on more than one line.
- 144 Information obtained during an industry investigation of an incident similar to that at Ufton (paragraph 151) showed that, on a two track railway with the up line open to normal traffic and the down line under possession, level crossing attendants at four adjacent crossings had each received two red lights which they placed as follows (figure 17):
- at two crossings: both lights were placed on the down line, one on each side of the crossing;
  - at one crossing: one light was placed on each line, the lights were on opposite sides of the crossing;
  - at one crossing: one light was placed on each line, both on the same side of the crossing.

Figure 17: Ufton AHB crossing and the four crossings near March showing positions of red lamps

- 6 *The intent of this recommendation is to provide consistent and appropriate instructions to level crossing attendants about the positioning of red lamps and flags used when level crossings are under local control.*
