Rail Accident Report

Freight train derailment at Reading West Junction 28 January 2012

Report 02/2013
January 2013

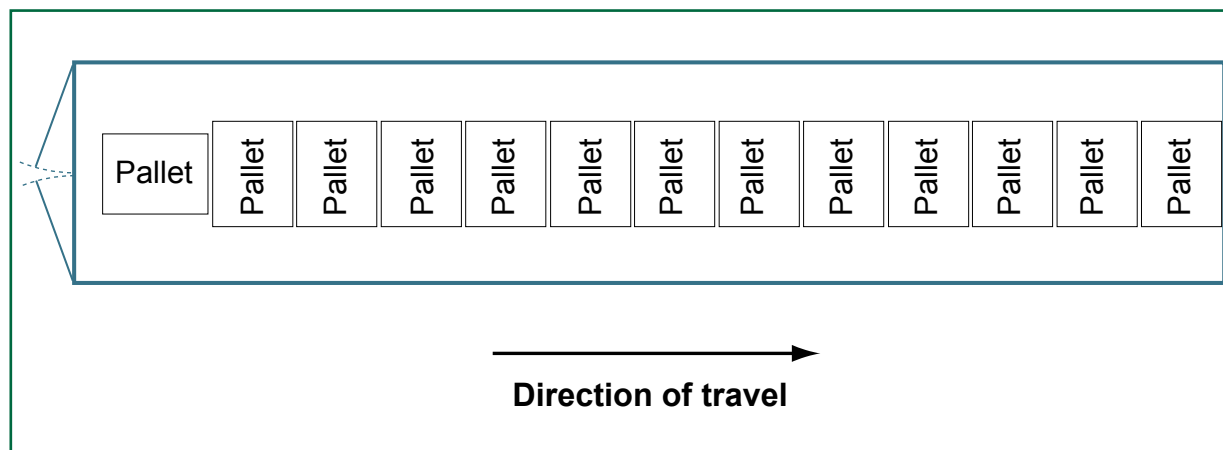
Figure 4: Container WFHU 4147370 as packed at Schaeffler's warehouse

- 26 Schaeffler's warehouse assistant then used a forklift truck to pack the container with 13 wooden pallets of pre-packaged automotive components; each pallet was around 1200 mm by 800 mm and weighed approximately 1300 kg. There were not enough pallets to cover the floor of the container in a tightly packed arrangement. As a result the warehouse assistant placed the pallets in a line down the centre of container so that the container's end-wall and doors limited any longitudinal movement due to braking and acceleration during road transit. Figure 4 shows how the pallets were packed.

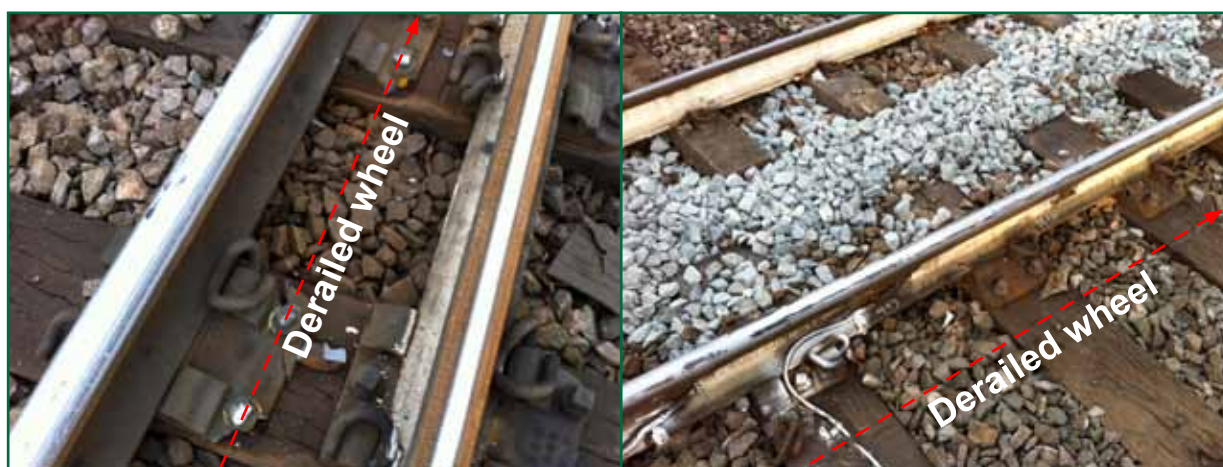
Figure 5: Damage to track and track circuit cables (photographs courtesy of Network Rail)

- 8 There was minor damage to the track and the derailed wagon, and significant disruption to rail services in the area. No-one was injured. The design of the track and signalling arrangements at Reading West Junction prevented the possibility of collision with the majority of other trains at that location, including those going into and out of Reading station. However, train 4002 was at risk of derailing elsewhere on its journey, including locations where it could have infringed the path of passenger trains.

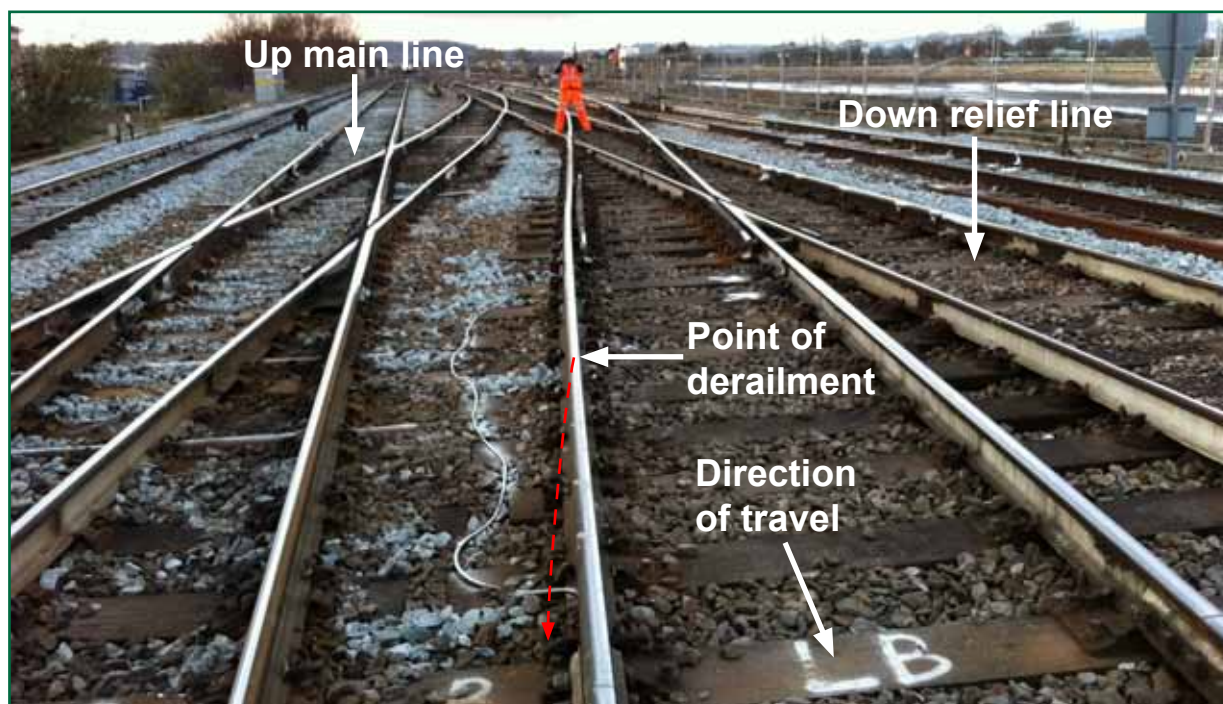
Figure 6: Location of the derailment on crossover 3717 (photograph courtesy of Network Rail)

- 45 The point of derailment was identified as being at the seventh *timber bearer*, on crossover 3717, after the *crossing nose* of the diamond crossing on the down relief line. Network Rail surveyed the track in the vicinity using a *track gauge* and found a track twist that measured 1 in 188 over the standard 3 metre base. It started close to the point of derailment, and continued over the next two timber bearers in the direction of travel.

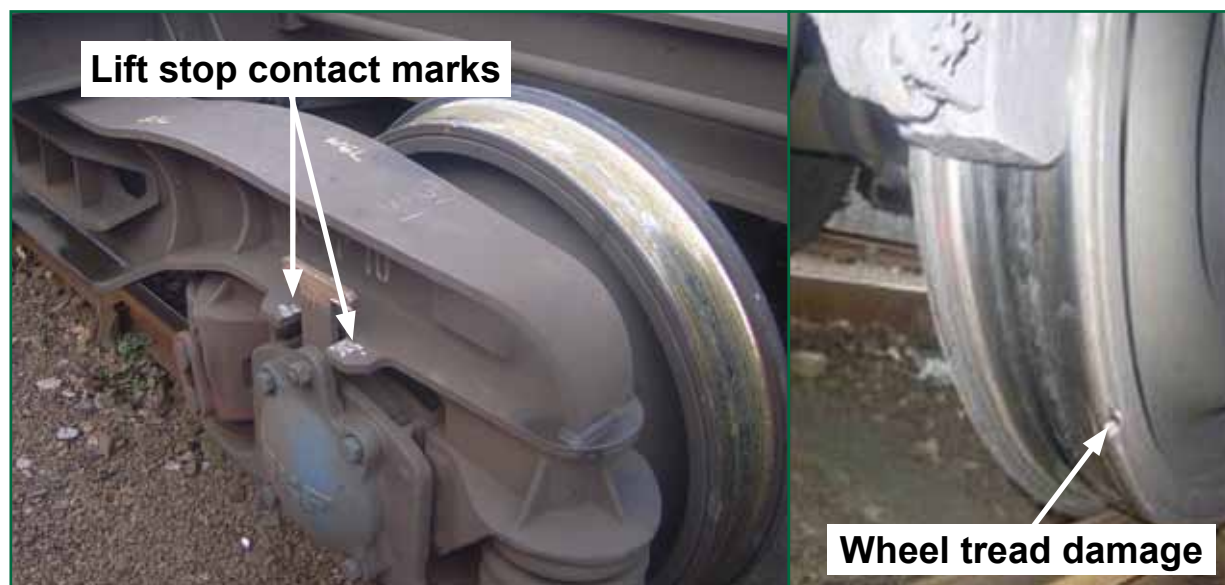
Figure 7: Evidence of primary suspension lift stop contact and wheel damage on leading bogie of wagon 24

- 35 The RAIB examined the train after the derailment and identified evidence of heavy *primary suspension lift stop* contact and wheel damage (figure 7), which indicated that the leading bogie on wagon 24 had run derailed.

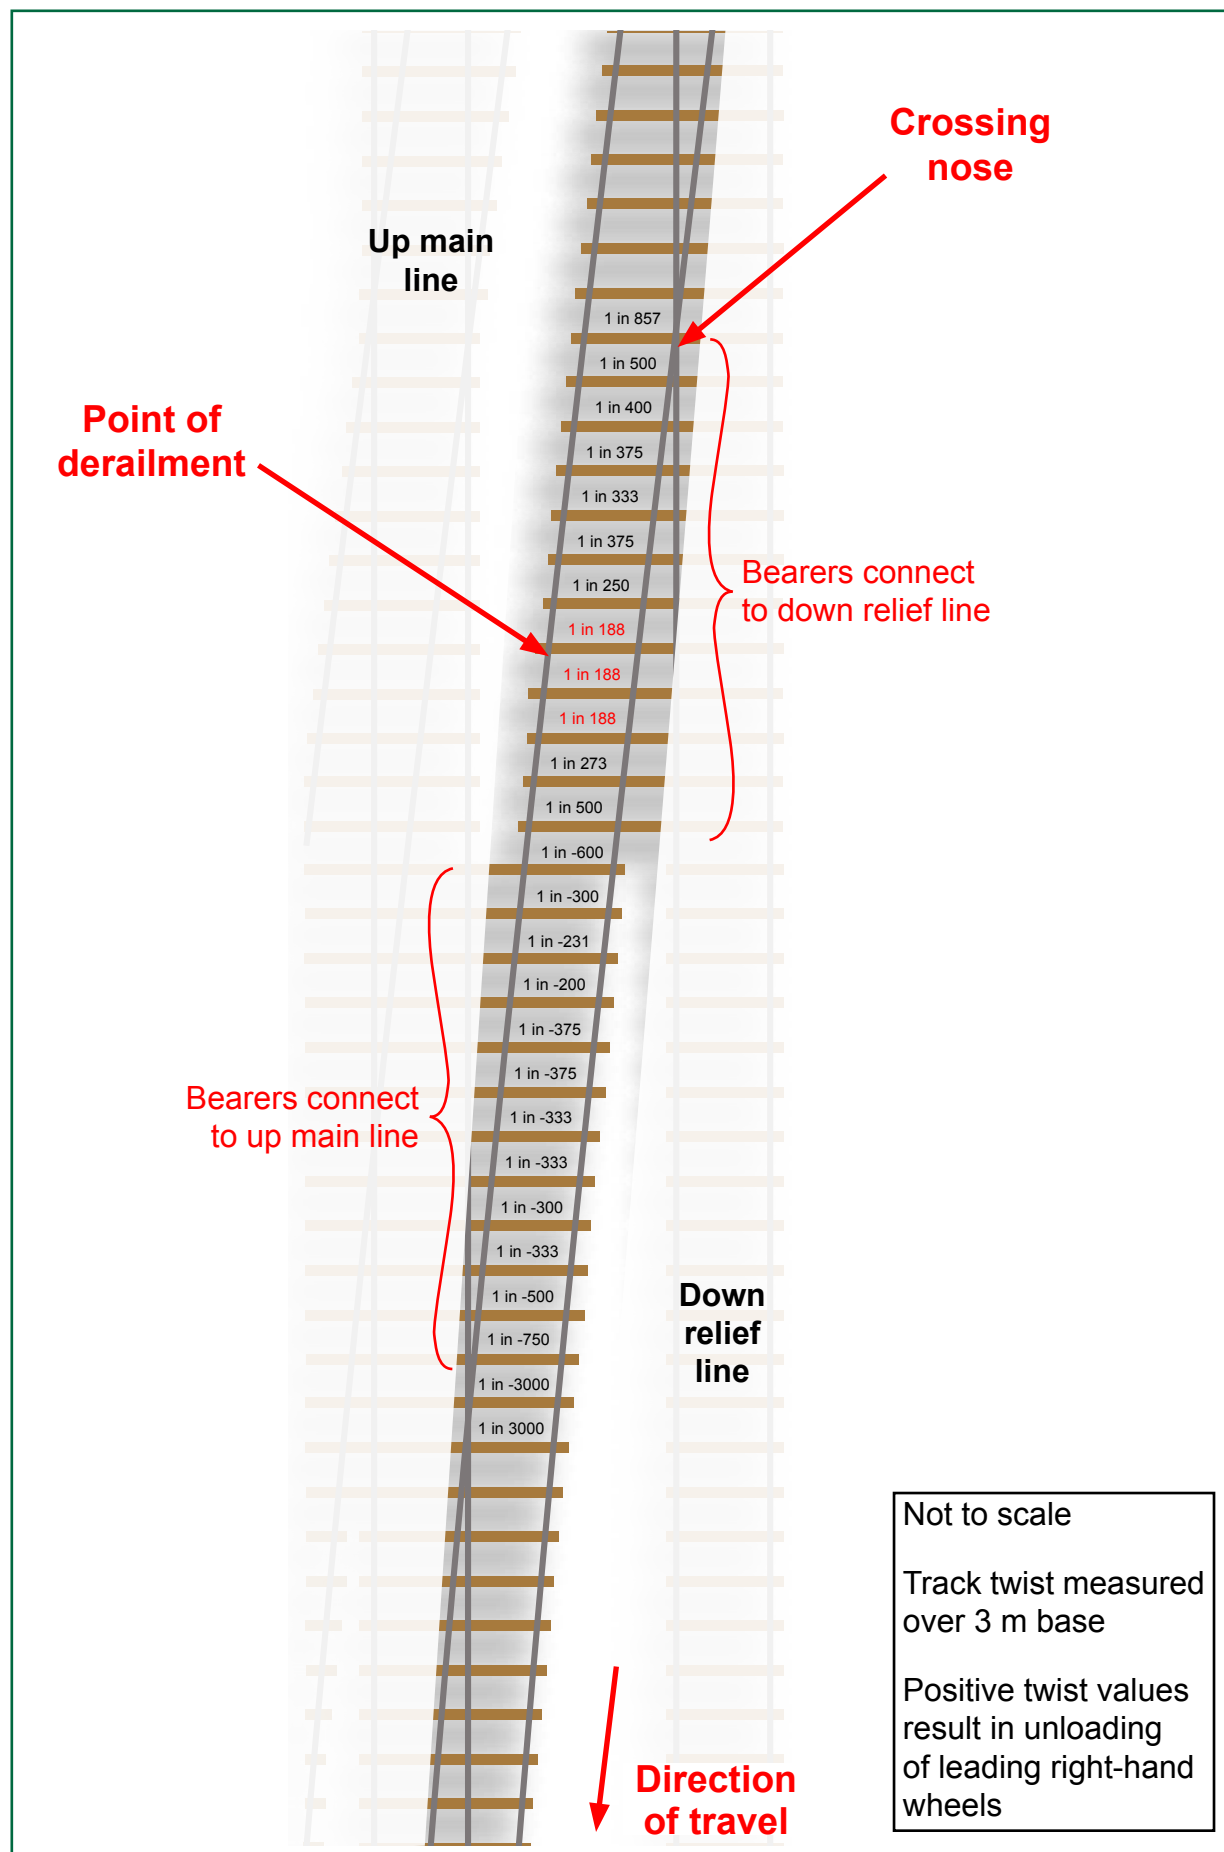
Figure 9: Track layout in the vicinity of crossover 3717 showing the measured twist values

- 46 The timber bearers connect the crossover to the adjacent through running lines. The timber bearer connection changes just after the point of derailment. The bearers leading to the fourth timber bearer after the point of derailment connect to the down relief; beyond the fifth timber bearer they connect to the up main. Figure 9 shows the layout of the crossover in the vicinity of the derailment, the point of derailment, the values of the measured track twist and the arrangement of the timber bearers.

- 84 The post-derailment track survey revealed a track twist of 1 in 188 on crossover 3717 (paragraph 45). While this exceeded the 1 in 200 limit that Network Rail's standard NR/L2/TRK/001 requires to be repaired in 14 days²¹, it was less than the 1 in 90 limit for which the standard requires the line to be immediately blocked to traffic. It was therefore a condition that Network Rail allows to exist for a limited number of days, and a track feature that any vehicle could expect to encounter. Calculations indicate, however, that it was large enough to increase the unloading on the already lightly loaded front right-hand wheel on wagon 24 beyond the criterion in GM/RT2141 (paragraph 60).

- 85 The post-incident track survey was made with the track in the unloaded condition, and did not account for deflection due to train weight (paragraph 43). It is therefore possible that the track twist under wagon 24 may have been worse.

- 112 Network Rail has repaired the twist fault that it found on crossover 3717. It has also re-planned one of the measurement schedules for one of its track measurement train runs so that it routinely records the track geometry on crossover 3717.

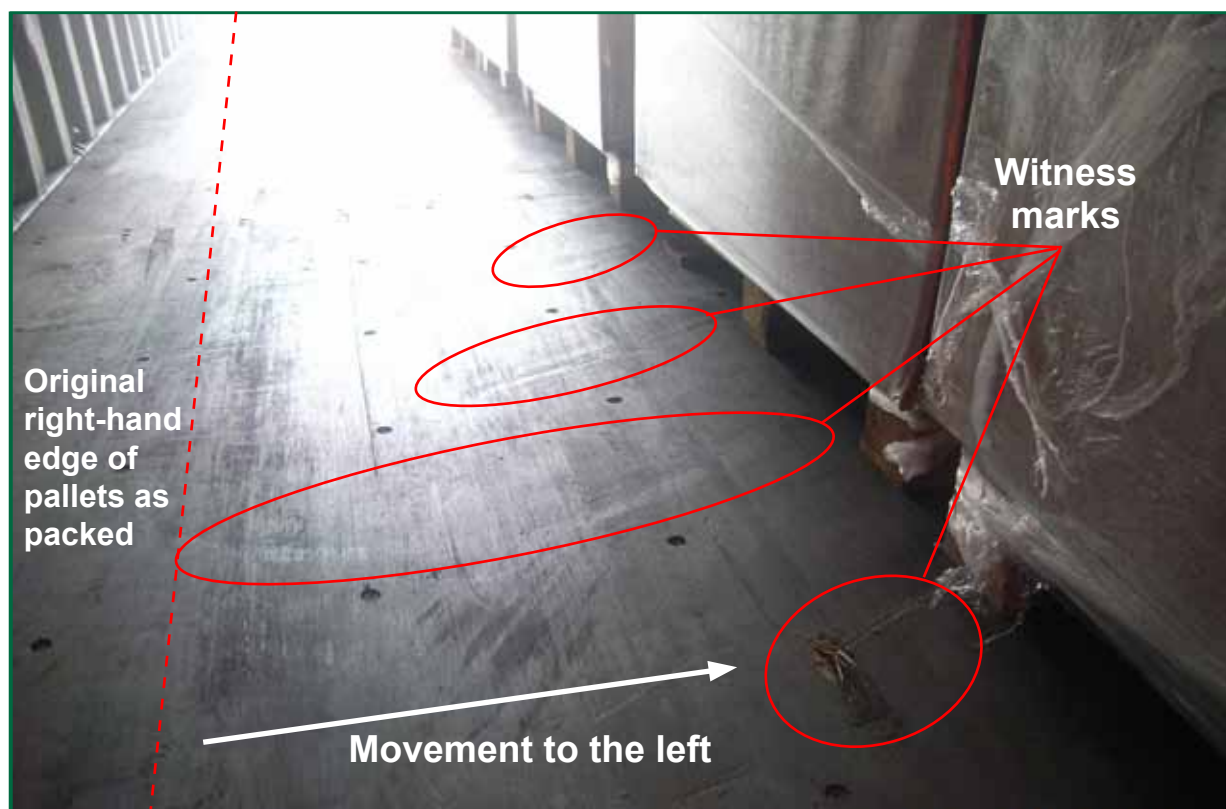
Figure 10: Witness marks on the floor of container WFHU 4147370 showing how the pallets moved

- 67 Marks on the container floor showed that the pallets moved uniformly to the left from a position near the longitudinal centre line (figure 10). This supports the warehouse assistant's recollection that he had packed them centrally in the container (paragraph 26 and figure 4).
