Rail Accident Report

Derailment of a tram at East Croydon 17 February 2012

Report 04/2013
March 2013

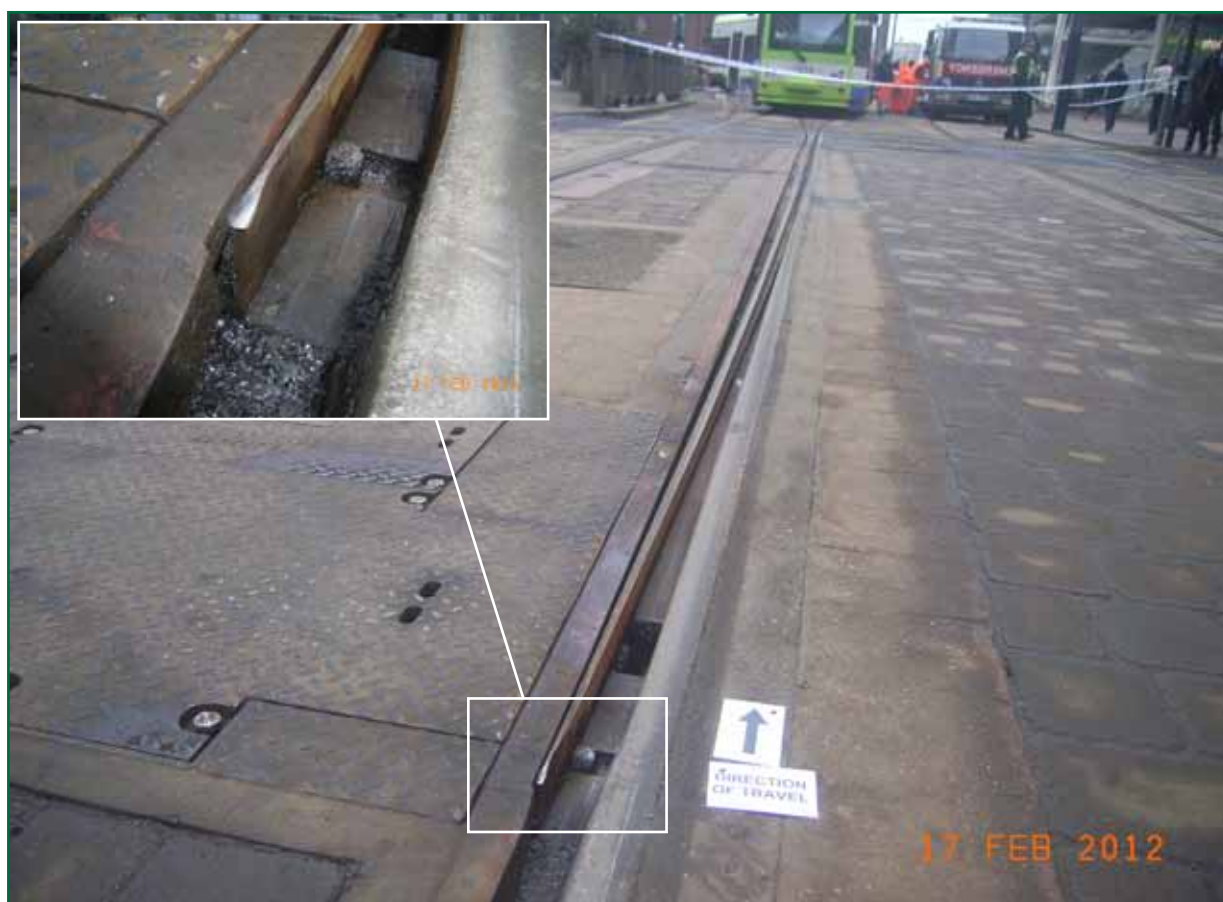
Figure 5: Damage to right-hand switch rail tip (points ECR06M)

- 18 The derailment caused minor damage to tram 2538's wheels, the road surface and points ECR06M.
- 19 Following an examination of the derailed tram and testing of the infrastructure by London Tramlink and the RAIB, tram 2538 was removed from site and the line was reopened in time for the evening rush-hour service. Points ECR06M were secured to direct westbound services into platform 3 while London Tramlink undertook a detailed review of the signalling arrangements at East Croydon. This work remains ongoing at the time of publication of this report.

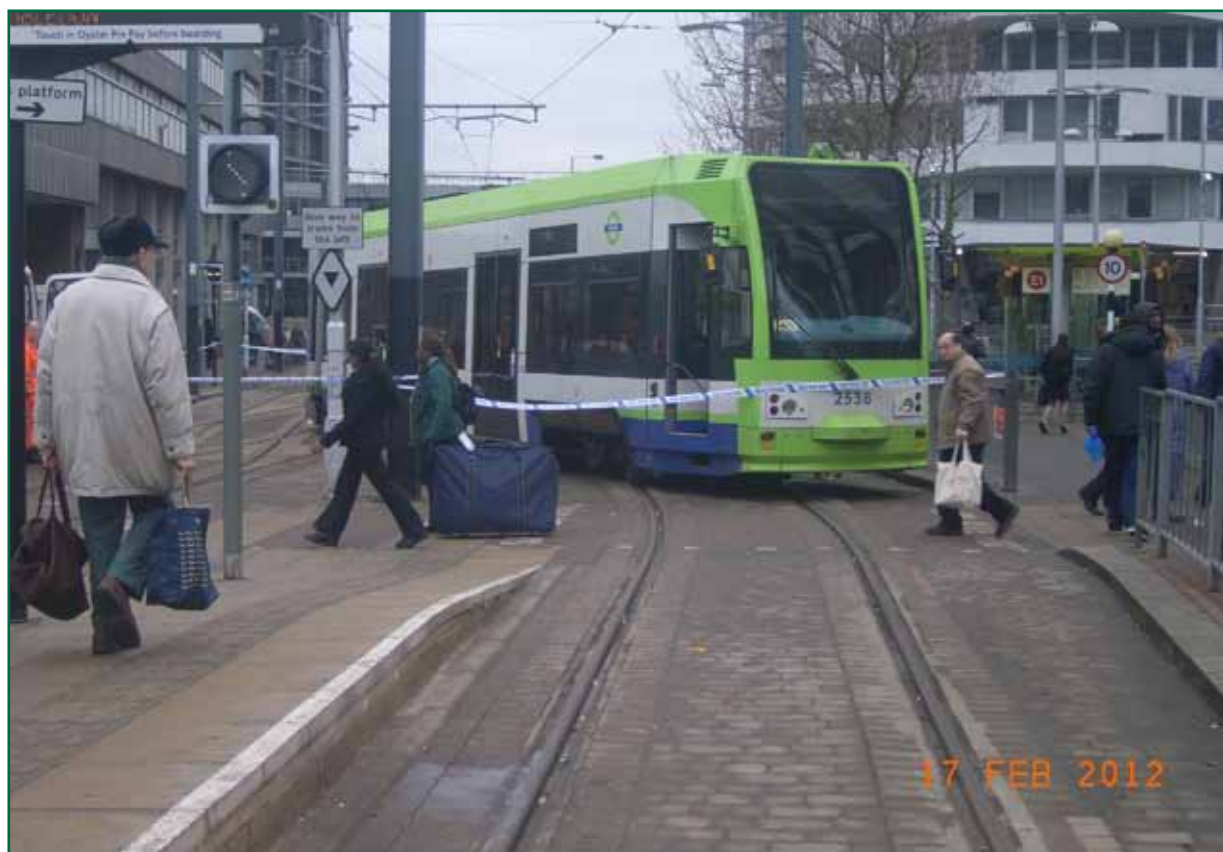
- 16 Tram 2538 was travelling at 12 km/h (7.5 mph) when the centre bogie derailed to the left. This occurred 34 metres beyond the switch rail tip when the vehicle's articulation was unable to accommodate the diverging routes taken by the leading and centre bogies. The tram driver sensed an unusual movement and applied the vehicle's emergency brake. The tram came to a stop after travelling for a further 4 metres in a derailed condition (figures 6 and 7).
- 17 There were no injuries among approximately 100 passengers on the tram, some of whom were standing. Passengers left the tram under the guidance of the driver via the leading passenger door which had stopped close to East Croydon tram stop.

Figure 6: Front view of tram 2538 following derailment

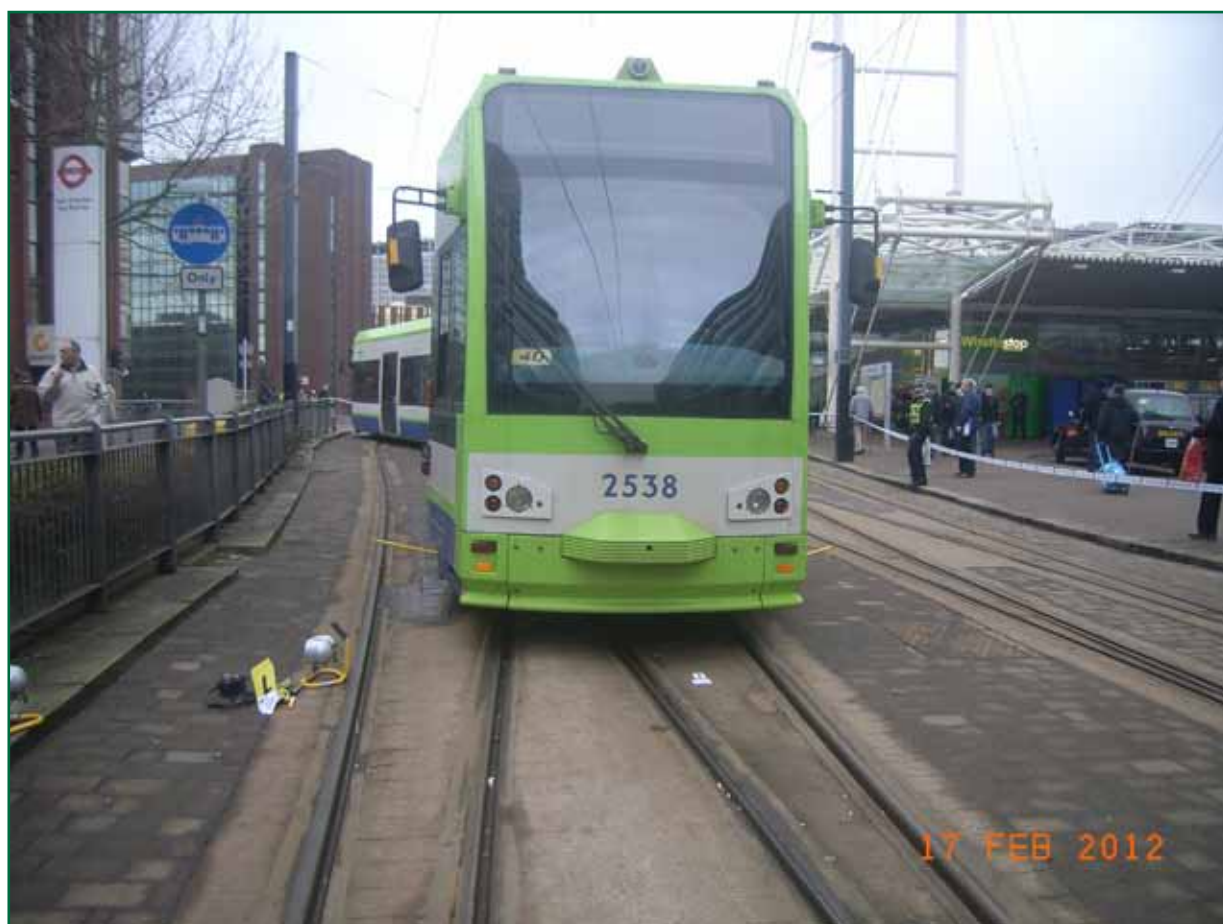
Figure 7: Rear view of tram 2538 following derailment

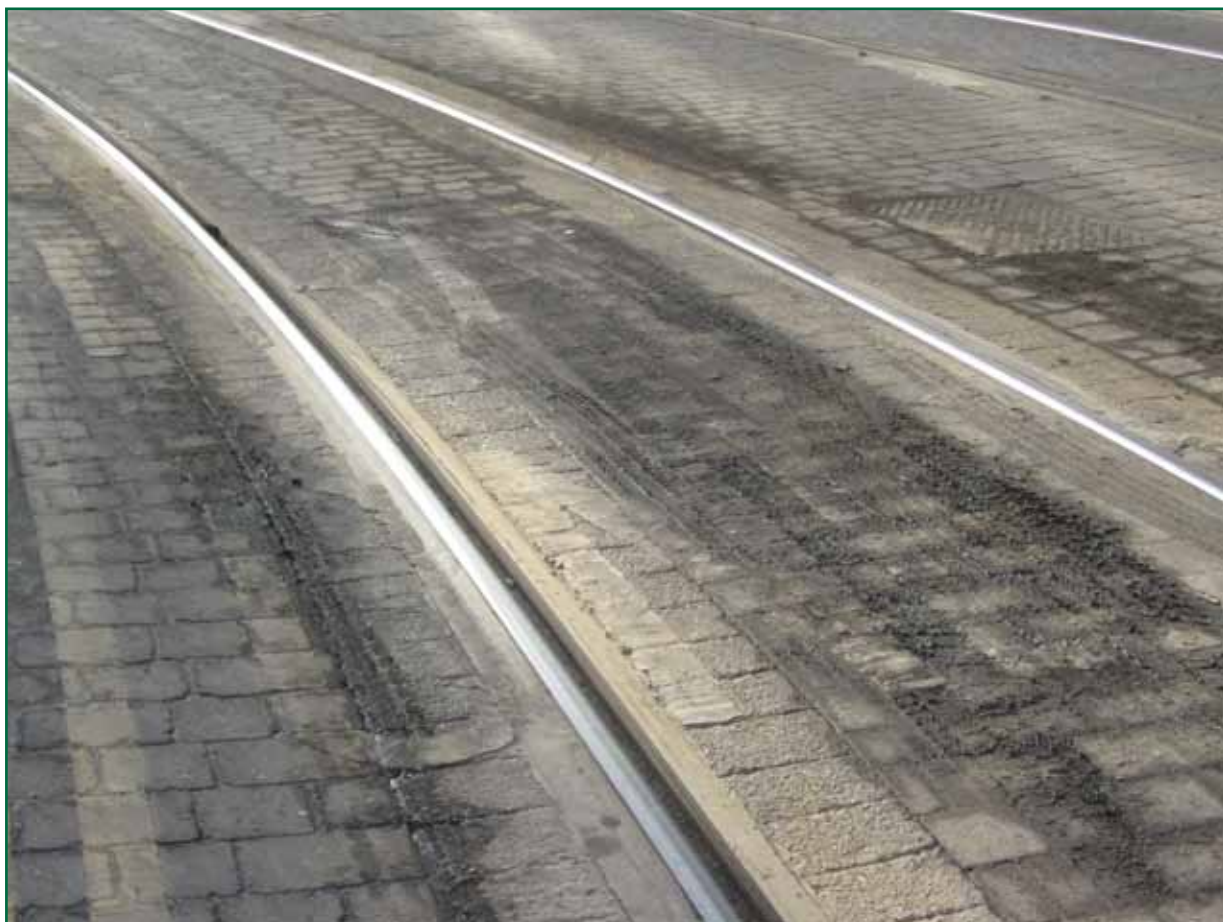
53 The track circuit performance was probably affected by contamination on the rail head.

- 54 Although a post-accident inspection by the RAIB did not identify any unusual contamination on the track circuit rail head, some silt contamination was seen. It is possible that this was sufficient to prevent the track circuit, as set up at the time of the accident, from responding to the presence of tram 2538.
- 55 It is possible that some of the silt seen on the rail head had come from an accumulation of silt seen on the roadway near Cherry Orchard Road crossing during the RAIB's inspection (figure 12). It is probable that this silt had accumulated since the area was swept mechanically one week before the derailment as part of the routine fortnightly mechanical sweeping of embedded track in Croydon town centre. Drainage works were undertaken in 2009 which had reduced, but did not eliminate, the accumulation of silt near Cherry Orchard Road.

Figure 12: Silt on paved surface west of Cherry Orchard Road crossing on 17 February 2012

- 2 *The intention of this recommendation is to reduce the risk of rail head contamination affecting the correct operation of track circuits. This should include inspections immediately after events which could lead to accumulation of silt.*

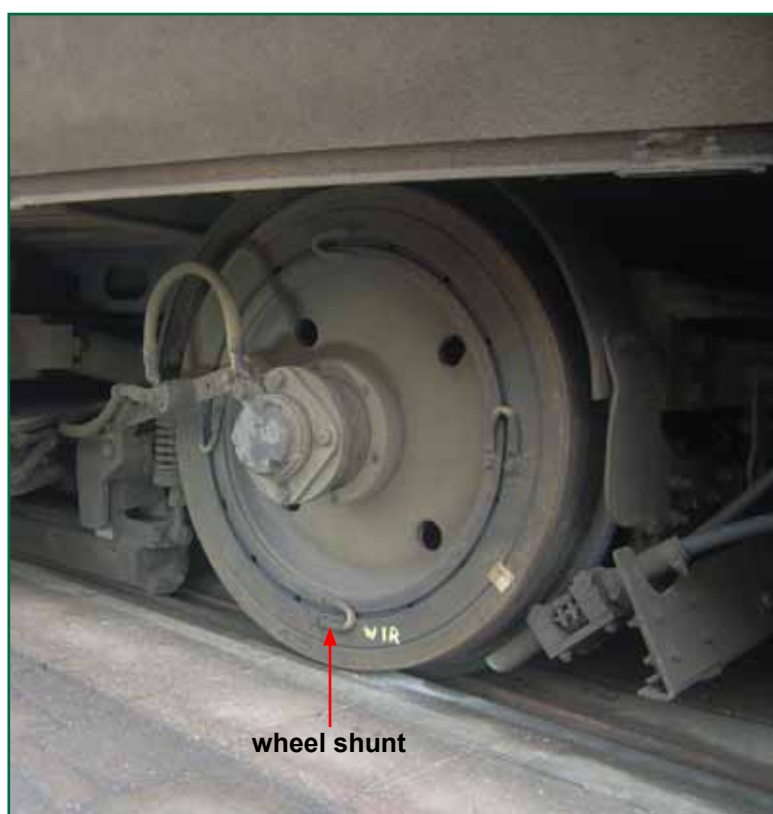
56 Tram 2538 had a relatively high wheel tyre to wheel tyre resistance.

- 57 All axles on the CR4000 tram have *resilient wheels* with braided copper bonds (*wheel shunts*) on each wheel providing electrical continuity between the wheel hub and tyre (figures 13 and 14). Bombardier's maintenance specification for the CR4000 fleet states that wheel tyre to wheel tyre resistance should not exceed 0.01 ohms on a new bogie, or rise above 0.1 ohms in service. The wheel shunts are designed to provide an electrical path for traction current to return to the rails, and Bombardier stated that the requirement for the trams to operate track circuits was not specified when the trams were designed. At the time of the derailment, Bombardier's maintenance staff remained unaware that the wheel shunts performed both roles.

Figure 13: Leading bogie of tram 2538 showing wheel shunt

- 3 *The intention of this recommendation is to establish boundary values for tram wheel tyre to wheel tyre resistances and introduce requirements to take appropriate measurements during planned maintenance.*
