Rail Accident Report

**Accident involving a pantograph and the
overhead line near Littleport, Cambridgeshire
5 January 2012**

Report 06/2013
May 2013

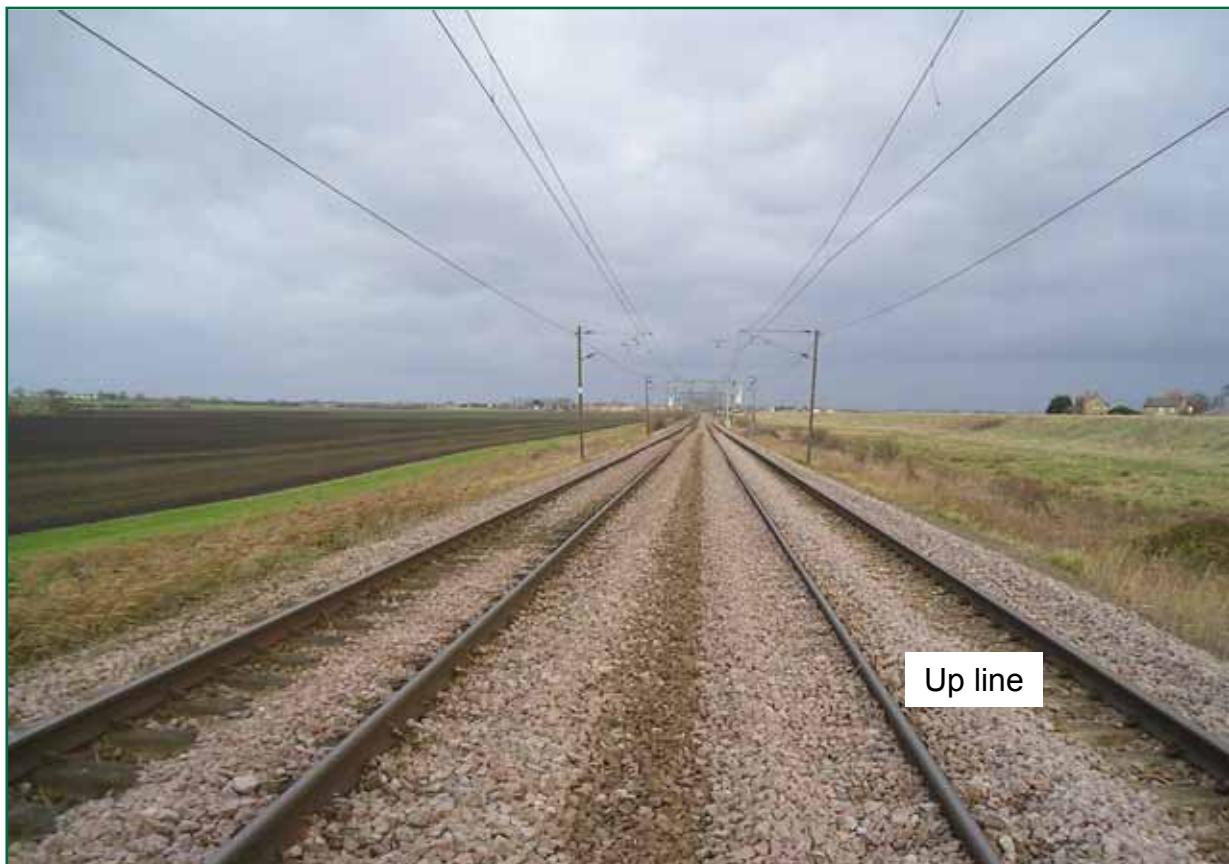
Figure 2: General view of accident location (Courtesy of First Capital Connect)

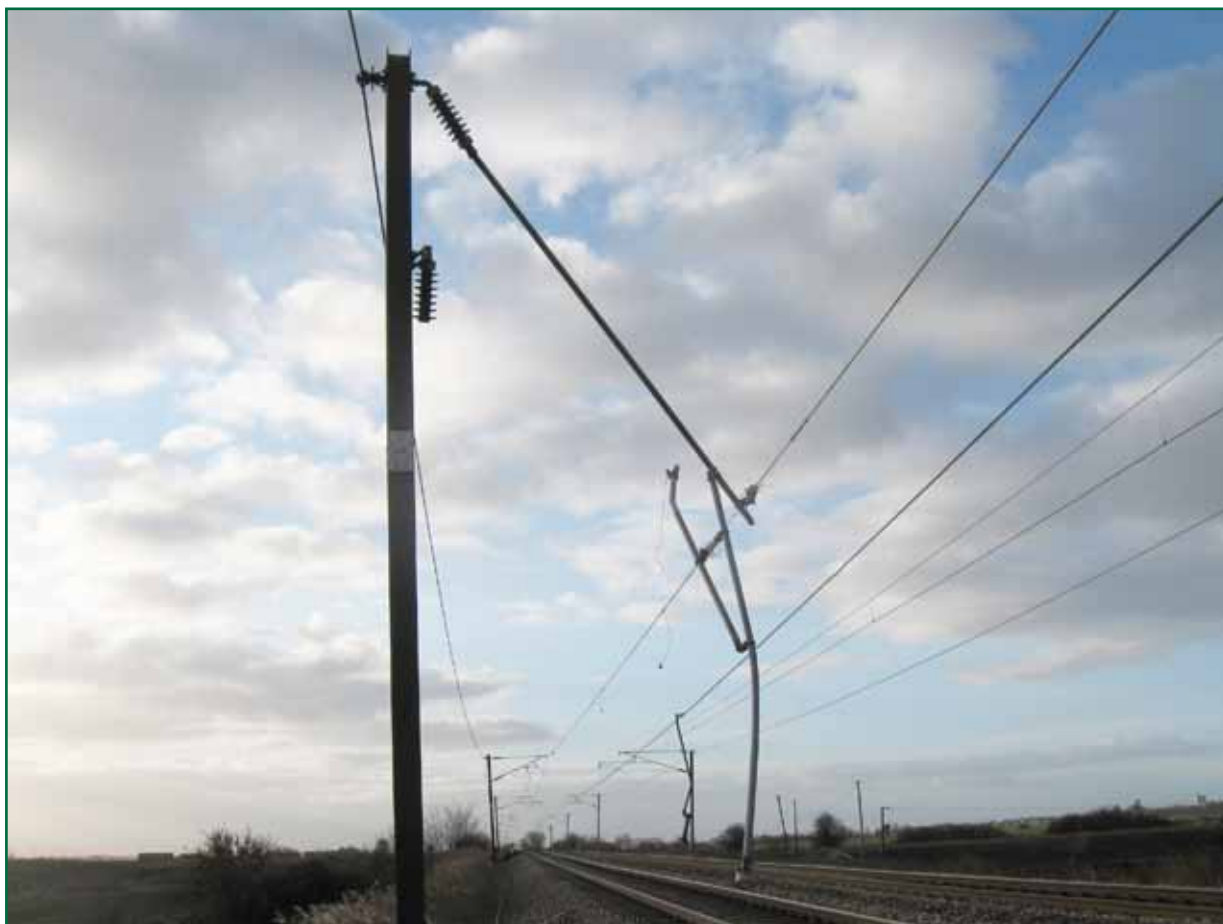
Figure 4: Support structure hit by the pantograph, at mast C118/32 (courtesy of Network Rail)

- 75 The pantograph assembly, which weighs around 225 kg, was travelling at 80 mph (129 km/h) when it hit the cantilever structure at mast C118/32. This would have resulted in a sudden large impact loading. RAIB calculations have shown that an impact load in excess of that required to break each of the insulators was likely to have resulted from the collision between the pantograph and the cantilever structure. The pantograph manufacturer also considered that it was possible that such an impact loading would cause the insulators to break.

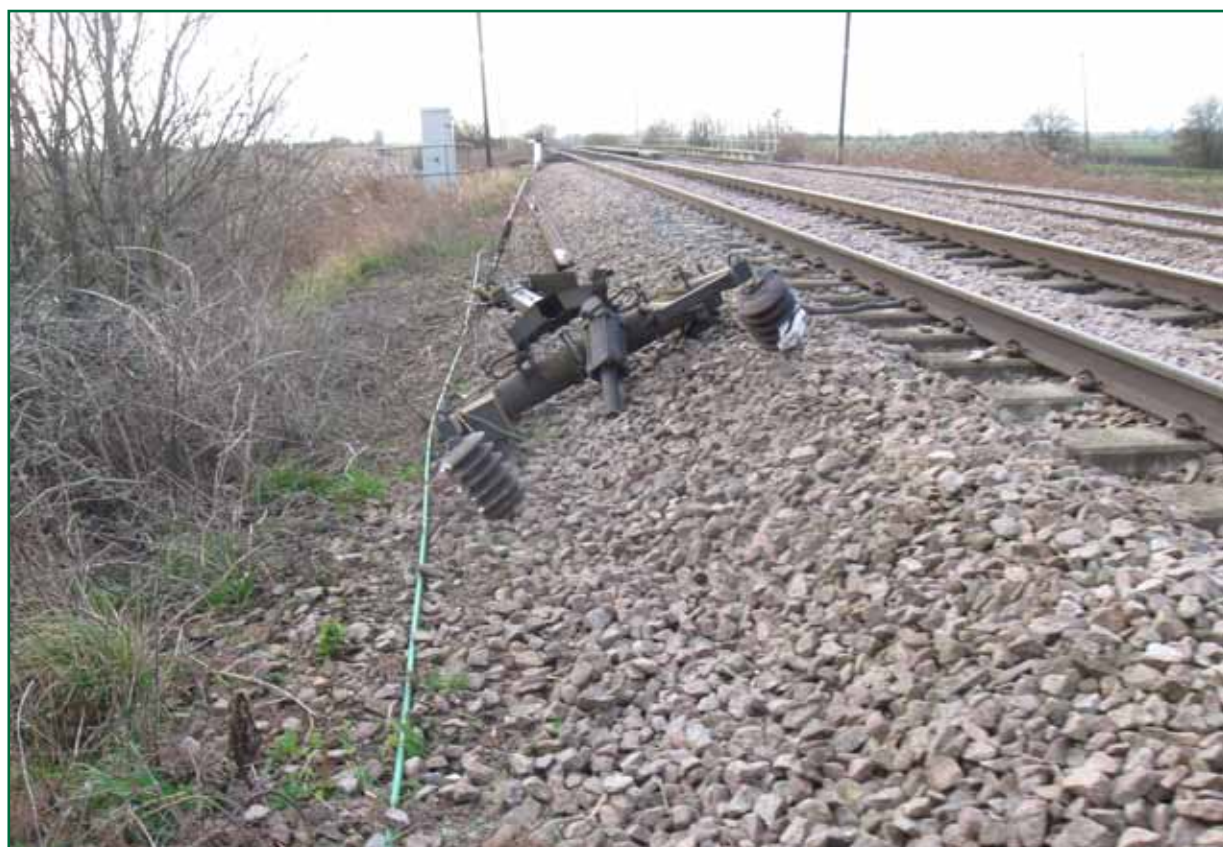
Figure 5: Remains of the pantograph in the cess (courtesy of Network Rail)

- 73 The ceramic post insulators are secured to the train using a metal collar that is bolted to the train roof. All four of the insulators broke just above the collar. Because there was no deformation of the metal collars, it is likely that the insulators suffered a sudden impact loading, leading to the failure.

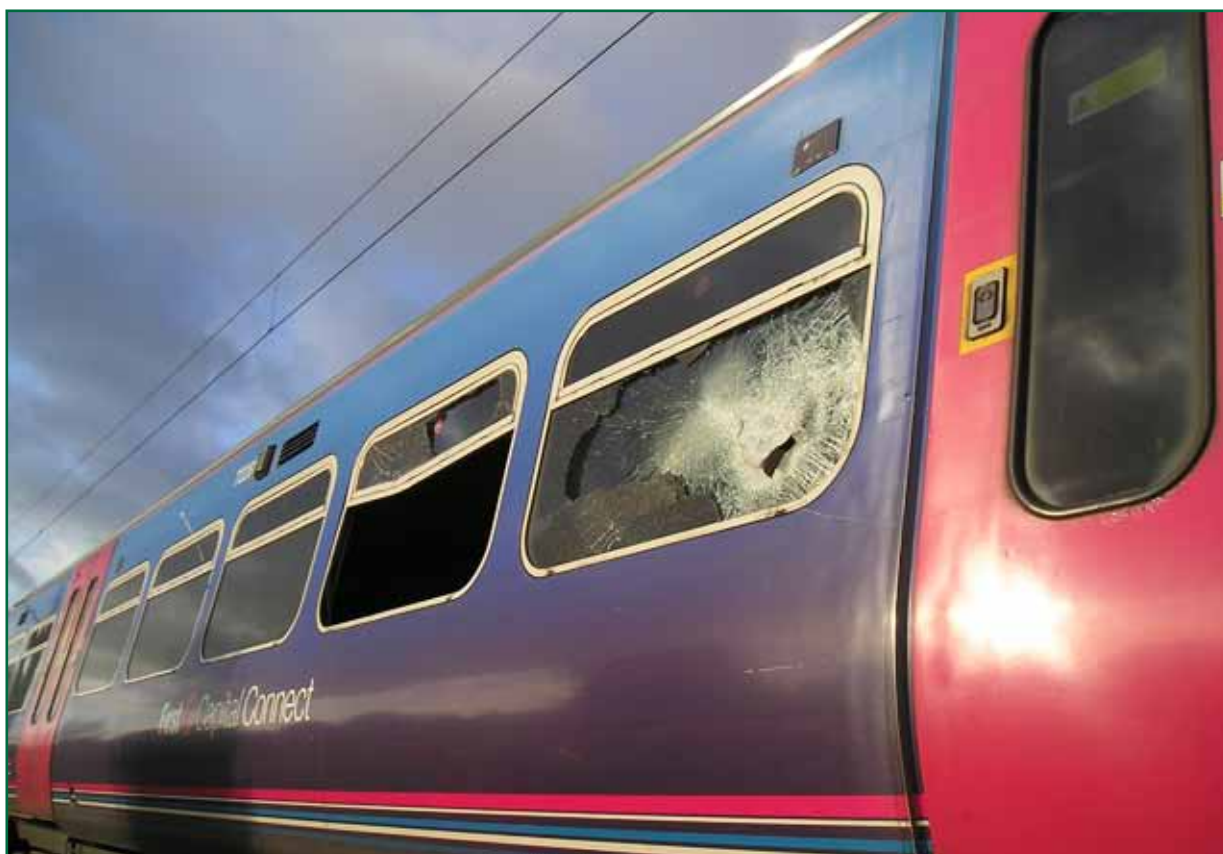
- 13 Two of the train's windows were broken. There was superficial damage to the roof and side, and extensive damage to the pantograph assembly.

Figure 6: External damage to the train (courtesy of First Capital Connect)

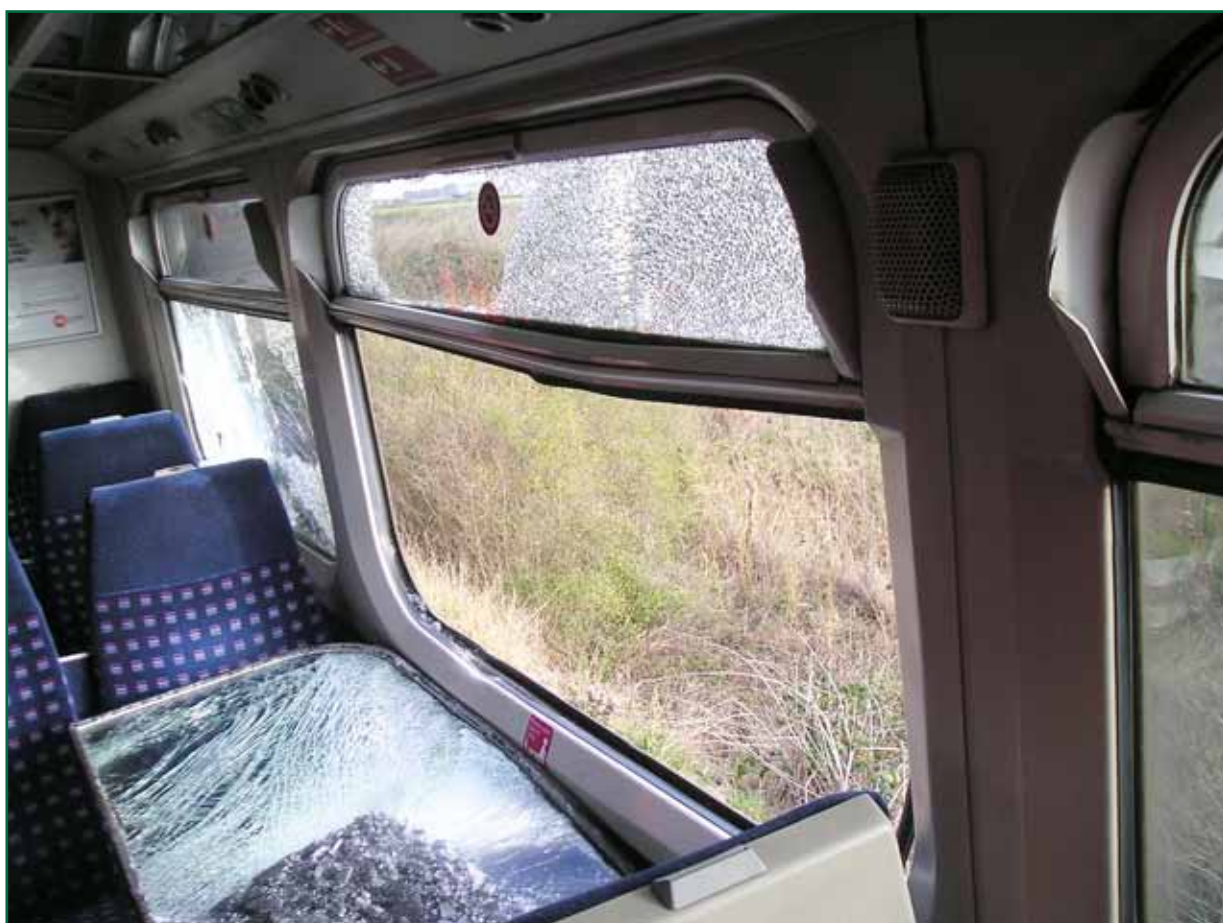
Figure 7: Window after falling into passenger area (courtesy of First Capital Connect)

- 82 **The window was forced into the train by impacts from the pantograph assembly.**
- 83 The pantograph was mounted towards the rear of the second coach of the train. Scrape marks on the train roof show it was displaced onto the roof of the third coach, before falling down the left side. As the pantograph fell, it impacted the left side of the third coach several times. This caused scrape marks to the coach bodywork, showing that the pantograph was moving backwards relative to the moving train. There were signs of impact on the frames and panes of the sixth and seventh windows (out of nine) on the left side of the third coach. These impacts resulted in the pane of the sixth window falling onto the adjacent table inside the coach (figure 7).

- 89 However, it is very probable that the impact from the pantograph included a perpendicular component exceeding the resistance required to satisfy the missile penetration and passenger containment standards. There was no evidence of a pre-existing defect in the window. It is certain that the impact also included substantial components parallel to the window in the downward and backward directions.

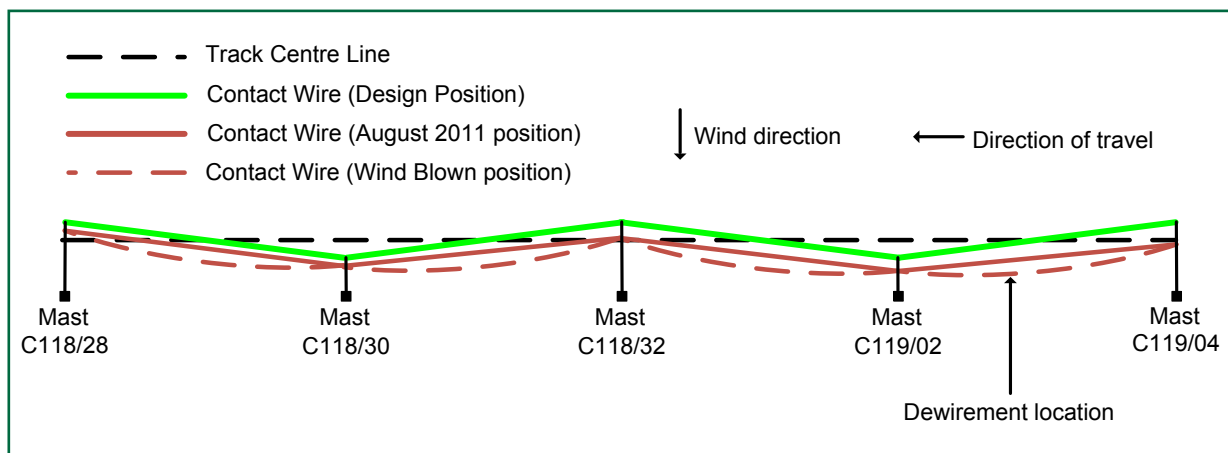
- 94 Extrapolation of site measurements taken by Network Rail between 2007 and 2011 (paragraph 126) indicates that movement of mast foundations had caused the contact wire to be offset by approximately 230 mm from the track centre at the mid-span between masts C119/04 and C119/02.
- 95 The design drawings for the overhead line showed that the mid-span position of the overhead line was intended to be directly above the track centre line (figure 16).

Figure 16: Overhead line alignment at accident location (plan view not to scale)

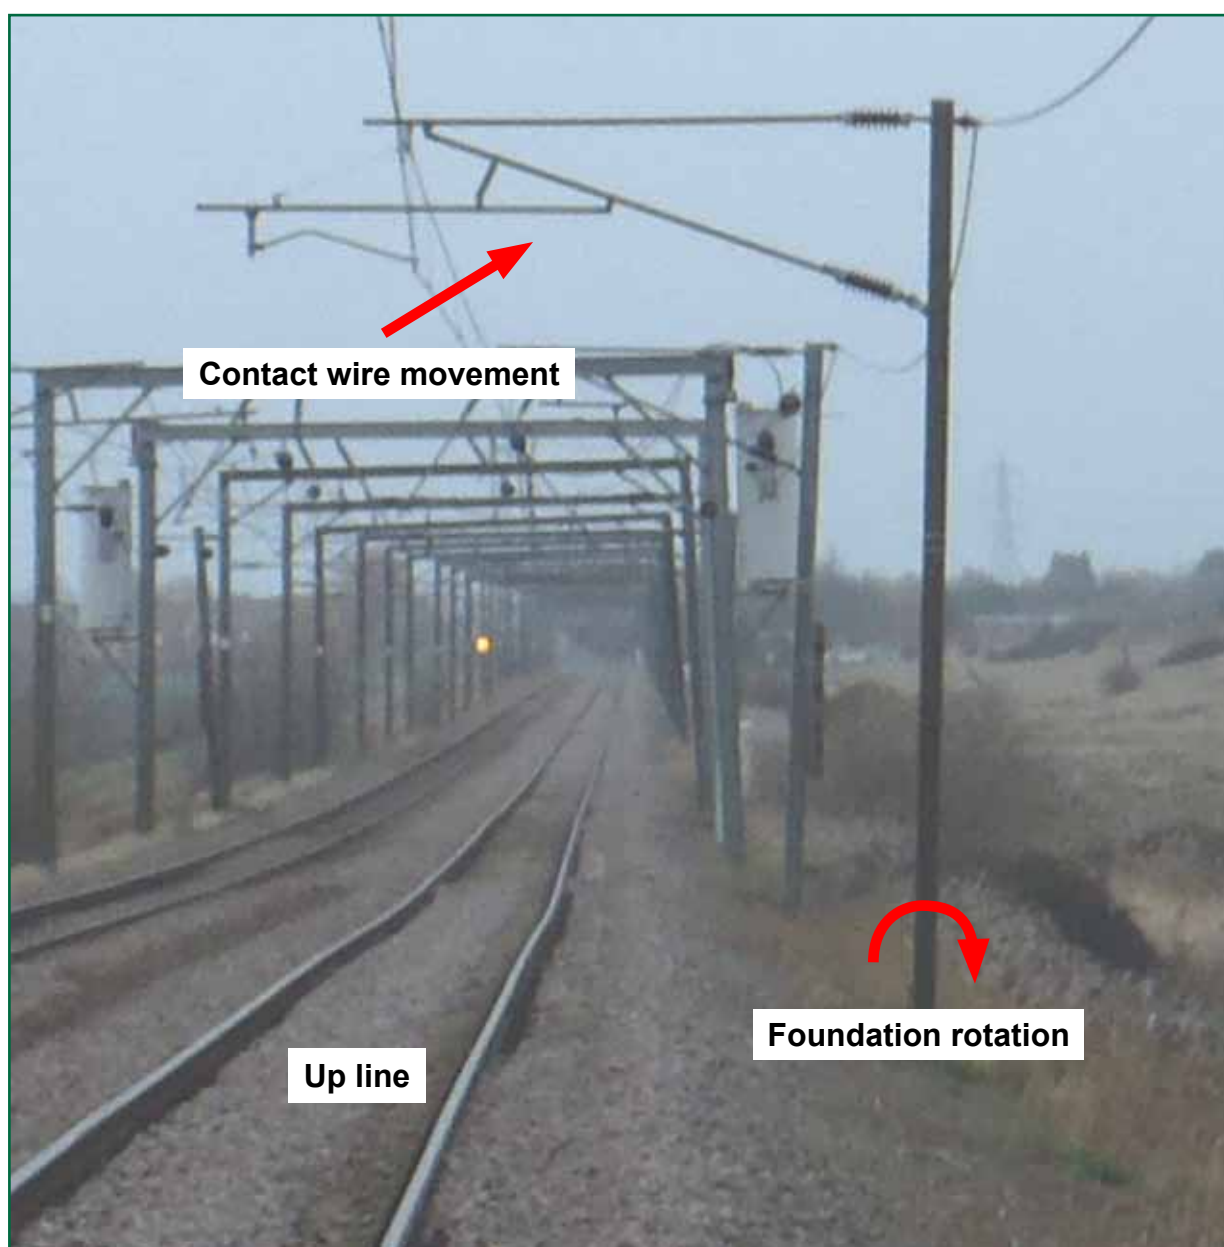
- 62 **The immediate cause of the accident was that the pantograph became detached from the train roof, impacting the train windows as it fell to the ground.**

Figure 23: Masts at the accident location, showing results of foundation movement (courtesy of First Capital Connect)

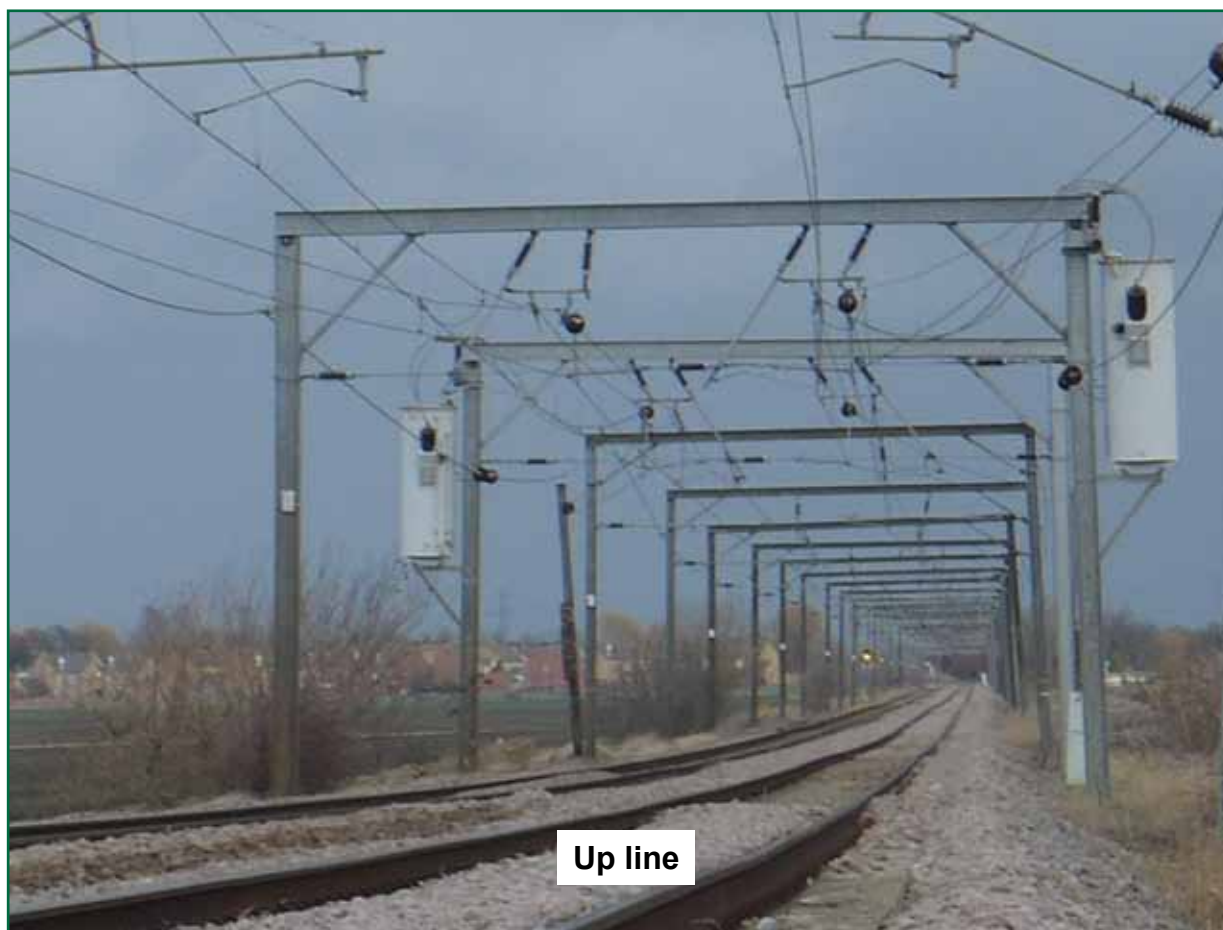
122 Portals, where the two masts on either side of the line are connected together by an overhead structure, are more resilient to this type of movement. Figure 24 shows an example of portal structures. The overhead line up to 200 metres before the accident was supported on portal structures. After this point, separate masts were used.

Figure 24: Portal structures immediately before mast C119/04 (courtesy of First Capital Connect)

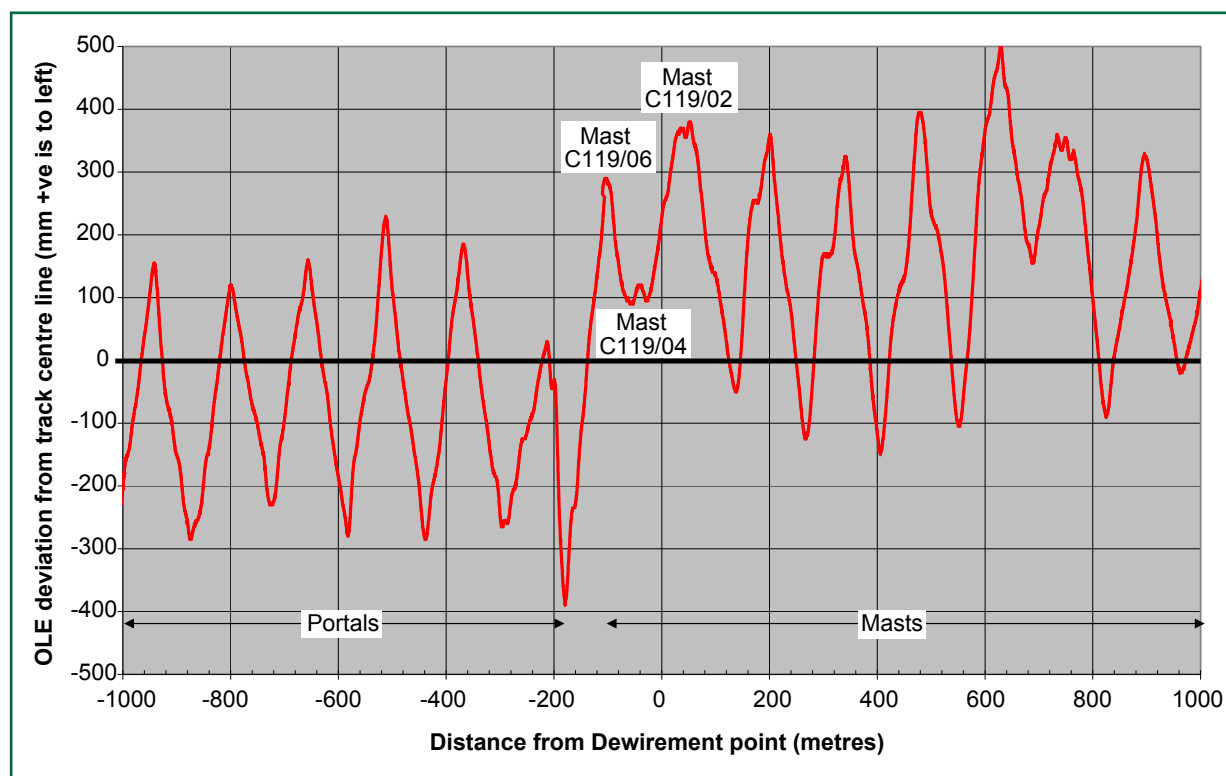
123 The horizontal alignment of the OLE contact wire on the up line in the vicinity of the accident is shown in figure 25. This data was collected by the 'MENTOR' overhead line measurement coach in November 2011, and adjusted by the RAIB to take account of known inaccuracies in the method of measurement⁷. These inaccuracies included calibration differences that led to inconsistencies between successive recordings, and the absence of compensation for dynamic movement (sway) of the coach during recordings. The position of the contact wire is seen to alternate from one side of the track centre line to the other, whilst supported by portal structures. However, where the OLE is supported by separate masts, the alignment of the contact wire is seen to be predominantly left of the track centre line.

Figure 25: Overhead alignment recorded by MENTOR coach

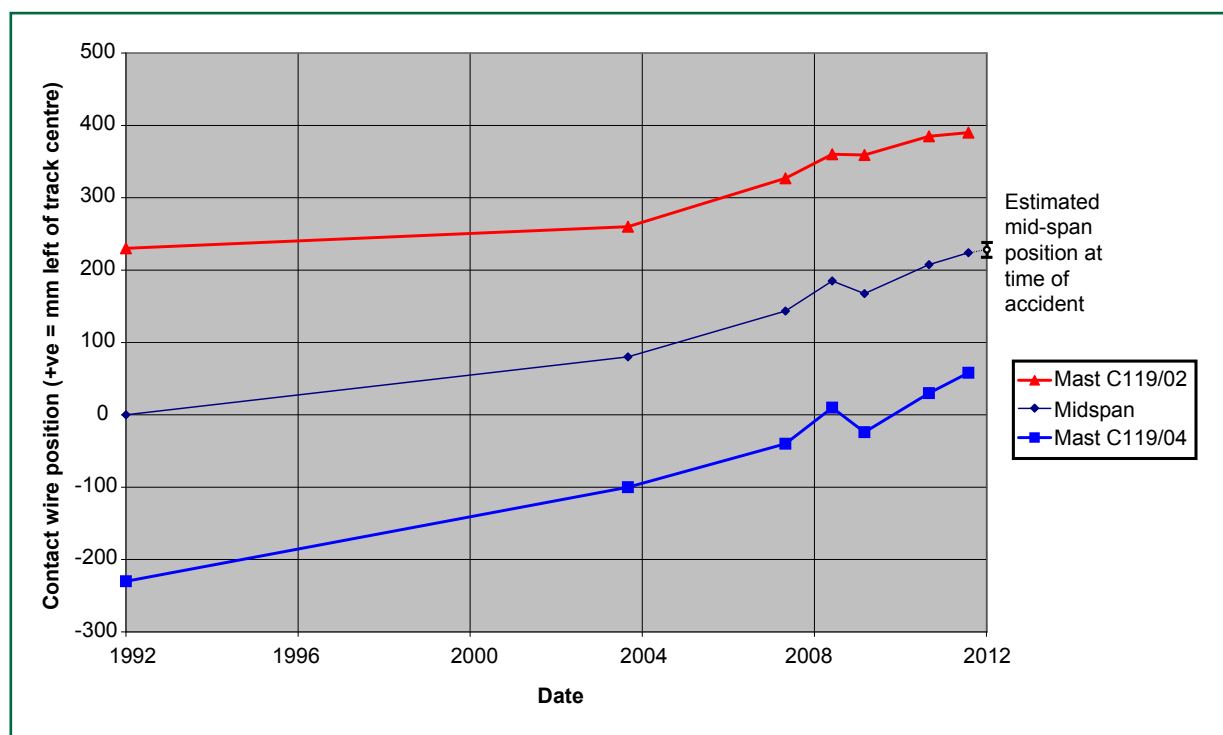
126 The slipping structure monitoring had been undertaken annually since 2007. The RAIB has extrapolated this data to estimate that the contact wire at mid-span was likely to have been 230 mm (± 15 mm) left of track centre at the time of the accident (figure 26). It is probable that this movement consists of both a long term trend and seasonal fluctuations.

Figure 26: Movements of OLE at masts C119/02 and C119/04, and at mid-span
