Rail Accident Report

Derailment of a freight train at Shrewsbury station, 7 July 2012

Report 08/2013
July 2013

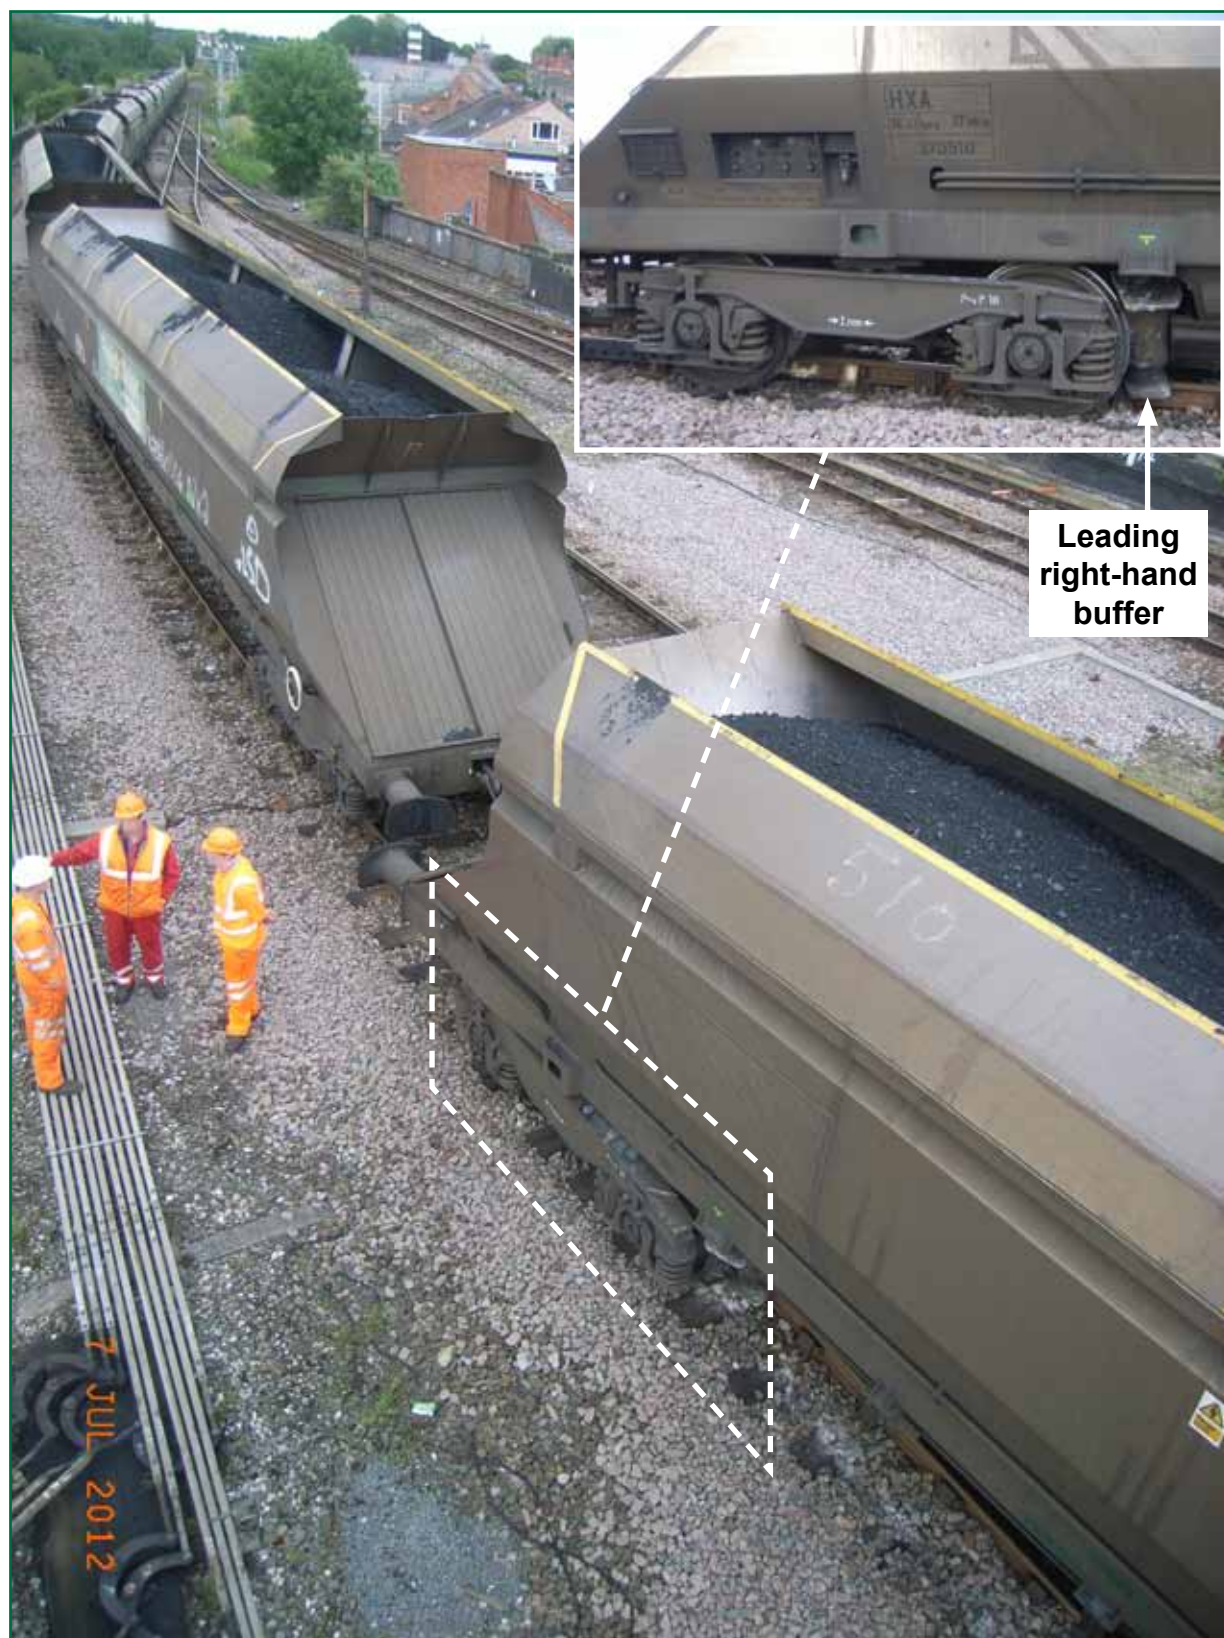
- 7 The leading bogie of wagon 370510 ran derailed for approximately 65 metres causing significant track damage in the process. The train was eventually stopped by a brake application initiated by the parting of the brake pipe between the 15th and 16th wagons. The *screw coupling* between these wagons remained intact.
- 8 There were no injuries as a result of the derailment. The derailed bogie of wagon 370510 was damaged. The leading right-hand *buffer* detached and became lodged between the trailing left-hand wheel of the derailed bogie and the wagon underframe (figure 2).

Figure 2: Wagon 370510 after the derailment

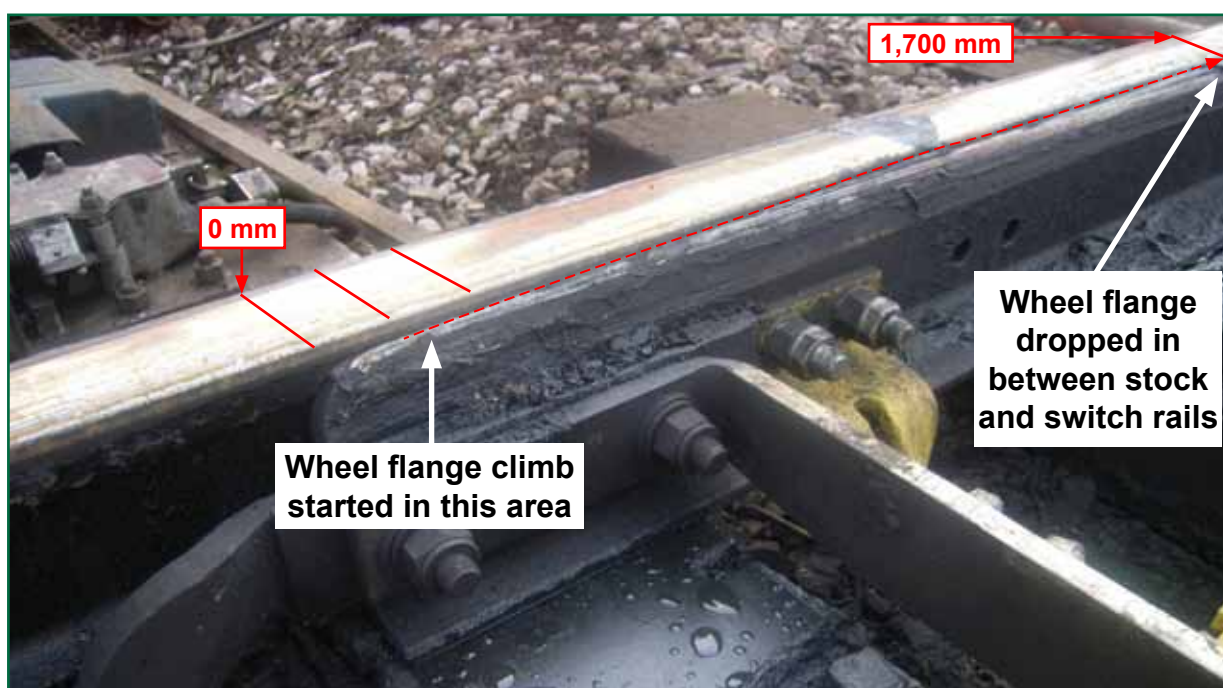
- 20 After the change of drivers, train 6M61 departed signal CJ106 at 14:12 hrs. The driver applied power and reached a speed of 8 mph (13 km/h) as the locomotive traversed No. 75 points. As the rest of the train was traversing the points, the speed gradually increased to 14 mph (22 km/h) which was the speed at which wagon 370510 entered the points. The marks left on the switch rail suggest that the *flange* of the leading left-hand wheel of wagon 370510 is likely to have started climbing the switch rail close to the toe of the points (figure 6).

Figure 6: Toe of No. 75 points showing left-hand stock/switch rails and path of derailment

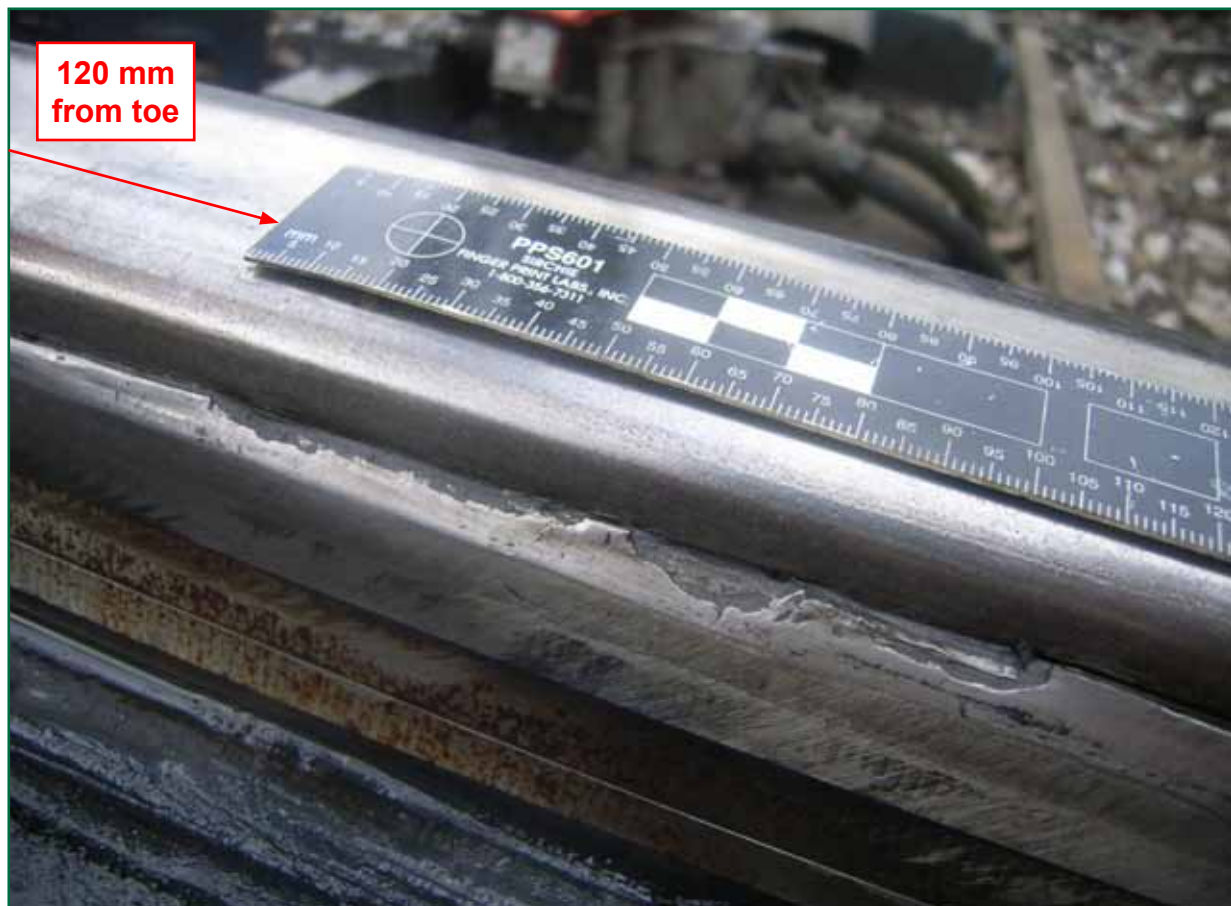
- 24 After the derailment at Shrewsbury and before any further rail traffic passed over them, the RAIB examined No. 75 points and found signs of wear and damage which are believed to have been there before the derailment. After removal of the grease and residue, the examination revealed that the left-hand switch rail was worn and damaged close to the toe of the points (figure 7). The switch rail damage started 120 mm from the toe of the points and continued for an additional 110 mm. The switch rail wear started close to the toe of the points (approximately 50 mm from the toe) and extended beyond the damage. The presence of grease obscuring the damage on the switch rail indicates that the damage is unlikely to be a consequence of the accident. The RAIB carried out a detailed inspection of No. 75 points against the requirements of TRK/053. The detailed inspection revealed that No. 75 points failed three out of the four checks for derailment hazards identified within the standard for this type of points. No. 75 points were therefore at risk of creating a derailment (see appendix B for more details about the results of this detailed inspection). Measurements carried out by the RAIB indicated that the first section of the switch rail, between 50 mm and 120 mm from the toe, in front of the damage, was compliant with TRK/053 despite the presence of wear.

Figure 7: Left-hand switch rail damage

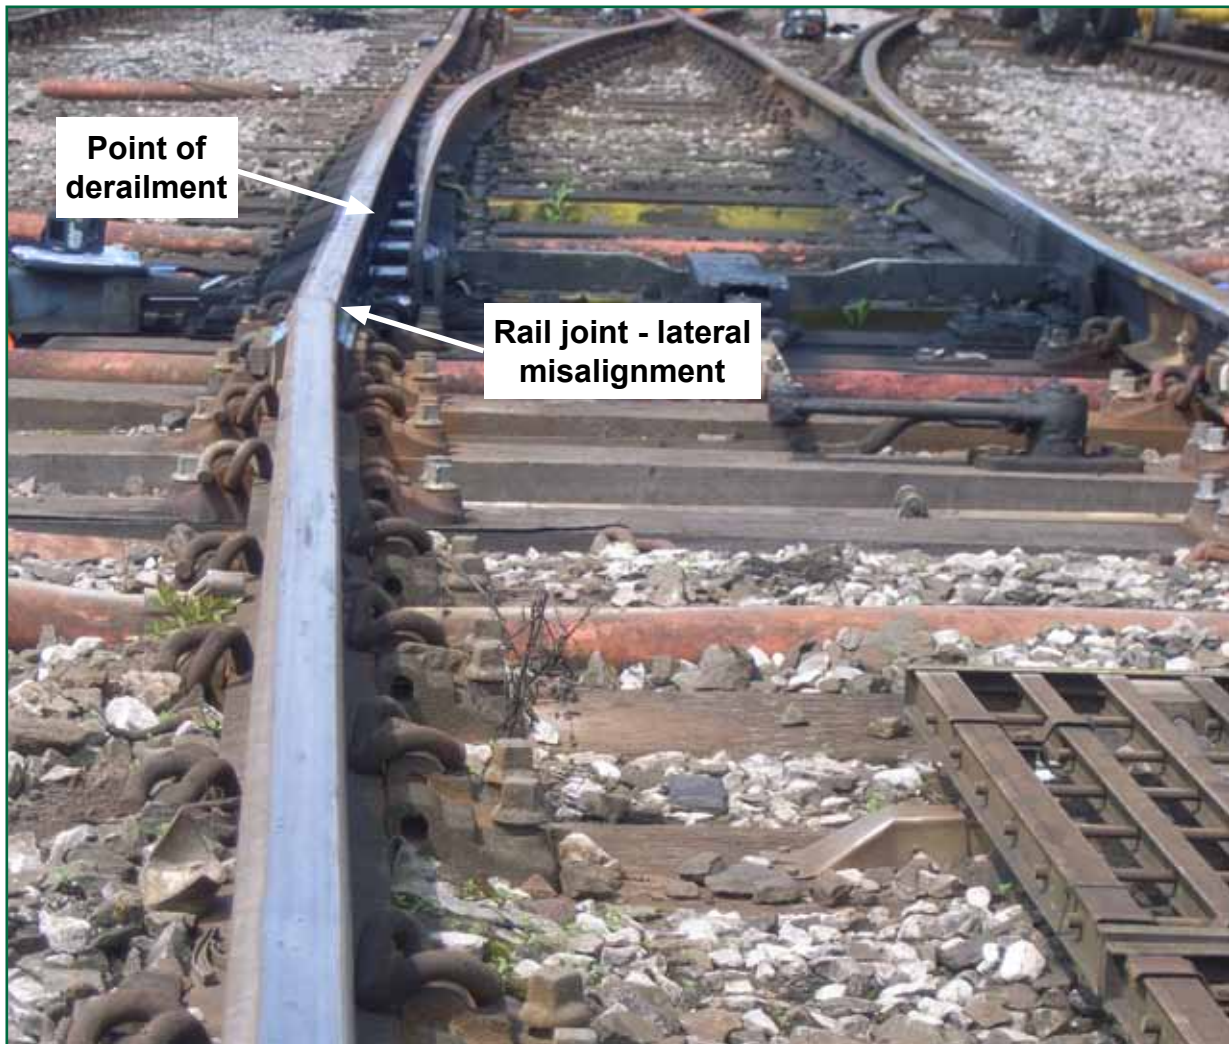
Figure 8: Track lateral alignment approaching No. 75 points

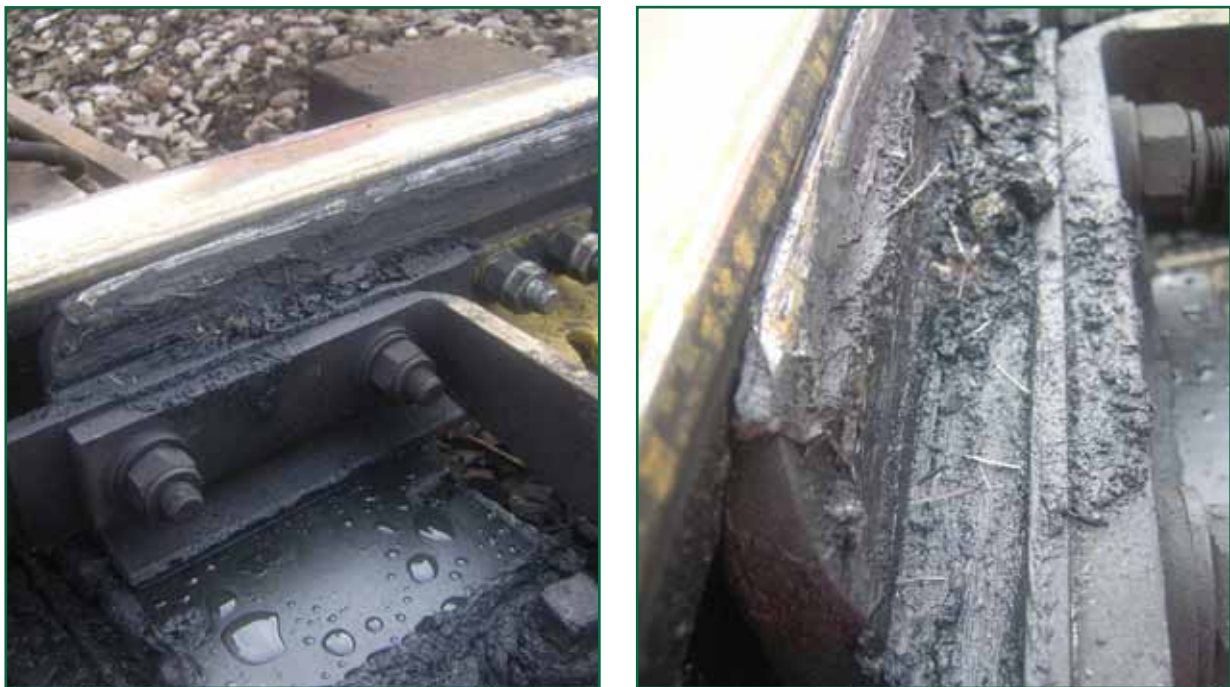
- 57 It is possible that the damage to the switch rail occurred after the last basic visual inspection. The inspection of the points immediately after the accident identified fresh shards of metal, presumably from the switch rail, embedded within the grease at the base of the rail (figure 9). The size and appearance of these shards suggests that the creation of the damage could have been a fairly rapid process which could have taken place shortly before the accident (the presence of grease obscuring the damage on the switch rail indicates that the damage is unlikely to be a consequence of the accident). However, the more gradual nature of the wearing process suggests that the wear on the rails was already present at the time of the last supervisor's visual inspection and the last basic visual inspection.

Figure 9: Left-hand switch rail at No.75 points immediately after derailment

- 74 The RAIB's inspection of the points that took place immediately after the accident indicated that the switch rail damage might have been obscured by grease at the time of the visual inspections (figure 9). There is no requirement in TRK/001 or TRK/053 to remove grease from points during a basic visual inspection or a supervisor's visual inspection. The requirement appears in TRK/053 only for a detailed inspection. It is therefore possible that grease was obscuring the damage to the switch rail during the visual inspections.
