Rail Accident Report

Dangerous occurrence involving an engineering train at Blatchbridge Junction, near Frome, 19 March 2012

Report 15/2013
September 2013

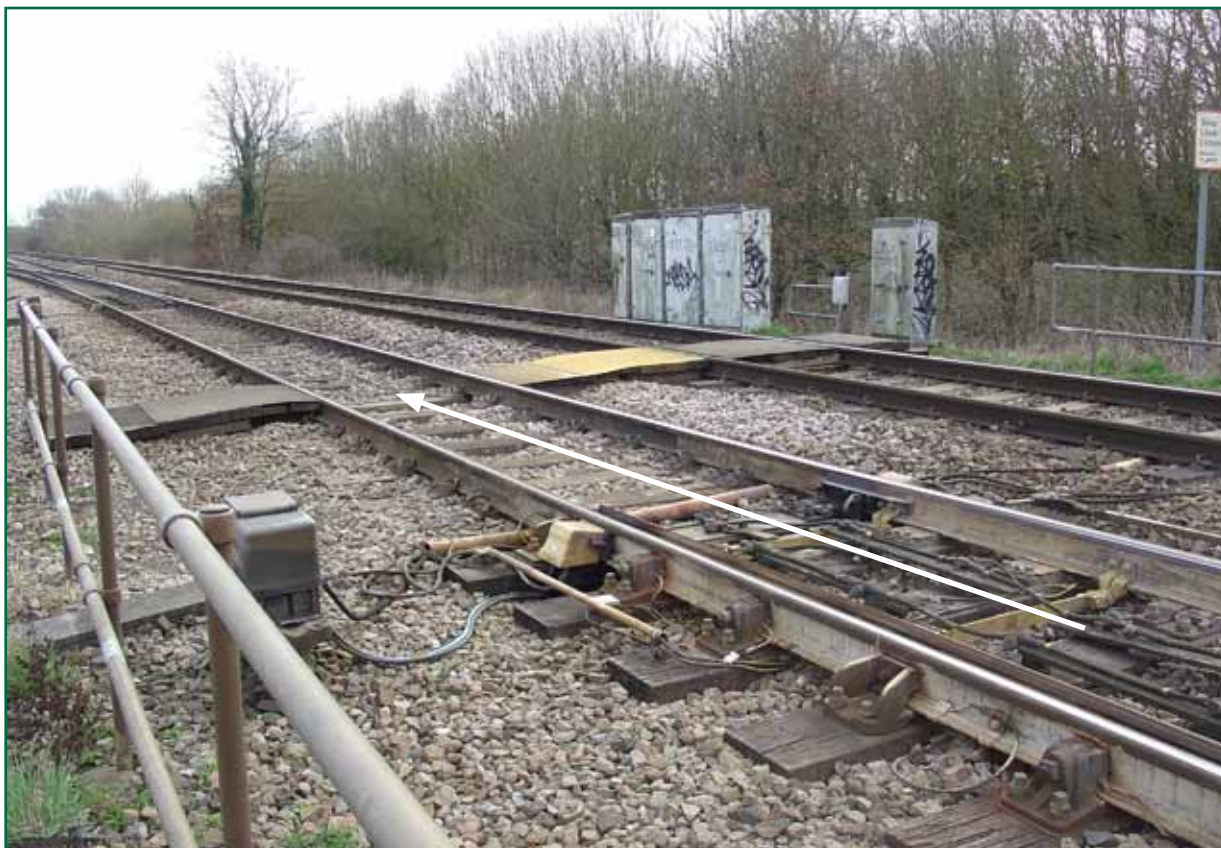
- 31 Approaching Blatchbridge Junction, the P3 control cab became detached from the supporting structure and fell onto the track beneath the train. The control cab continued to slide along the surface of the rails partially restrained by electrical cables and the brake hose. Timbers forming part of the foot crossing at Blatchbridge Junction were damaged as the detached control cab passed over it (figure 6).

Figure 6: Blatchbridge Junction and the partially destroyed foot crossing (path of train 6Y33 indicated by white arrow)

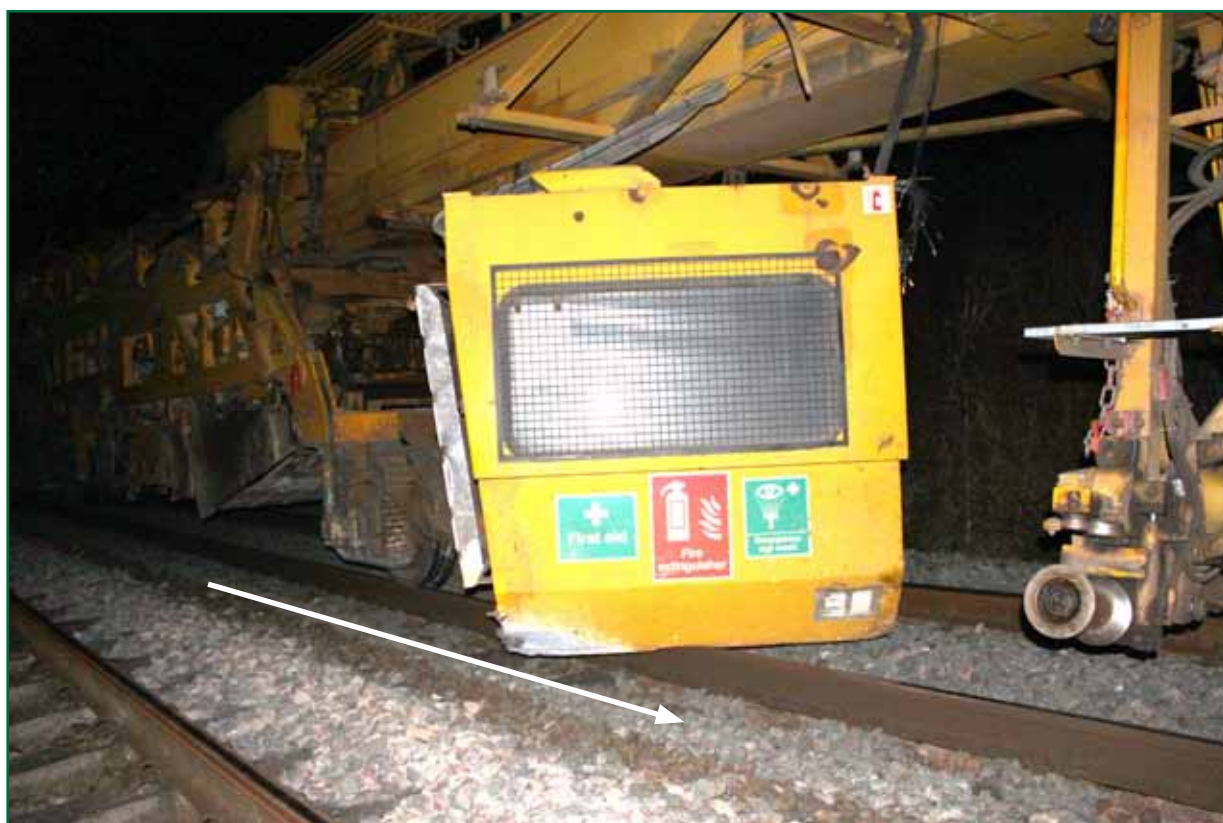
- 34 The Westbury signaller set the signal on the approach to Clink Road Junction to red to stop any other trains approaching along the line adjacent to train 6Y33. The driver examined the train and found that the detached control cab had rotated to the left and had moved closer to the adjacent line (figure 7).

Figure 7: The detached control cab (path of train 6Y33 indicated by white arrow)

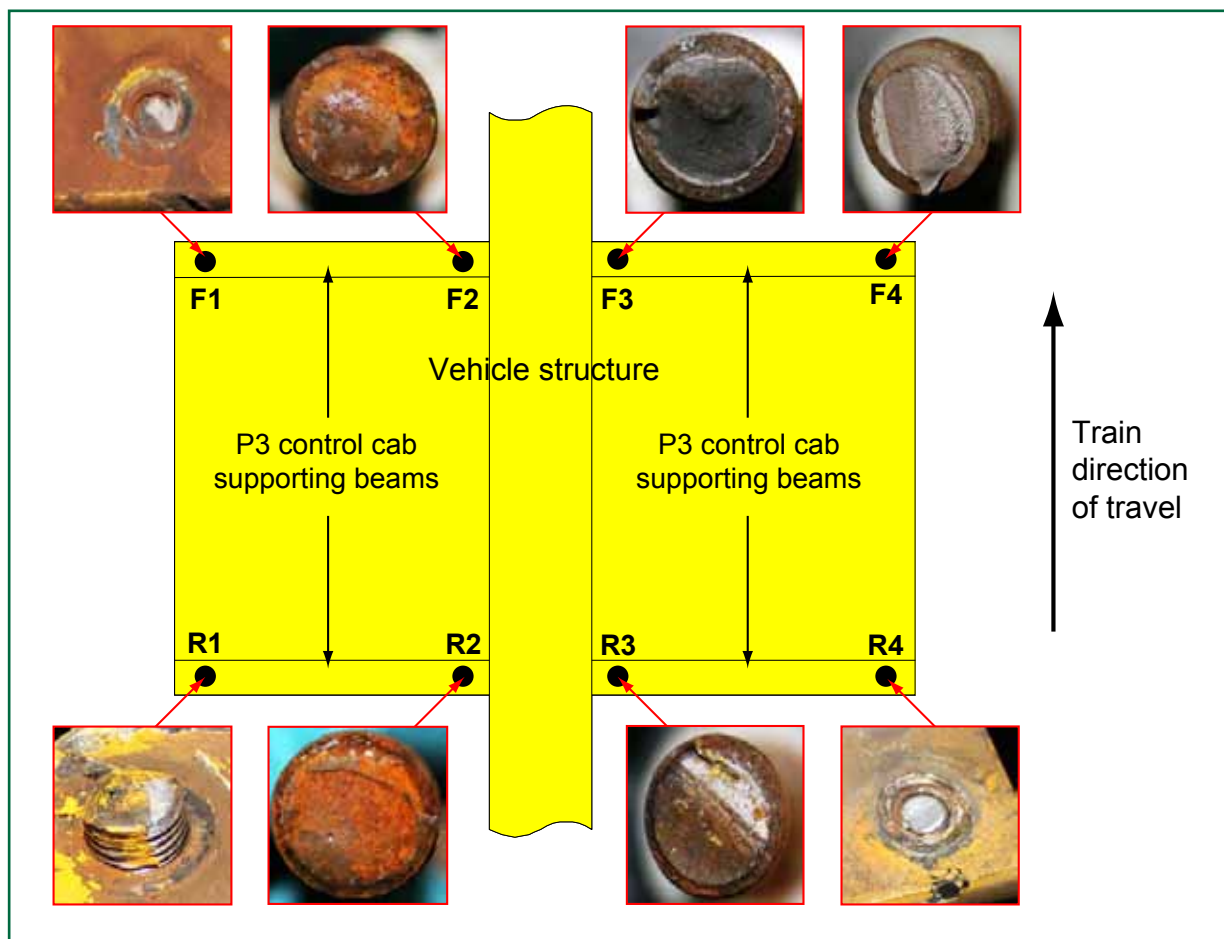
- 40 The RAIB examined the detached control cab at the site of the incident before it was moved clear of the track. All eight bolts had failed at the interface between the bottom of the flexible rubber mount and the top of the cab roof. Figure 9 and table 1 show the condition and type of failure exhibited by each of the eight bolts within the cab's flexible mountings.

Figure 9: Bolt condition and location

Bolt	Failure mode of bolt (based on metallurgical analysis)
F1	<i>Rapid rate fatigue failure leading to final failure by overload.</i>
F2	<i>Slow rate fatigue failure.</i>
F3	Some evidence of fatigue cracking with the final failure by overload.
F4	Rapid-rate fatigue failure.
R1	The fractured face of this bolt was damaged during the incident. There is evidence of overload failure on part of the undamaged surface of the fracture. The top half of bolt R1 was not found after the incident.
R2	Slow-rate fatigue failure.
R3	Slow-rate fatigue failure.
R4	Overload failure.

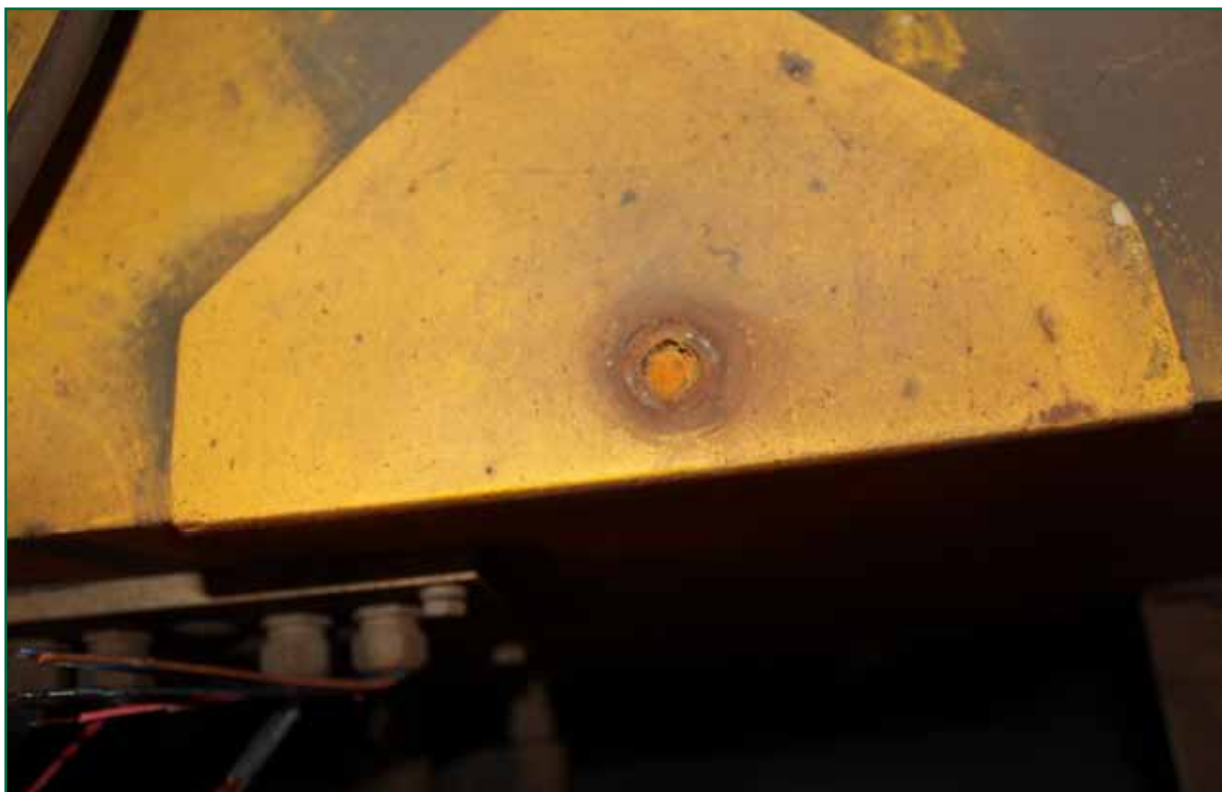
- 41 The fracture faces of bolts F2 and R2 had rusted over, indicating that these two bolts were probably the first to fail and had done so some time before the incident (figure 10). Bolts F3, F4 and R4 exhibited overload failure and are most likely to have failed shortly before the control cab detached (figure 11). The remaining three bolts, F1, R1 and R3 exhibited evidence of pre-existing fatigue failure with final failure caused by overload as the cross-sectional area of the bolt diminished (figure 12).

Figure 10: Lower section of bolt F2 (inserted into cab roof) showing rusted-over fracture face

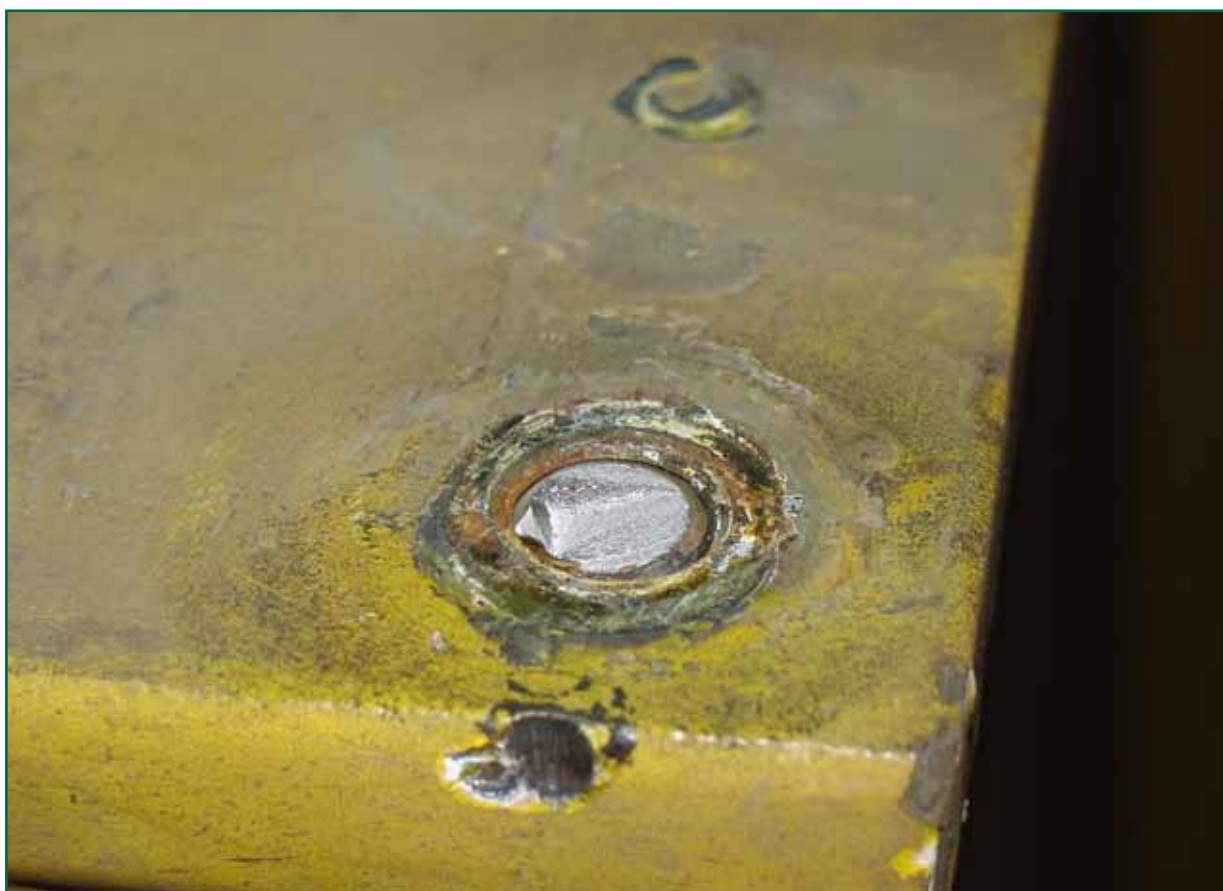
Figure 11: Lower section of bolt R4 (inserted into cab roof) showing clean-break indicating overload failure of the bolt

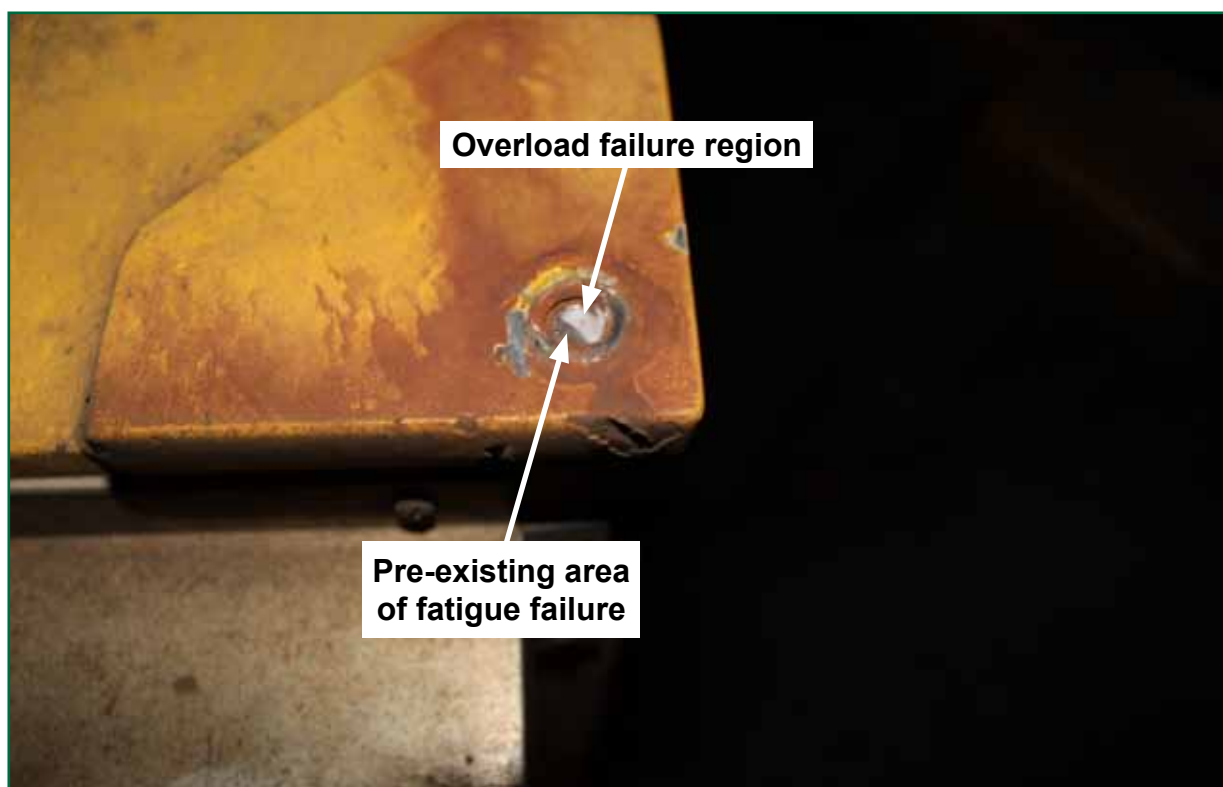
Figure 12: Lower section of bolt F1 (inserted into cab roof) showing evidence of pre-existing fatigue and final overload fracture

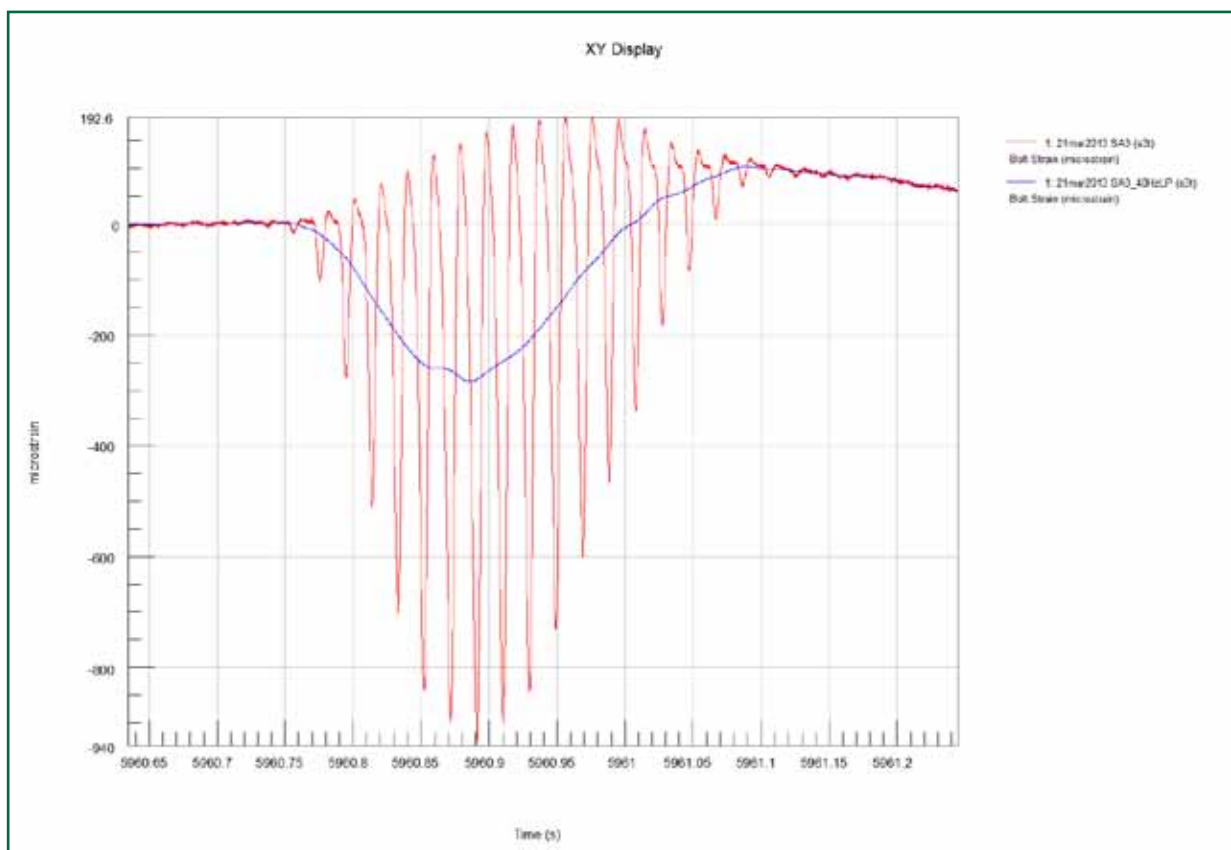
Figure 14: High strain event (blue line) and oscillating 50 Hz stress (red lines)

- 53 The frequency of the alternating current power supply to the strain gauges was 60 Hz, so it could not have been the cause of the observed 50 Hz oscillation. To understand if some other *electromagnetic interference* was being recorded, rather than genuine strains, a 'dummy' strain gauge was fitted to the cab. This dummy strain gauge was fitted to a metal block located close to the strain gauged bolts but structurally disconnected from the mounting structure. This meant that the dummy strain gauge would only detect any false strains caused by electromagnetic interference. Data collected during the second working shift was analysed and this showed that the dummy strain gauge had not recorded any activity when compared to the eight strain gauges mounted on the bolts. This indicated that the data collected during both working shifts had not been corrupted by electromagnetic interference, and were real. The cause of the high strain events has not been determined (see paragraphs 56 to 59).

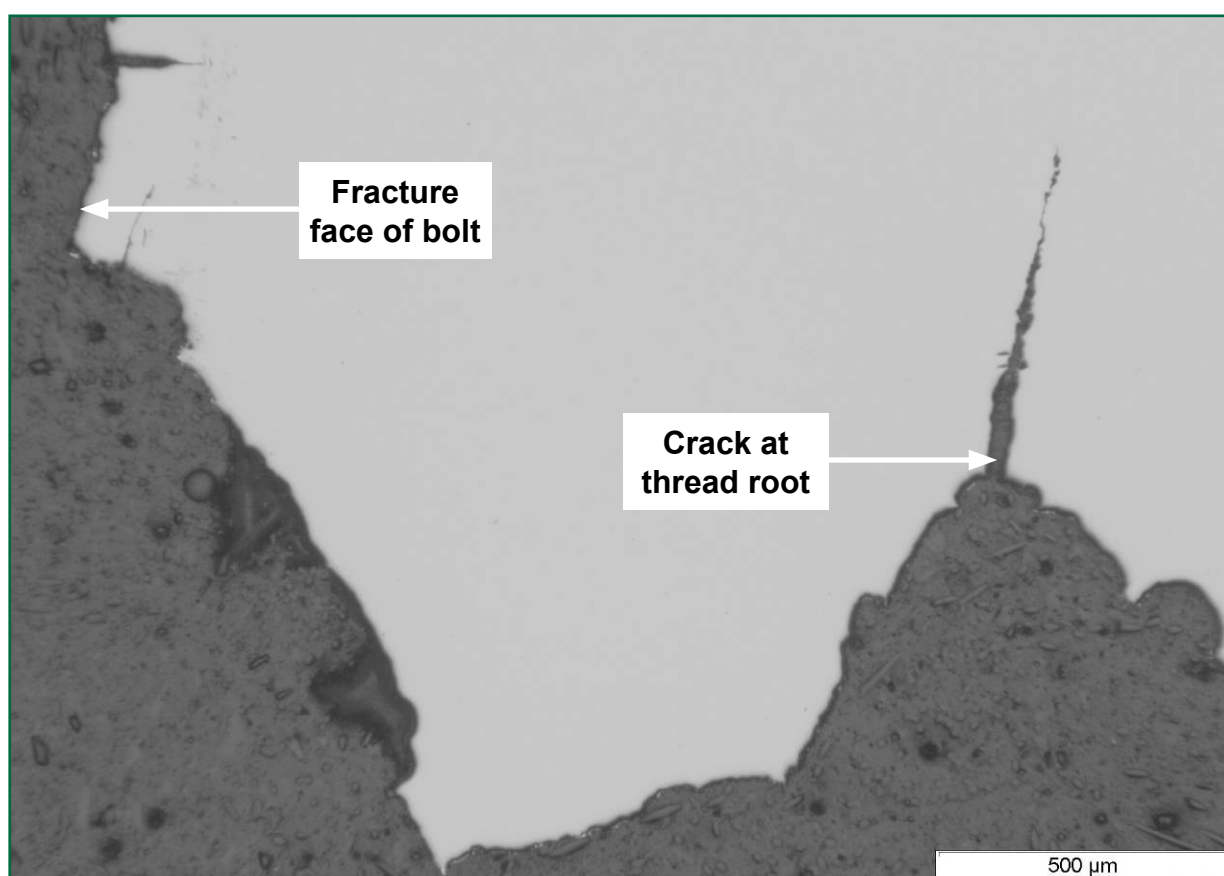
- 61 The metallurgical analysis (paragraphs 43 and 44) of the failed bolts from the P3 control cab and the used bolts from the smaller P2 cab on the P95/1 UK and the used bolts from the P3 cab of the P95/2 UK found that they were all severely corroded. When this corrosion was cleaned off the failed P3 cab bolts, there was evidence of cracking at the end of the threaded region (figures 16 and 17). The metallurgical analysis did not identify any irregularities at the thread roots, such as defects during the manufacture of the bolts, and so the most likely starting point of the fatigue failure was from a point at the bolt thread root affected by corrosion. Bolts F2, R3 and R2 appeared to have failed by fatigue from the *thread root* at a relatively slow rate. Bolt F4 showed signs of fatigue failure from the root, but this had occurred relatively rapidly in a small number of cycles. Although the majority of bolt F3 had failed by rapid overload, there were signs of fatigue cracks in the root of the bolt thread.

Figure 16: Cross sectional evidence of fatigue cracking and corrosion of the teeth of bolt F2 (picture courtesy of SERCO)

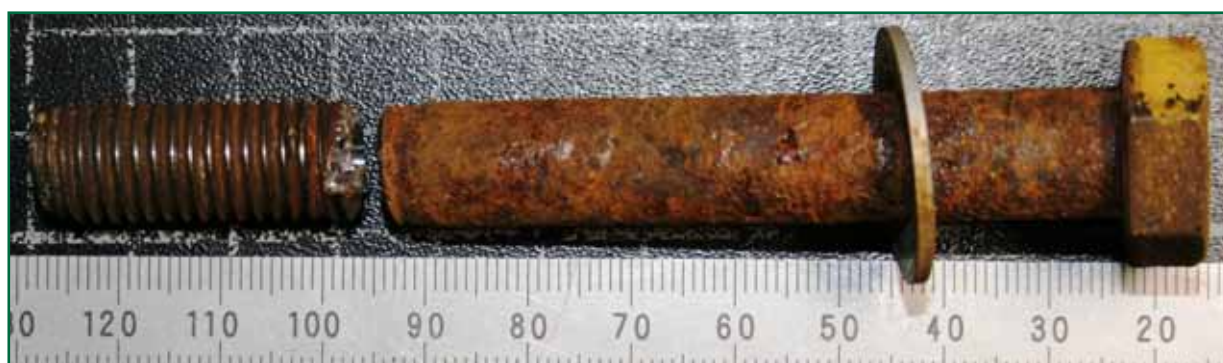
Figure 17: Corrosion on bolt R3

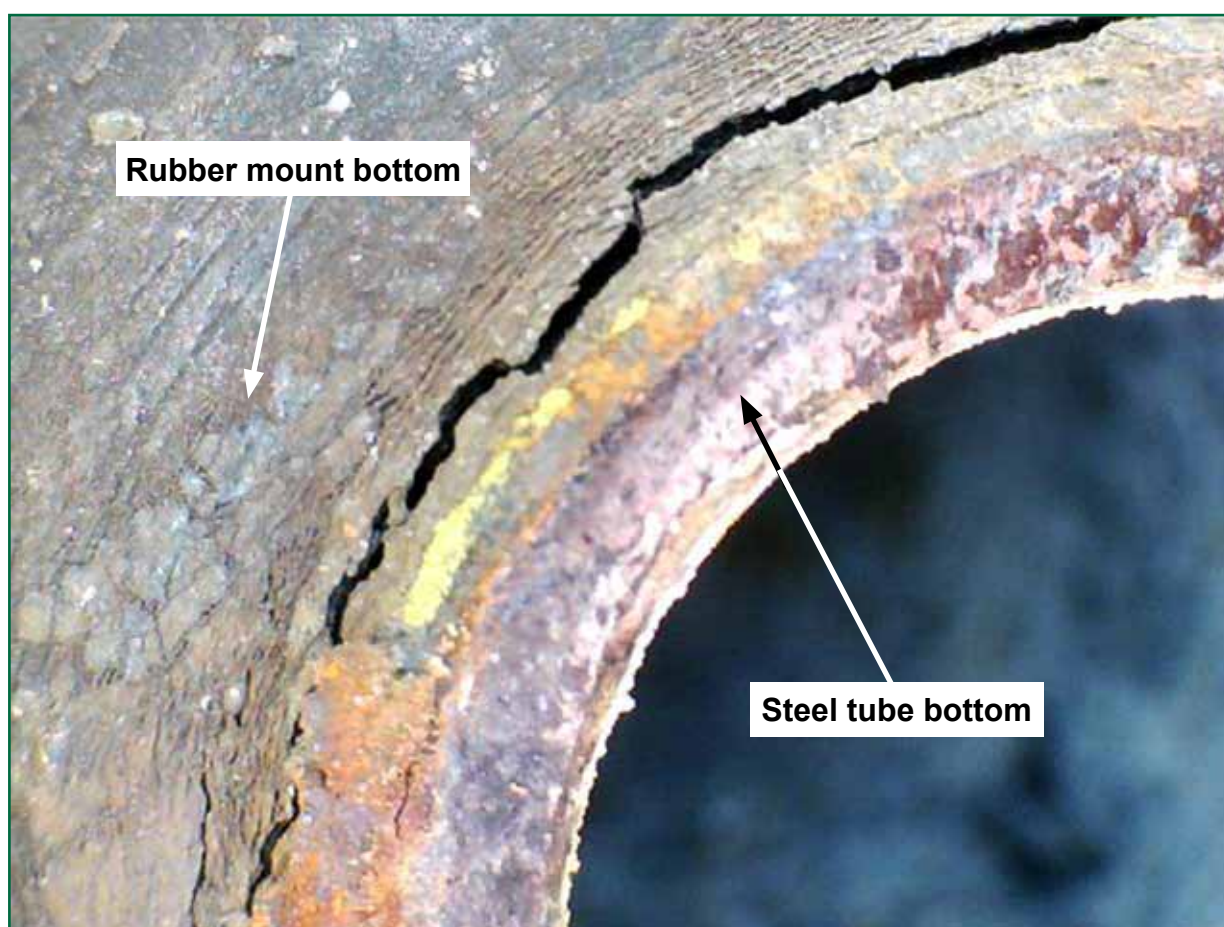
- 62 The corrosion on the threads was most likely to have been caused by moisture ingress through capillary action at imperfections around the interface between the bottom of the flexible mount (which was not designed to seal against the P3 cab) and the cab roof (figure 8). Bolts that had corrosion along their shanks, right up to the bolt heads, may have been exposed to moisture ingress from the interface between the bolt head and the top of the flexible mount, once the bolt had failed and the joint was no longer tightly clamped. Although the bolts were zinc plated for corrosion protection, contact between the threads of the bolt and the threaded hole of the cab roof appears to have removed this protection (figure 19 insert). It is also possible that the corrosion protection was imperfect at the thread roots. In either case, unprotected metal could have been exposed to moisture, allowing corrosion to develop and fatigue cracks to initiate from some of the corrosion pits in the presence of service stresses (paragraphs 50 to 54) until the affected bolts eventually fractured.

Figure 18: Imperfections of the steel tube and the bottom face of the rubber mount allowing moisture to reach the bolt threads

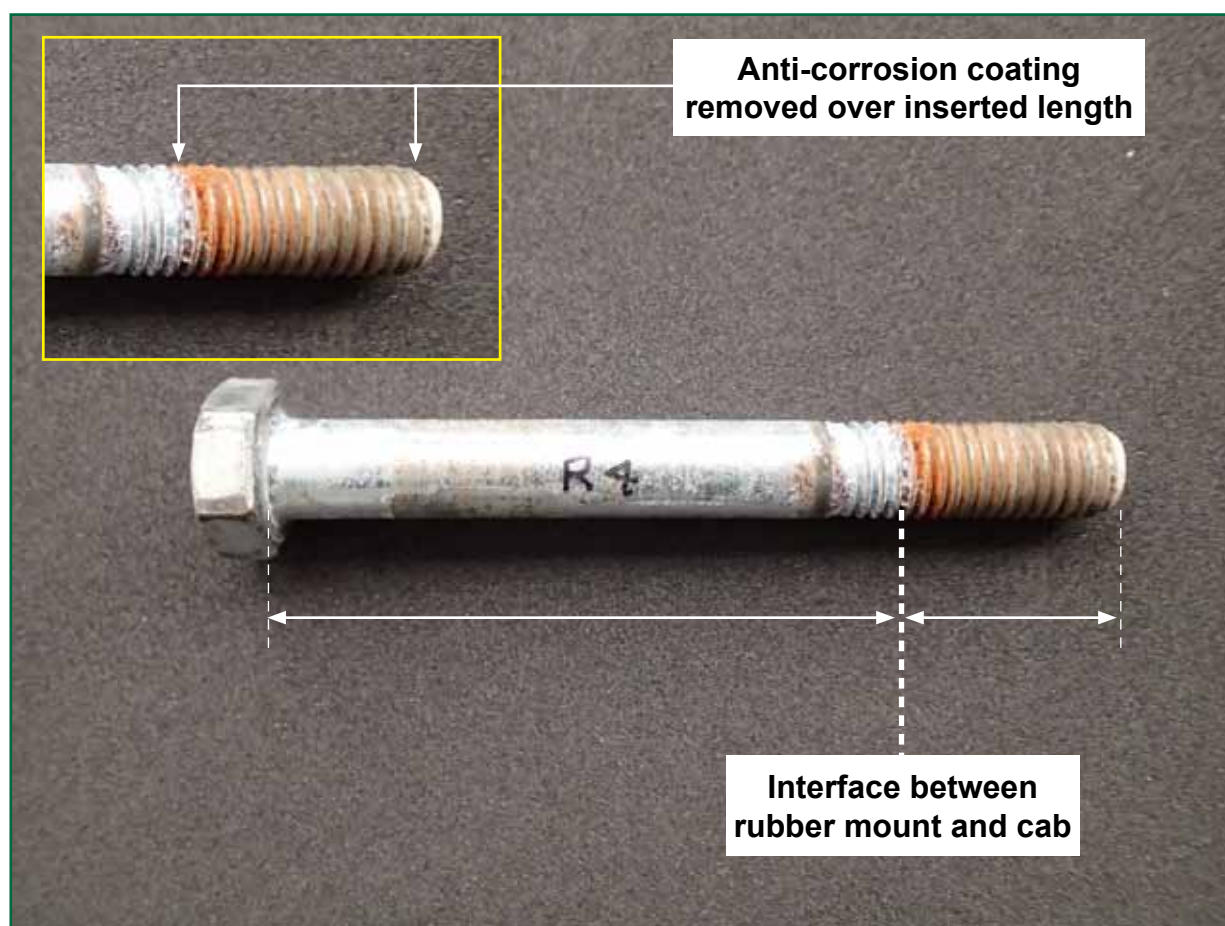
- 63 The RAIB inspected the new P3 cab bolts that had been installed after the incident at Blatchbridge Junction, rubber mountings and contact areas during a visit in April 2013, around 12 months after the P3 cab had been rebuilt and refitted to the P95/1 UK. Corrosion was already evident on the replacement bolts. The area of corrosion was near the top of the bolt threads at the point where the failed bolts had previously corroded. Since installation, the bolts had been regularly checked to make sure they were correctly torque tightened. There was little evidence of corrosion of the bolt shank or the bolt head or washer. This indicates that moisture was reaching the bolt at the interface between the bottom of the rubber mount and the cab roof surface. Figure 19 shows replacement bolt R4. The length inserted into the blind hole in the cab was 28 mm which corresponded to the length exhibiting signs of corrosion. The worst corrosion corresponded to the interface between the bottom of the rubber mount and the cab roof surface. At this point corrosion was clearly visible for 3 to 4 turns down the threaded length of the bolt with lighter corrosion propagating further down the threaded length.

Figure 19: Bolt R4 removed for inspection with evidence of corrosion forming at the interface between the rubber mount and cab roof surface. Inset: anti-corrosion coating removed by the action of inserting the bolt into the blind hole.

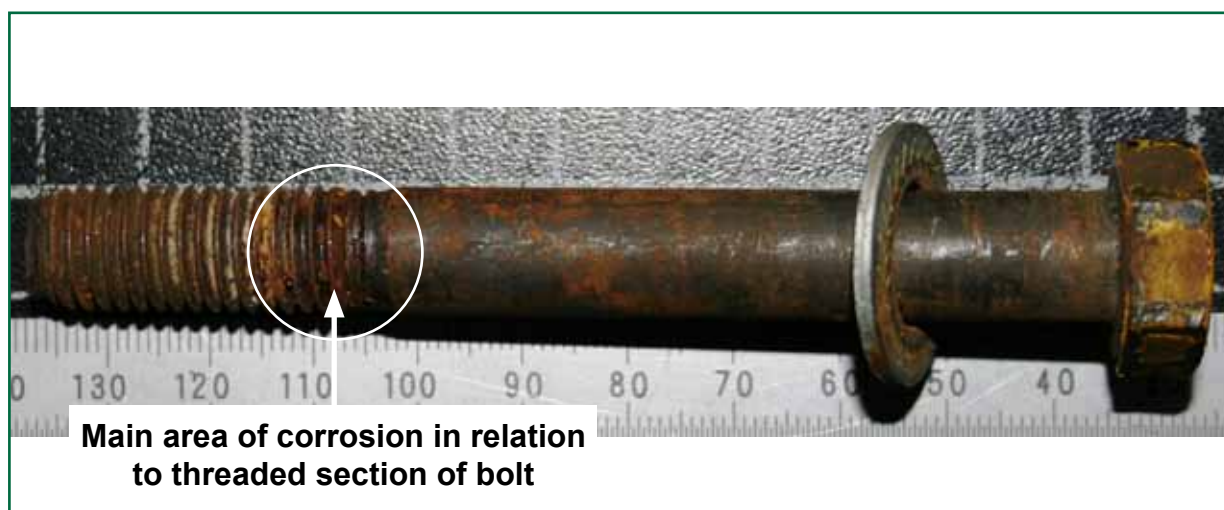
- 64 Six used bolts were also analysed (paragraph 43) for comparison with the failed bolts from the P3 control cab. Four came from the smaller P2 control cab on the P95/1 UK, and two from the P3 control cab on the P95/2 UK. All the used bolts showed evidence of corrosion around the top of the threaded region. The location of the corrosion was identical to that seen on the failed bolts from the P95/1 UK P3 control cab that has identical, but fewer (four) flexible mountings (figure 20).

Figure 20: Location of corrosion seen on the used bolts from the smaller P2 cab from the P95/1 UK

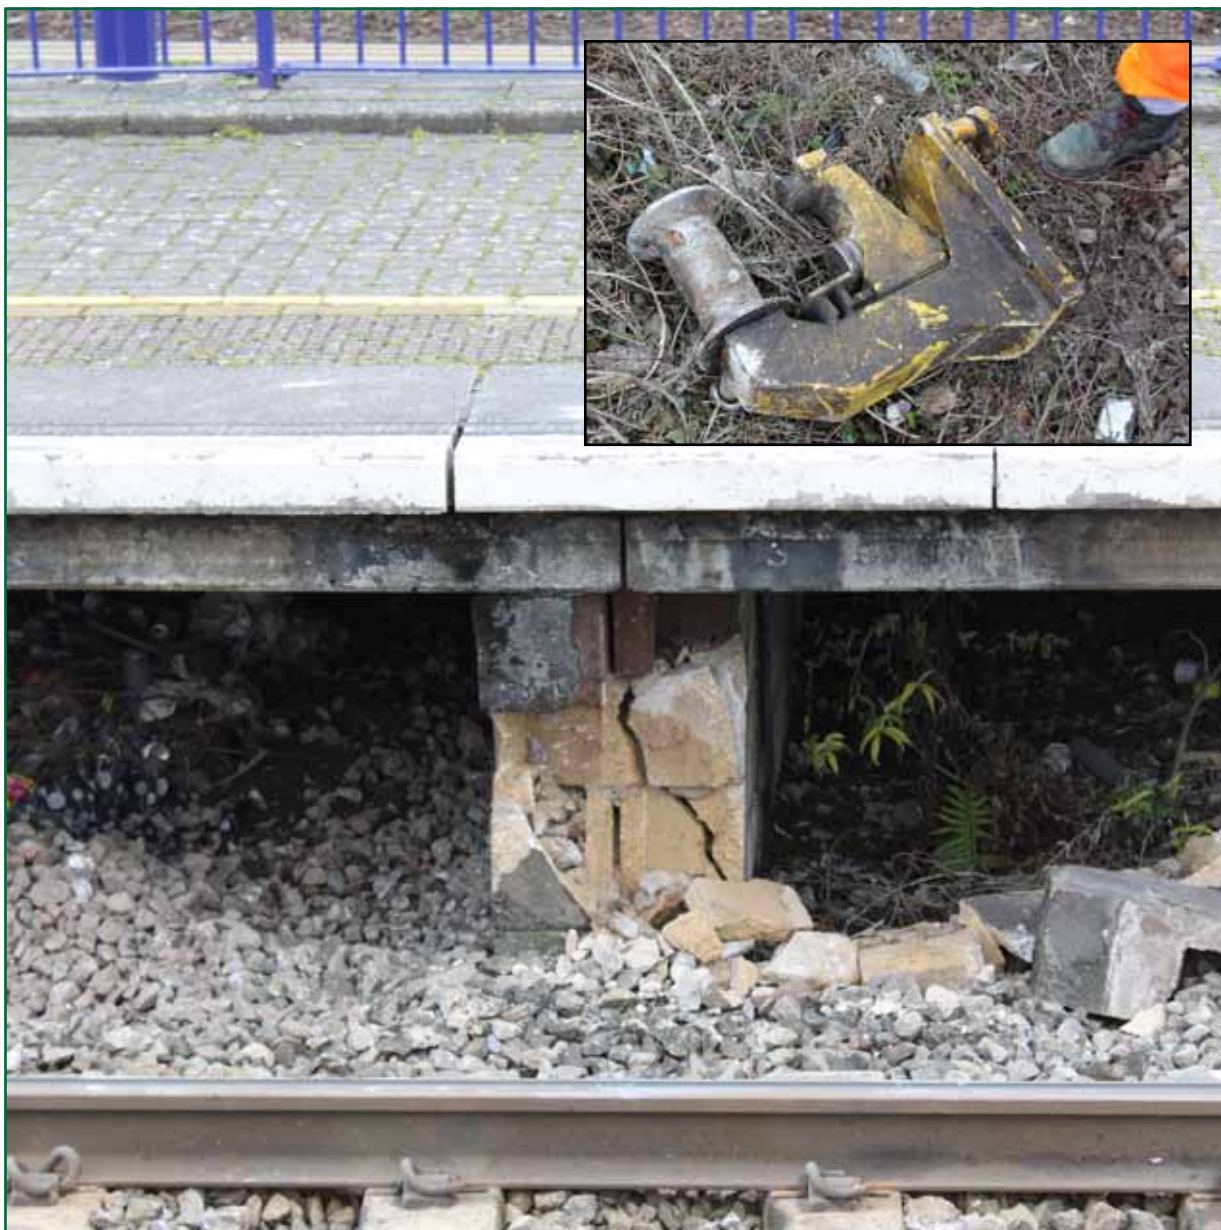
- 69 The clamp became detached because there was no positive locking mechanism fitted to prevent the clamp moving into an unsafe position, and there was no requirement to check that the clamp was correctly stowed prior to the machine entering service.

Figure 21: The damaged brick platform support at Thatcham station and the detached clamp (inset)

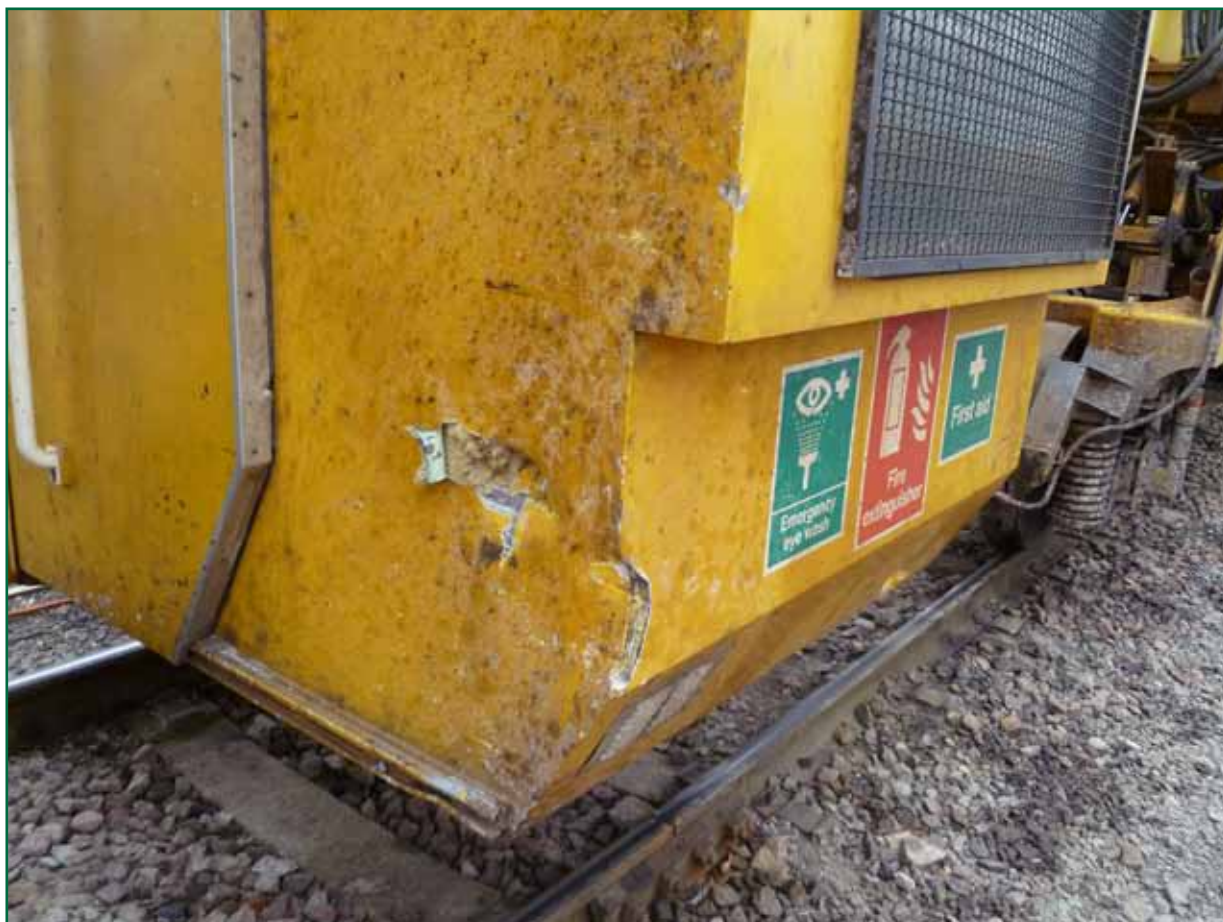
Figure 22: The damaged leading left edge of the P3 control cab following impact from the detached clamp on 26 January 2011

- 75 Paragraph 71 explains that the impact between the clamp and P3 cab may have caused movement within some of the flexible mount assemblies as a result of the applied forces overcoming bolt grip. Figure 22 indicates that the damage to the P3 cab looked superficial in nature. It was not until the cab was rebuilt following the incident at Blatchbridge Junction that a deformed cross member was found, which indicated that the impact force could have been significant (figure 23).

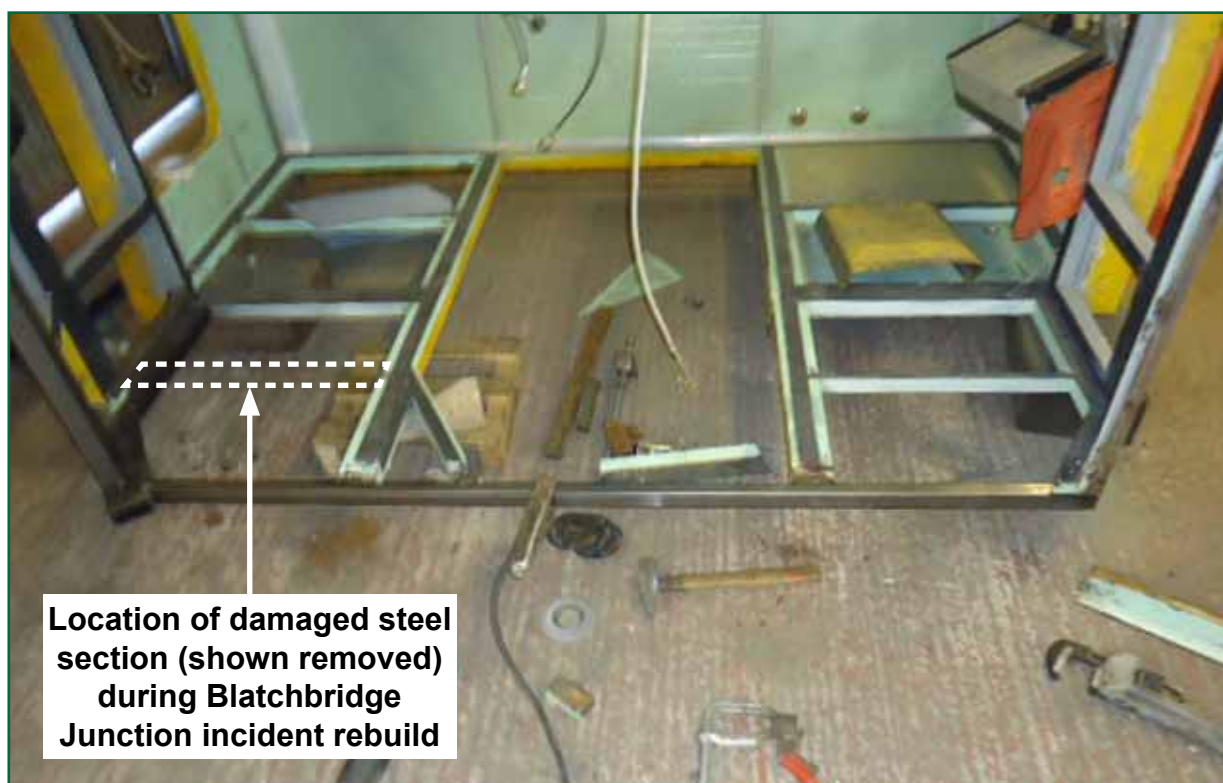
- 70 Following the incident at Blatchbridge Junction on 19 March 2012, the P3 control cab had to be rebuilt. When the body panels were removed, a 40 mm x 40 mm x 2 mm steel cross member was found to be deformed. There was no evidence that the P3 cab had been involved in any other collisions or impacts before or since the incident at Thatcham, and so this deformation had almost certainly been caused by the impact with the clamp on 26 January 2011. It was estimated that the cross member had deformed by no more than 50 mm (figure 23).

Figure 23: Damaged steel section removed for replacement during re-build of the P3 cab after the incident at Blatchbridge Junction. The front of the cab is lying face down in this image.
