Rail Accident Report

**Collision between a train and a car at Beech Hill
level crossing, near Finningley
4 December 2012**

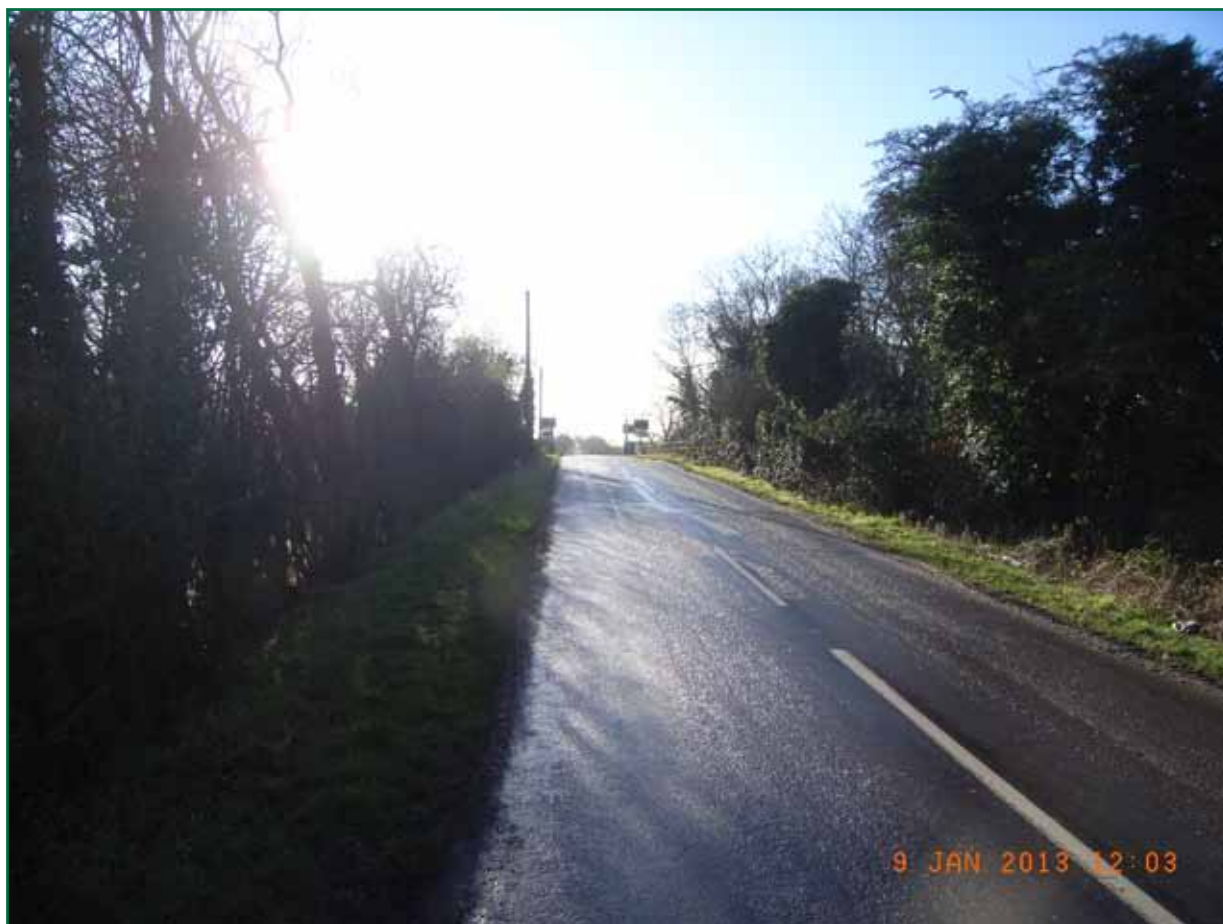
Figure 2: Road approach to Beech Hill AHB crossing

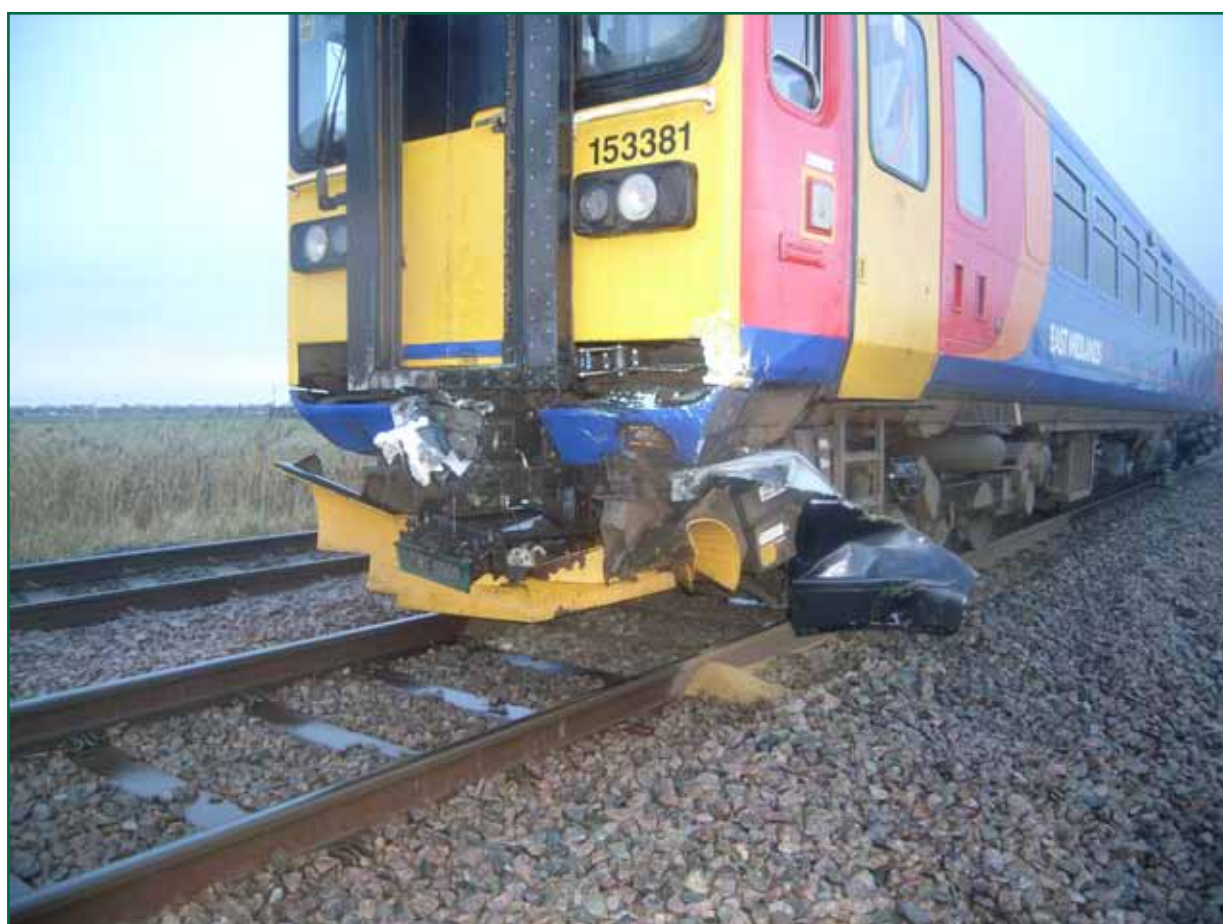
- 28 The train driver could not see the car approaching the level crossing as his view of the road approach was obstructed by buildings and vegetation. He was looking towards a signal further up the line and was unaware of the car's encroachment onto the crossing as it was below his field of view. After the collision he went to apply the brake and found that it had already been applied automatically as a result of damage sustained by the train in the collision.

Figure 3: The train involved

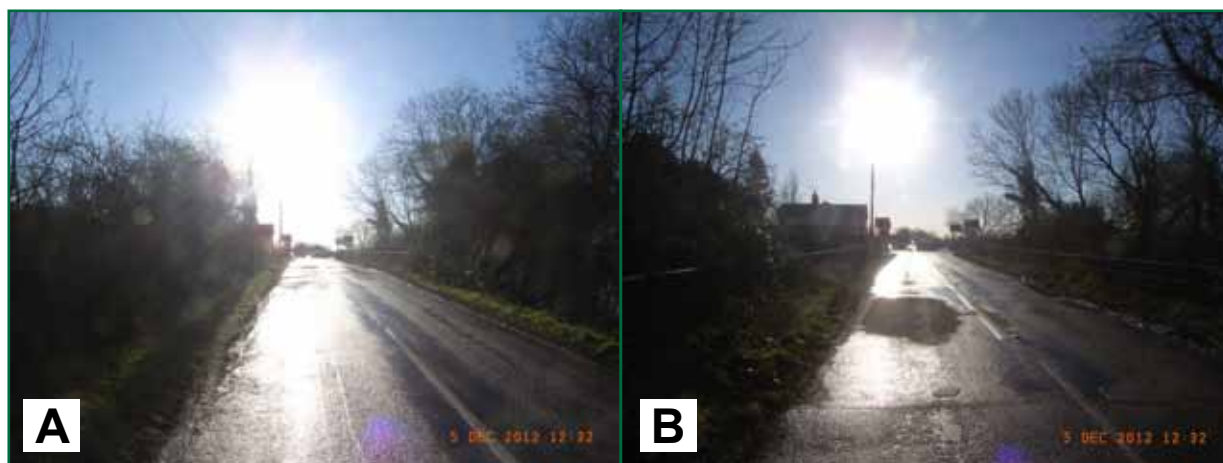
- 41 **The visibility of the level crossing wig-wag lights and barriers against the background was poor. This was a causal factor.**
- 42 After the accident, Network Rail attached a replacement crossing boom on the side from which the car approached and connected the red boom lights to their electrical supply. The weather conditions on the day after the accident were similar to the day of the accident, with bright sun and a wet road surface. The road approach to the crossing was photographed at the same time of day as the accident. Figure 4a is a photograph taken from a point in the road 62 metres back from the crossing and figure 4b is taken from 45 metres back in conditions similar to those at the time of the accident. This is around the point at which a road vehicle driver travelling at the average speed of traffic on this road⁶ should have seen the wig-wags and be preparing to stop.

Figure 4: The approach to the crossing in similar conditions at the same time of day on the day after the accident – (a) shows the view from 62 metres and (b) shows the view from 45 metres away

43 The crossing barrier was down, with the boom lamps lit and the wig-wag lights were flashing when the photographs of the approach were taken. The optical response of the camera may not match that of the human eye, however the photographs match the observations made by the RAIB inspector who was accompanied by several observers from Network Rail. That the crossing was activated was not readily apparent to any of those present when viewing the crossing from a range of distances between 129 metres and 45 metres. The wig-wag lamps became more clearly visible at distances closer to the crossing than 45 metres.

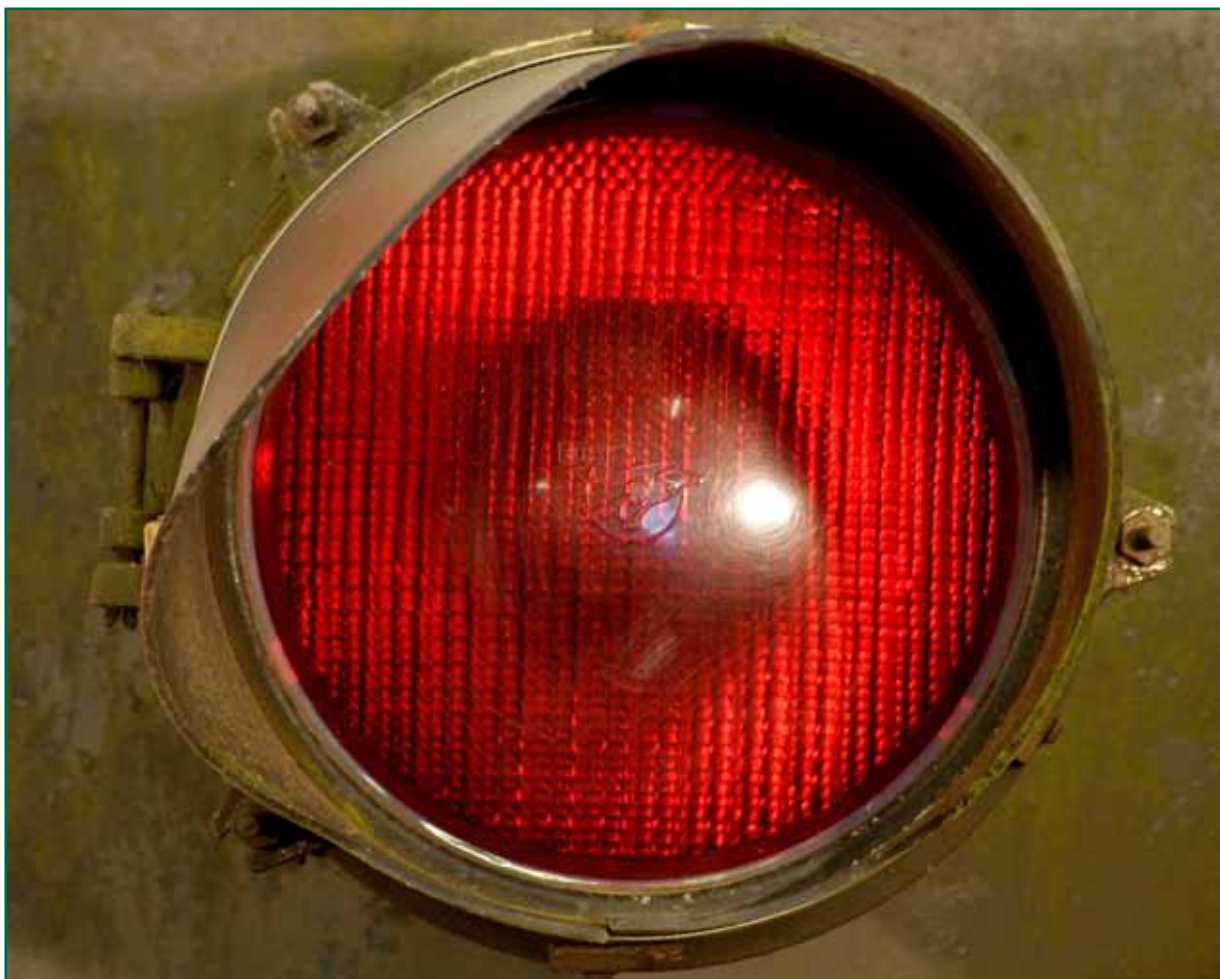
- 57 The lenses fitted to the wig-wag light units were marked with a raised motif of an eagle and the word 'Bliss' at their centre (figure 5). The markings are the trademark of the company which manufactured them, E.W.Bliss Eagle Signal Company. The BRB 908 specification requires that the external surface of the lens is completely smooth, so the lenses did not comply with the specification in this respect, though it is possible that these lenses might predate the specification. The effect of the raised motif on the performance of the lens was not assessed. The inside surface of a wig-wag lens is moulded with many small indentations to focus the light. The quality of finish of these indentations on the lenses from Beech Hill was not as high as on modern lenses and this may have impaired the performance of the lens.

Figure 5: Close up of 'Bliss' lens fitted to one of the wig-wag units at the north side of the crossing

- 58 The effect of the lens on the light output of the red light units was assessed in the laboratory by replacing the 'Bliss' lens with the modern equivalent, taken from a new 50 W halogen wig-wag unit. The right-hand wig-wag lamp from the unit on the nearside of the road was selected for testing. The diameter of the 'Bliss' lens is less than the diameter of the modern lens and a temporary clamp arrangement was used to hold the new lens in front of the lamp. The luminous intensity of the combined lamp and lens was improved from 110 cd to 178 cd but still did not reach the 500 cd level required by the BRB 908 specification.

- 65 The last annual maintenance and inspection visit prior to the accident was conducted on 11 July 2012 and the inspector noted only one non-conformance requiring corrective action (this stated that the site plan was out of date, rather than that the crossing did not comply with the plan). The list of checks to be carried out at the annual service included checking the alignment of the lights but not their level of light output. The list also included checking that '*the signal lenses are undamaged, clean and correctly orientated*'. The inspector noted that he had cleaned the lenses and that they satisfied this check. The list of checks did not include checking that the lenses met their specification. The lenses fitted at this crossing did not meet this requirement in that they had a raised manufacturer's name and logo at their centre (figure 5).

- 1 *The purpose of this recommendation is to replace, with LED units, all remaining 36 W wig-wags at level crossings, with those having 'Bliss' lenses a priority. Network Rail issued Special Inspection Notice SIN121 on 9 May 2013 to locate all such crossings on its infrastructure. This inspection is to be completed by 27 September 2013.*

Infrastructure managers should determine which level crossings are fitted with 36 W road traffic light signal (wig-wag) units or with 'Bliss' lenses and draw up a time bound plan so that their replacement with LED units is done as soon as possible, those with 'Bliss' lenses being dealt with first.

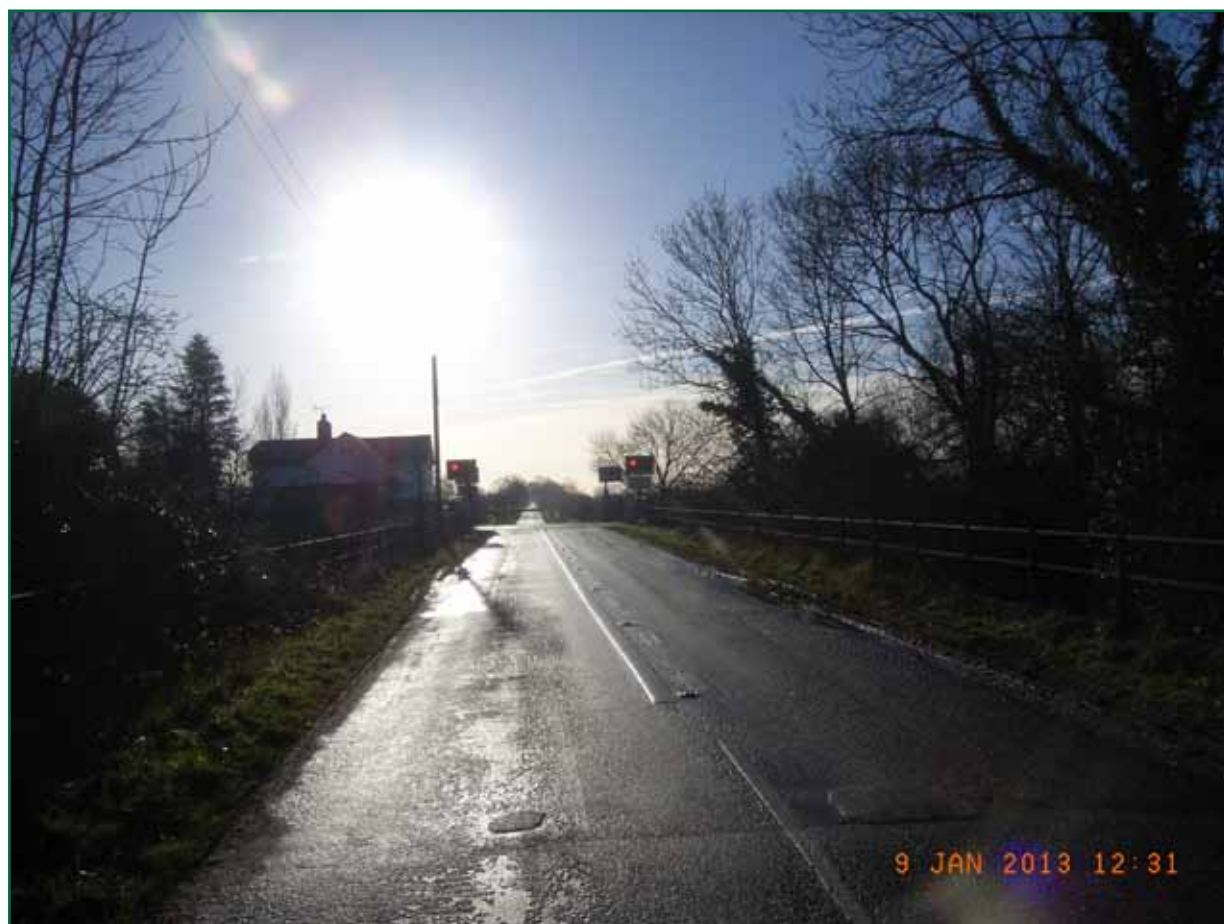
- 119 The picture in figure 7 was taken from the same place as figure 6; a point in the road 45 metres back from the nearside wig-wag, which is between the Highway Code stopping distances for speeds of 40 mph and 50 mph (36 metres and 53 metres respectively). The average speed for most vehicles over the crossing was 49 mph (paragraph 42). The position of the photographer in figures 6 and 7 was therefore at approximately the point at which a typical driver would start to brake for the crossing.

Figure 7: The view from the same point as figure 6, in similar conditions on 13 January 2013, with standard LED wig-wag light units

- 118 Network Rail replaced the 36 W wig-wag units at Beech Hill with LED units on 16/17 December 2012. The RAIB viewed the crossing in similar conditions to the day of the accident on 13 January 2013. Photographs were taken of the crossing while it was activated at the same time of day and from the same positions in the road as on the day after the accident. The exposure time of the photograph is short compared to the time of the flash cycle and it is possible that the 36 W lamps may not have reached full output at the instant of exposure. However, the photographs give an indication of the visibility of the crossing and wig-wags and confirm the observations made on the day after the accident (paragraph 43).
