# Rail Accident Report

## **Train fire at South Gosforth 8 January 2013**

Report 18/2013  
September 2013

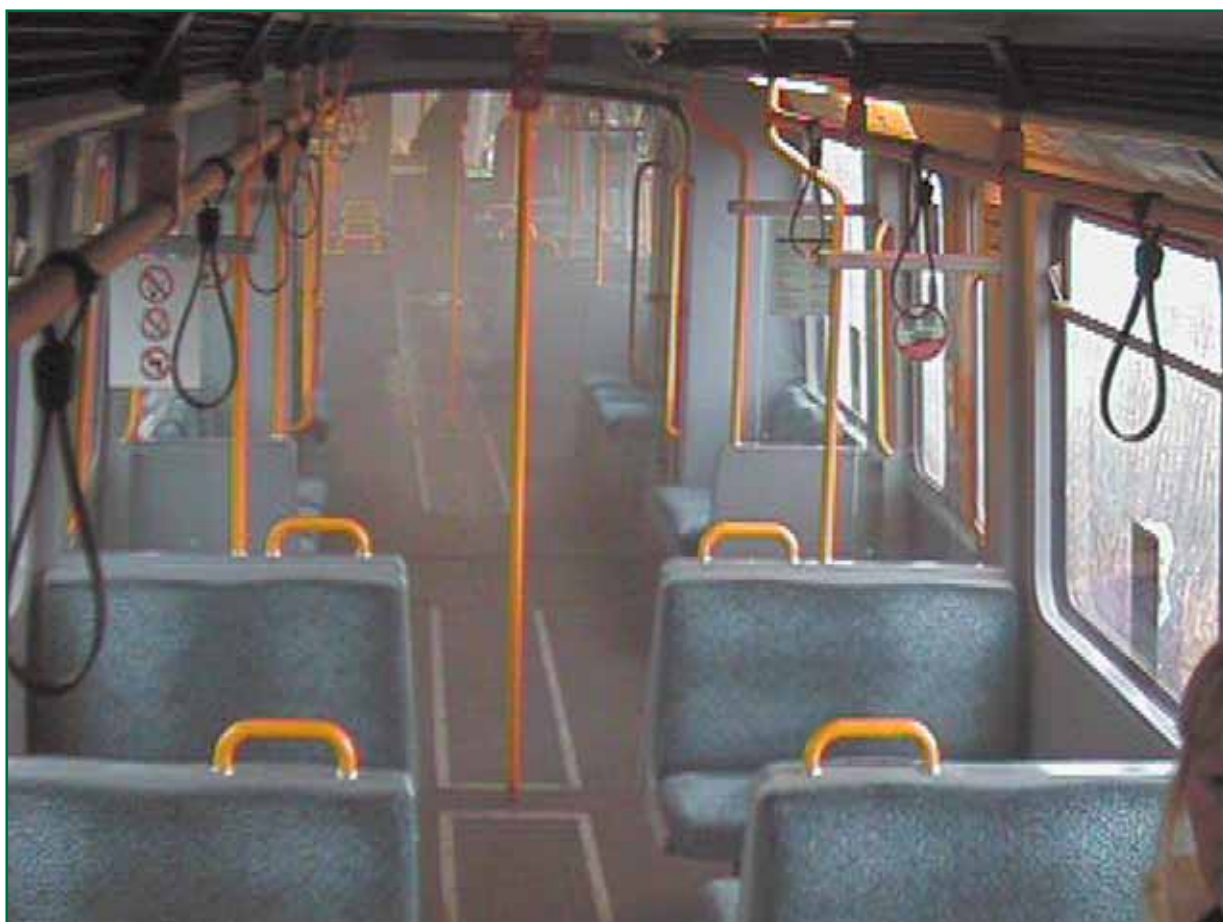
Figure 5: Interior of car 4052 during the evacuation of passengers, 4 minutes 19 seconds after the start of the accident. Door 6 is on the right (image courtesy of DBTW).

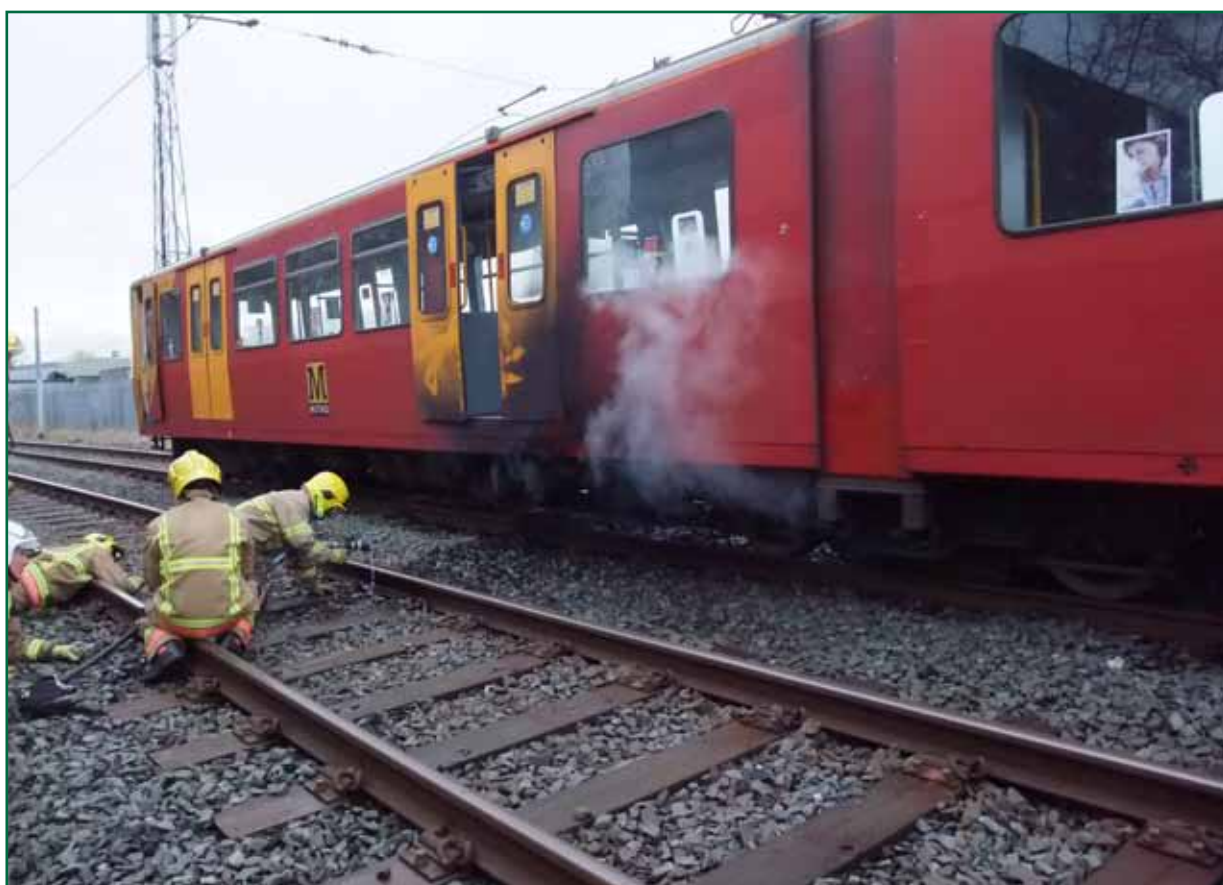
*Figure 6: Car 4052 after the accident, with fire brigade in attendance. The doors nearest the camera in this view were opened after the arrival of the emergency services, and were not used for the evacuation of passengers (image courtesy of DBTW)*

- 87 There are four sets of doors on either side of each Metro car. Two of the doors on the left-hand side of car 4052 (in the direction of travel) were opened by passengers and used to evacuate the car. Of the other two sets of doors, one was directly above the line breaker case which was the source of the fire, and was probably avoided by passengers because of the quantities of smoke rising outside it (figure 6 shows the smoke damage on the outside of the vehicle opposite these doors).

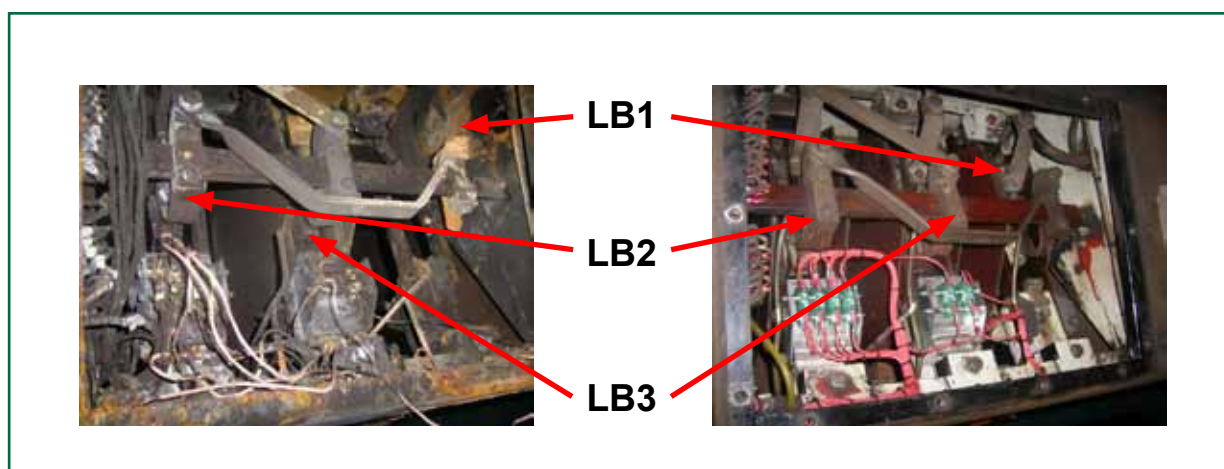
- 43 **The immediate cause of the fire was electrical arcing following a fault in the line breaker case on car 4052.**
- 44 The fire was the result of a sustained arc, which burnt away much of the equipment in the vicinity of the line breaker LB1. This produced a large volume of smoke, some of which entered the passenger saloon.
- 45 The size and position of the arc is clear from the condition of the equipment in the line breaker case after the accident (figure 7).

Figure 7: (left) Interior of line breaker case, showing damage to LB1; (right) the same equipment in an undamaged state

- 1 *The objective of this recommendation is that Nexus, with support from DBTW, should identify and mitigate the risk associated with electrical breakdown in the train line breaker assemblies.*

Appropriate actions to reduce the risk and potential consequences of failures should be defined and implemented following the review (paragraphs 104a, 104b and 104c).

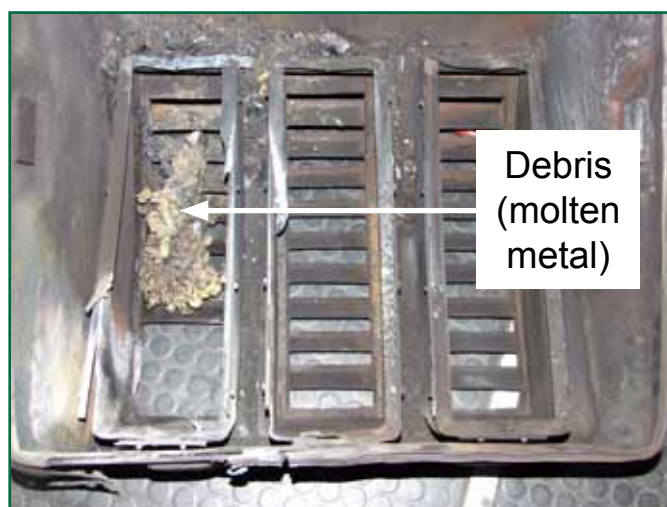
- 46 Line breaker LB1 was almost completely destroyed. Molten metal from the contactor assembly and support bar was sprayed around the interior of the line breaker case (figure 8).

Figure 8: Interior of the line breaker case cover (image courtesy of DBTW)

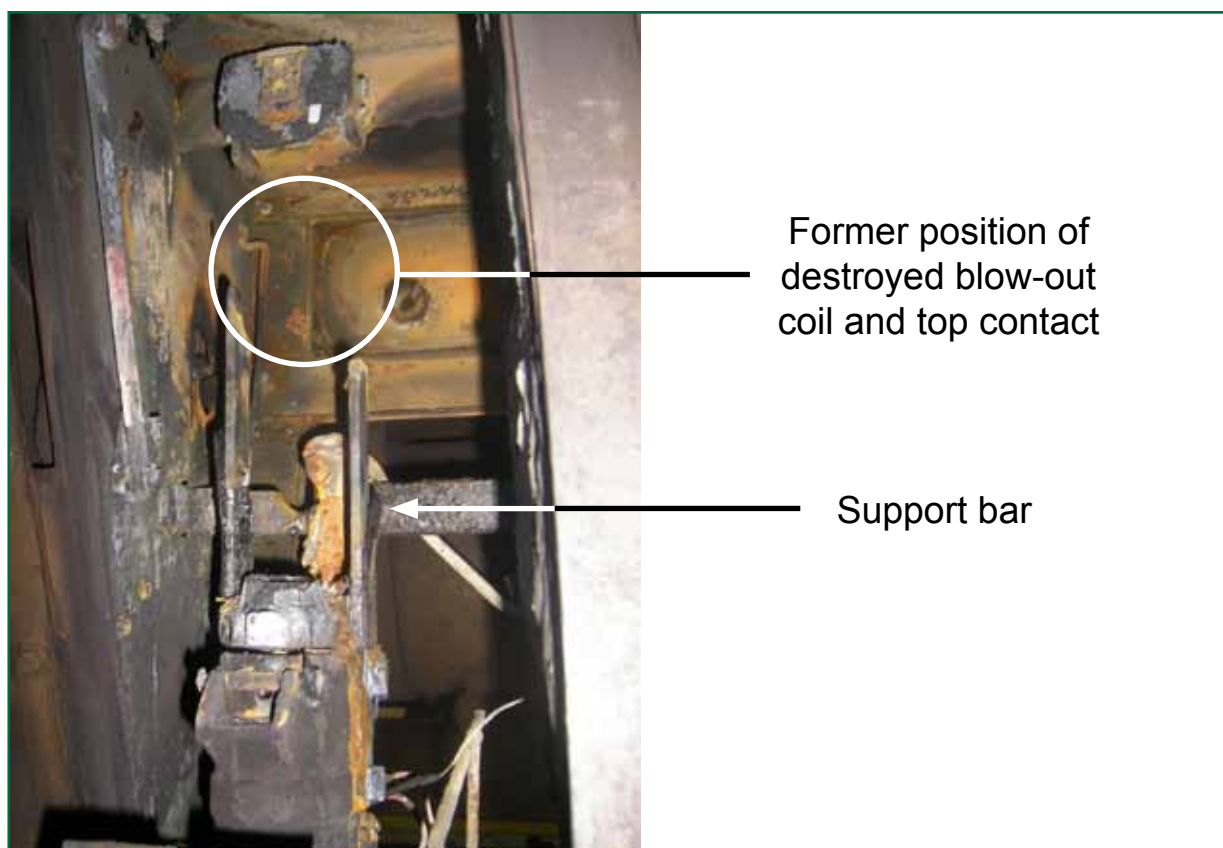
- 49 The *flashover* which initiated the arcing was the result of an earth fault (ie a short circuit of the power supply on this design of system) on or around the input side of line breaker LB1. This is likely to have manifested itself, and caused the initial damage to the line breaker, when the driver shut off power to coast through the neutral section.
- 50 The upper section of LB1 (the vertical support bars, blow-out coil, top contact and brackets, braid and upper support block) was completely destroyed. The horizontal support bar was burnt through about two-thirds of its section (figure 9).

Figure 9: Damage to line breaker LB1 blow-out coil and support bar

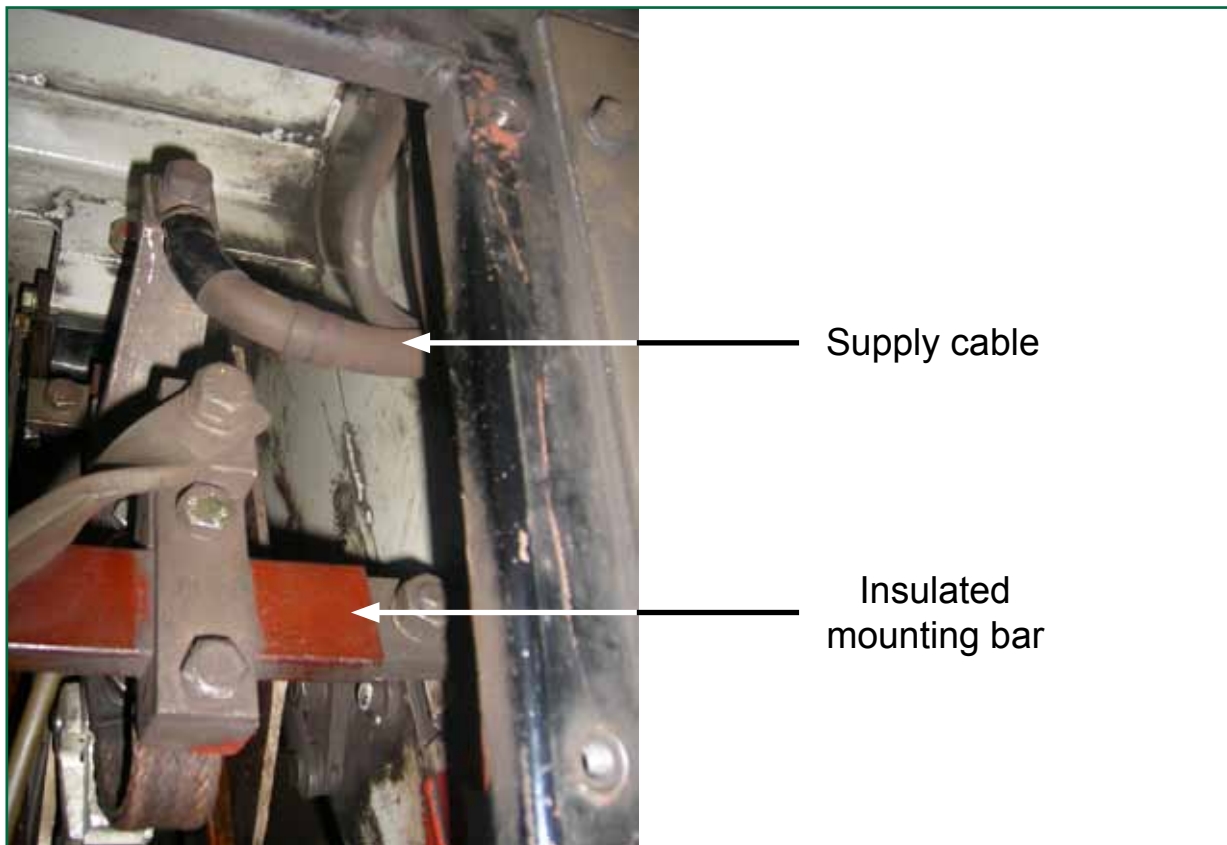
- 53 The damage to LB1 and the surrounding equipment was so severe that it is not possible to identify the exact location or nature of the original fault, or the reason why it manifested itself when it did. Possibilities include degradation or damage to the insulation of the mounting bar, or a build-up of dirt.

Figure 10: Line breaker mounting bar and supply cable in undamaged state

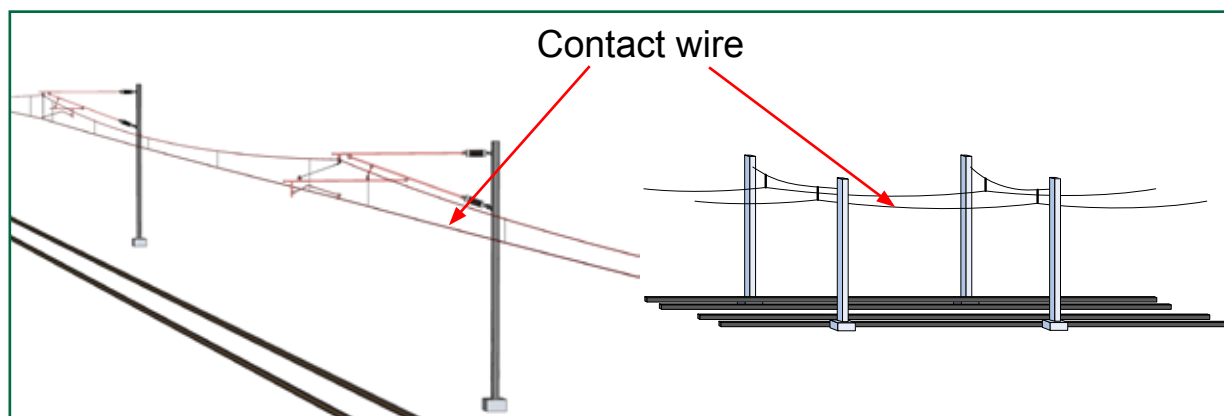
80 The overhead line parted about twelve seconds after the train stopped (as shown by the CCTV footage) and up to three seconds before the power was finally cut off from the South Gosforth – Benton Square section. At the place where the train stopped, the contact wire is a single conductor supported by solid droppers suspended from transverse cables (as distinct from catenary, figure 11), and is designed to withstand a continuous current of 360 A.

Figure 11: Catenary OHL (left) and tramway-type OHL (right)

- 81 The point where the contact wire failed corresponds to the position of the pantograph on the rear car, and it is likely that the high current flowing through a small contact area between the wire and the pantograph produced sufficient local heating to melt the wire. Examination of the wire showed marks of arcing on the wire on the side of the failure point from which the train had travelled.

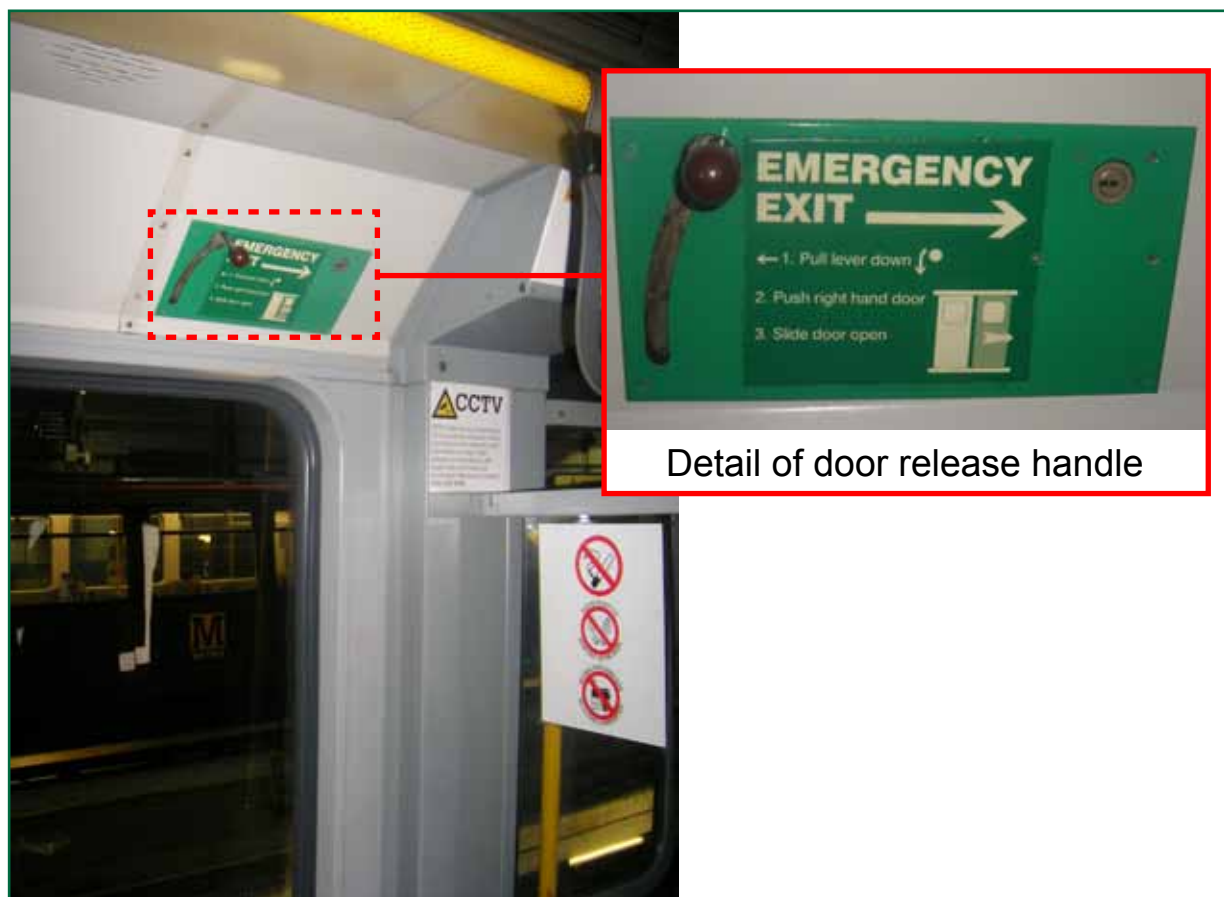
- 88 The remaining set of doors, not opened during the evacuation, were the second set from the front of car 4052 (identified as door 6). CCTV shows a passenger attempting to use the emergency door release handle to open door 6, but giving up after a short time and joining the evacuation from the other doors. After the evacuation, a number of passengers reported to the driver that they had had difficulty with the door release handles. Subsequent examination of the release handle mechanism for door 6 found that it was extremely stiff to operate, and tests using a diverse range of people showed that many passengers were likely to have been unable to obtain sufficient purchase to operate the handle far enough to open the doors.

- 89 The emergency release handle is shown in figure 12. It is designed to be pulled downwards to release the doors, and uses a wire-in-tube system to operate a latch on the door closing mechanism, and a valve to release the air pressure in the door actuator system. The angle at which the handle is mounted is intended to make it possible for it to be worked from outside the vehicle by a hooked pole wielded by the emergency services and passed through the open window immediately below, avoiding the need to break windows to enter the vehicle. However, this makes it more awkward for a person inside to use the handle without instruction and/or practice.

- 90 The regular examination schedule for the Metro cars (defined by Nexus, and carried out by DBTW) requires the operation of the emergency release handle for each door to be checked during each 'A' exam. These generally take place every 12000 km (approximately three weeks running). DBTW's records showed that these checks had been carried out on car 4052, most recently on 13 October 2012. The car was in Gosforth depot from 2 November 2012 to 2 January 2013 for a 'D' exam, which included under-frame equipment renewal along with traction motor, gearbox and associated work, but not checks on the doors. The RAIB found that staff in the Gosforth depot, where these checks are carried out, were accustomed to carrying out the functional test of the emergency release handles, which consisted of operating the handle and confirming that doing so released the doors. However, during and after the accident on 8 January, people who were not familiar with them found the handles difficult to operate and stiff, particularly so in the case of the handle for door 6 on car 4052 (paragraph 34).

Figure 12: Emergency door release at door 6 in car 4052

- 2 *The objective of this recommendation is to facilitate passenger evacuation from trains using the emergency handles to release doors by identifying a maximum level of force required to operate them and then periodically checking that handles comply with the identified maximum.*
