Rail Accident Report

Fatal accident at Athelney level crossing, near Taunton, Somerset 21 March 2013

Fatal accident at Athelney level crossing, near Taunton, Somerset, 21 March 2013

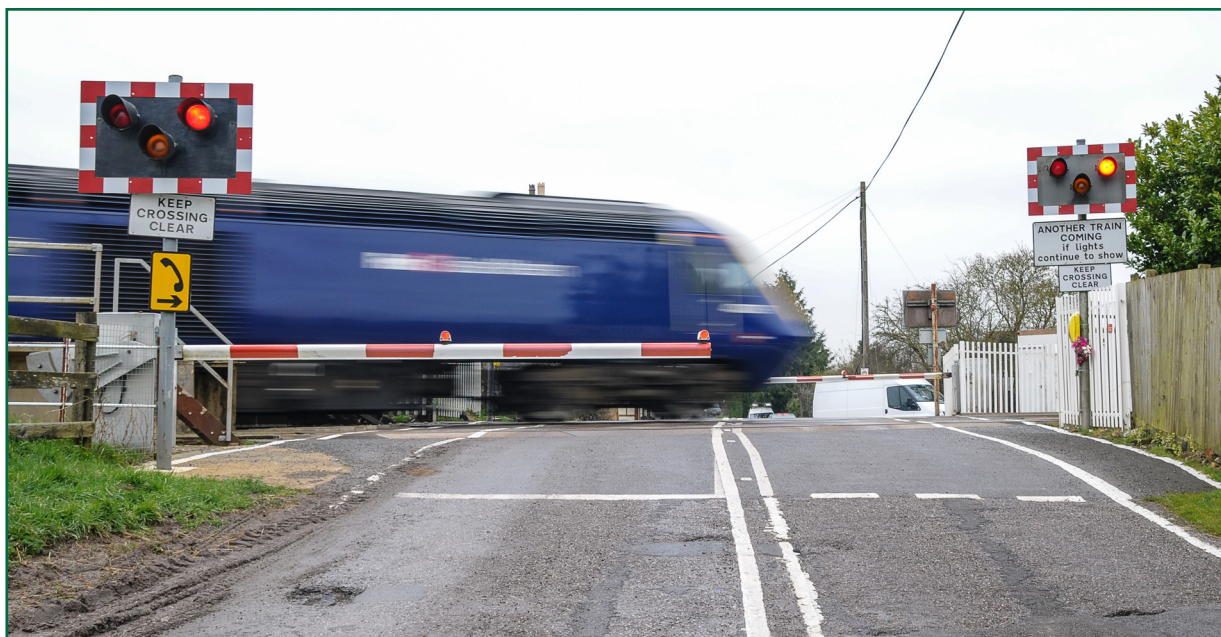
- 7 At about 06:23 hrs on Thursday 21 March 2013, a car drove around the barriers of Athelney *automatic half barrier crossing* (AHBC) and into the path of an approaching train (figure 1).

Figure 1: View of Athelney level crossing (courtesy British Transport Police)

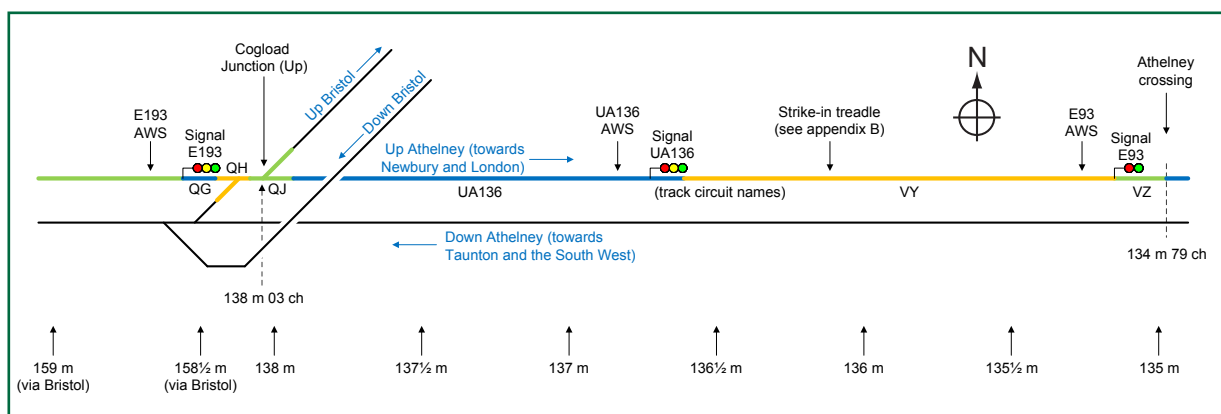
- 16 Athelney level crossing was commissioned in 1986 and is supervised from Exeter signal box. The maximum permissible speed for trains on both the Up and Down Athelney lines is 100 mph (161 km/h).
- 17 For trains running on the Up Athelney line, a signal (E93) is located 277 metres on the approach to the crossing. This is a *controlled signal* with an *automatic working* facility and is normally switched into automatic mode. It is the last signal before the boundary with the area controlled by Westbury signal box. The previous automatic signal (UA136) is located 2,808 metres on the approach to E93 signal (figure 3).

Figure 3: Track layout, showing signals and track circuit names on the Up Athelney line

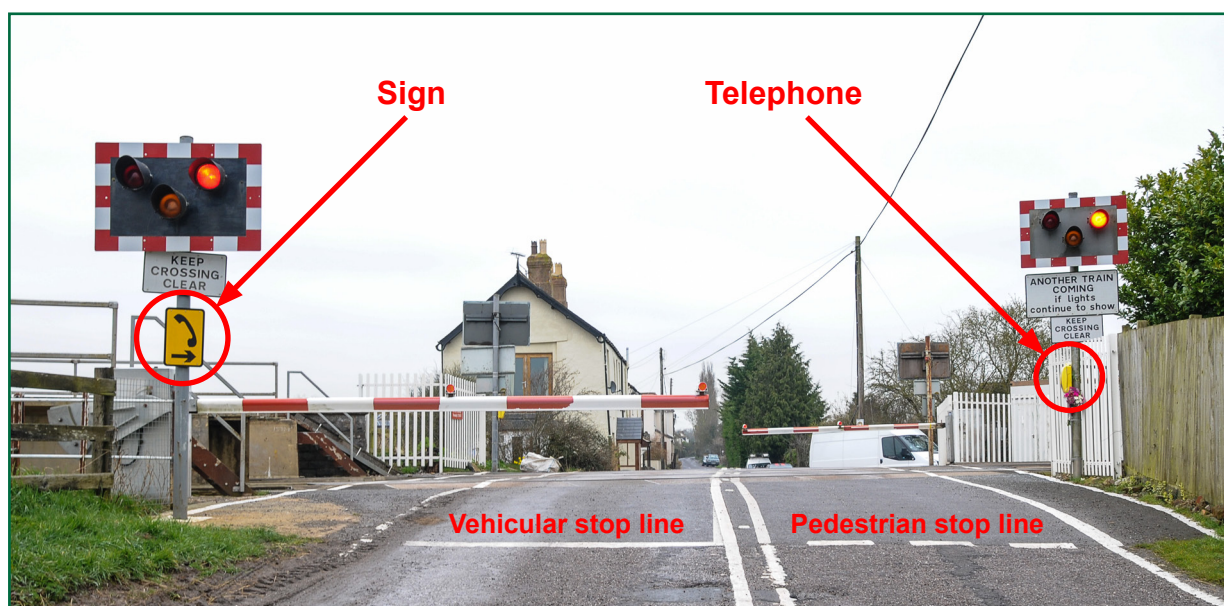
61 Whatever the motorist's understanding, he did not use the telephone provided at the level crossing to contact the signaller. This may have been because he was not aware of the existence or purpose of the telephone.

Figure 6: Level crossing telephone and signage at Athelney AHBC (courtesy British Transport Police)

- 62 The location of the telephone at Athelney level crossing is indicated by a yellow sign with a telephone symbol on the near side of the carriageway, with an arrow pointing to the telephone mounted on the offside road traffic light signal post (figure 6). Such telephones are described by Network Rail as 'public emergency telephones'; they are also intended for use by the drivers of large or slow vehicles. There is no signage to advise a motorist detained at closed level crossing barriers that they could use the telephone to contact the signaller.

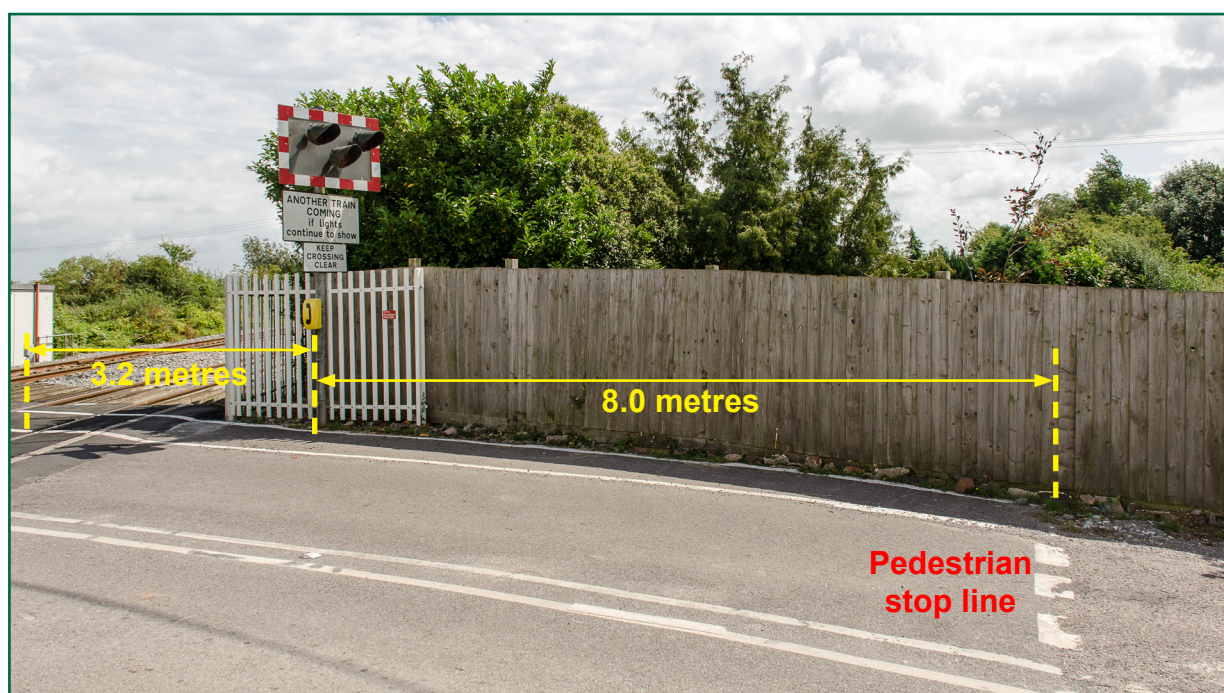
- 75 **The road markings are not consistent with Network Rail's *ground plan* for Athelney level crossing or the ORR's level crossing guidance.**
- 76 The telephone at Athelney level crossing is eight metres beyond the pedestrian 'stop' line (figure 7). Highway Code Rule 34 for pedestrians states 'You MUST NOT cross or pass a stop line when the red lights show'.

Figure 7: Location of the telephone at Athelney level crossing
