Rail Accident Report

**Collision at Buttington Hall user worked
crossing, Welshpool
16 July 2013**

Report 06/2014
March 2014

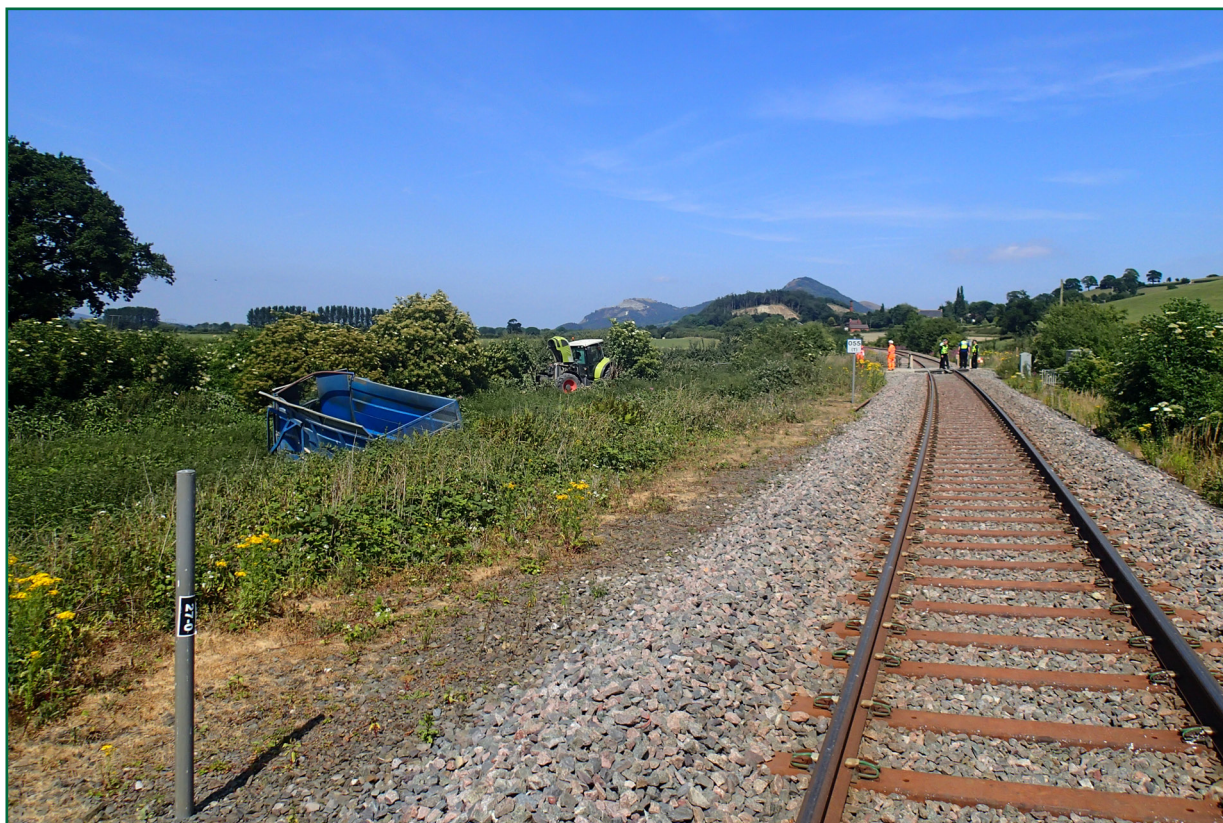
- 7 The impact caused extensive damage to the trailer and to the tractor that was pulling it (figure 2). The tractor driver and two other agricultural workers who were standing close by at the time sustained minor injuries.
- 8 Several passengers on the train were injured and two were taken to hospital for treatment, but were discharged later that day.
- 9 The train did not derail, but sustained significant damage to the front end (figure 3). A window in the passenger compartment was broken and some interior panels were dislodged during the impact.
- 10 The railway was closed until 17:30 hrs on the same day for recovery of the train.

Figure 2: Buttington Hall crossing, looking towards the Shrewsbury direction showing the tractor and trailer in their post-accident positions

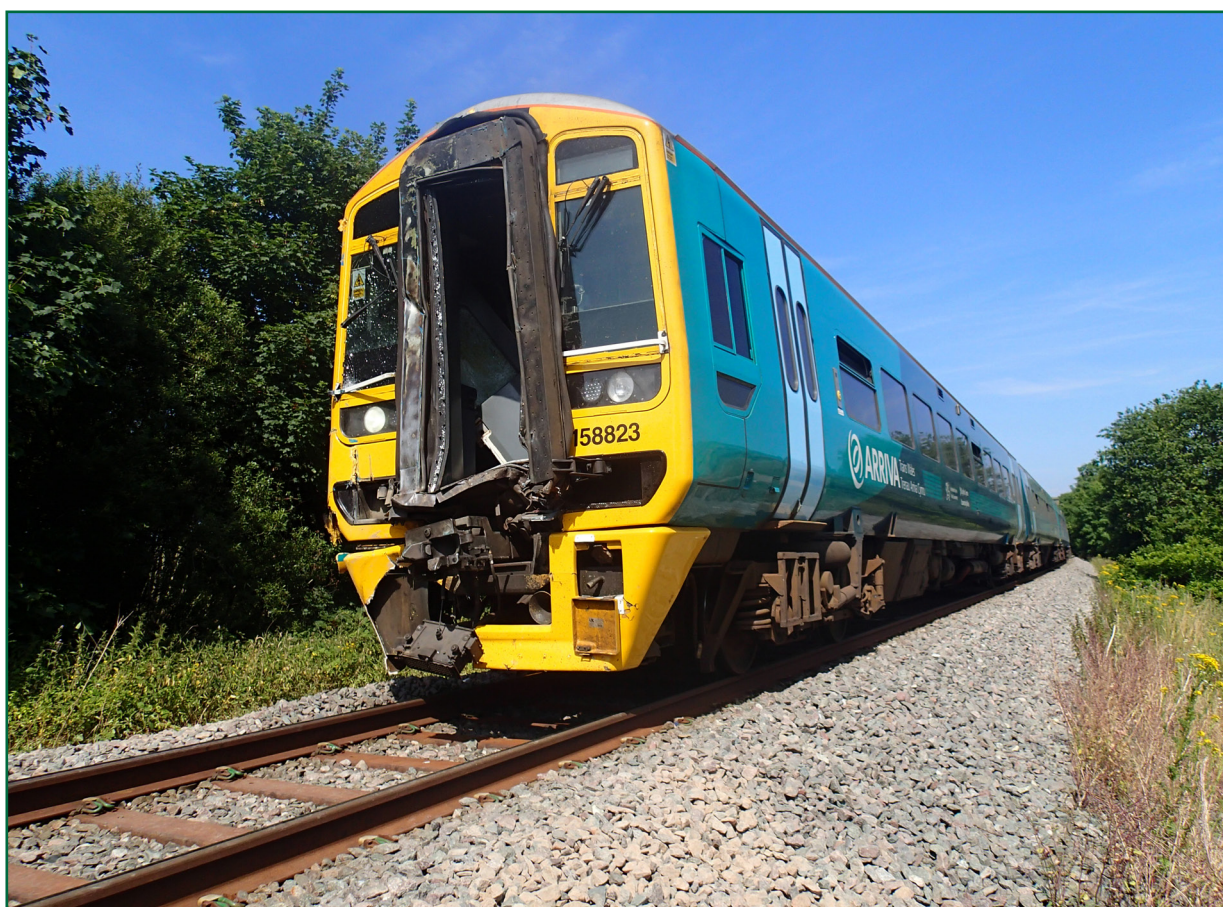
Figure 3: The front of the train involved

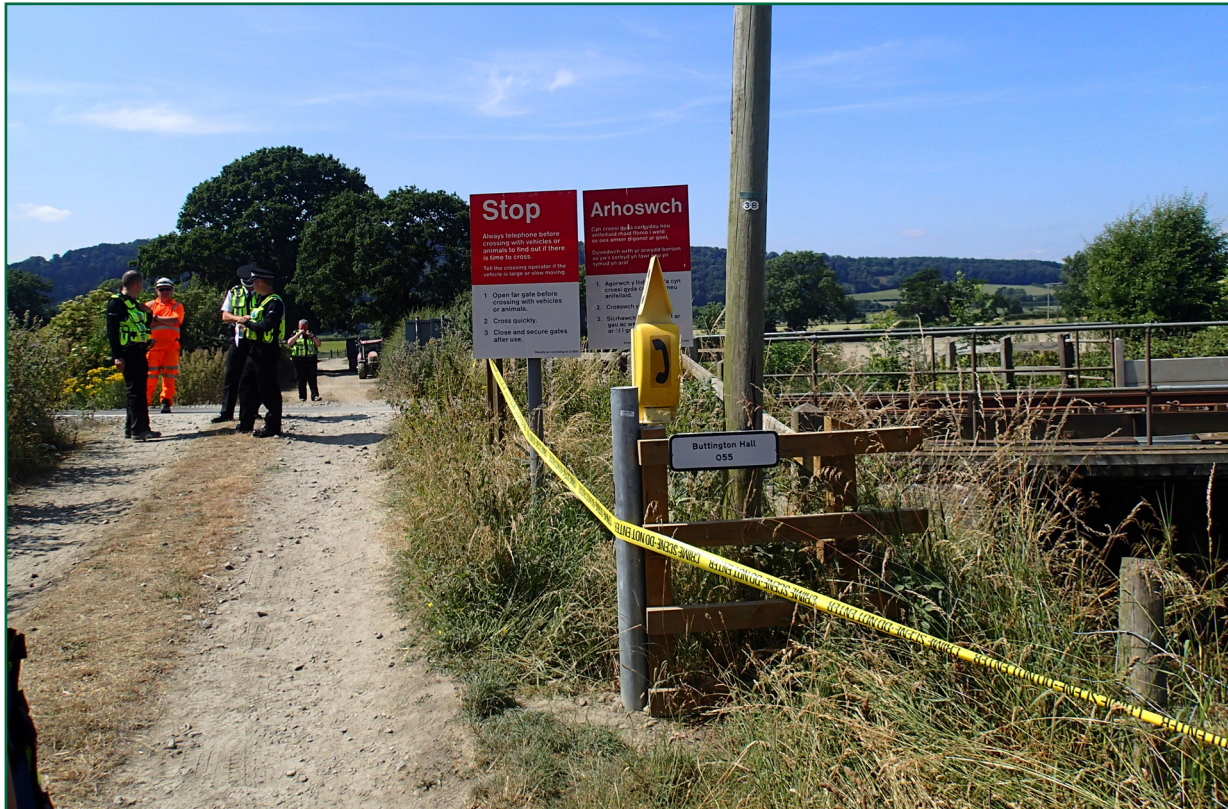
- 17 The line is controlled by the *European Rail Traffic Management System* (ERTMS), *level 2*, from Machynlleth signalling centre.
- 18 Buttington Hall UWC is an *accommodation crossing* that provides access to fields from Buttington Old Hall and Buttington New Hall farms. The road over the crossing is an unmade farm track. There is also a bridge under the line adjacent to the crossing, but this has restricted headroom and is too low for tractors and trailers to pass beneath. The crossing is provided with gates, which open away from the line, and telephones which connect to Machynlleth signalling centre. There are signs at the crossing instructing users on how to use it. These signs are in both English and Welsh languages (figure 4).

Figure 4: Buttington Hall crossing, looking in the direction that the tractor was travelling, showing the signs and telephone
