Rail Accident Report

Accidents involving a wheelchair rolling onto the track at Southend Central, 28 August 2013; and a pushchair rolling onto the track at Whyteleafe, 18 September 2013

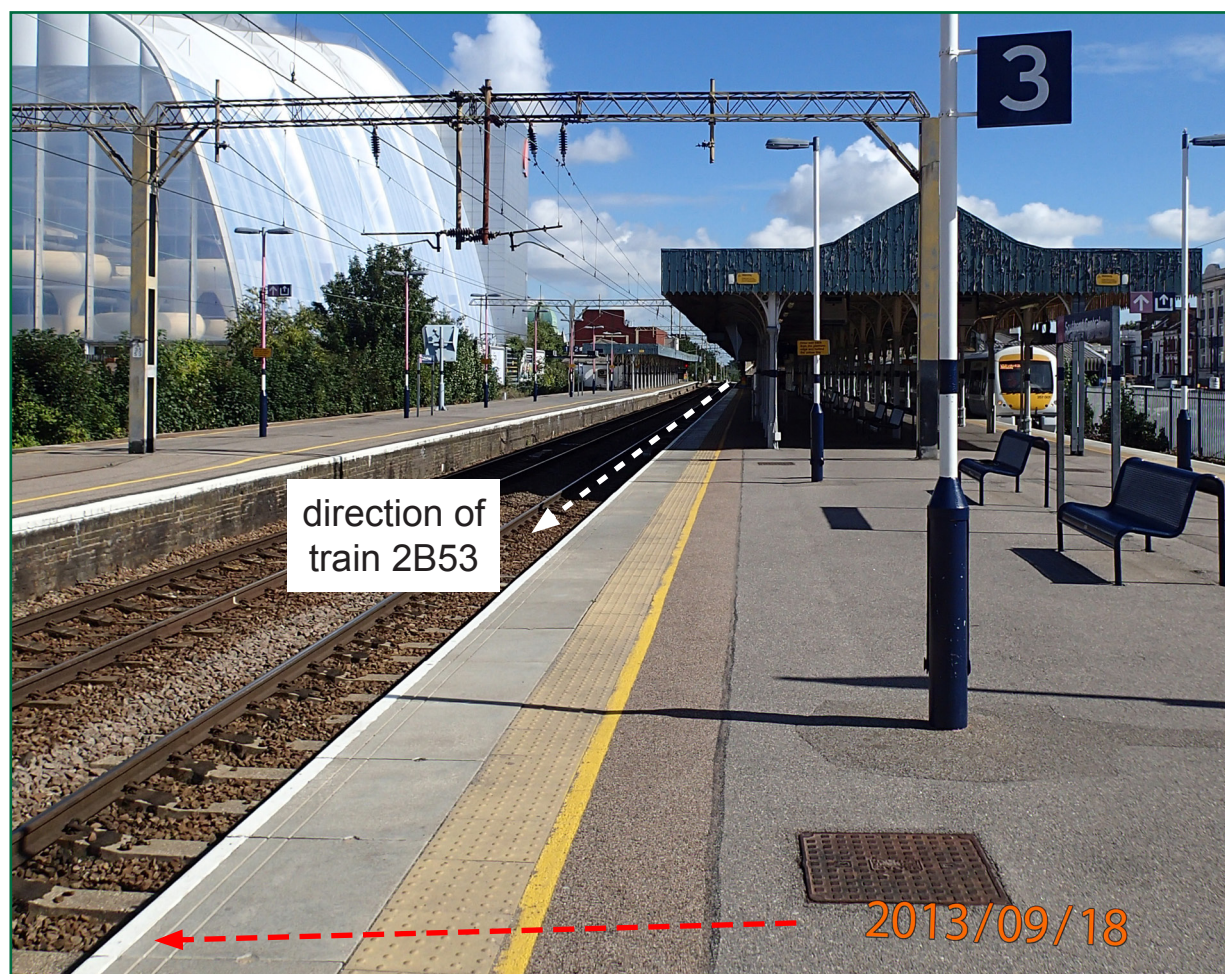
- 7 Shortly before 18:13 hrs, a wheelchair user and her carer were escorted onto platform 3 by a member of station staff. The carer, who was pushing the wheelchair, and the member of station staff awaited the imminent arrival of train 2B53, the 18:05 hrs Shoeburyness to London Fenchurch Street service, which was due to stop at Southend Central at 18:15 hrs. The carer did not apply the parking brake on the wheelchair, and before the arrival of the train the carer became distracted. Neither the carer nor the member of station staff noticed the wheelchair start to move slowly forward towards the platform edge (figure 2). The wheelchair and its occupant, who was strapped in, rolled forward approximately 2.6 metres before falling off the platform and onto the railway line. The wheelchair occupant sustained a fractured hip and shock.

Figure 2: Southend Central station platform 3 showing position of the wheelchair when stationary, and its route (red dotted line)

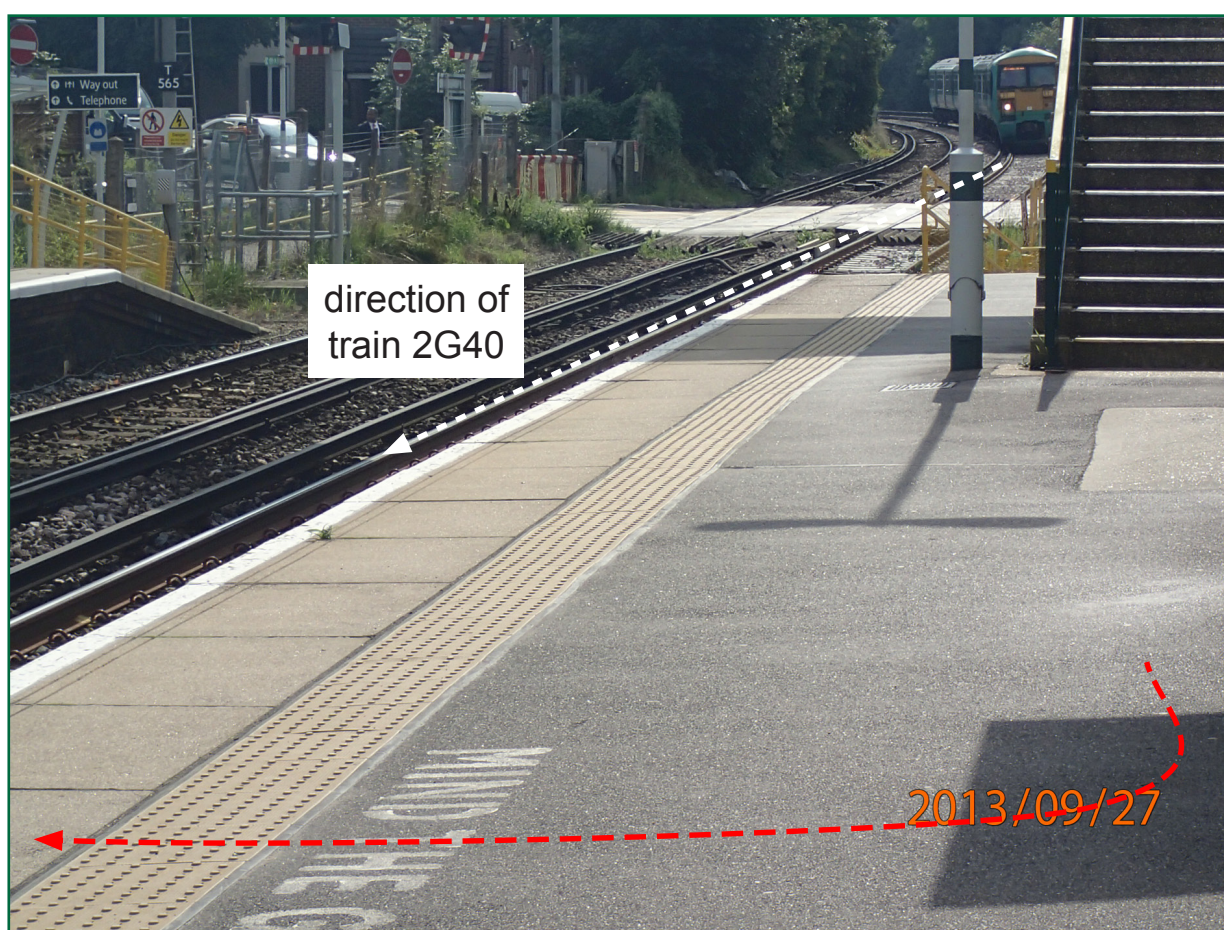
- 8 At 10:39 hrs, a mother and her two children (a baby strapped into a pushchair and a toddler walking beside her) walked onto platform 1, the London-bound side of Whyteleafe station, intending to travel on train 2G40, the 10:39 hrs Caterham to London Bridge service, which was on its way to Whyteleafe and due to arrive at 10:43 hrs. The mother stopped the pushchair while she operated the ticket machine on the platform, but did not apply the pushchair's parking brake. While her attention was focused on the purchase of her ticket, she was unaware that the pushchair had started to roll slowly along the platform and had then veered to the right and towards the platform edge (figure 3). The mother was alerted by the toddler to the pushchair's movement, and turned to see it rolling towards the track. She tried to reach it before it fell onto the track, but was unable to do so. The pushchair narrowly missed the electrified *conductor rail*. The baby suffered minor cuts and bruising.

Figure 3: Whyteleafe station platform 1 showing position of the stationary pushchair and its route (red dotted line)

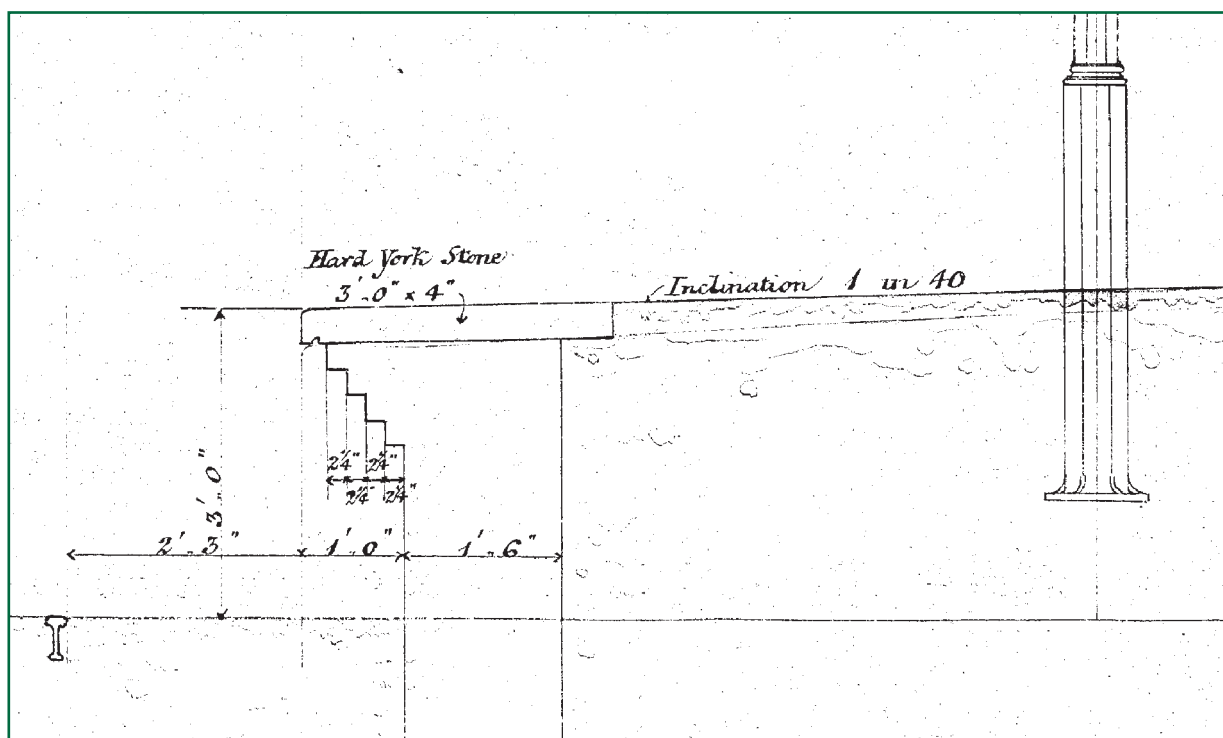
- 11 The platforms at Southend Central and Whyteleafe stations were originally designed with a 1 in 40 (2.5 %) slope, falling towards the railway (figure 4). This was to assist in the drainage of water from the platform onto the track. At the time of the accidents in 2013, each platform still had a slope falling towards the track.

Figure 4: Southend Central station – cross-section drawing from 1899 showing 1 in 40 slope on the platform, falling towards the railway

34 The platforms on both stations were constructed with a 1 in 40 (2.5%) slope, falling towards the railway. This was probably intended to provide natural drainage from the platform towards the track, preventing the pooling of water on the platform and avoiding the need for any other form of drainage to be provided. Although prams and wheelchairs were in use at the time the stations were constructed, the hazard that slopes presented to them may not have been considered as the railways were not designed at that time with the accessibility requirements of the very young or disabled in mind. Early references to wheeled vehicles on station platforms mainly related to barrows, which were the responsibility of railway staff. Rules for their use appear in official documents from an early date. However, roll-off incidents did occasionally occur. An investigation by the Railway Inspectorate into a derailment at Wellingborough station in 1898⁶ identified the immediate cause of the accident as the platform sloping towards the railway. A luggage trolley rolled forward onto the railway, where it was struck by a passenger train, which derailed with serious consequences. Other such 'luggage trolley and barrow' type roll-off incidents across the rail network were identified in the investigation report. The Wellingborough accident report recommended that platforms should be level, or slope away from the track. However the government requirements for new railway construction were not modified accordingly, and the recommendation seems to have been forgotten.

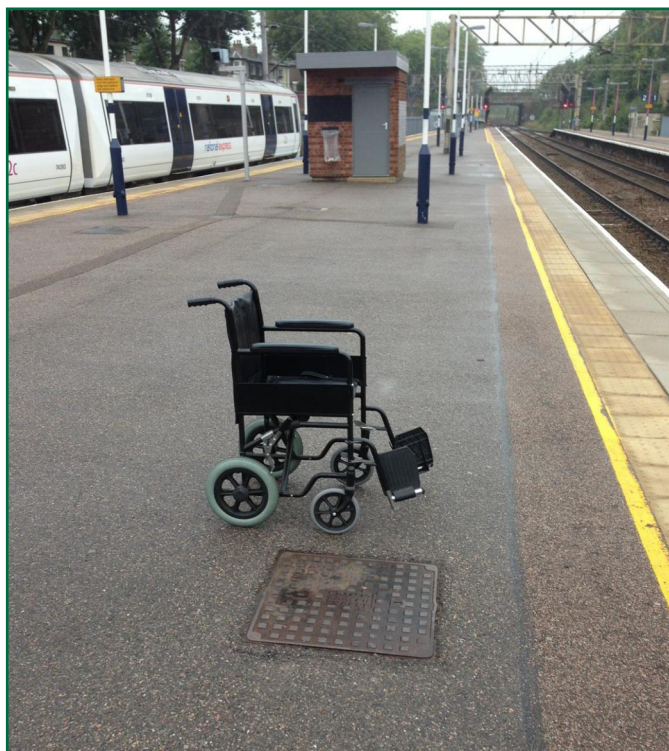
Figure 5: Photograph showing the position (reconstruction) of the stationary wheelchair on platform 3 at Southend Central station before it started to roll forward (image courtesy of c2c)

- 17 The wheelchair and its occupant rolled approximately 2.6 metres before falling off the platform onto the *up* line (figure 5). Members of public who were standing on the platform jumped down onto the railway, followed by the member of station staff (who was aware of the imminent arrival of train 2B53). The member of staff contacted the booking office clerk using his radio¹, advising him of the accident and requesting that the line be blocked.

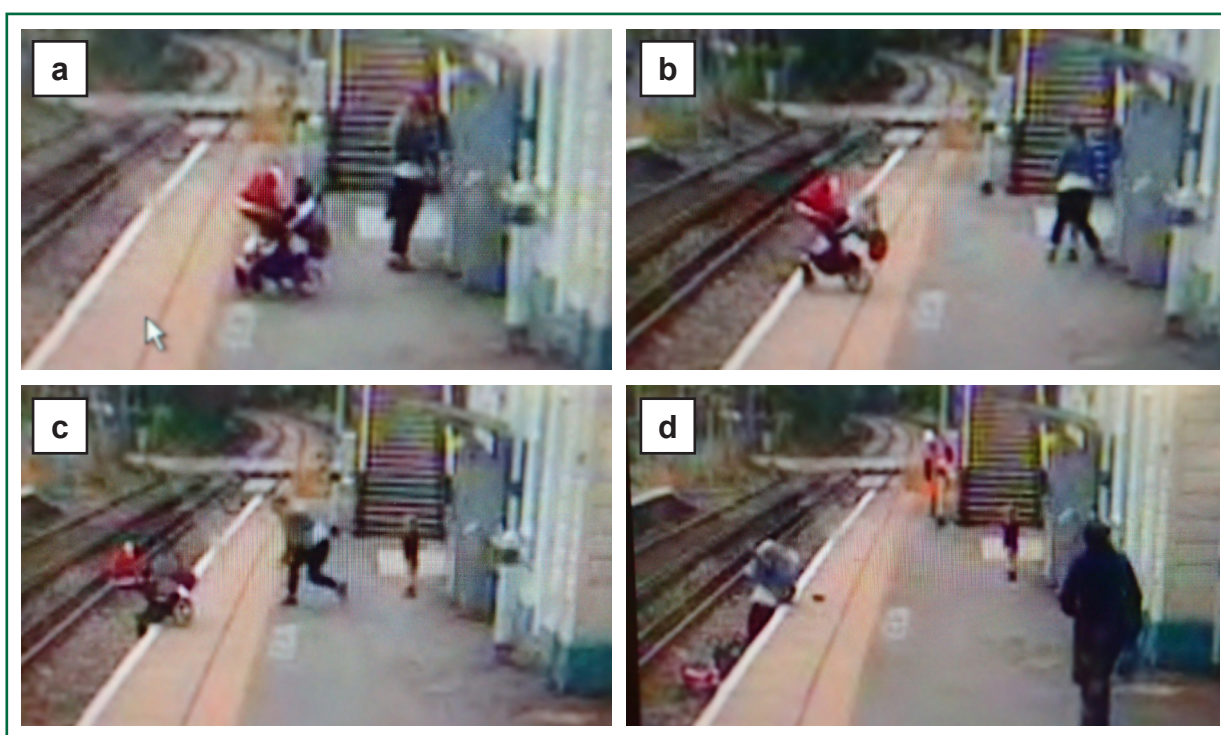
- 21 The pushchair initially rolled slowly and parallel to the railway, but the incline towards the track caused it to turn right and run towards the edge of the platform (figures 6a and b). The older child, who was standing to her mother's left, saw the pushchair moving towards the railway and alerted her mother (figures 6c and d). The mother turned and ran, attempting to grab the pushchair, but she was unable to prevent it rolling off the platform and onto the track. The mother shouted for help before jumping down onto the railway track to retrieve her baby.

Figure 6: Closed Circuit Television (CCTV) images showing the accident at Whyteleafe station. The configuration of the CCTV system resulted in periodic gaps of a few seconds at a time when no recording was made².

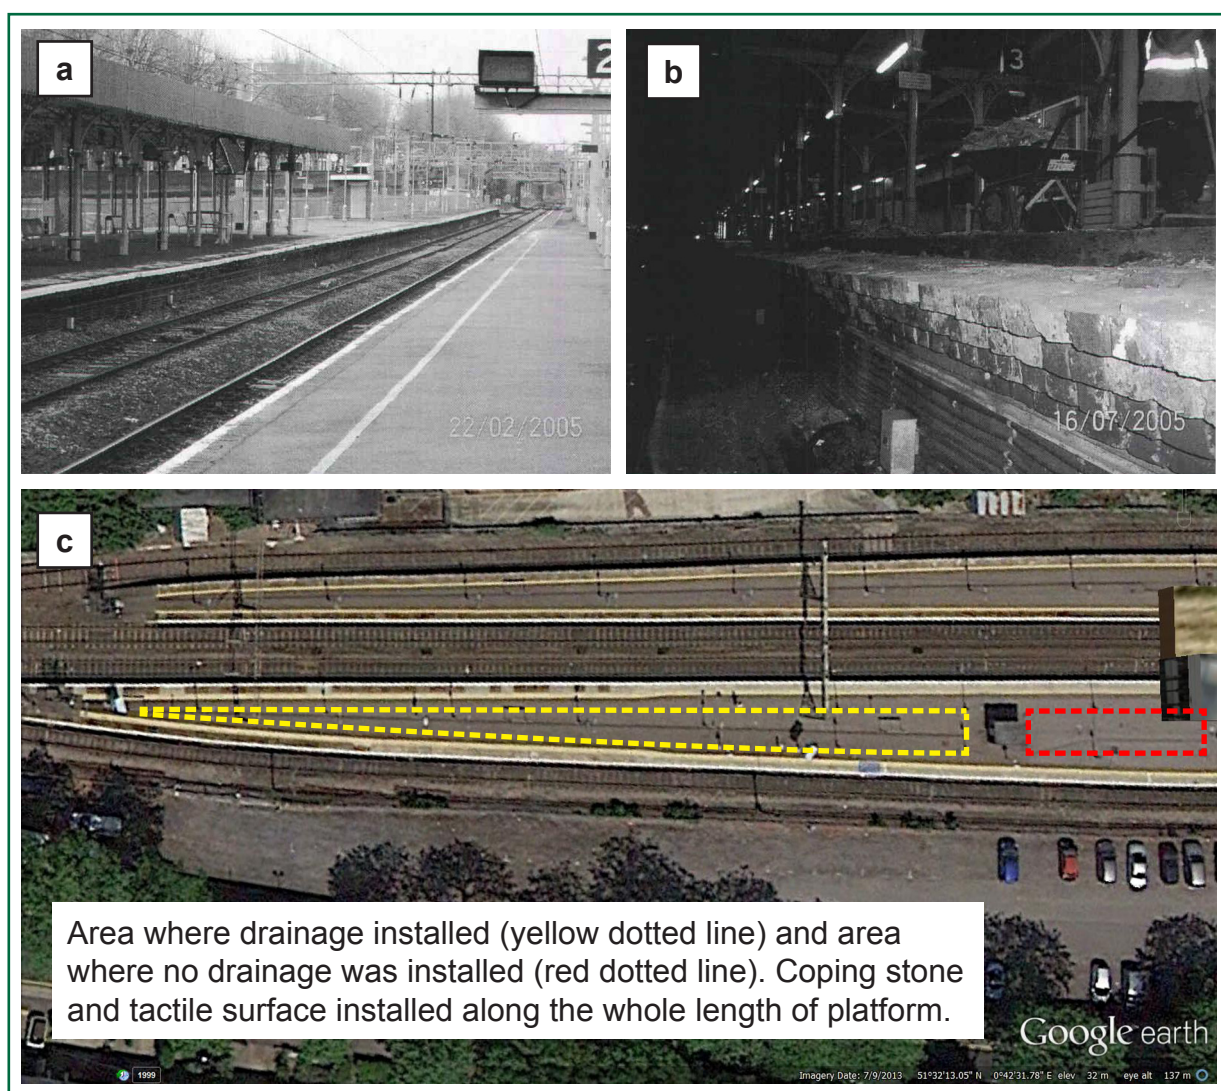
- 44 Work was undertaken on platform 3 at Southend Central between 2005 and 2007, including installation of coping stones and tactile surfaces over the whole length of the platform and the refurbishment of the island part of the platform where it adjoins platform 4 (paragraph 9). Part of the refurbished platform sloped away from the track and towards a new central drain (marked in yellow at figure 7c). However, the works on the portion of the island platform where no central drain was installed (marked in red at figure 7c) resulted in the existing slope towards the track becoming steeper. The gradient falling towards the railway at the location where the accident occurred (figures 7a and b) increased from the 'as-designed' 1 in 40 (2.5%) to 1 in 28 (3.5%) with some sections being 1 in 8 (12.5%) (figure 8). The RAIB has been unable to establish why this happened.

- 45 The RAIB considers that the extent of the work undertaken on the platform at Southend Central (installation of coping stones and tactile surfaces throughout and the installation of central drainage) could have constituted a reasonable opportunity to bring the whole length of the platform into compliance with Railway Group Standard GI/RT7016, which would then have entailed removal of the falling slope towards the track.

Figure 7: Refurbishment work undertaken on platform 3 (a and b) at Southend Central station and Google Earth image

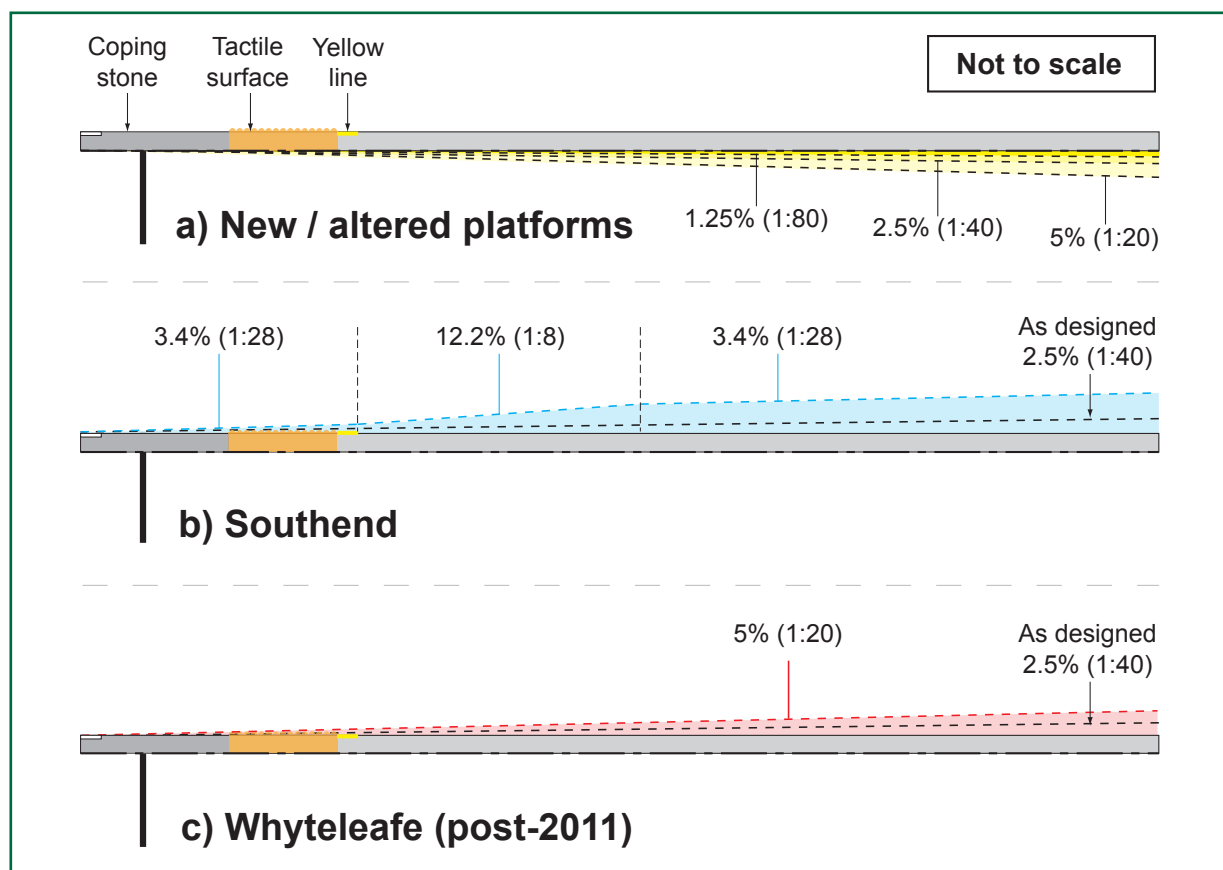
Figure 8: Diagrams showing standard gradient against gradients at Southend Central and Whyteleafe stations

- 47 The RAIB considers it possible that the work at Whyteleafe resulted in the gradient towards the railway increasing from the originally designed 1 in 40 (2.5%) to around 1 in 20 (5%) at the location where the accident occurred. In other areas the platform sloped at 1 in 14 (7%) towards the railway (figure 8). The RAIB has been unable to identify any other works on the platform that could have caused the change in gradient.

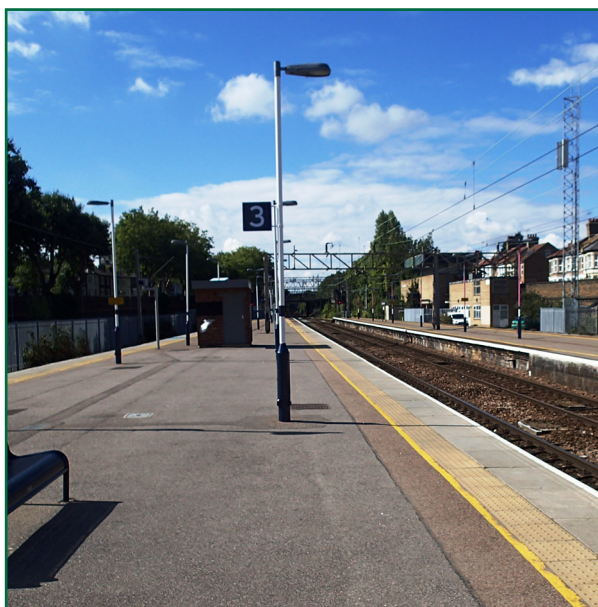
Figure 9: Southend Central station

- 55 An individual's interpretation of slant is affected by their perception of the orientation of the surface they are standing on relative to the objects and structures within their line of sight. An individual's perception of optical slant will vary as their line of sight changes. The nature of the intersections between the structures in their line of sight affects how easy it is to identify slant; it is easier to see slant where there is a rapid change in angle or intersection (figures 11 and 12). Other than the ticket machine at Whyteleafe and a station lighting column at Southend Central, there were no structures intersecting the platform surface in the immediate vicinity of the places where the accidents happened. The lack of intersection with the platform surface would have made the optical identification of the slope more difficult.

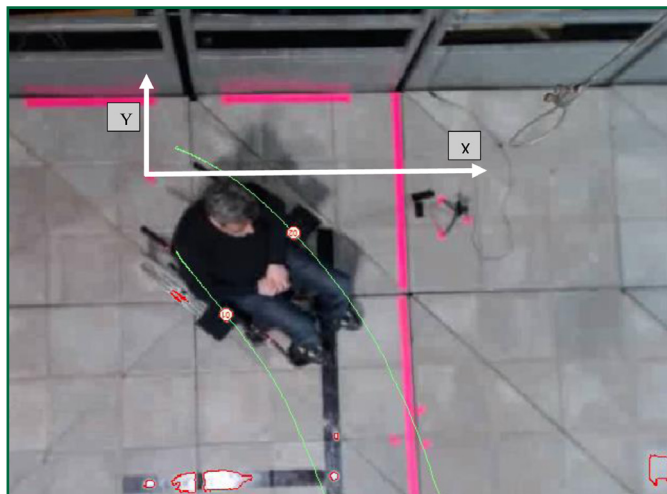
A detailed description of a single run from what is theoretically the 'best case' scenario in terms of safety of the wheelchair user with wheelchair at 0° and casters at 90° is analysed in detail for this initial investigation. The trajectory of the wheelchair for the 1:28 (3.5%) slope is shown in figure F2 and the trajectory for the 1:11 (9%) slope is shown in figure F3.

Figure F2: Tracked wheelchair (green lines) as it rolls down a 2° (1 in 28) slope

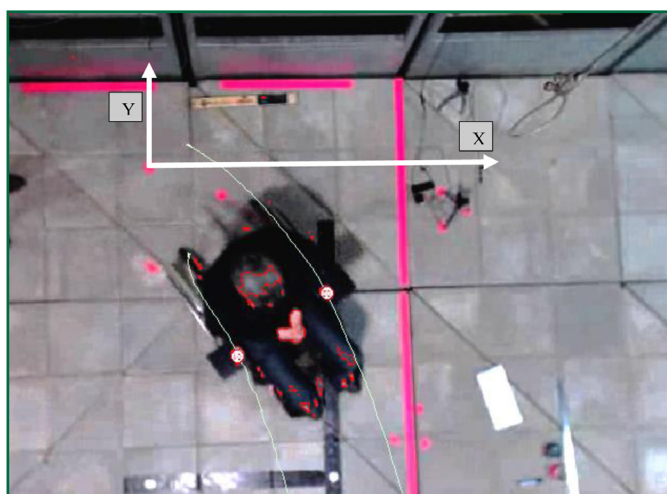
Figure F3: Tracked wheelchair (green lines) as it rolls down a 5° (1 in 11) slope

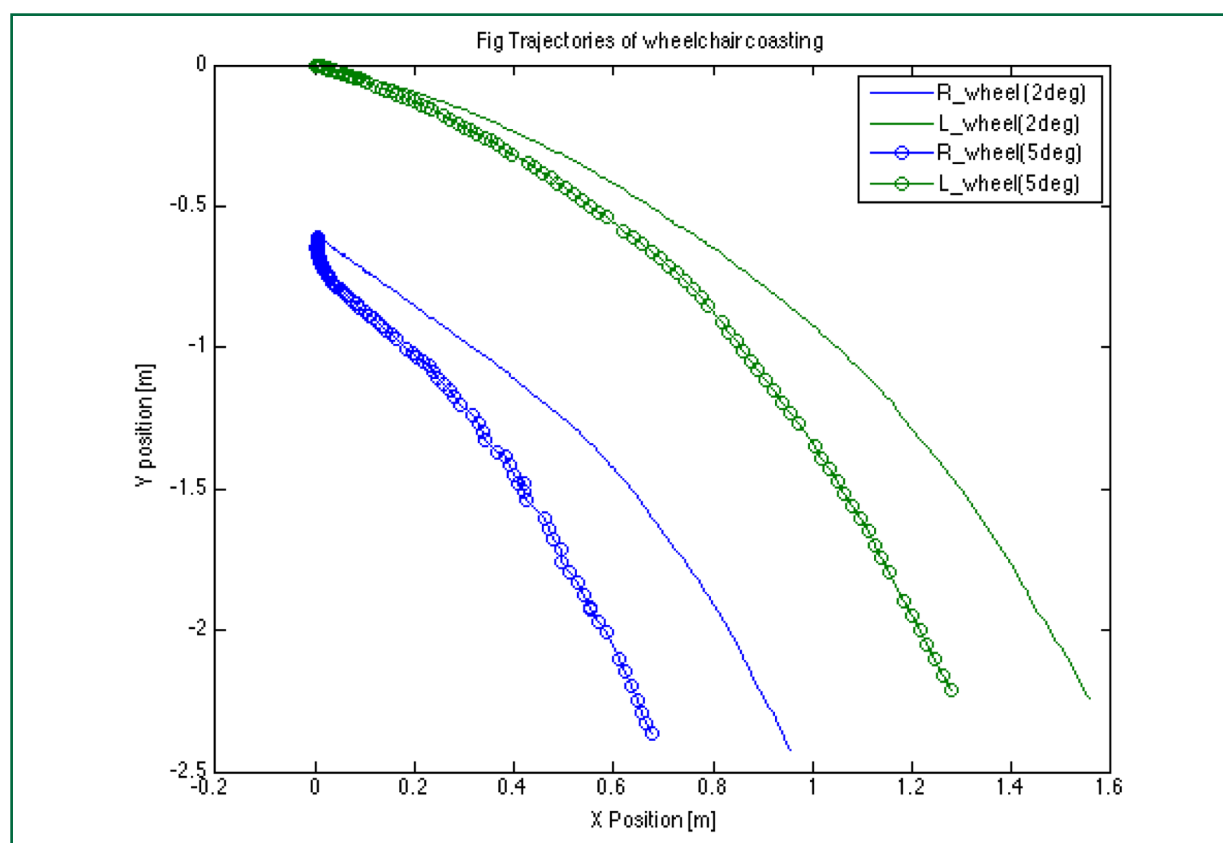
The trajectories for both slopes are also shown in figure F4, with the left wheels shown in green and right wheels in blue. The 1:11 (9%) slope (circles) resulted in a much tighter turning circle of the wheelchair compared with the 1:28 (3.5%) slope (solid lines).

Figure F4 details the trajectories of the left and right wheels of the wheelchair as indicated by the tracked markers. Y position is in the direction of the (imaginary) railway tracks. X position is travel along the length of the platform.

Figure F4: Trajectories of the left and right wheels of the wheelchair as indicated by the tracked markers

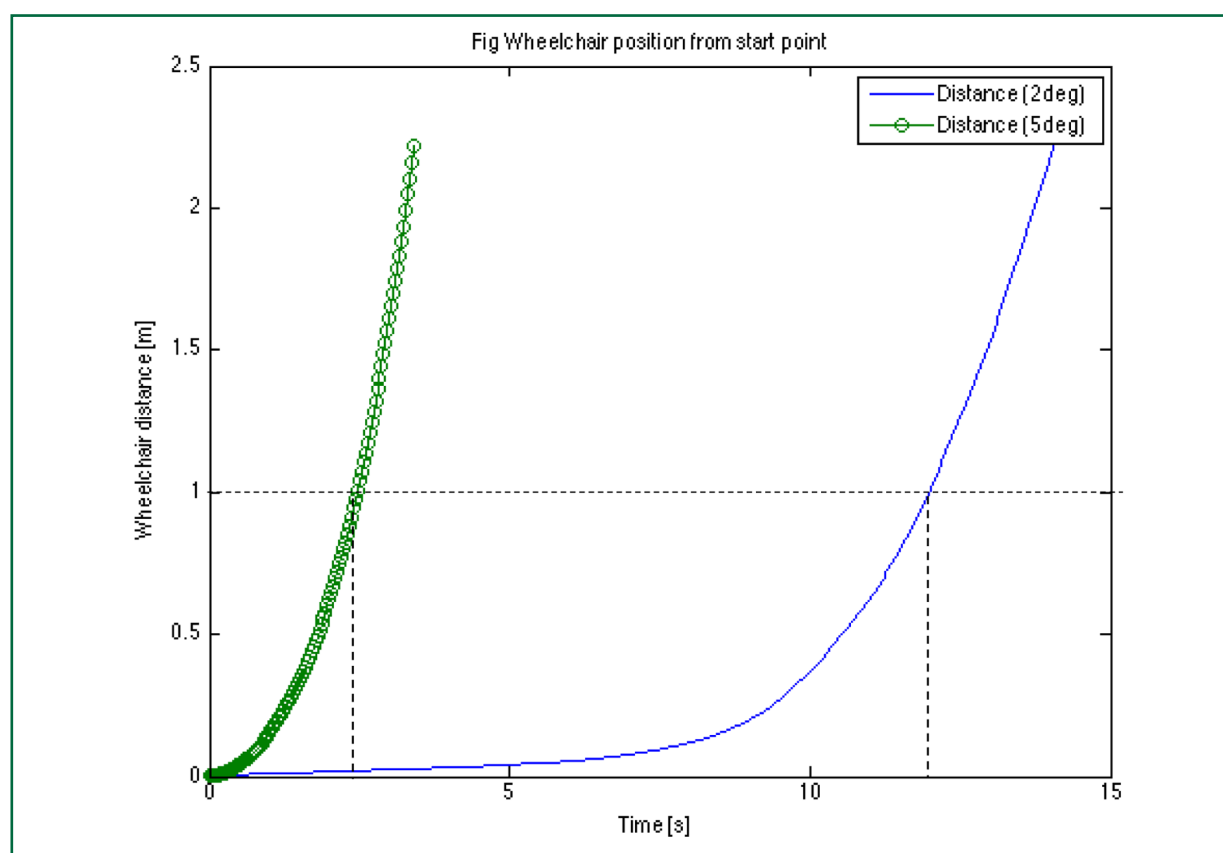
Figure F5 shows the distance travelled by the wheelchair against time. On a 1:11 (9%) slope the wheelchair begins to move within a second and has travelled 1m (shown as a black dashed line) in approximately 2.5 seconds. On the 1:28 (3.5%) slope the wheelchair takes longer to begin to move and takes approximately 12 seconds to move 1m, having moved very slowly for the first 7 seconds.

Figure F5: Time series plot of wheelchair movement as indicated by the tracked markers. Y position is in the direction of the (imaginary) railway tracks. X position is travel along the length of the platform.
