DUTCH
SAFETY BOARD

Train derailment Hilversum

January 15th 2014

The Hague, December 2014

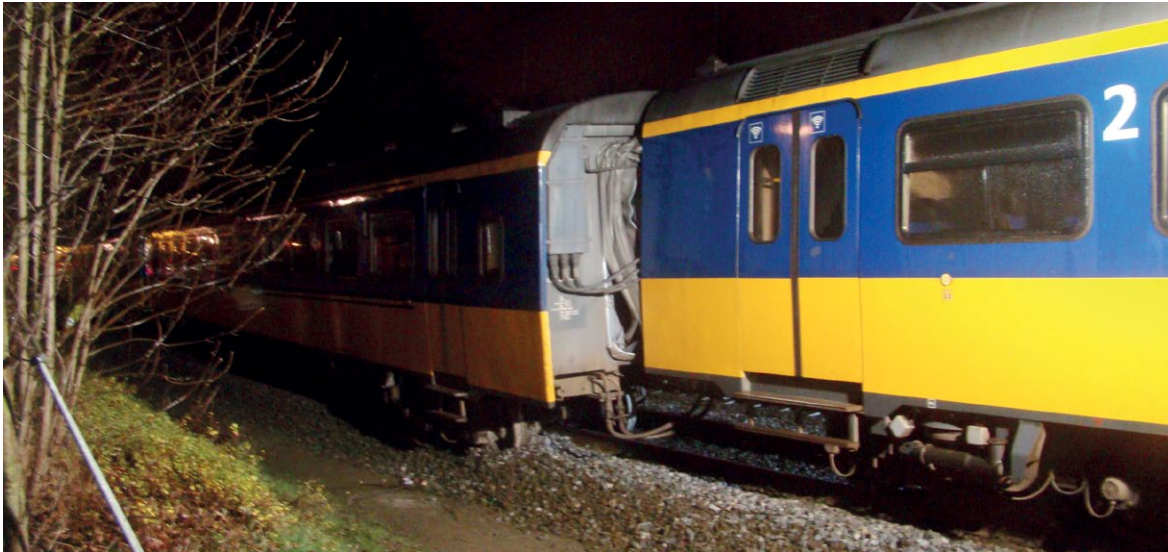
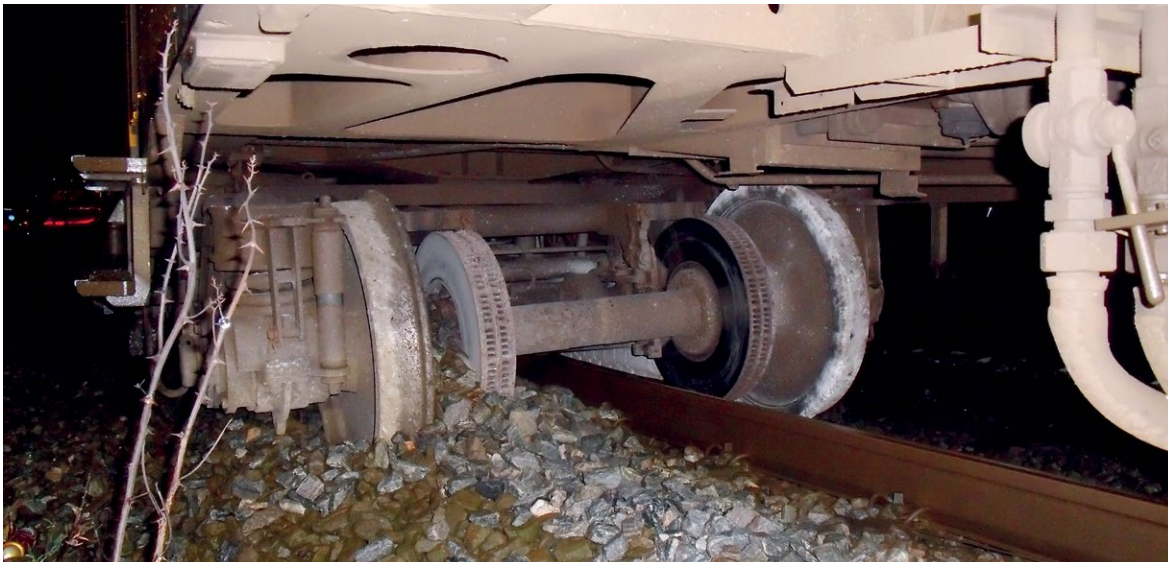
Figure 3: Wheel set of the second carriage that ended up alongside the rails. (Source: upper photograph Nedtrain, lower photograph ProRail)

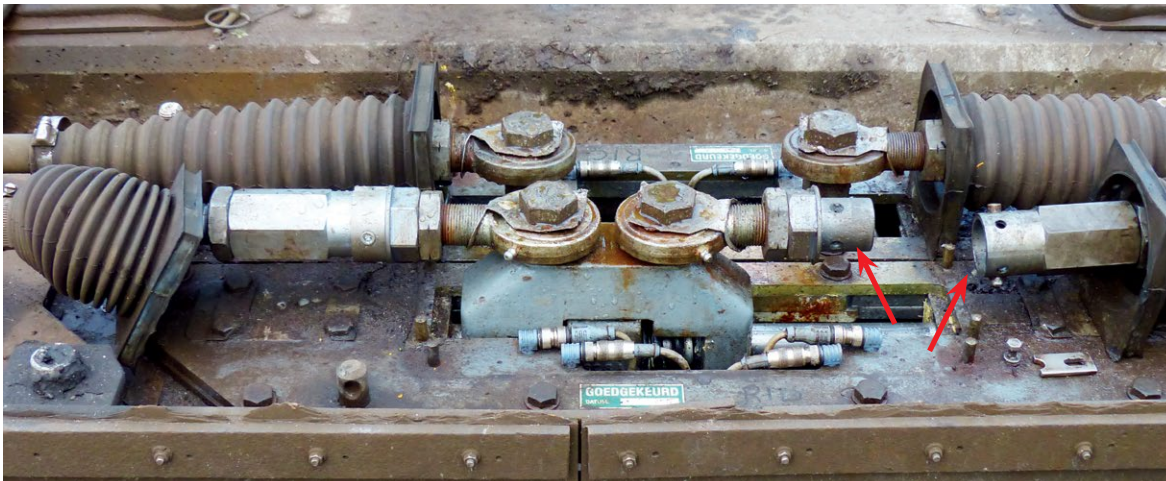
The failure of the release mechanism meant that the two parts of the locking rod were disconnected (see figure 4).

Figure 4: EBI switch in switch 3B: the release mechanism in the right-hand locking rod has failed. (Source: ProRail)

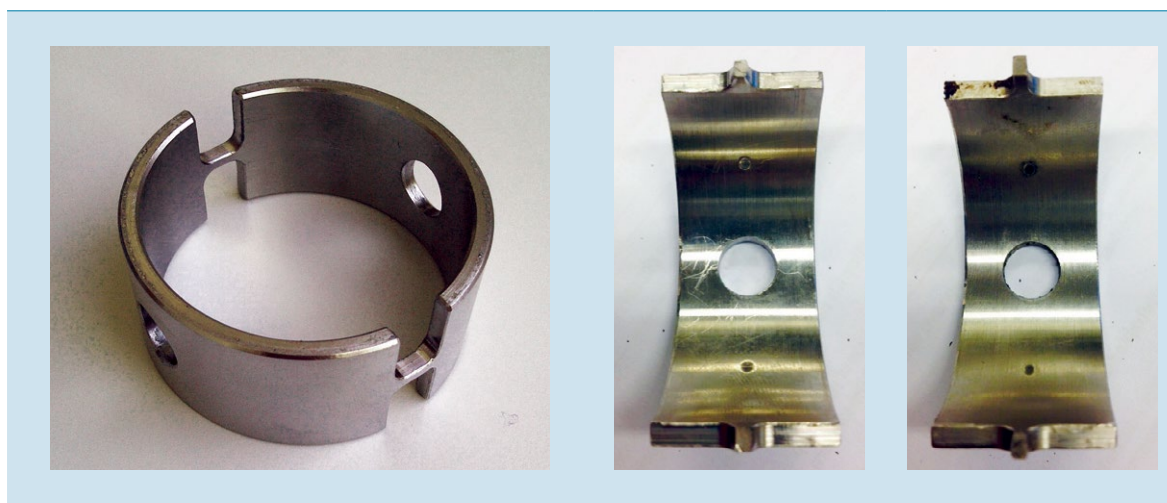
The release mechanism of the locking rod failed because the ring, part of the release mechanism, broke in two. The ring is intended to break in a specific situation, namely a run-through event. The photographs below show the ring in question: the left-hand photograph shows an example of an intact ring. The two photographs on the right show the two broken halves of the ring from switch 3B. The ring shows two fracture surfaces. A further explanation is given in appendix C.1.3.

Figure 6: Ring: left an intact example; on the right, the two broken halves of the ring from switch 3B in Hilversum. (Source: ProRail)

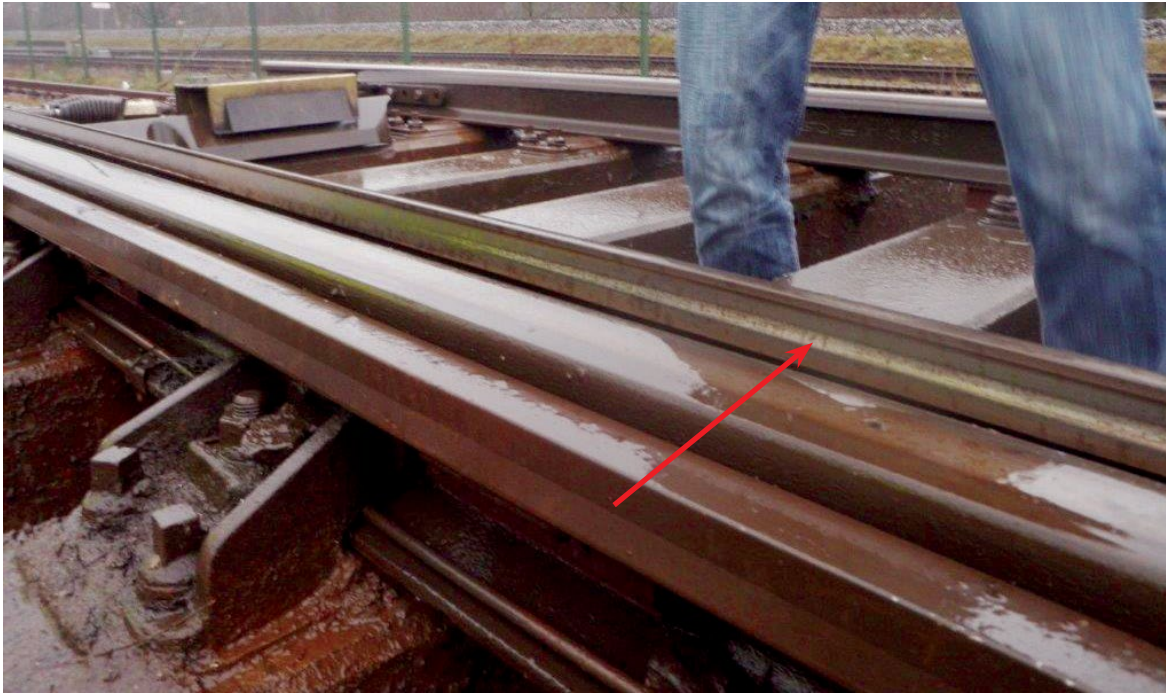
Figure 8: Flange-back contact marks on the right-hand switch blade of switch 3B. (Source: ProRail)

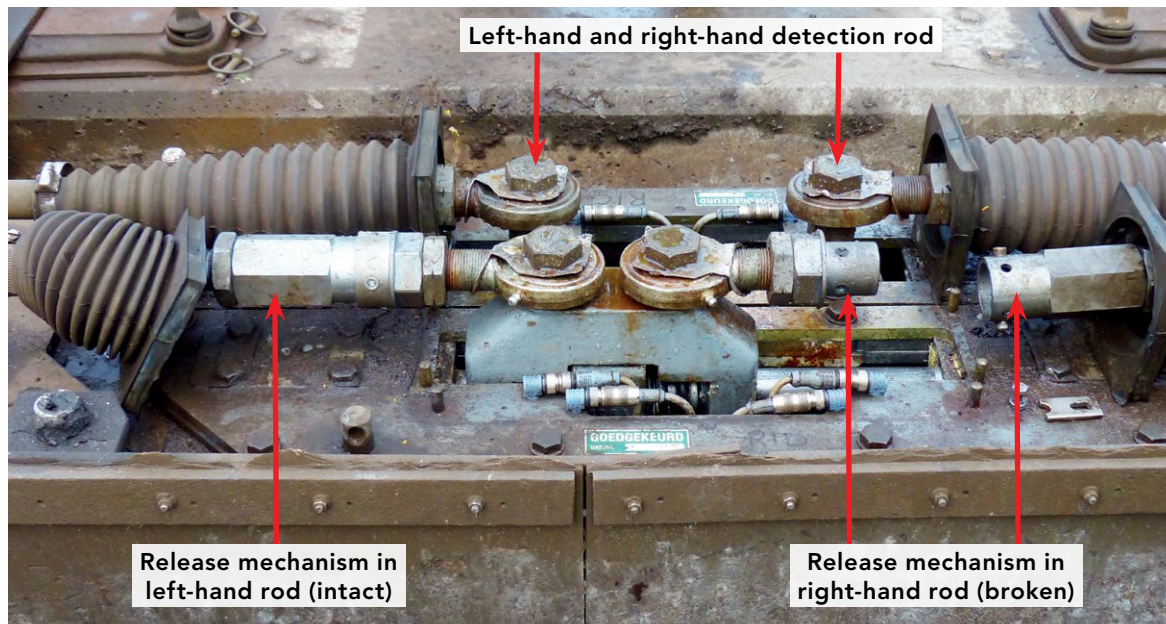
The photograph in figure 17 shows the system of rods of an EBI switch with release mechanism. In this case it is the point machine for switch 3B in Hilversum. The two front rods are the locking rods (that link the switch blades to the drive motor and the locking device) while the rear rods are the detection rods (used to detect the position of the switch blades). The two front rods are equipped with a release mechanism: the left-hand rod is intact, the right-hand rod is 'broken'.

Figure 17: The locking and detection rods in switch 3B. (Source: ProRail)

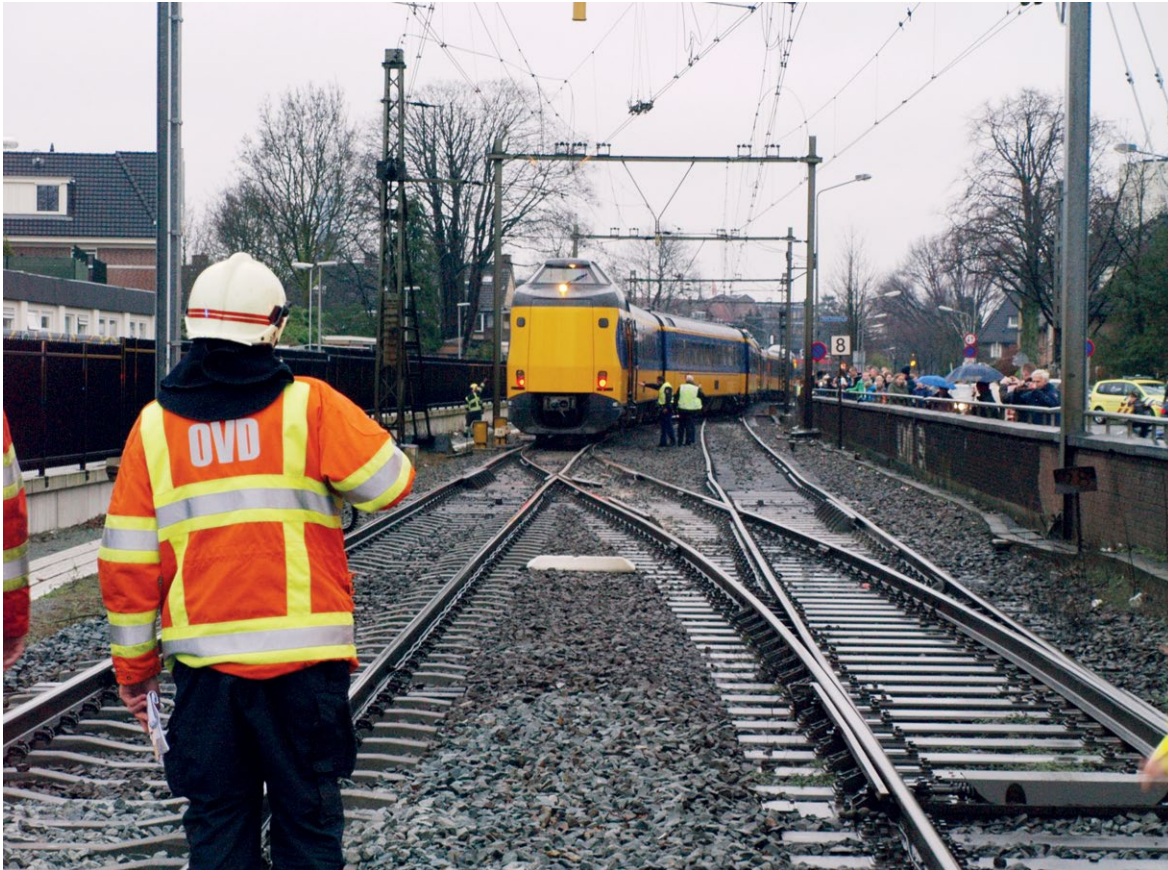
- Of the passengers, two suffered minor injuries.
- The train suffered severe damage, particularly to the bogies and wheels. There was also damage to the carriages (because the bogies had adopted abnormal positions during the derailment), the bellows between the carriages and to a pantograph. Roughly estimated, the damage to the train amounted to approximately 225,000 euro (source: NS Reizigers).
- Severe damage was also caused to the railway infrastructure, which viewed from the direction of travel of the train started at switch 3B and continued as far as the final position adopted by the train. The damage related to the four switches and the tracks, the sleepers, the ballast bed and the catenary wires. Roughly estimated, the damage to the railway infrastructure amounted to about 2,200,000 euro (source: ProRail).

Figure 25 The photograph shows the final situation (seen in the direction of travel of the train). In the foreground, the first crossover switch is visible, with in the background, the rear section of the train. (Source: Jan Barnier – Model Centre Hilversum)

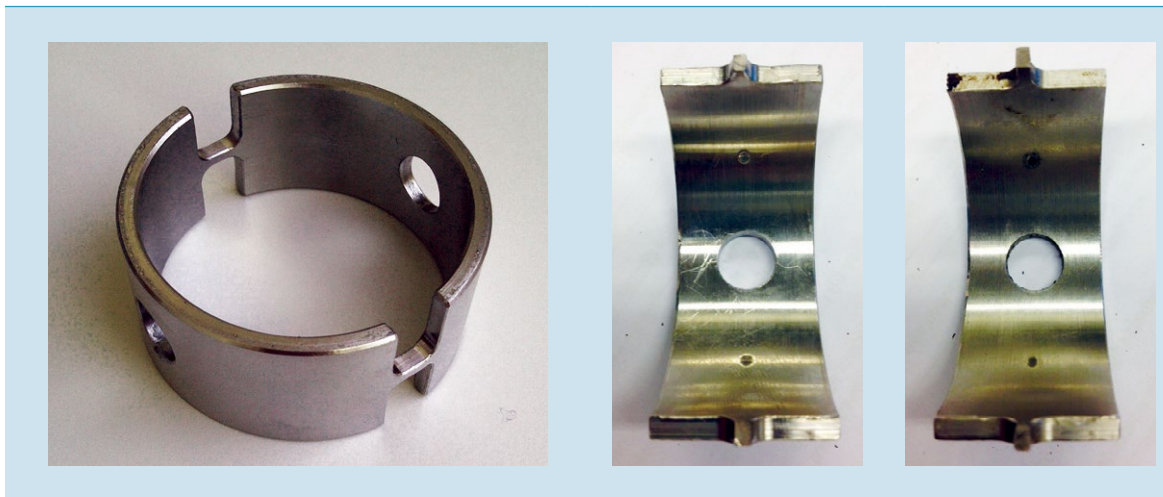
The release mechanism failed because a ring in this mechanism broke into two pieces. The photographs in figure 28 show the ring in question. The photograph on the left shows an example still intact while the two photographs on the right show the ring from switch 3B, broken into two halves.

Figure 28: The photograph on the left shows an undamaged ring. The two photographs on the right show the ring from switch 3B, broken into two halves. (Source: ProRail)

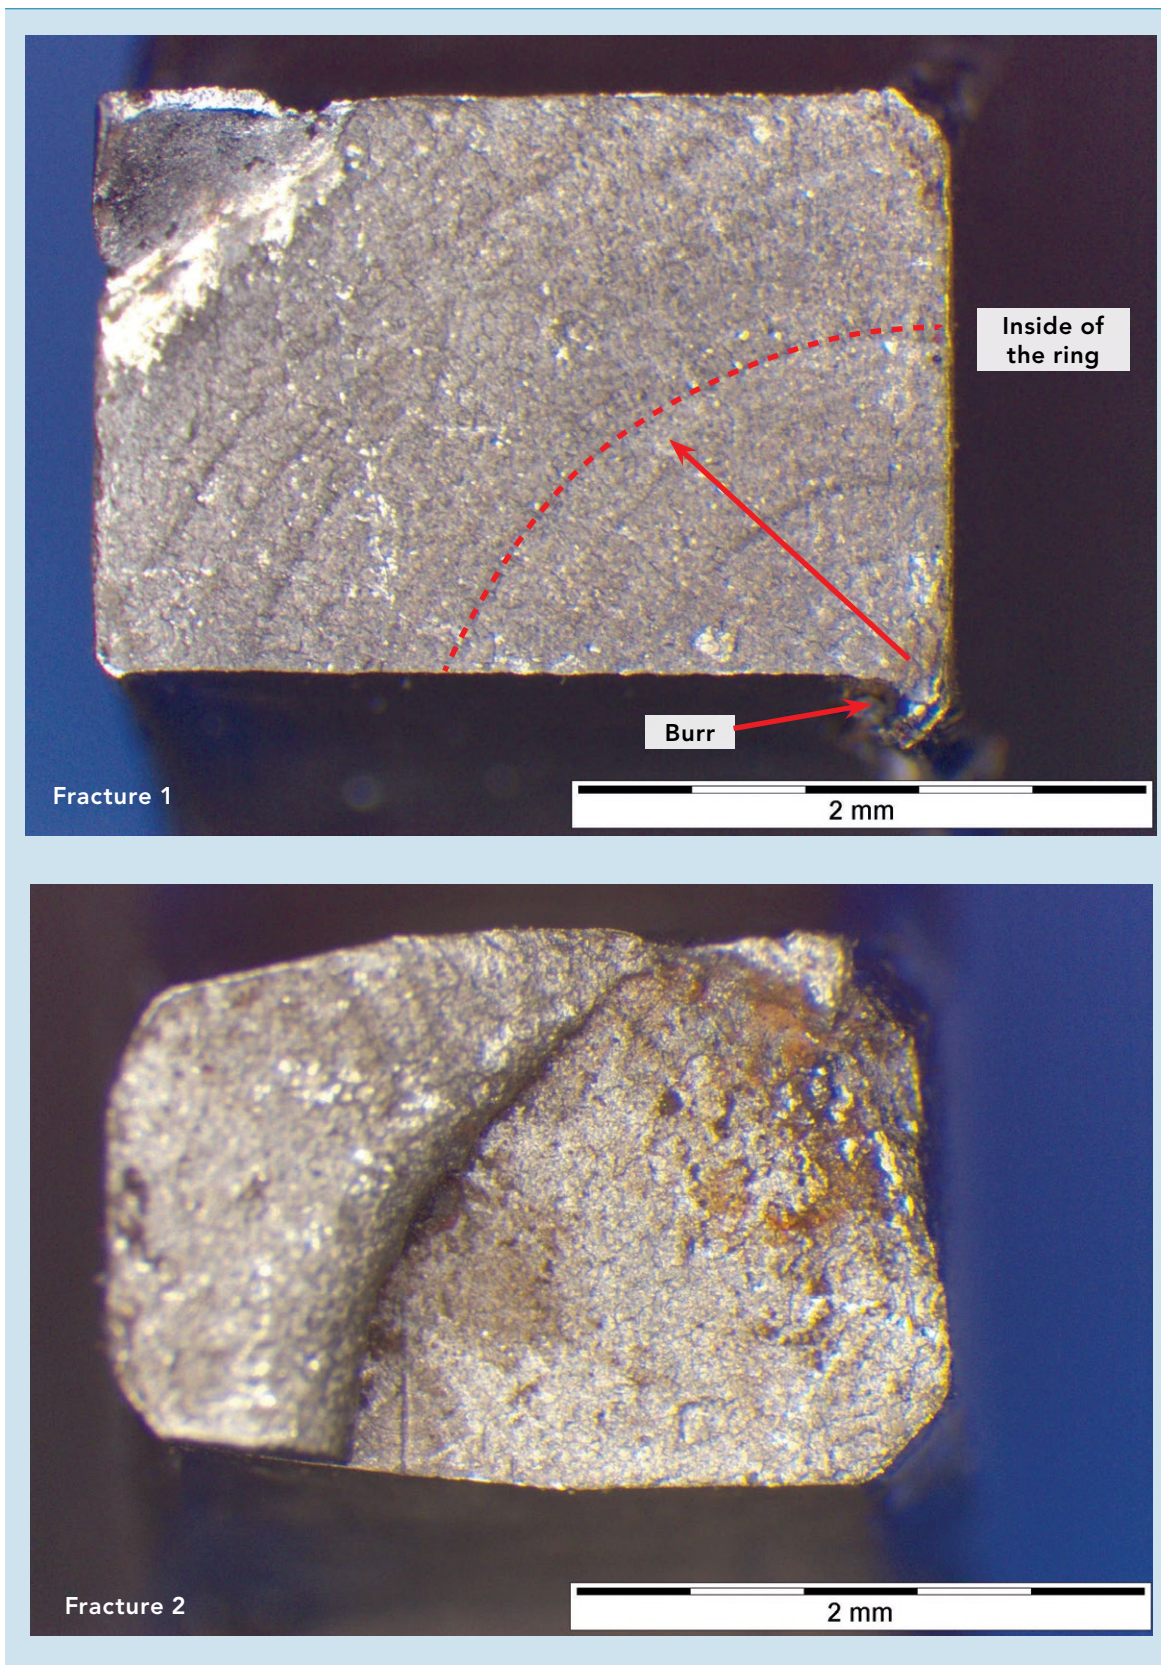
Figure 29: The photographs show the two fractures in the ring from switch 3B. The fracture surfaces demonstrate evidence of fatigue fractures. (Source: ProRail)

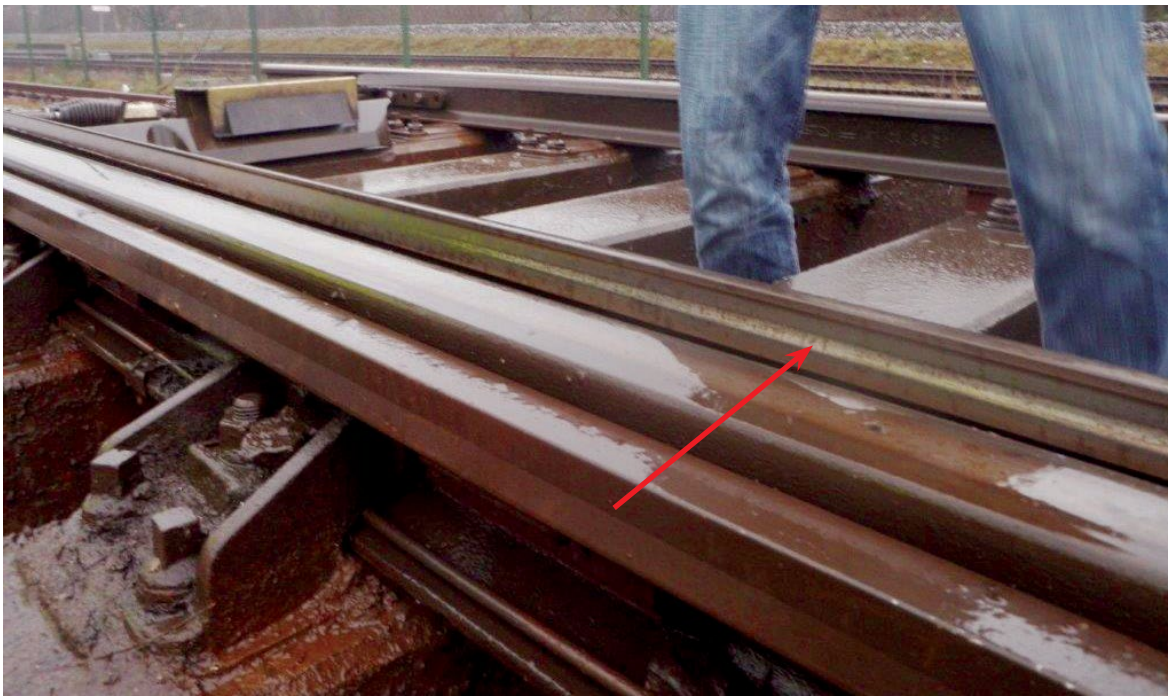
Figure 30: This photograph shows considerable flange-back contact marks on the right-hand switch blade of switch 3B. (Source: ProRail)

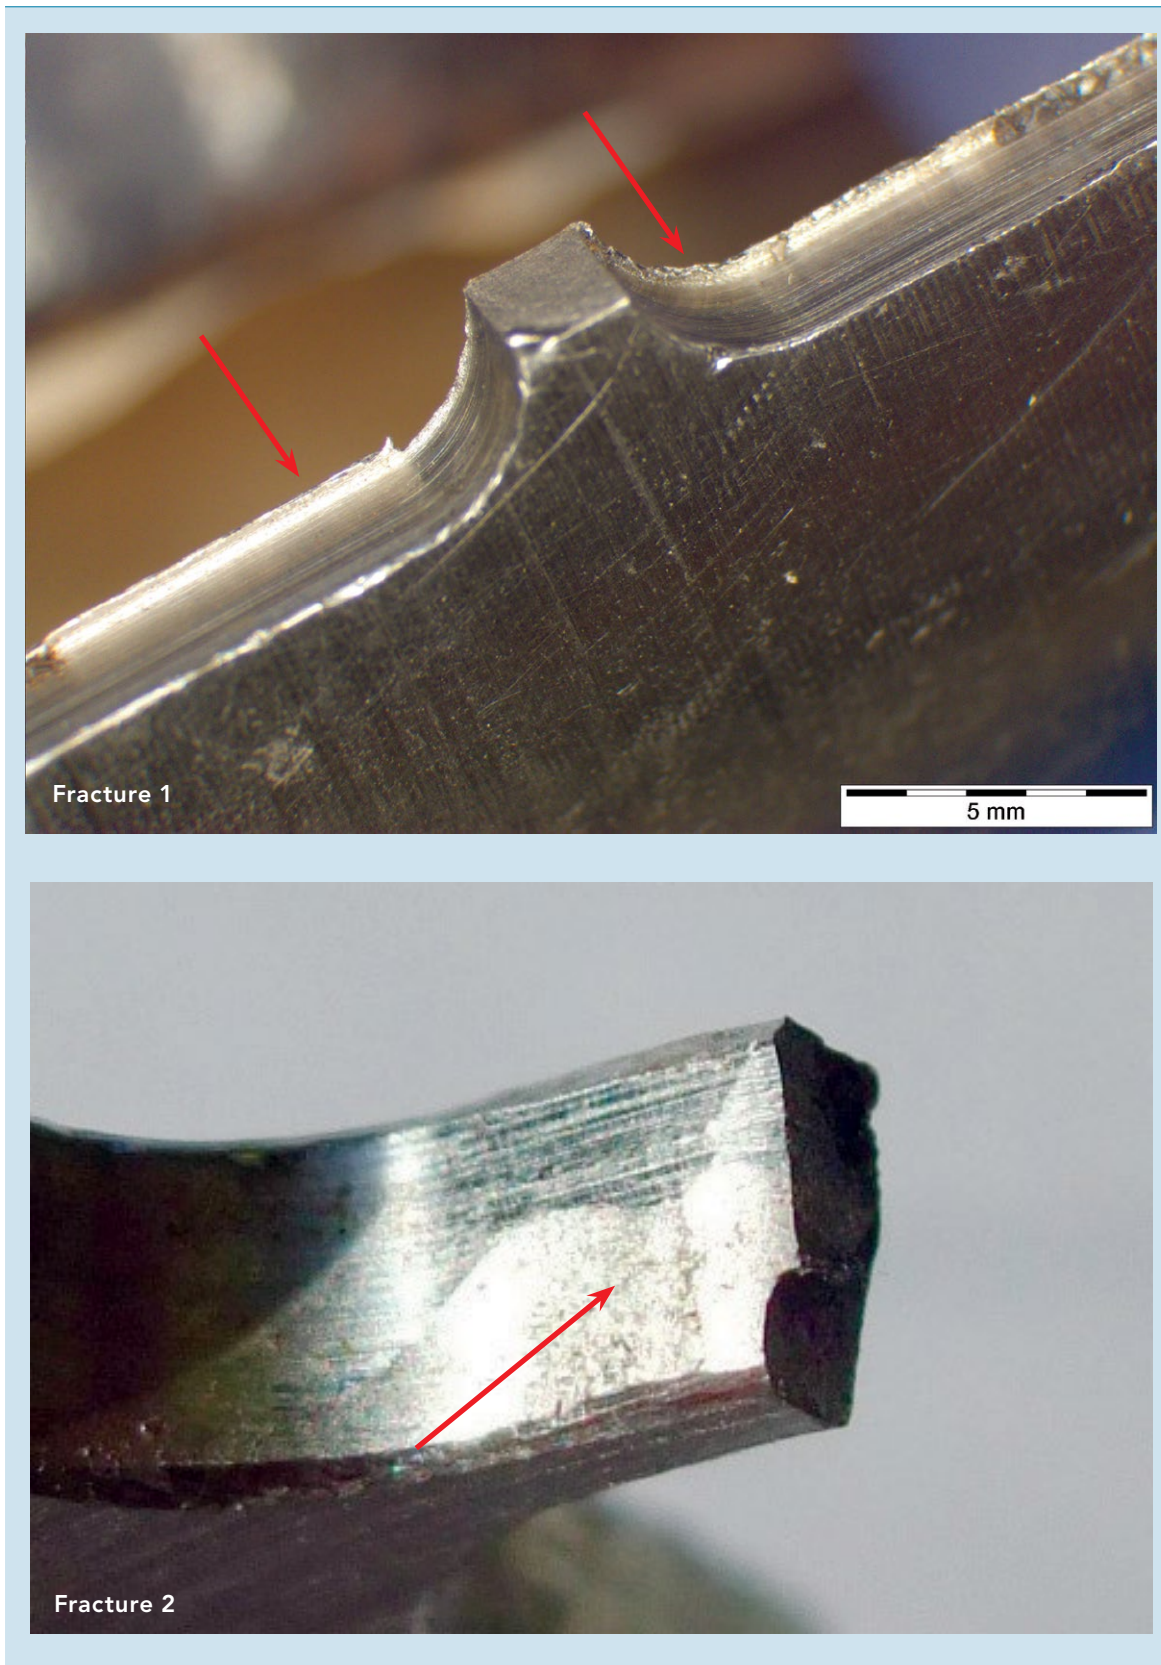
The ring found in the switch in Hilversum revealed a rough grinding spot near one break link and burrs near the other. These non-conformities influenced the fatigue strength of the ring. In addition to the dimensions and material characteristics, the fatigue strength is determined by the shape and condition (roughness) of the surface. In final finishing, machining burrs were not correctly removed from this ring: at one break link the burrs remained, while at the other link too much material had been ground away, leading to a

Figure 32: These photographs show the finishing defects demonstrated by the ring in switch 3B. Near break link 1, the defect concerns residual machining burrs, near break link 2 the defect concerns too much and too rough grinding. (Source: ProRail)

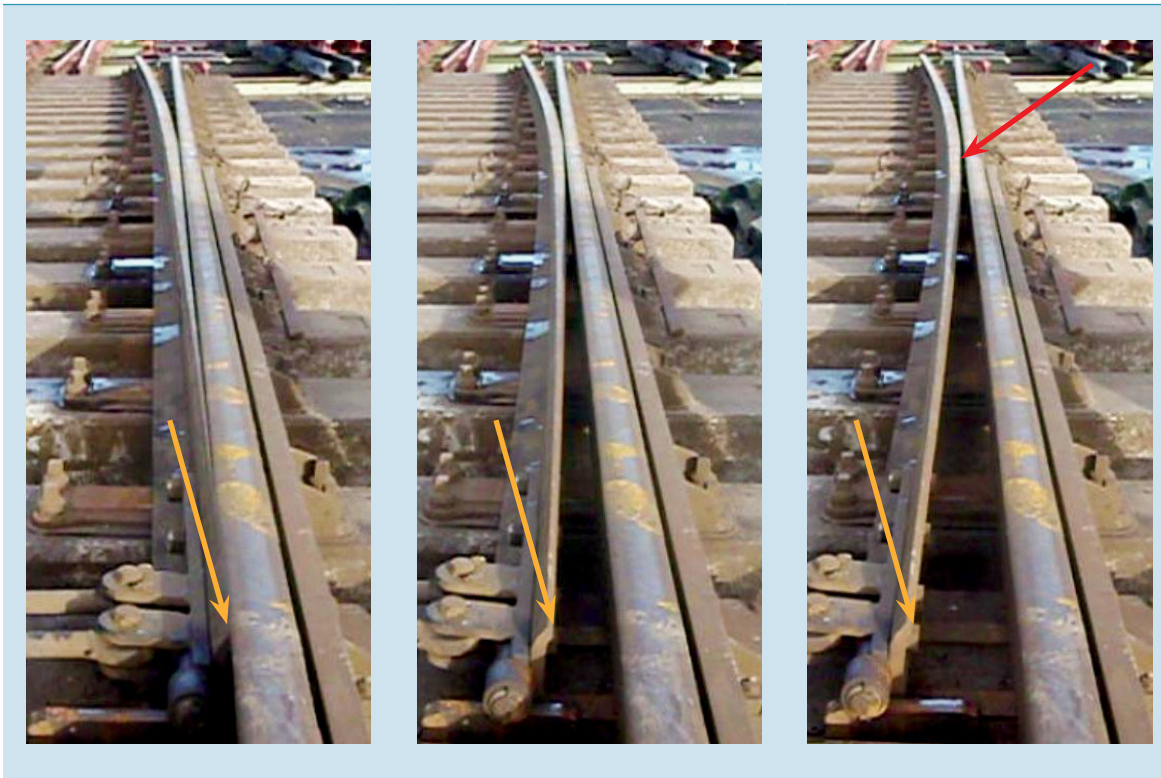
Figure 34: These photographs show the movement of the right-hand switch blade of switch 3B, from locked to open position (see the yellow arrow) whereby an oversized free wheel clearance arises (see red arrow) because the switch blade remains too close to the stock rail in the top of the photograph. (Source: ProRail)

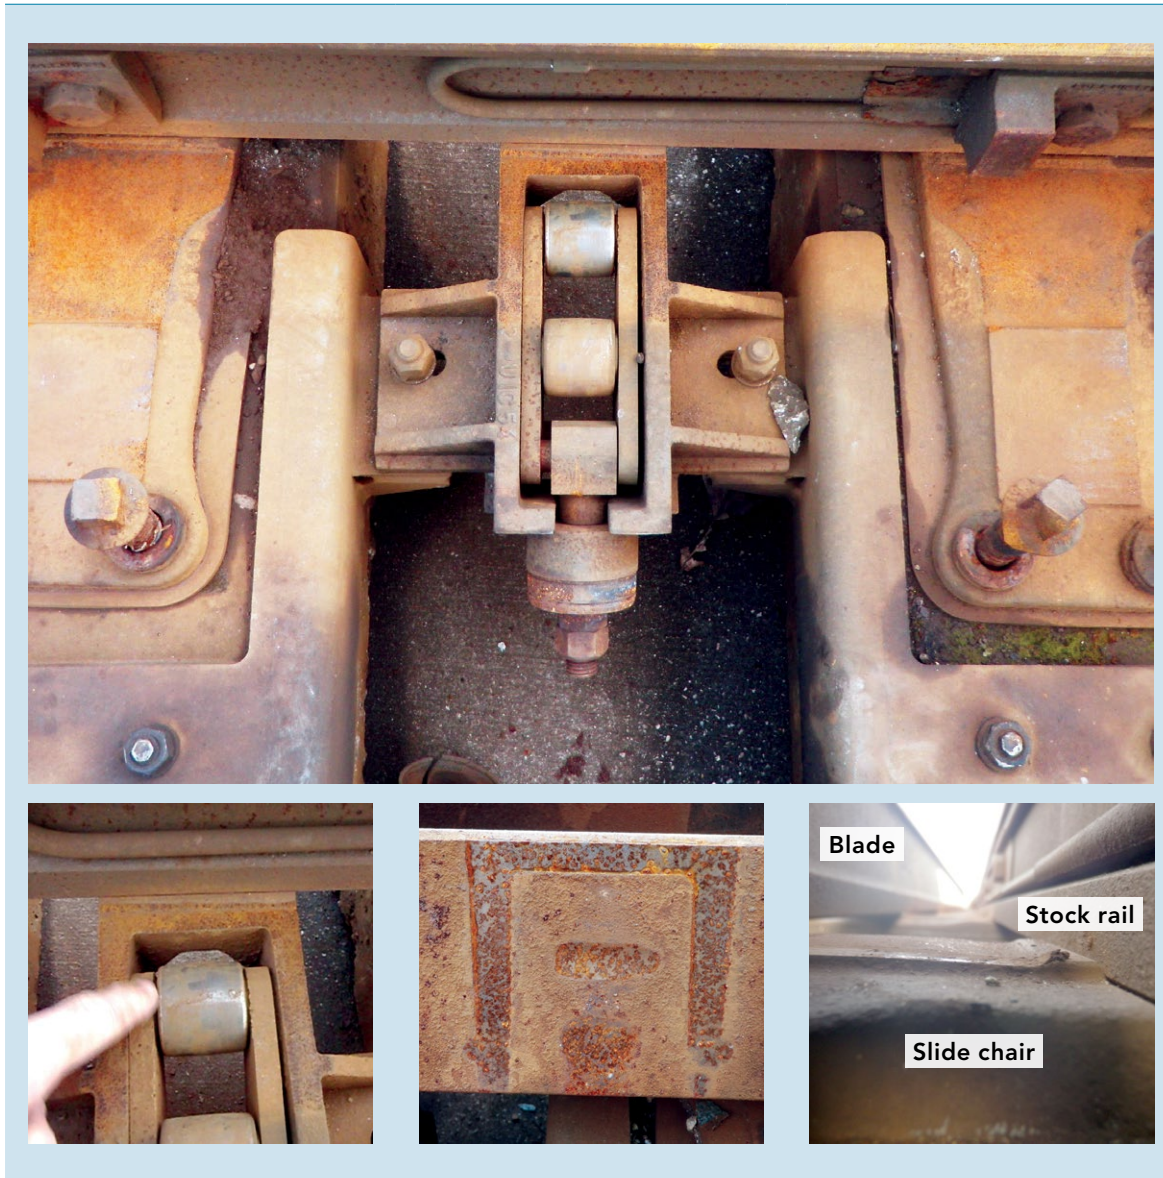
Figure 36: These photographs show the worn parts that support the right-hand switch blade of switch 3B. The upper photograph shows the top view of the Ekos-V system. The lower left-hand photograph shows the wear on the rollers. The lower middle photograph shows the stamp of the Ekos-V system on the underside of the blade. The lower right-hand photograph shows one of the worn slide chairs. (Source: ProRail)

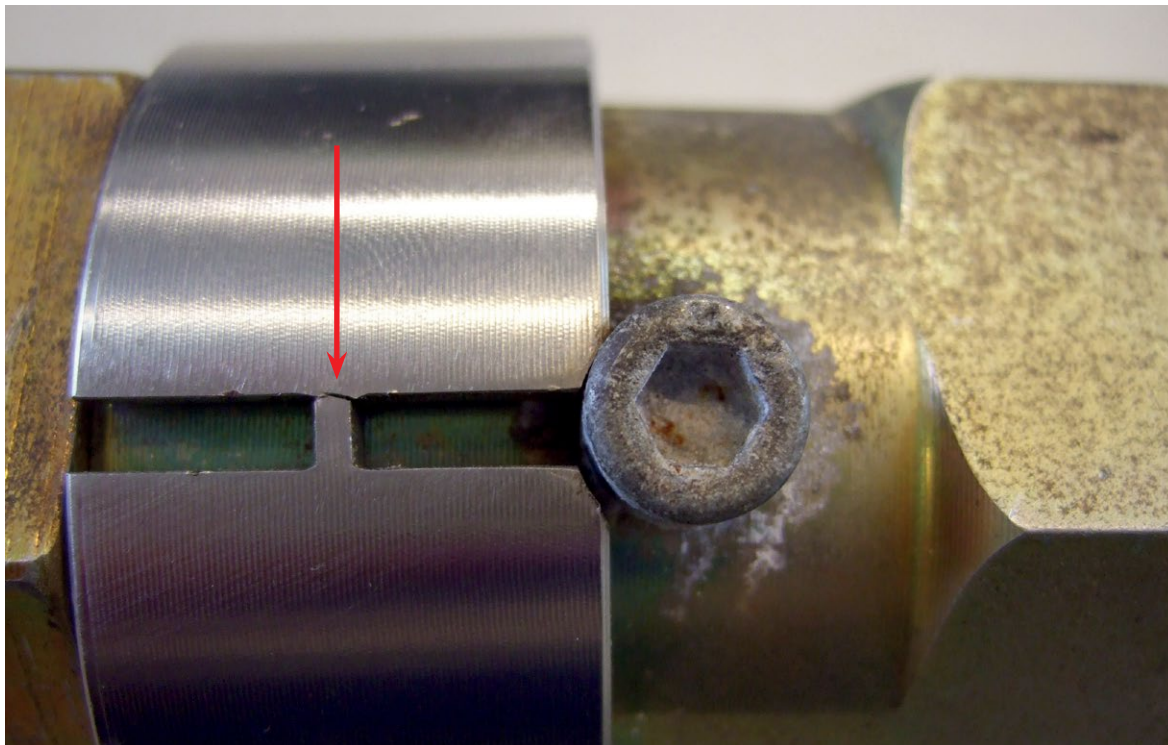
Figure 37: This photograph shows one of the damaged rings discovered in 2008. The arrow points to a fracture in the break link. (Source: ProRail)

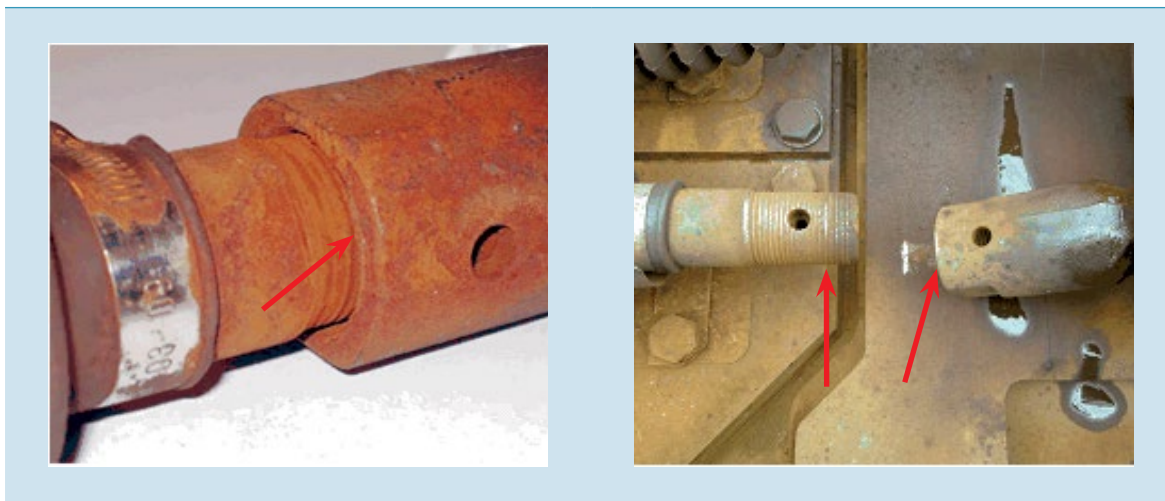
Figure 40: These photographs show the threaded connection of both damaged rod heads from 2008. (Source: Bombardier)
