Rail Accident Investigation Branch

Rail Accident Report

Wagon derailment at York station 18 January 2006

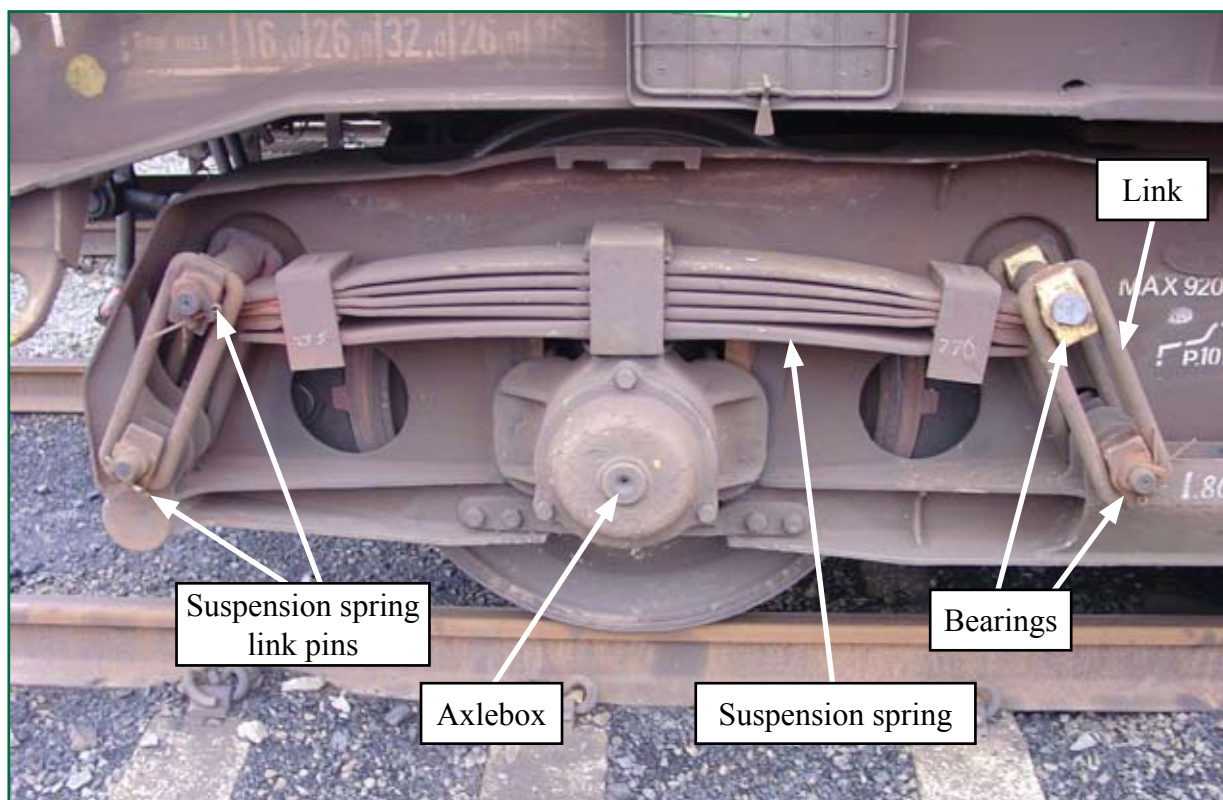
Figure 3: Bogie suspension

- 16 The wagon is fitted with bogies and has a maximum load per axle of 22.5 tonnes. The suspension is attached to the bogie frame via an assembly of links, link pins and bearings - see Figure 3. This type of bogie suspension is fitted to hundreds of wagons in the UK and is used extensively in other parts of Europe.

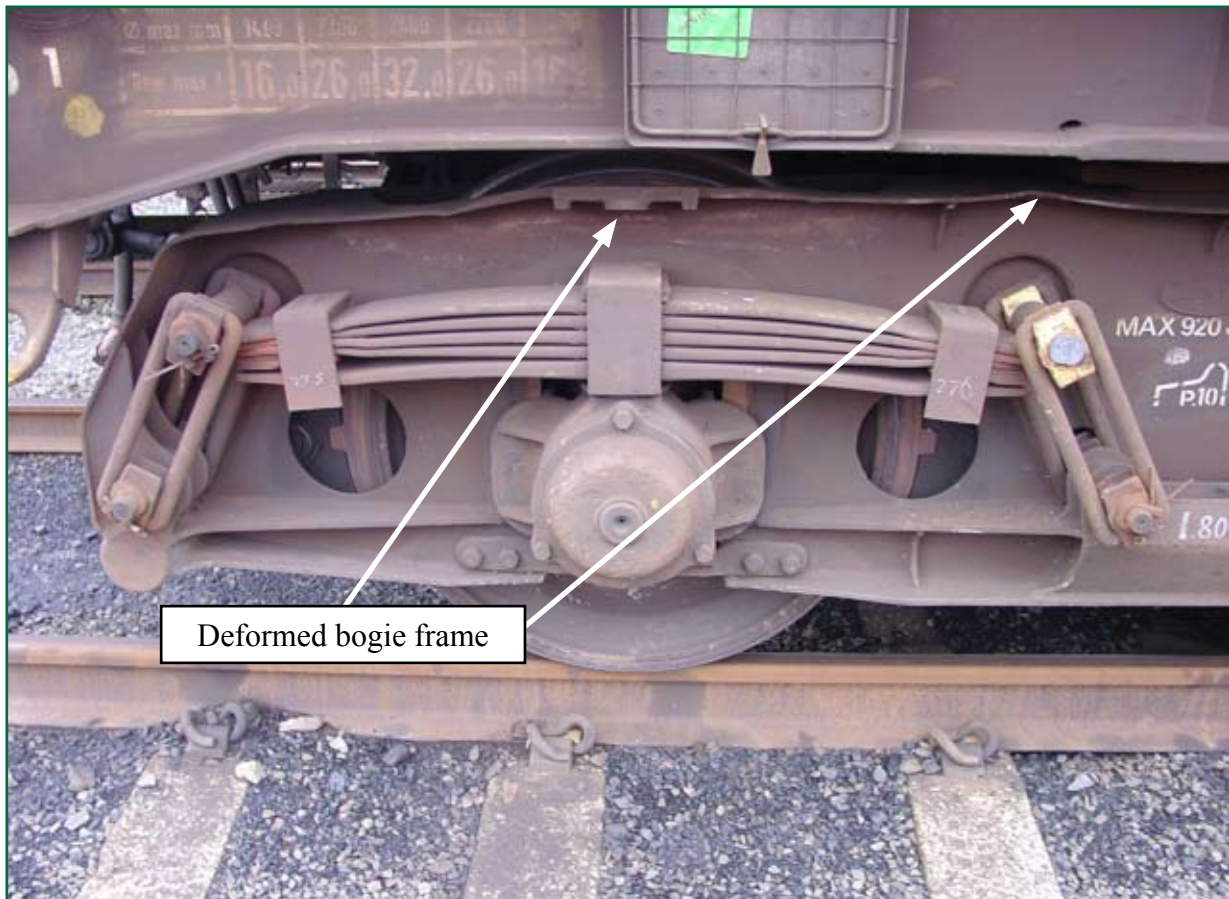
- 36 Damage to the wagon from the incident included: (i) deformation of the bogie frame due to impact by the suspension spring - see Figure 7; (ii) deformation of the bogie frame by the wagon structure due to excessive relative movement during derailed running - see Figure 8 and (iii) damage to wheel three from number 788 points check rail - see Figure 9.

Figure 7: Photograph of deformation of the bogie frame due to impact by suspension spring

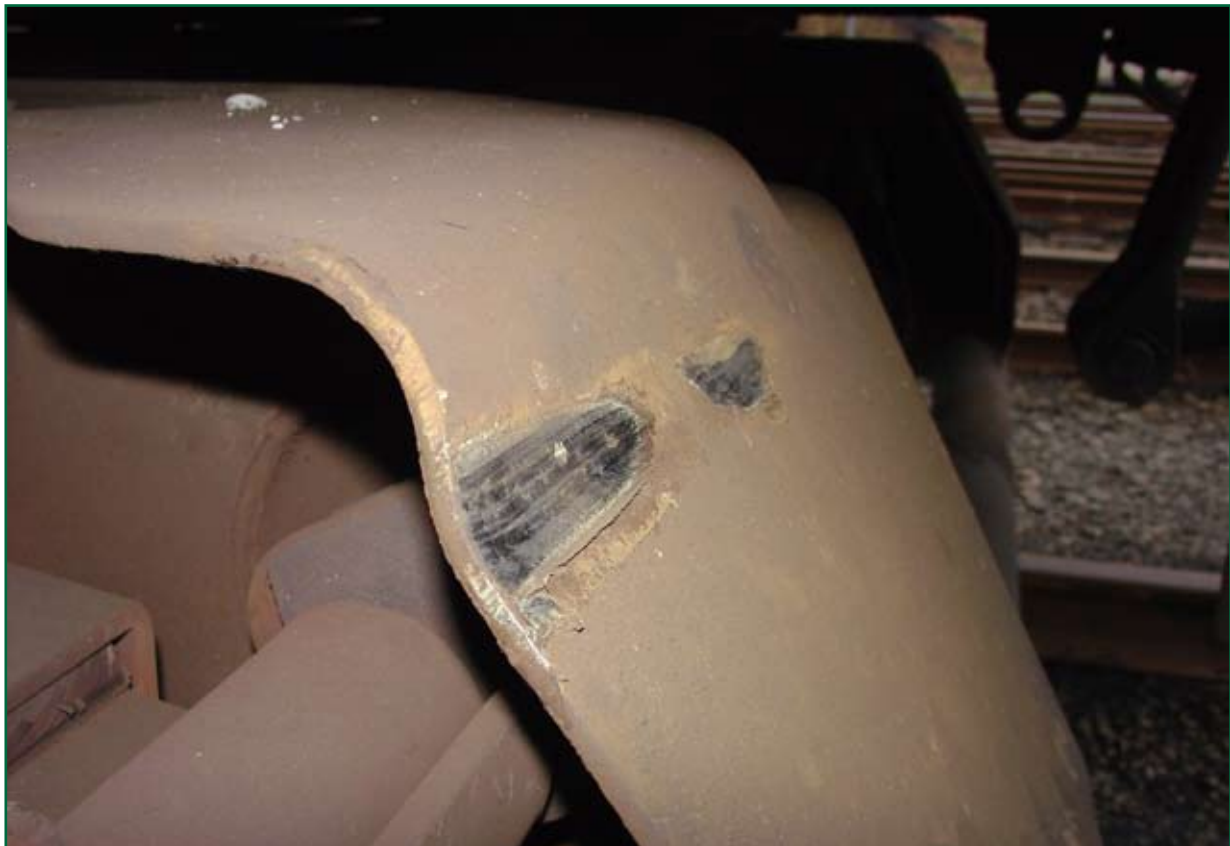
Figure 8: Photograph of deformation of the bogie frame by the wagon structure due to excessive relative movement during the incident

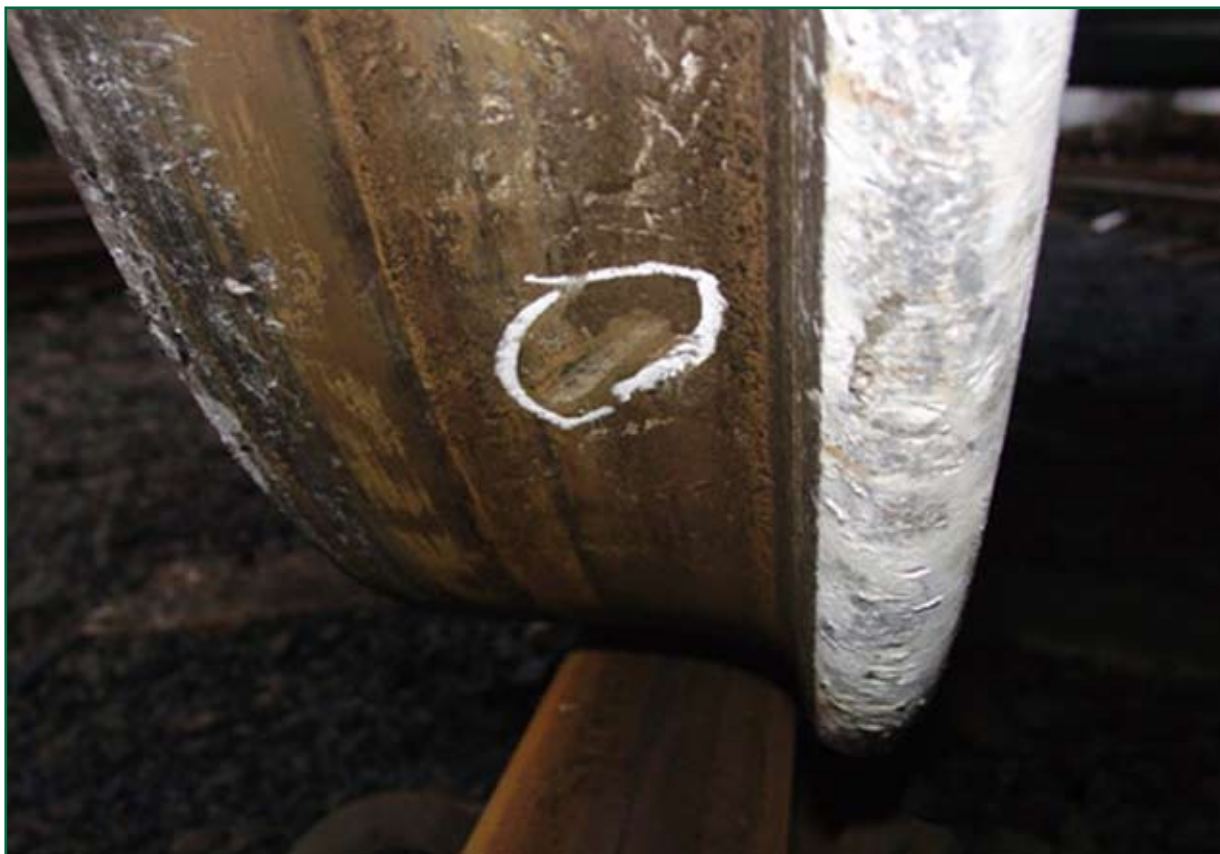
Figure 9: Damage to wheel three from number 788 points check rail

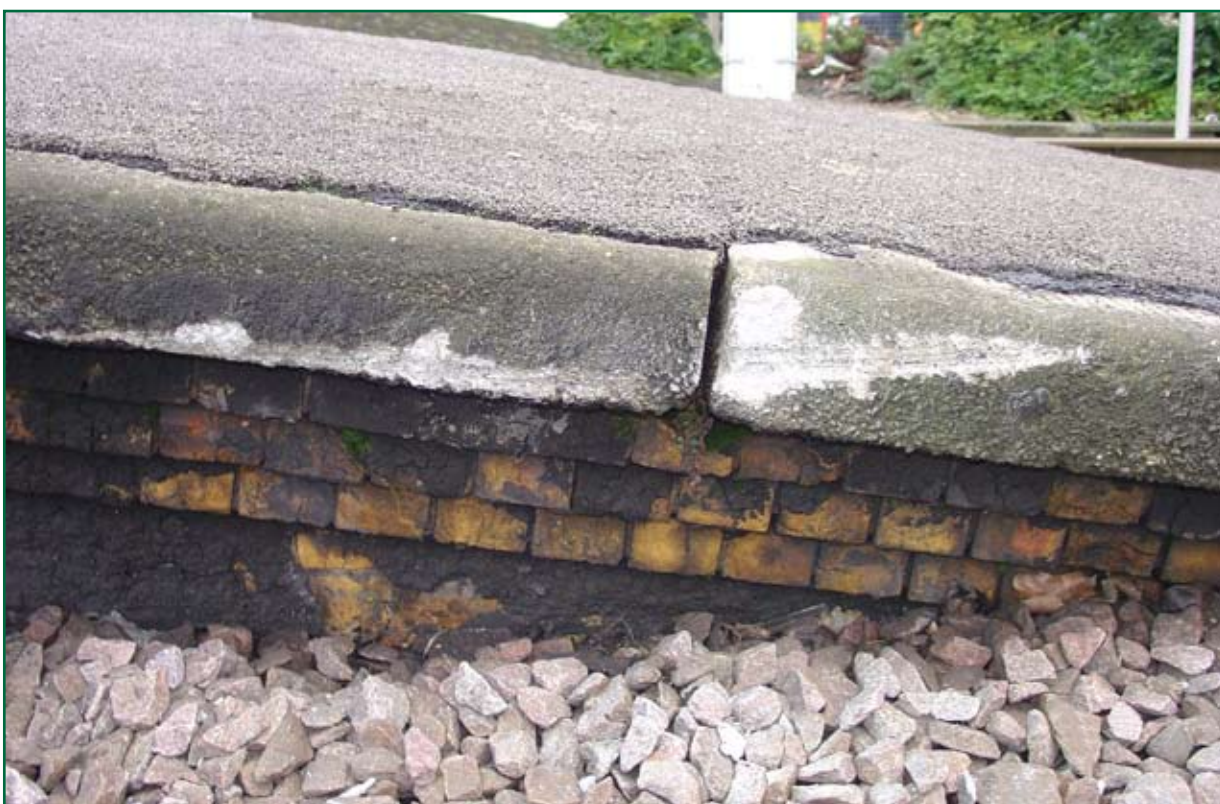
- 37 Infrastructure equipment damage extended over approximately 250 m and included: (i) approximately 400 *sleepers*; (ii) 20 *Pandrol* clips; (iii) 18 *bearers*; (iv) 8 track circuit cables; (v) *Train Protection and Warning System* (TPWS) equipment mounting bars and (vi) check rail and *fish plates* at number 788 points. The coping stone at platform three was misaligned and scored by impact with the bogie as shown in Figure 10.

Figure 10 Platform three coping stone misaligned by impact with bogie
