Rail Accident Investigation Branch

Rail Accident Report

Trackworker fatality at Trafford Park 26 October 2005

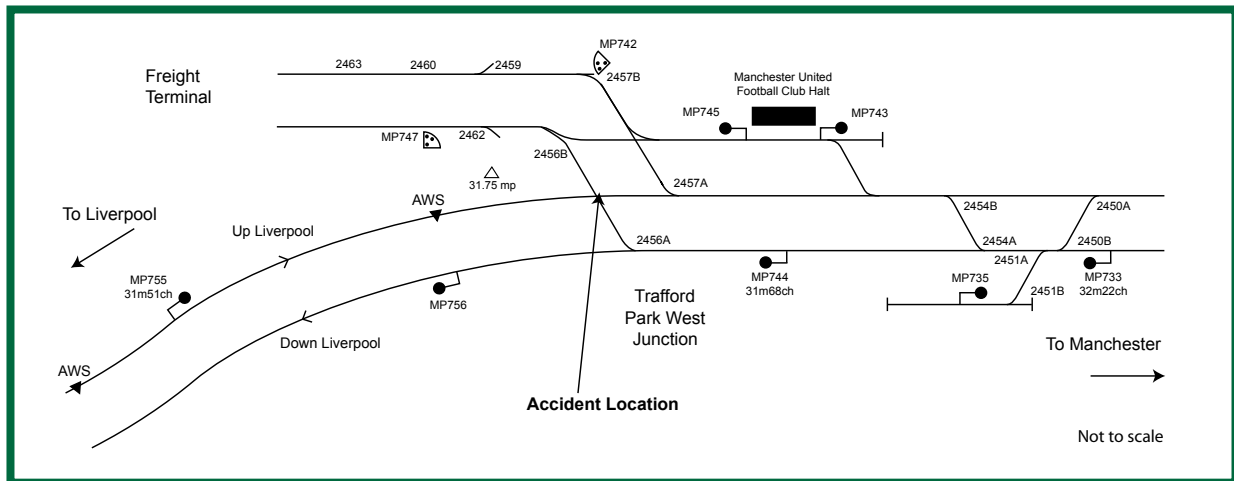
Figure 3: Track layout at the accident site

- 26 The track layout at the accident site is shown in Figure 3. There are two main running lines at Trafford Park West Junction – the Up Liverpool and the Down Liverpool. The Up direction is towards Manchester.
- 27 To the west and north of the main lines is the Trafford Park freight terminal complex. This is accessed via a double junction, which allows access to and from the Manchester direction.
- 28 To the east of the junction on the north side, is a single platform, the Manchester United Football Club Halt. This is accessed by a loop line from the Up Liverpool line which can also be used to provide an access to and from the freight complex.
- 29 The main lines from Manchester, as far as and into the freight terminal, including the loop line, are electrified on the 25 kV overhead line system.

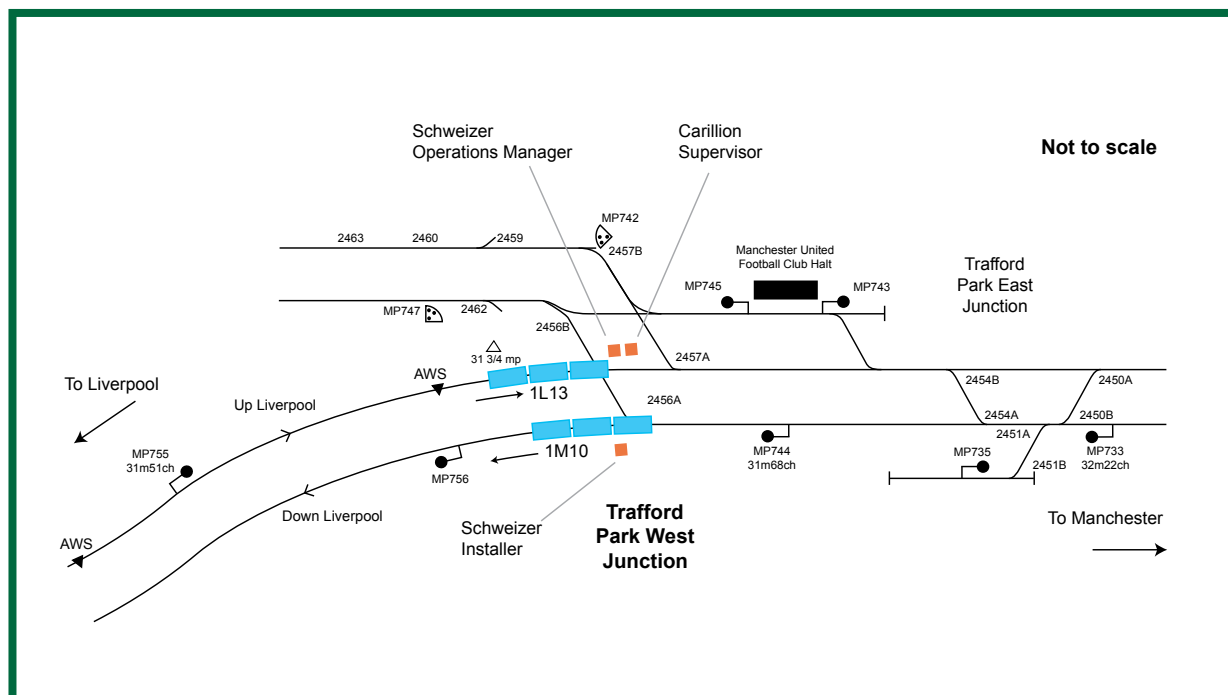
Figure 9: The location of people and trains during the incident

- 103 As train 1M10 travelled along the straight section of line towards Trafford Park East Junction, the Driver observed men in the four foot of his line ahead, in the vicinity of Trafford Park West Junction. One of the men moved into the Down cess. At a distance estimated by the Driver to be 300 metres to 400 metres from the group, the Driver sounded the warning horn. There was no acknowledgement from any of the three men. The two men standing in the *four-foot* moved from the Down line, across the Up line and stood in the space between the Up line and the platform loop, as shown in Figure 9. They were however still close to the cess rail of the Up line.

- 104 As train 1M10 reached Trafford Park West Junction it's speed was approximately 65 mph (104 km/h). The Driver noted that the two men on the up side were facing each other, in conversation, side-on to the line, and the larger man was holding a clipboard, drawing or similar item.

- 105 The Driver of train 1M10 noted that the third man remained in the Down cess.
- 106 As train 1M10 passed the two men on the track the Driver remarked, to his colleague in the cab, that the two men were standing close to the line in a potentially dangerous position.

- 107 At that point the Driver observed an oncoming Central Trains DMU; train 1L13. Having concern for the men's safety, the Driver of train 1M10 sounded the high tone of the warning horn with a long blast.

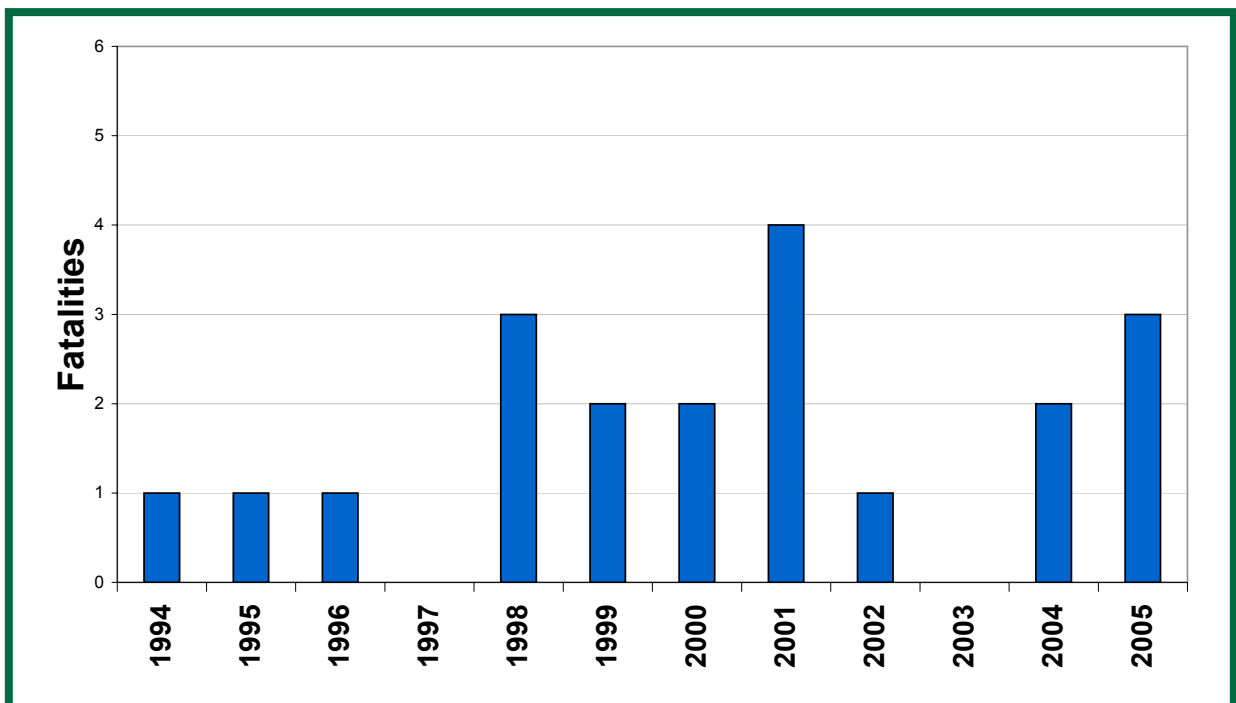
Figure 10: Trackworker fatalities (struck by trains)

- 136 Appendix D shows a table of all trackworker fatalities from 1994 to 2005. Figure 10 shows the numbers by year where these fatalities resulted from being struck by trains. In all of these instances, a major contributor to the cause of the accident was non-compliance with rules and instructions forming part of track safety certification by the individuals concerned.
