Rail Accident Report

Collision between train and buffer stops at Sudbury 27 January 2006

Collision between train and buffer stops at Sudbury, 27 January 2006

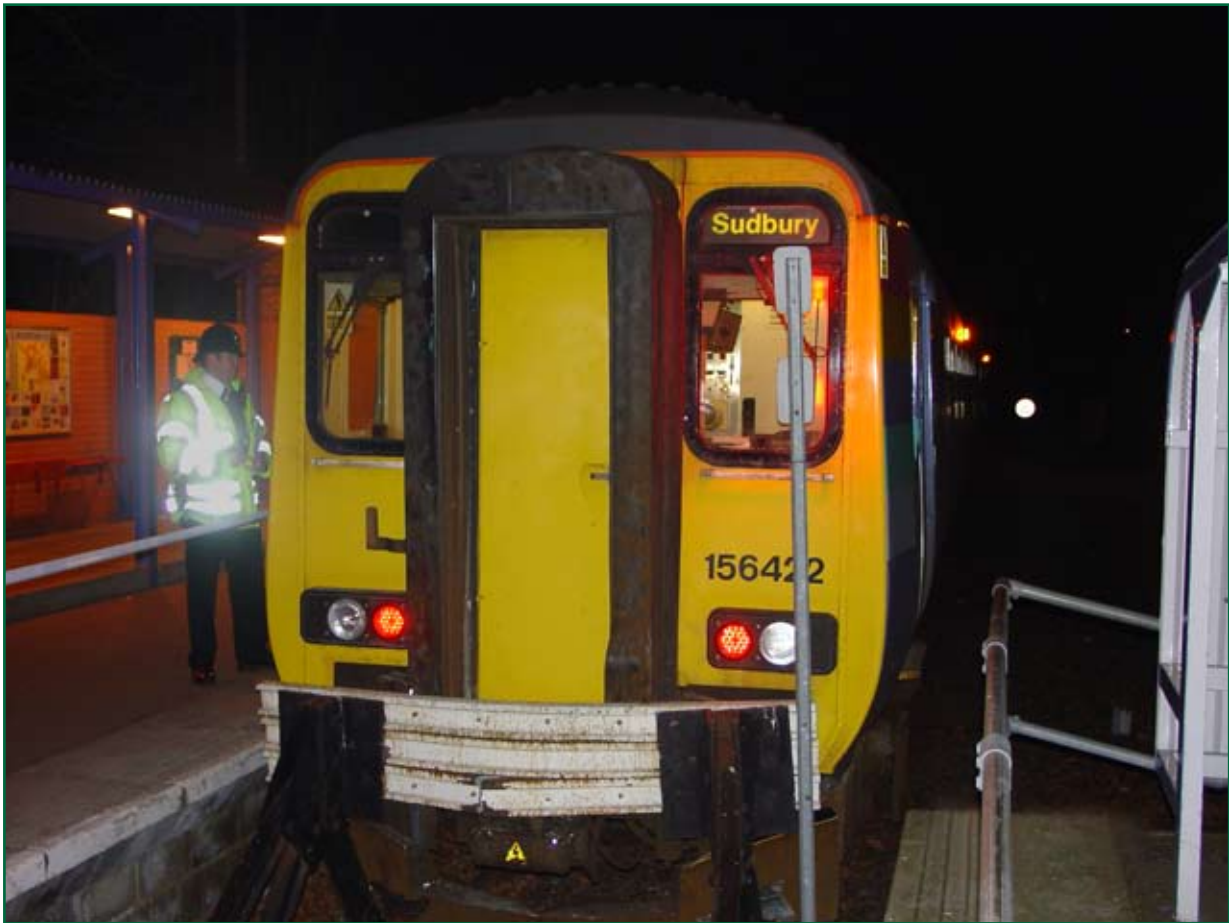
Figure 2: 156422 at the buffer stops at Sudbury immediately after the collision

- 11 On 27 January 2006 at 18:27 hrs a passenger diesel train, reporting number 2T28, ran into the buffer stops at Sudbury Station (Figure 2). It was formed of two coach unit 156422, comprising vehicles 57422 (leading) and 52422 (trailing). Both the train and the station were operated by 'one'. The collision occurred at about 6.4 mph (10.2 km/h) as the train was braking to a stand. Approximately 100 passengers were on board at the time; a number of them received minor injuries as a result of falls caused by the rapid deceleration of the collision. Minor first aid attention was given by other passengers and shortly afterwards by paramedics who were called to the scene. One passenger sustained suspected fractured ribs. No passengers were conveyed to hospital.

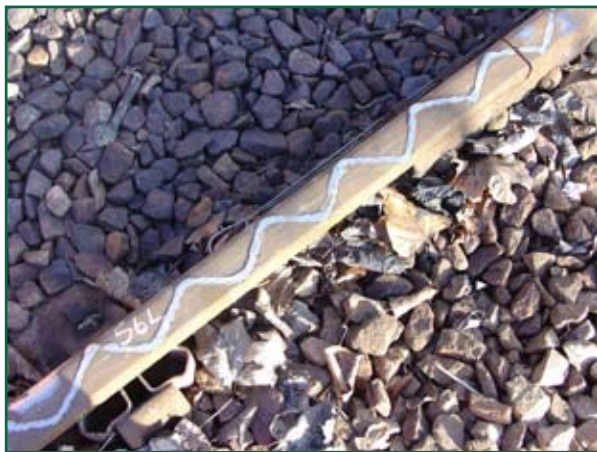
- 17 The track in the platform at Sudbury comprises of 95 lb Bullhead rail held in cast iron chairs with wooden keys on softwood sleepers. The rail heads have *rumble strip* welds added to them (Figure 5); these ensure a good electrical contact between the rail and wheel for *track circuit* purposes. Rumble strips are commonly used where the train service is insufficient to ensure that rust, detritus and contaminants do not build up on the surface of the rail and thus inhibit *train detection*. Although the branch is operated on the single train principle, confirmation has to be received by the signaller that the train has *berthed* at Sudbury before authority is issued for it to depart for Marks Tey. The track circuit at Sudbury, and hence the rumble strips, are provided for this purpose.

Figure 5: Track in Sudbury platform. Example of railhead with rumble strip

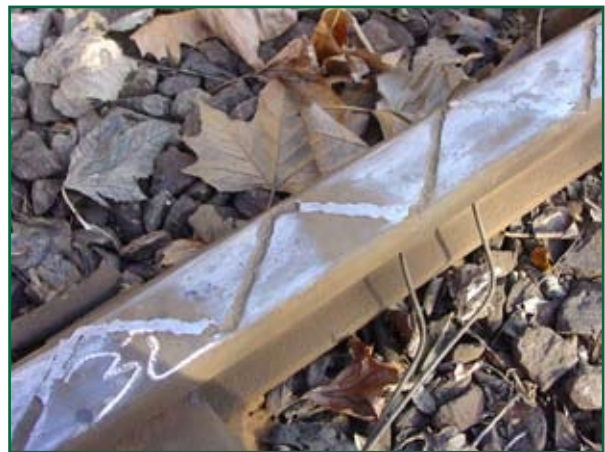
- 18 Certain parts of the rumble strips at Sudbury are nearing the end of their life. Along the length of platform track various examples of defect were found:

- flattened weld;
 - worn down weld with an unusual triangular wheel contact pattern with the normal head of the rail;
 - *spalling* of the weld from the head of the rail.

Figure 6: Track in Sudbury platform. Example of spalling of rumble strip

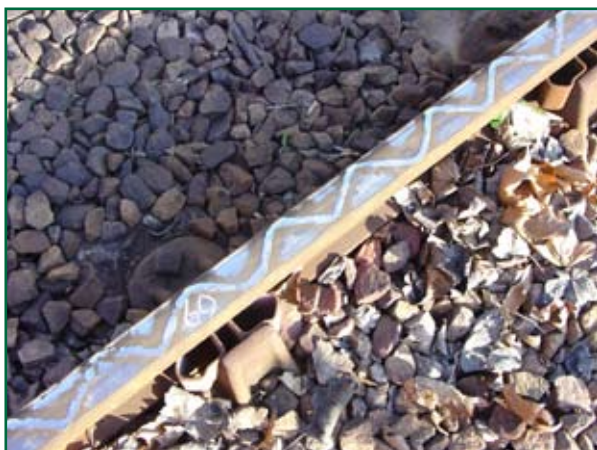
Figure 7: Track in Sudbury platform. Example of worn rumble strips and triangular rail head contact

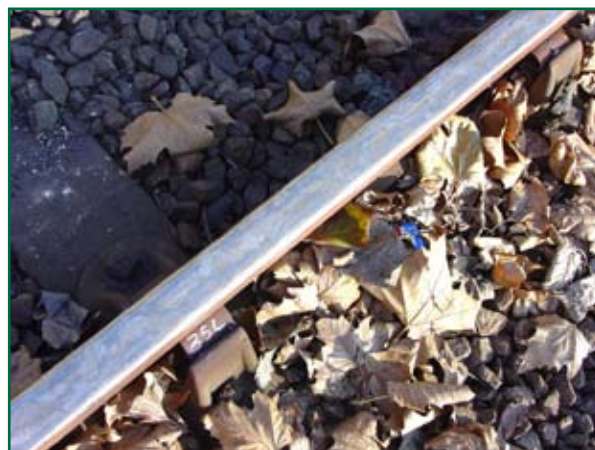
- 19 Some time prior to the incident, Network Rail had started work to replace the welds. This involved grinding the weld off the head of the rail, grinding out any corrosion from spalling, and re-profiling the head prior to laying down a new zigzag weld pattern. Some parts of the rail head were already awaiting the attention of specialist welders who would apply new weld strips. Figure 8 shows a section of ground rail head.

Figure 8: Track in Sudbury platform. Example of smooth rail head

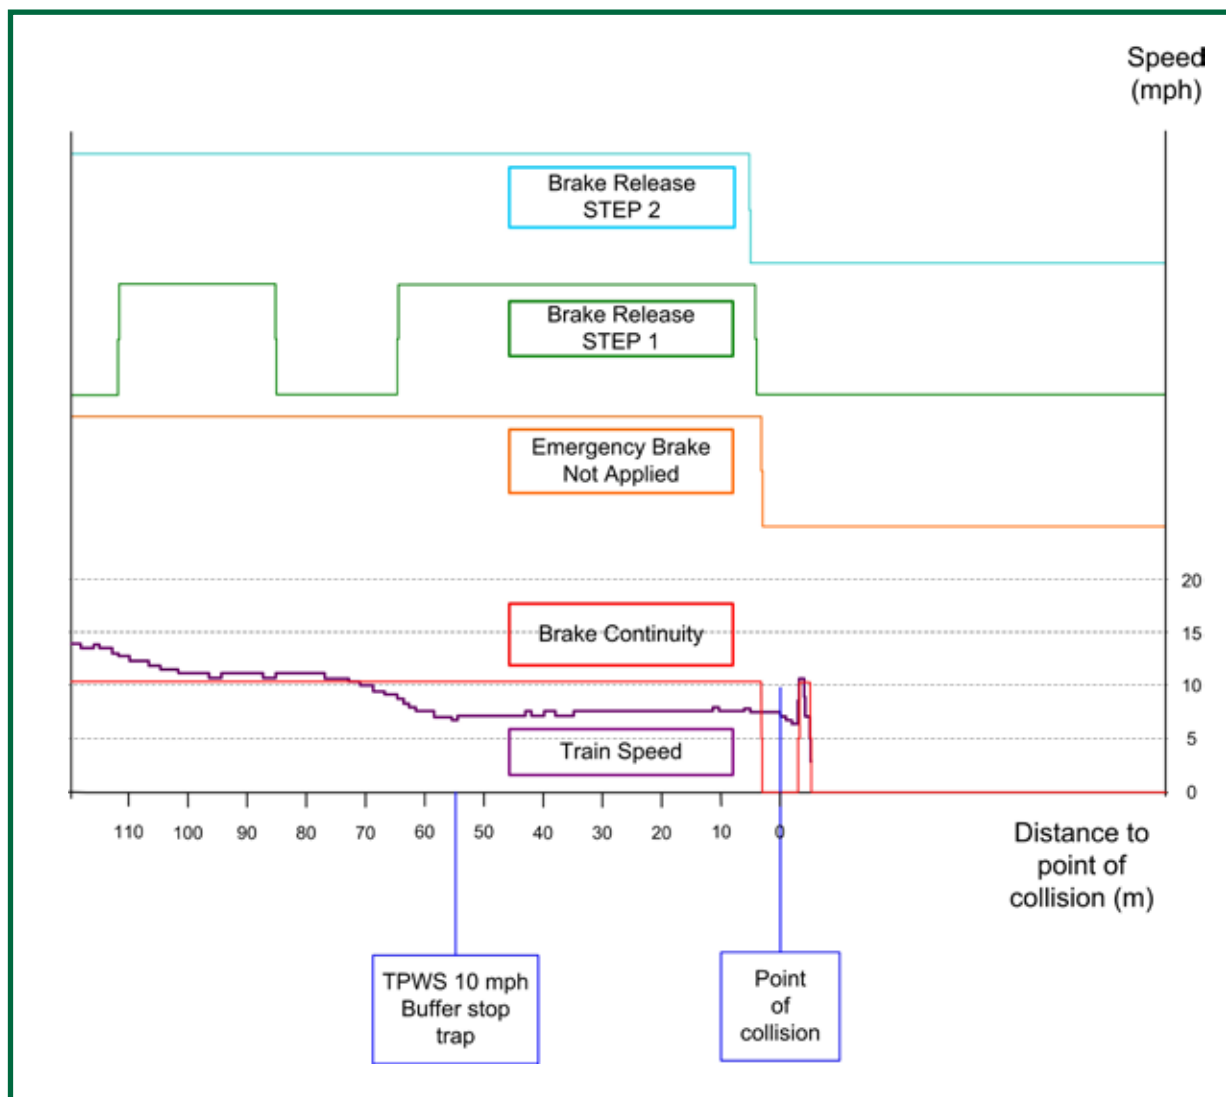
Figure 12: Extracted data from OTMR trace of 57422

- STEP 3 braking was selected when the train was very close to the buffer stops, followed almost immediately by EMERGENCY.
- 43 The OTMR records a different approach pattern from the driver's recollection: STEP 1 braking was selected only once when part way down the platform. EMERGENCY was selected, after momentarily passing through STEPS 2 and 3, almost immediately prior to the impact. This sequence of brake demands did not decelerate the train sufficiently to stop it from hitting the buffers at slow speed. The speed of the initial impact could not be exactly determined from the OTMR records, however the collision probably occurred at no more than 6.4 mph (10.2 km/h) (see paragraph 99).

98 Had a fault existed in the brake controller or on the train wires it is highly unlikely that the correct sequence of energisation changes on the train wires would be achieved. From inspection of the OTMR data, no evidence of such a fault existed before the accident, nor was one found during subsequent testing at Norwich. Thus it is probable that the origin of the braking sequence was from the RELEASE position and not from STEP 1.

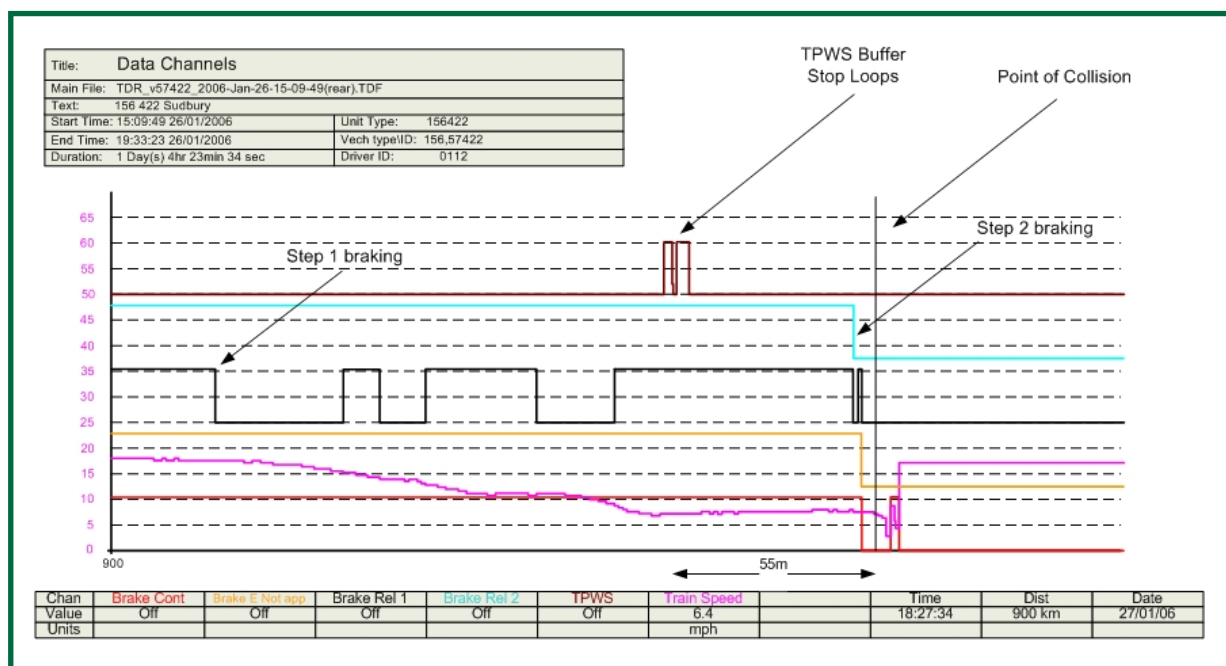
Figure 13: OTMR trace from 57422

101 The speed trace for both OTMRs shows an initial drop from 6.4 mph (10.2 km/h) to 2 mph (3.2 km/h), it then climbs rapidly to 10 mph (16 km/h) and is followed by an exponential decay curve to zero. This feature has not been investigated but its cause is believed to be due to the tripping of a number of circuit breakers caused by the rapid deceleration. Despite this feature, the integrity of the OTMR data has separately been proven by the analysis of records relating to runs before and after the collision.

- 104 The speed trace of the OTMRs shows that the driver correctly braked down to below 10 mph (15 km/h) prior to passing over the TPWS buffer stop loops on the approach to the platform. Whilst it has not been possible to determine what effect TPWS had on the severity of this accident, it is certain that the presence of TPWS caused the driver to suitably control the speed of the train on the approach to the platform, thus limiting the possible collision speed.

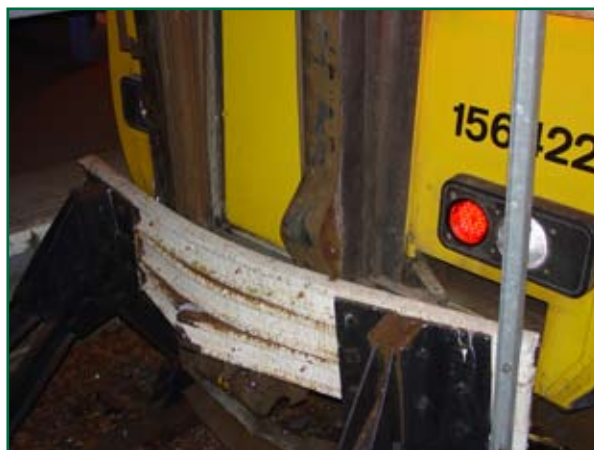
- 44 The collision significantly damaged the buffer stops which suffered severe bending and the fracture of one of the cross bars. The train suffered damage to the obstacle detector, coupler and gangway connection.

Figure 15: Damage to buffer stop with 57422 in its final position

- a) There is no buffing or seating block that mates with the centre coupler.
 - b) It does not offer any form of controlled retardation.
- 106 The absence of a centre buffing block resulted in the tongue of the coupler on the train taking the initial brunt of the impact as it hit and fractured one of the buffer stop cross rails.

- 107 The energy of the collision was dissipated by the bending and fracture of the buffer stop and by bending of various parts of the train. Even with the low speed and deceleration experienced it is possible that a different design of buffer stop may might have beneficially altered the jerk experienced by the passengers that caused them to be thrown forward. The provision of a more modern design of buffer stop would enable these forces to be focused into defined areas with more predictable results for the train deceleration.

- 108 Replacement of the buffer stop by a more modern design that includes a retardation mechanism would be an advantage; however these designs invariably require an additional length of track on which to fit them. At Sudbury fitment of such a design would almost certainly require the platform to be lengthened and for the TPWS loops and other electrical systems to be altered. The service pattern and likelihood of a repeat incident may make the expenditure difficult to justify. Nevertheless Network Rail should investigate the provision of an alternative design of buffer stop that should be fitted if it is practical to do so (Recommendation 2).

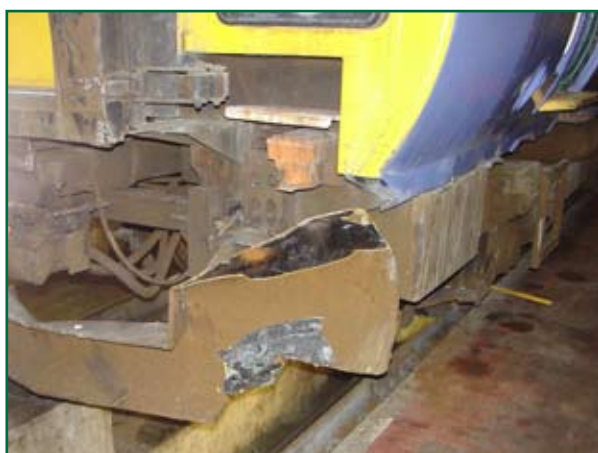
Figure 16: Damage to 57422 (left-hand side)

- 109 The damage to the train was relatively minor. The coupler, gangway connection and obstacle deflector all required remedial action prior to the train re-entering service. There was no evidence that caused concern regarding the train's crashworthiness.

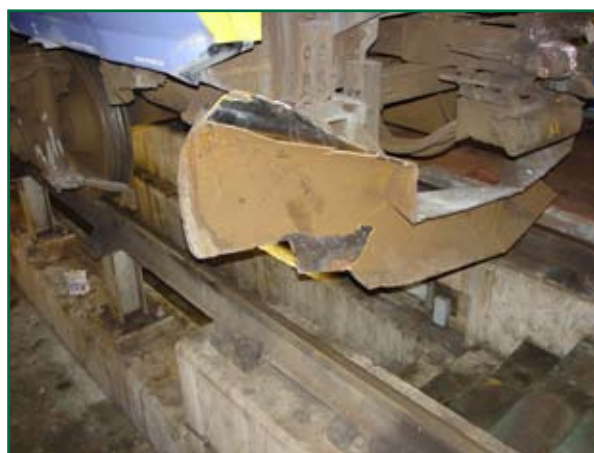
Figure 17: Damage to 57422 (right-hand side)

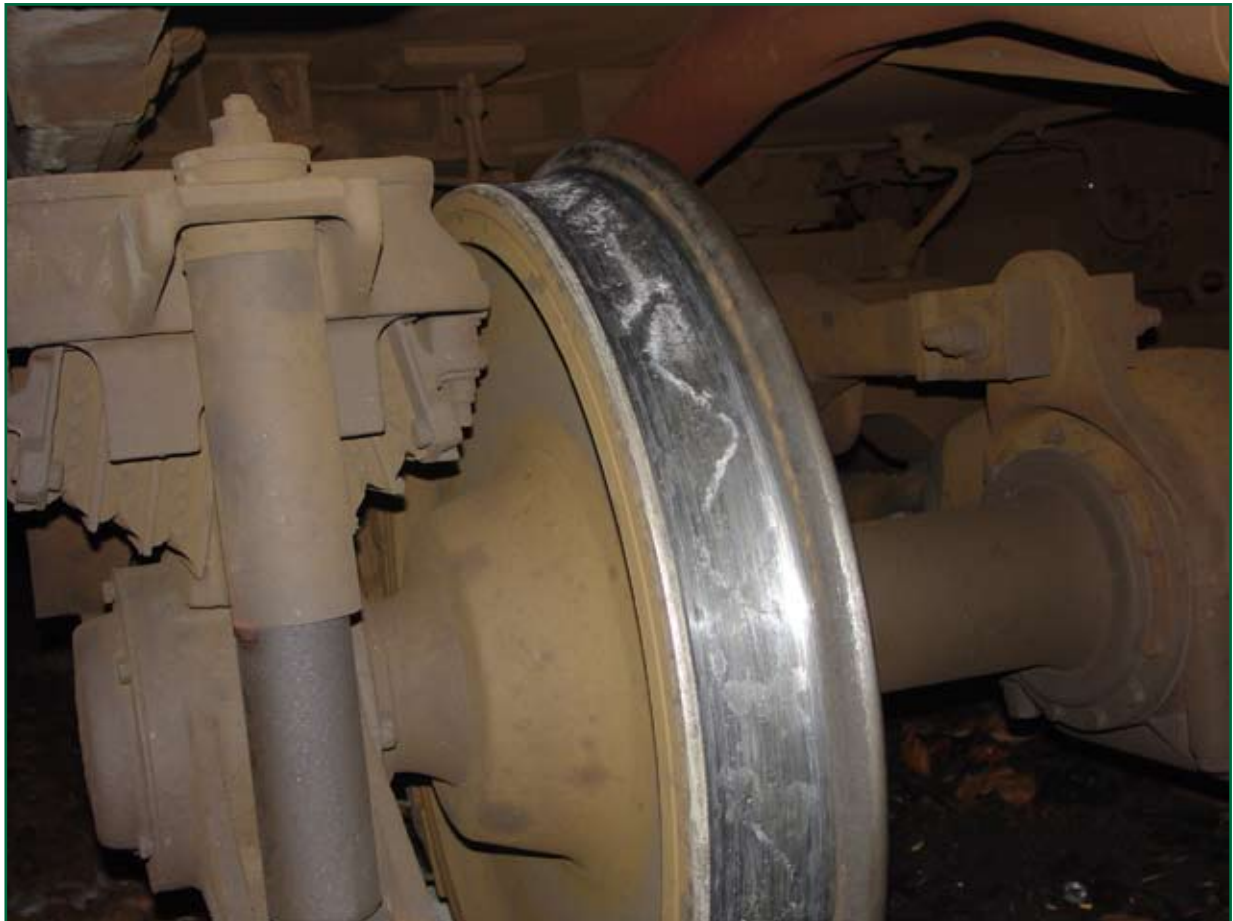
- 74 Inspection of the track did not reveal any indication of *wheel slow up* or slide except for a short length, approximately 100 mm long, immediately before the point of collision. The wheel treads showed a clear imprint of the zigzag rail head rumble strips; no signs of pattern distortion were present that would indicate a wheel not rolling correctly along the rail head. The imprints on the treads were made by crushed sand that was deposited on to the rail head by the automatically activated sanding gear during emergency braking. With evidence of the wheels rolling during emergency brake the likelihood of wheel slide during lower brake rates is very unlikely and has thus been discounted.

Figure 18: Sand pattern on wheel
