Rail Accident Investigation Branch

Rail Accident Report

Collision at Badminton 31 October 2006

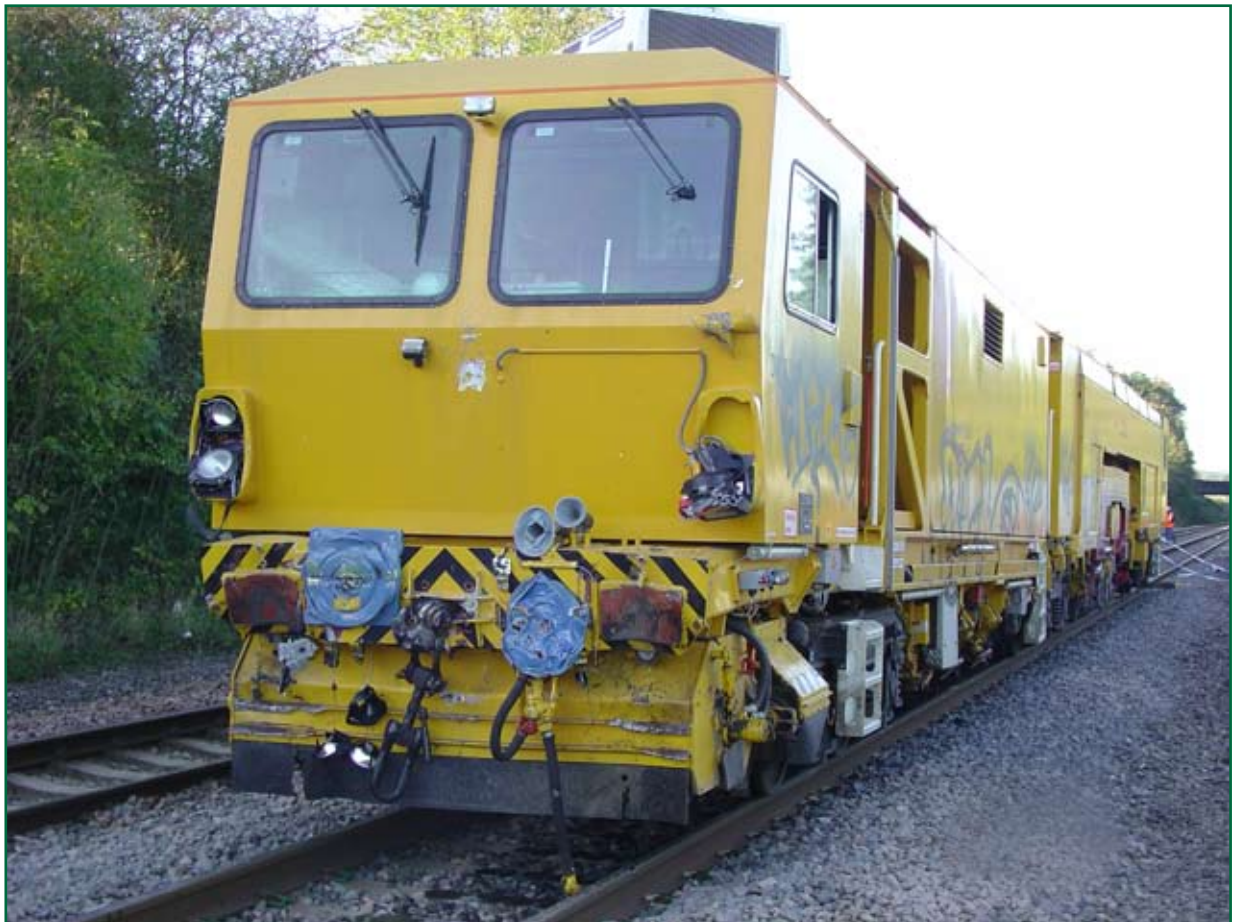
Figure 2: The tamper after the collision, showing damage to the front end

- 40 The tamper driver was seriously injured. The tamper was extensively damaged: the underframe was distorted and the articulation drawbar (which connects the two sections of the machine) was buckled. Both front buffers were knocked off, the bufferbeam was bent and the drawgear was distorted (Figure 2). Debris from the collision was spread along the line for about 28 m beyond the point of impact. One buffer was found near the yard access gate, about 13 m away from the line.
