REPORT

Accident Investigation Board Norway
P.O. Box 213
2001 Lillestrøm
Norway
Phone: +47 63 89 63 00
Fax: +47 63 89 63 01
<http://www.aibn.no>
E-mail: post@aibn.no

Date issued: 04.10.2007
JB Report: 2007/10

Date and time:	Wednesday 26 July 2006 at time 1640
Accident site:	Eidsvoll-Dombås line, km 339.700 between Dovre and Dombås
Form of operation:	Remotely controlled
Safety system:	Automatic line block
Type of incident:	Derailment
Train type and number:	Freight train no. 5718
Operator:	CargoNet AS
Transportation type:	Freight transport
Gross train weight:	571 tonns
Train length:	422 m
Brake group and percentage:	P 80%
Weather conditions:	Air temperature approx 30 °C and bright sunshine
Light conditions:	Good
Track operating conditions:	Dry
People onboard:	1 locomotive driver
Injuries to persons:	None
Material damage:	Damage to 7 wagons. Several overhead conductor masts and approx 500 concrete sleepers were destroyed.
Other damage:	
Locomotive driver:

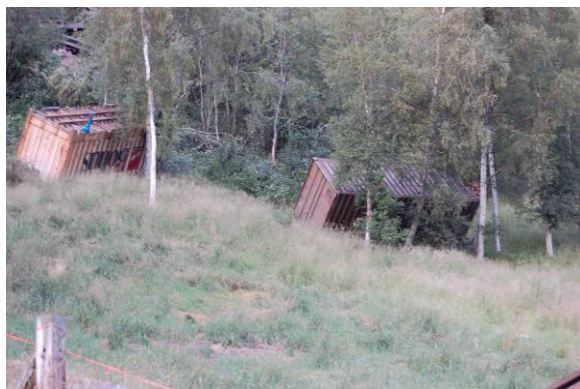
Figure 1:

It was established that there had been serious material damage to the wagons; two containers had fallen off and were lying approximately 100 m from the track in a steep slope, while a third container was standing on its end. Several overhead conductor masts, rails and approx 500 concrete sleepers were destroyed.
