## REPORT

Date issued: 04.10.07  
JB Report: 2007/11

Date and time:	Thursday 06 July 2006 at time 1505
Accident site:	Østfold line, km 77.5 at Råde station
Form of operation:	Remotely controlled
Safety system:	Automatic line block
Type of incident:	Derailment
Train type and number:	Freight train no. 45955
Operator:	Green Cargo AB
Transportation type:	Freight transport
Gross train weight:	432 tons + locomotive
Train length:	372 m
Brake group and percentage:	P, 432 ton braked weight
Weather conditions:	Air temperature approx 30 °C and intense sunshine
Light conditions:	Good
Track operating conditions:	Dry
People onboard:	1 locomotive driver
Injuries to persons:	None
Material damage:	Minor damage to wagons, extensive damage to approx 500 sleepers and two overhead conductor masts
Other damage:	
Locomotive driver:

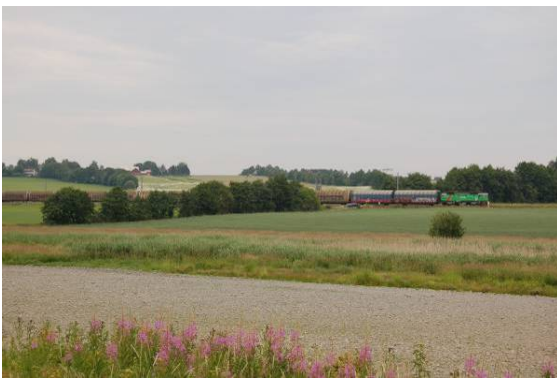
Figure 1:

In the derailment area, the track curves gently to the right in the train's direction of travel. The trackway is virtually horizontal and the line passes through a flat agricultural area (see figure 1). It is a single-track line, powered by electricity and remotely controlled from the train control centre in Oslo. The maximum permitted speed at the derailment site is 95 km/h. There are no buildings in the immediate vicinity of the derailment area.

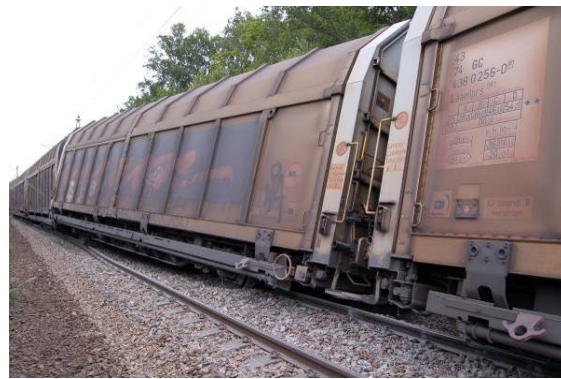
Figure 2:

Relatively minor damage to the wagons was registered. Two overhead conductor masts had been hit by the wagons and bent, but the overhead conductor remained suspended. Approximately 500 concrete sleepers were either crushed or damaged, and had to be replaced.

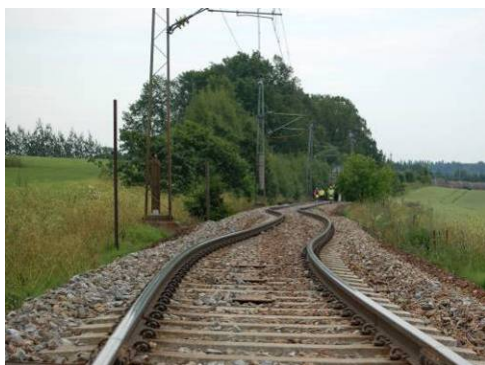
Figure 3:

The track's status after the derailment (see figure 3 and 4) showed that there must have been very high compressive forces in the rails at the time of the derailment.

- Probably an incorrect neutral temperature as a result of changed horizontal geometry for the track after neutralisation.
- Weakened resistance to lateral displacement as a result of general status and tamping of a double sleeper.
- Rail temperatures up to (and possibly above) the assumptions for the regulations.

*The investigation has uncovered discrepancies between set regulations and actual performance both in the prevention and repair of buckling. It is recommended that Norway's National Railway Inspectorate should order the National Rail Administration to investigate whether there are any conditions in the regulations, methods, training, organisation or supply of resources that ought to be amended.*
