Rail Accident Report

**Dispatch of a train with an unsecured load,
Basford Hall Yard, Crewe
21 February 2006**

This report is published by the Rail Accident Investigation Branch, Department for Transport.

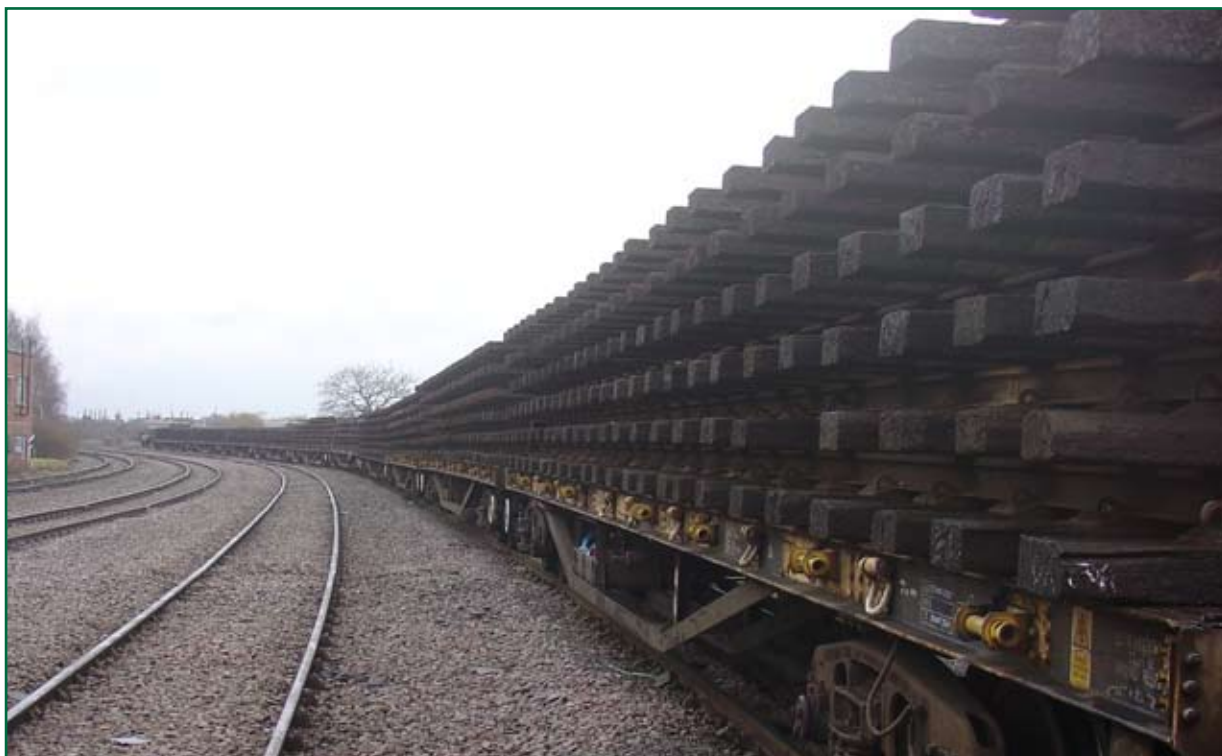
- 87 Train 6D51 was viewed and photographed at Toton on 22 February 2006 in the condition it arrived from Basford Hall. Only one strap was in place over the track panels on one of the wagons. A number of other straps were found loose on the load. It was not possible to determine how many straps had been removed by TMA at Basford Hall, and how many fell from the wagons during the journey.

Figure 10: Part of the train after arrival at Toton

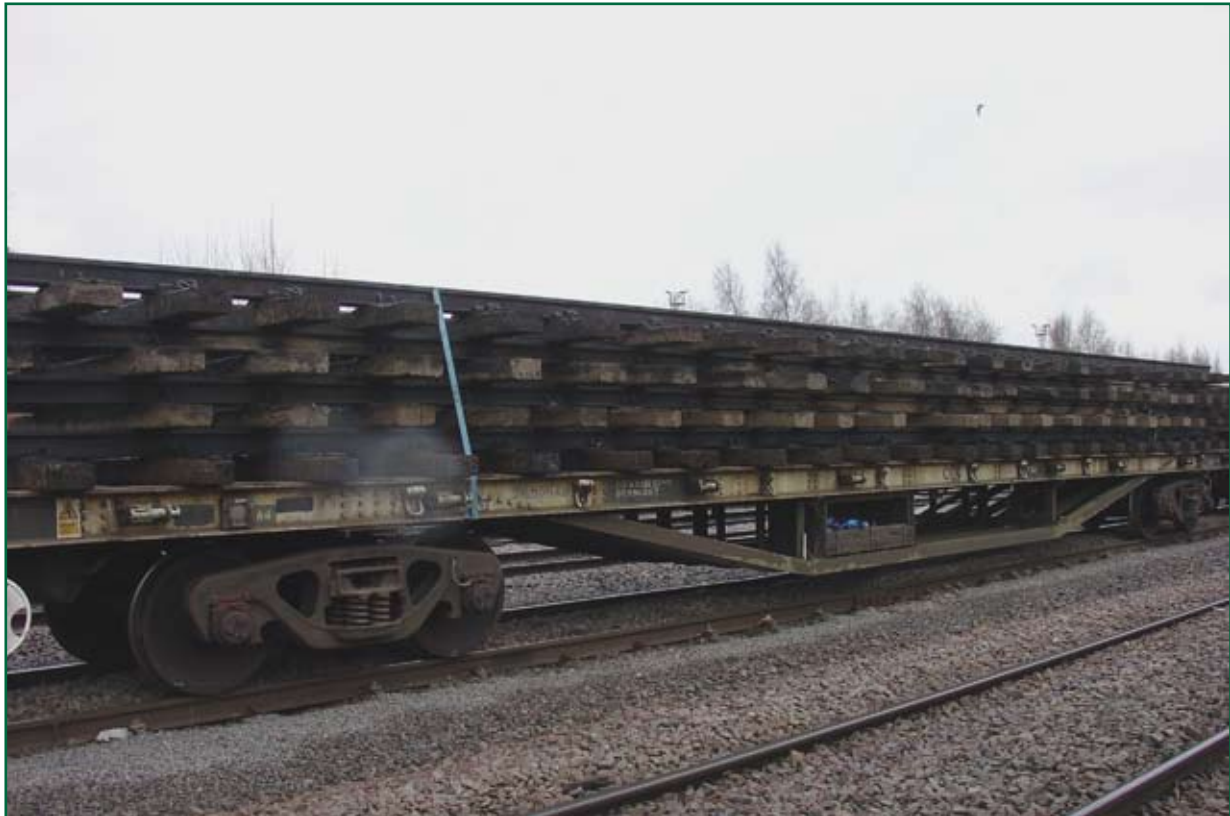
- 56 During the afternoon of 21 February the TMA staff member walked to siding MO13; he unfastened all the straps securing the track panels to the wagons except one, which was too tight to release. He did not remove all the straps he had unfastened. It was his intention to return the following day to remove the straps and complete the unloading. Because the straps had been unfastened, the load on the wagons was no longer in a secure state for transit.

Figure 11: Wagon with one strap attached.

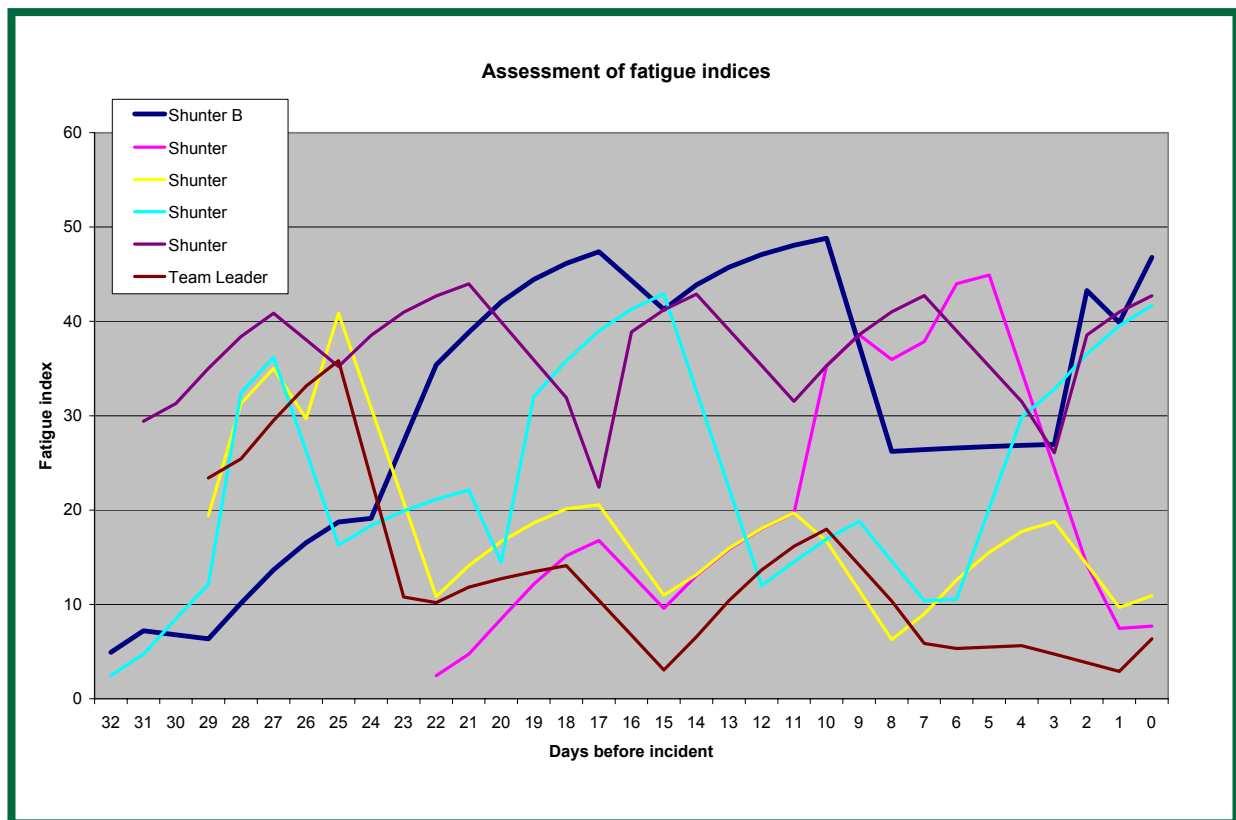
125 The RAIB assessed the hours that five shunting staff, including shunter B, and a team leader worked over the preceding weeks using the newly developed HSE Fatigue and Risk Index (FRI) (This is made up of two separate Risk and Fatigue indices, as detailed in Appendix C).

Figure 12. Chart showing the fatigue indices of a sample of the Freightliner staff

- 4 Freightliner to put in place a company process to assess and take account of fatigue arising from the shifts that members of staff work together with any disclosed off-duty factors so as to reduce the likelihood of staff making errors due to fatigue. Action should include consideration of amending staffing levels and roster patterns where appropriate (Paragraph 142).

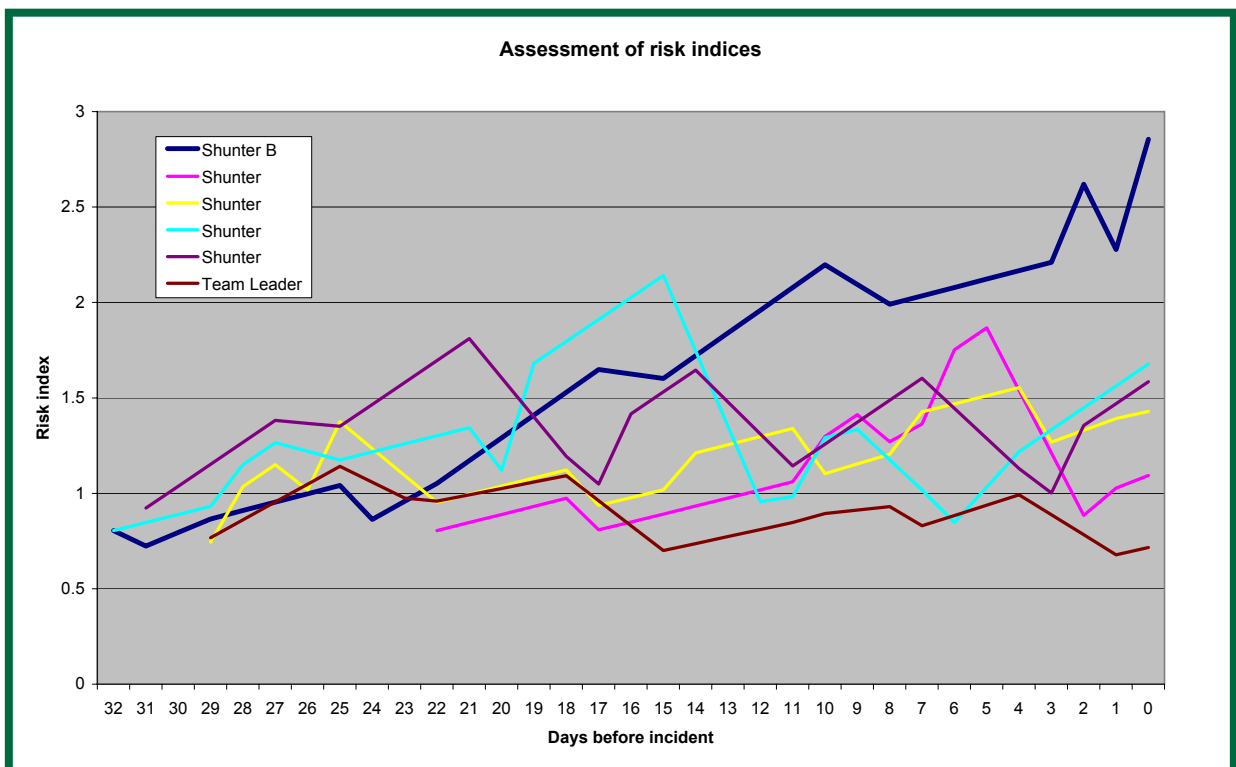
Figure 13. Chart showing the risk indices of a sample of the Freightliner staff
