Rail Accident Investigation Branch

# Rail Accident Report

## Passenger train derailments on the Ravenglass & Eskdale Railway 29 May & 5 July 2006

Report 07/2007  
March 2007

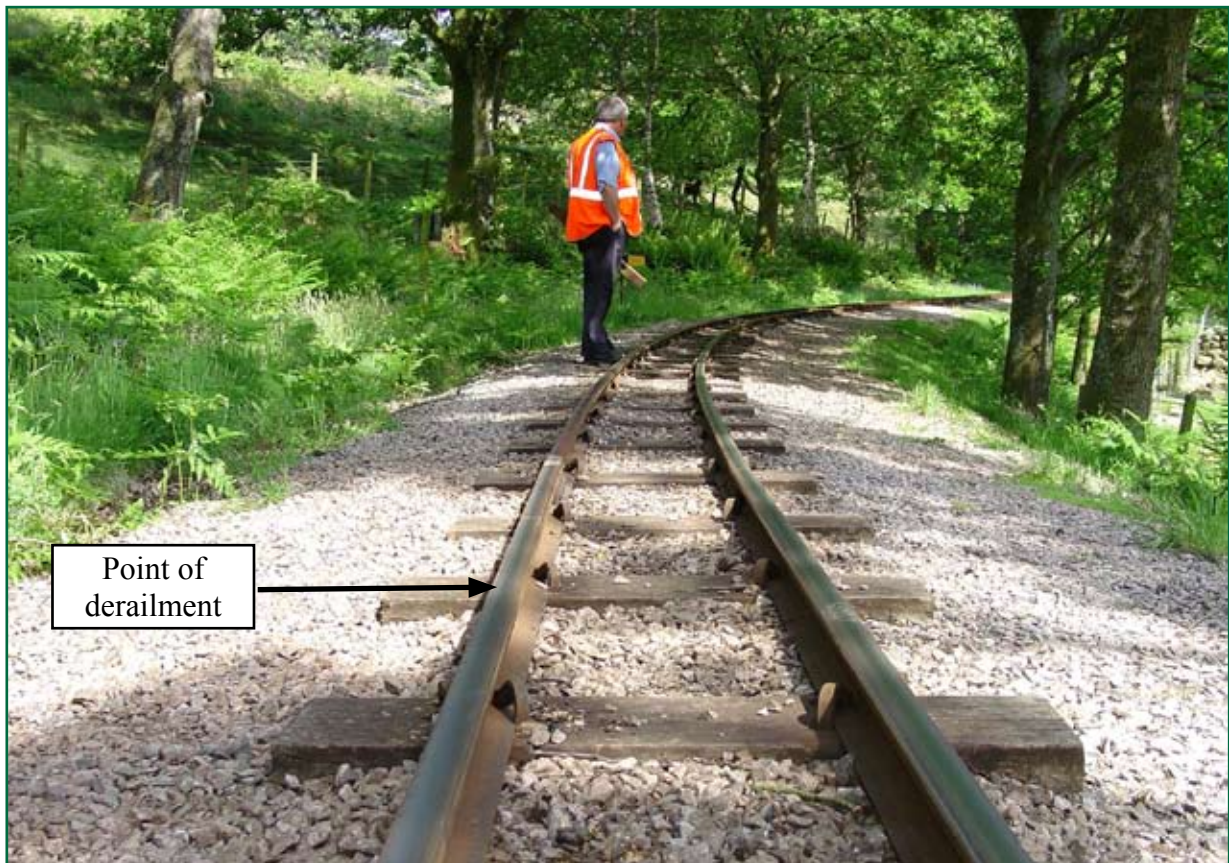
Figure 2: Site of derailment at Spout House Curve.

- 45 When inspected by RAIB, on 7 June 2006, the *track top*, alignment and general condition of the rails, sleepers and fastenings was satisfactory. However, some voiding below the right hand rail at the POD, estimated to be approximately 3 mm deep, had been found by R&ER and repaired on the morning after the accident, before the RAIB had been notified.
- 46 The track gauge narrowed from 15¼ inches (387 mm), 2 sleepers before the POD to 15 inches (381 mm) 1 sleeper before the POD. The cant varied from a maximum of ¾ inch (19 mm) 10 sleepers before the POD to zero (ie level) 4 sleepers before the POD. These values are generally in accordance with R&ER's standard track design parameters.

- 65 The immediate cause of the derailment was flange climb of the leading right wheel of coach 134, due to the combination of a vehicle fault and the track condition. As it derailed to the right hand side of the track and the bogie yawed, the trailing wheelset was also pulled into derailment.

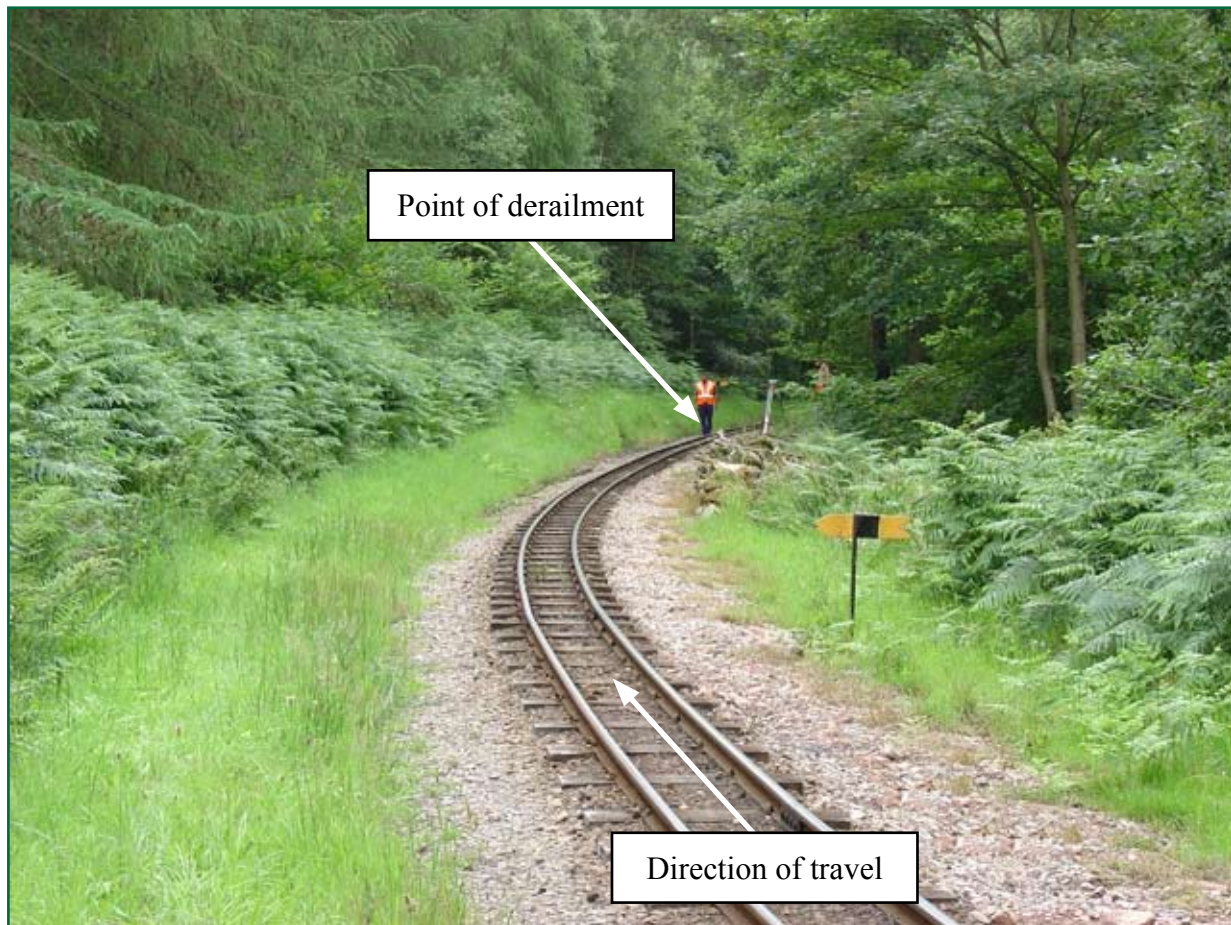
Figure 3: Site of derailment at Millwood Bank

- 79 Track voids were noted at 9 of the last 20 sleepers on the approach to the POD and their depth was measured using void meters. The recorded void depths varied from 1 mm to 7.5 mm; the deeper voids were further away from the POD.

- 92 The investigation identified three causes of the excessive sway and the resulting wheel unloading.
- 93 The survey of the track at Millwood Bank revealed voids, variations in gauge and cant and alignment problems at regular intervals on the approach to the POD. The track would have generated periodic force inputs to passing vehicles, which at a speed of 15-18 mph (24-29 km/h), excited the natural sway frequency of coach 110. The reason the track problems existed at the time of the derailment was that remedial work to correct this known problem had not been carried out. This was because the risk at Millwood Bank had not been recognised by the track foreman, although the deterioration of the track condition had been recognised and was being monitored by him. The lack of timely remedial action was a causal factor.

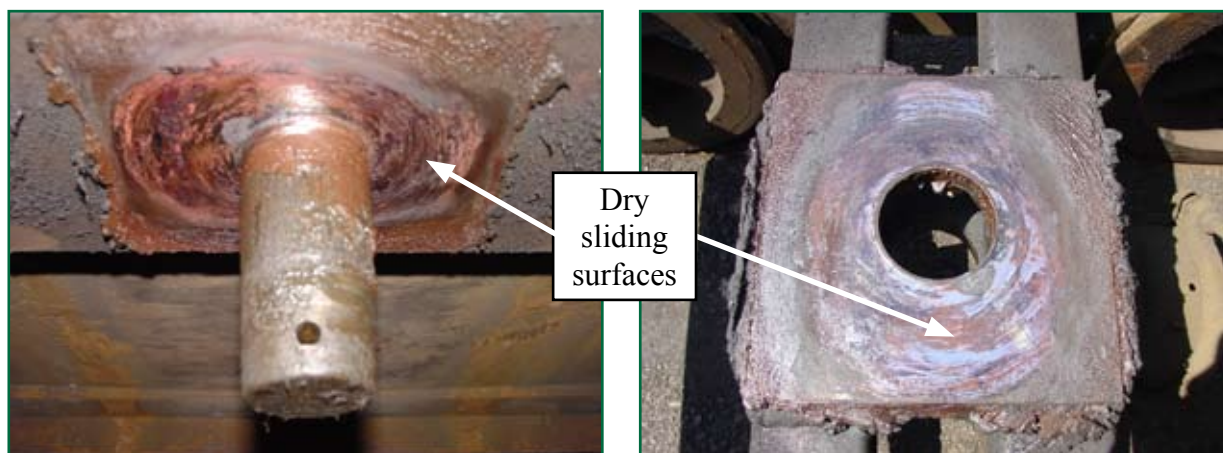
Figure 5: Vehicle body bolster (left) and bogie bolster (right)

- 47 The sliding interface between the body and leading bogie *bolsters* was devoid of grease in the load bearing areas (Figure 5) and there was evidence of metal pick up and scoring indicating a high level of friction between the surfaces.

- 69 The body and bogie bolster plates, which support the weight of the body and which slide against each other as the bogie negotiates curves, were devoid of lubrication at the load bearing points. Although not causal or contributory to this accident, high friction at this interface can increase bogie rotational resistance and could be a hazard (Recommendation 8).

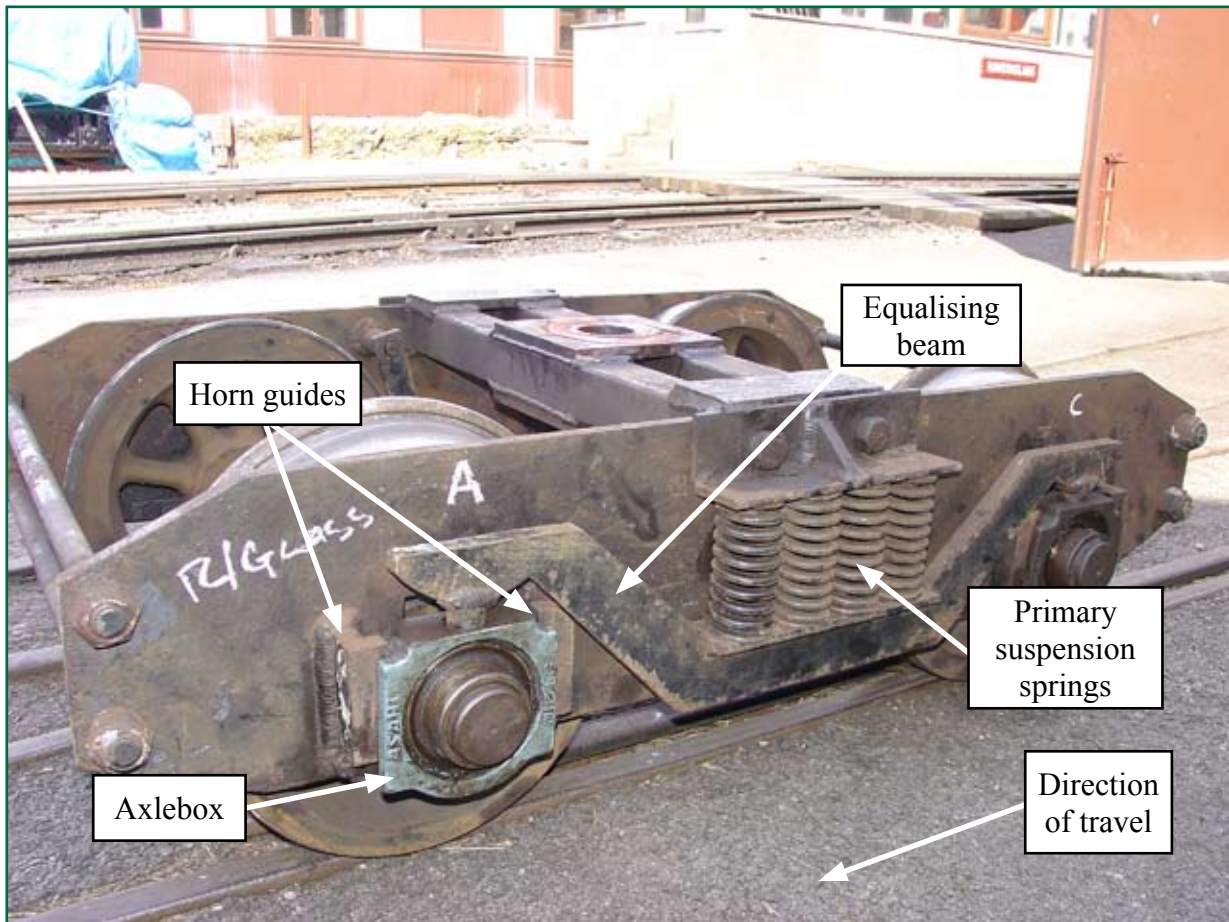
Figure 6: Derailed bogie of coach 134 (after reassembly)

- 48 On the leading bogie, the longitudinal clearance between the leading left axlebox and its horn guides (Figure 6) was 0.3 mm (ie 0.15 mm per side). This was much smaller than the corresponding clearances on the other three axleboxes, which varied between 1.7 mm and 4.3 mm. The lack of clearance on the leading left axlebox was due to a combination of the bearing and horn guide spacing being slightly bigger and smaller respectively, than at the other three axlebox positions. The sliding surfaces were dry, without any oil or grease lubrication. Parts of the inboard surface were also scored and pitted indicating that there had been high friction between the two surfaces and that free movement of the axlebox had been restricted. This was later found to be the case (paragraph 50).

- 49 The left leading axlebox had been changed around March 2001, when the previous one was found to be cracked, and had run without incident for several years.

- there was no specific requirement to check clearances of axleboxes in the horn guides on assembly or at maintenance or lubricate this interface, which resulted in the lack of sufficient clearance going undetected (Recommendation 1).

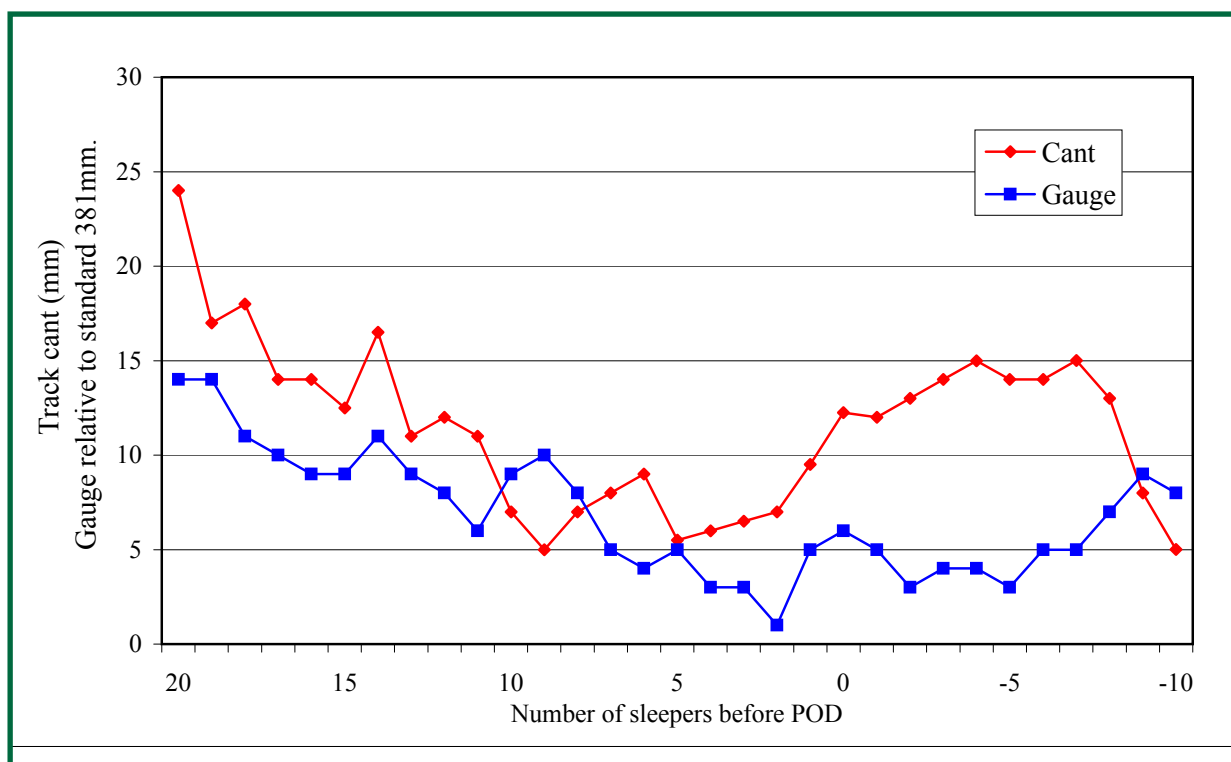
Figure 8: Cant (height of left rail above right rail) and gauge relative to standard 381 mm.

- 80 Track levels were also taken from 20 sleepers before the POD to 10 sleepers beyond the POD and adjusted to include the measured void depths. From this data, the level of the (low) right rail relative to the (high) left rail (ie the cant) as seen by the passing train was obtained. The track gauge was also measured at the same sleeper positions and the results of both are shown in Figure 8, from which the following were noted:

- The cant varied from 24 mm at 20 sleepers before the POD to 5 mm at 9 sleepers before the POD. It then rose again to 12 mm at the POD. For the curve radius and line speed the *balancing cant* is 5 mm and therefore there was excess cant over most of the measured section, which would have caused a small net lateral force (up to 6 % of the static weight of about 1.5 tonnes) on the vehicle acting towards the inside of the curve;

- The variation in cant was not smooth, with rapid changes occurring, on average, every 4.5 sleeper bays or 4 m. The vehicle would therefore have been subjected to force inputs at a relatively regular frequency as it passed these positions. Taking a train speed at the middle of the estimated range of 16.5 mph (7.3 m/s), the regular force inputs would have occurred at a frequency of approximately 1.8 Hz, which is the same as the sway frequency of the vehicle (paragraph 85);

- The track gauge varied from 395 to 382 mm over the last 20 sleepers before the POD. The peaks and troughs in the gauge variation also showed a regular spacing in a similar manner to the changes in cant. This indicated that there were small variations in the lateral alignment of on one or both running rails. The effect of this would have been to apply additional lateral force inputs to the vehicle at a frequency close to the sway frequency.

- excess cant over the last 20 sleepers before derailment which would have caused a small lateral force acting towards the inside of the curve.
  - lateral misalignment of the track on approach to the POD as observed from the variations in track gauge (Figure 8) and the video record (paragraph 88).

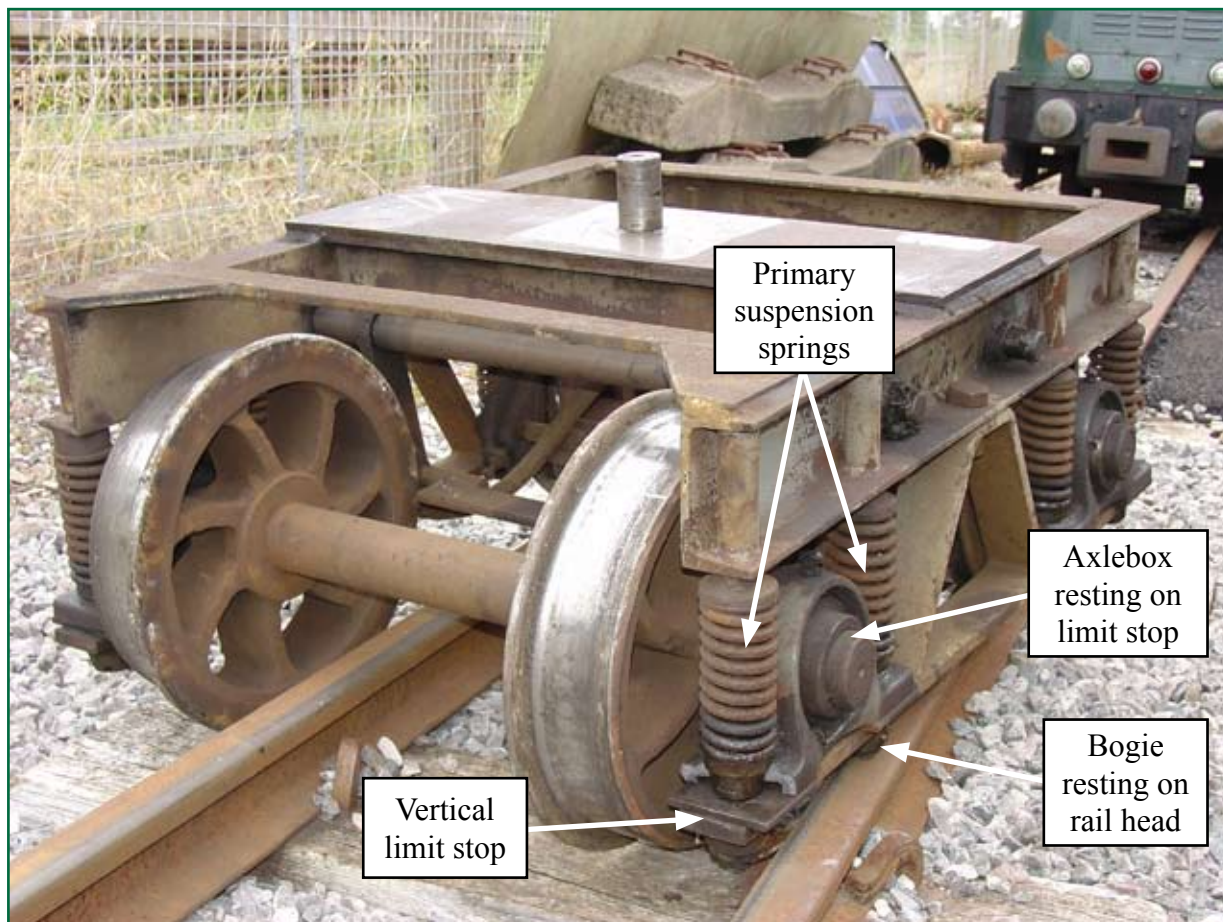
Figure 9: Leading bogie of coach 110 in initial derailed position.

82 There were gouge marks at the bottom of the leading left primary suspension locking nuts on the bogie. This indicated that the leading end of the bogie had slid along the rail head, propping up the leading wheelset in the position shown in Figure 9, and preventing heavy contact with sleepers and ballast.

83 The vehicle primary suspension comprises two vertically mounted springs either side of each axlebox which are located on two spring posts (Figure 9). When the vehicle is in tare condition, the axlebox sits directly on the vertical limit stop, which is fixed to the bogie frame. Hence the suspension has little or no flexibility in the wheel unloading (springs extending) direction and wheelsets will tend to unload excessively when traversing track with even moderate *twist faults* or dips caused by voiding.

84 There are no formal records or drawings of the bogie design or its optimum set up with regard to suspension clearances. Information available from the memories of R&ER staff indicated that when the bogies were first delivered in 1968, there was a clearance of 12 mm between the bottom of the axlebox and the vertical limit stop of the bogie in the tare condition, allowing that amount of flexibility in the unloading direction. However the ride performance at that time was unsatisfactory and vehicles were found to roll excessively. The decision was then taken by R&ER around 1970 to fit 12 mm spacers at the bottom of the springs. This spacer had the desired effect of improving ride quality, but flexibility in the unloading direction at tare had been virtually eliminated.
