Rail Accident Investigation Branch

Rail Accident Report

**Derailment in Hooley Cutting, near Merstham,
Surrey
13 January 2007**

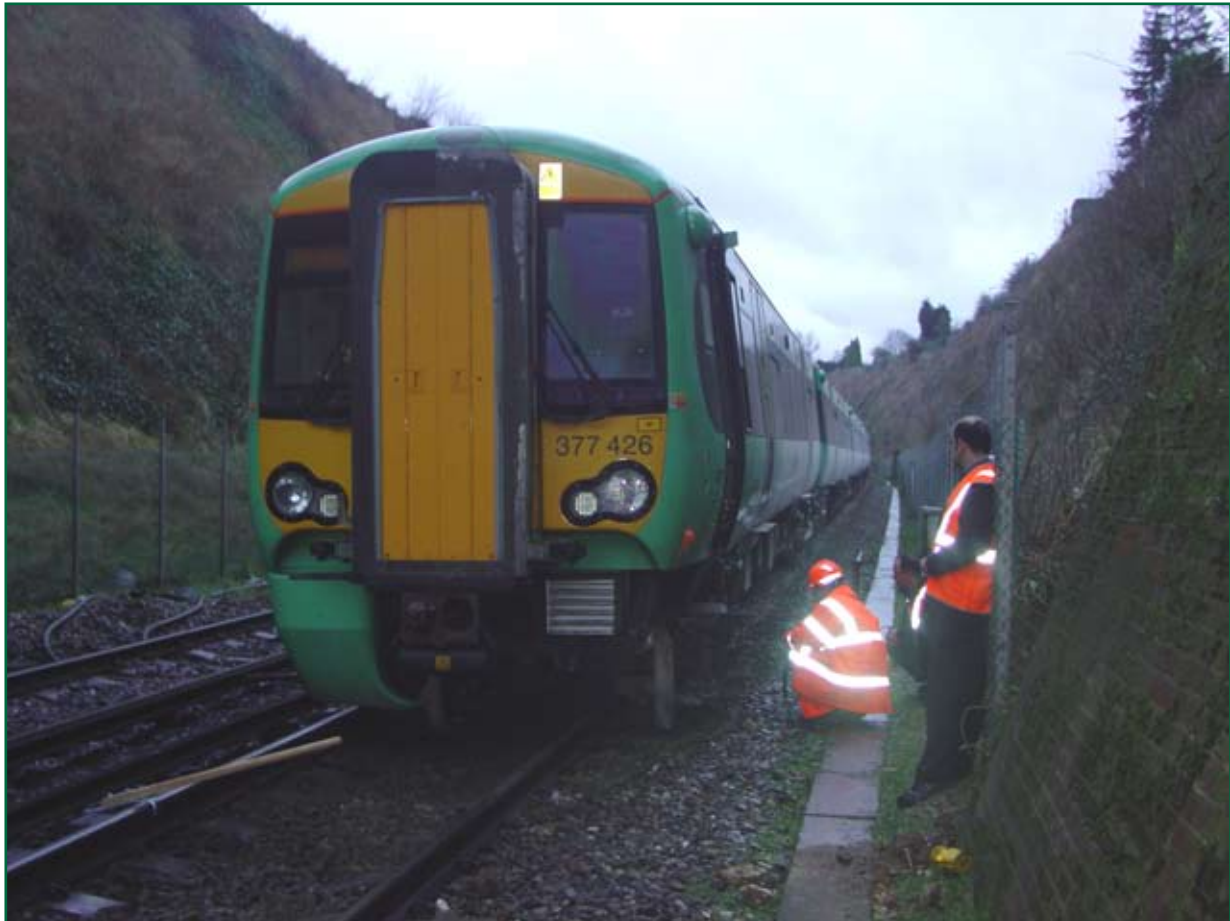
Figure 3: General view of the derailed train in Hooley cutting

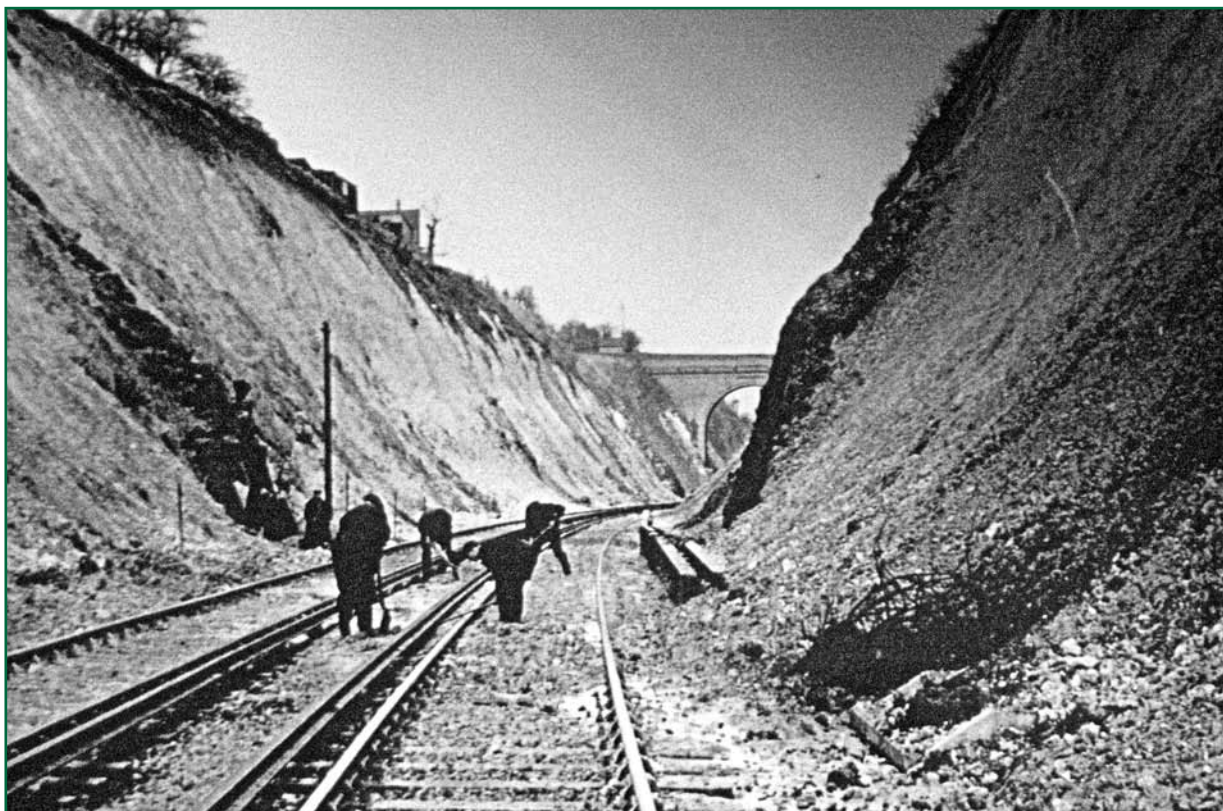
Figure 5: A rock fall on the down side of Hooley cutting during the snows of 1947. The variable depth of gravel can easily be seen on the left side of the cutting (courtesy of Network Rail)

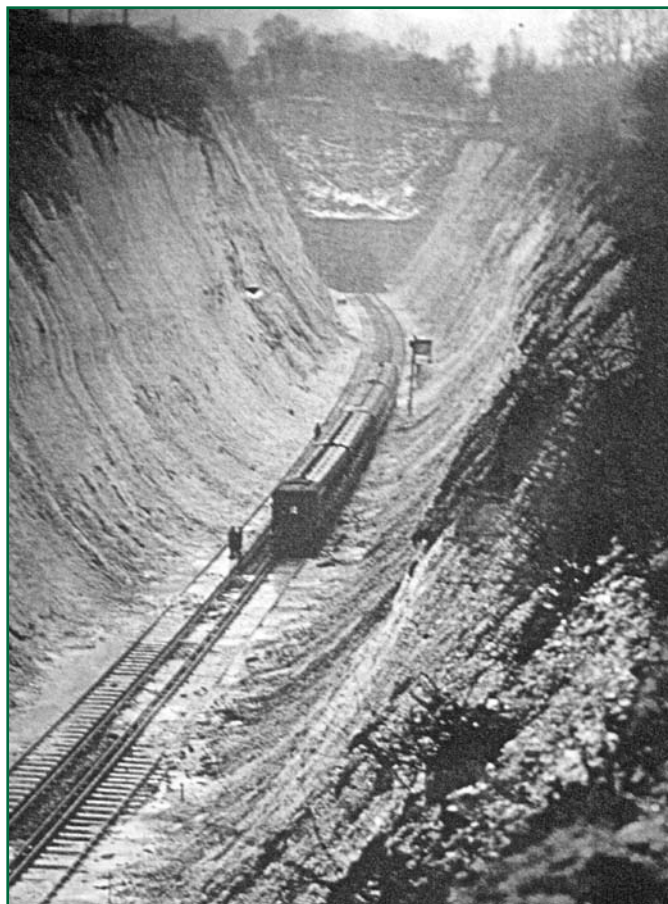
Figure 6: Photograph taken in 1947 showing a rock fall on the up side of Hooley cutting (courtesy of Network Rail)

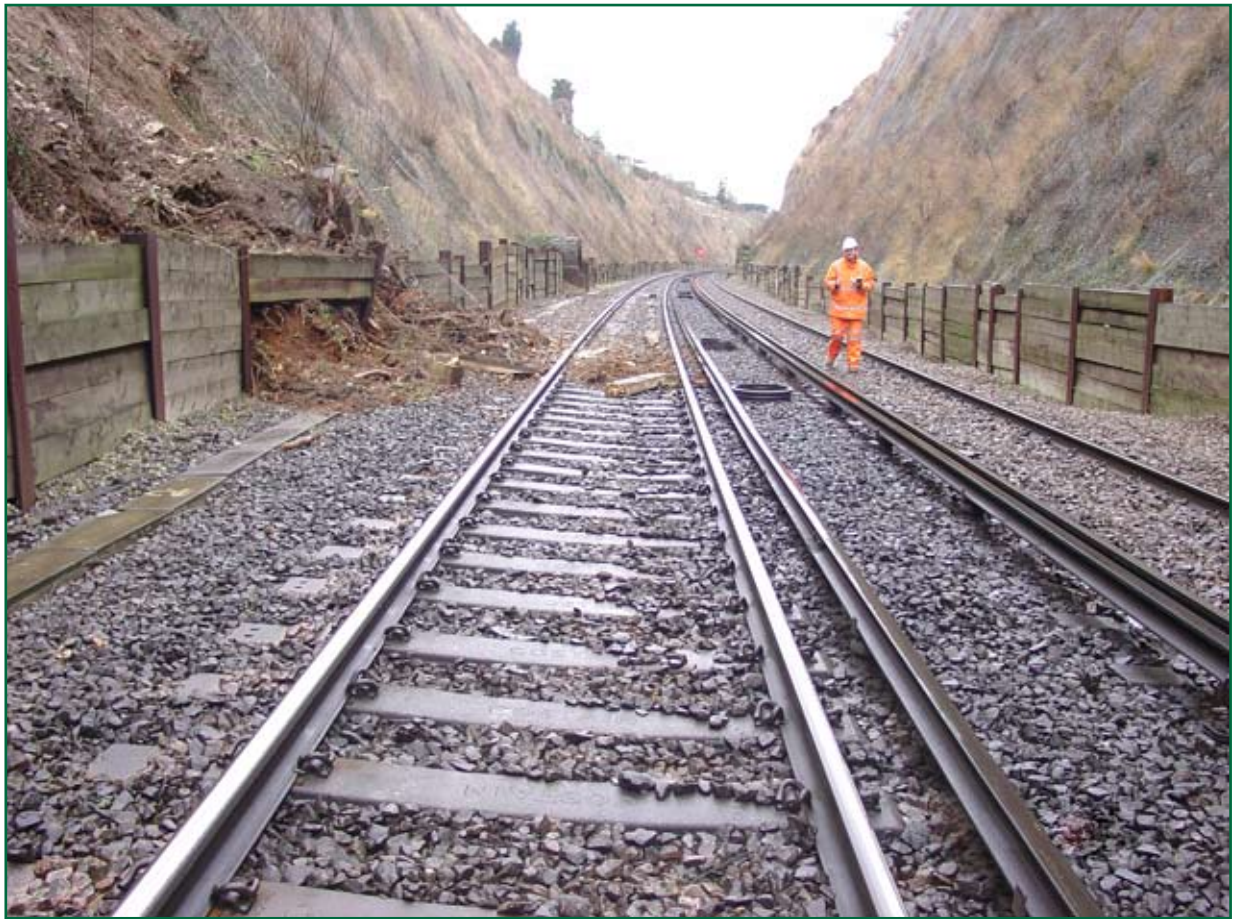
Figure 8: Hooley cutting following the derailment showing the king post wall viewed looking towards London.

38 Prior to train 1C23 emerging from the tunnel, a root ball from a previously felled tree (paragraphs 70 and 104) slipped down the cutting side approximately 100 m from the tunnel mouth. The root ball and ground material hit the king post wall, breaking the horizontal timber beams that formed the wall. Two of the beams were projected forward on to the up line (Figure 2), together with debris formed of gravel, clay, soil and small pieces of rock. The root ball was stopped from reaching the track by a vertical steel wall I beams. Most of the debris came to rest between the cess and the left hand rail (Figure 8).

- 104 The root ball came from a tree which had been felled sometime between 2001 and 2003. No records exist to determine the exact date although it is probable that it was felled in 2003 when most of the larger trees received attention. By 2007 the root ball had only rotted to a small extent. There were some small suckers growing from it indicating that it had not completely died. Most of the small roots that would have provided stability within the cutting side were missing (Figure 8).

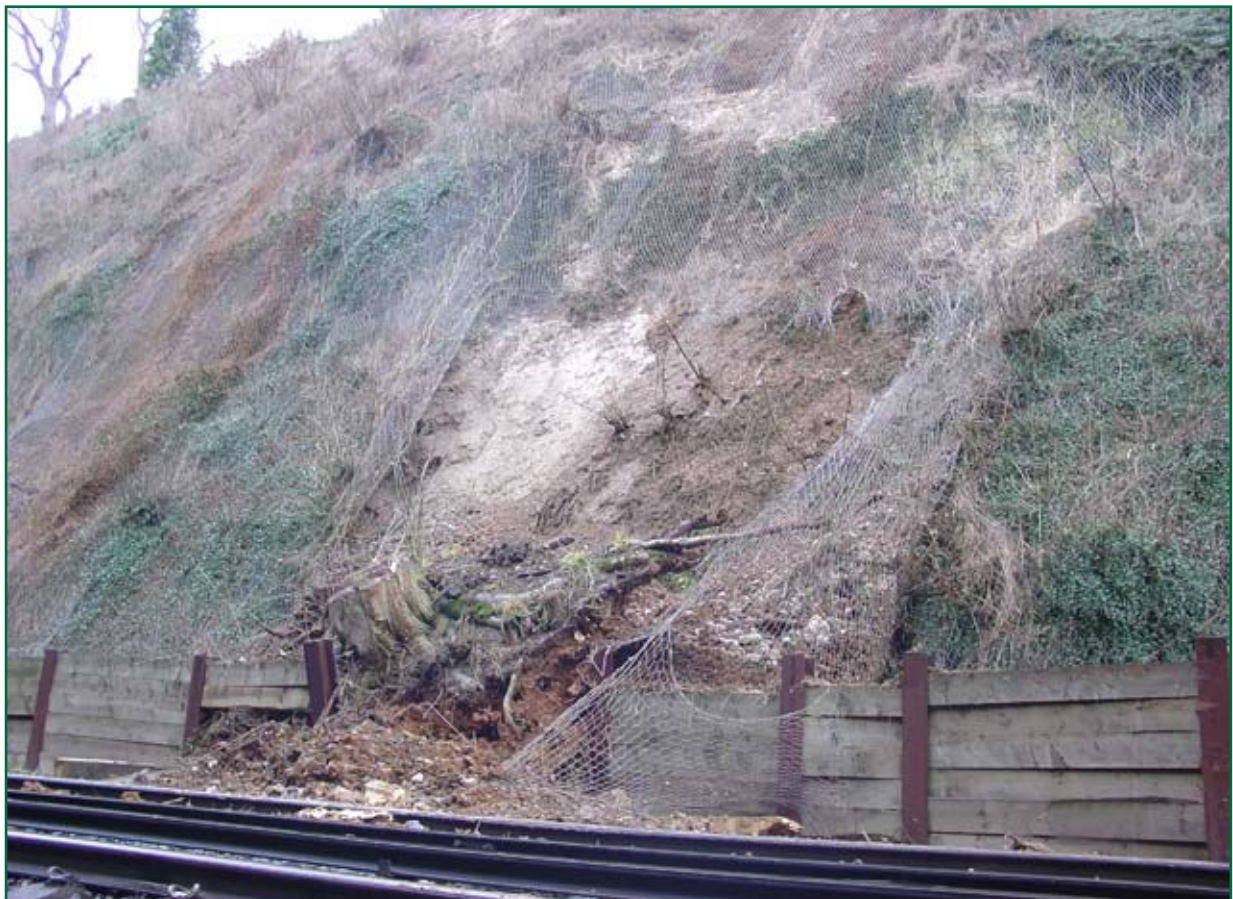
Figure 9: Hooley cutting showing the landslip

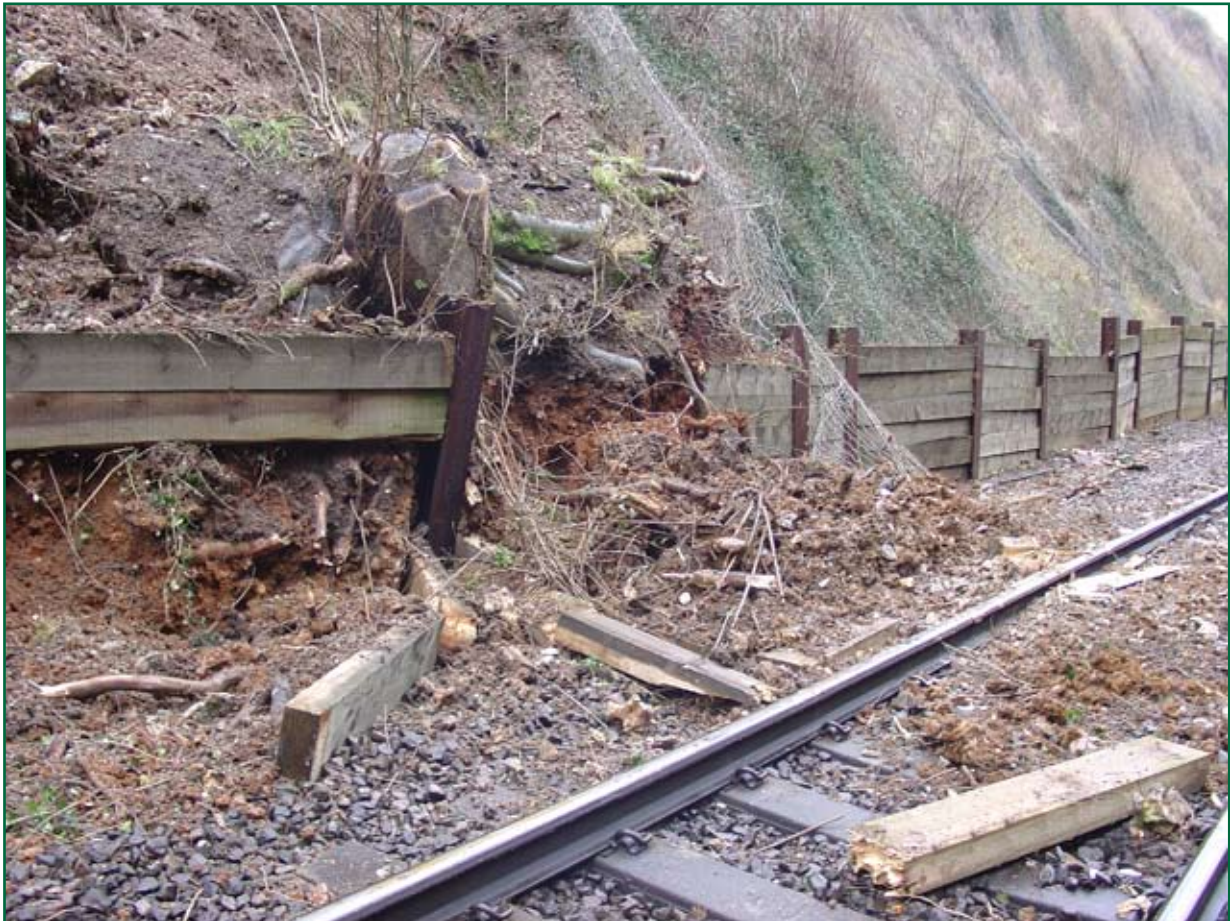
Figure 11: Debris on the track following the derailment

- 95 The debris blocking the line comprised gravel, clay, small pieces of rock, and broken parts of several timber beams from the king post wall. Most of the debris lay between the cess and the left hand rail. Only a small amount of debris lay between the rails. The 6 tonne (estimated) root ball had been contained by the wall; no part of it infringed the line, nor were any of the vertical columns displaced sufficiently to hit the train (Figures 8 and 9). Apart from the timber beams no material was present that was sufficiently large to derail a train.
- 96 The immediate cause of the derailment was an obstruction on the left hand rail formed by displaced timbers from the king post wall.

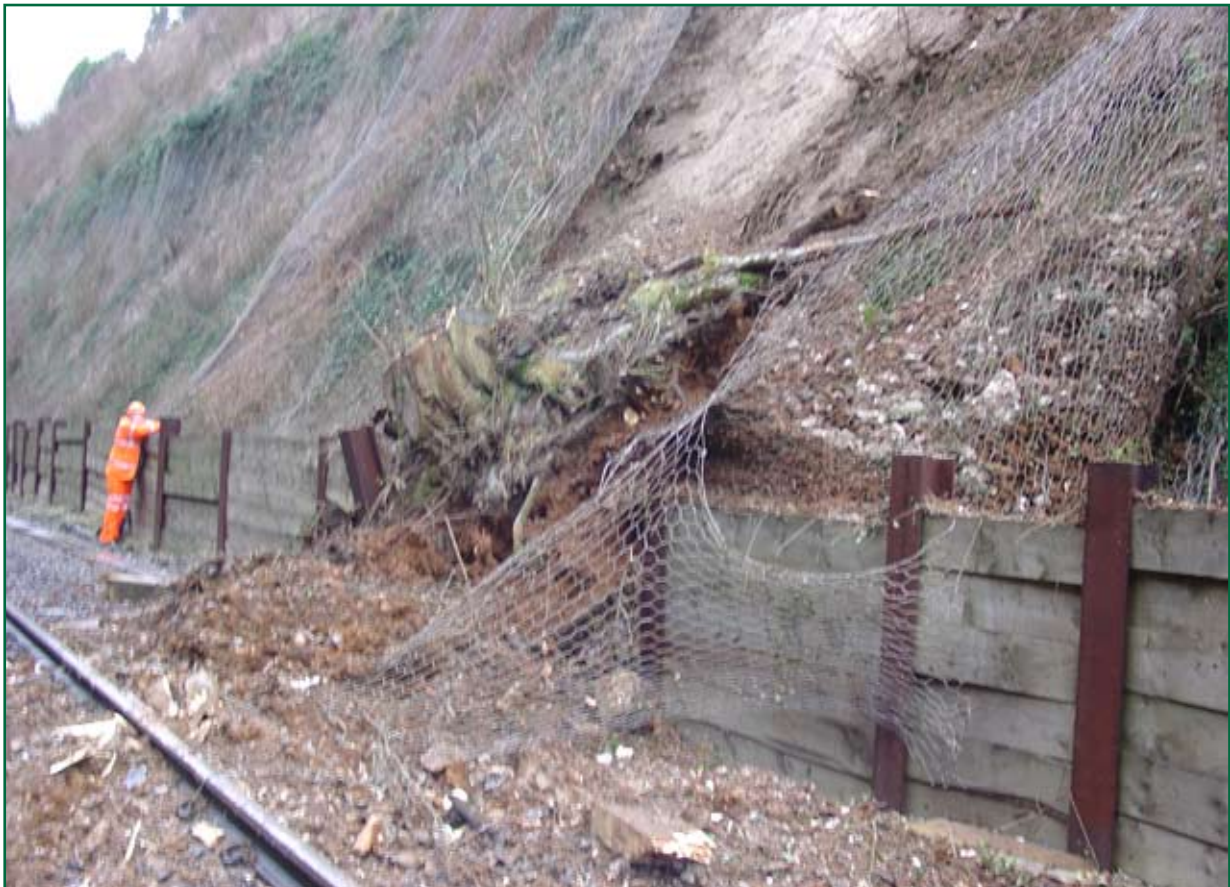
Figure 12: Debris and rootball against the king post wall

- 93 The fall of the root ball was contained by the steel verticals forming the king post wall. The impact displaced some of the timber beams, several of which were buried under small amounts of debris. Two beams were thrown forward towards the track. These were found in a broken condition. It was not possible to determine whether they had been broken by the initial impact from the tree stump or subsequently by the impact from a train wheel.
- 94 One of the vertical steel I beams was displaced towards the track by the impact from the tree stump. It did not foul the *structure gauge* of the line.

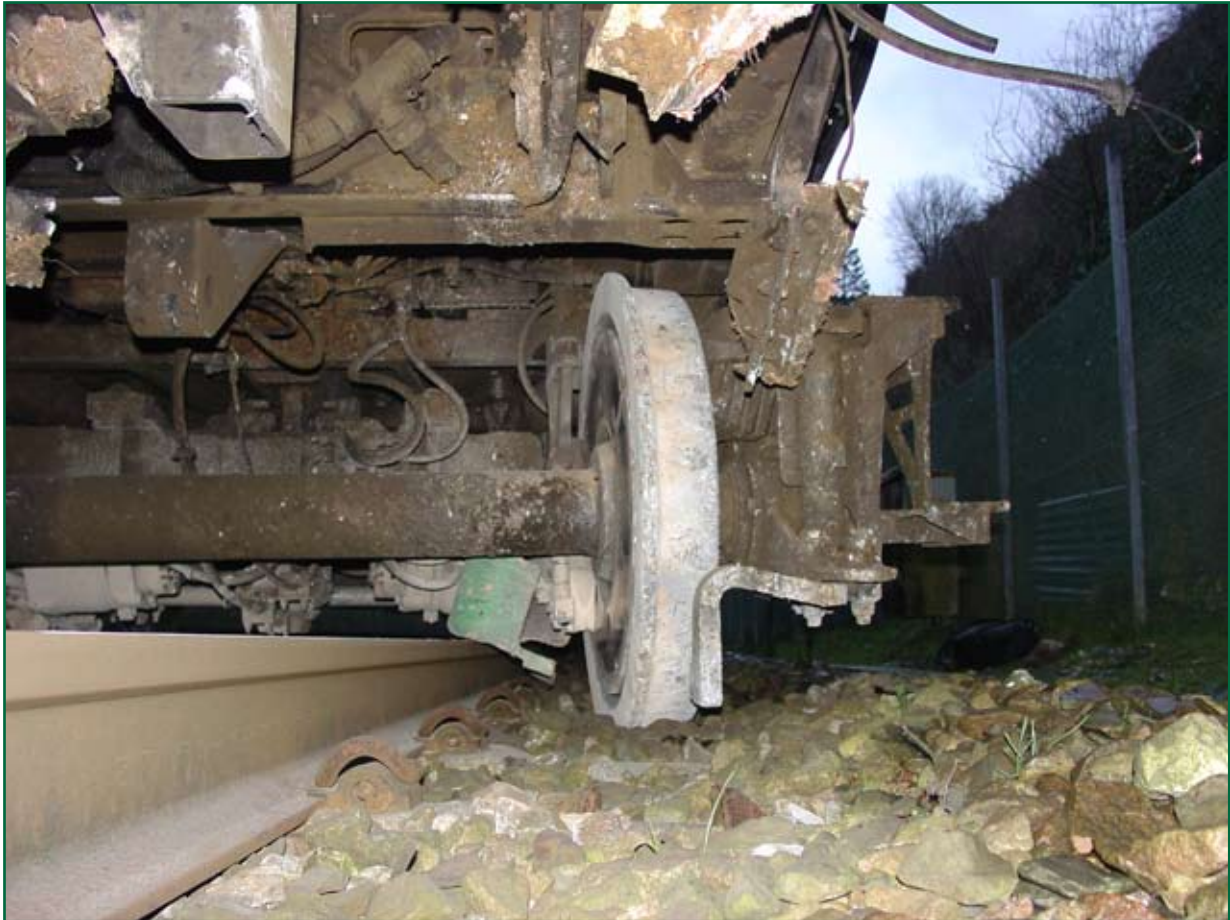
Figure 13: Damage to the front bogie of the train

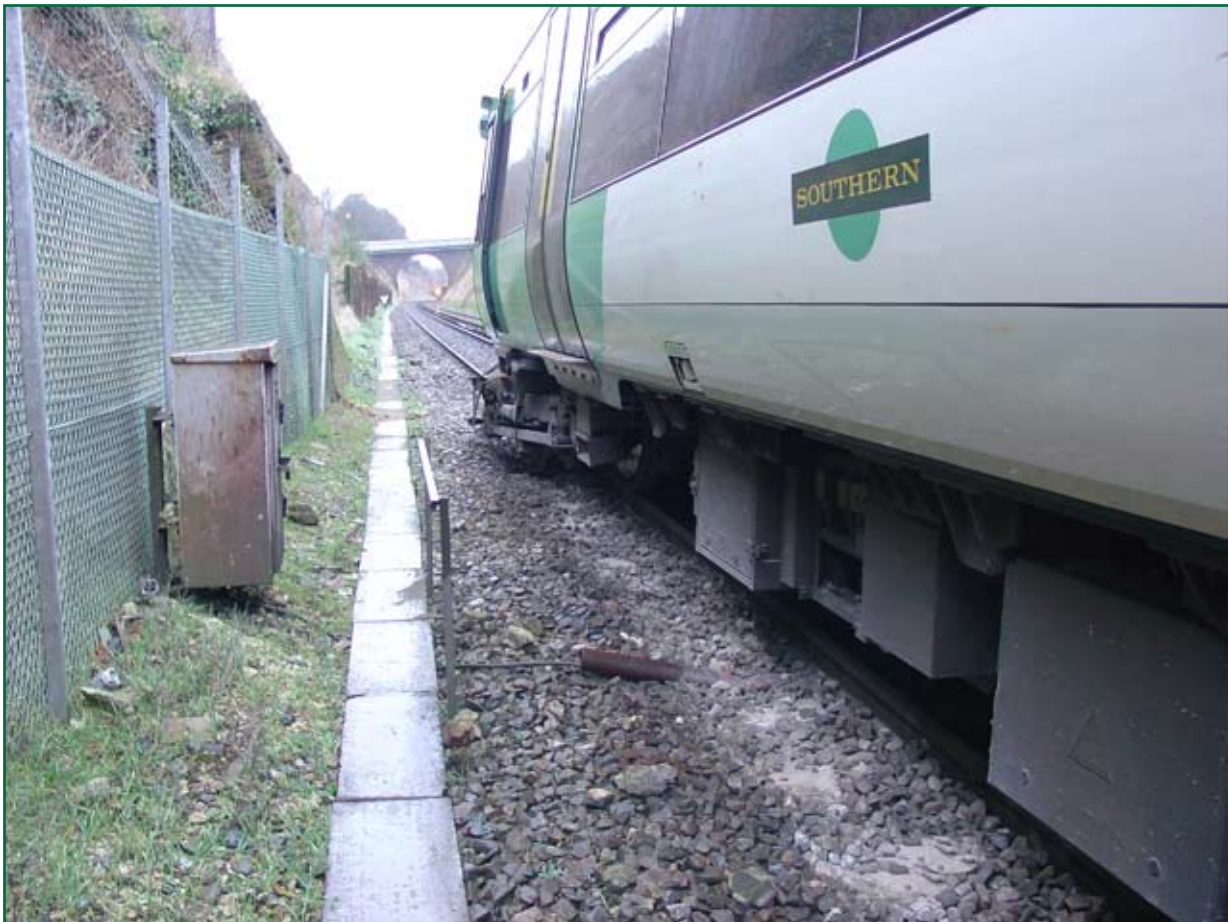
Figure 14: The derailed bogie and side of the train

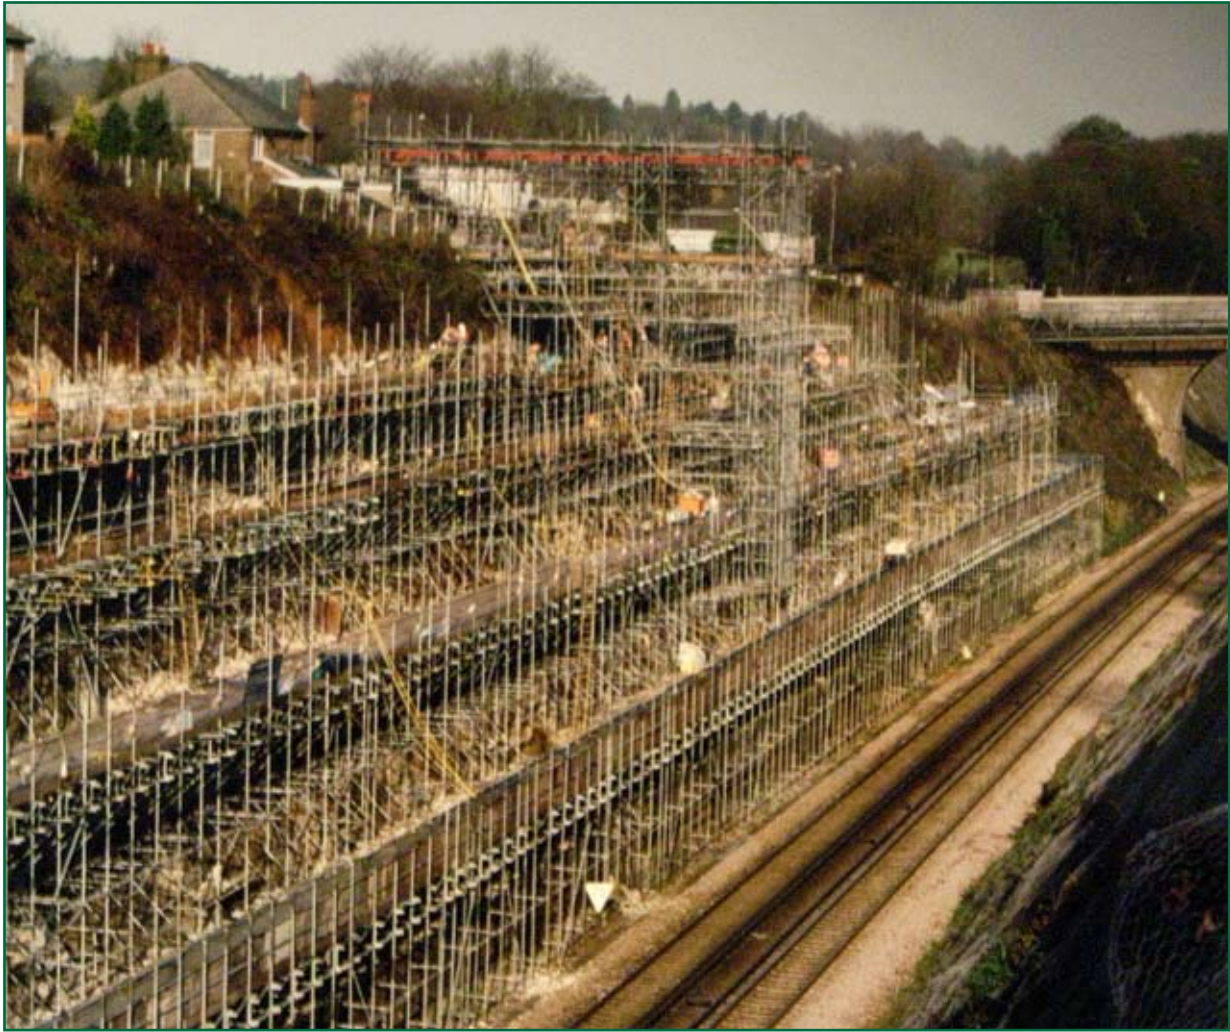
- 33 The train was fitted with a *cab secure radio* (CSR) that permits the driver to talk to the signalling centre. The driver used this system to report the derailment.

Figure 15: Photograph showing the stabilisation works of 2001 - 3 (courtesy of Network Rail)
