# Rail Accident Report

## **Derailment at Wigan North Western station 25 August 2009**

A derailment occurred on the night of 25/26 August 2009 at Wigan North Western station. A container train travelling from Glasgow to Manchester and Birmingham was slowing down to stop at Wigan when one of its wagons derailed. The wagon which derailed was an empty container wagon and its front bogie derailed at low speed whilst running round a sharp curve into the platform.

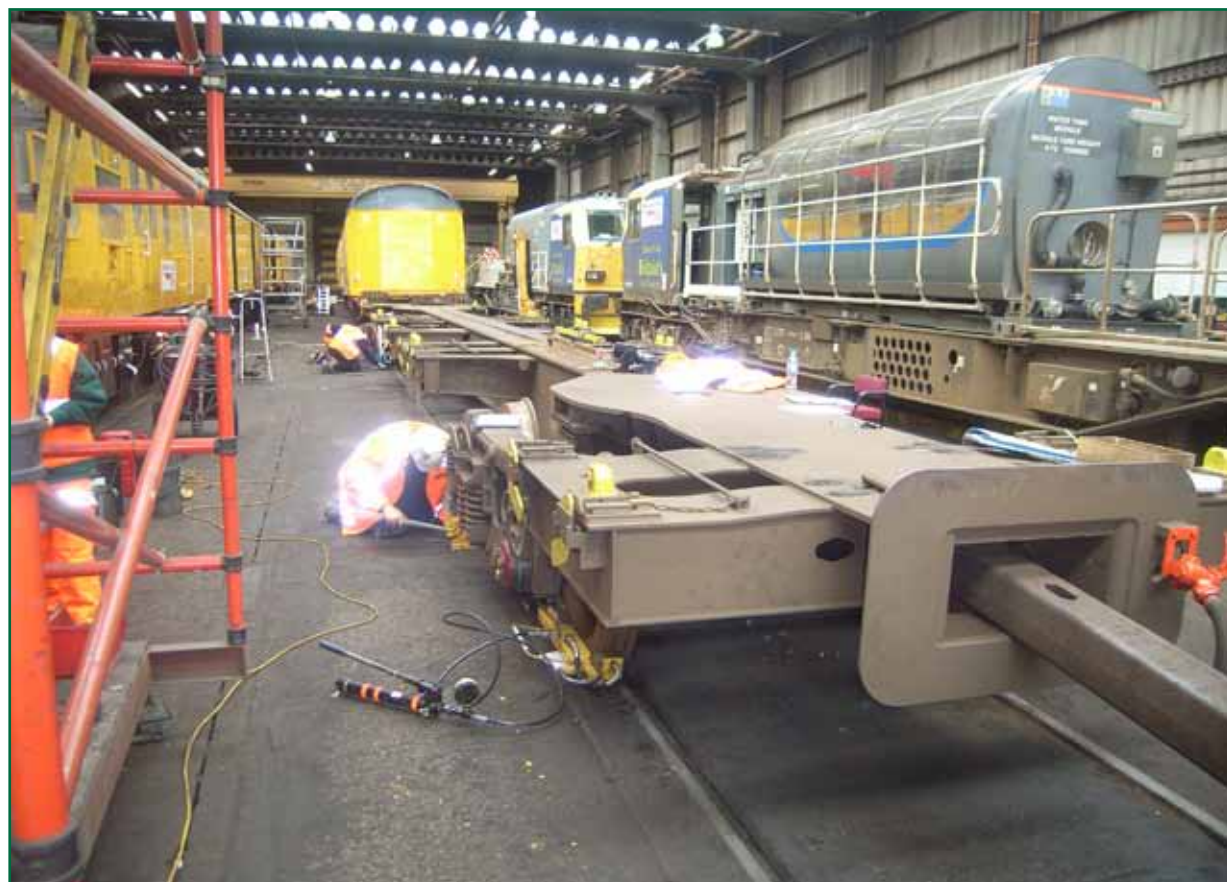
Figure 2: Wagon which derailed showing bar coupling to adjacent wagon

- 48 **The frame of the vehicle which derailed was twisted, and the *sidebearers* of this wagon were fitted with packings that did not compensate for this twist. This reduced the weight on the leading right wheels. The uncompensated twist in the frame was a causal factor in this derailment.**
- 49 Twist can exist in wagons and is apparent as a difference in height between one corner of the wagon and the plane defined by the other three corners. The effect of twist in a wagon is to cause the wheel(s) at the corner that is raised to carry a reduced load, along with the wheel(s) at the diagonally opposite corner. Twist within the frame of a vehicle can cause a wheel to lose firm contact with the rail.

- 50 When surveyed by the RAIB following the re-railing operation, the frame of wagon 610117 was found to be twisted by 11 mm over its length, in the sense that the leading right-hand corner of the wagon deck was higher than the left. Given the low speed at the time of derailment and the fact that the wagon was unladen, the RAIB consider it unlikely that the wagon twist was caused by the derailment.

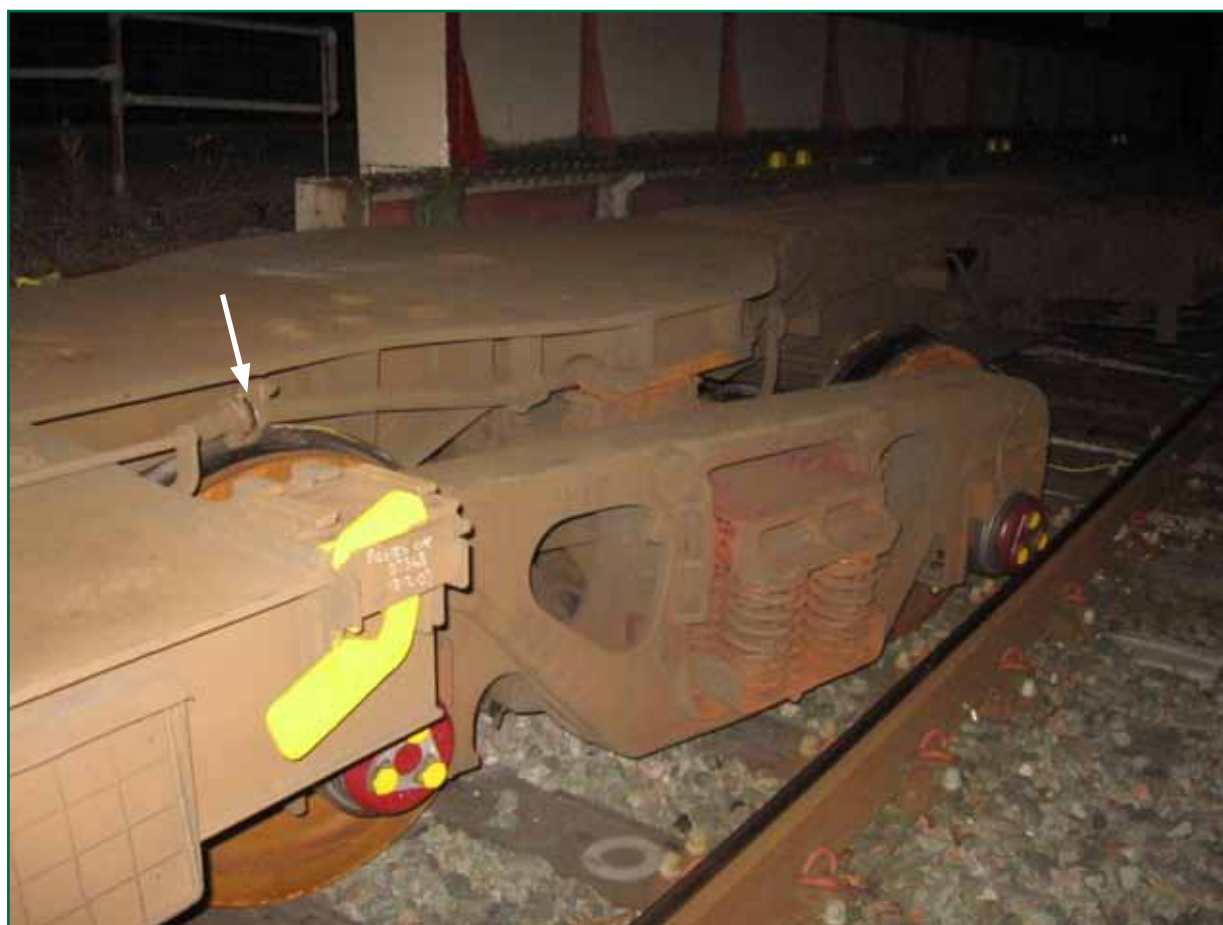
Figure 5: The derailed bogie with (arrowed) the fractured brake pipe (photograph courtesy of Network Rail)

- 19 Nobody was injured in the derailment. All wheels of the leading bogie of wagon 610117 were derailed and slight impact damage was caused to some of the sleepers and the cross girders of the bridge. Several signalling cables were cut, affecting signalling circuits of the up loop line.
- 20 The up loop line and platform one at Wigan North Western station were out of use for 24 hours while track and cable repairs were undertaken. The potential consequences of this derailment were limited by the low permitted speed of the line.

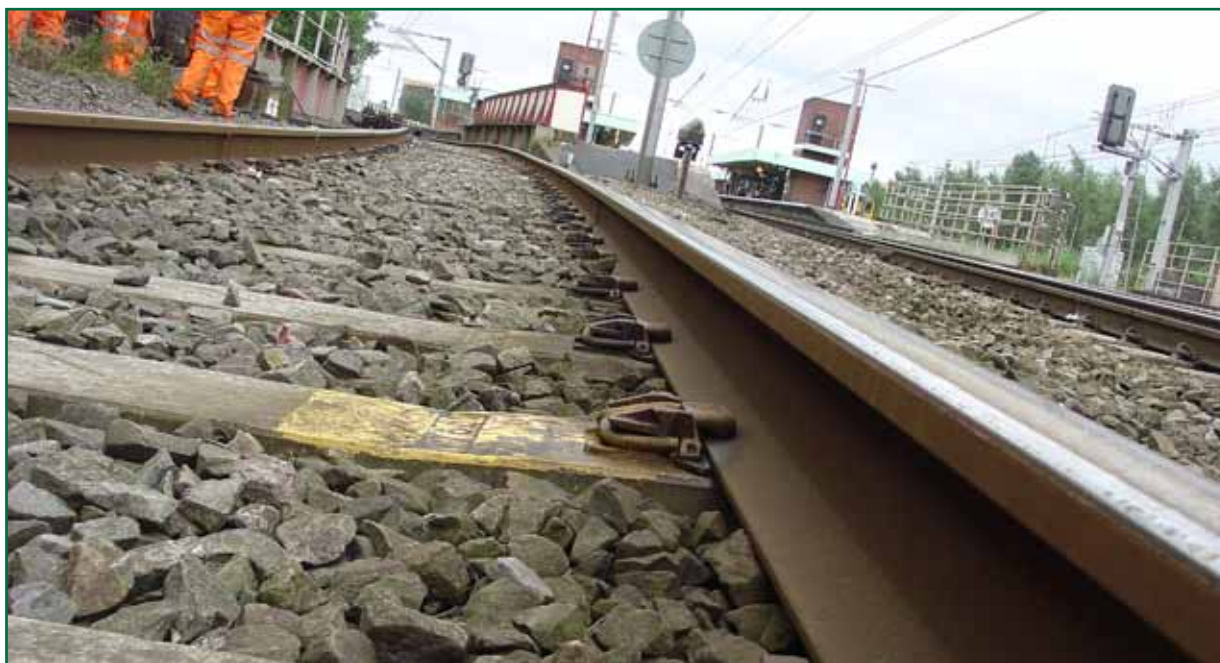
- 28 The track had been installed with a radius that was sharper than designed and was not fitted with a *check rail*. The lack of a check rail was causal to the derailment.
- 29 The track survey undertaken following the derailment showed that the track at the point of derailment had a minimum radius of 140 metres. The design drawing for the track showed that the design radius was 175 metres. Figure 6 shows the track at the site of the derailment following recovery of the train.

Figure 6: Site of the derailment, looking in the direction of travel of the train

- the track had been installed to a minimum radius of 140 metres without the fitting of a check rail (paragraphs 28 and 75); and
- the wagon had a twist in its frame that had not been correctly compensated (paragraph 48 and **Recommendation 1**).

2. *The purpose of this recommendation is to identify and rectify other sites where design or construction is not in accordance with the track construction standard.*

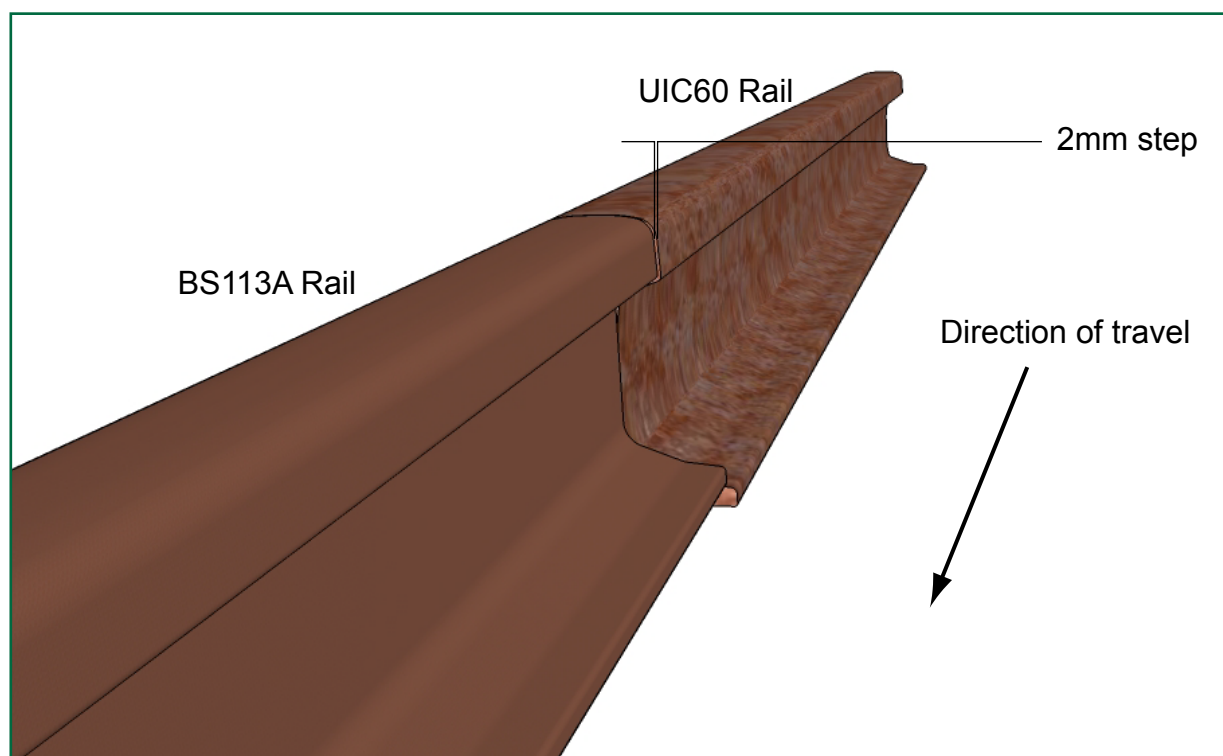
- 37 Transition rails were specified for the up loop line where the new UIC60 rail was to join the existing BS113A rail leading into the platform. The transition rails had to allow for the 2 mm difference in head width between UIC60 and BS113A rail. In the case of the rails fitted at Wigan north the transition rails were manufactured with the *running edges* aligned and a 2 mm step on the *field side* of the rail head. This meant that there were left and right-hand versions of the transition rail. When examined after the derailment, the transition rail fitted to the left side of the track (in the direction of travel) was found to be a left-hand one, but the rail fitted to the right side was also a left-hand rail. The effect of this was to produce a 2 mm step outwards (i.e. away from the *four-foot*) in the running edge of the rail where the UIC60 rail ended and the BS113A began (figure 7). The flanges of the wheels on the right-hand side of the train were in contact with the right-hand rail due to the curvature, as shown by the polished running edge of the right-hand rail. The derailment started at the transition between the rail sections.

Figure 7: Transition between UIC60 and BS113A rail

- 38 The drawing produced by the S&C manufacturer showing the details of the track construction showed the transition rails in the wrong orientation, i.e. with the UIC60 rail at the south end adjacent to the existing BS113A rail. It is not known whether the rails were delivered to site this way round and had to be turned on site (they were 10.8 metres long) or whether the error was spotted before dispatch and rectified. There were a pair of transition rails in the up loop and another pair in the up main, a total of four rails; two left-hand and two right-hand. It is possible that the rails became wrongly placed during installation due to them becoming misidentified during an operation to turn them lengthways.

- A transition rail of the wrong hand was installed in the right-hand rail. Network Rail maintenance staff were unaware of the presence of this (paragraph 36 and **Recommendation 2**).

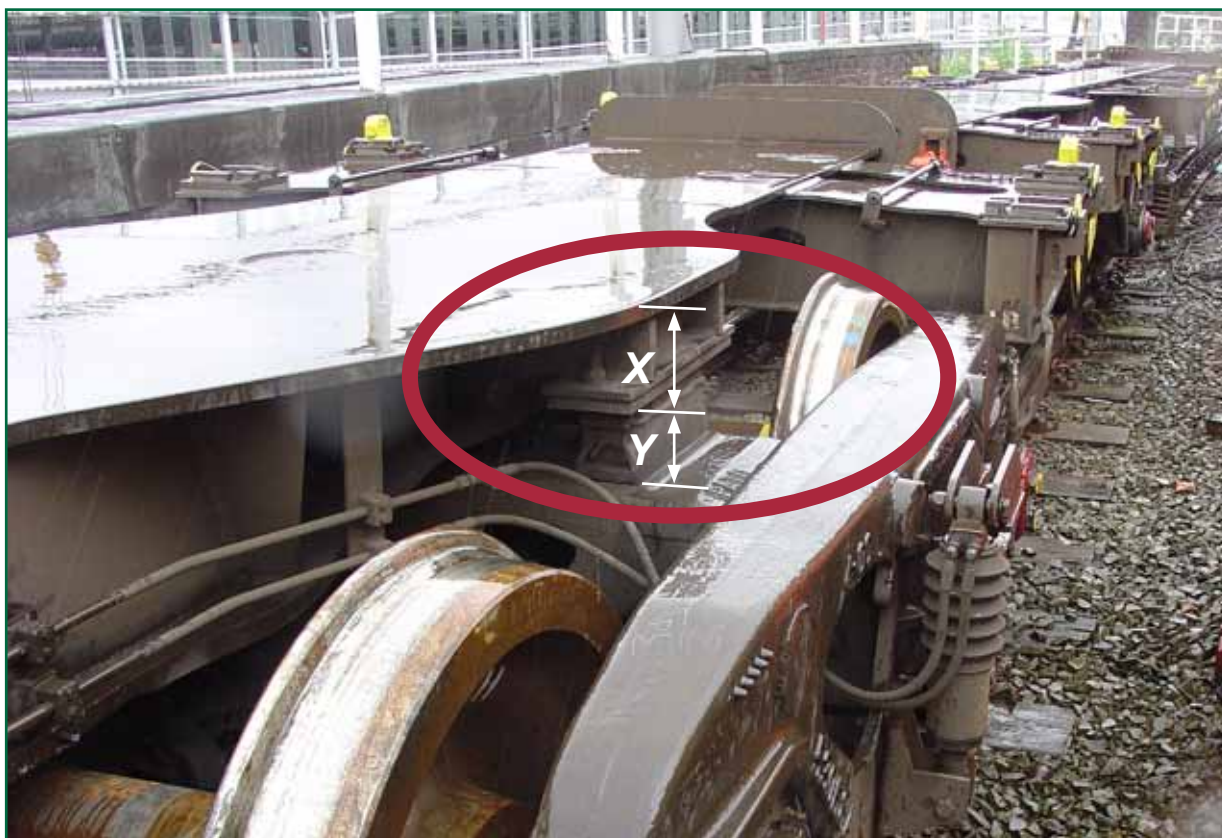
Figure 9: Right side of leading bogie of wagon 610117 showing (circled) sidebearer unit

- 57 The maintenance standard states that packing shims should be inserted to correct the sidebearer clearance. When measured by the RAIB the total distance from the top surface of the deck to the underside of the sidebearer shims (dimension X in figure 9) was as given in table 1.

Bogie	Left side	Right side
leading	177	165
trailing	174	175

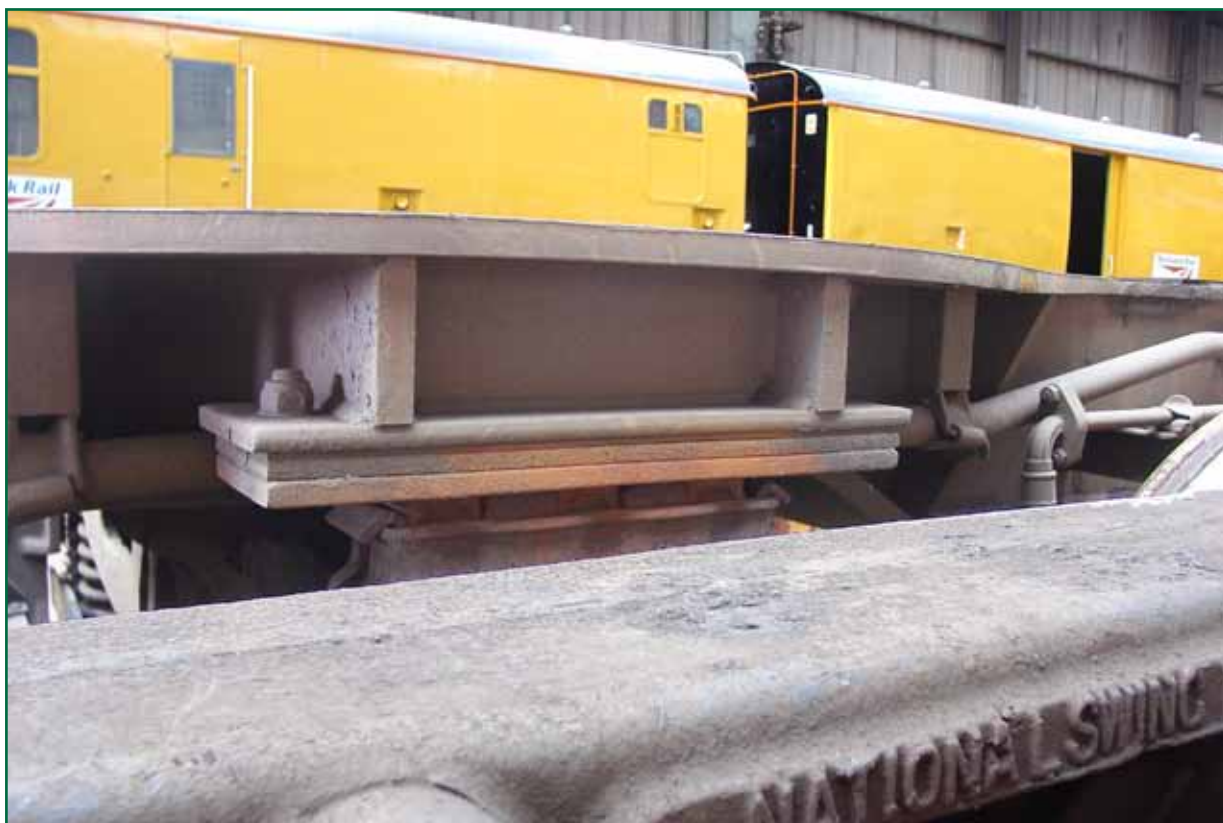
- 58 The packings at the leading end were 12 mm thicker on the left side than the right. This is in the opposite sense to the wagon twist and sidebearer clearance and would have acted to further unload the leading right wheel. The packing shims were retained by bolts and, when examined after the derailment, the appearance of the bolts did not suggest that they had been removed during the recent VIBT. Figure 10 shows the sidebearer and its packings at the leading left side of wagon 610117.

- 59 As described in paragraph 48, uncorrected twist in the frame of a vehicle will result in uneven wheel loadings. Packings of the wrong thickness inserted above the sidebearers will also produce the same effect. The wheel loads of the wagon were measured following the derailment using equipment that can only give an approximation of the true load. The values used in the computer simulation were adjusted to remove an erroneous reading and are given in figure 11. A sensitivity analysis indicated that when the values for the wheel loads were changed to those recorded, the derailment became more likely.

Figure 10: Sidebearer and packings fitted to leading left side of wagon 610117

1. *The purpose of this recommendation is to put in place a clear and consistent set of instructions to maintenance staff on the measurement and rectification of twist in wagons.*

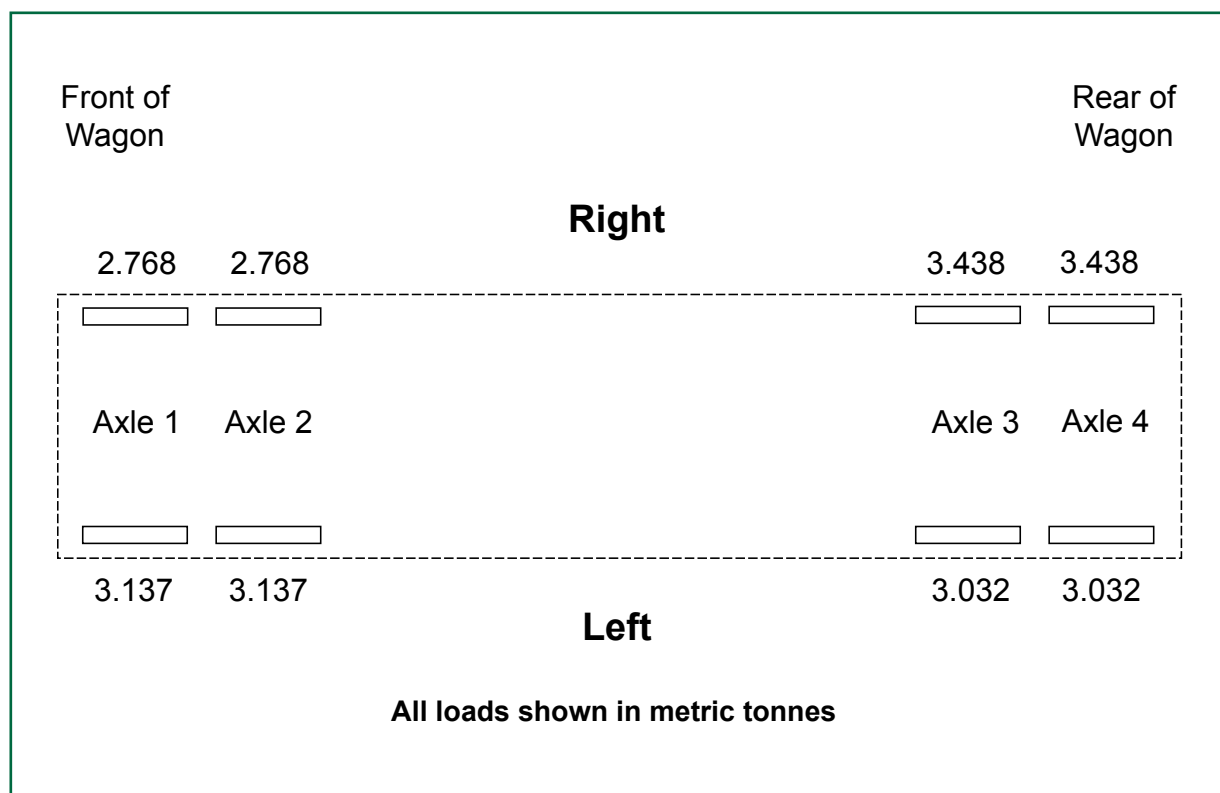
- 60 The computer simulation compared two vehicle models, one with the sidebearers set up to provide an even load on both sides of the vehicle, and one where the sidebearers were set up so as to produce wheel loads which matched those measured on wagon 610117 after the derailment. The wheel loads used are given in figure 11. The wagon with evenly loaded sidebearers was found to not derail when run over the track geometry measured at the site, even with the step in the running edge. The model with uneven loadings was predicted to derail shortly after passing the UIC60 to BS113A rail profile transition.

Figure 11: Wheel loads used in the dynamic analysis
