Rail Accident Report

Derailment of a Docklands Light Railway train near West India Quay station, London, 10 March 2009

This report is published by the Rail Accident Investigation Branch, Department for Transport.

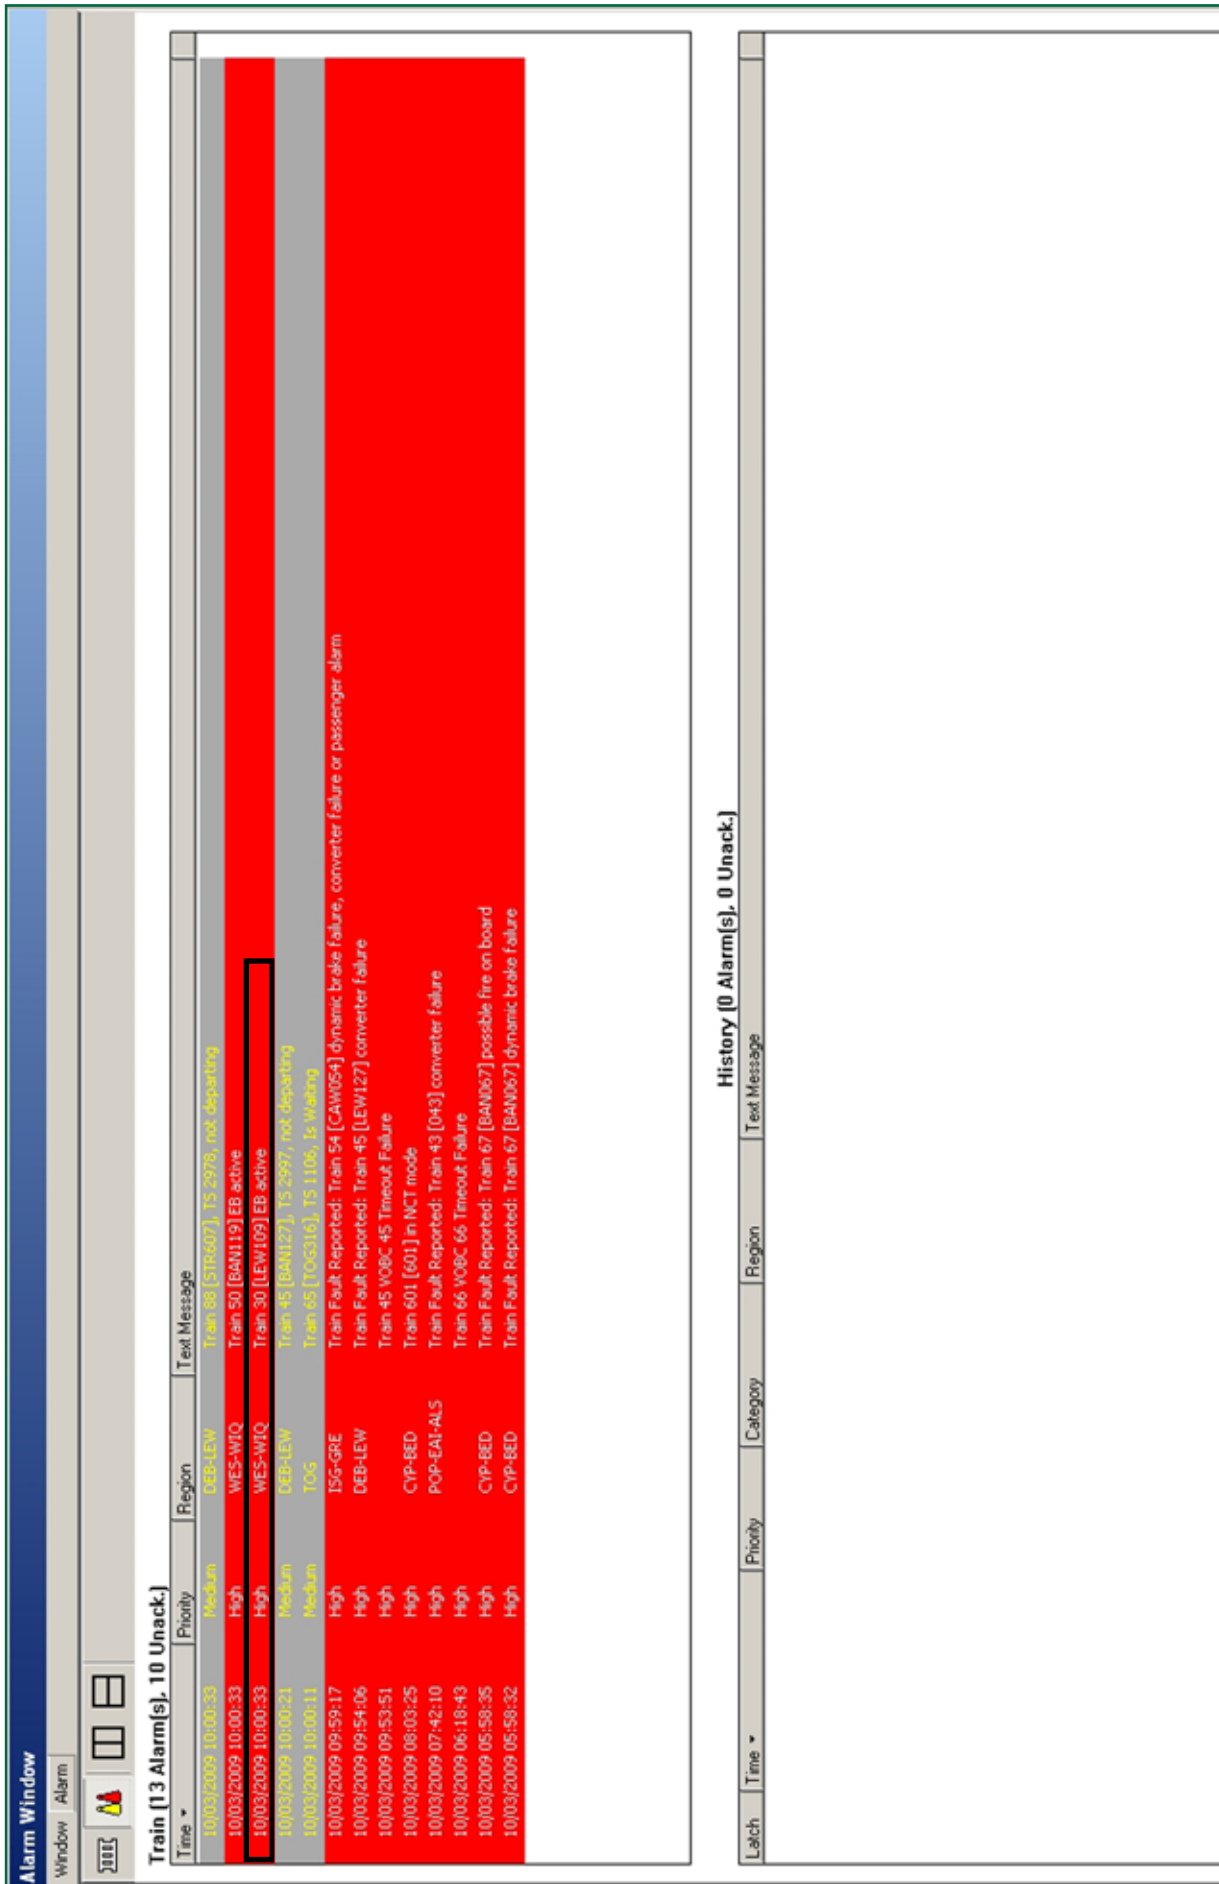
Figure 7: Alarm overview screen at 10:00:33 hrs displaying only high priority train alarms

- 84 Figure 7 shows the alarm screen, shortly before the derailment, that the controller had chosen to display with high priority train alarms only. All other alarms had been turned off. Train LEW109 emergency brake application (E.B. active) can be seen displayed at 10:00:33 hrs.

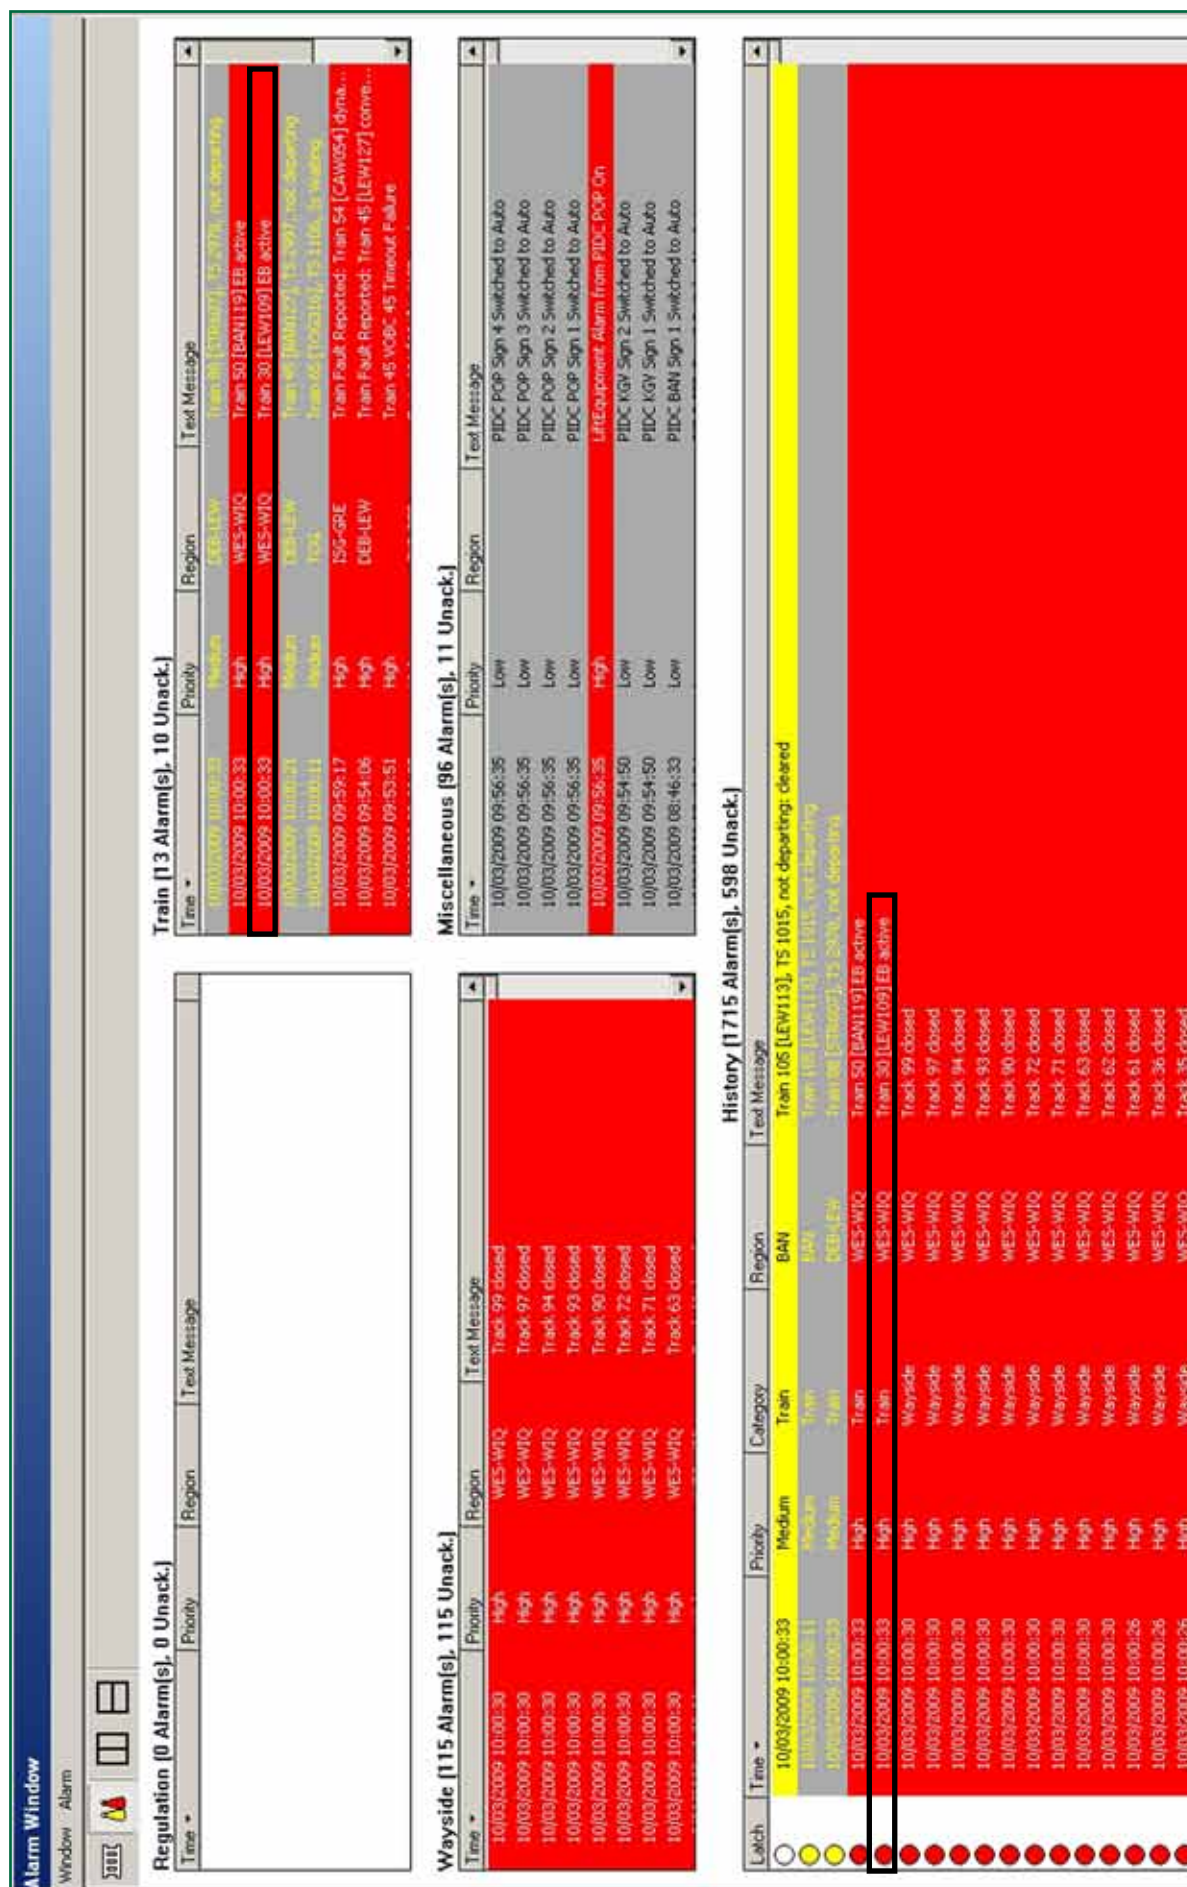
Figure 8: Alarm overview screen at 10:00:33 hrs displaying all alarms

- 85 Figure 8 shows the alarm overview screen that the controller could have seen at 10:00:33 hrs, if the screen had been configured to display all alarms. Train LEW109 emergency brake application (E.B. active) can be seen displayed at 10:00:33 hrs under both the train and history category headings on the screen.

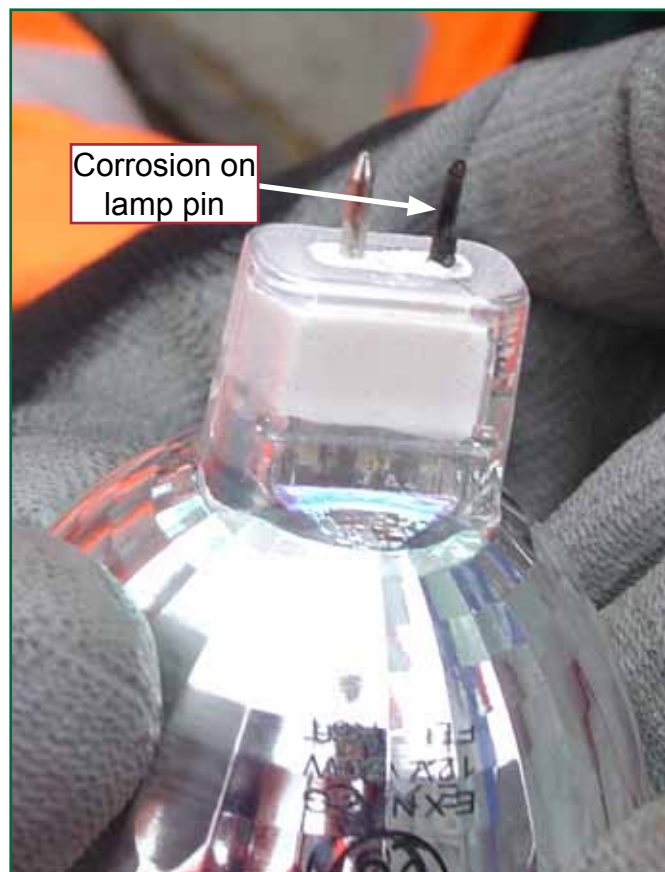
Figure 9a: Lamp from 1125B red bar indicator

- the poor conspicuity of point position indicators when unlit;
- the corroded pin of the lamp inside 1125B point position indicator;
- the maintenance organisation were unaware of the unlit 'red bar' lamp;

- 115 1125B point position indicator is approximately fifteen years old. It is a signal that uses a separate 12 V, 50 W halogen lamp to illuminate each of the two possible indications: a white arrow when points are detected in the normal position and a red bar when the points are not detected in the normal position.
- 116 The status of lamps is monitored by the SMC system in the control centre.
- 117 Following the derailment, the RAIB found that the lamp associated with the illumination of the red bar indication was not functioning because one of its connection pins was corroded (figure 9a).

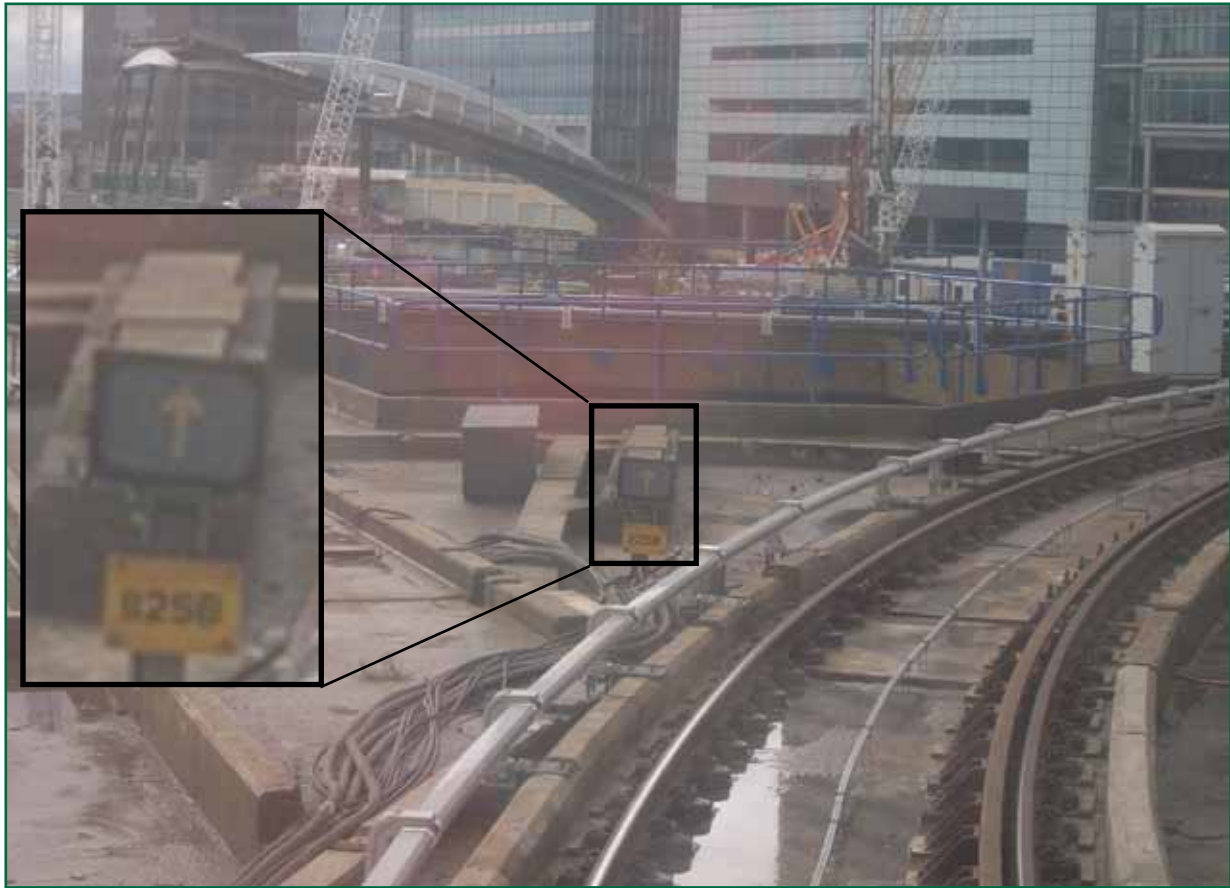
Figure 10: 1125B point position indicator displaying a white arrow and viewed from a stationary train in approximately the same position as train LEW109 was after emergency braking

- 121 Following the derailment on 10 March, the 1125B point position indicator was removed from site for further testing. A replacement indicator (of the same type) was installed and photographed with a white arrow displayed. Figure 10 shows the 1125B indicator, displaying a white arrow, as viewed from a test train that was located at the approximate position occupied by train LEW109 after the emergency brakes had applied.

- 123 There is no evidence to suggest that sunlight either behind or reflecting onto the front of 1125B point position indicator could have made the white arrow difficult to see.

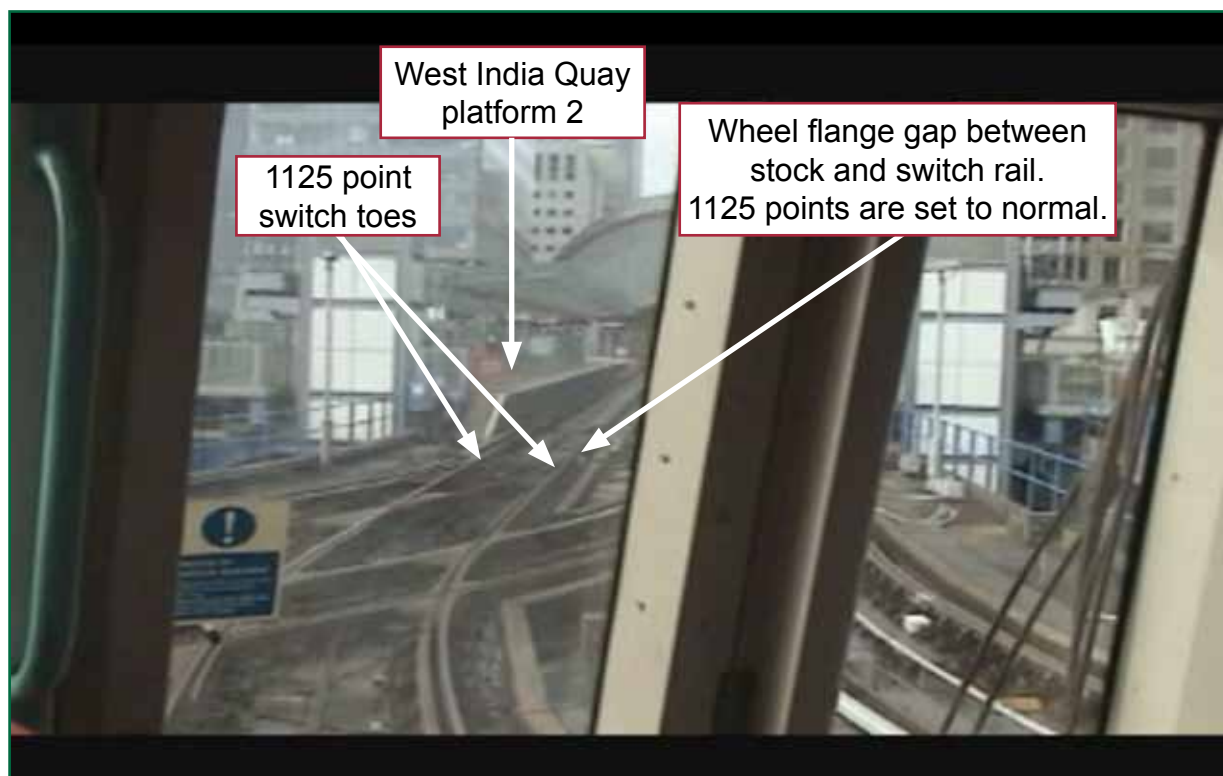
Figure 11: 1125 points set normal showing position of switch rails. Photograph taken from a test train approaching West India Quay, platform 2

- 127 At the time of the derailment, 1125 points were maintained at 6 weekly intervals by teams of technicians who undertook their visits at night when passenger trains were not running. The maintenance visits also included the three associated point position indicators; 1125A, B and C. The maintenance of the points involved checking (which included the points being moved between the normal and reverse positions) and repairing as necessary.
