Rail Accident Report

Bridge strike and road vehicle incursion onto the roof of a passing train near Oxshott Station 5 November 2010

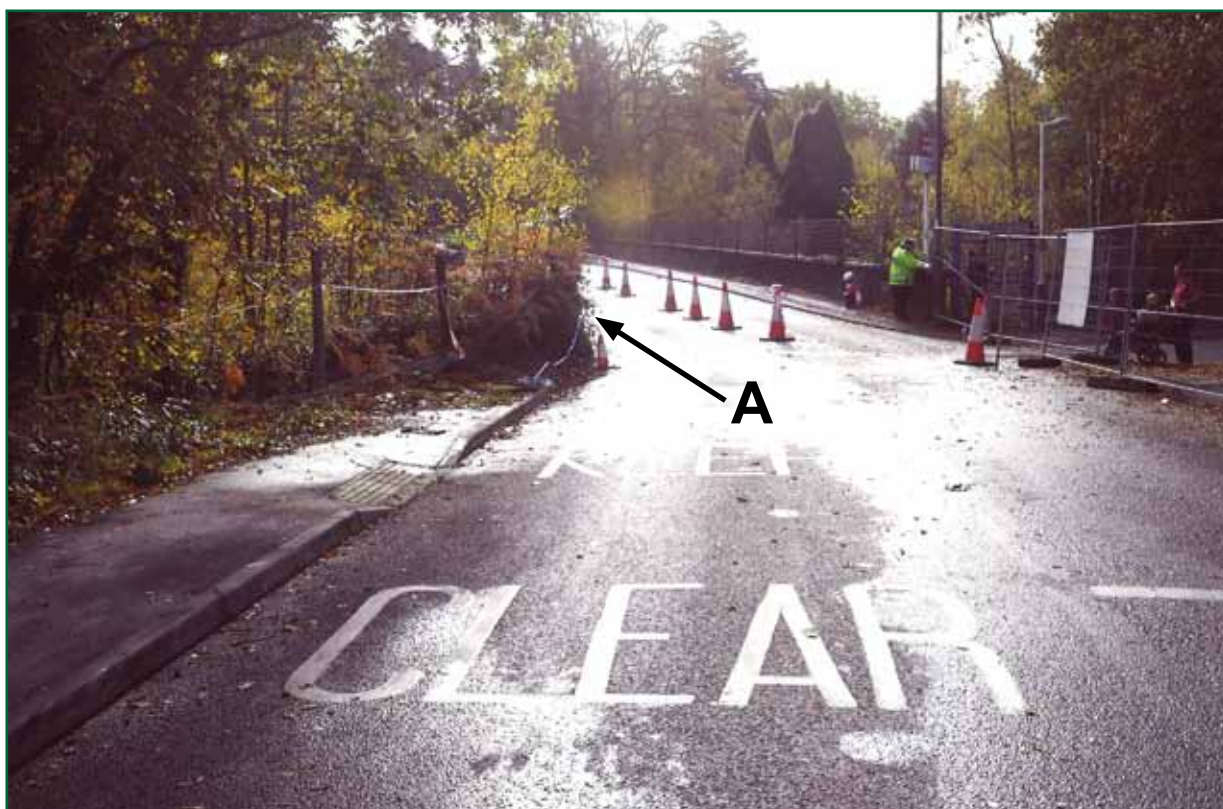
Figure 2: View of approach to bridge 11 for southbound traffic showing left-hand bend. The parapet end struck by the lorry is hidden by vegetation, and is marked 'A' (photograph courtesy of Surrey Police)

- 50 The parapet end was obscured by vegetation growth on the inside of the bend (figure 2), and a reflective marker at the parapet end was missing after its supporting post had collapsed as a result of previous damage. These defects were not identified during routine highway safety inspections and as a consequence, no corrective action had been taken or was planned.

- 1 *The purpose of Recommendation 1 is to promote the checking of visibility markings associated with road bridges over railways as part of the existing highway safety inspection regime.*

Surrey County Council should reinforce the requirement for regular checks to be made (for example, as part of safety inspections carried out by staff on the condition of highways) of the ends of parapets on bridges over railways to ensure that, where provided, markers or markings are maintained in good condition and free from obstruction by vegetation or other material. Any signs of damage should be reported to the risk owner for appropriate action (paragraph 98a).

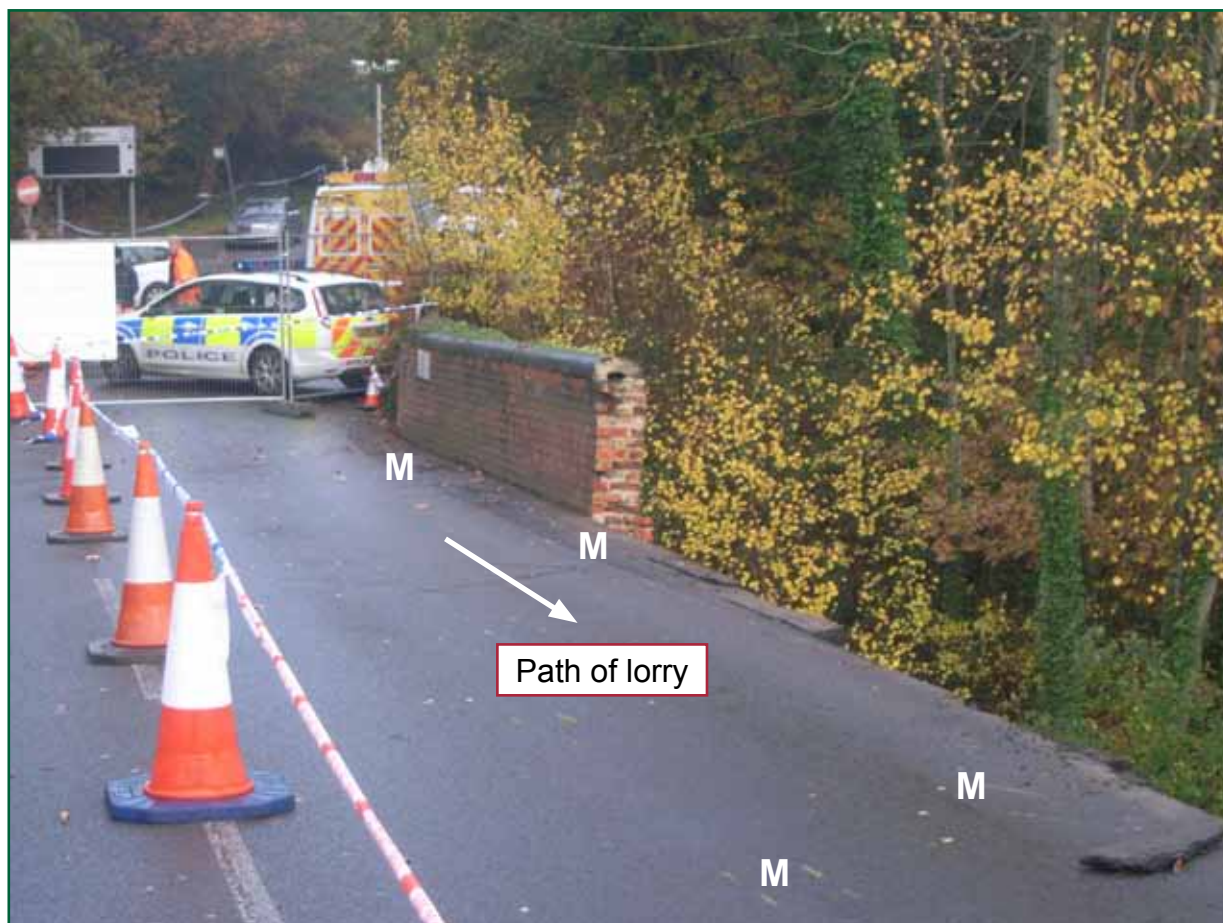
- 32 Skid marks on the road surface indicate that the lorry continued to travel close to, and parallel with, the east parapet for a further 10-15 metres. The lorry then steered slightly to the left and collided with the side of the parapet. The parapet broke off below road level, leaving an unprotected edge (figures 5, 6 and 12). The lorry's left-hand wheels slipped over the edge, dragging the vehicle sideways to the left.

Figure 5: Photograph of bridge deck showing missing section of parapet and skid marks denoted 'M'

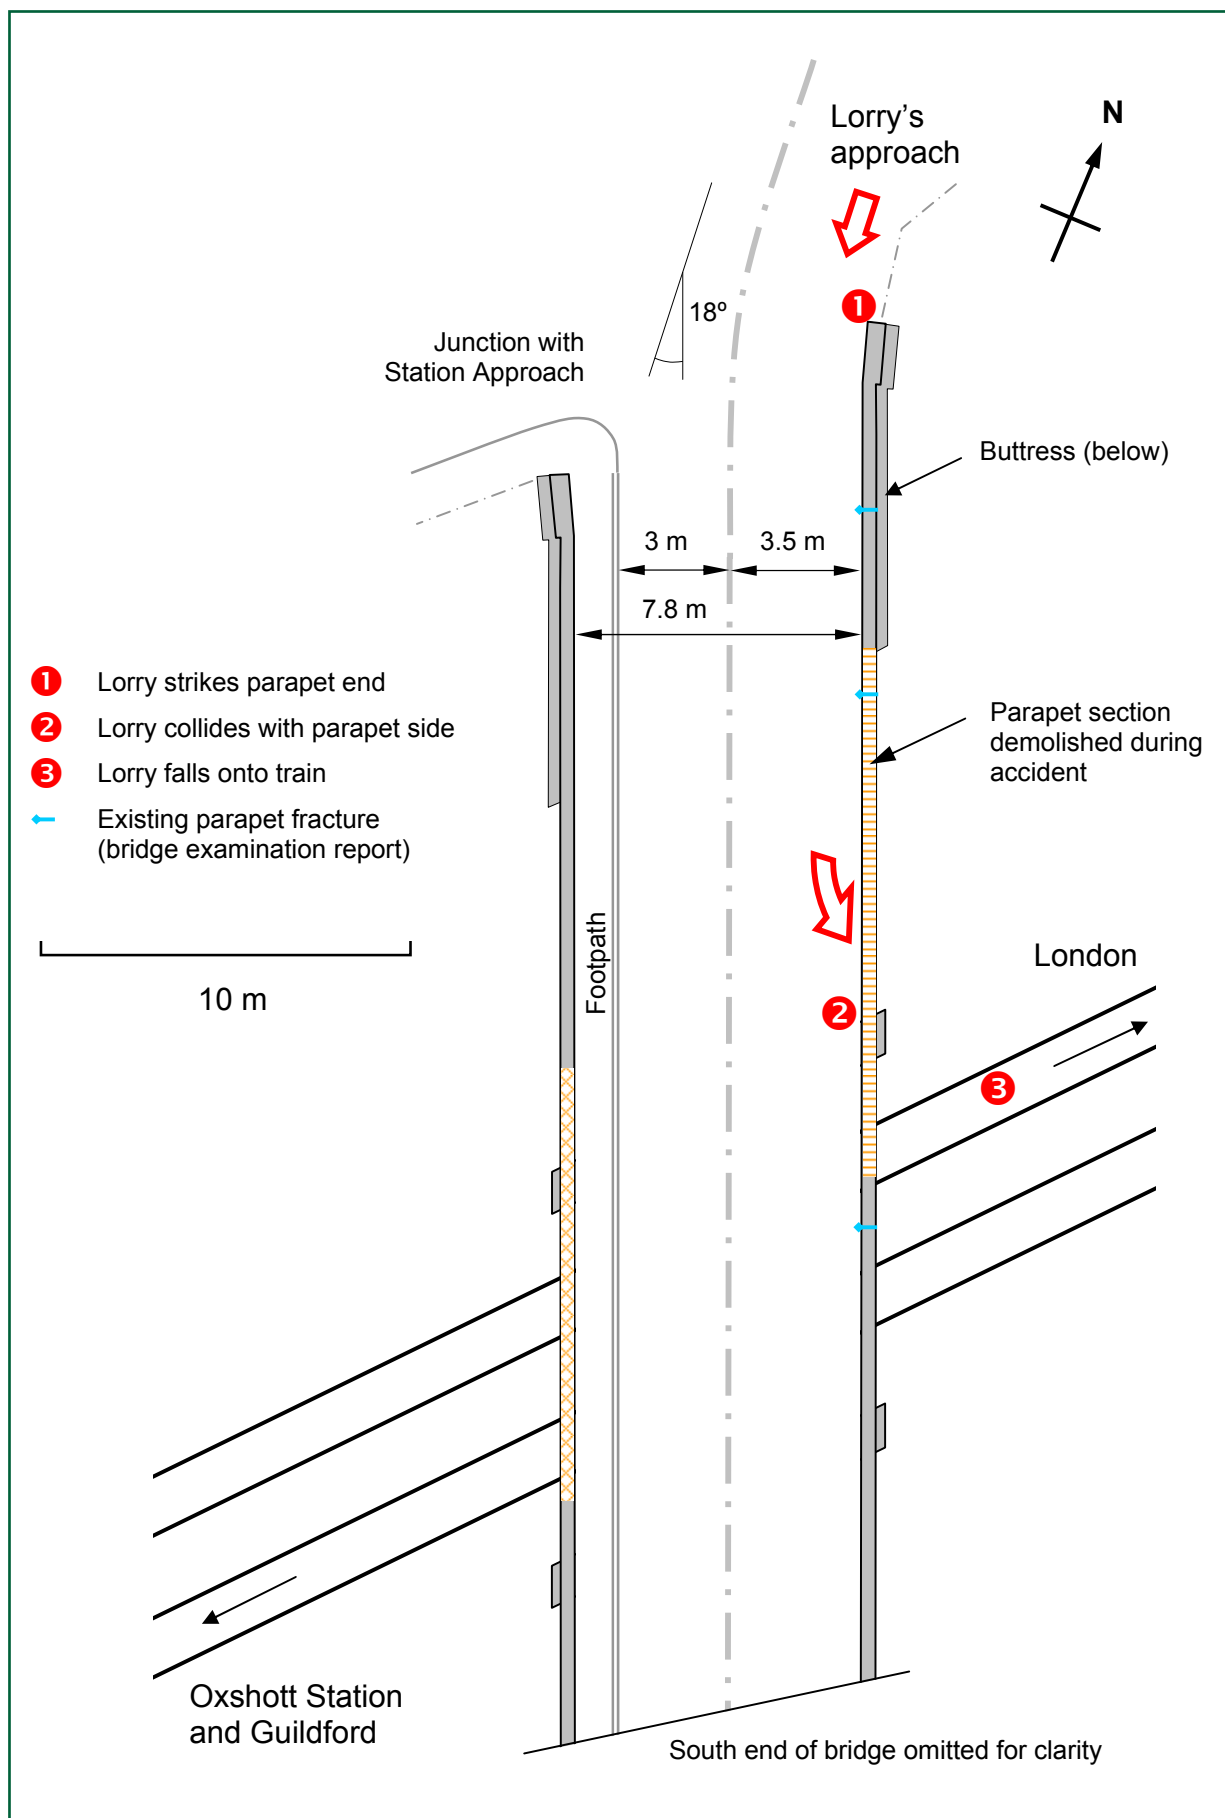
Figure 6: Schematic diagram of bridge deck showing path of lorry

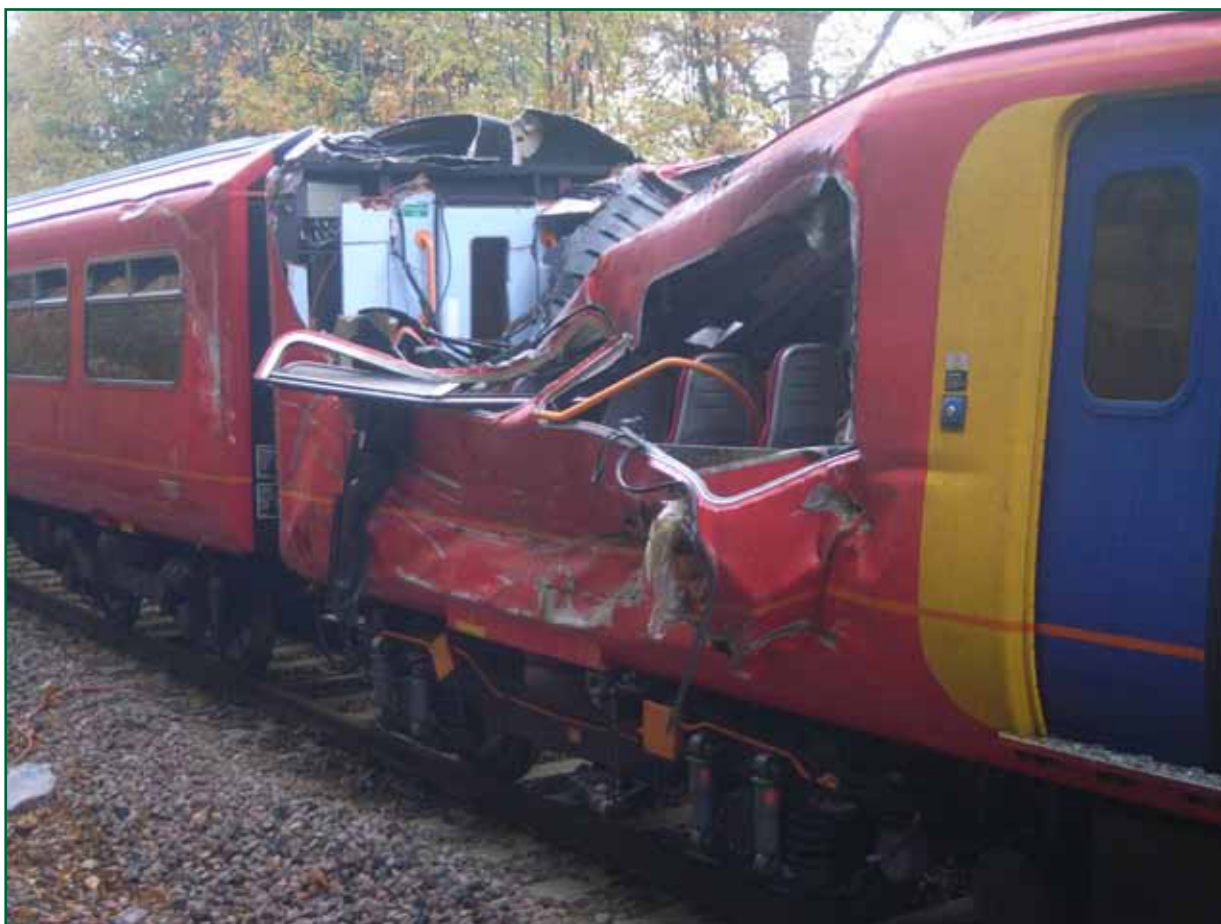
Figure 7: View of coach 6 (leading end) which sustained a vertical impact from the falling lorry

- a. The roof structure on coach 6 took the brunt of the impact with the lorry which landed on the leading end of the vehicle offset to the left-hand side in the direction of travel. As a result of the impact, there was extensive damage to the roof and bodyside structure on coach 6.

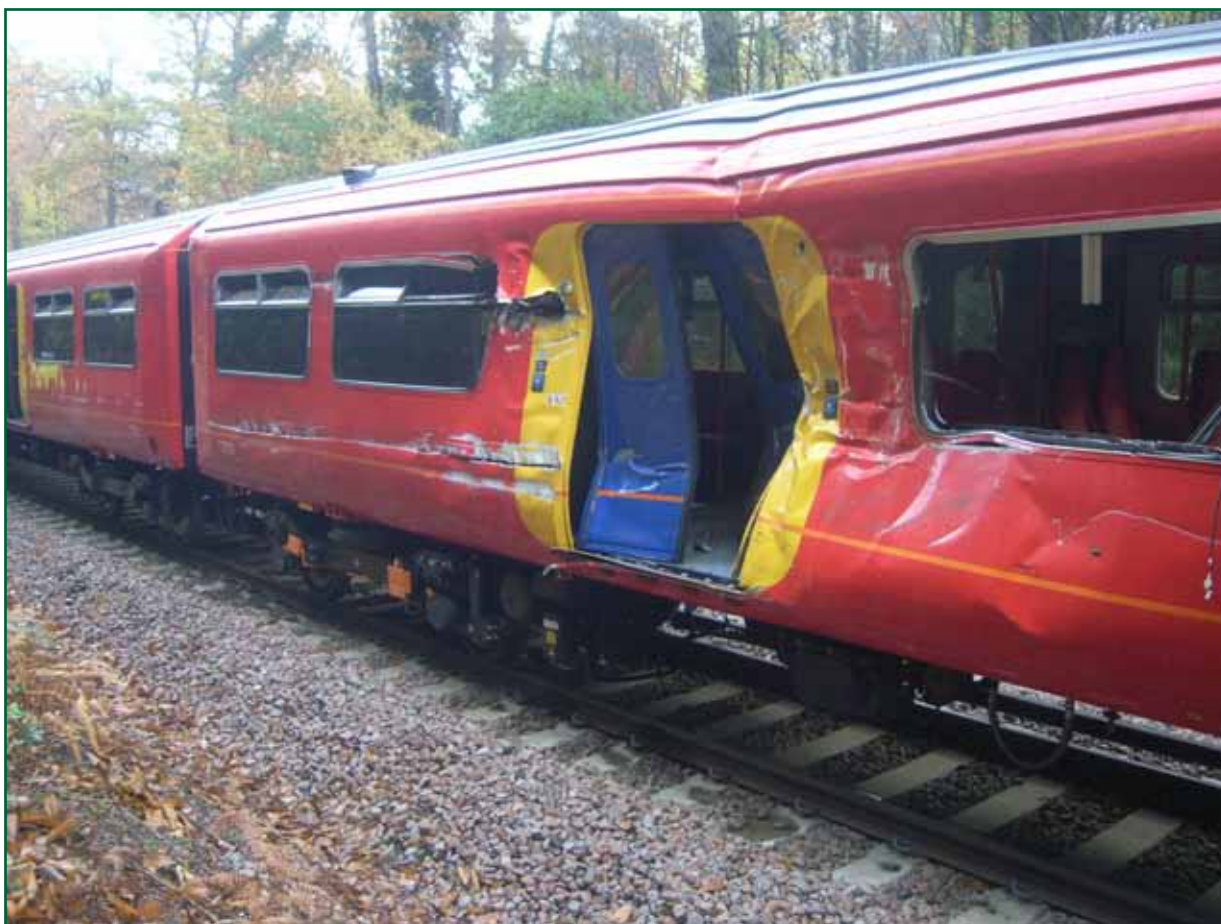
- 38 The most severe secondary impact occurred to coach 8. The disintegrating lorry chassis made contact with the leading doors of coach 8 causing significant damage and intrusion into the passenger area (figure 8).

- 39 The lateral force imposed on coach 8 was sufficient to move the track approximately 350 mm to the right, and towards the down line (figure 8). The rear bogie of coach 8 was knocked off the rails and landed 300 mm to the right. The train remained upright throughout.

Figure 8: View of coach 8 which sustained a side impact from the disintegrating lorry chassis

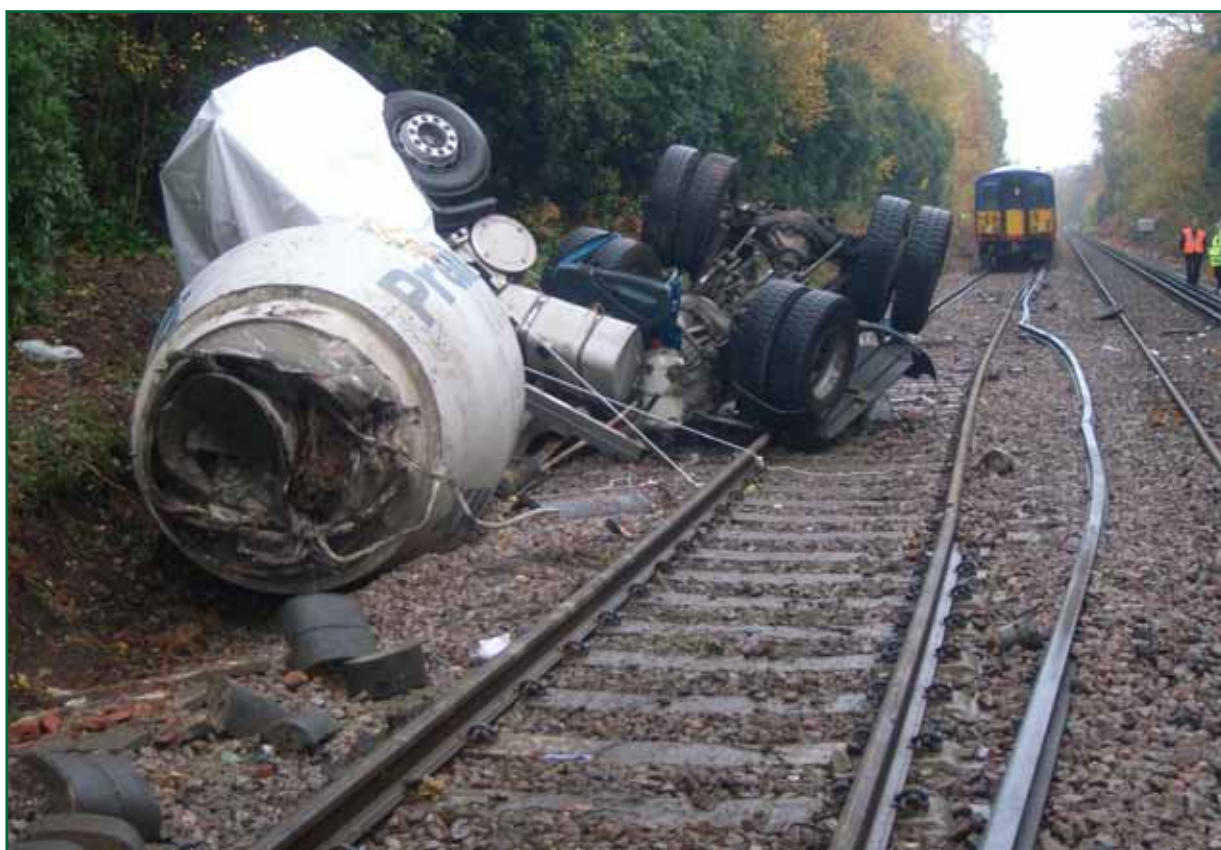
Figure 9: View of damaged lorry and train. Note displaced track and conductor rail

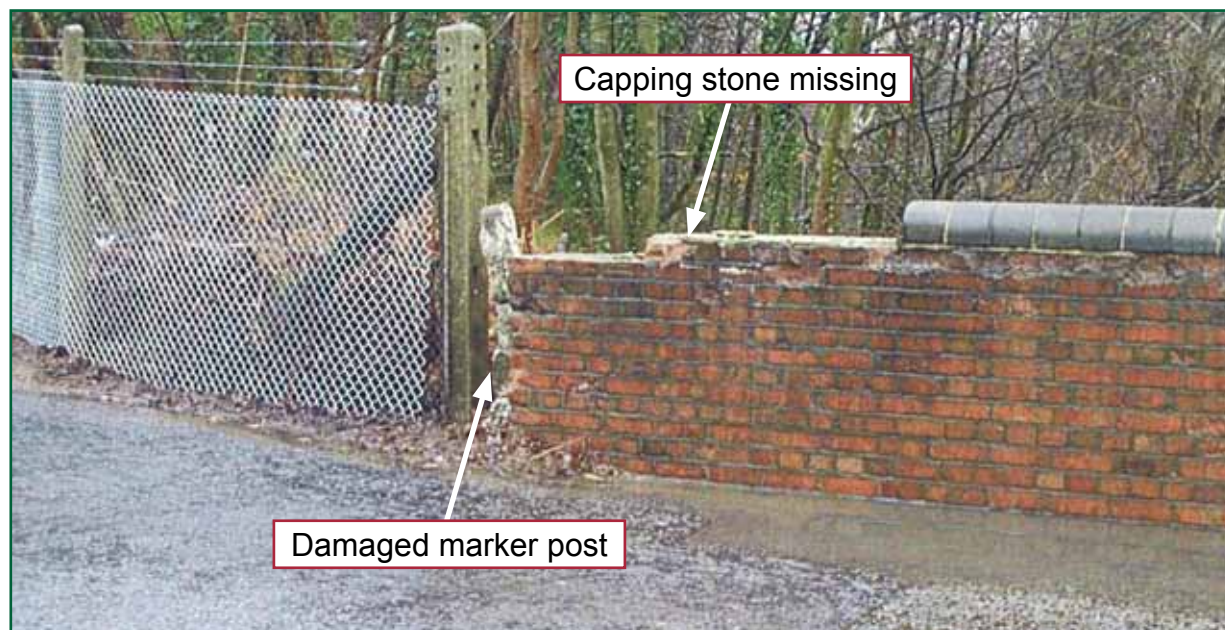
- 55 The reflective marker was present although its supporting post was in poor condition in a photograph taken for Network Rail in January 2004 (figure 10). It was still present in a photograph taken when the bridge had its detailed examination in August 2006. However, there is no reference to signing or vegetation in the three-monthly highway safety inspection reports between August 2006 and August 2010, and the RAIB has not been able to determine for how long the reflective marker had been missing prior to the incident.

- 74 The same capping stone was knocked off during a collision between a car and the parapet end in December 2003. A bridge strike report, commissioned as a consequence of this event, included a photograph noting 'new and longstanding damage' to the parapet end (figure 10).

Figure 10: Photograph of the north end of the east parapet showing 'new and longstanding damage' after a similar collision in December 2003 (photograph January 2004, courtesy of Network Rail)

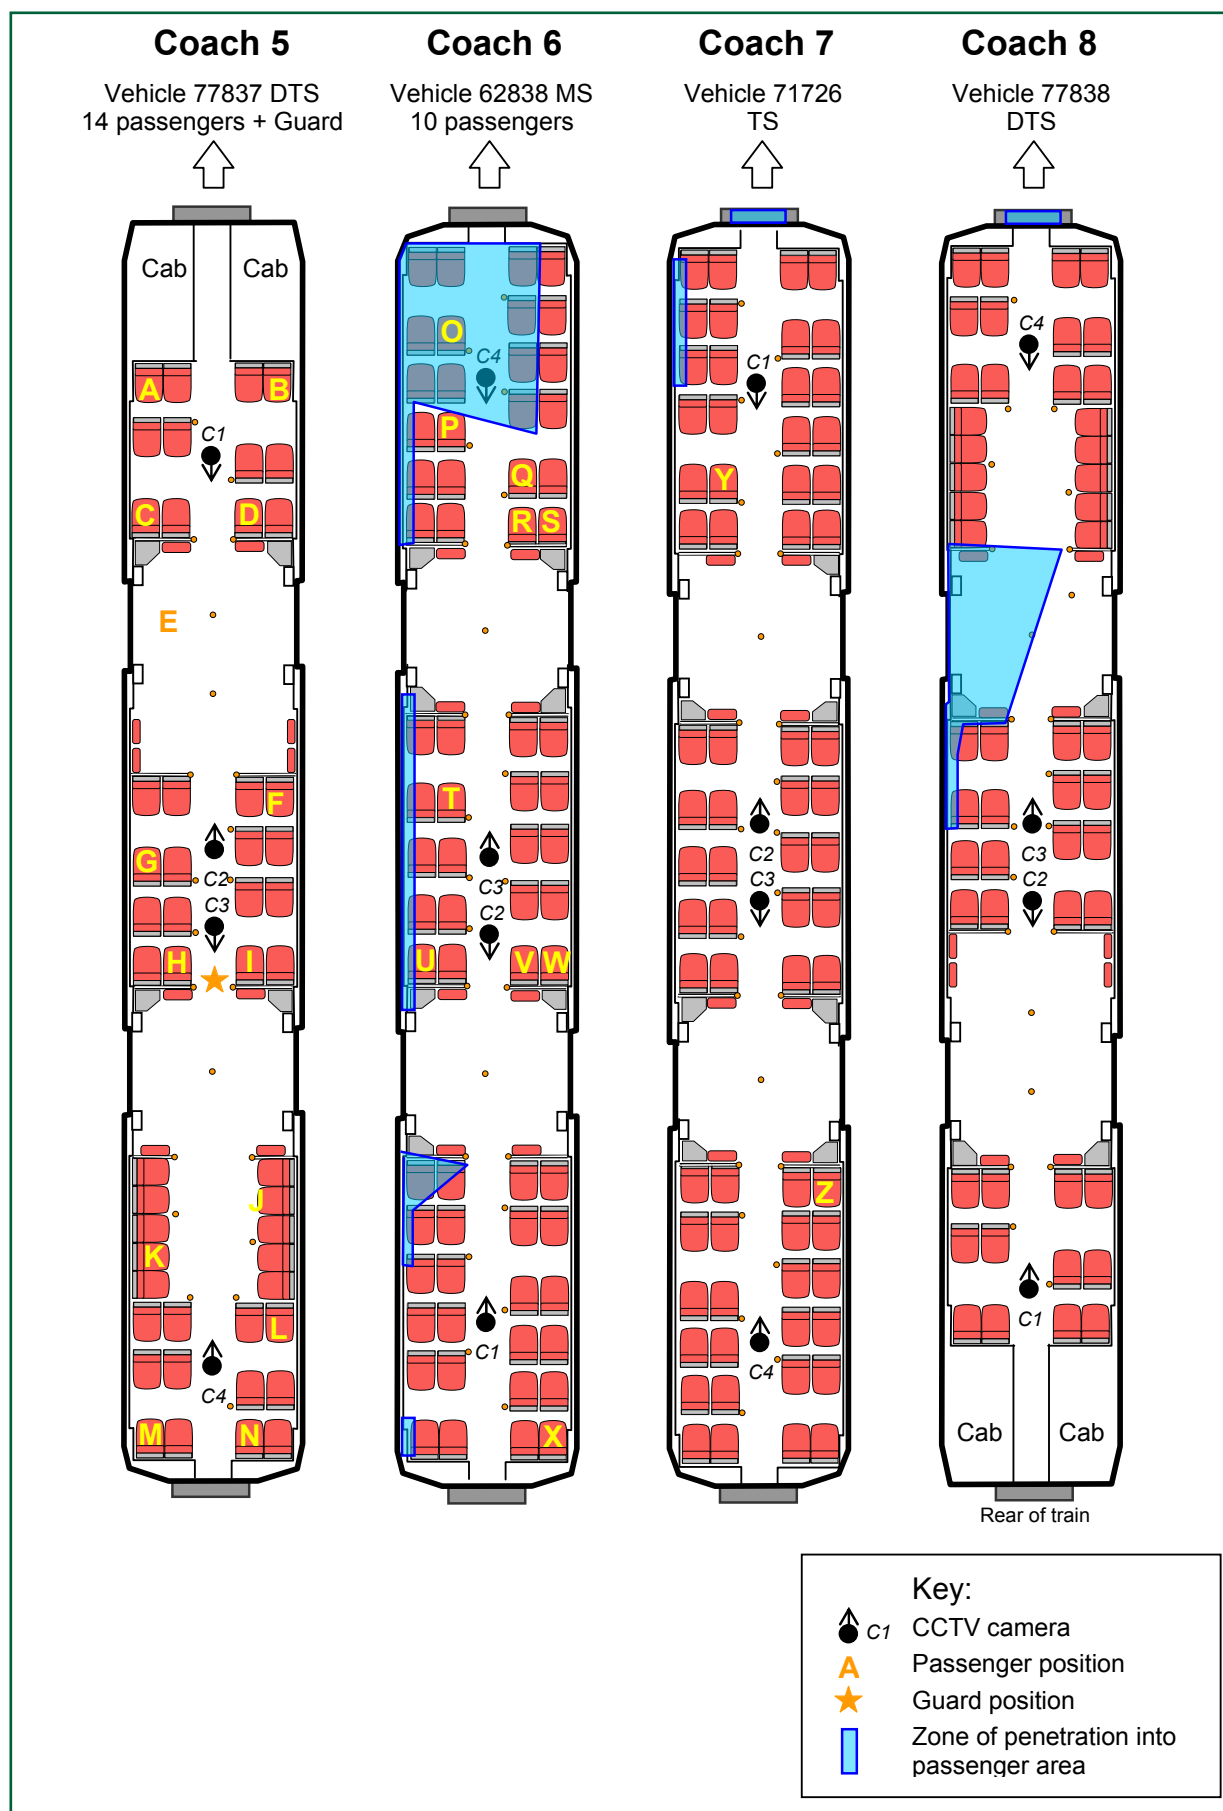
- 36 Four of the five passengers travelling in the leading end of coach 6 were able to escape from the damaged part of the train without assistance. The fifth passenger was trapped. This person, a 60 year old male, sustained serious injuries including fractures to his lumbar vertebra and hip. A further ten seats in coach 6 were affected by bodywork distortion or flying debris. None of these seats was occupied (figure 11).

Figure 11: Diagram indicating the extent of damage to unit 455913 and the position of passengers on the train

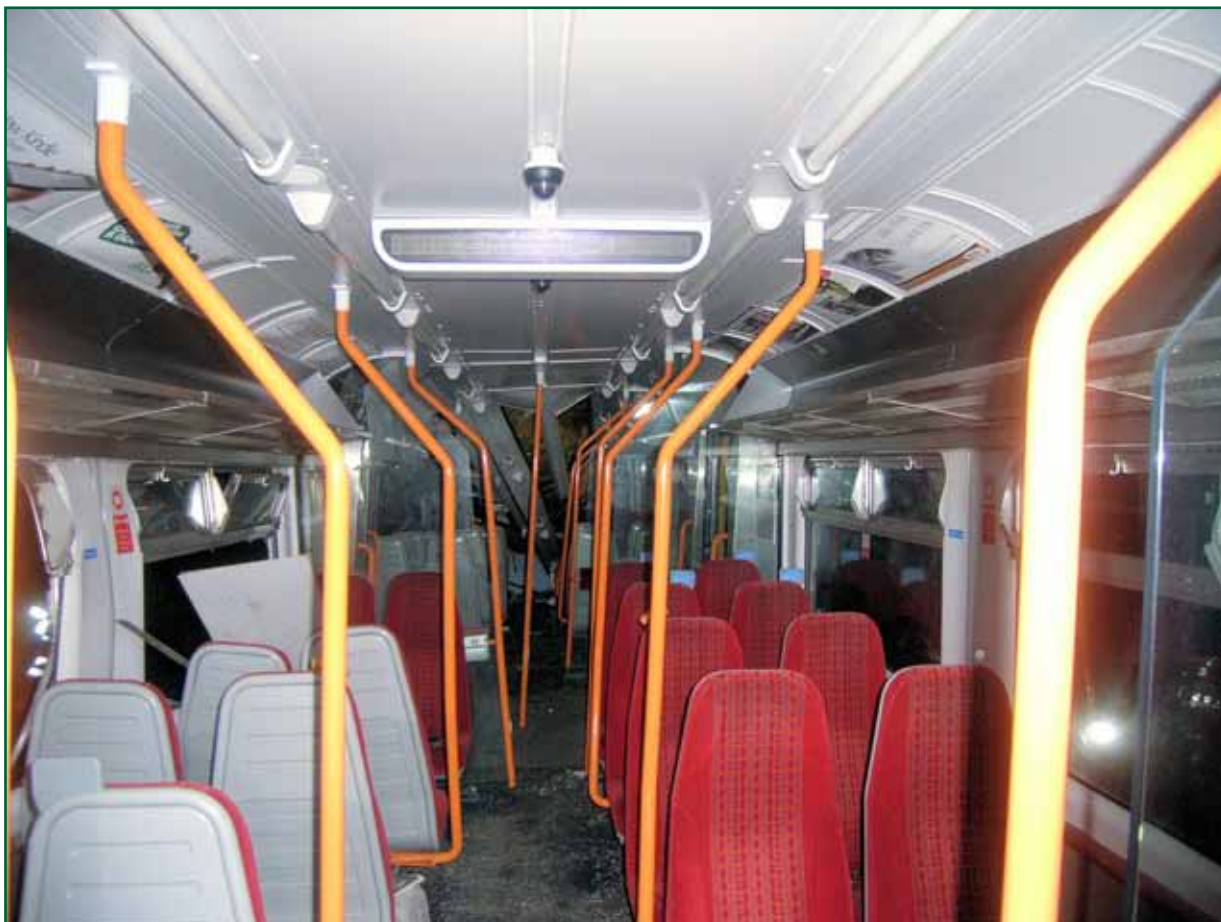
Figure 12: Internal view of coach 6 looking towards the front of the train

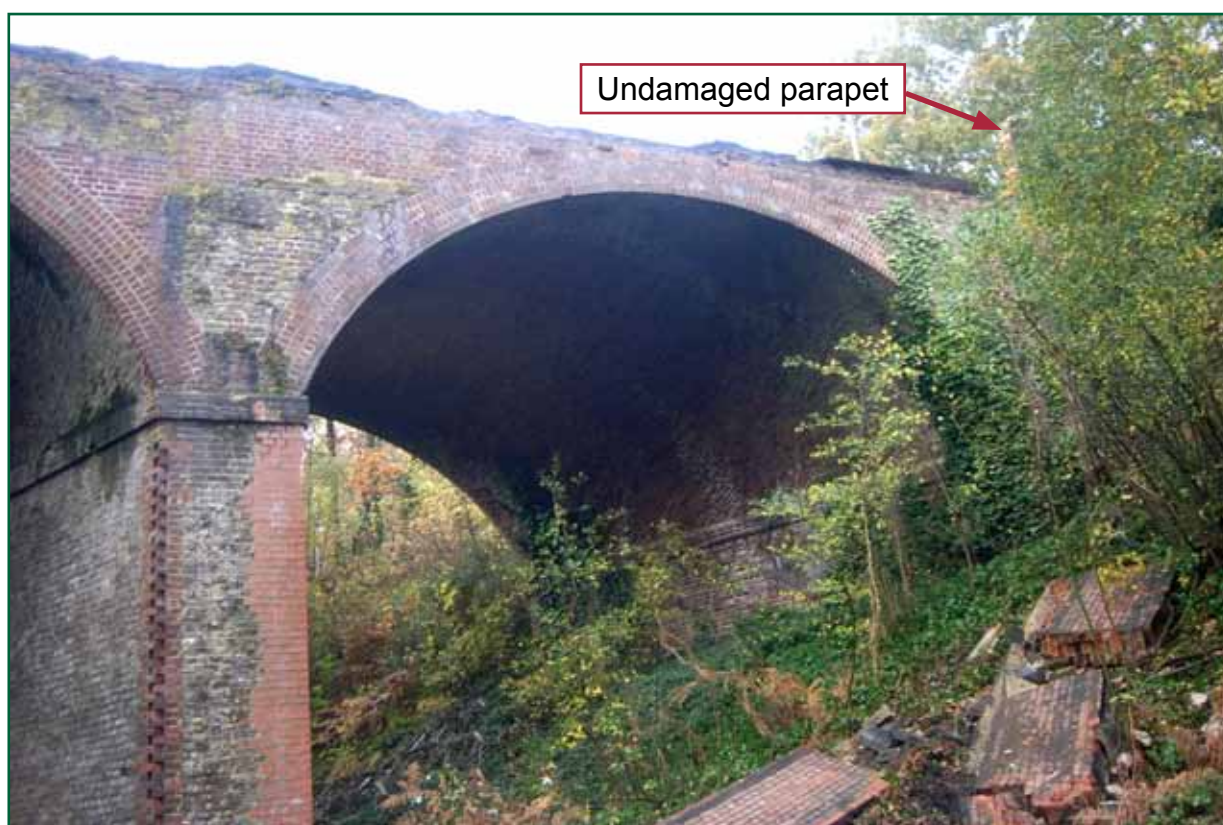
- 33 The impact of the lorry demolished a 14.3 m section of parapet which fell from the bridge. Most of the brickwork fell onto the cutting slope, but some sections struck the roof and left-hand side of coach 5 of the train which was passing beneath the bridge at the same time. Within this coach, bags were knocked from overhead luggage racks, although there was no penetration of the passenger area or injury caused.
- 34 The lorry struck the upper left-hand corner (*cantrail*) of Coach 6 ahead of the leading doors (figure 7). The cantrail became detached from the *corner pillar* at the front of the coach and moved downwards and inwards with the deforming roof. This deformation caused the lorry to rapidly fall off the train to the left and onto the ground beside the track.

Figure 13: View of bridge and missing parapet from track level. The parapet fell in sections weighing up to 1800 kg
