No.: ŽS - 02/17

## FINAL REPORT ON ACCIDENT INVESTIGATION

Type of accident: Derailment  
Train No.: 62946  
Place: Belgrade, open railway line between Junction “B” and Junction “K”  
Date: August 16, 2017  
Time: 15:30

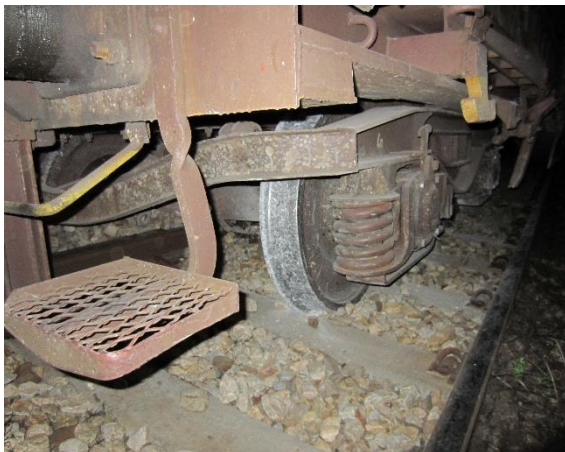
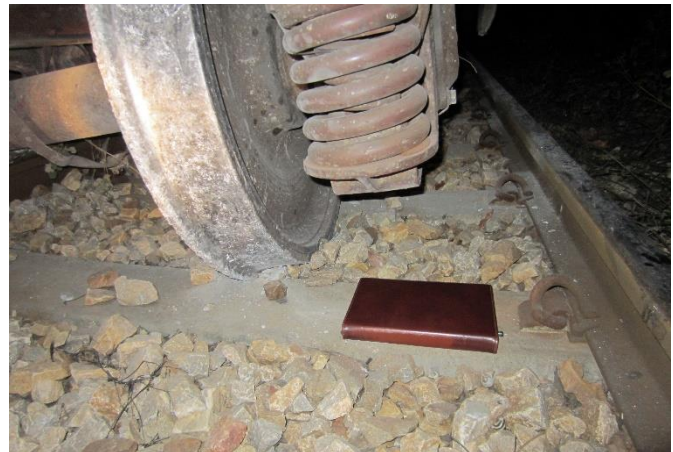
The derailed wagon was found at *km* 3+809 (front buffers of the wagon). The front bogie of the mentioned wagon derailed to the right side (when looking in the direction of the train movement), whereas the rear bogie was found on the rails. The wheels of the derailed bogie were found at a distance of 60 *cm* from the rails. On the derailed wagon damage was noticed on the derailed bogie and on the body of the wagon. The appearance of the front part of the derailed wagon is shown in figures 3.4.4.1 and 3.4.4.2.

**Figure 3.4.4.1:** Appearance of a part of the derailed bogie

**Figure 3.4.4.2:** Appearance of a part of the derailed bogie

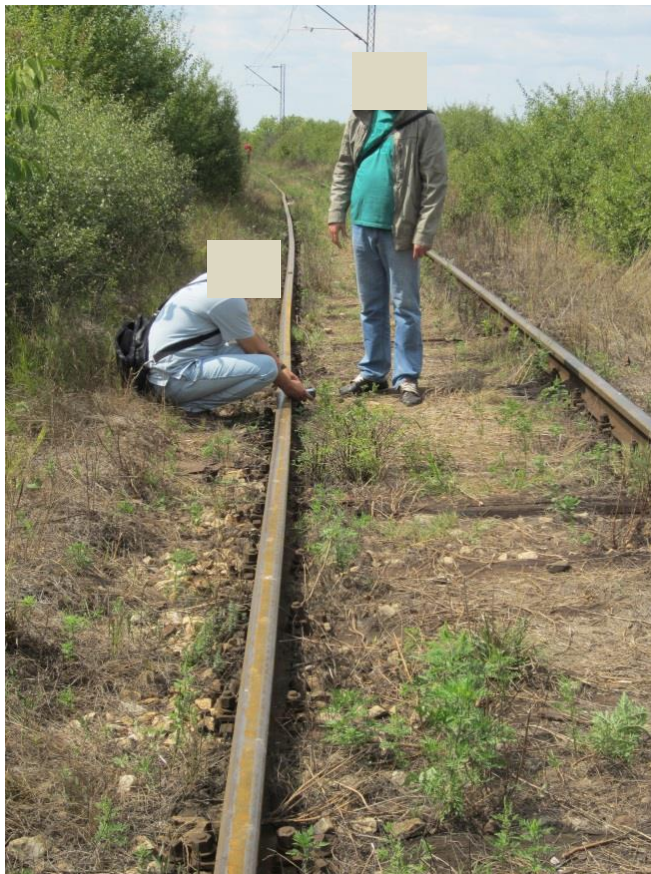
Figure 4.1.1: Point where the wheel fell into the track

The inspection on site and the submitted information no. 1/2017-4822 from August 18, 2017 from „IŽS“ a.d showed that the train was moving from Junction „K“ to Junction „B“. At km 5+678 (at the 4<sup>th</sup> sleeper after the catenary mast No. 98 in the direction of the train movement), in the left curve in the direction of the train movement,  $R=900\text{ m}$ , the first trace of the left wheel falling into the track was noticed, fig. 4.1.1. Immediately after that also twisted metal chips stemming from the wheel were found. The sleeper where the first trace on the rail and on fasteners was noticed was marked as sleeper 0 for the needs of this report (fig. 4.1.2 and 4.1.3). The next two sleepers in the direction of the train movement were marked as sleeper 1 (fig. 4.1.4) and sleeper 2 (fig. 4.1.5), and sleepers before sleeper 0 as sleepers -1, -2 etc, looking in the direction of the train movement. The sides of the sleepers were marked as L – left and D – right.

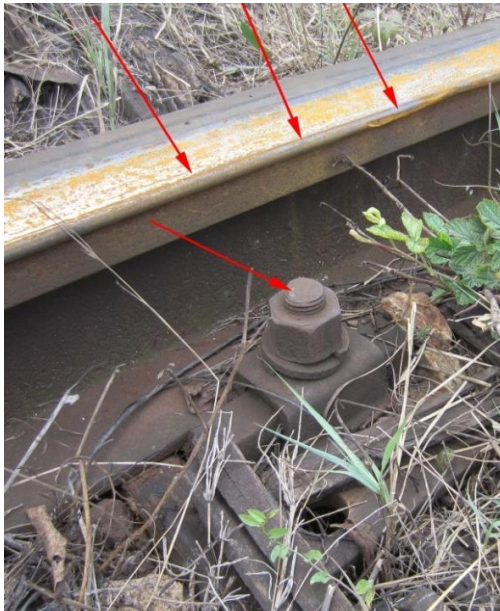
**Figure 4.1.2:** Traces at sleeper 0L

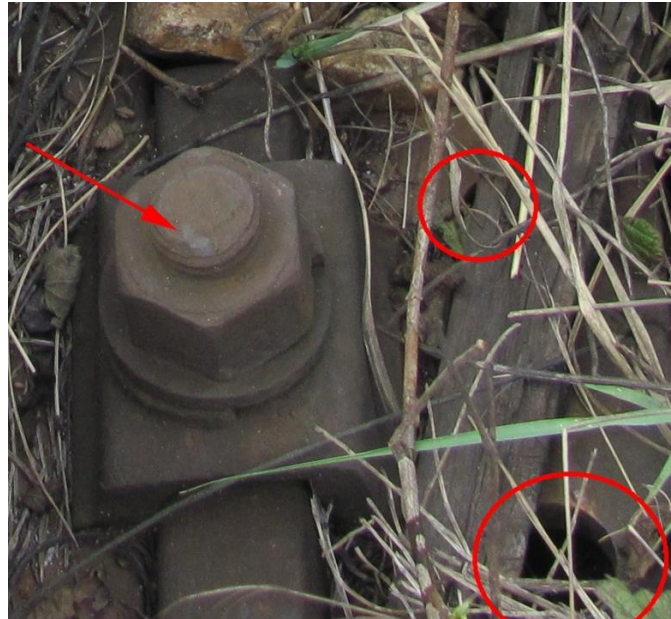
**Figure 4.1.3:** Condition of the sleeper and of the fasteners at sleeper 0L

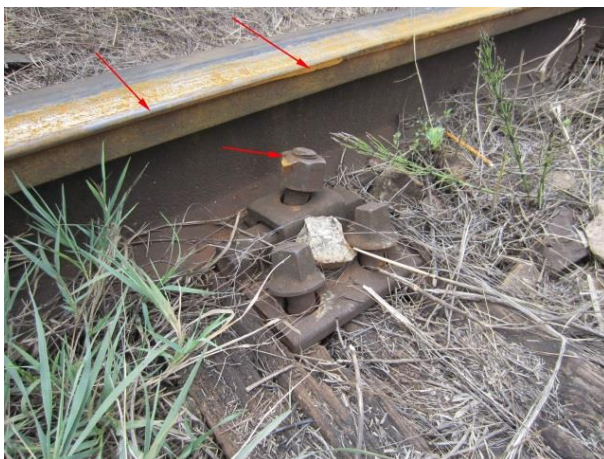
**Figure 4.1.4:** traces at sleeper 1L

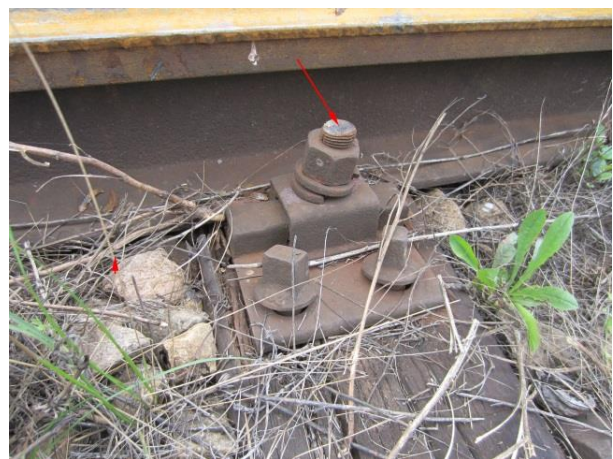
**Figure 4.1.5:** Traces at sleeper 2L

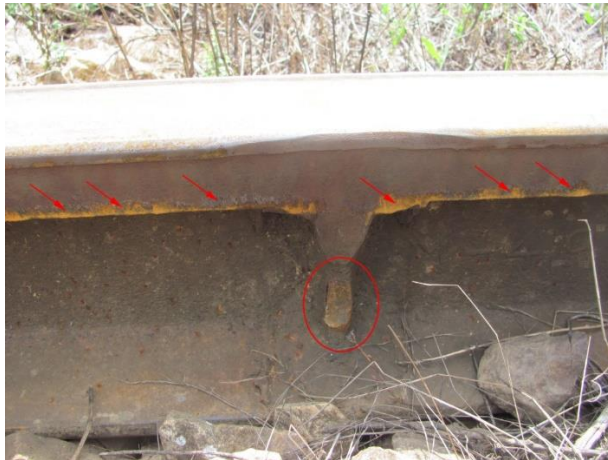
The left wheel continued to move within the track next to the left rail, and the right wheel continued to move on the rail. Such movement continued for the next 25 m causing the widening of the track from 50 to 60 mm, when the fallen left wheel hit the welded rail composition (traces in figure 4.1.6, recorded 12 days after the accident), which caused the right wheel to climb onto the rail and to move on the rail with the tip of the wheel flange (traces in fig. 4.1.7).

**Figure 4.1.6:** Traces on the left rail in the direction of motion, at 25 m after the point where the left wheel fell in

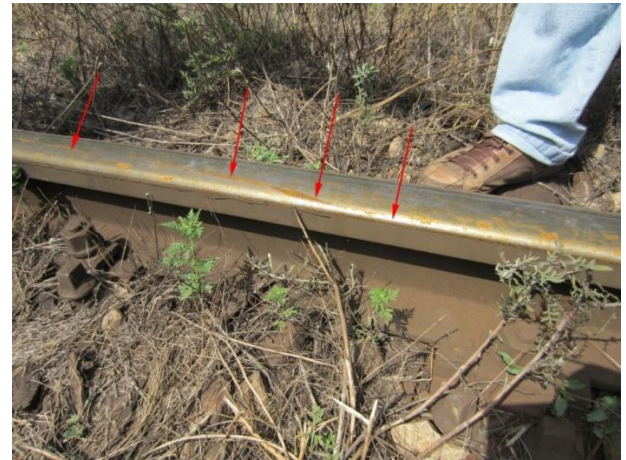
From that point the measured width of the track is within the permissible tolerance, therefore less than 35 mm because, consequently, the side force diminished. The right wheel was twisting, which is shown by the traces of movement of the wheel flange on the head of the rail and after 8 m (at sleeper 58 from the catenary mast No. 98) it returned onto the track, that is, it continued moving on the running surface. During that time the left wheel moved within the track next to the left rail. From the place where the right wheel went back into normal position and further on, it has been determined that the track widened by 60 mm as a consequence of the increase in the side force due to the fallen wheel.

**Figure 4.1.7:** Traces of the first derailment of the right wheel at 25 m after the point where the left wheel fell into the track

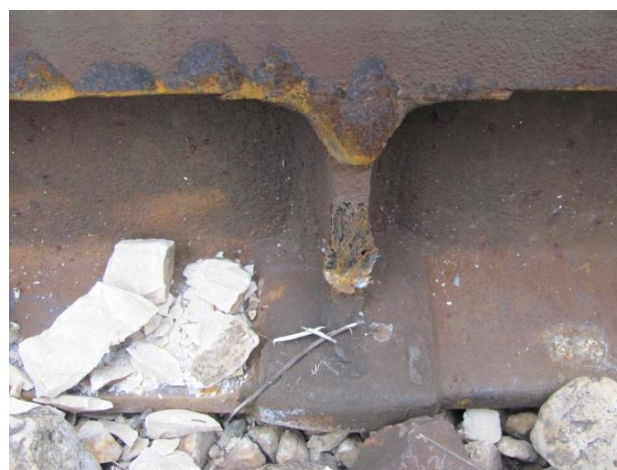
The second climbing of the right wheel onto the rail and the movement of the wheel flange on the rail head was noticed on the 119<sup>th</sup> sleeper after the catenary mast No. 98, that is, 70 m after the point where the left wheel fell into the track (km 5+608). The point is located 1.2 m after a similar welded composition on the left rail on which there is also a trace of impact of the left wheel (figure 4.1.8), so that the side force induced and increased in this way probably caused the wheel to climb onto the rail and after less than 2 m, that is, between the 121<sup>st</sup> and the 122<sup>nd</sup> sleeper, the right wheel to descend outside of the track. At that moment, the second axle in the direction of motion continued moving on the rail. Several tens of meters after that, due to the ejection of the protection, the train stopped (explained in more detail in item 4.2.1) and after that it started moving again.

**Figure 4.1.8:** Trace of the second impact of the left fallen wheel on the welded joint

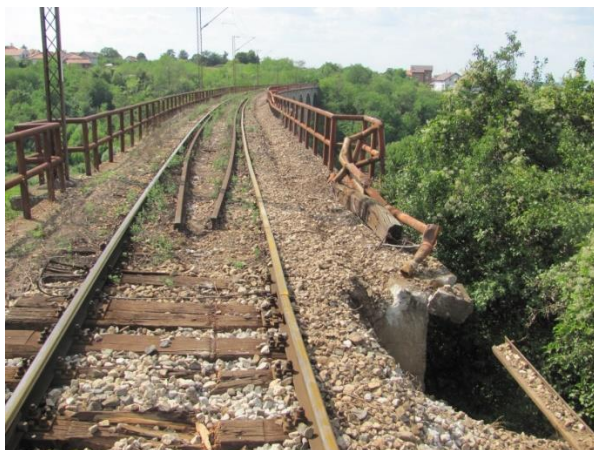
The derailed wagon hit later on, on the right side when looking in the direction of the train movement, into the beginning of the concrete structure of the bridge, after which it continued moving and damaged the fence of the bridge (figures 4.1.9 and 4.1.10). The train driver felt in that period a jolt and looked first through the left and then through the right window and saw the derailment, after which he initiated full application of the brake (Minutes from the interview with the train driver from August 23, 2017 for the case No. 38/2017-833).

**Figure 4.1.9:** Point where the wagon hit the beginning of the concrete structure of the bridge

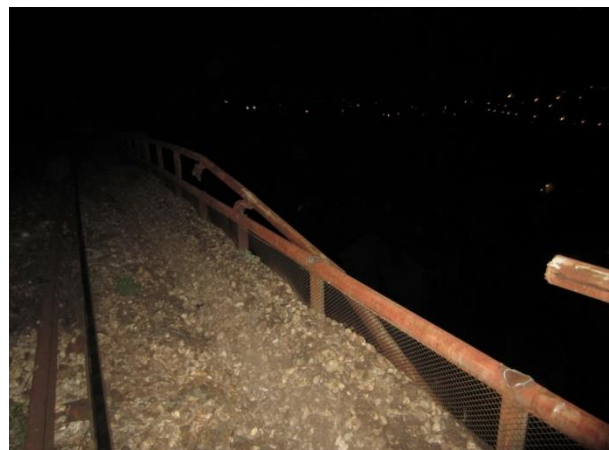
**Figure 4.1.10:** Damage to the fence of the bridge

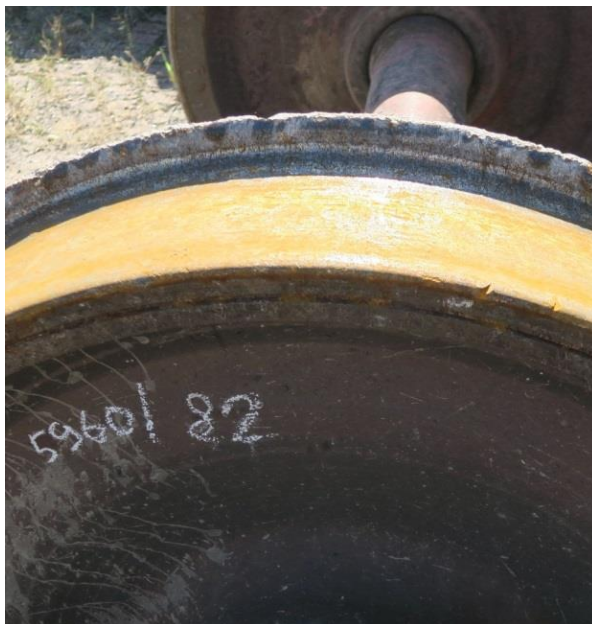
- The interior distance between wheels of axles 1, 2 and 3 are within permitted limits,
- On the fourth axle the wheels and the axle have been deformed due to the movement outside of the track and impact with the concrete structure of the bridge after the derailment, so the interior distance between wheels was measured in three sections as being unequal and not within permitted limits, in two sections „-“, and in the third in „+“.

- The exterior distance of flanges on axle 1 is within the permitted limits, on axles 2 and 3 it is below the lower permitted limit by 1 mm and 2 mm, respectively. On axle 4 due to deformations this distance cannot be determined. The exceeded permitted limits at axles 2 and 3 are not relevant for this case of derailment, but could be critical in other situations (going over crossings and turnout points).

Figure 4.2.2.1: Damaged flanges of wheels 3L

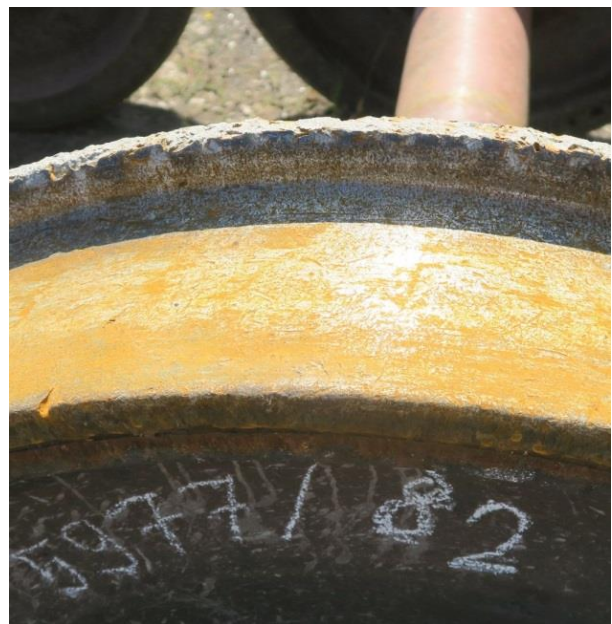
Figure 4.2.2.2: Damaged flanges of wheels 4L

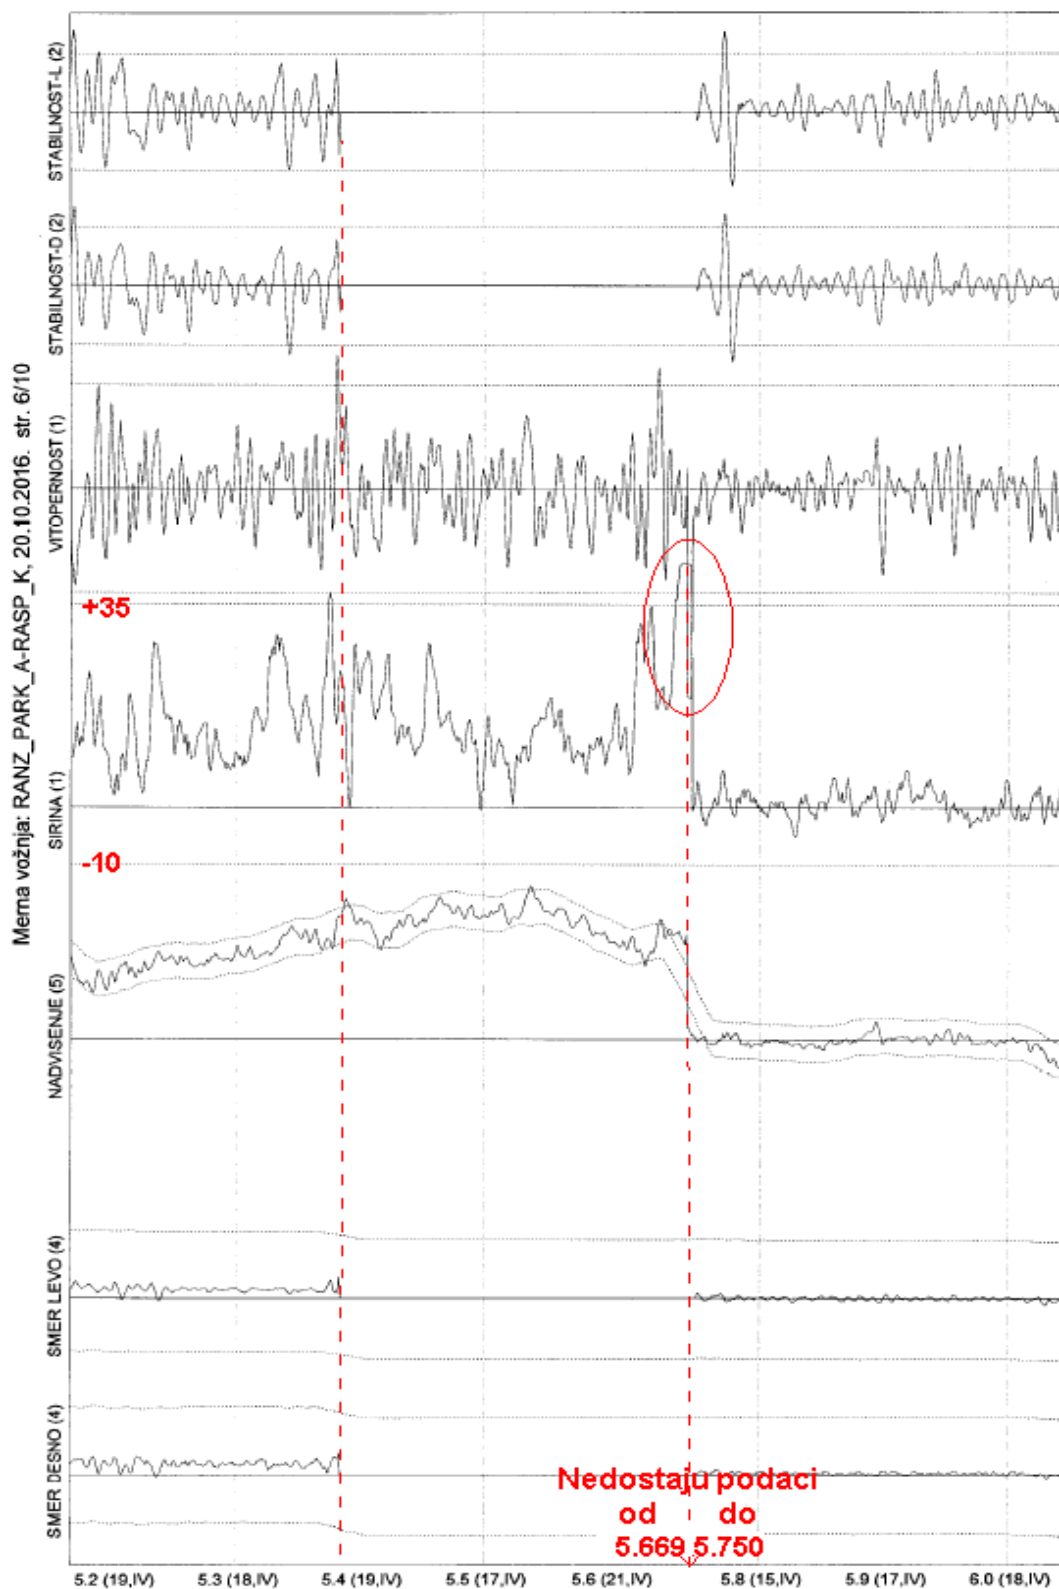
In figure 4.2.5.1 an excerpt from the records of the track recording wagon in the critical zone of the railway line from October 2016 is shown, and in figure 4.2.5.2. from April 2017. It has been noticed that the disturbance in the operation of the track recording wagon occurs at points where limit values are significantly exceeded, in particular for parameters „warping“ and „track width“. There is a very strong indication that the condition of the track in the zone where the wheel fell in is very bad, because the operation of the track recording wagon was disturbed in that same zone during two successive recordings and the critical zone was skipped during both recordings, due to the disturbance in the operation of the track recording wagon.

„IŽS“ a.d. submitted an analysis of the records of the track recording wagon, but not a report on measures taken after discovering irregularities during the recording with the track recording wagon. By comparing the two subsequent records it can be concluded that in the zone of the accident there has been no improvement of the track condition. In compliance with the effective Guidelines 339 (see item 3.3.5) the measure taken was the permanent reduction of speed to 20 km/h, and with this measure it is obviously not possible to prevent an accident.

**Figure 4.2.5.1:** Records from the track recording wagon from km 5+000 to km 6+000 from October 2016.

**SR\_04/17** “IŽS” a.d. shall prescribe in its internal documents that, if during the measurement using the measuring wagon, there is a disorder in the continuity of the measurement, the control of the superstructure parameters must necessarily be carried out at the site of the resulting disturbance and in the zone for which data are missing. The control aims to eliminate the cause of the measurement disorder and to check the condition of the superstructure, visual control and measurement of the superstructure parameters with alternative measuring devices. After removing the cause of the disorder, it is necessary to repeat the measurement with measuring wagon on that kilometre.

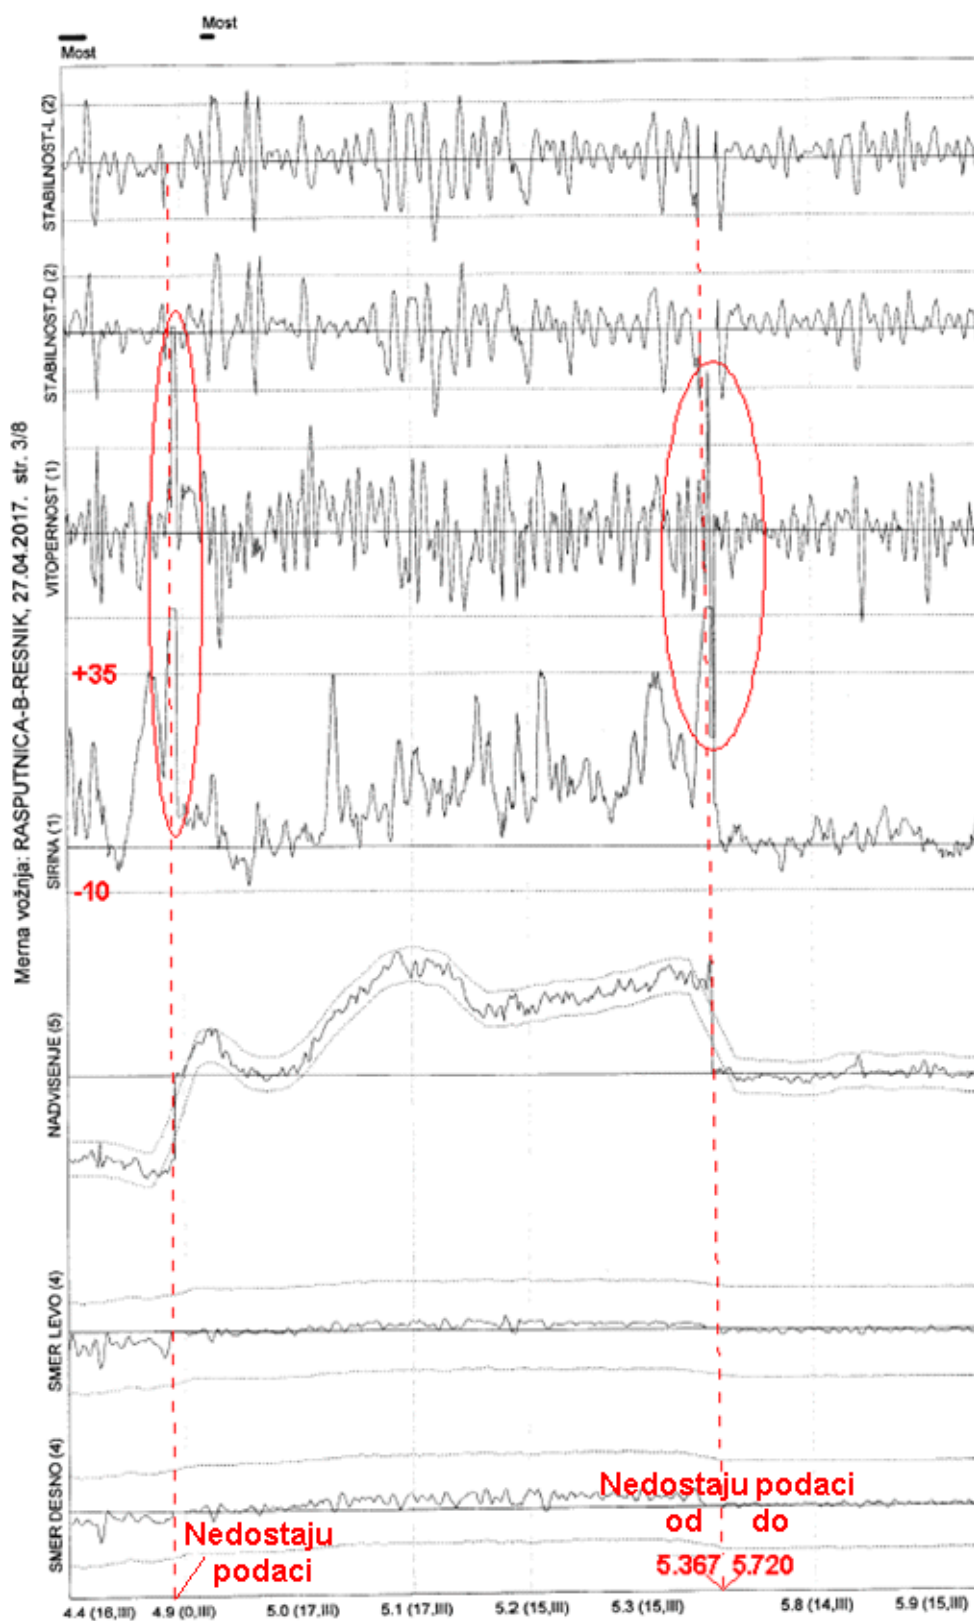
Figure 4.2.5.2: Records from the track recording wagon from April 2017

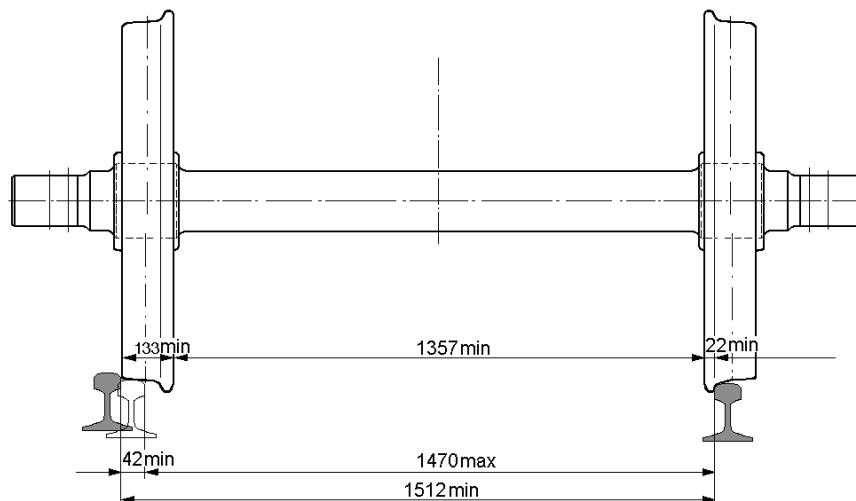
The falling in of the wheel into the track can occur due to the movement of wheels on the axle (weakening of the pressed set) and reduction of the inside distance between the wheels, or due to the moving apart of the rails. When inspecting the wagon, no movement of wheels on the axle was found and also no deviation of relevant dimensions over the permitted limits.

**Figure 4.2.6.1:** Conditions for the wheel to fall into the track

In figure 4.2.6.1 the special relation between the dimensions of the track and of the wheelset is illustrated that is necessary for the wheel to fall into the track, when the reference dimensions reach the permitted limits. It has been observed that it would be necessary that the rails move apart, due to loose or missing fasteners and fittings or rottenness of the sleepers, for at least 42 mm over the permitted limit of 1435+35 mm. The records of the track recording wagon show that on several points the widening of the track is above the operational limit of +35 mm, and at such points it is possible for the wheel to fall into the track even with a small additional moving apart of the rails.

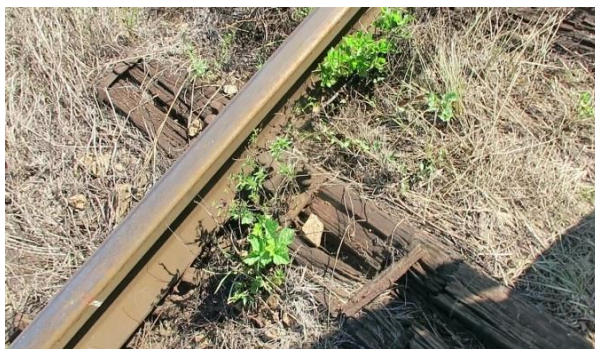
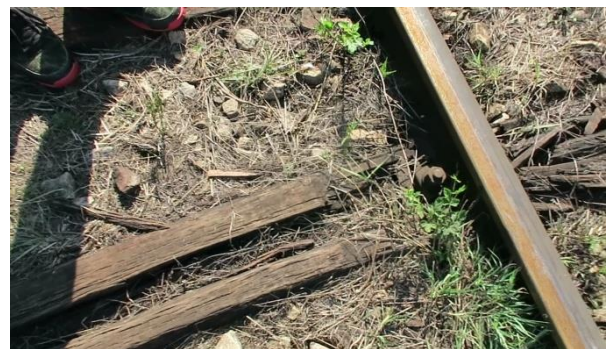
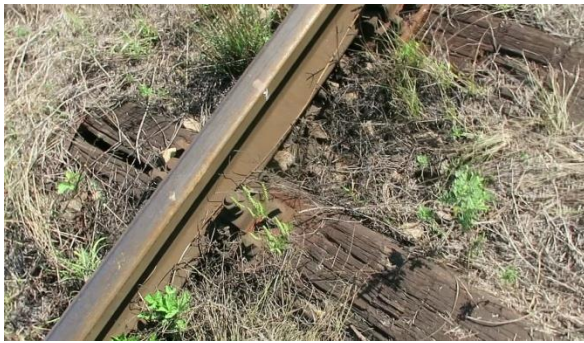
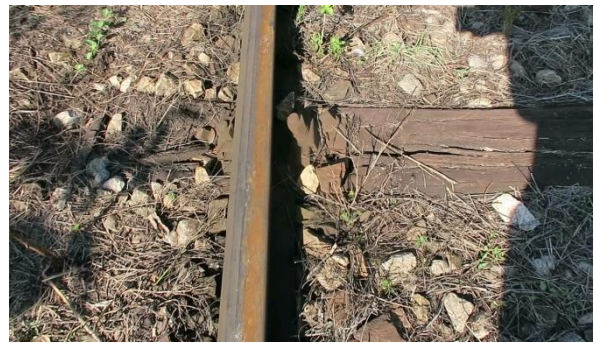
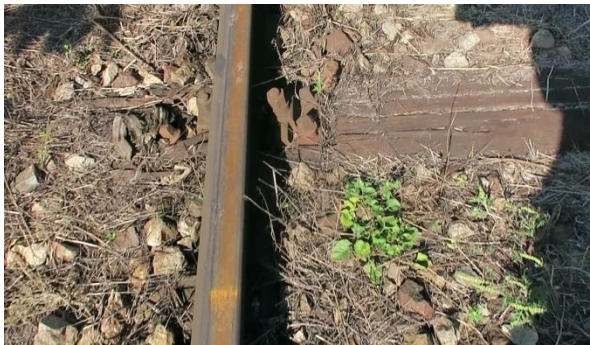
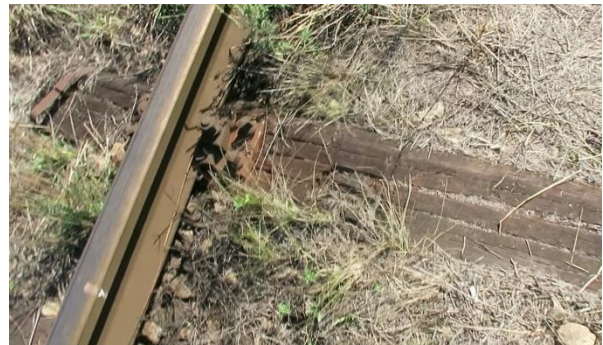
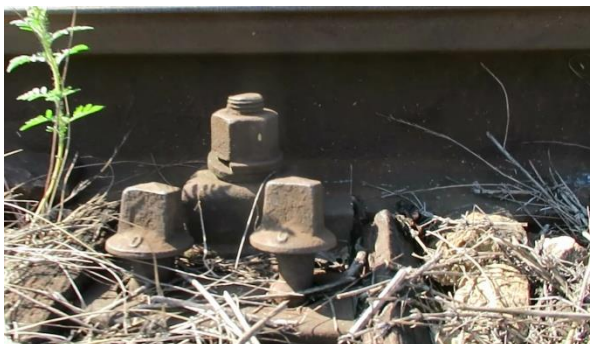
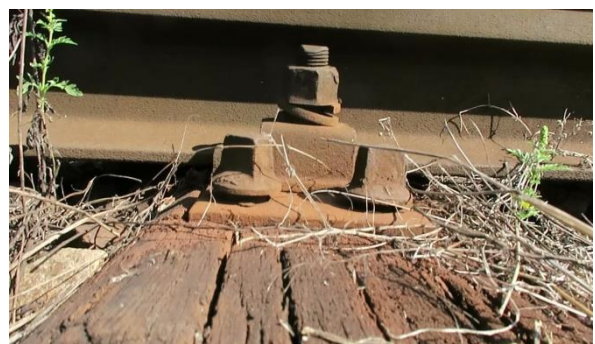
1	Both inside screws unscrewed by ca. 20 mm. The rail fastening screw is unscrewed by some 15 mm. On the outside both sleeper screws are loose. The sleeper has deep cracks.	The screws are loose.	4.1.4
2	On the outside one sleeper screw is missing, the other is unscrewed by some 10 mm. The sleeper on the outside is decomposing. Both inside screws are unscrewed by 10 mm.	The inside screws are unscrewed by some 5 mm. The outside screws are loose.	4.1.5
3	The outside screws are missing. In the inside screws are unscrewed by 5 -10 mm.	The screws are loose.	-

The mentioned condition is not in accordance with the requirements from the applicable Rulebook on Technical Conditions and Maintenance of the Superstructure of Railway Lines No.: 340-201-2/2016 (Official Gazette of Republic of Serbia no.39/16 and 74/16), see item 3.3.6.

**SR\_05/17** “IŽS” a.d. shall, having in mind inadequate maintenance and condition of the tracks, sleepers and fastening devices, to assess the risk of train traffic on the main arterial route Belgrade marshalling yard “A” – Junction “B” – Junction “K” – Resnik, between junctions “B” and “K”.
