No.: ŽS - 04/17

FINAL REPORT ON ACCIDENT INVESTIGATION

Type of accident:	Derailment of shunting composition
Train No.:	Shunting composition
Place:	Belgrade, open track between junction K1 and station Rakovica
Date:	17 September 2017
Time:	08:45

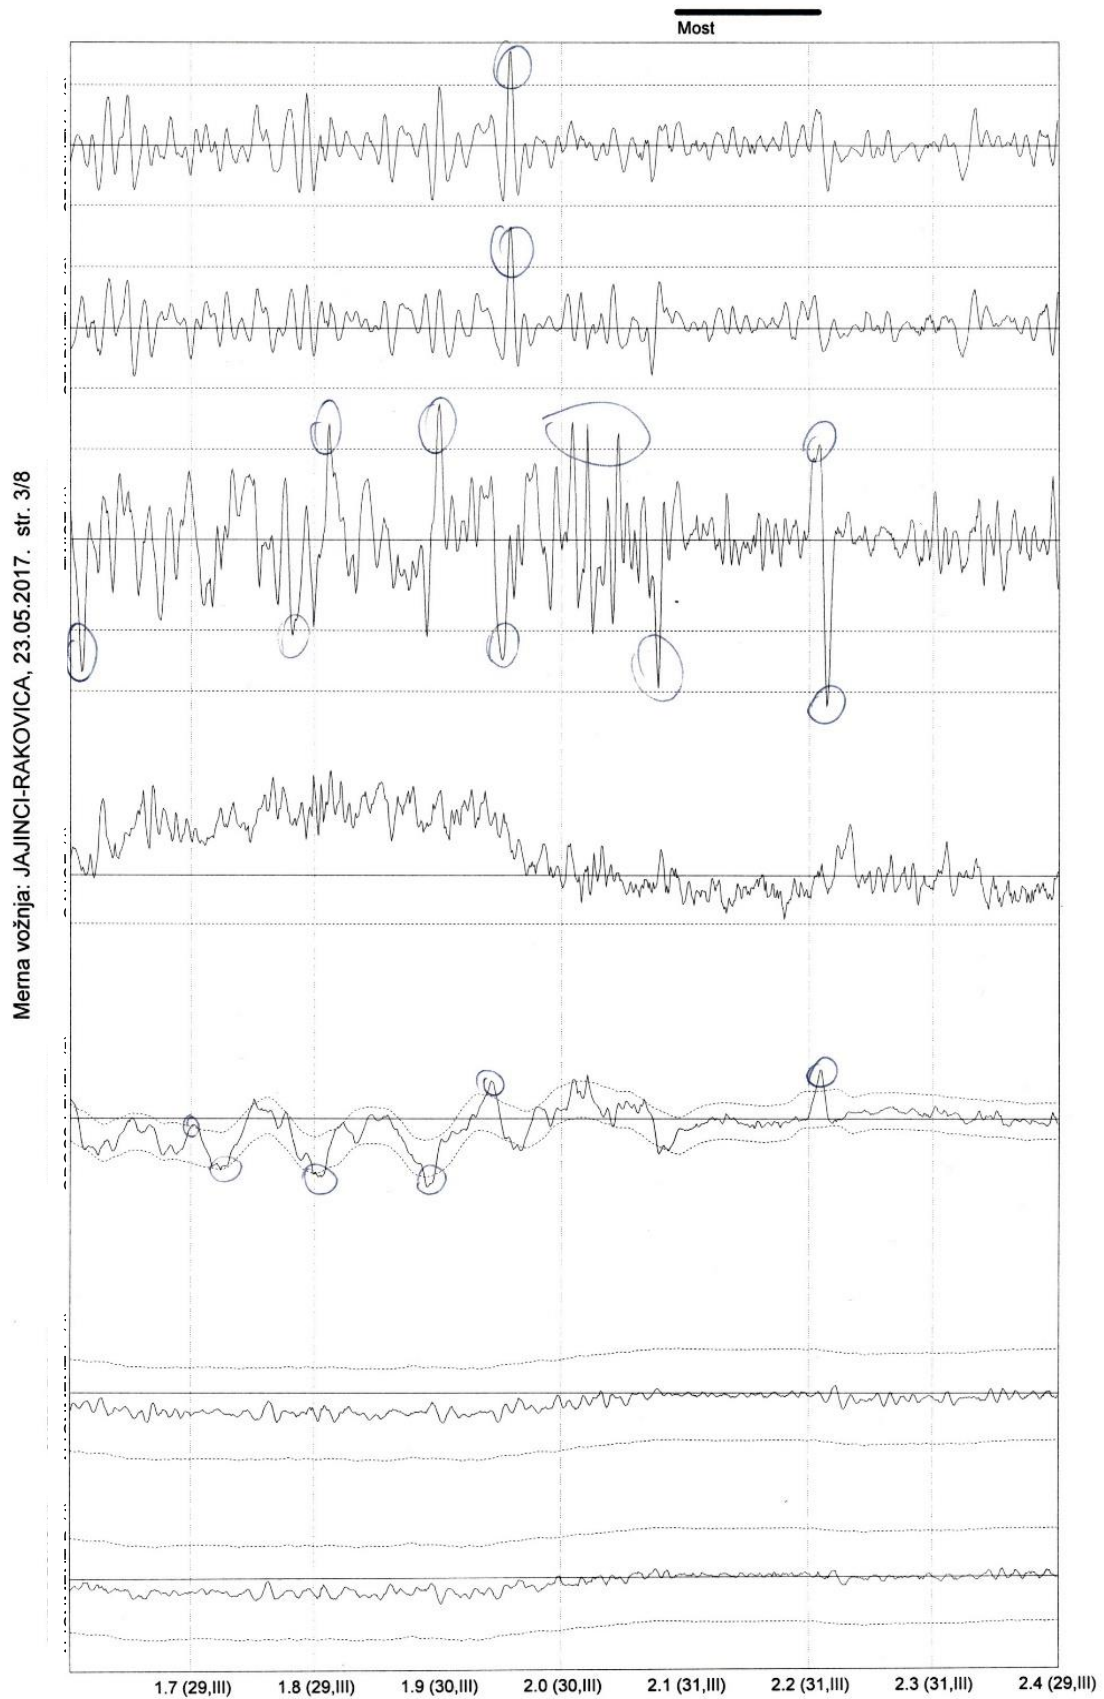
Fig. 3.4.2.1: Part of graphic report of the track examination coach

During the investigation on-site, measurement of the track gauge and cross level was performed in the area where the first signs of derailment were noticed. The measurement was carried out after the resulting derailment, and before a mechanical regulation of track which is performed after clearing the site of an accident in order to repair the damages.

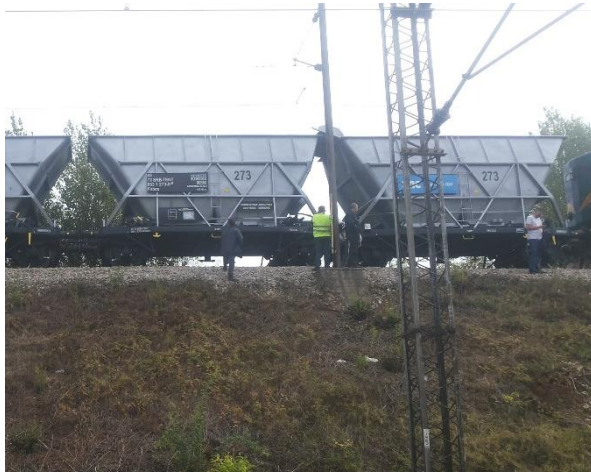
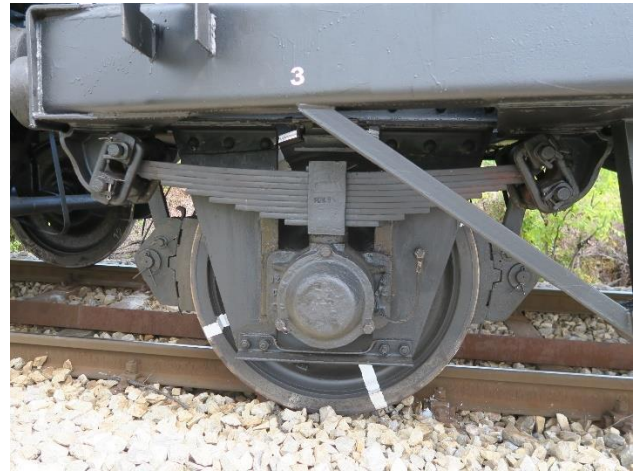
The wagon derailed was found so that the derailed axle was at km 1+929.75 and is caught in a manner that the left wheel, viewed in the direction of movement of shunting composition, fell on the outside of the track, a right wheel fell into a rut. The other three axles of respective wagon were caught on the tracks. The wheels of derailed axle were found at a distance of 7 cm from the rails. On the derailed car are observed damages on the wheels of slipped axles (lanes caused by movement on track equipment and broken stone).

Shunting composition was not decoupled. Derailed wagon type Arbel series Faboo No. 43 72 6531 273-0 are caught up as the first next to locomotive in the area of track on its wheels. There was no tilting or overturning of the car.

Fig. 3.4.4.1: The view of the derailed wagon

Fig. 3.4.4.2: The view of the derailed wagon

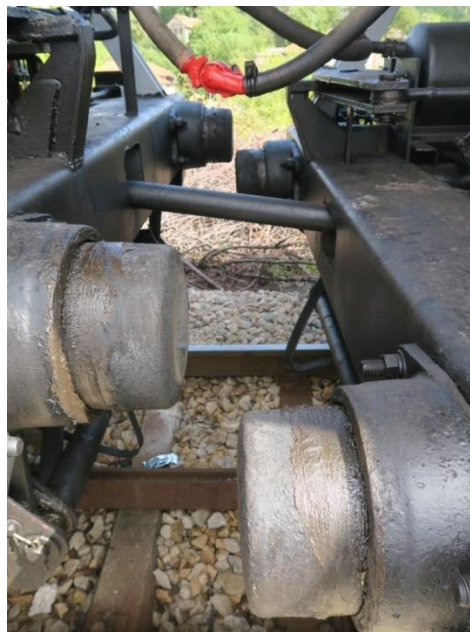
Fig. 4.1.3.3: The position of traction-buffing devices between the parts of the wagon serie Faboo
No. 43 72 6531 273-0 after the derailment

During an investigation after an accident on the shunting composition standing it is determined that on all the buffers between two composite parts of wagon, buffers are apart. Given the fact that shunting composition was stiff, this is not applicable, but it is indicative. At the derailed wagon the situation seen after the derailment is shown in Figure 4.1.3.3.

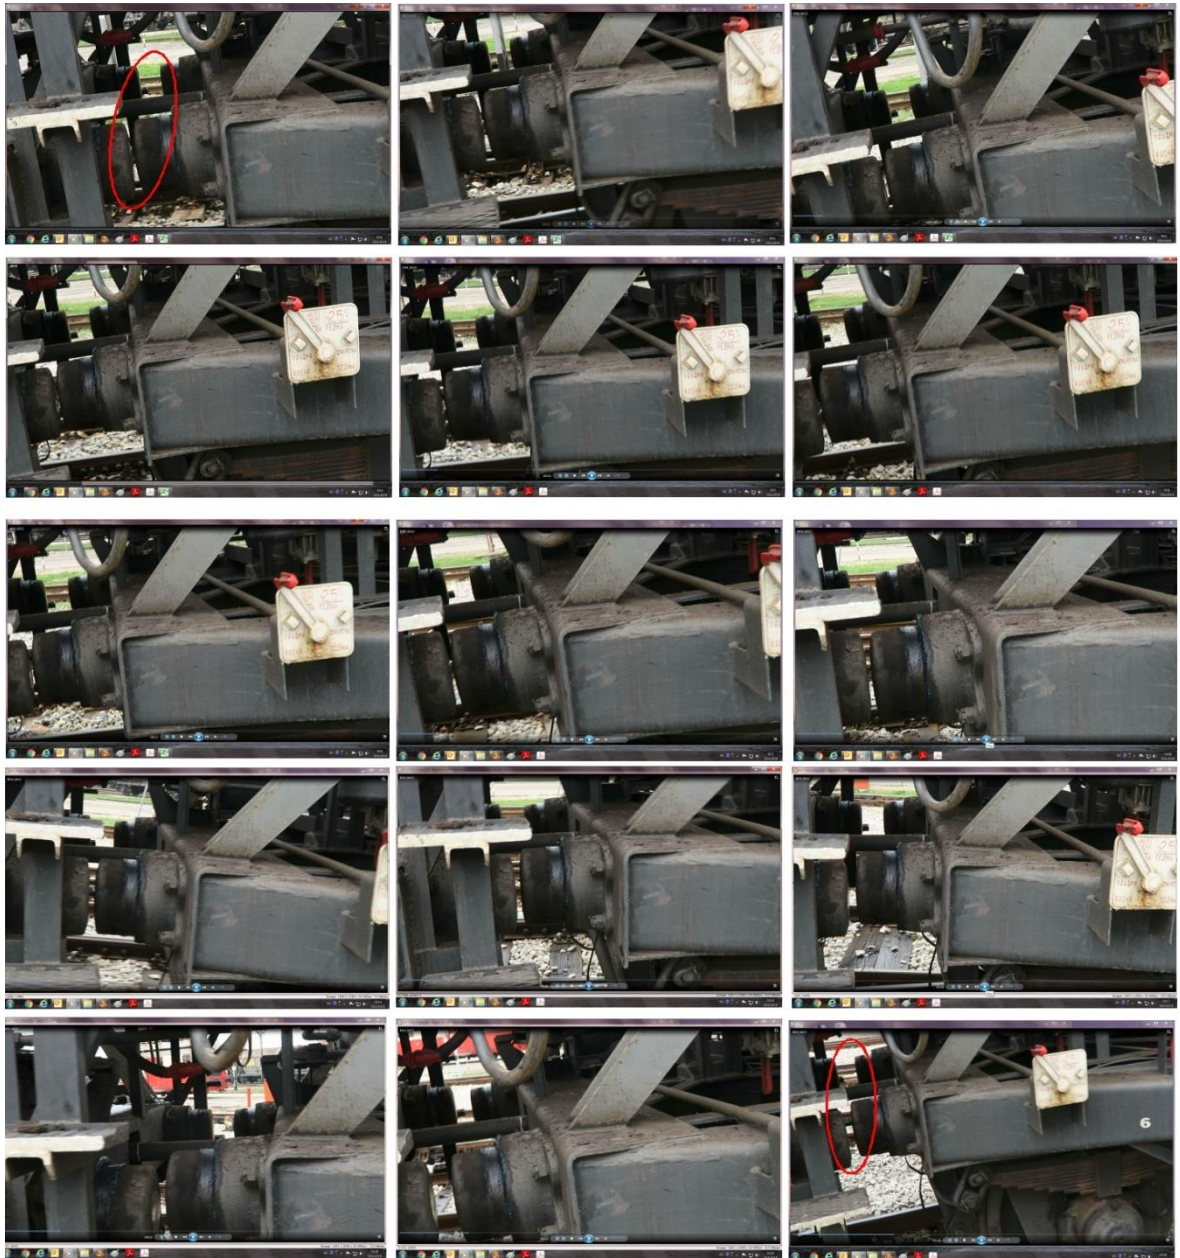
Fig. 4.1.3.4: Clearance between buffers in the rehearsal of suppression

During a visit to TENT by the investigation team of CINS, it was noted that it often happens that when standing or when pushing, buffers are not in contact, so that the thrust force is transmitted through the drawbar, which should not be happening. Therefore, the test of a light suppression of wagon via the sharp curve within TENT is performed. Figure 4.1.3.4. is a display of sequences from a video clip recorded in repression.

The reason for this phenomenon is not entirely clear. The explanation would be that the radical clearance between the ore -1 nad -5 pressed sleeve are too small. When the ore in the suppression is found in the set position, it is possible that it is leaning diagonally on the sleeve and pressing the force transmitted by friction.
