No.: ŽS - 05/17

FINAL REPORT ON SERIOUS ACCIDENT INVESTIGATION

Type of accident: Serious accident at level crossing
Train no: 4905
Place: Grdelica, open track between stations Grdelica and Predejane
Date: 09 October 2017
Time: 20:26

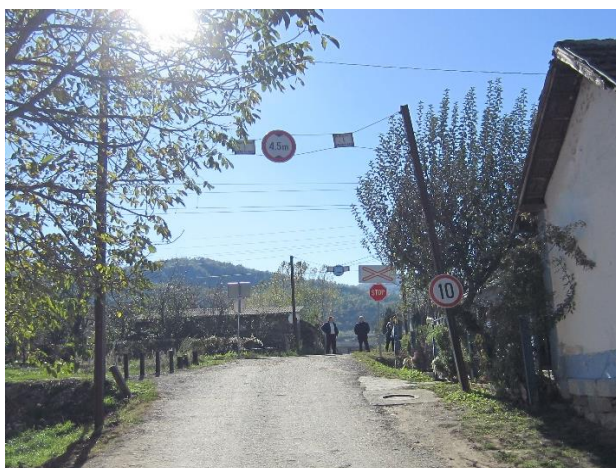
Fig. 2.2.3.1: The view of the crossing (view from the direction of Grdelica center)

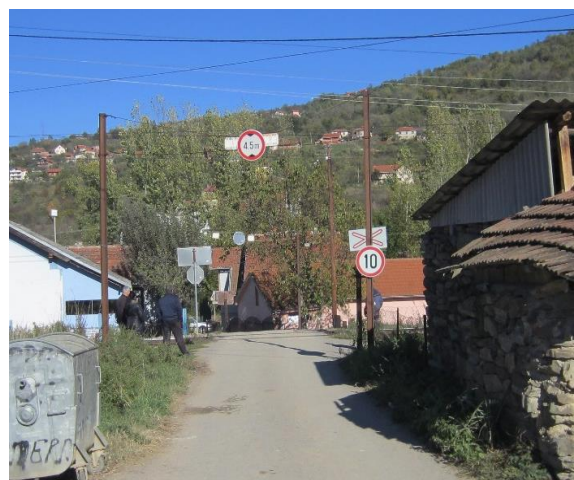
Fig. 2.2.3.2: The view of the crossing (view from the direction of the settlement Oraovica)

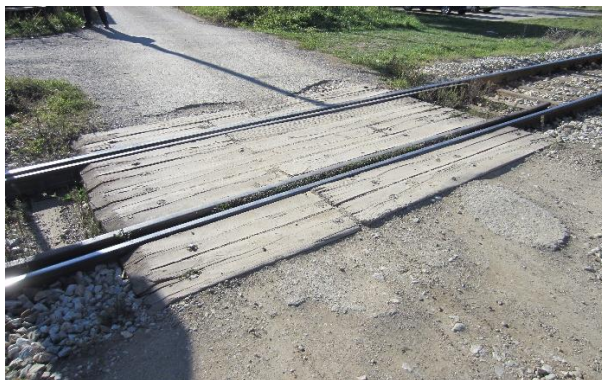
Near the crossing, the road on the uncategorized road is asphalt road. The width of the road on the right side of the crossing, viewed from the direction of the growing mileage of the track, is 3,60 m, and on the left side is 3,80 m. On the joint of wooden sleepers on the crossing and the asphalt road, on the right side of the crossing, viewed from the direction of growing mileage of the track, two smaller damages are noticed on the asphalt. On the left side of the crossing, viewed from the direction of growing mileage of the track, at length of approximately 7 m in the direction to the center of Grdelica, the damages in the form of “coronation” of asphalt have been noticed, under which the basis of the road is visible. Other damages on the road near the crossing have not been noticed. The noticed damages are shown in Fig. 2.2.3.3. and 2.2.3.4.

Fig 2.2.3.3: The view of the damage on the road

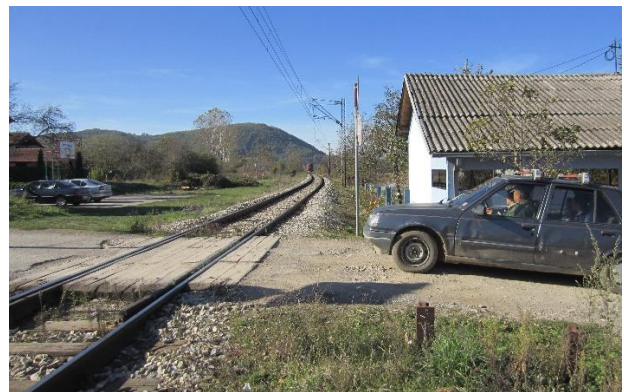
Fig 2.2.3.4: The view of the damage on the road

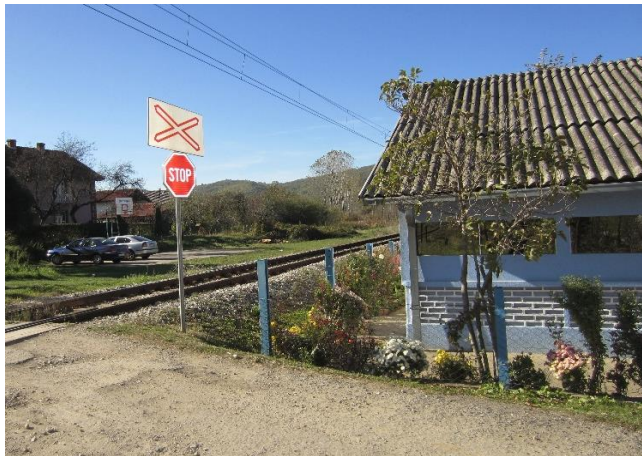
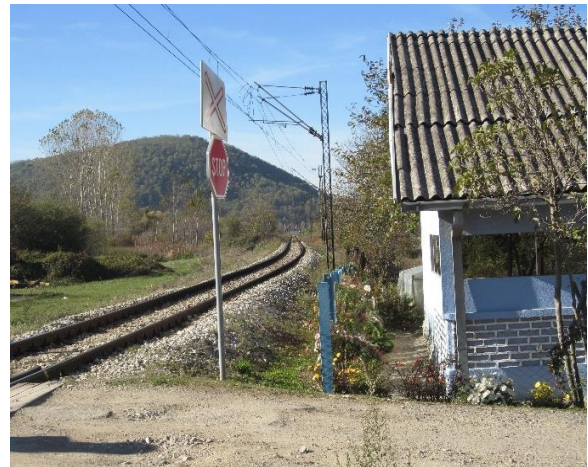
On the left side of the track, between the stations Grdelica and Predejane, viewed in the direction of increasing mileage, in front of the level crossing, there is a brick facility, a railway guard. The building is away from the left rail 4,23 m, and from the right edge of uncategorized road, viewed from the direction of Grdelica to the village Oraovica, away 3,70 m. In front of the facility, there is a fence made of woven wire, away from the left rail 2,86 m, and from the right edge of the road 1,30 m.

Fig. 2.2.3.5: The view of the facility- the guard

Fig. 2.2.3.6: The view of the facility-the guard

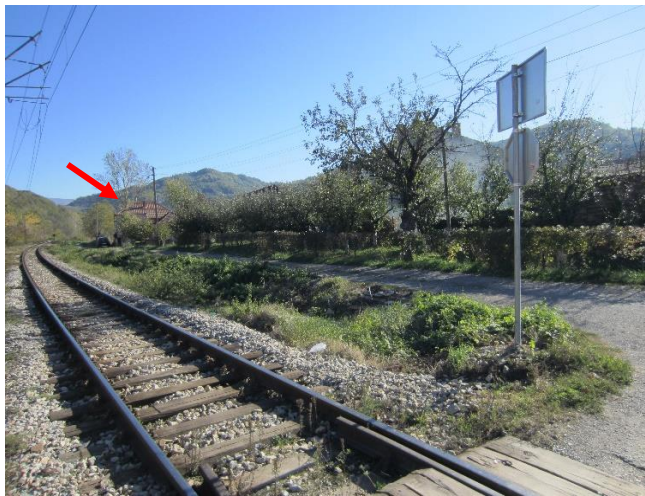
In abovementioned whole excels built housing facility (in Figs. 2.2.3.7, 2.2.3.9 and 2.2.3.10. marked with an arrow), positioned so that the distance from the right rail of the railway track and the proximal end of the facility is 12 m.

Described housing and ancillary facilities, orchard and other plants are positioned so that when viewed from the direction of the level crossing to stop Predejane, form a single unit which prevents the view from the level crossing to the rail track and from the track to the crossing.

Fig. 2.2.3.7: The view of the access macadam road, the facility and the vegetation on the right side of the track

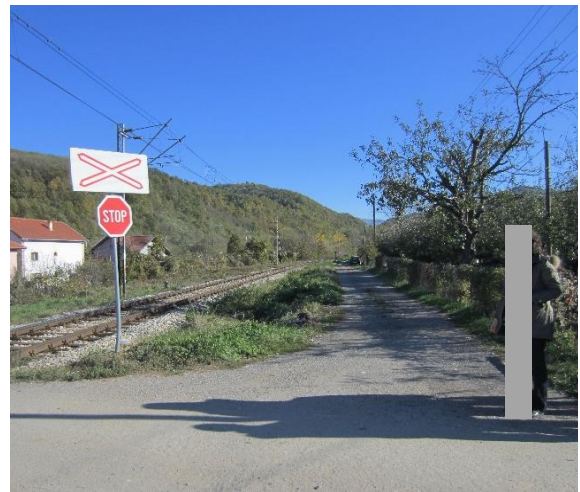
Fig. 2.2.3.8: The view of the access macadam road and the vegetation on the right side of the track

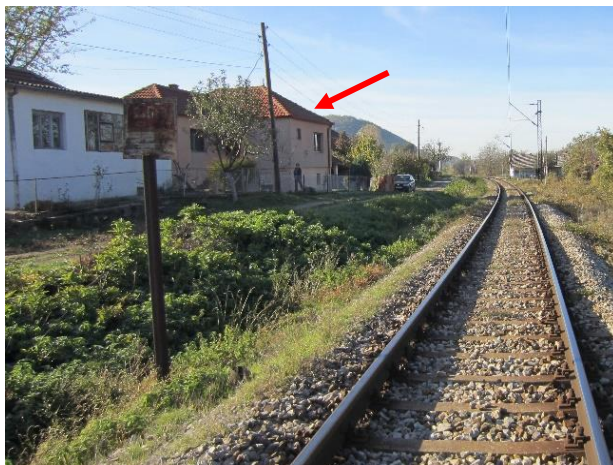
Fig. 2.2.3.9: The view of facility on the right side of the track

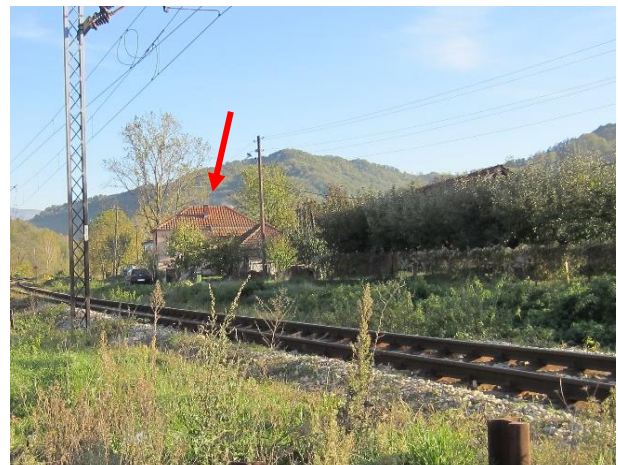
Fig. 2.2.3.10: The view of facility, orchard and the vegetation on the right side of the track

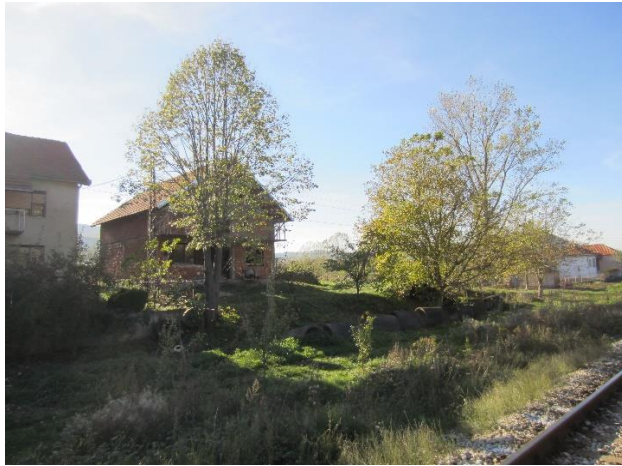
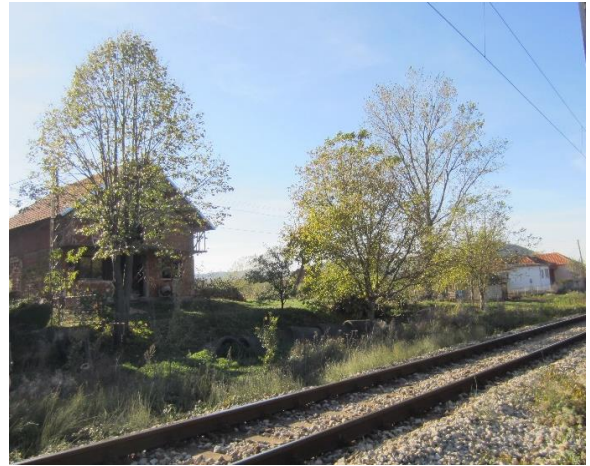
At the same place, out of the infrastructure zone, at the distance between 25 and 30 m, there are two brick residential facilities - houses. The houses are positioned so that the aforementioned trees are located between the house and the railway.

Fig. 2.2.3.11: The view of the trees and the facilities on the right part of the track

Fig. 2.2.3.12: The view of the trees and the facilities on the right part of the track

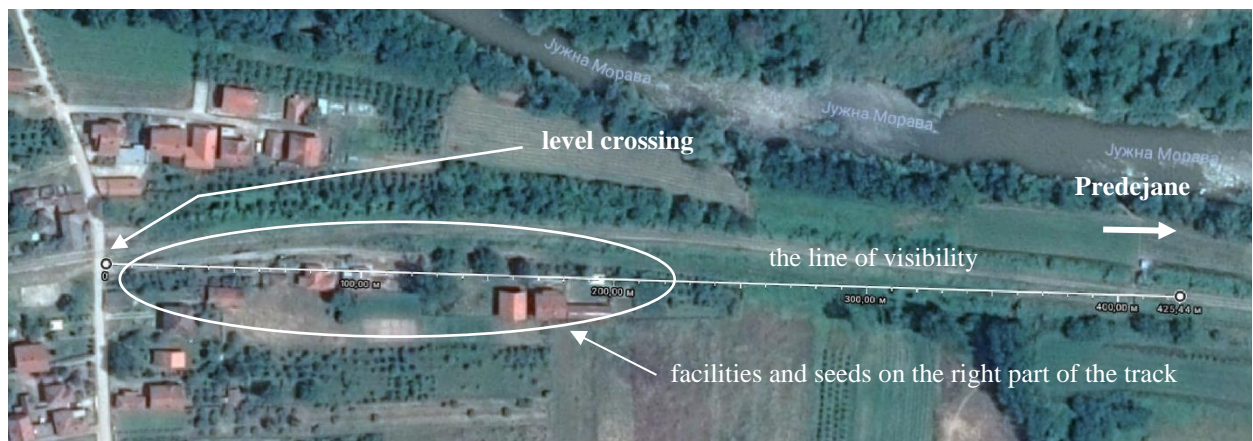
The spatial distribution and impact on visibility of the described facilities and plants located on the right side of the track, is shown in Figure 2.2.3.13

Fig. 2.2.3.13: Satellite video of the area of the crossing (source: *Google maps*)
