REPUBLIC OF SERBIA
CENTER FOR INVESTIGATION OF ACCIDENTS IN TRANSPORT
SECTOR FOR INVESTIGATION OF ACCIDENTS IN RAILWAY TRAFFIC
AND INTERNATIONAL COOPERATION
Nemanjina 11, 11000 Belgrade

FINAL REPORT ON ACCIDENT INVESTIGATION

Type of accident:	Derailment of train
Train No.:	56990
Place:	Despotovac, open track between stations Svilajnac and Despotovac
Date:	11 November 2017
Time:	15:25

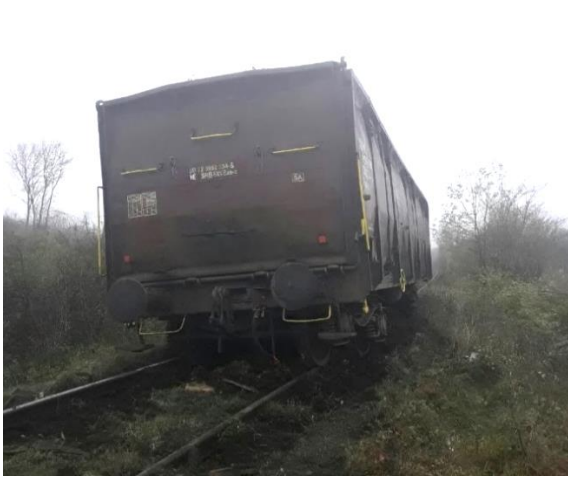
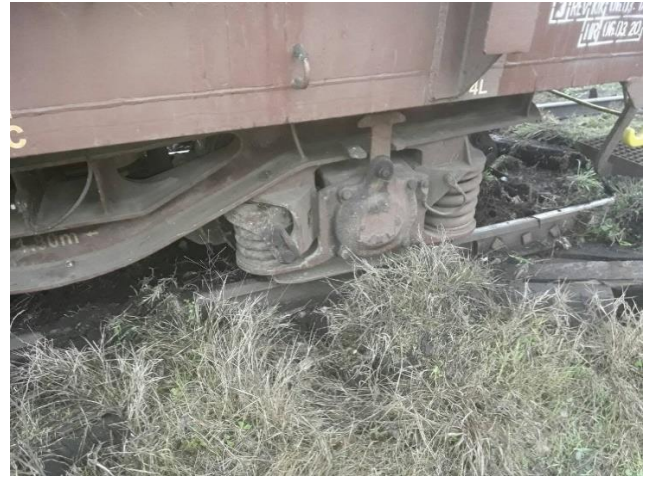
Derailed wagon was found as the last part of the train, in the area of track, on its wheels. There was no tilting or overturning the wagon. Derailed wagon was not decoupled from the penultimate wagon. Decoupling occurred between the fifth and sixth wagon, as viewed from the driving locomotive.

Fig. 3.4.4.1: The view of derailed wagon

Fig. 3.4.4.2: The view of derailed wagon

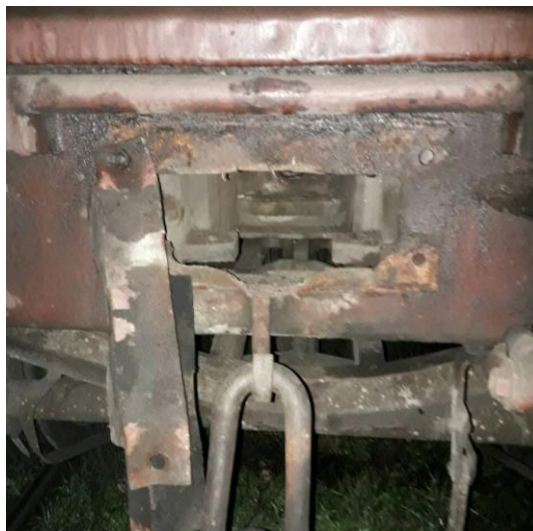
Fig. 3.4.4.3: The view of the broken coupling device on the sixth wagon

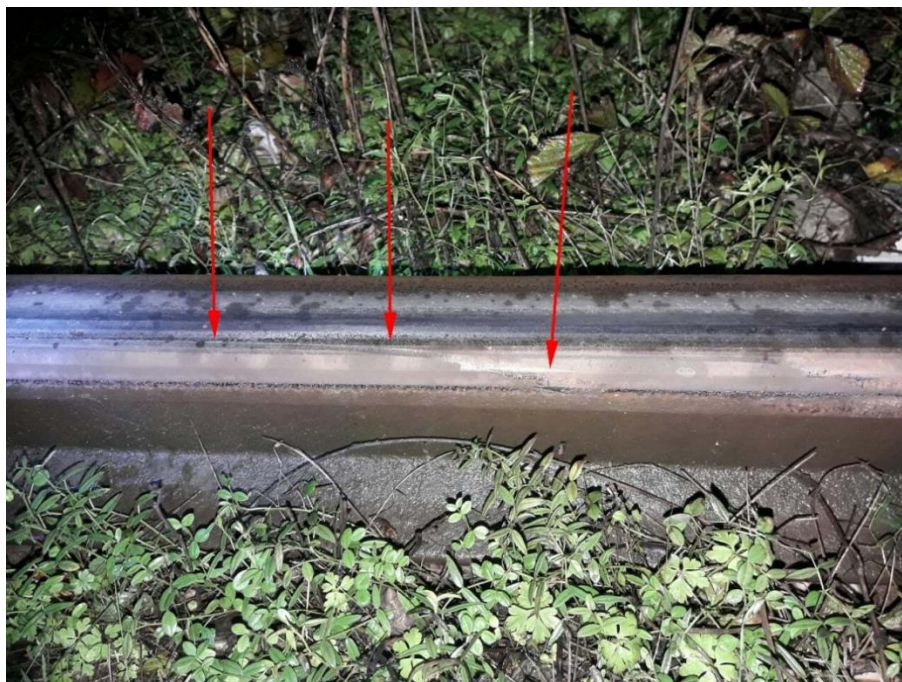
Fig 4.1.1: The first trace of falling of the wheel on the left rail, as seen from the direction of the train movement (source: „IZS“ a.d.)

Based on the data obtained by reviewing the track by the investigative committee "IZS" a.d. and "Srbija Kargo" a.d., the first trace of derailment was observed on the inner side of the left rail in the direction of the train movement (Figure 4.1.1.). Beyond that, the next 24 m there are traces of hitting of the wheel on the fixing accessories on the inside part of the left rail.

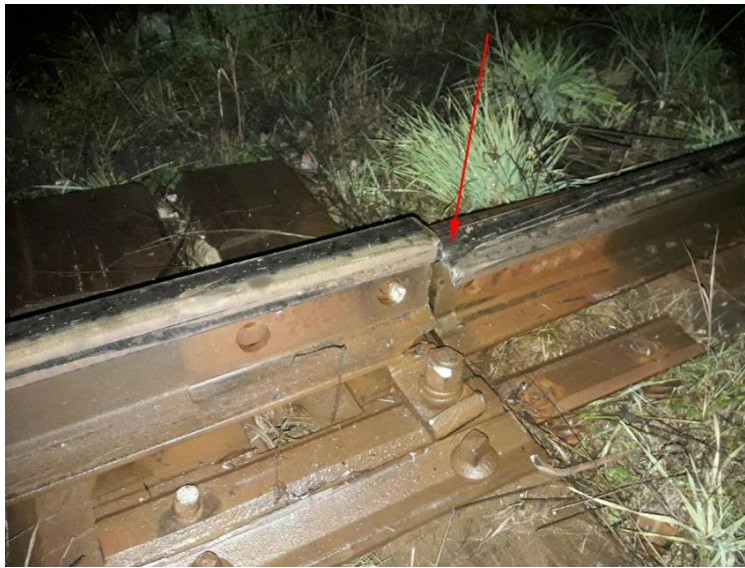
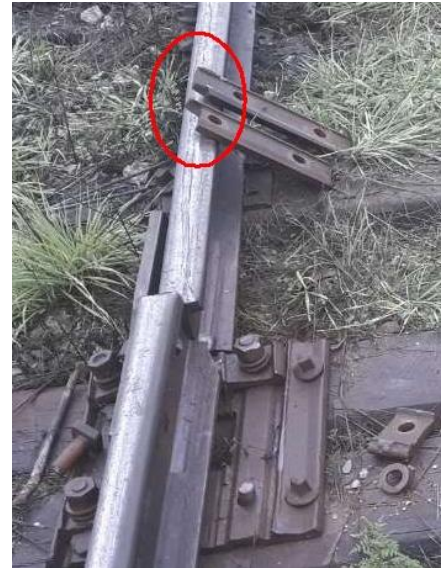
After 24 m at the left wheel strokes transversely displaced hovering composition of the left rail (Figure 4.1.2.). On the composition the inner longitudinal tie was broken. With photos it can be observed rusty intersection of fractures of the ties on the basis of which it can be concluded that it was broken before the accident, which is why the compound was dislocated laterally.

Fig. 4.1.2: The trace of hitting and lifting the wheel on the moved composition of the left rail and broken tie
(source: „IZS“ a.d.)

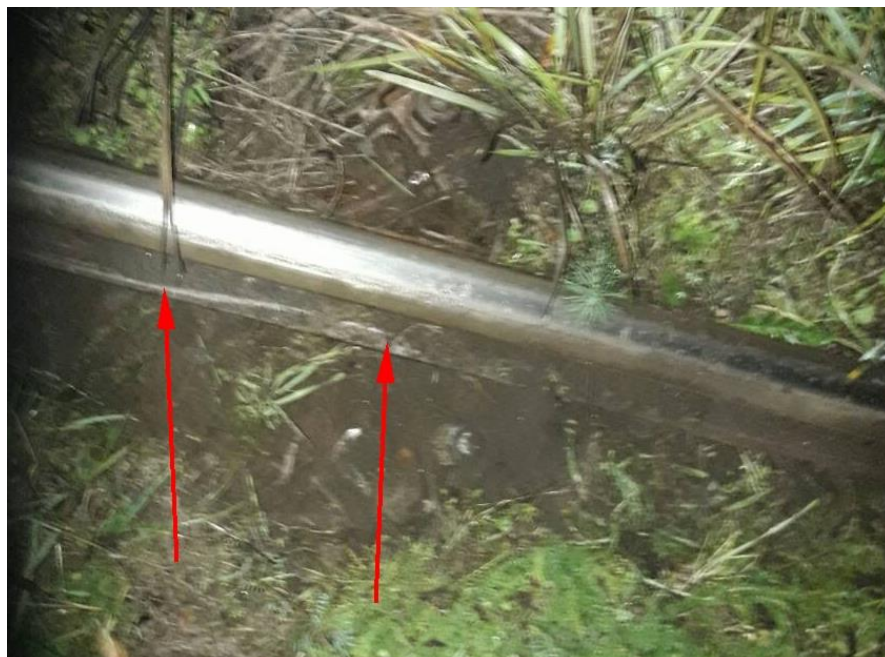
Fig. 4.1.3: The trace of falling out of the wheel on the external part of the right rail
(source: „IZS“ a.d.)

In the same intersection on the right rail, climbing of right wheel on the rail and the trace of derailed right wheel on the outer part of the right rail. (Figure 4.1.3.).

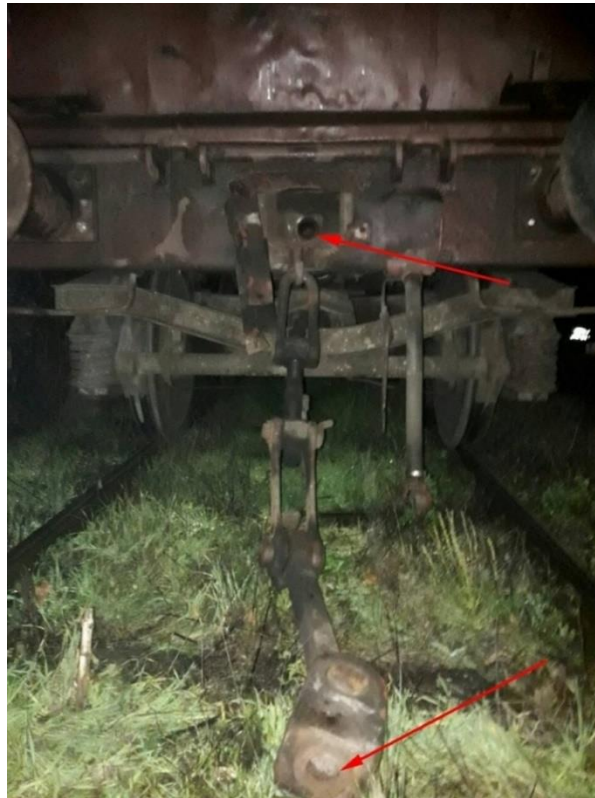
From this composition, traces of derailed wheels are visible to the point of stopping. In Figure 4.1.4. uprooted coupling device of sixth wagon in the composition of the train is shown, on the point of decoupling that is made as a result longitudinal twitches after the derailment of the last wagon in the train.

Fig. 4.1.4: Torn coupling device of sixth wagon (source: „IZS“ a.d.)

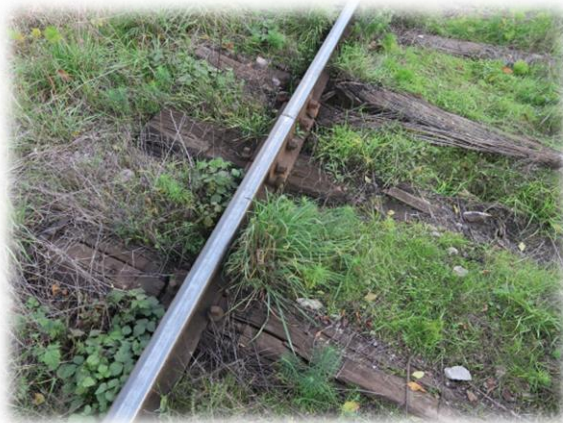
On the open section and main driving tracks 70353 pieces of wooden sleepers have been built in, out of which 31803 pieces due to the large rottenness are unusable (bad connection rail-sleeper, figure 4.2.3.6.), which constitutes 46% of total built-sleepers. At many places there are three or more rotten sleepers in a row ("nests" of rotten sleepers - Figure 4.2.3.7.), which directly affects the stability and geometry of the track. On the section from the station Markovac (km 0+500) to km 19+000 ballastway was formed from highly polluted broken stone (over 15% - Figure 4.2.3.8.), while the rest of the railway ballast is made of slag, which turned into the ground.

Fig. 4.2.3.7: Nest of rotten sleepers

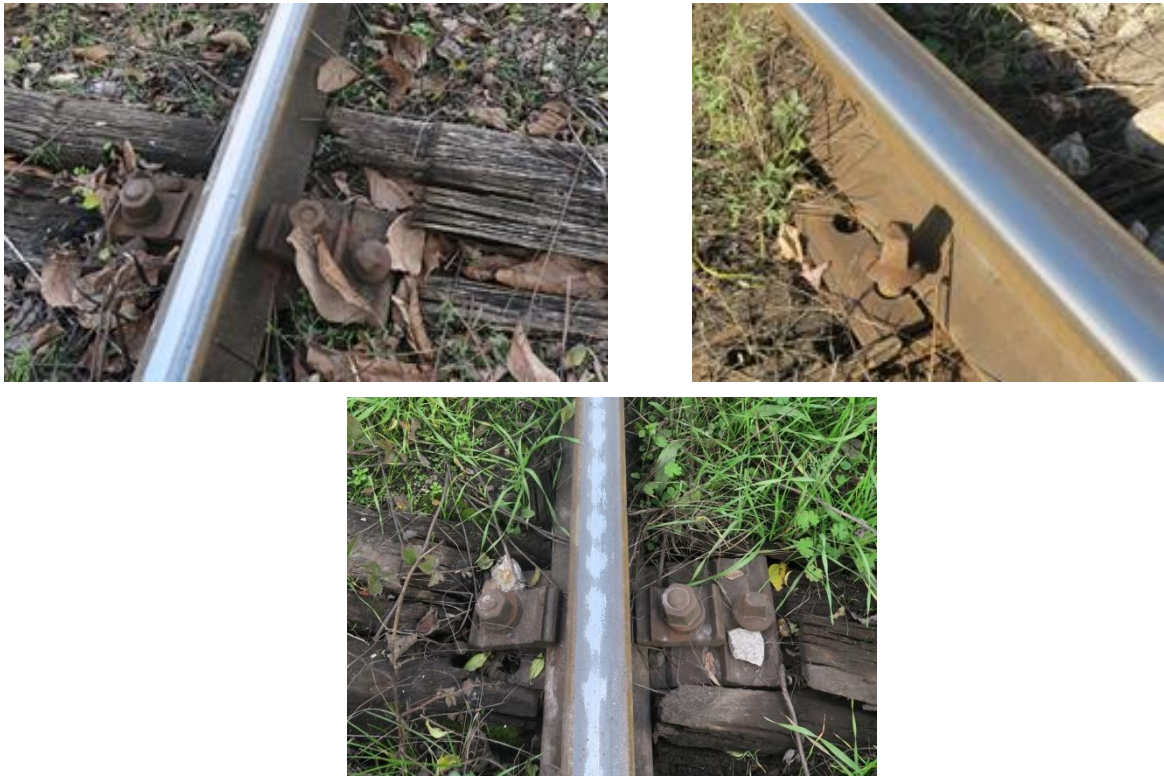
By checking the condition of the sleepers and fastening materials it is noted that in the wider area around the point of falling of the wheel in track, track is in a state of disrepair due to a loose or missing fastening systems, shifted fastening plates and cracked or rotted sleepers. Bearing in mind that the railway is built in the early fifties of second-hand materials, sleepers are over 70 years old.

Fig. 4.2.5.2: Local rot beneath the support of the rail and longitudinal cracks of sleepers

The shown state is not in accordance with the requirements of the applicable Rulebook of technical conditions and maintenance of the superstructure of railway track No.340-201-2/2016 (*“Official Gazette RS”* No.39/16 and 74/16), see section 3.3.5.

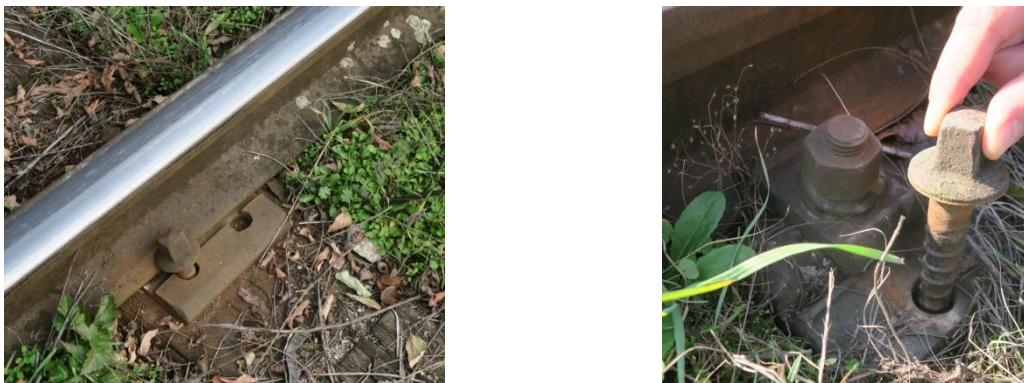
Fig. 4.2.5.3: Rail- sleeper link with fastening plate and direct fastening with coach screws

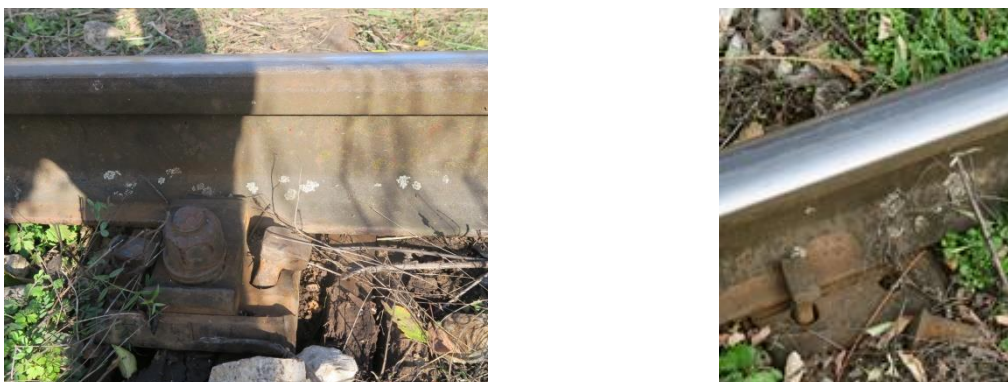
Fig. 4.2.5.4: Rail-sleeper link with supporting plate and direct support with track nails

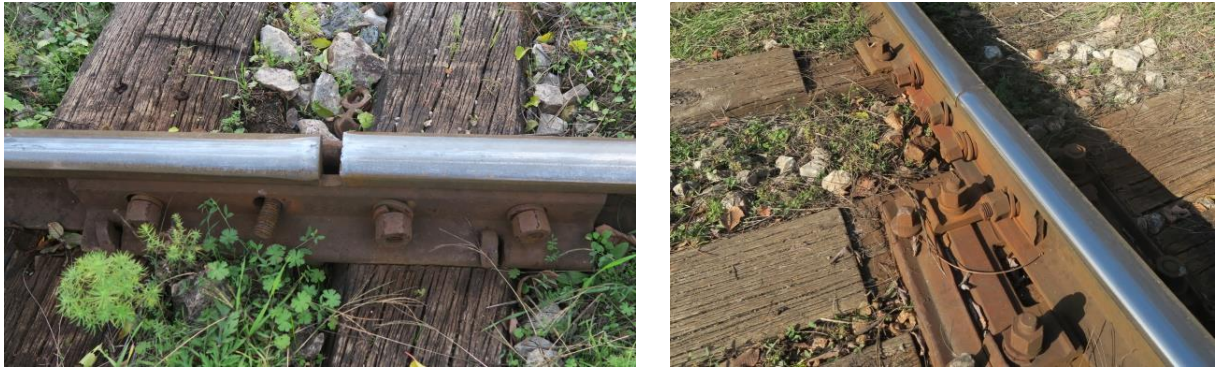
Fig. 4.2.5.5: Rail-floating and supporting joint

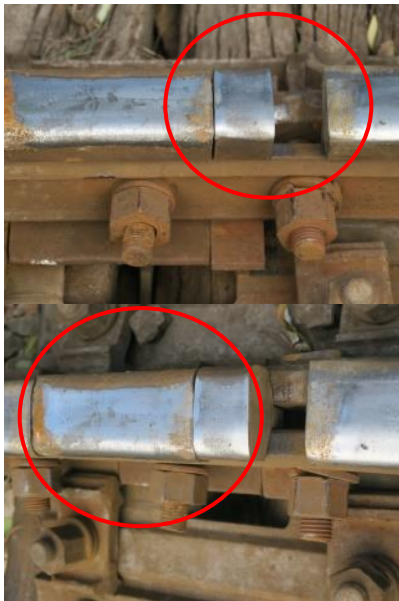
Also, a large number of improperly repaired rail joints has been noted.

Fig. 4.2.5.1: Repaired rail travel

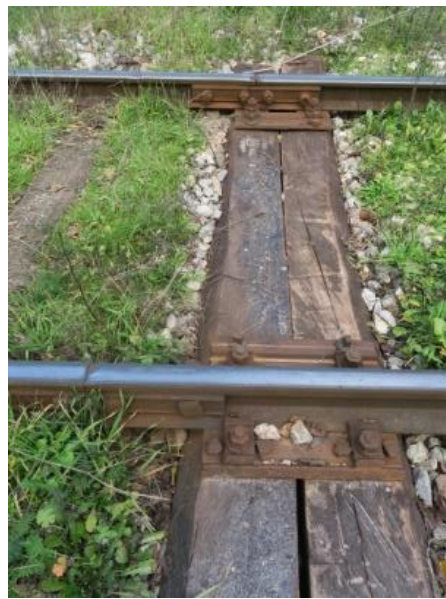
Fig. 4.2.5.2: Consequence of rail travel
