REPUBLIC OF SERBIA
CENTER FOR INVESTIGATION OF ACCIDENTS IN TRANSPORT
SECTOR FOR INVESTIGATION OF ACCIDENTS IN RAILWAY TRAFFIC
AND INTERNATIONAL COOPERATION
Nemanjina 11, 11000 Belgrade

FINAL REPORT ON ACCIDENT INVESTIGATION

Type of accident: Derailment of train
Train No: 53527
Place: Novi Bečej, the area of the station Novi Bečej, between the entrance signal and the first entrance switch
Date: 23.12.2017
Time: 13:15

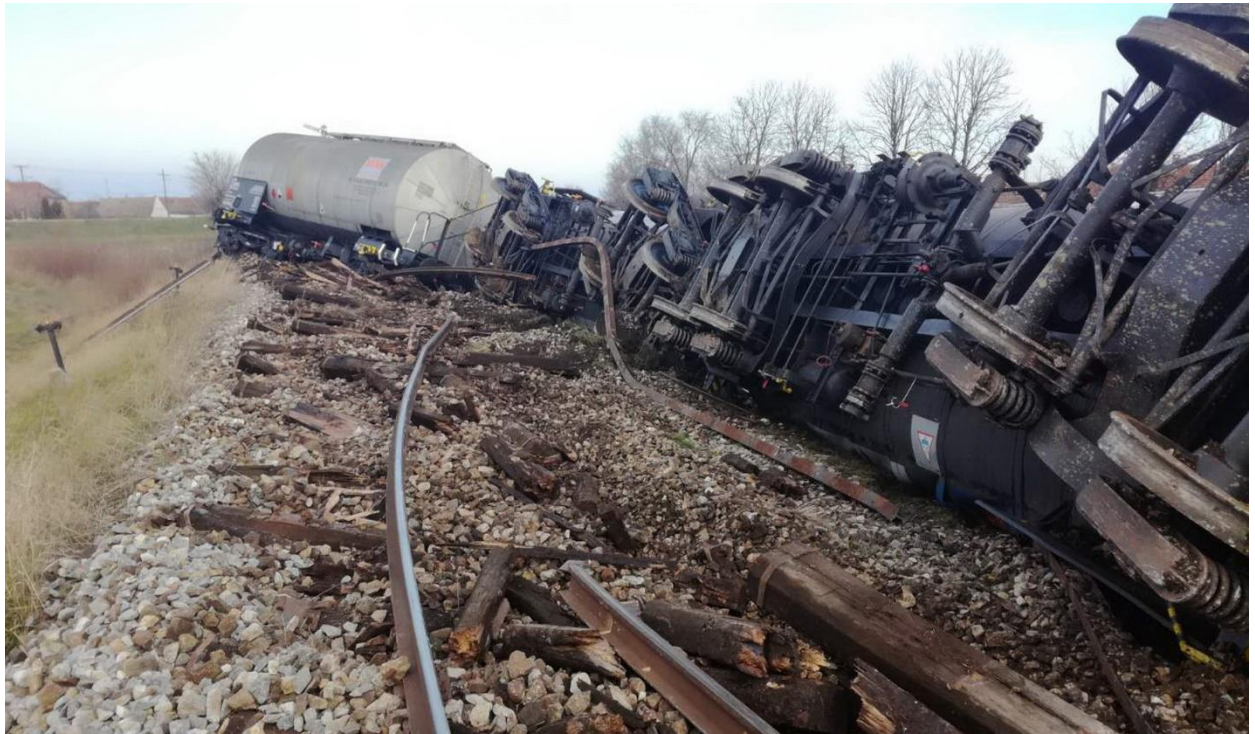
Fig. 3.4.4.1: The view of derailed and turned over wagons

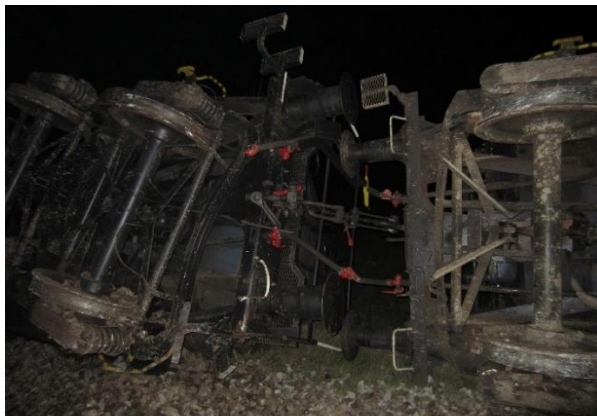
Fig. 3.4.4.2: The view of turned over wagons

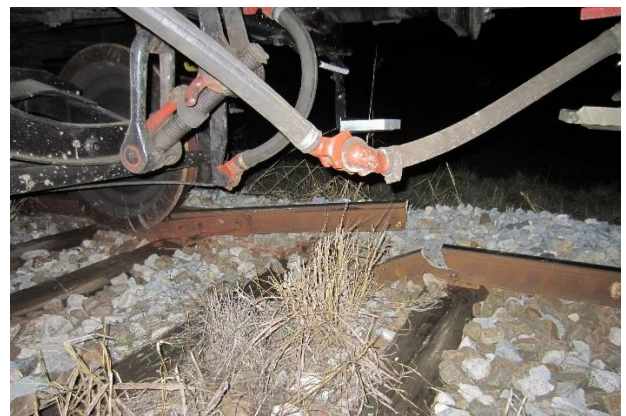
Fig 3.4.4.3: The view of the broken rail

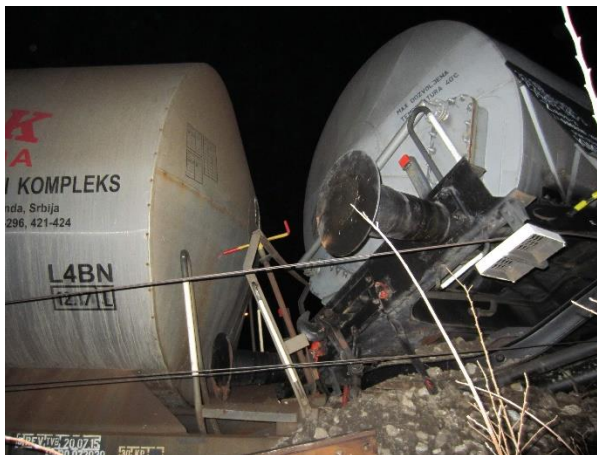
Fig 3.4.4.4: The view of derailed wagons

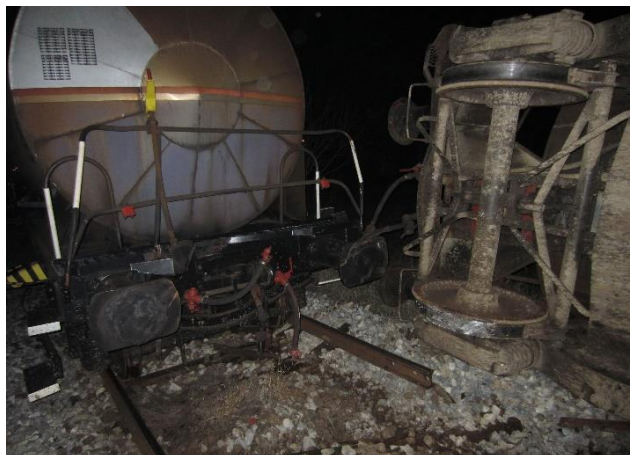
Fig 3.4.4.5: The view of derailed and turned over wagons

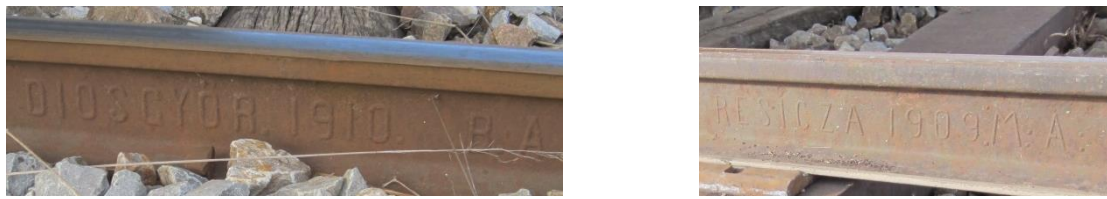
On the part of the regional railway line between the official positions Novi Bečej (km 121+624.00) and Banatsko Miloševo (km 141+291.00) track was built in 1883 with a rail type “I” of length $L=9.00$ m and in 1931 the rails type “C” of length $L=12.00$ m were installed. Installed rails in the track have been non-standard, the type 35a, 35b, I, C (Fig. 4.2.4.1.), Xa and 8a with the respective non-standard arrangements of connecting and fastening accessories (mounting of rails with rail nails and sleeper screw Fig. 4.2.4.2.). The rails are connected by classic compositions that are floating (Figure 4.2.4.3.).

Fig. 4.2.4.1: Non-standard rail type “C”

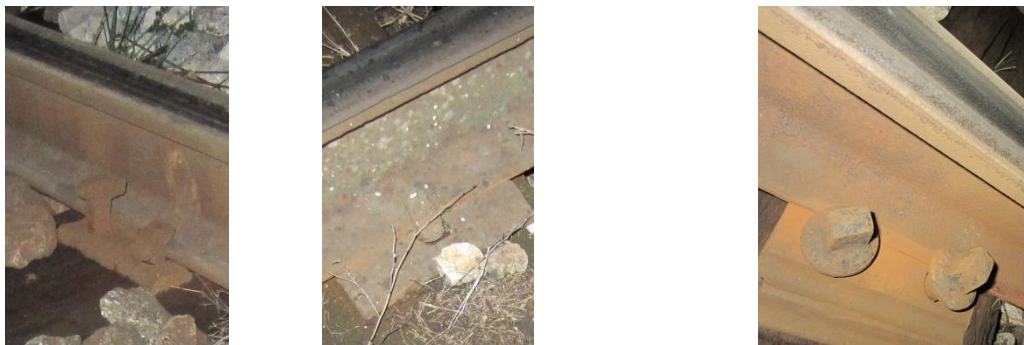
Fig. 4.2.4.2: Fastening of rail with rail nails and sleeper screws

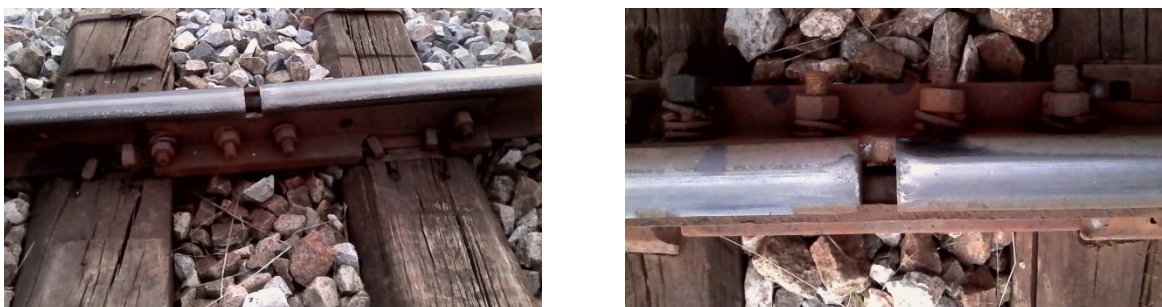
Fig. 4.2.4.3: Floating composition

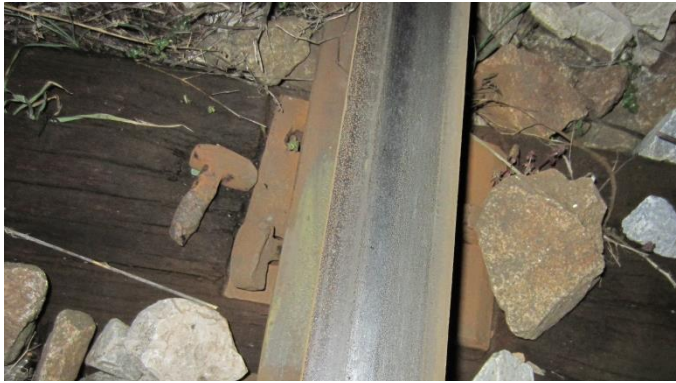
Fig. 4.2.4.4: Sleeper-rail connection

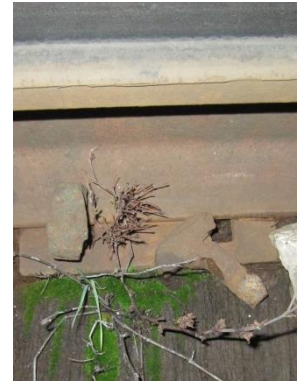
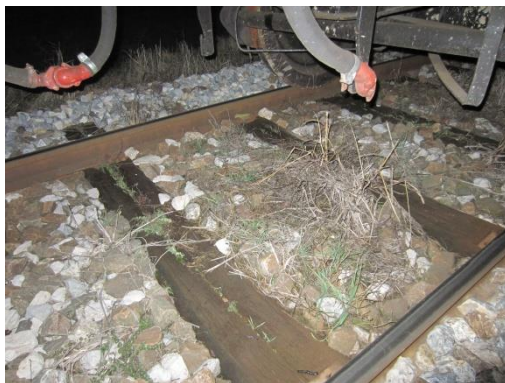
Fig. 4.2.4.5: Nest of rotten sleepers

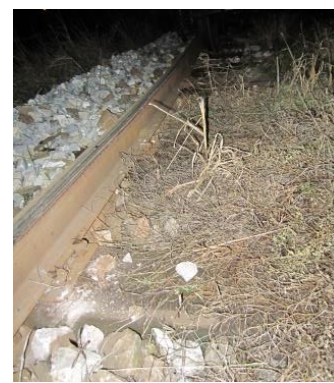
Sleepers installed on the part of the regional railway line between the official positions Novi Bečej (km 121+624.00) and Banatsko Miloševo (km 141+291.00) are wooden, and according to the list of sleepers from 2017, from embedded 28571 pieces, due to the large amount of rottenness, 6021 pieces are unusable (bad connection rail-sleeper Fig. 4.2.4.4.), which constitutes 21.1% of the total number of the built-in sleepers. At many places there are three or more rotten sleepers in a row (“nests” of rotten sleepers - Figure 4.2.4.5.), which directly affects the stability and geometry of the track. Ballast way is formed from highly polluted crushed stone (over 50% - Figure 4.2.4.6.)

Fig. 4.2.4.6: A ballastway

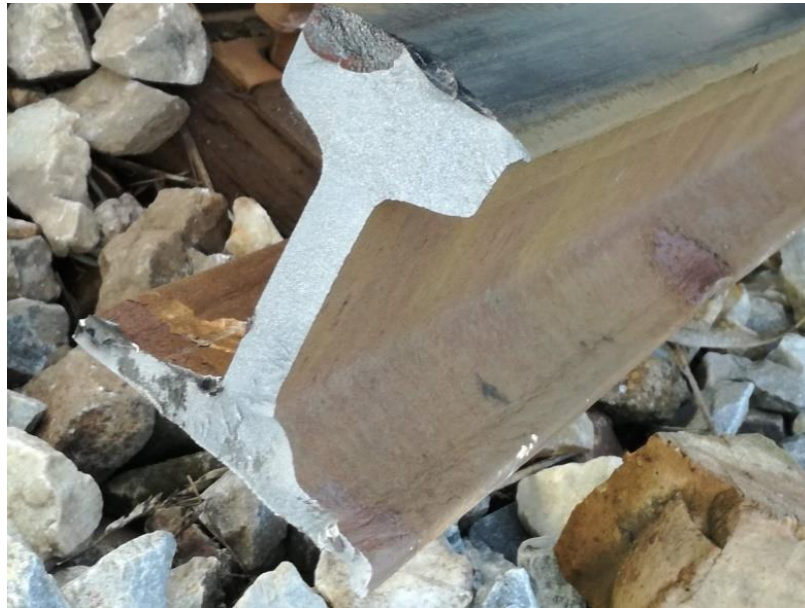
On the railway line with limited speed of 30 km/h are used locomotives of series 661 with the axle load of 183 kN and a load of 59.5 kN/m, which further influences the rapid collapse of the railway line. Also, based on the letter of “IŽS” a.d. from 28.09.2018 it was established that during 2017 from a total of 644 freight trains, 220 was operating with an overload, which indicates that this practice is not an exception, but the rule. “MSK” a.d. Kikinda via e-mail of 28.09.2018 submitted the information that all of their deliveries in 2017 have had an overload (with a load of 18 t/axle and 5.32 t/m). As a consequence of the aforementioned, the Fig. 4.2.4.7. displays a rail after the respective accident, which appearance has the character of a fracture due to the occurrence of fatigue damages to the rails.

Fig. 4.2.4.7: Review of the fracture of rail at the accident site

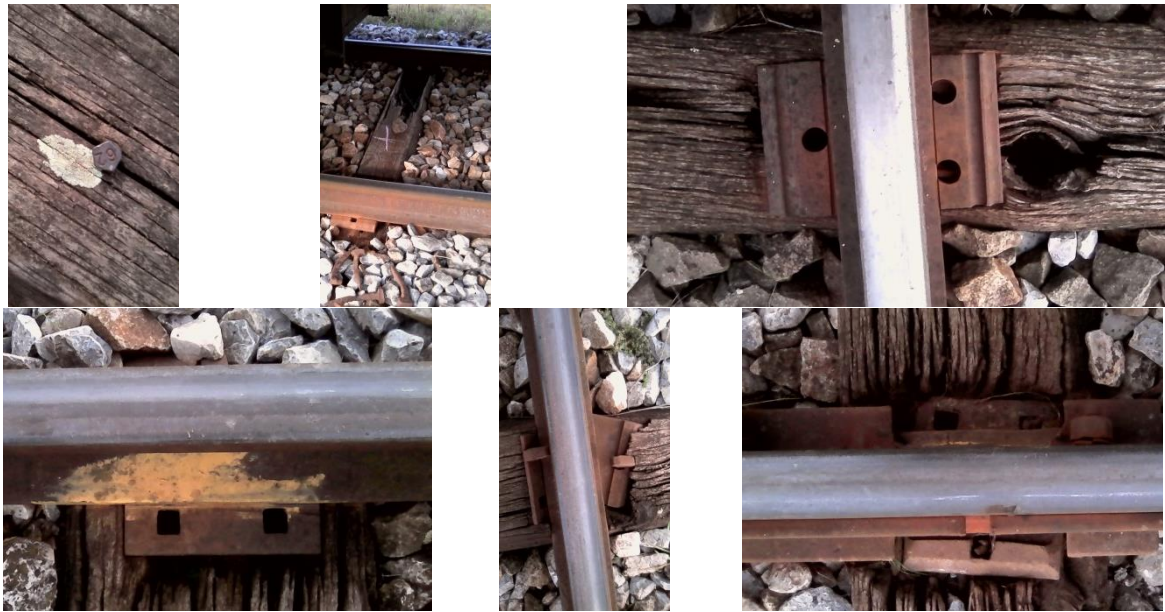
Reviewing the condition of sleepers and fastening accessories was noted that in the wider area around the point of fall of wheel into the track, the track in a state of disrepair due to a loose or missing fastening accessories, fastening plates that are shifted and cracked or rotted sleepers. Bearing in mind that the railroad was built in the period from 1883 to 1889, but it was repaired from 1961 to 1964 (from km 57+108.00 to km 113+500.00) and since 2004 until 2005 (from km 57+108.00 to km 64+212.00), with new and used material sleepers are over 57 years old.

Fig. 4.2.6.2: Local rot under the support of rail and longitudinal crack of the sleeper

The shown state is not in line with the requirements of the applicable Rulebook on technical conditions and maintenance of the superstructure of the railway track No. 340-201-2/2016 (*“Official Gazette of RS”* No. 39/16 and 74/16), see the point 3.3.4.

Damaged, worn out or missing elements of track accessories should be replaced or supplemented, tighten loose fittings, and if necessary, lubricate some of the elements.

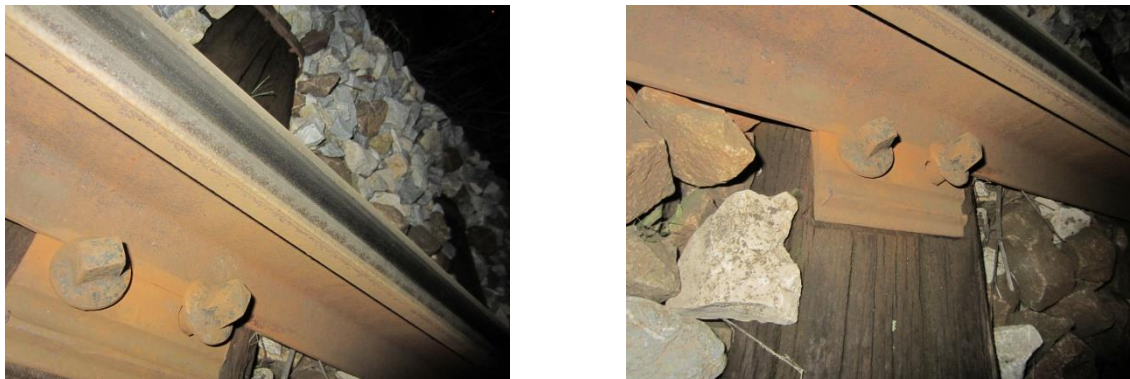
Fig. 4.2.6.3: Rail sleeper connection with a supporting plate, fastening with sleeper screws

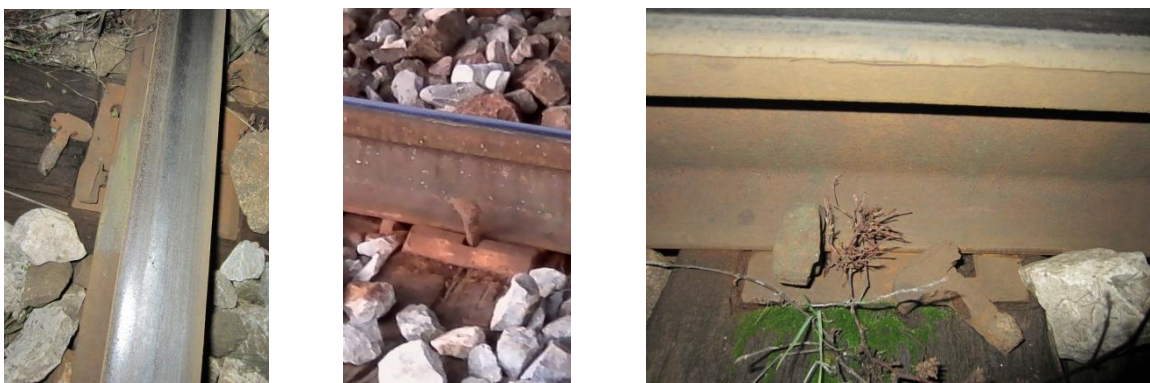
Fig. 4.2.6.4: Rail sleeper connection with the supporting plate, fastening with track nails

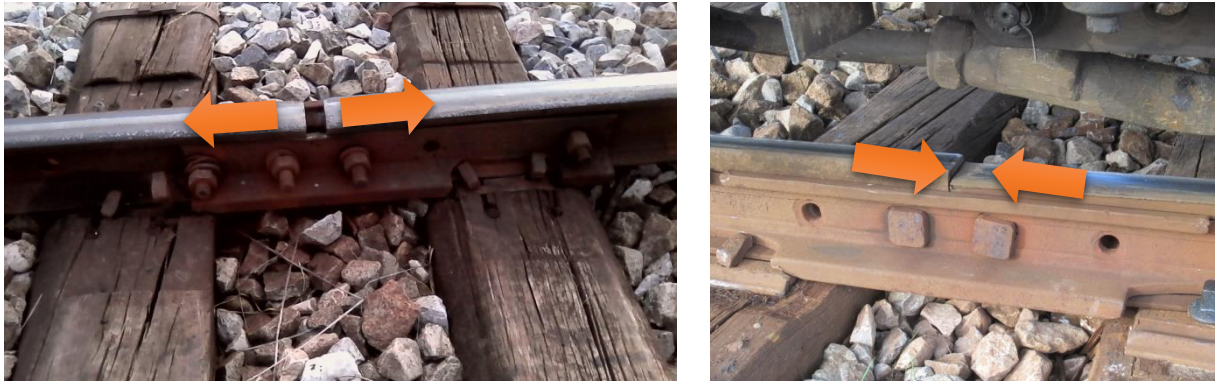
Fig. 4.2.6.5: Connection rail - floating composition

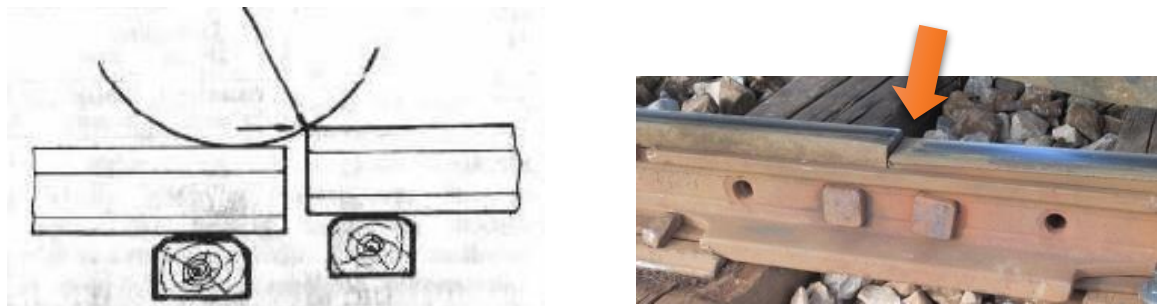
Fig. 4.2.6.6: The influence of the wheel on the rail composition

Due to the operation of the horizontal longitudinal forces especially when braking or starting of the train, as well as the temperature changes, when there is reduced friction between the fastening accessories and the rails and between the rail leg and its substrate, there happens a longitudinal movement of the track (*“travel of rail”*). The connection of rail composition on many places is achieved with a smaller number of connecting bolts (Figure 4.2.6.6.).
