REPUBLIC OF SERBIA
CENTER FOR INVESTIGATION OF ACCIDENTS IN TRANSPORT
SECTOR FOR INVESTIGATION OF ACCIDENTS IN RAILWAY TRAFFIC
AND INTERNATIONAL COOPERATION
Nemanjina 11, 11000 Belgrade

FINAL REPORT ON ACCIDENT INVESTIGATION

Type of accident: Fire on the train
Train No.: 2746
Place: Hadžićevo,
open track between stations Matejevac and Svrlijig
Date: 30.03.2018.
Time: 17:50

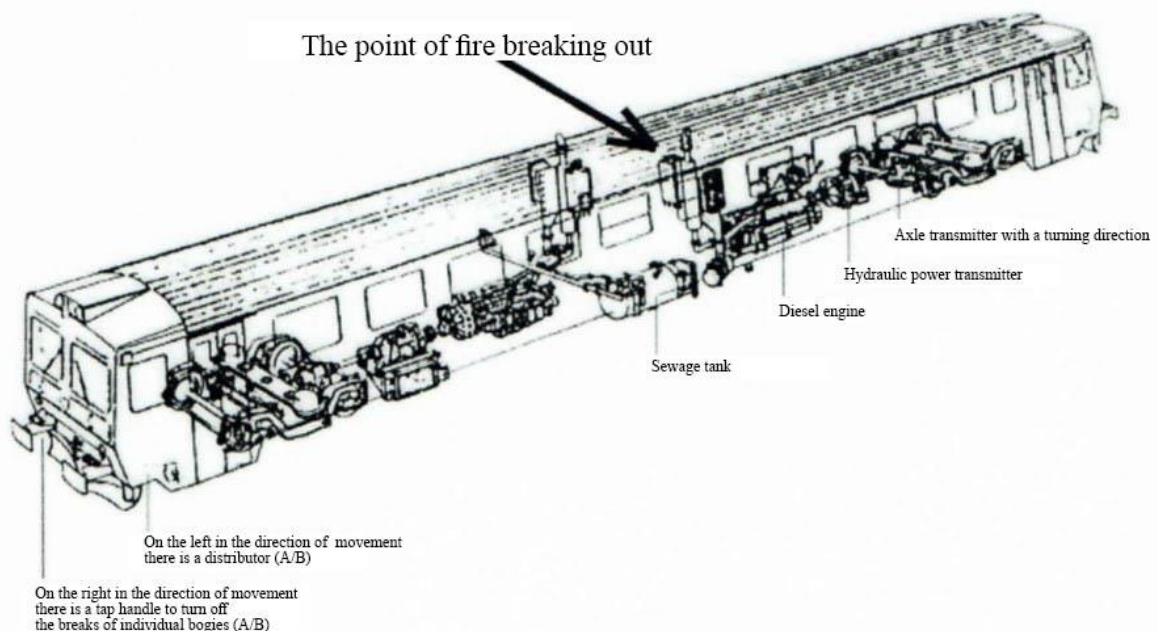
Fig. 2.1.1.2: The schematic review of the place of the fire on DMK 710-004 (source “Srbija Voz” a.d.)

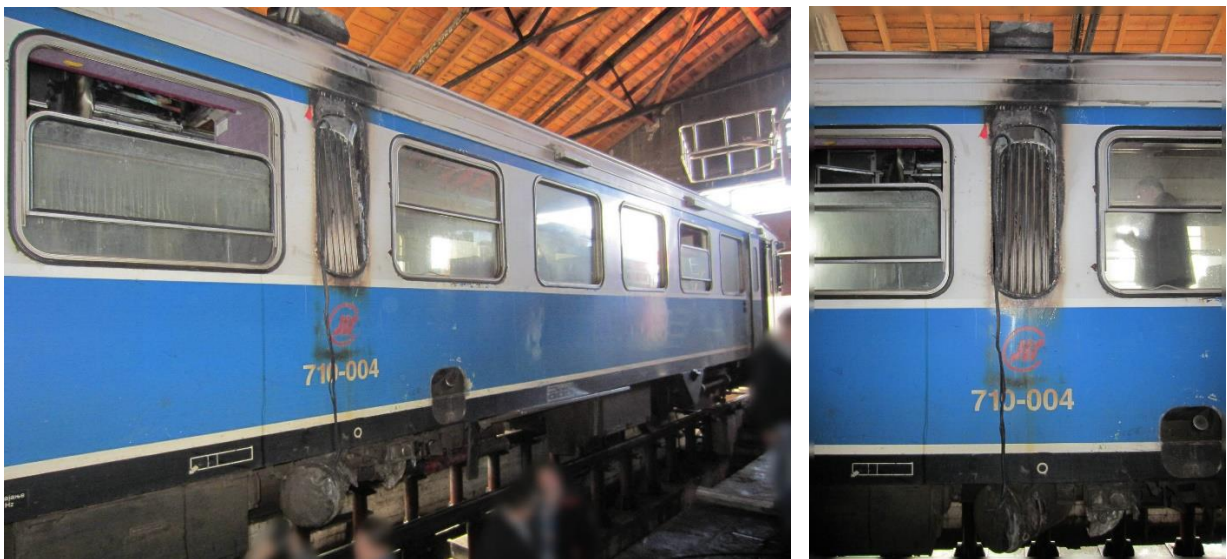
Fig. 3.4.4.1: View of DMK 710-004 on fire (middle part from the outside)

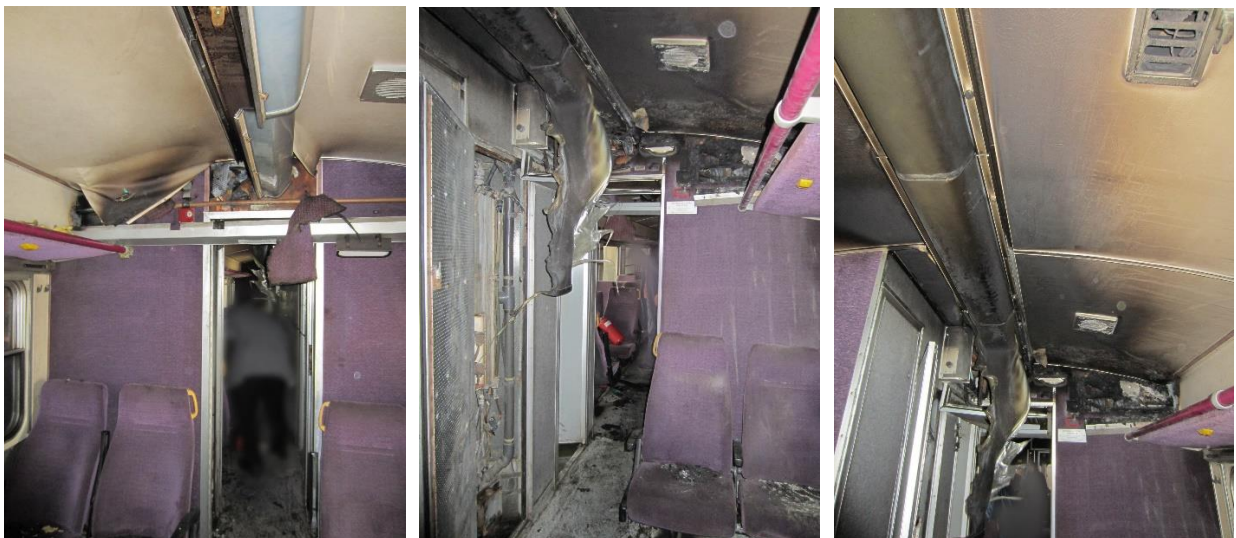
Fig. 3.4.4.2: View of passenger compartment DMK 710-004 on fire

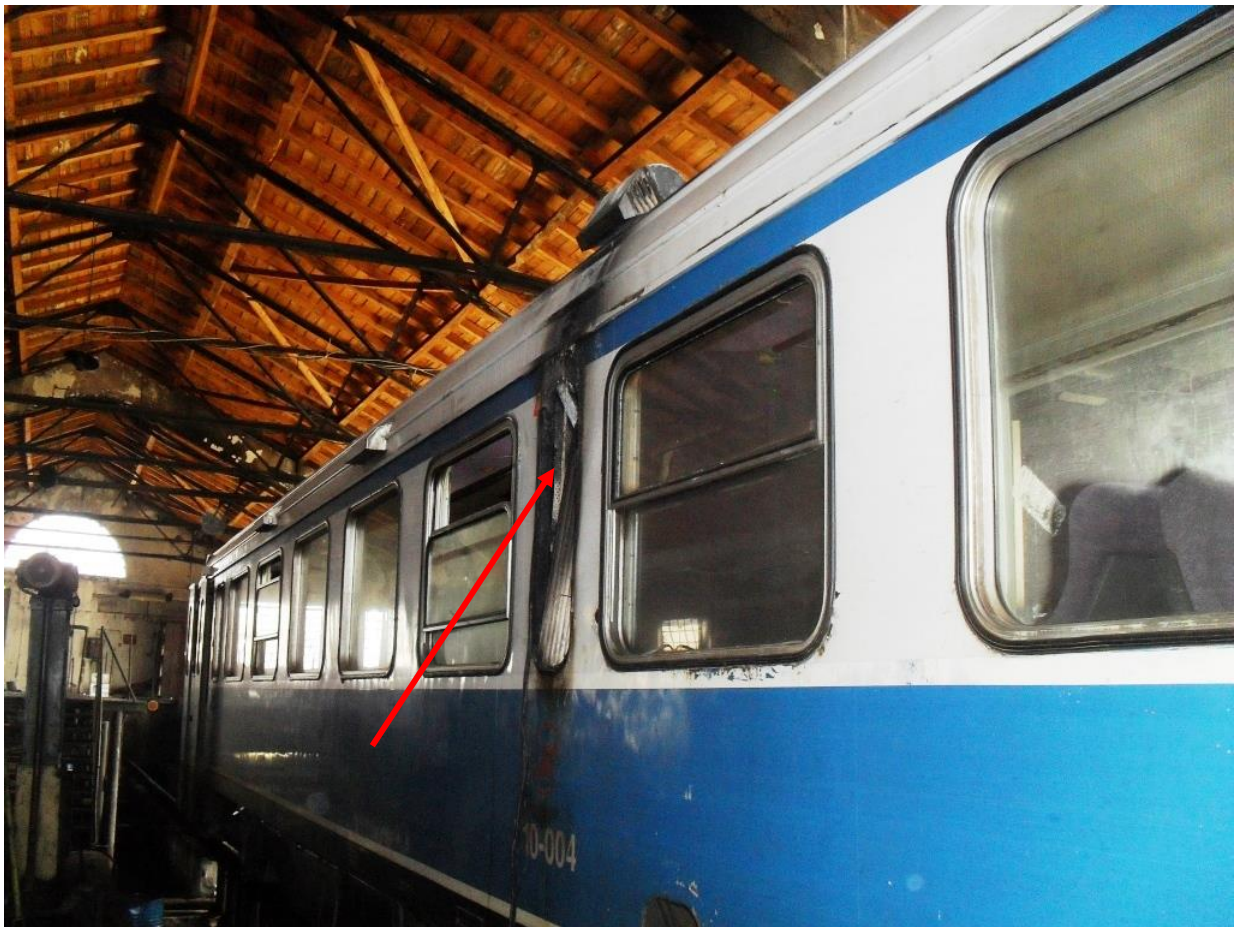
Fig. 4.1.1.1: View of the middle compartment of DMK 710-004 above DM “A”

A fire on DMK 710-004, which were operating as a train No. 2746, happened in the central part, with traces of burning above the engine compartment DM “A”, Figure 4.1.1.1.

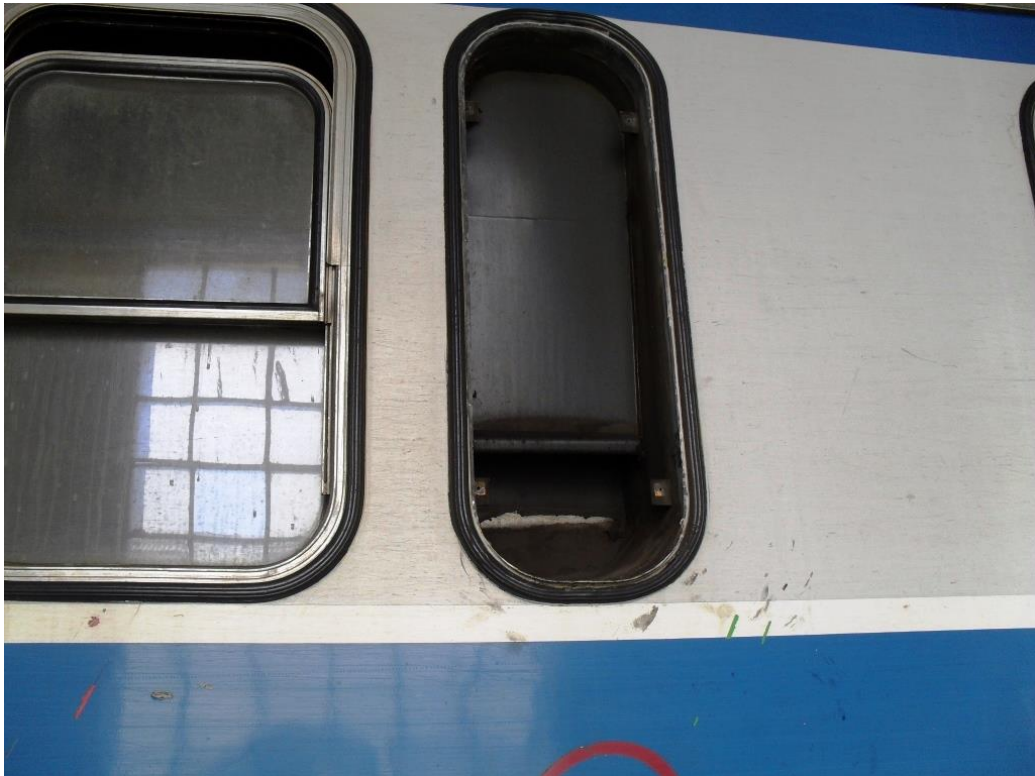
Fig. 4.1.1.2: Review of the middle compartment of DMK 710-004 above DM “B”

On the outer surfaces, above DM “B”, no traces of burning have been noted, Fig. 4.1.1.2.

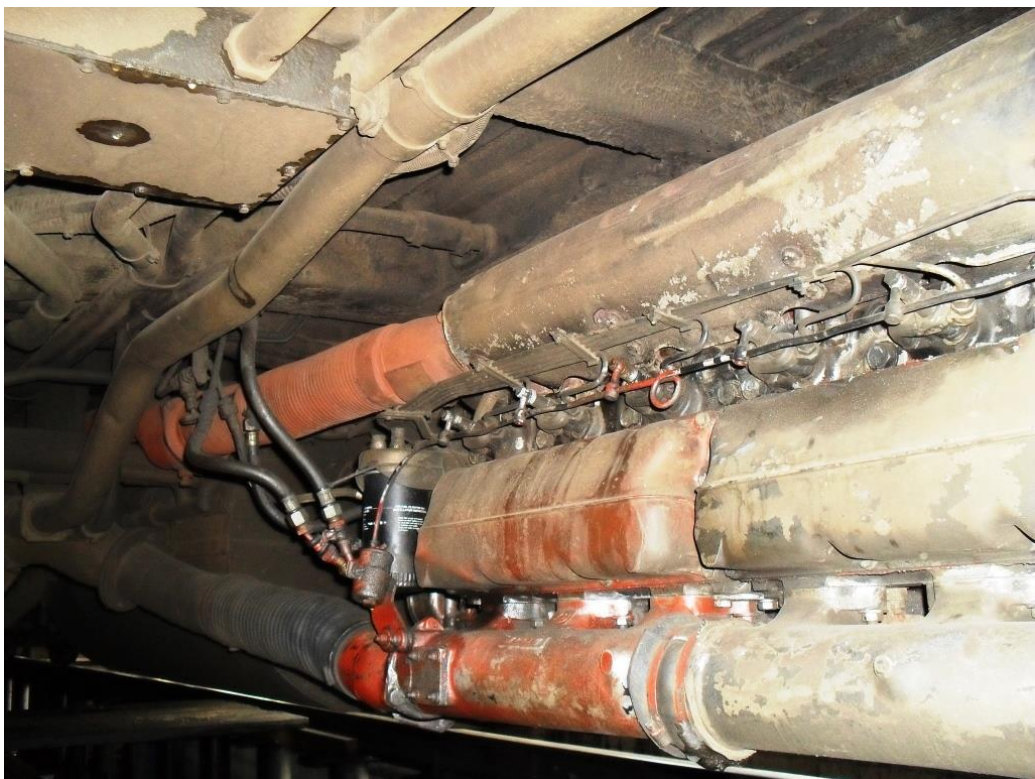
Fig. 4.1.1.3: Review of DM “A”

Traces of burning were not also noted on DM “A”, while above the same compartment they have been, Fig. 4.1.1.3.

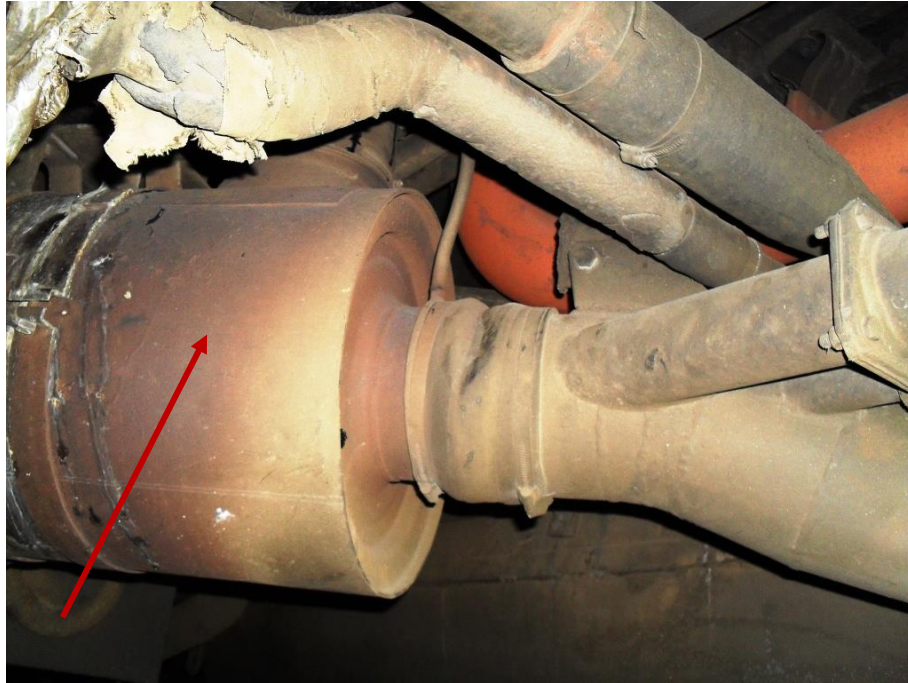
Fig. 4.1.1.4: View of the enclosure of the air filter DM “A”

The metallic enclosure of the air filter DM “A” shows the change of the color of the metal housing part as a result of the development of high temperature, as well as the thermal degradation of the paint, Figure 4.1.1.4.

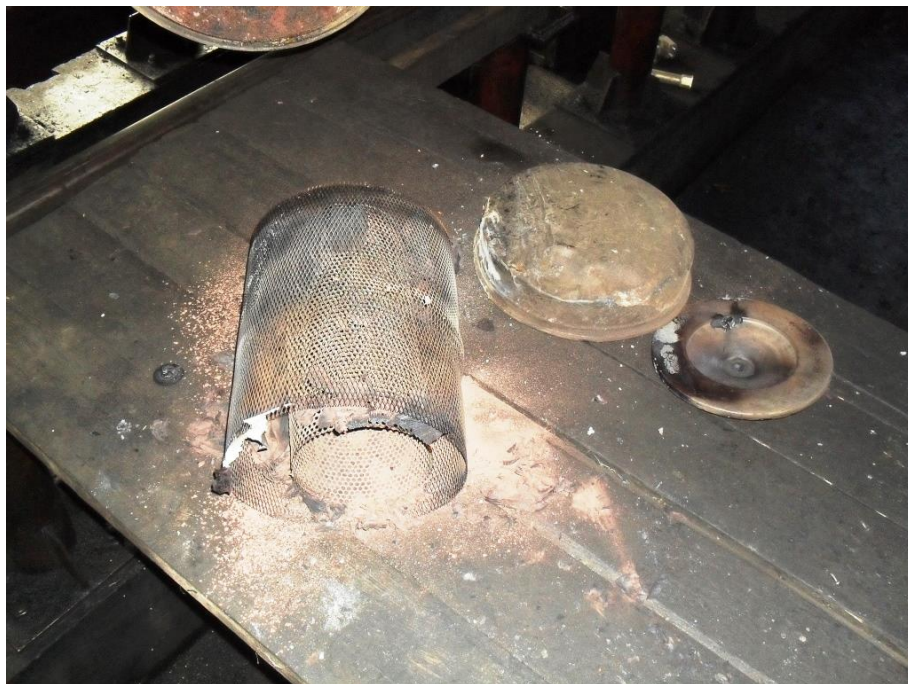
Fig. 4.1.1.5: Review of the internal parts of air filter DM “A”

Also, it was noted that the internal inflammable elements of the air filters, except the metal ones, were thermally degraded, Fig. 4.1.1.5.

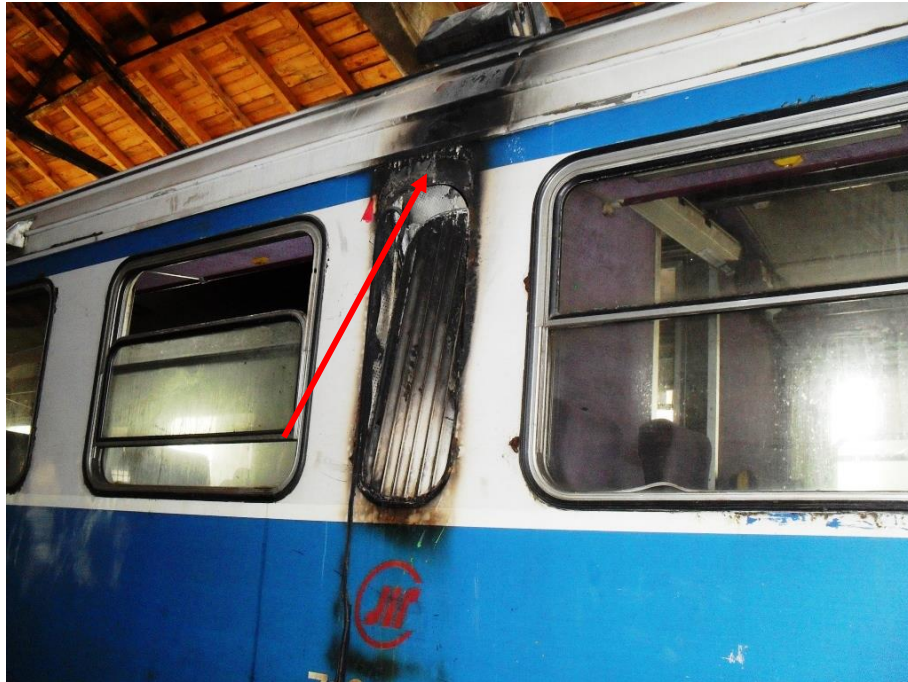
Fig. 4.1.1.6: Review of the air intake DM “A”

The traces of burning on the outer surfaces of the air intake DM “A” and the surfaces of the outer sheath DMK expressed in the upper part, Figure 4.1.1.6.

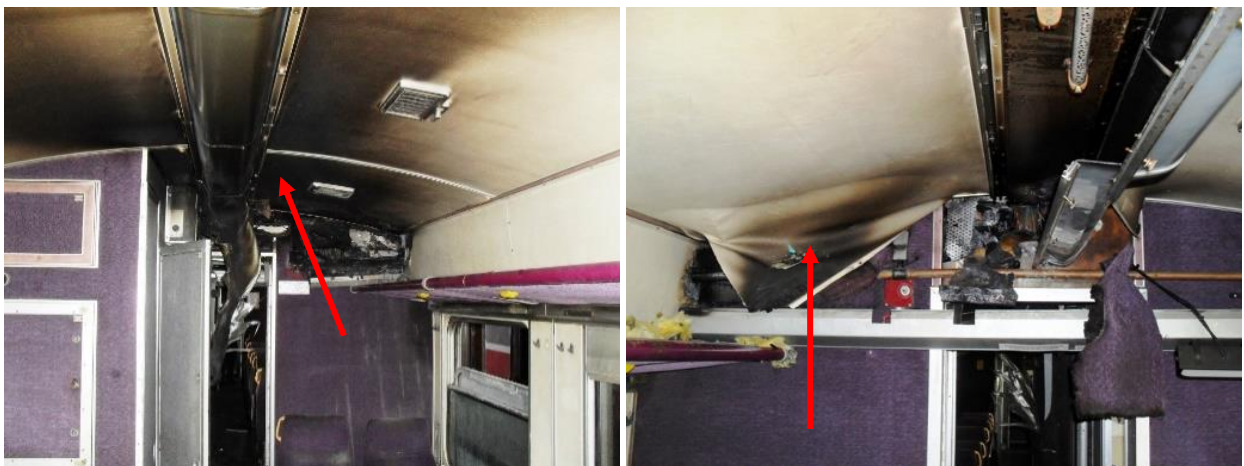
Fig. 4.1.1.7: Traces of fire in the inner part of DMK

Tracks of burning in the inner part of DMK, where the passengers are placed, were expressed on the side above DM “A”, on the surfaces in the upper part of the vehicle, Fig.4.1.1.7.

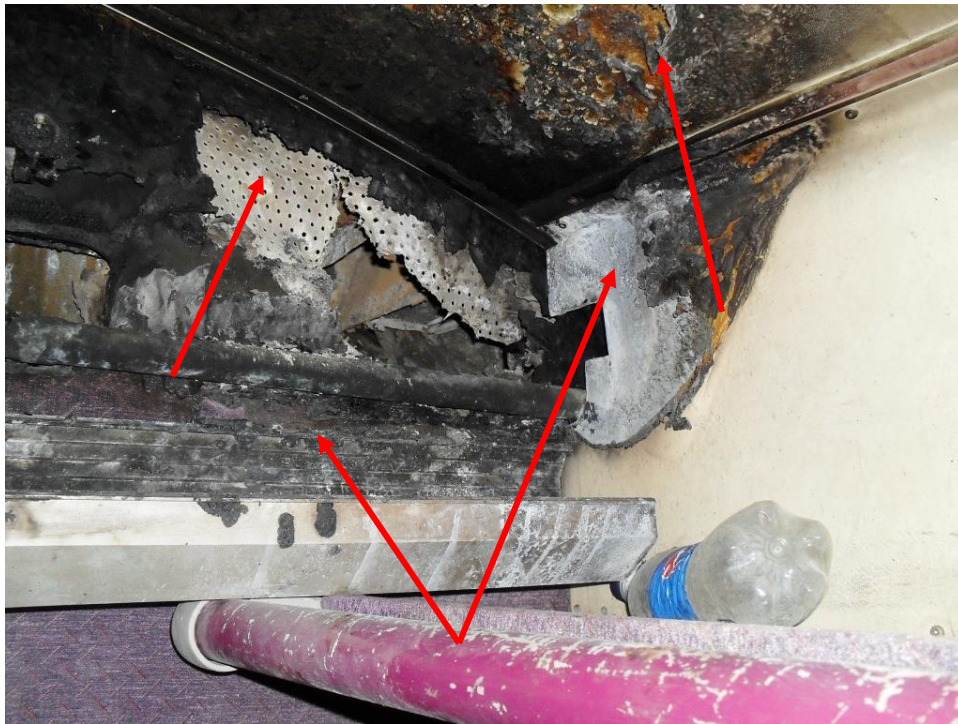
Fig. 4.1.1.8: View of other metal parts on fire

Textile upholstery is thermally degraded while the aluminum parts are melted as a result of the presence of a temperature above the melting point of aluminum, that is approximately 650°C. It was noted that on other metal parts, the paint is thermally degraded as a result of the presence of high temperature, Figure 4.1.1.8.

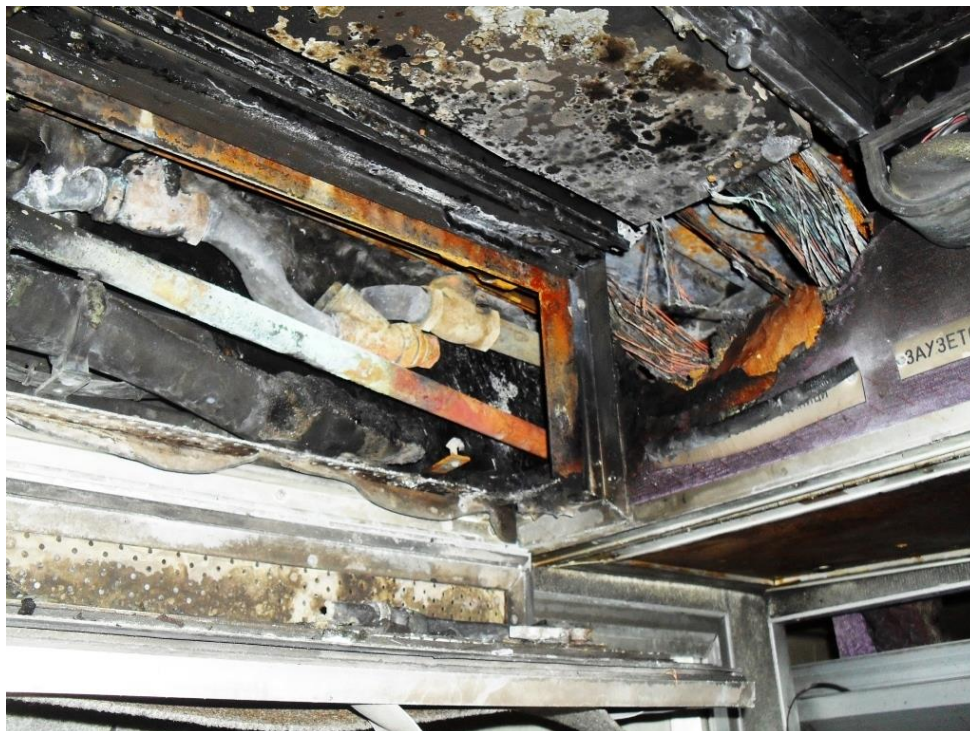
Fig. 4.1.1.9: Review of the traces of burning on the installation in the roof construction

Traces of burning on the installation that is located in the roof construction are of a greater intensity, Fig. 4.1.1.9.

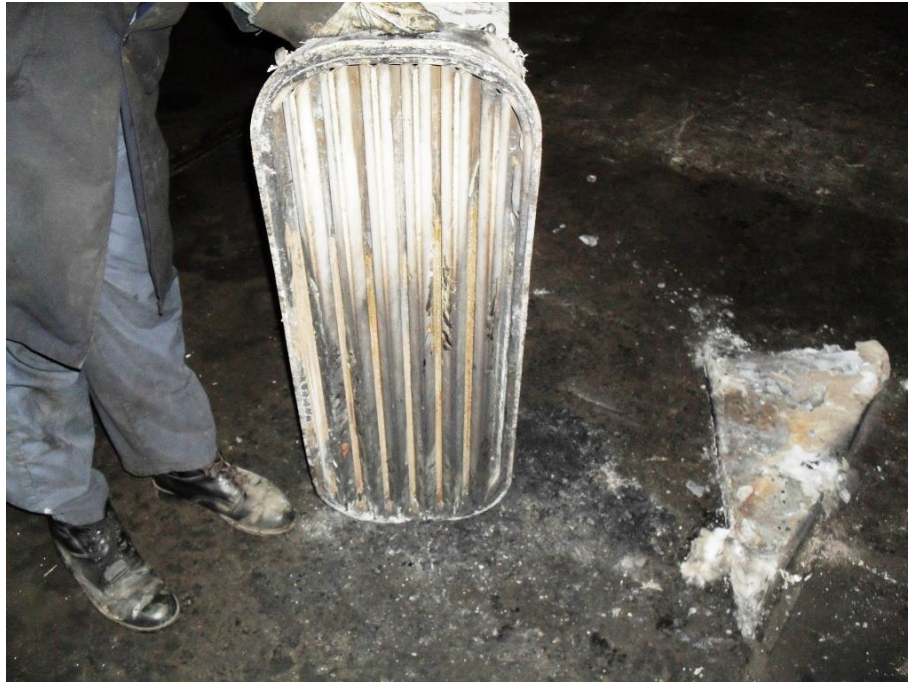
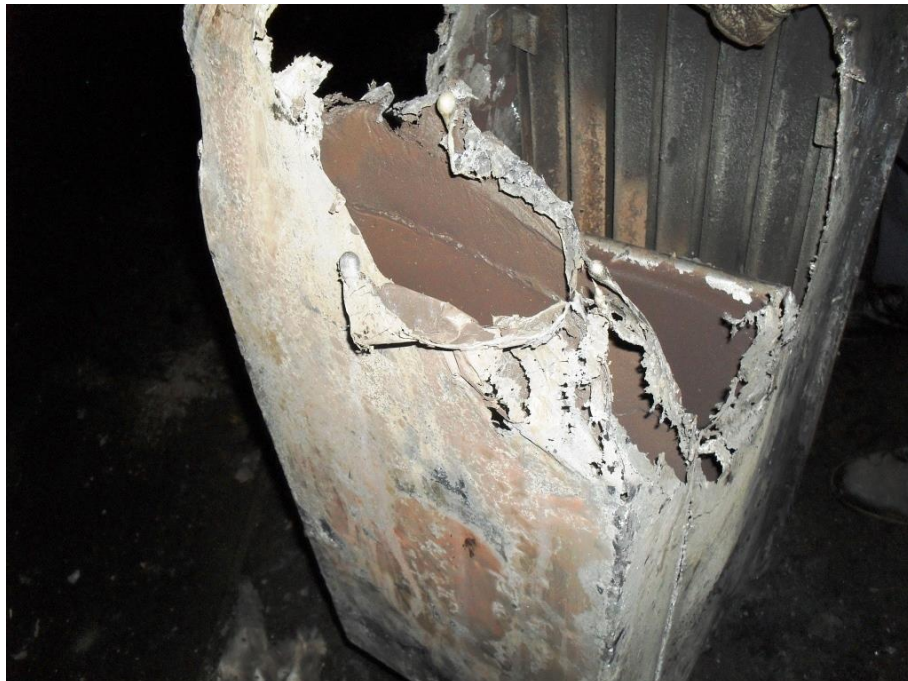
The aluminum air intake on the outer part, which is located in front of the metal channel through which the exhaust pipe passes, with the traces of combustion expressed in the lower part, Figure 4.1.1.10. and the rear side of the air intake with the traces of melting expressed on the under side as a result of the fall of the burnt wooden and textile parts, Figure 4.1.1.11.

Fig. 4.1.1.10: View of the front part of aluminum intake

Fig. 4.1.1.11: View of the rear side of aluminum intake

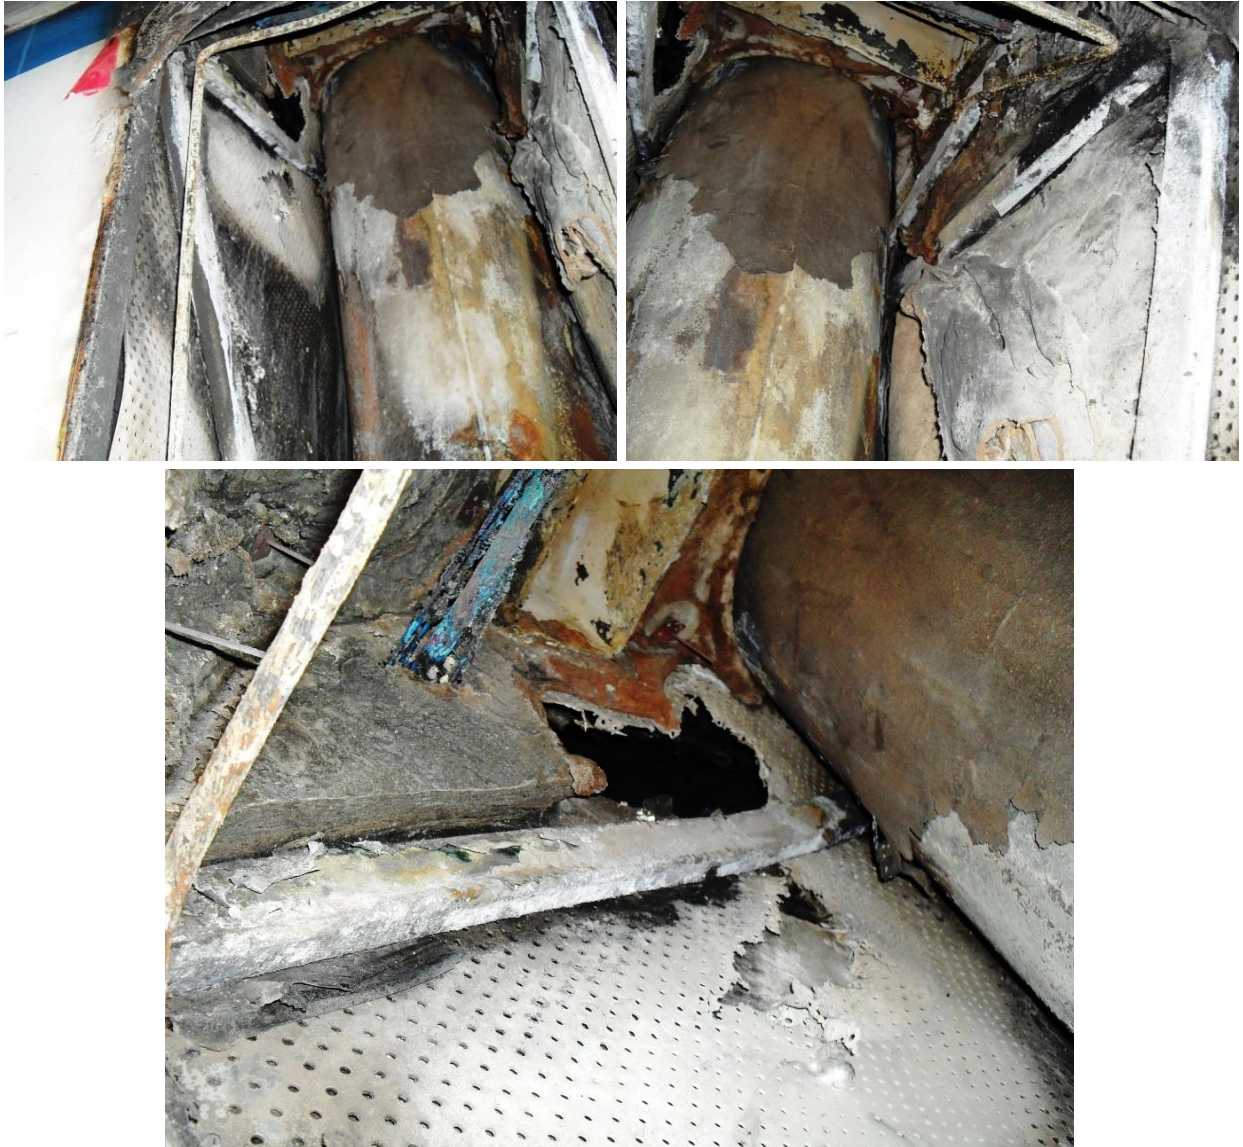
Fig. 4.1.1.12: Parts of isolation to the metal protective tube

Traces of burning on a metal pipe through which the exhaust pipe DM “A” passes are with the traces of burning of the greatest intensity on the surface in the upper part directly to the roof. The color is thermally degraded, and the aluminum parts on the left and right sides are melted as a result of the presence of high temperature. Parts of the isolation to the metal protective tube are thermally degraded, Figure 4.1.1.12.

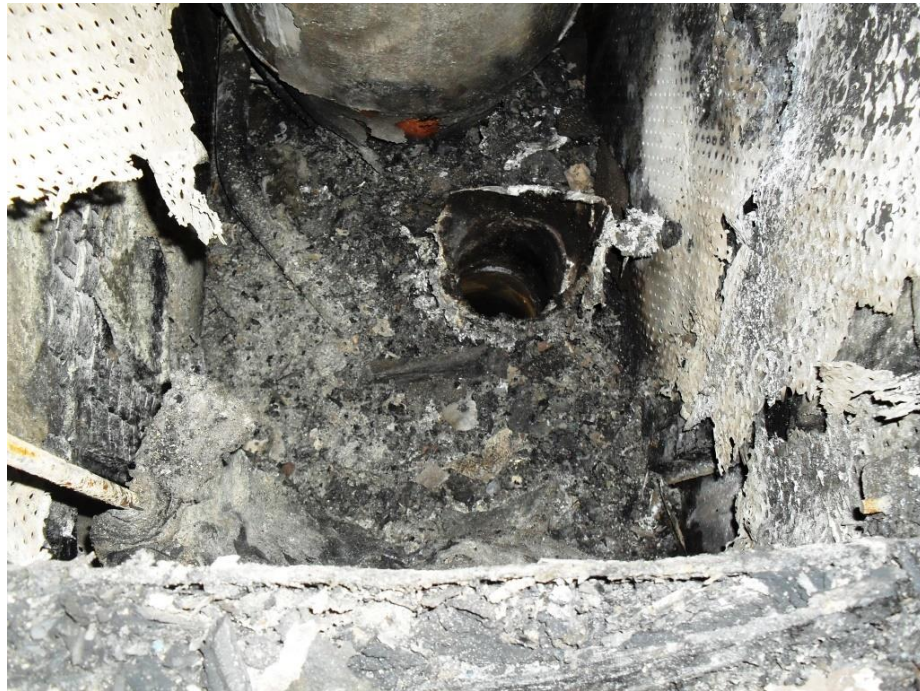
Fig. 4.1.1.13: The view of the floor on which the intake was found

The floor on which the aluminum intake was located is with traces of burning of high intensity, which were caused as a result of falling of inflammable elements from the upper surfaces, Figure 4.1.1.13.

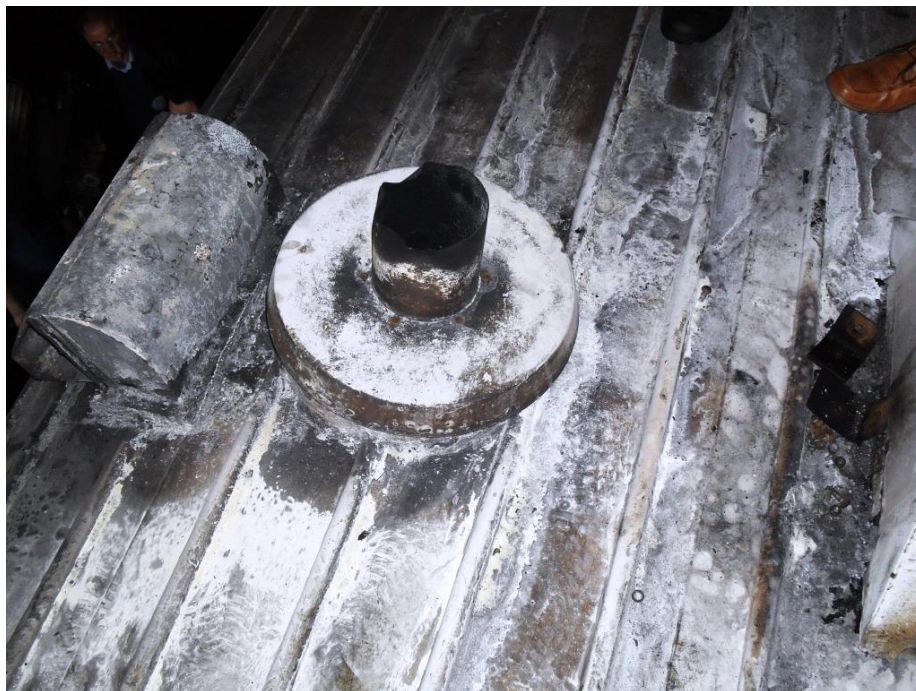
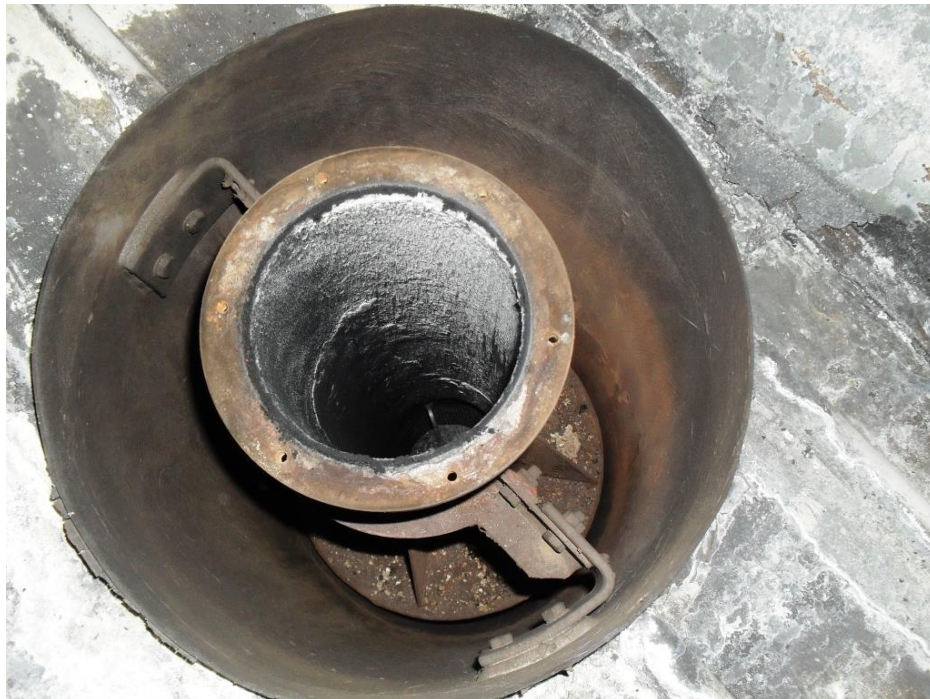
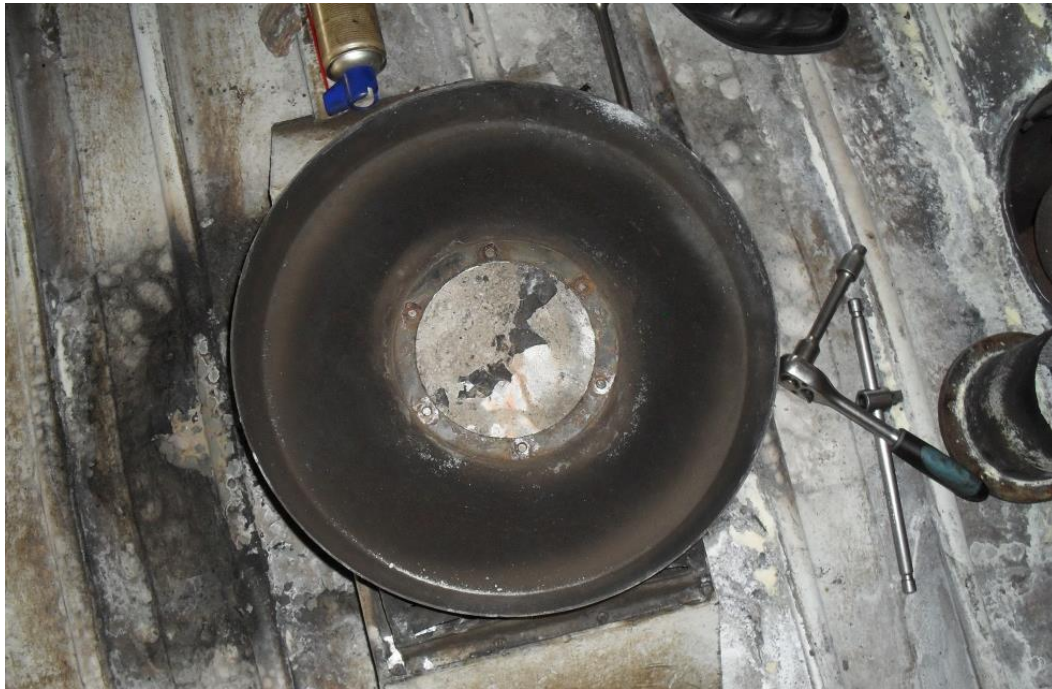
During the inspection (disassembly operations) on the roof of the motor vehicle, it was concluded that the end of the exhaust pipe - the extension of the exhaust manifold DM “A” that comes out on the roof, was fitted with a flange connection without a seal (dichotung), that there are traces of contamination with the products of exhaust gases from DM to the inner wall of the metallic tube through which the exhaust pipe of DM passes through at the part with the connection with the exhaust pipe, Figures 4.1.1.14, 4.1.1.15, 4.1.1.16. and 4.1.1.17.

Fig. 4.1.1.17: The view of the seal of the protective pipe DM “A” with the traces of grime on the inner surface

Based on the traces of burning and combustion products it was determined that the centre of the fire was located in the upper part, on the point of contact of the protective pipe through which the exhaust manifold DM “A” on the roof pipe passes.
