REPUBLIC OF SERBIA
CENTER FOR INVESTIGATION OF ACCIDENTS IN TRANSPORT
SECTOR FOR INVESTIGATION OF ACCIDENTS IN RAILWAY TRAFFIC
AND INTERNATIONAL COOPERATION
Nemanjina 11, 11000 Belgrade

FINAL REPORT ON SERIOUS ACCIDENT INVESTIGATION

Type of accident: Overtaking of the train on the worker
Train No.: Locomotive CEM -7
Place: Obrenovac, TENT Obrenovac, the area of the depot at the station Obrenovac
Date: 13.04.2018.
Time: 13:30

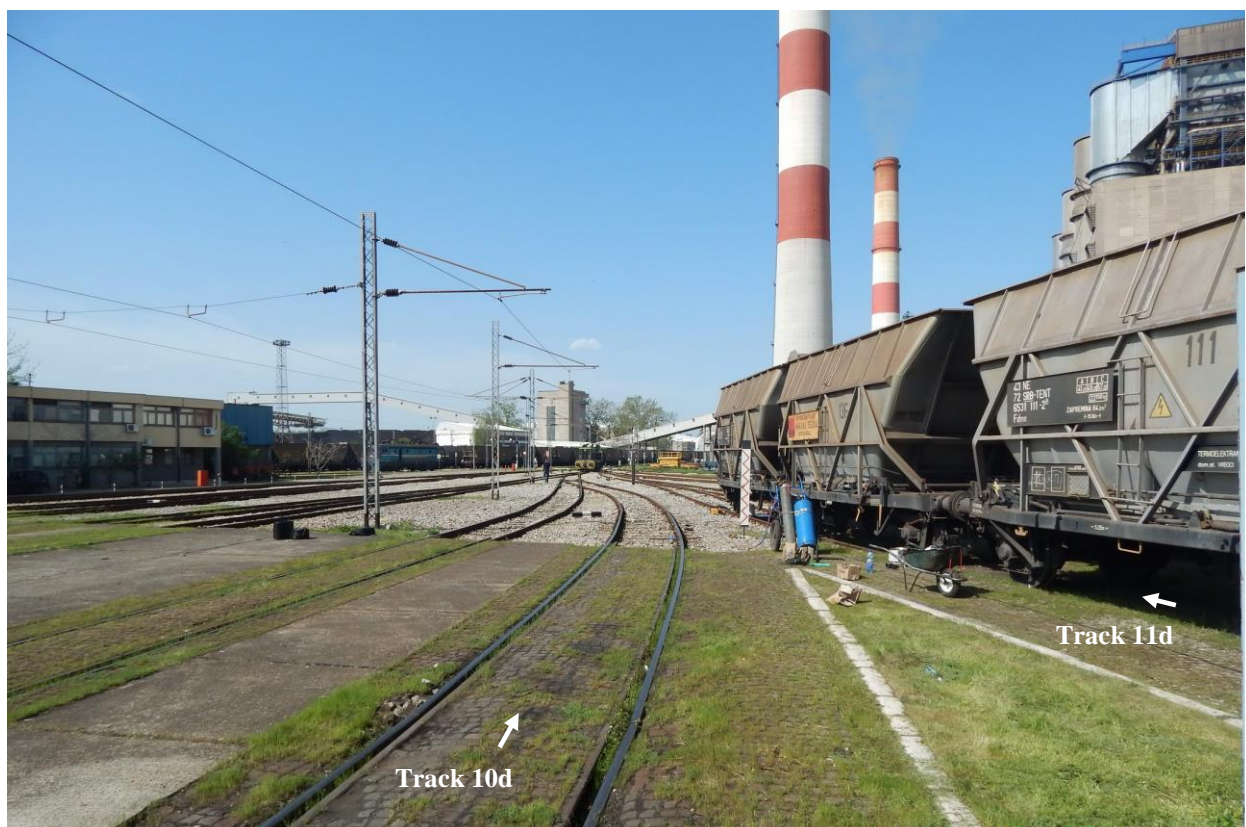
Figure 2.2.5.1: The appearance of the place of works on the wagon of series Faboo (source: OJT from Obrenovac)

The appearance of the place of works is shown in Fig. 2.2.5.1.

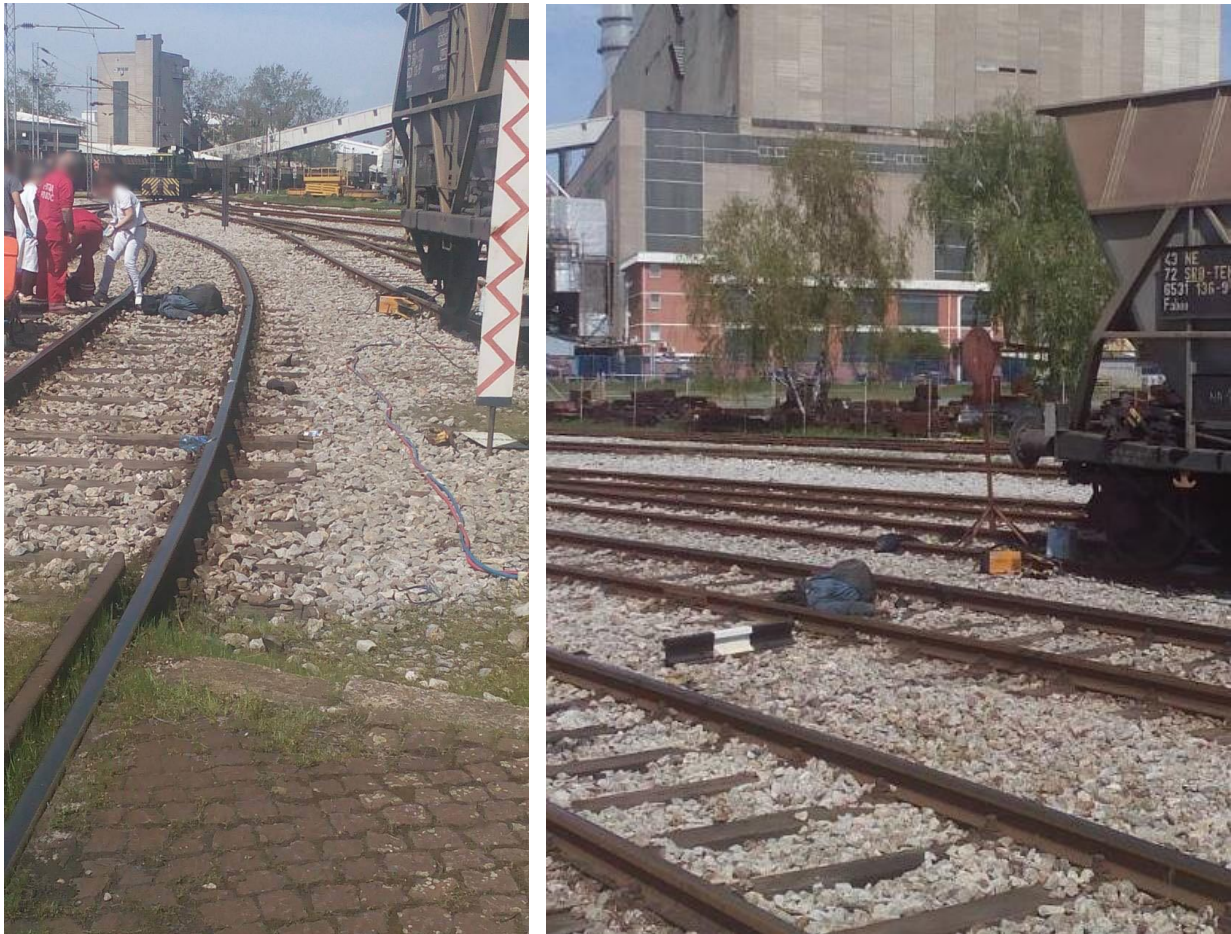
Figure 4.1.1: The appearance of the accident site where the deceased worker was found (source: TENT)

During the CEM-7 locomotive drive, a deputy manager (a deceased worker) was taken out of the group of workers and entered the profile of the 10d track to drink water from a plastic bottle (according to individual workers' statements). Although they could not with certainty assess the distance of the site of the injured worker from the encountering locomotive CEM-7, they were sure that it was in the track 10d. On that occasion, a locomotive overtook him. After driving on the track 10d to the switch No. 10d, the train driver learned from a shunter and another train driver that in the track 10d stayed a runover man.

On the basis of photo documentation (source: TENT), the deceased worker was found at track 10d after a serious accident, at a distance which corresponds to the place between the 16th and the 17th sleeper from the end of the paved part of the track (Figure 4.1.1.).

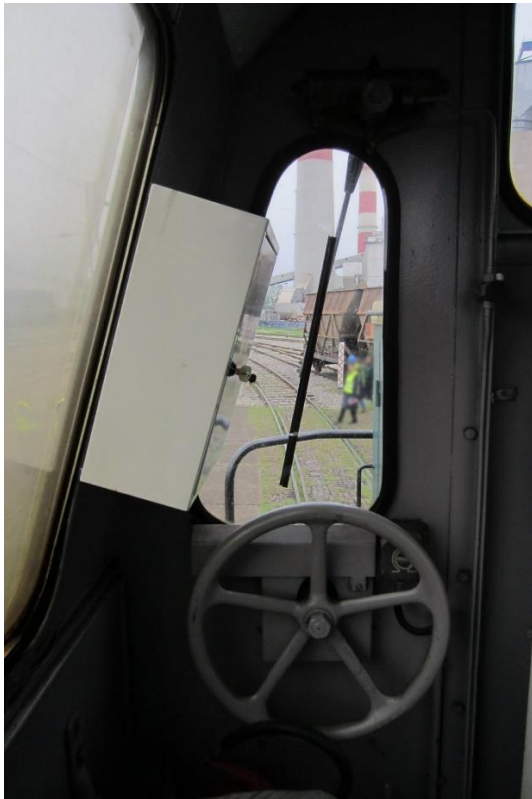
Figure 4.2.2.2: View from the left front window

When, looking in the direction of the intended shunting movement, a seat on the left side of the steering column behind the counter with locomotive controls is used, so that the head is put through the side window, looking through the side window at the locomotive driver's cab (Figure 4.2.2.3.) you can see the entire shunting route and the place where the locomotive CEM-7 (place

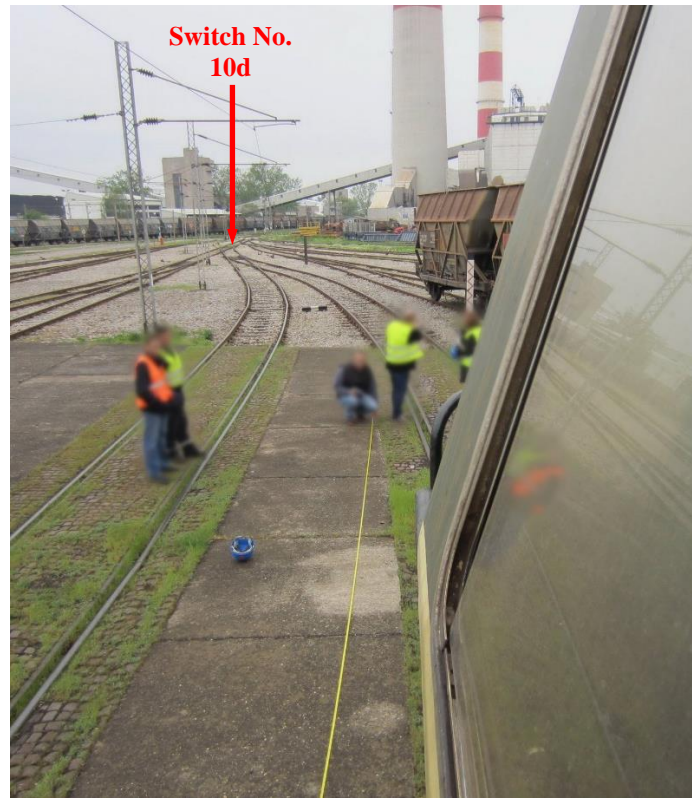
Figure 4.2.2.3: View from the left side window

behind the turning point number 10d) should be stopped after the shunting-movement, that is, the place where the shunter was to be located, part of the track 11d and part of the last wagon was on track 11d. Looking through the side window it is not possible to spot people standing on the right track of the track 10d and located at a distance less than 8 m from the locomotive CEM-7 locomotive (at a distance of less than 11.3 m from the side window from which the observation was carried out). Also, in the direction of the planned shunting movement, all the persons who are standing to the right of the line passing through the point where the train driver and the point on the right track are located 8 m from the locomotive buffer from the place where the train driver was located, through the side window it can not be spotted.

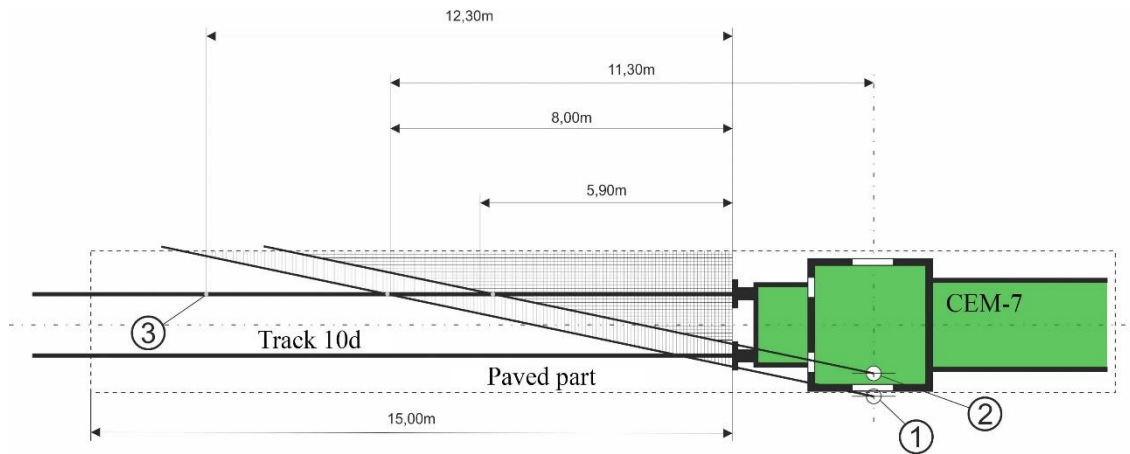
Figure 4.2.2.4: Schematic review of the area of visibility for the train driver from the position of starting the locomotive CEM-7

The sketch of visibility from the locomotive CEM-7 from the position of the train driver determined during the reconstruction is shown in Figure 4.2.2.4.

- 1 - position (aspect) of the train driver with head through the side window
- 2 - position (aspect) of the train driver when the head is not shoved through the window
- 3 - the place where (probably) was the deceased worker at the moment of overtaking of the locomotive CEM-7

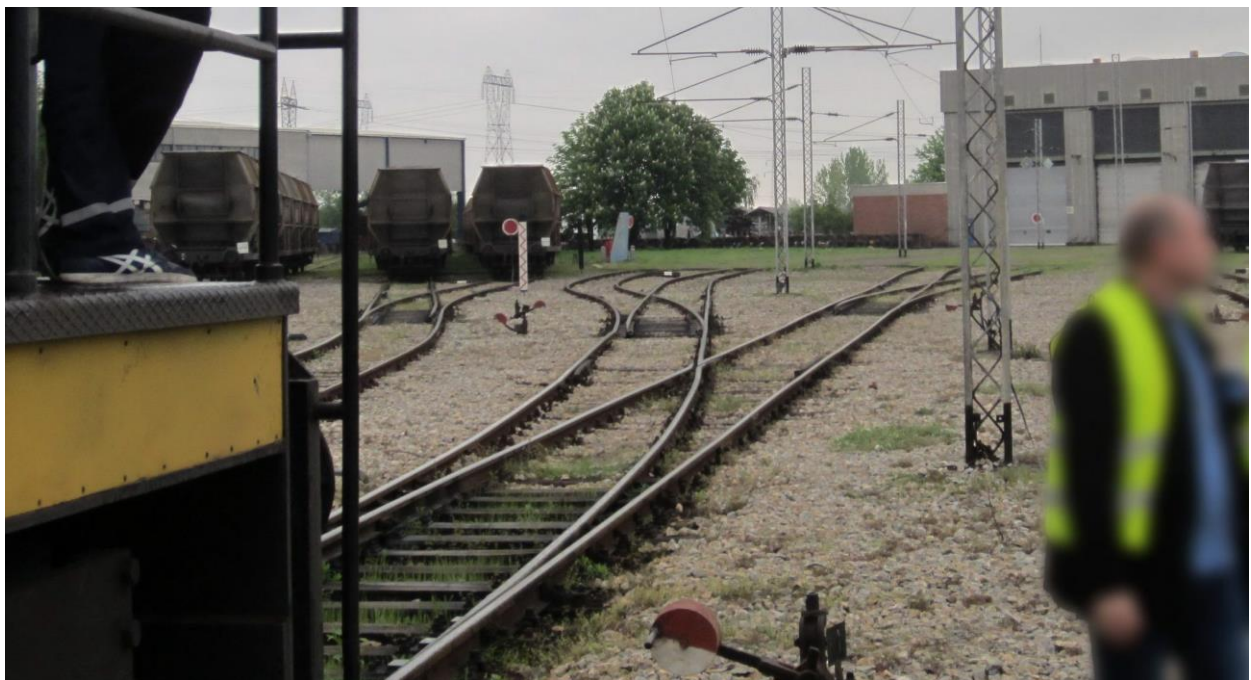
Figure 4.2.2.4: The view from the position of the shunter

From the place where the shunter was supposed to be located (in the area of the switch No. 10d at the switch device), one can clearly see the entire shunting route, the window of CEM-7 locomotive window on the side of the train driver, the wagon that was on track 11d and all persons who were in the area between tracks 10d and 11d in front of the locomotive, as viewed in the planned shunting movement. The space at the right part of the locomotive, as viewed in the direction of the planned shunting movement, from the point where the shunter should be (in the area of the switch No. 10d at the switch device) cannot be completely seen.

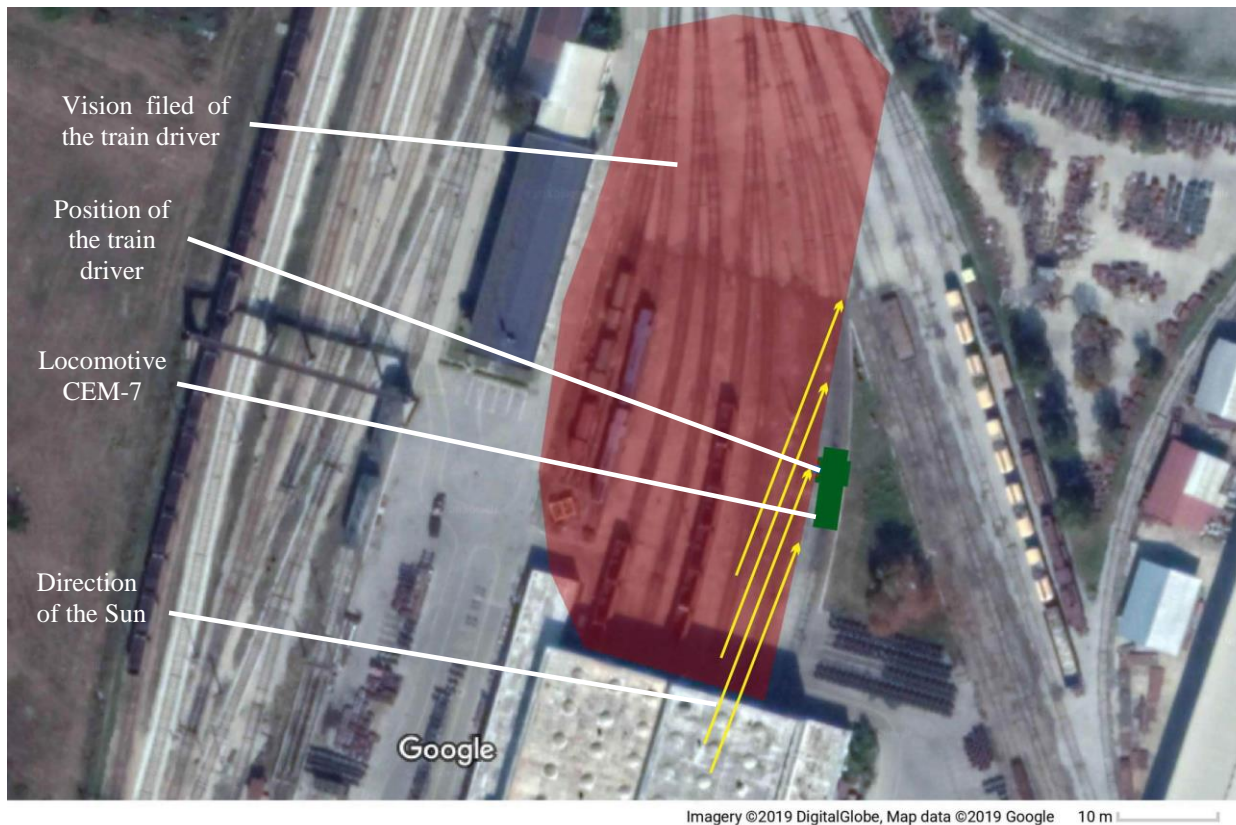
Figure 4.3.6.4: The direction of the Sun relative to the aspect of the train driver

Albedo, i.e. the measure of diffuse reflection of solar radiation, for concrete, is larger than the albedo for the grass surface. In this serious accident, the locomotive CEM-7 was located on a section of track paved concrete.

Based on the weather and visibility data, it can be concluded that the weather conditions could have affected the operation and behavior of all participants in the respective serious accident.
