No.: ŽS - 04/18

## FINAL REPORT ON INVESTIGATION OF SERIOUS ACCIDENT

Type of accident:	Serious accident on the level crossing
Train No.:	7821
Place:	City of Niš, settlement Donje Međurovo, area of the switch block 2 of the station Međurovo
Date:	21.12.2018.
Time:	07:30

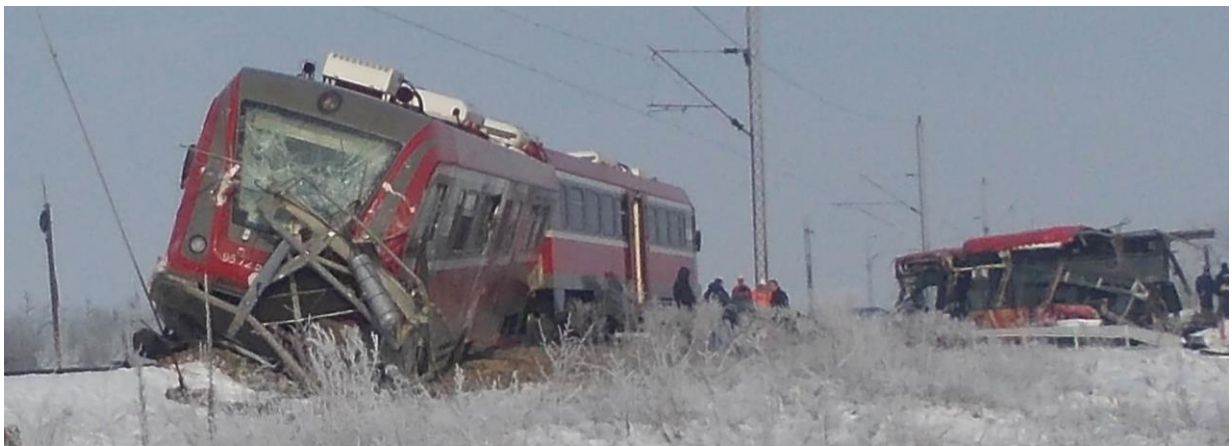
After the overtaking, the train continued its movement in length of 60 m, after which it stopped, so that the head of DMV 711-075/076 was found at km 250+125. On this occasion, part of DMV 711-075 derailed with both bogies, while part of DMV 711-076 did not derail (Figure 2.1.2.1.).

**Figure 2.1.2.1:** Appearance of DMV and the bus after the serious accident  
(looking at the direction to the train forehead, source: "IŽS" a.d.)

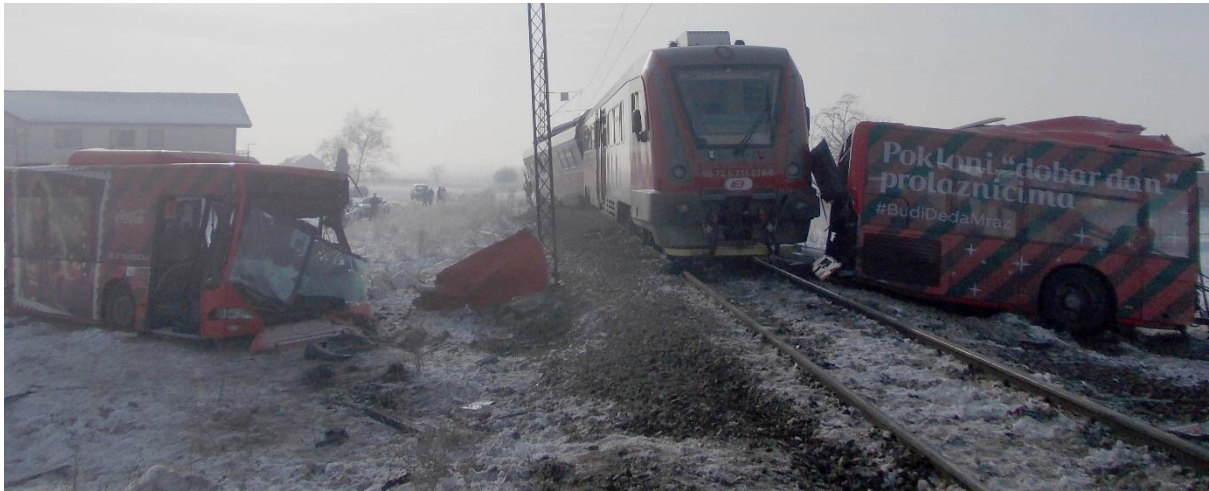
After the hit, the train pushed the road vehicle bus in front of itself in the length of about 10 m, after which the body of the road vehicle bus physically split into two parts in the middle of the road vehicle bus, with each part of the road vehicle bus being discarded out of the track, with one part at each side of the track. The road vehicle bus was found at 13 m from the middle of the level crossing, with the front part of the separated road vehicle bus located on the left side of the track, and the back part of the separated vehicle on the right side of the track (in the direction of the growing mileage, that is, the direction of the train drive). Parts of decoupled bus were found in normal position relative to the axes of the track so that the front end of the front part and the back end of the back part of the road vehicle bus were found neared to the track axes (Figure 2.1.2.2.).

**Figure 2.1.2.2:** Appearance of DMV and the bus after the serious accident  
(looking at the direction to the end of the train, source: “IŽS”a.d.)

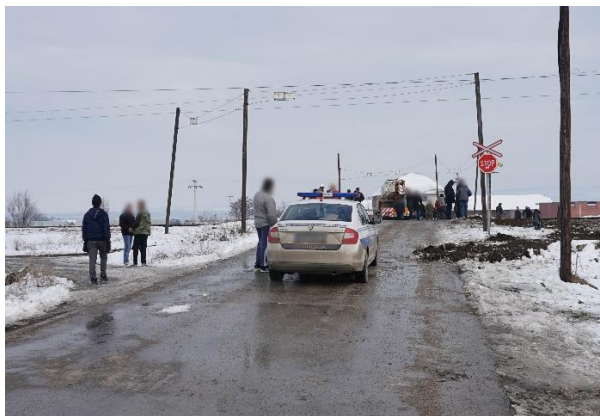
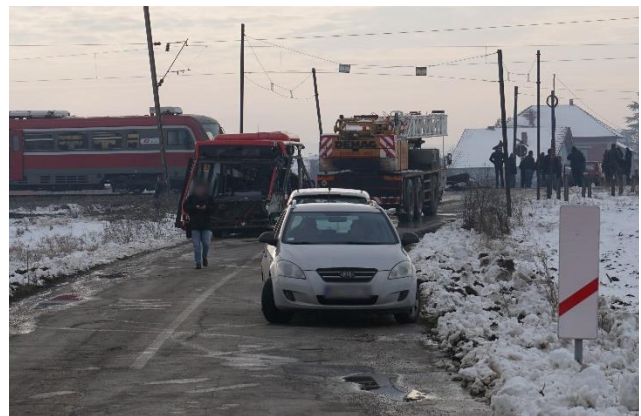
The condition of the asphalt pavement near the road crossing is tidy, with no damage observed. The local road, from the direction of Niš and from the direction of Donje Međurovo to the respective level crossing, is on the rise. The road on the mere crossing is horizontal.

**Figure 2.2.3.1:** Appearance of the level crossing (view from the direction of the center of Donje Međurovo)

**Figure 2.2.3.2:** Appearance of the level crossing (view from the direction of Niš)

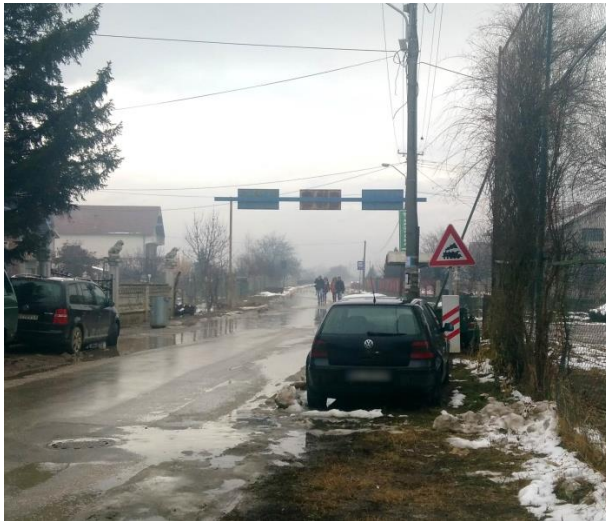
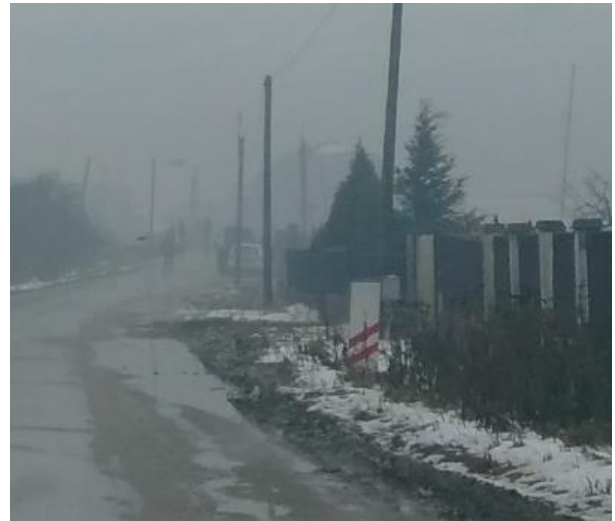
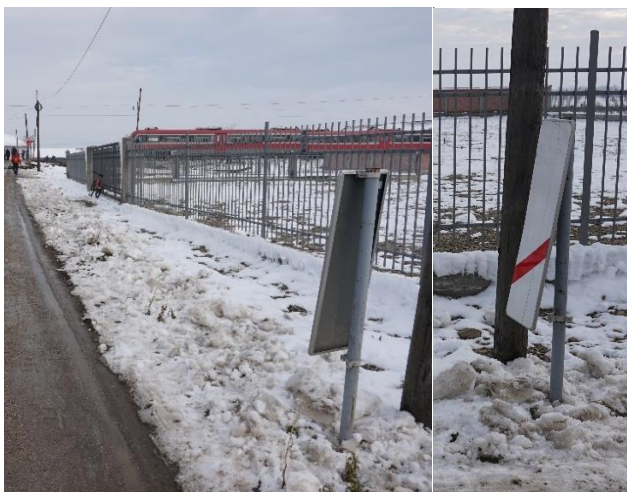
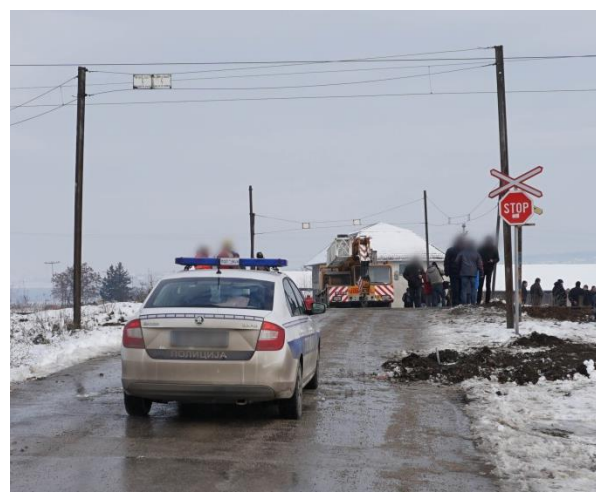
On the respective local road, before approaching the level crossing from the direction of Donje Međurovo, on the supporter which is located on the right side next to the track and is 240 m away from the level crossing, the traffic signs are set: I-33: “Crossing of a road with a railway line without barriers or semi-barriers” and I-35: “Approaching the intersection point of a road and

railway line” (Fig. 2.2.3.3.); on the supporter located on the right side of the road next to the track and 160 m away from the level crossing, the traffic sign : I-35: “Approaching the intersection point of a road and railway line” is set (Fig. 2.2.3.4.); on the supporter located on the right side of the road next to the track and 80 m away from the level crossing, the traffic sign I-35: “Approaching the intersection point of a road and railway line” is set (positioned incorrectly, facing opposite the direction from which the road vehicles approach, Fig. 2.2.3.5.) and on the supporter located on the right side of the road next to the track and 9.98 m away from the nearer rail of the railway track, the traffic signs I-34: “Andrejin krst” and II-2: “Obligation of stopping” are set. Behind aforementioned traffic signs, there is set a clearance gate, whose supporters are positioned on either side of the road, so that the left supporter is 8.45 m and the right supporter 8.2 m away from the nearest rail track of the railway. No signs were placed on the supporters of the gates and on the gate itself, but only a signboard - a warning of high life-threatening voltage (Figure 2.2.3.5.). In addition to the traffic signs indicated, no other traffic signs were placed in this section of the local road in the mentioned direction (traffic sign: II-30: “Speed limit” is not set).

On the road from the direction of the center of Donje Međurovo in front of the level crossing the traffic sign II-30: “Speed limit” has not been set, which would, according to provision of the Article 15 of the Rulebook on the manner of crossing of the railway line and the road, pedestrian or bicycle path, the point where crossing can be made and the measures to secure the safe traffic (“Official Gazette RS” No.89/2016), represent the beginning of the zone of necessary visibility. Given the existence of the facilities described in the Point 2.2.3. (the orchard and the fenced area), the zone of necessary visibility from the direction of Donje Međurovo to Niš is non-existent and

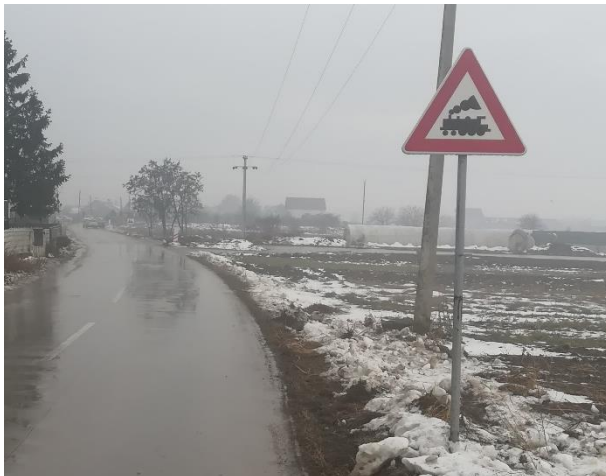
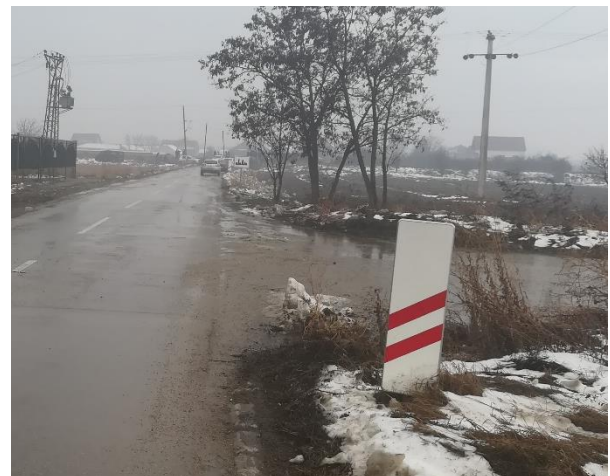
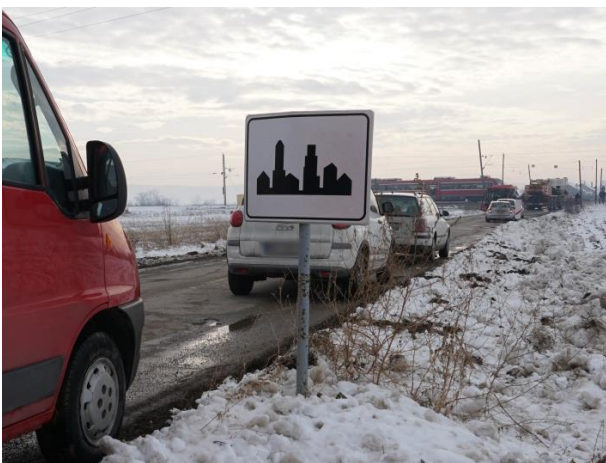
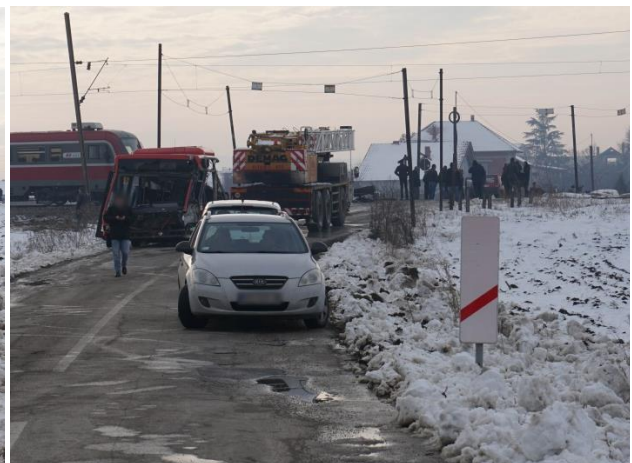
On the respective local road, before approaching the level crossing from the direction of Niš, on the supporter on the right side of the road next to the track and 240 m from the level crossing, a traffic sign is set: I-33: “Crossing of a road with a railway line without barriers or semi-barriers” (traffic sign I-35: “Approaching the intersection point of road and railway track” is not set, Figure 2.2.3.7); on the supporter located at the right side of the road next to the track and is 160 m away from the level crossing the traffic sign I-35: “Approaching the intersection point of a road and railway line” is set: (Fig. 2.2.3.8.), on the supporter located on the right side of the road next to the track and 110 m away from the level crossing, the traffic sign III-24: “Settlement” is set (Fig. 2.2.3.9.), and on the supporter located on the right side of the road next to the track and 80 m away from the level crossing, the traffic sign I-35: “Approaching the intersection point of a road and railway line” is set (Fig. 2.2.3.10.). Behind aforementioned traffic signs, there is a clearance gate set, whose supporters are positioned on either side of the road, so that the left supporter is 28.9 m and the right supporter 27.2 m away from the nearest rail of the railway track. There are also no traffic signs on the supporters of the gate and on the gate itself, but only a signboard - warning of high voltage life - threatening (Fig. 2.2.3.10.). In addition to the mentioned traffic signs, no other traffic signs were placed in this section of the local road in the aforementioned direction (traffic signs: II-30: “Speed limit”, I-34: “Andrejin krst” and II-2: “Obligation of stopping” were not set.

On the respective level crossing there were no traffic lights on either side of the road (observed for different directions of movement of road vehicles) announcing the approach of a train, since it is a level crossing with a modern pavement - asphalt, which is not in accordance with Article 153 of the Law on Road Traffic Safety ("Official Gazette RS" No. 41/2009, 53/2010, 101/2011, 32/2013 - decision US, 55/2014, 96/2015 - other law, 9/2016 - decision US, 24/2018, 41 / 2018, 41/2018 - other law and 87/2018). This Article of the Law on Road Traffic Safety ("Official Gazette RS" No. 41/2009, 53/2010, 101/2011, 32/2013 - decision US, 55/2014, 96/2015 - other law, 9/2016 - decision US, 24/2018, 41 / 2018, 41/2018 - other law and 87/2018) is in conflict with railway legislation governing this issue.

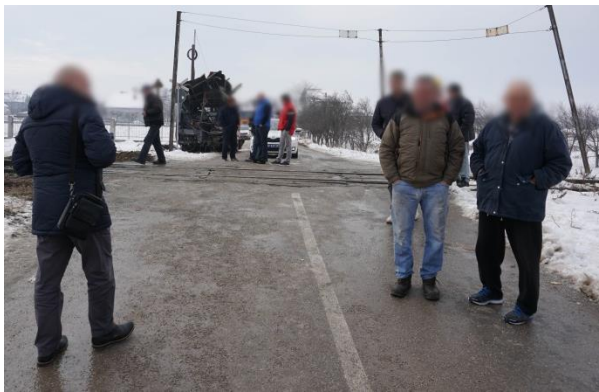
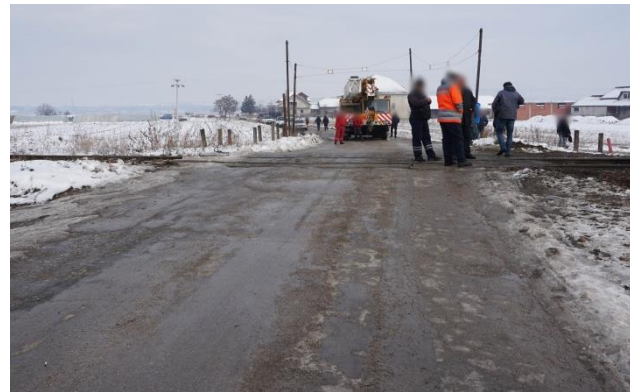
On the above mentioned local road, in the immediate vicinity of the level crossing, on the section from Niš to the level crossing, in the middle of the track there is a full dividing line, while on the part of the road from Donje Međurovo to the level crossing there is no dividing line. There are no other road markings (longitudinal, transversal and other). In the vicinity of the level crossing, the track was cleared of snow and sprinkled with ridge. The track appearance in the vicinity of the level crossing is shown in Figures 2.2.3.11. and 2.2.3.12.

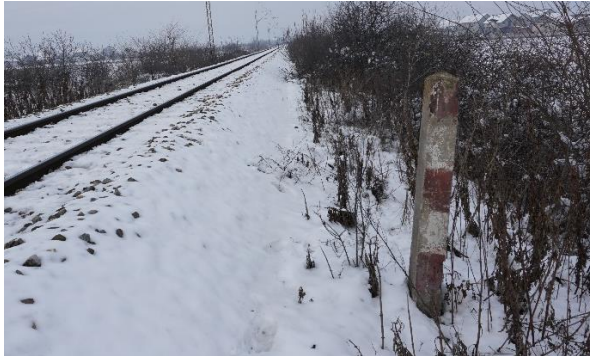
railway. The paint on the red and white areas on the signalling mark is partly peeled. The signalling mark is partly covered with vegetation.

**Figure 2.2.3.13:** Appearance of the signalling mark 209: “Watch out, level crossing”  
(view from the direction of the Belotince crossing)

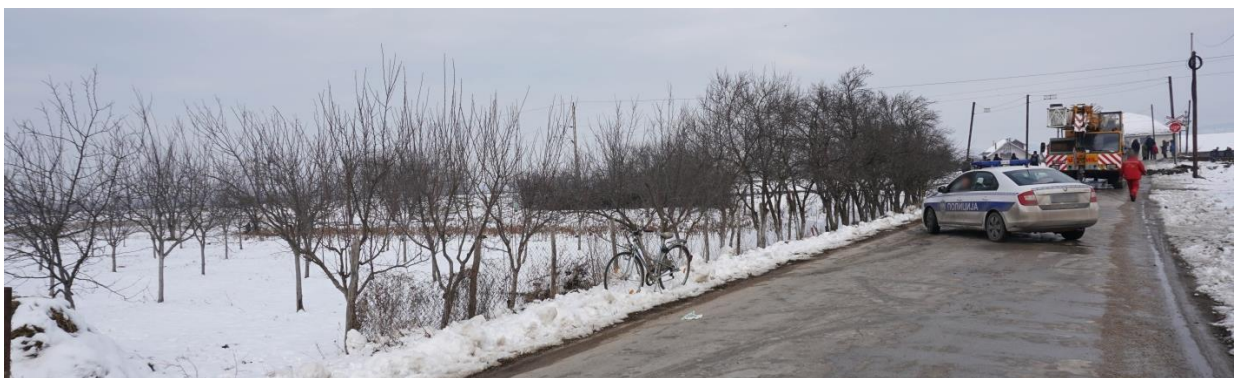
On the right side of the railway track, between the station Međurovo and Belotince crossing, looking in the direction of the growing mileage, in front of the level crossing, there is an orchard partly fenced with a hedge consisting of densely planted trees and shrubs approximately 3 m high. The orchard is positioned between the railway and the local road so that it extends 45 m along the railway line and 60 m along the road. The minimum distance of the orchard from the right rail of the railway track is 9 m, and from the left edge of the track of the respective local road, looking from the direction of Donje Međurovo to Niš, 2 m. The appearance of the orchard is shown in Figure 2.2.3.15.

**Figure 2.2.3.15:** Appearance of the orchard (view from the direction of Donje Međurovo)

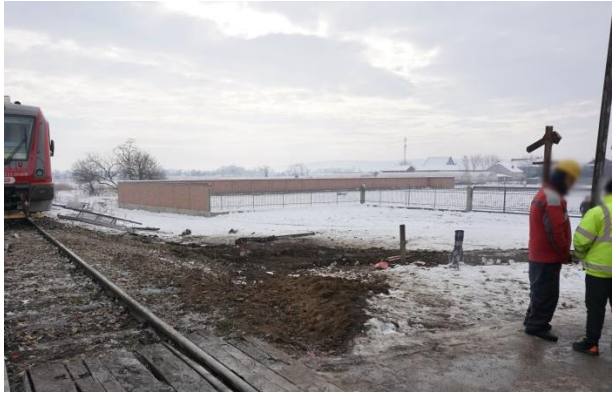
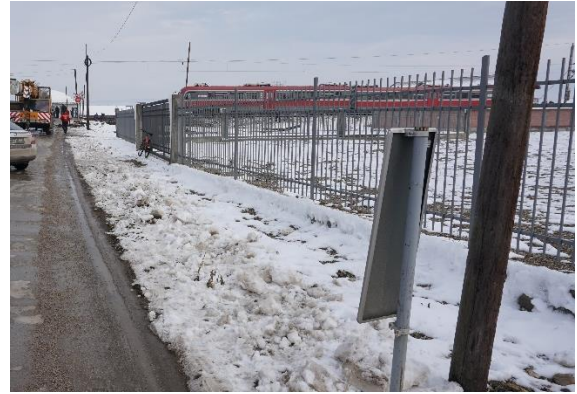
On the right side of the track, between the station Međurovo and the Belotince crossing, as viewed in the direction of increasing mileage, beyond the respective level crossing, there is a space surrounded by the fence made partly of the wall of solid building material of height of 2.6 m (that hinders the view), and partly of the grid metal structure set at low foundation (that does not hinder

the view). The fenced area is located between the railway track and the local road so that it extends along the railway track at a length of 60 m, and along the road at a length of 90 m. The minimum distance from the fenced area from the right rail of the railway track is 13 m, and from the right edge of the track of the respective local road, as viewed from the direction of the Donje Međurovo to Niš, is 3 m. The appearance of the fenced area is shown in Figures 2.2.3.16. and 2.2.3.17.

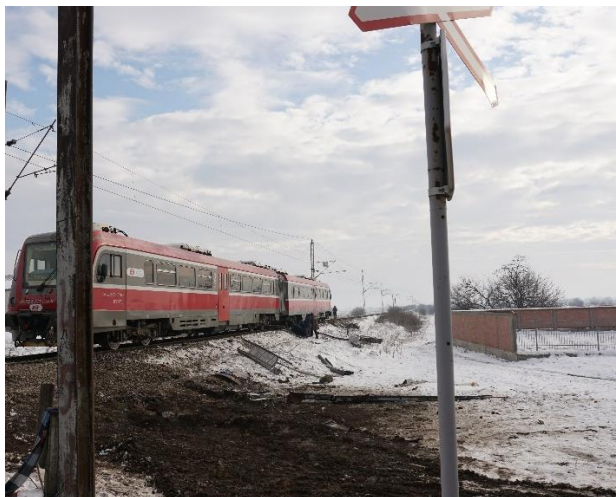
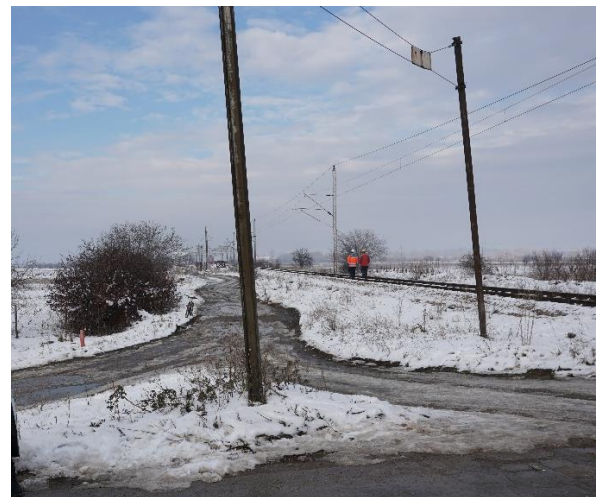
The described facilities (orchard and fenced area) are partly located in the infrastructure belt and partly hindered the view from the local road to the railway line and from the railway line to the local road. However, the driver of a road vehicle moving from the direction of Donje Međurovo to Niš, when stopping in front of the traffic signs I-34: “Andrejin Krst” and II-2: “Obligation of Stopping”, placed in front of the road crossing on the same supporter, has an uninterrupted view of the railway line in both directions, that is, it is possible to spot a road vehicle stopped in front of the aforementioned traffic signs (Figures 2.2.3.18 and 2.2.3.19).

**Figure 2.2.3.18:** View from the road to the railway line  
in the direction of Belotince crossing from the point at  
which the traffic signs are set

**Figure 2.2.3.19:** View from the road to the railway line  
in the direction of the station Niš from the point at which  
the traffic signs are set

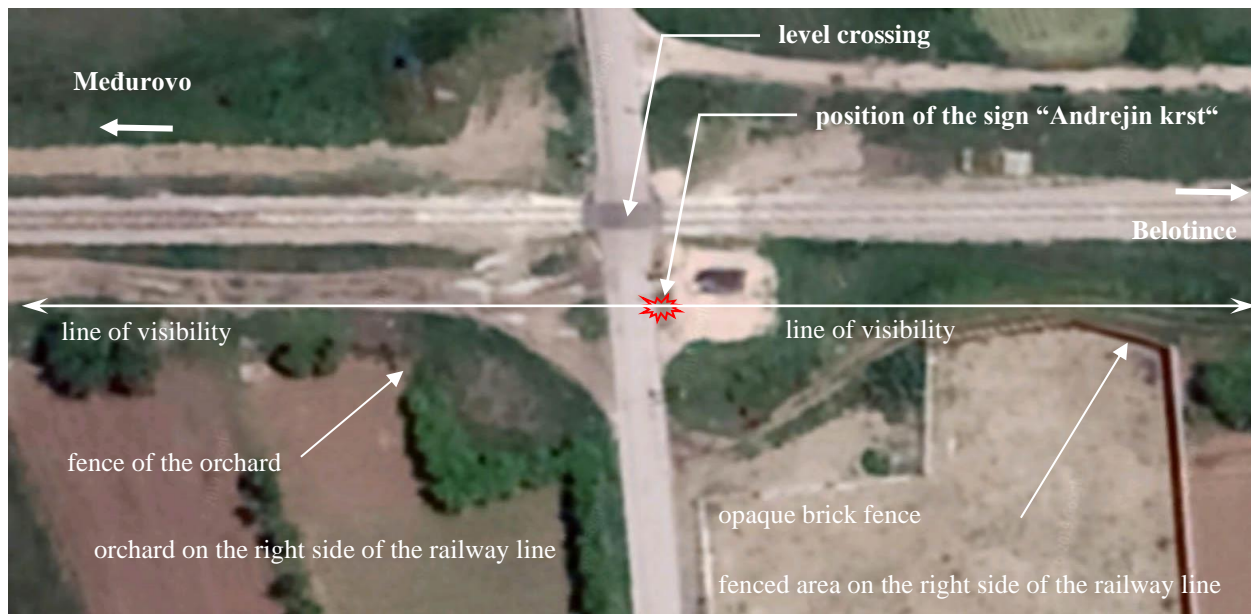
The spatial arrangement and the impact on the visibility of the described facilities to the right of the railway line is shown in Figure 2.2.3.20.

**Figure 2.2.3.20:** Satellite image of the level crossing area (source: *Google maps*)

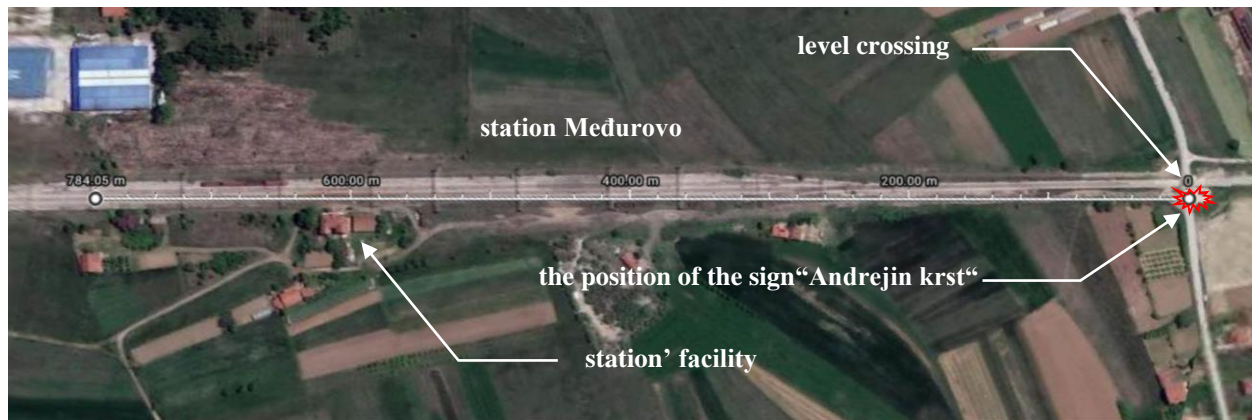
it cannot be secured without removing the aforementioned facilities, but the secure crossing of the road vehicle over the railway line is secured by existence of the necessary visibility.

**Figure 3.4.2:** Necessary visibility for the direction of drive of the train and direction of drive of the bus  
(source: Google maps)
