REPUBLIC OF SERBIA
CENTER FOR INVESTIGATION OF ACCIDENTS IN TRANSPORT
SECTOR FOR INVESTIGATION OF ACCIDENTS IN RAILWAY TRAFFIC
Nemanjina 11, 11000 Belgrade

FINAL REPORT ON INVESTIGATION OF A SERIOUS ACCIDENT

| Accident type: | Serious accident on the level crossing |
| Train No.: | 45403 |

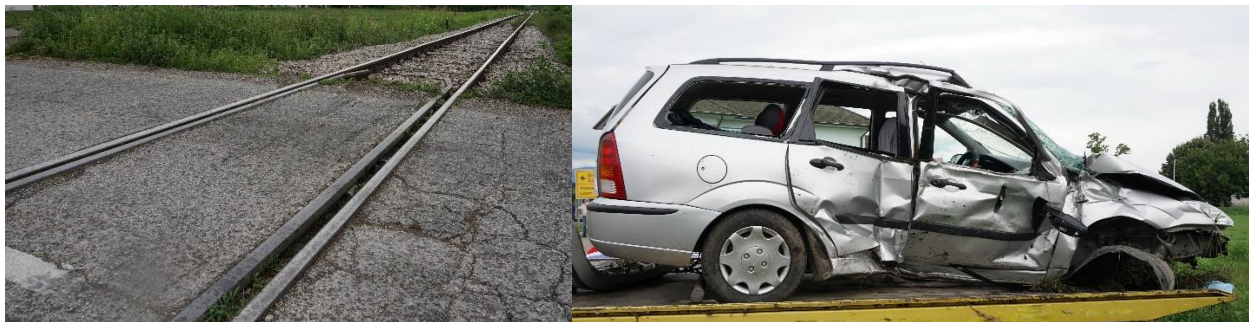
According to the traces on the road and the rails at the level crossing observed during the on-site investigation and damages on the road passenger vehicle made due to the impact of the locomotive of the train No. 45403 (see Figure 2.1.2.1.), contact between the train and the road passenger vehicle was made at the moment when the road passenger vehicle was on the level crossing so that the part of the road passenger vehicle in which the driver's and front passenger's seats were located was at the height of the left rail of the track, and the part of the road passenger vehicle between the front wheels and the front bumper of the vehicle at the height of the right rail of the track, so that the left buffer of the train locomotive series 661-033 of the train No. 45403 had hit the place where train number 45403 hit the place where the co-driver was seated in the road passenger vehicle.

Figure 2.1.2.1: View of the traces on the road at the level crossing and damages on the road passenger vehicle

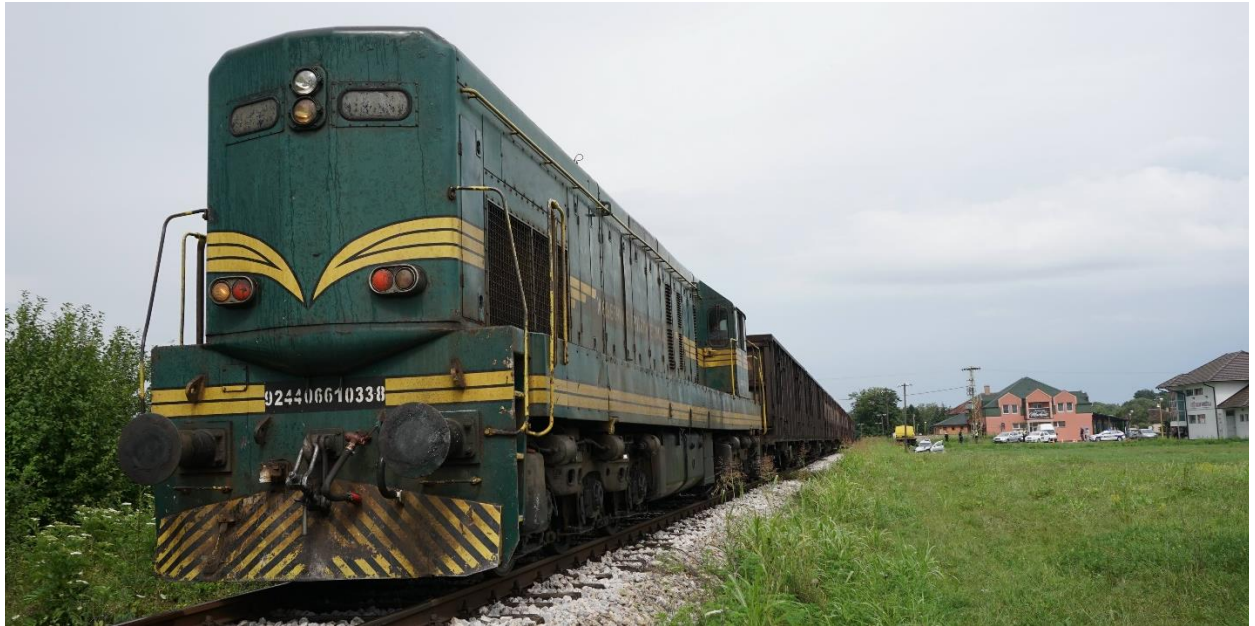
After the overtaking, the train No. 45403 continued its movement in the length of 145 m, after which it stopped, so that the front of the 661-033 series locomotive was found at km 20+792, with the longer part of the locomotive box ahead. On that occasion, no vehicle derailed out of the composition of the train No. 45403 (see Figure 2.1.2.2).

Figure 2.1.2.2: View of the train No. 45403 after the serious accident
(view in direction opposite to the direction of train movement)

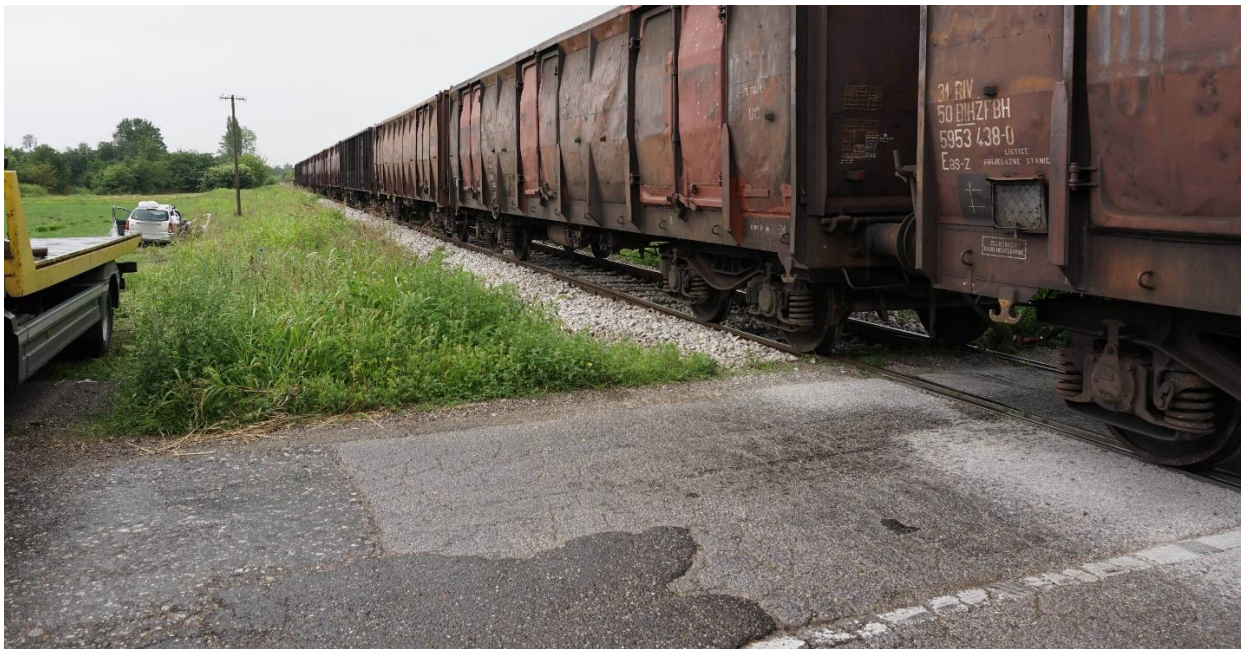
After the impact, the train threw the road passenger vehicle next to the track, to the left in relation to the direction of the train, after which the road passenger vehicle continued moving along the track for approximately 30 m, after which it stopped. The road passenger vehicle was found on the left side of the track, seen in the direction of the train, i.e. in the direction of increasing stationing of the track, in a position parallel to the track, i.e. the train, so that the front part of the road passenger vehicle was turned in the direction of the train. the passenger vehicle was 6.8 m away from the nearest track, and the rear of the road passenger vehicle was 30.1 m away from the middle of the road crossing (see Figure 2.1.2.3).

Figure 2.1.2.3: View of the train No. 45403 and the road passenger vehicle after the serious accident
(view in the direction of train movement)

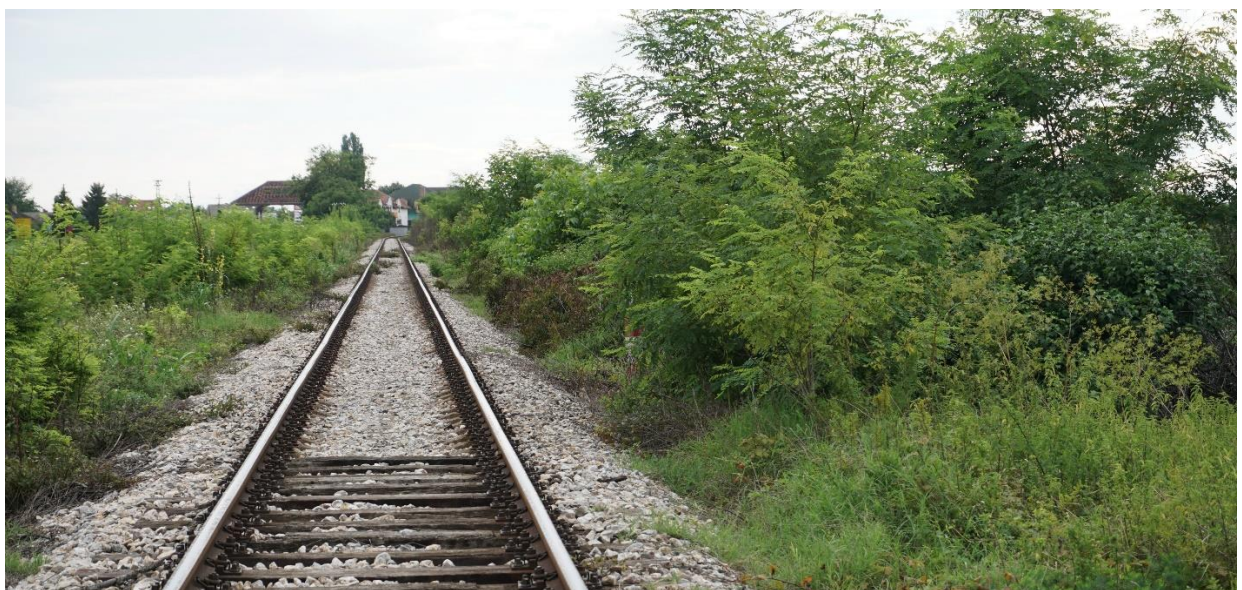
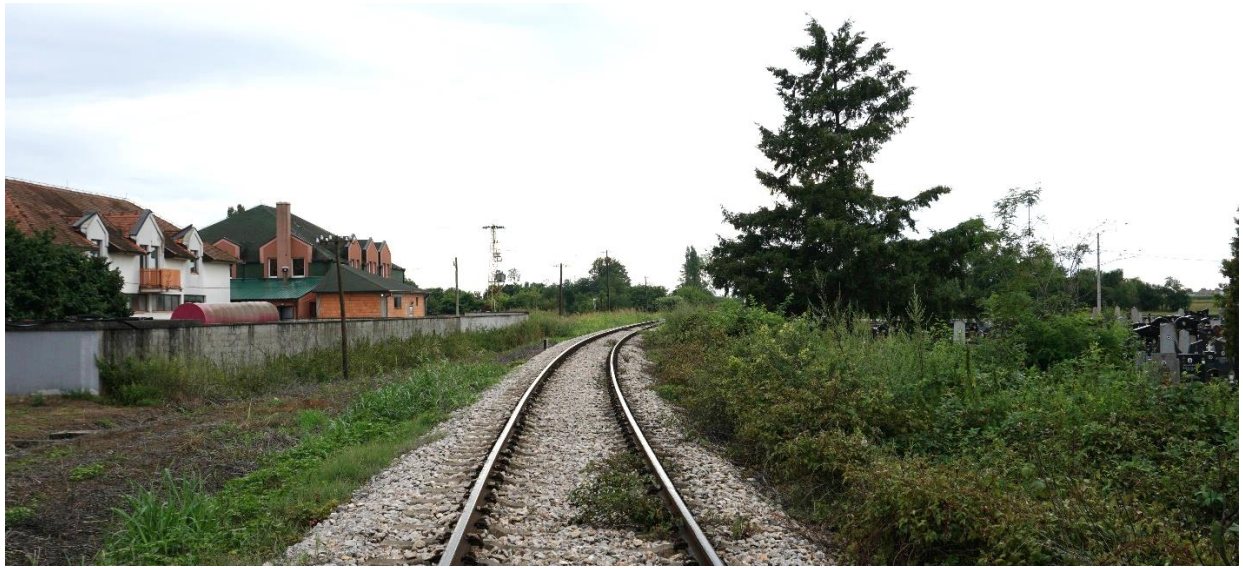
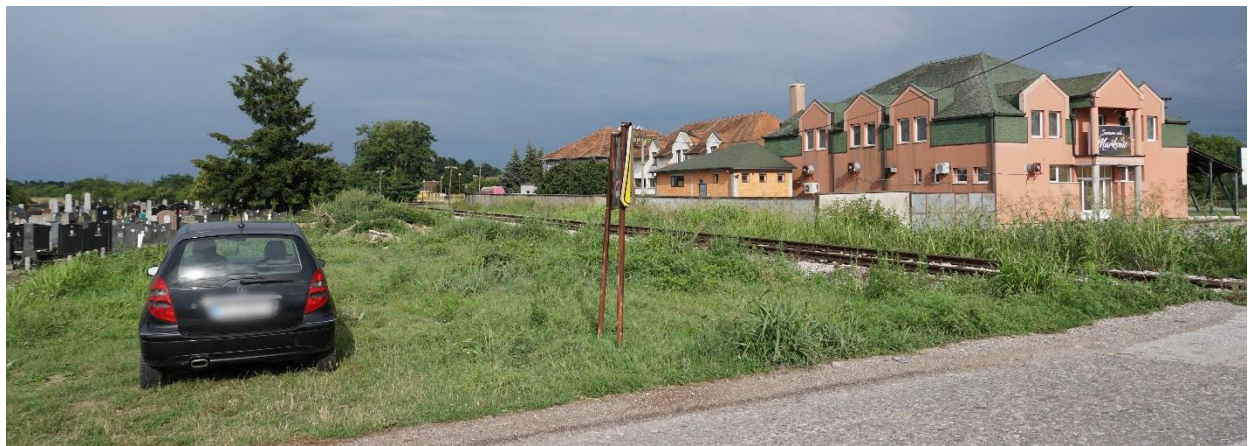
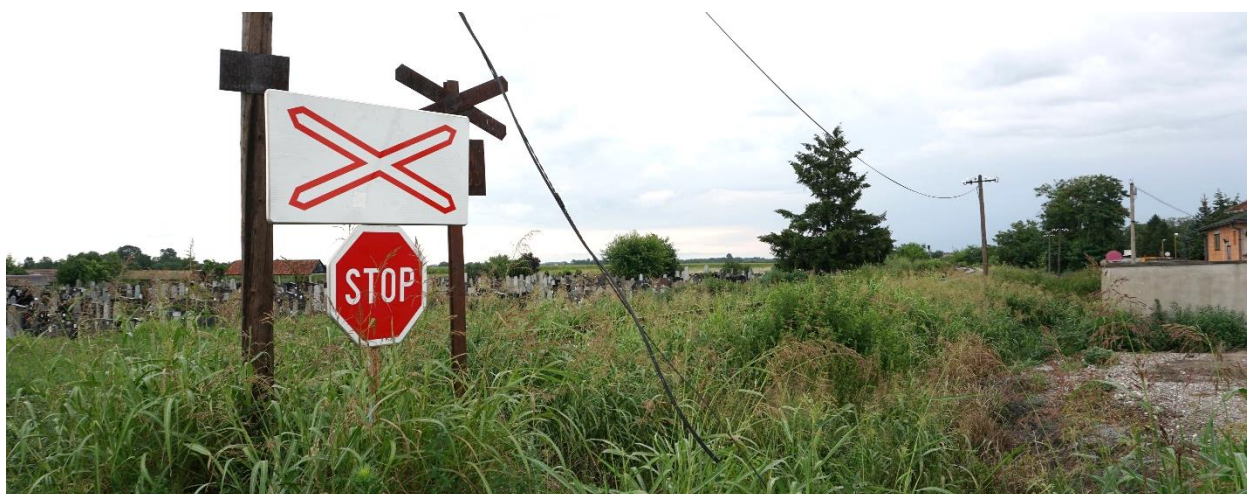
Between the crossing point Štitar and the station Petlovača, viewed in the direction of the growing stationing, in front of the level crossing in question, in the length of more than 600m, on the right side of the railway line extensive vegetation above 4m is noticed, which, in certain places, is located at a distance less than 2m from the nearest rail of the railway line. Also, on the same side of the railway line, 73 m in front of the level crossing and 9 m away from the nearest rail of the railway line, there is a tree, according to the estimates, over 10m high, with a branched canopy whose branches in the lower part of the tree trunk reach a distance of 5 m from the nearest rail of the railway line (see Figures 2.2.3.21, 2.2.3.22, 2.2.3.23, 2.2.3.24). The described vegetation is located in the zone of necessary visibility (in the part of the zone of necessary visibility which includes the railway belt and the part of the zone of necessary visibility which does not include the railway belt) and significantly obscures the view from the railway to the road, and view from the road to the railway line.

Figure 2.2.3.21: The appearance of vegetation next to the railway line
(view from the direction of the crossing point Štitar to the level crossing)

Figure 2.2.3.22: The appearance of vegetation next to the railway line
(view from the direction of the crossing point Štitar to the level crossing)

Figure 2.2.3.23: The appearance of vegetation next to the railway line
(view from the direction of the level crossing to the crossing point Štitar)

Figure 2.2.3.24: The appearance of vegetation next to the railway line
(view from the direction of the level crossing to the crossing point Štitar)

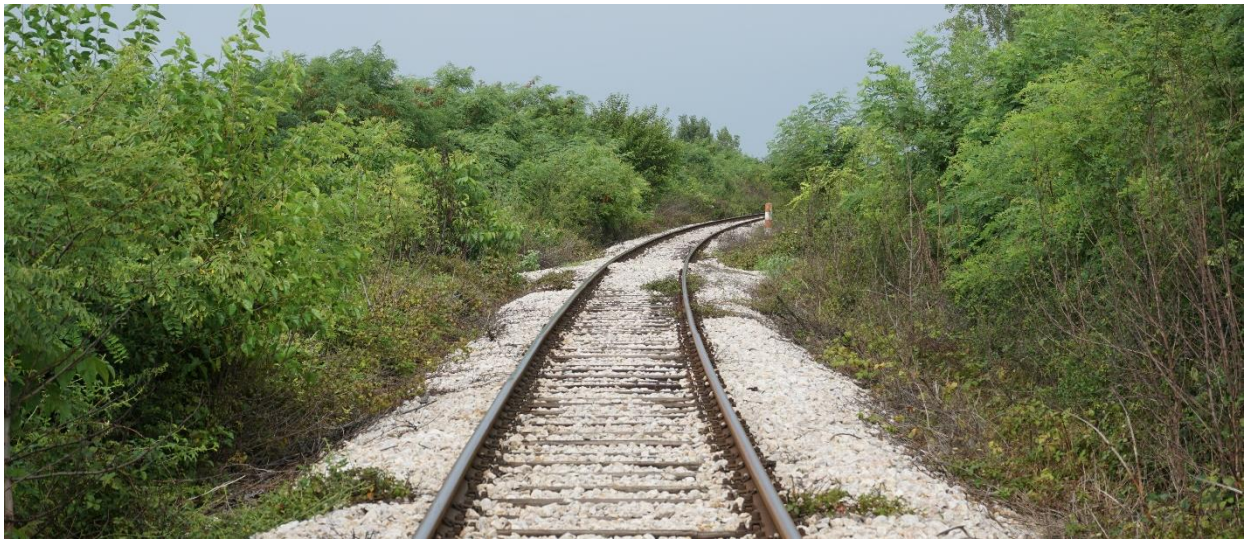
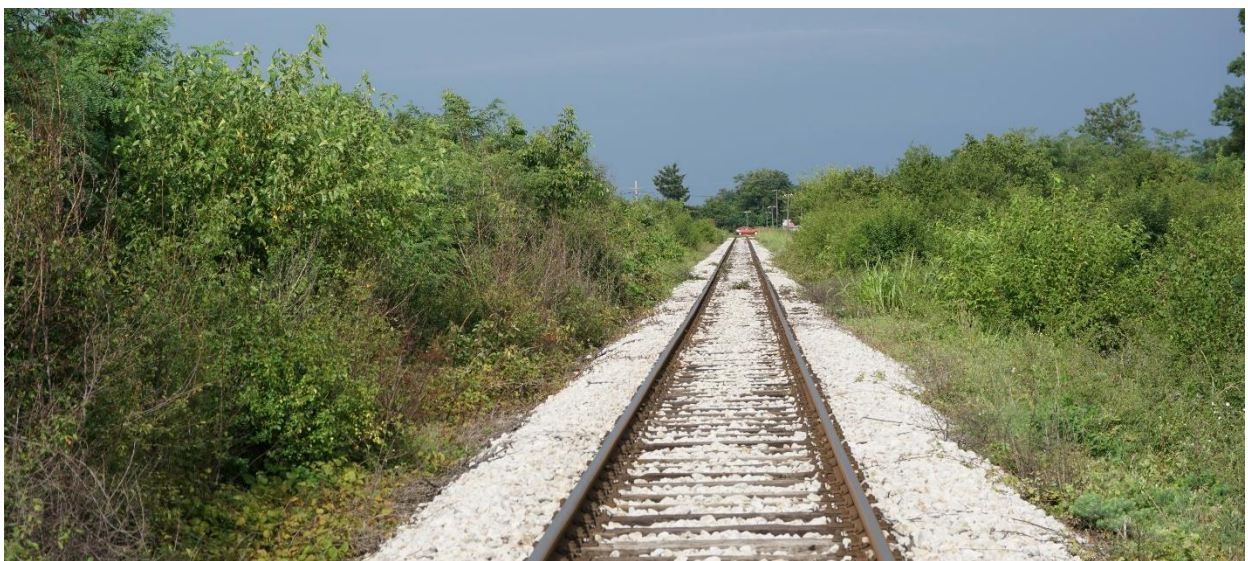
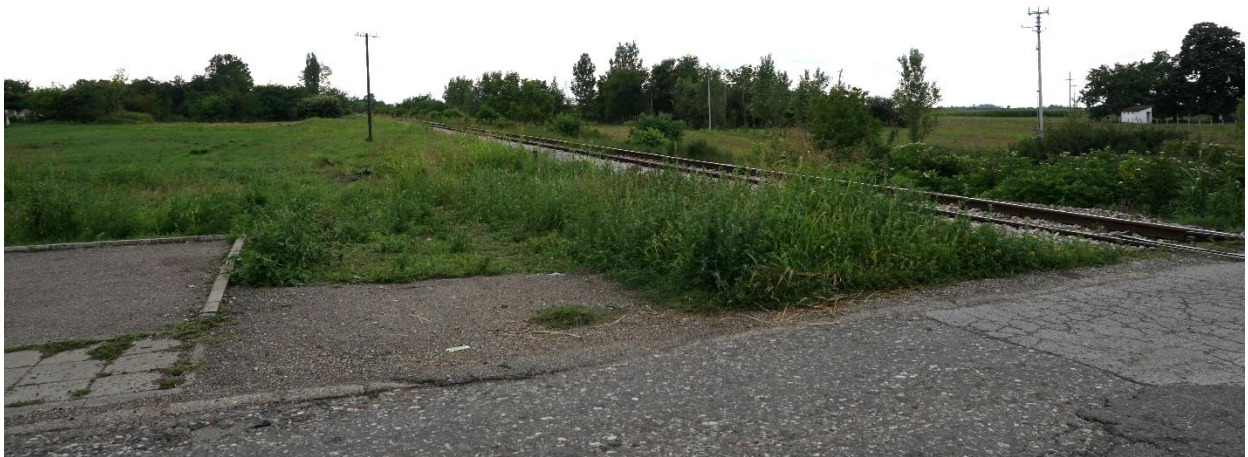
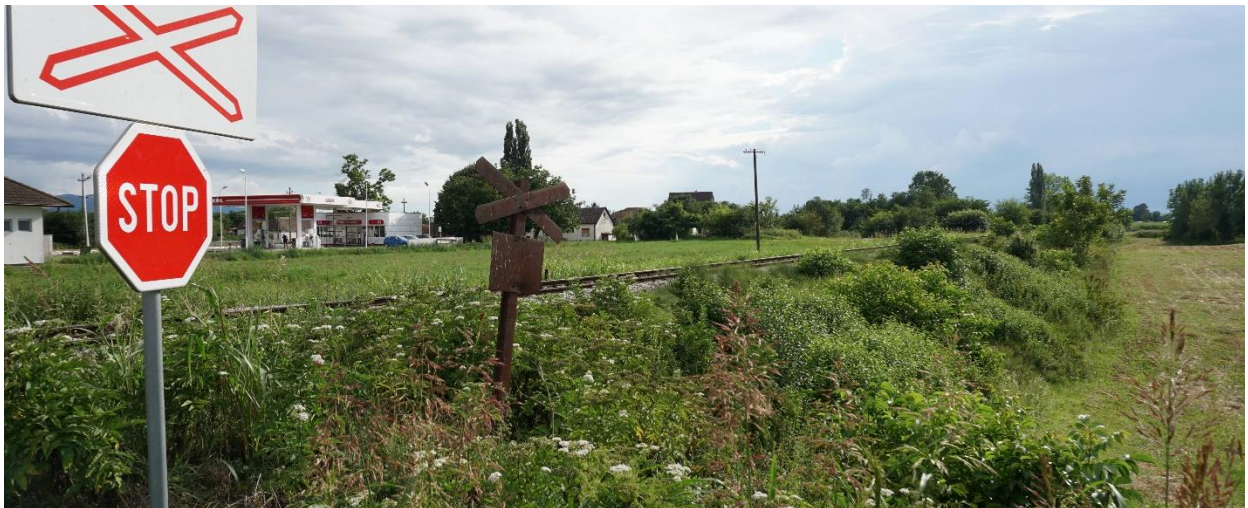
Between the crossing point Štitar and the station Petlovača, viewed in the direction of the growing stationing, behind the level crossing in question, in the length of more than 600 m, on the right side of the railway line an extensive vegetation is noticed of the length of more than 3 m, which in certain places is located at a distance less than 3m from the nearest rail of the railway line, while on the left side of the railway line, viewed in the direction of the growing stationing, there is no vegetation in the direct vicinity of the railway line at a distance of 300 m from the railway line, but at a distance between 300 m and 600 m there exists vegetation (see Figures 2.2.3.25, 2.2.3.26, 2.2.3.27. and 2.2.3.28.). The described vegetation is located in the zone of necessary visibility (in the part of the zone of necessary visibility which includes the railway belt and the part of the zone of necessary visibility which does not include the railway belt) and significantly obscures the view from the railway to the road, and view from the road to the railway line.

Figure 2.2.3.25: View of the vegetation next to the railway line
(view from the direction of the station Petlovača to the level crossing)

Figure 2.2.3.26: View of the vegetation next to the railway line
(view from the direction of the station Petlovača to the level crossing)

Figure 2.2.3.27: View of the vegetation next to the railway line
(view from the direction of the level crossing to the station Petlovača)

Figure 2.2.3.28: View of the vegetation next to the railway line (view from the direction of the level crossing to the station Petlovača)

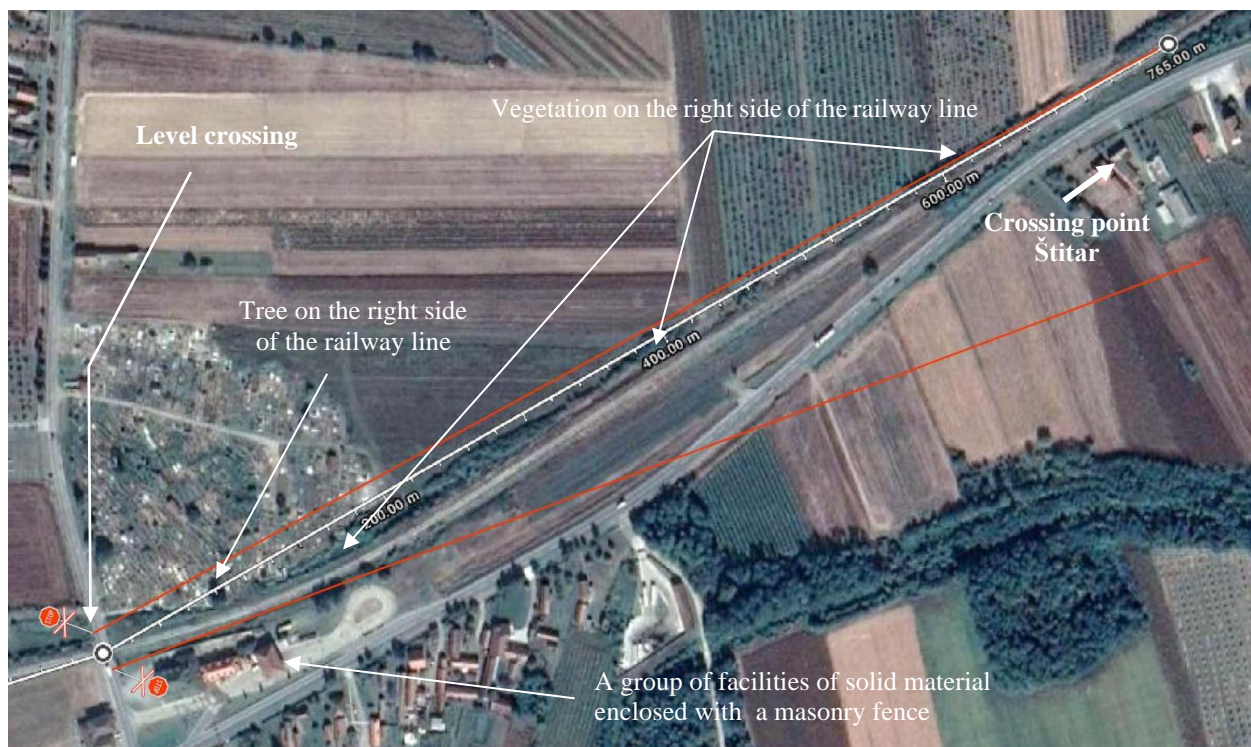
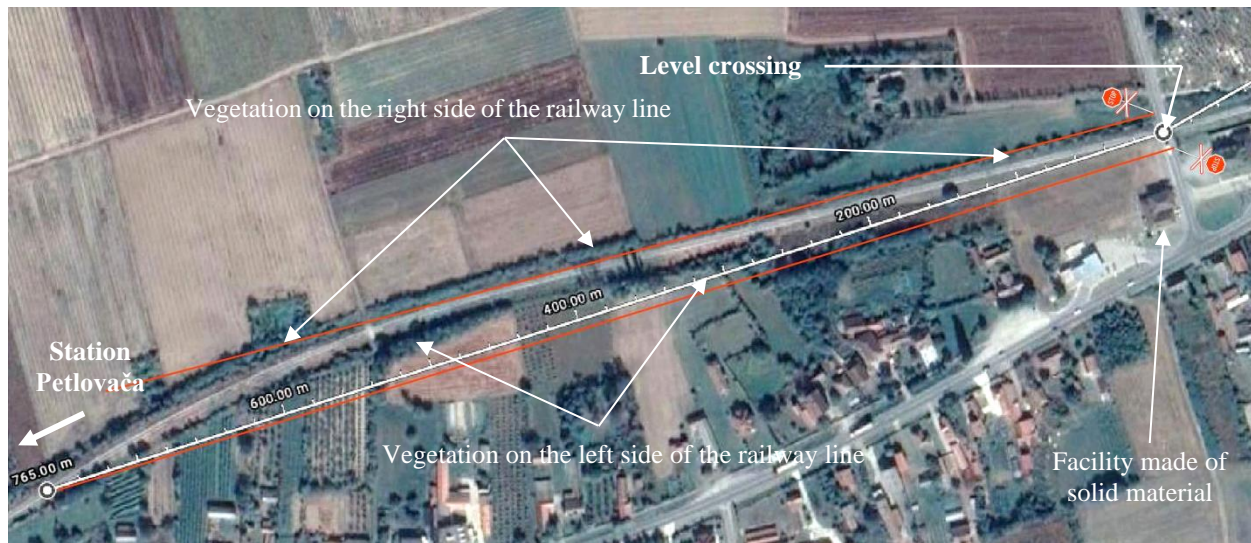
The spatial arrangement and impact on the visibility of the facilities and vegetation described in section 2.2.3, which is located next to the railway, is shown in Figures 3.4.2.1. and 3.4.2.2.

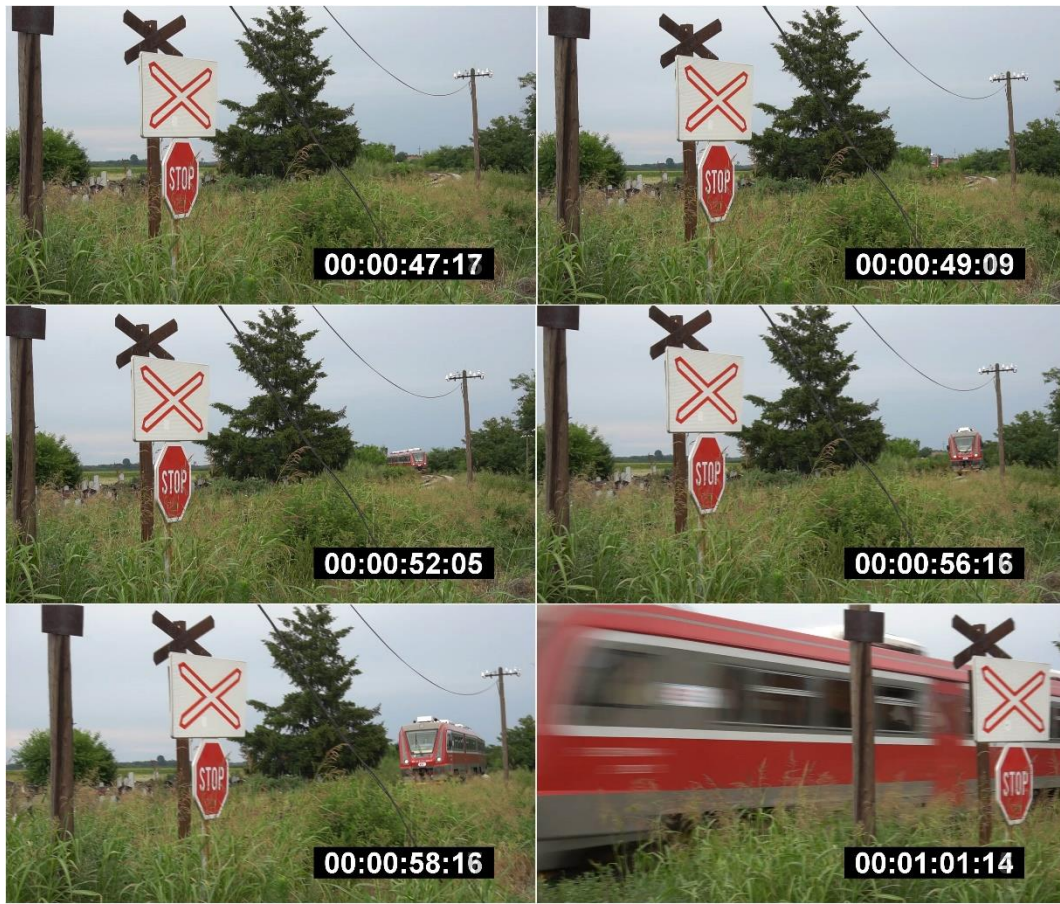
Analysis of the video recording made on the spot during the passage of train No. 921 over the level crossing, it can be stated that from the moment when behind the vegetation next to the track (described in section 2.2.3.) until arrival of the front of the same train to the level crossing 12 s passed. The place where the video was made is on the road on the section of the state road IIA rank, marking 136 between the intersection with the state road IB rank, marking 26 and the level crossing, where there would be a road passenger vehicle (driver's position) stopped in front of the supporter on to which traffic signs I-34: "St. Andrew's cross" and II-2: "Obligation of stopping" were placed. From that place, the sound of a train siren is clearly heard (aspect of a signal 67: "Watch out") even before the train is spotted. From the moment when it is possible to spot the train for the first time, until the arrival of the train at the level crossing, it is possible to clearly see the movement of the train all the time. Sequences of the video of the train No. 921 approaching the level crossing are shown in Figure 4.2.1.4.1.

Figure 4.2.1.4.1: Sequences of the video recording of the train No. 921 approaching the level crossing

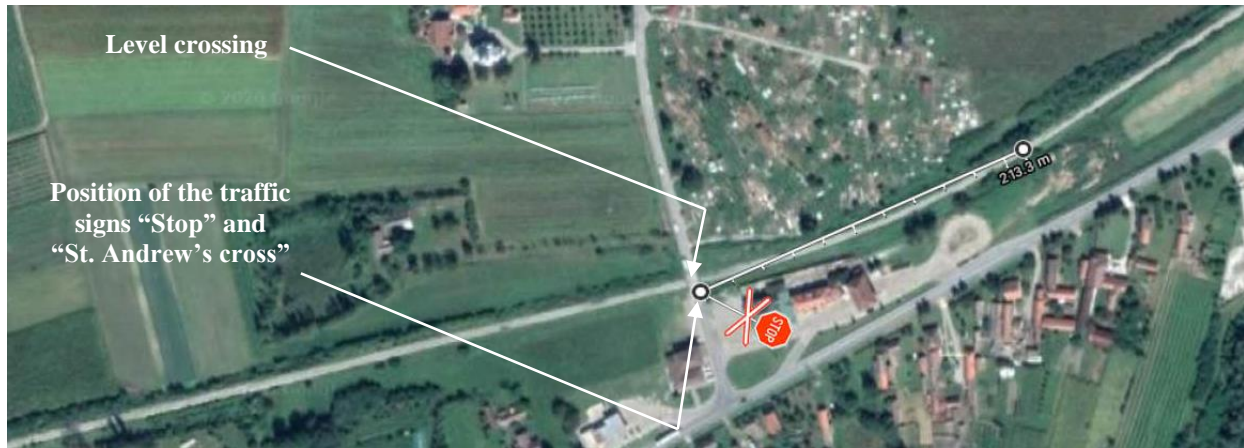
The actual distance at which the driver of a road passenger vehicle moving from the direction of the state road IB rank, marking 26 in the direction of the settlement Zminjak, stopping his road passenger vehicle in front of the supporter on which are placed the following traffic signs I-34: “St. Andrew’s cross” and II-2: “Obligation of stopping”, can spot a train moving towards the level crossing from the direction of the crossing point Šitar intersection, is shown in Figure 4.2.1.4.2.

Figure 4.2.1.4.2: Actual visibility for the direction of the train No. 45403 movement and for the direction of the road passenger vehicle movement (source: *Google maps*)
