REPUBLIC OF SERBIA  
CENTER FOR INVESTIGATION OF ACCIDENTS IN TRANSPORT  
SECTOR FOR INVESTIGATION OF ACCIDENTS IN RAILWAY TRAFFIC  
NEMANJINA 11, 11000 BELGRADE

No.: ŽS - 03/20

## FINAL REPORT ON INVESTIGATION OF AN ACCIDENT

Accident type:	Train derailment
Train No.:	45022
Place:	Municipality of Jagodina, open track between the stations Jagodina and Bagrdan
Date:	28.11.2020.
Time:	19:27

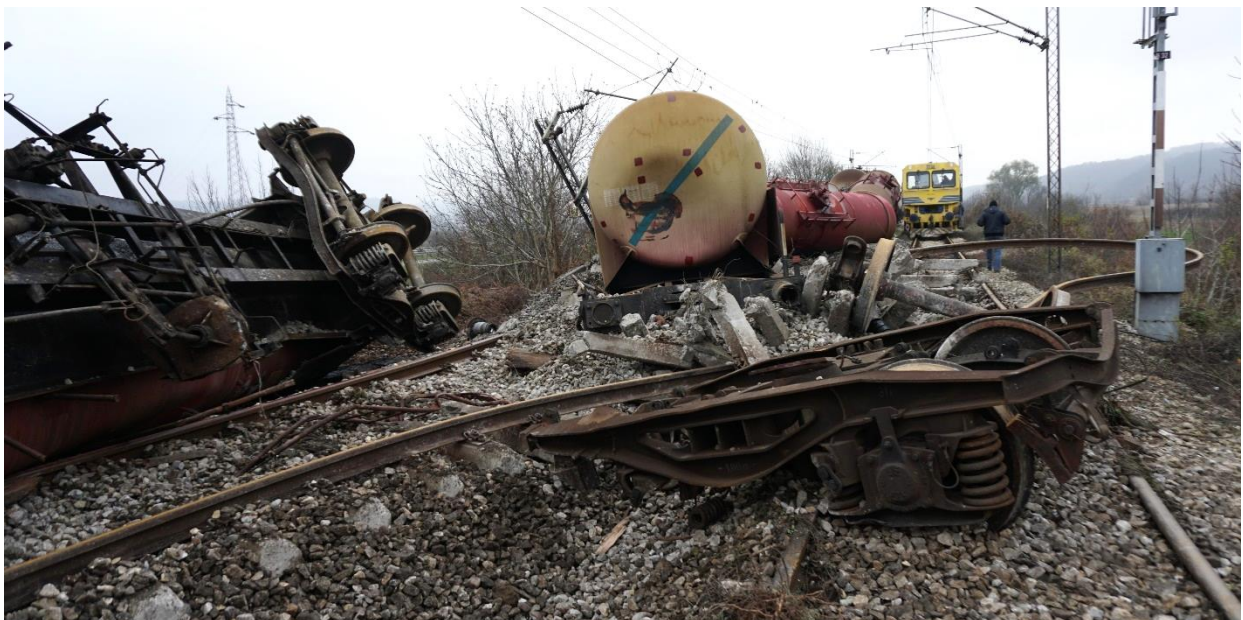
**Figure 2.1.2.1:** The view of the accident site (the point of derailment)

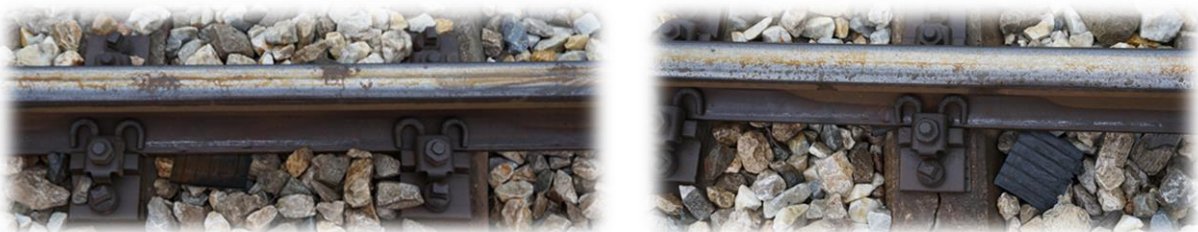
Due to the bursting of the rails, there came to an uneven longitudinal movement of the rails (longitudinal movement of the rails is shown in Figure 3.4.2.7.) and thus narrowing of the track. Poor rail-sleeper connection (compression and lack of rubber inserts whose appearance is shown in Figure 3.4.2.8.), as well as the condition of the fastening accessories that are not lubricated, loose and missing (the appearance of the fastening accessories is shown in Figure 3.4.2.9.), caused the bevel and damage of the sleepers (the appearance of bevel and damage of the sleeper is shown in Figure 3.4.2.10.), and thus narrowing of the track.

**Figure 3.4.2.7:** The view of longitudinal movement of rails

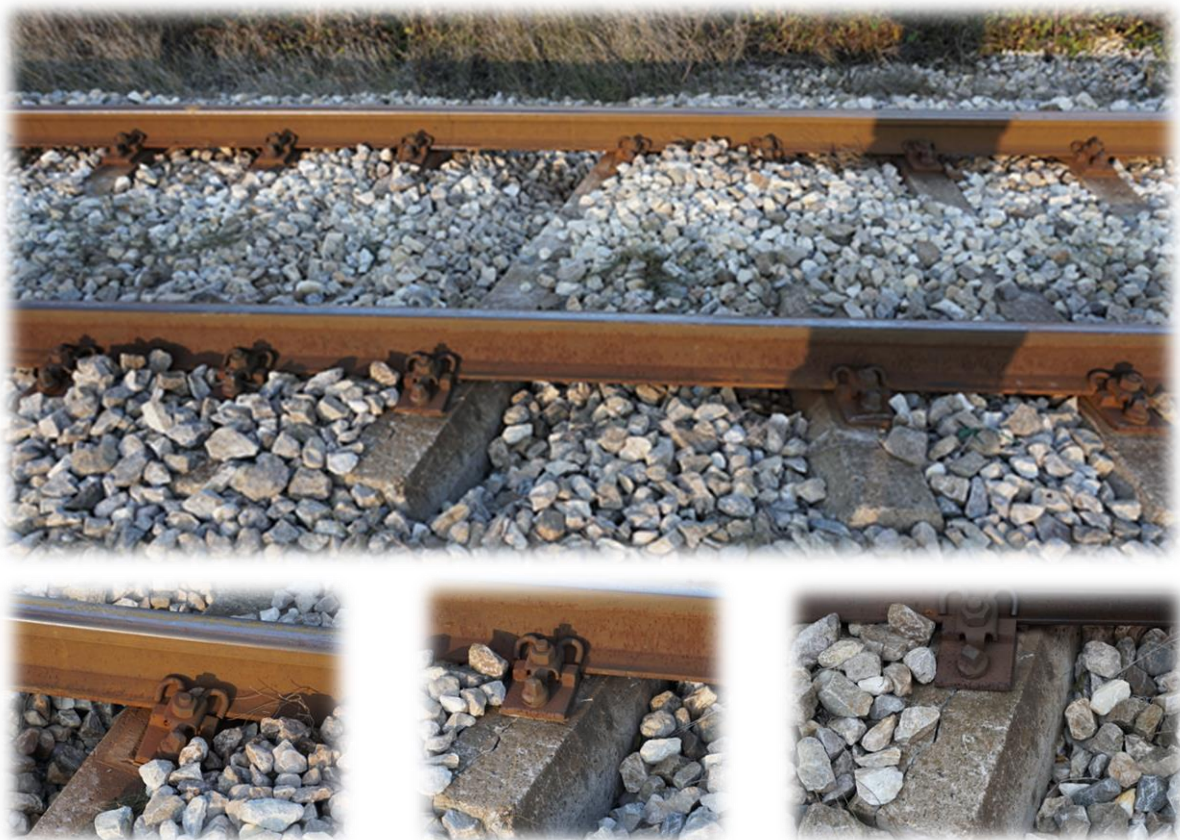
**Figure 3.4.2.10:** The view of sleepers after the accident

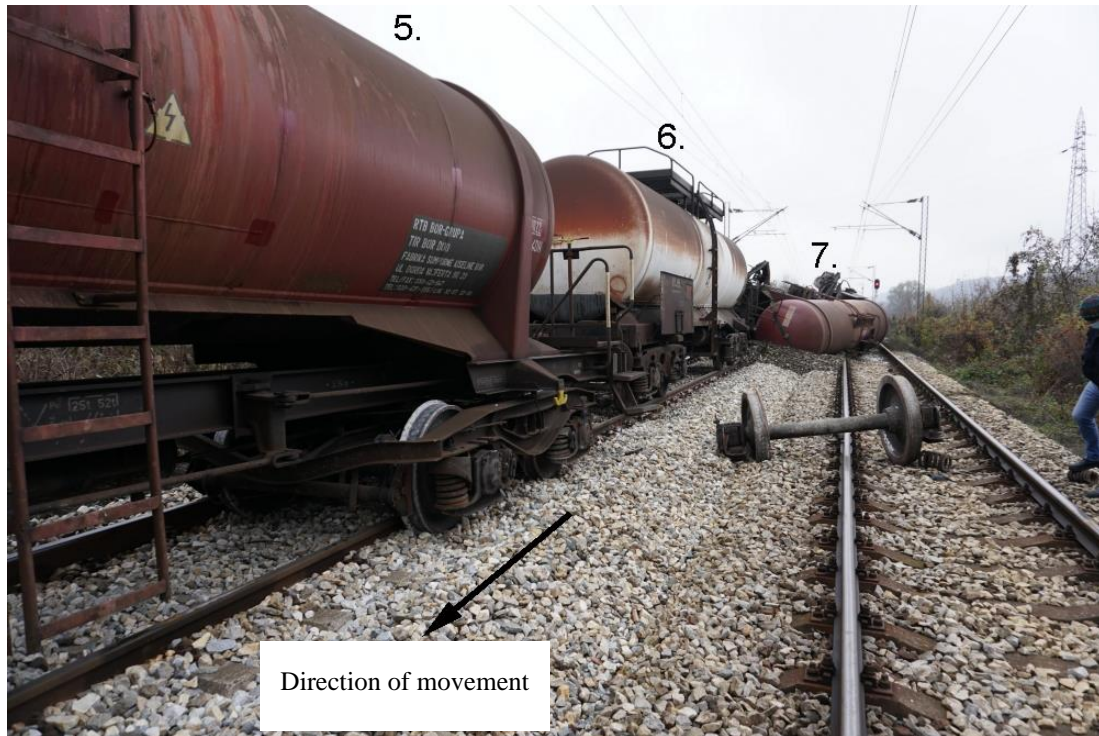
On 29.11.2020., representatives of CINS went to the scene of the accident. The 193-916 locomotive and the first four wagons were on track. The fifth wagon No. 33 72 7867 810-3 derailed with the rear bogie on the left side of the track in the direction of movement. On the adjacent track (right track of the two-track line), between the fifth and sixth wagons, there was a failed axle assembly of overturned seventh wagon (Figure 4.2.1.1).

**Figure 4.2.1.1:** Fifth derailed wagon

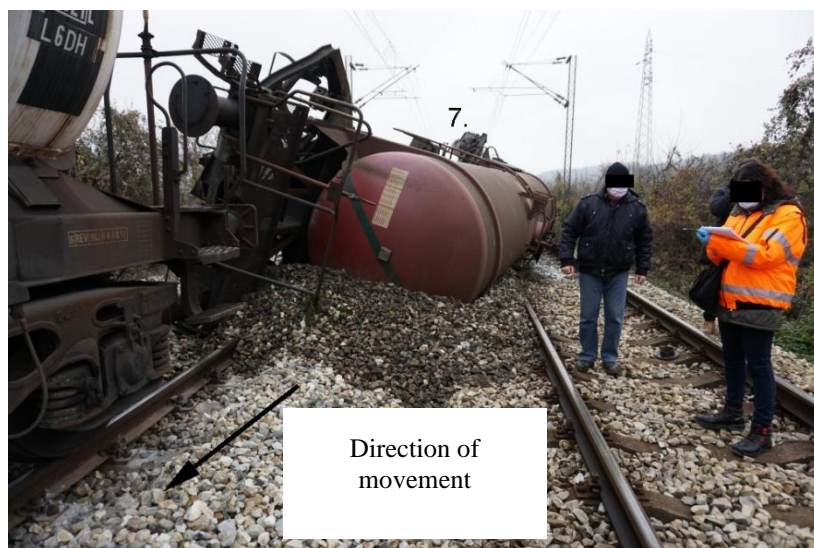
The sixth wagon No. 33 87 7866 749-7 remained on the rails. The seventh wagon No. 31 72 7865 013-8 was overturned on the left side in the direction of movement, buried in the gravel (Figure 4.2.1.2) and partially on the adjacent track, but remained hooked to the sixth wagon. Two of the four screws were missing on one lid of the overturned seventh wagon and one of the four screws on the other lid. Sulfuric acid leakage occurred under the improperly closed lid (Figure 4.2.1.3).

**Figure 4.2.1.2:** Seventh derailed wagon No. 31 72 7865 013-8

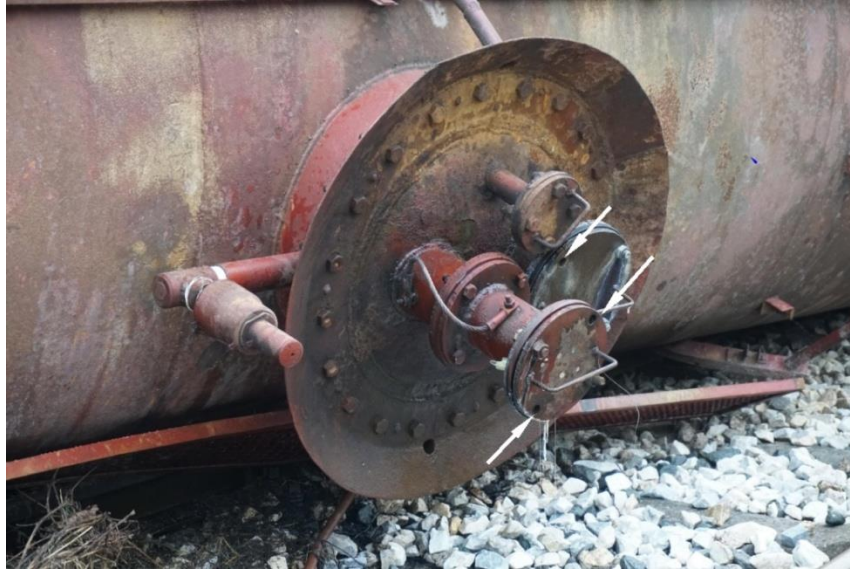
**Figure 4.2.1.3:** Sulfuric acid leakage from the wagon No. 31 72 7865 013-8

**SR\_20/21** “Srbija Kargo” a.d., to train the staff to carry out the measure at the reception points, that if it is possible to establish the lack of screws on the tank lids by visual inspection, to refuse the transport of improperly closed tanks (see item 4.2.6.).

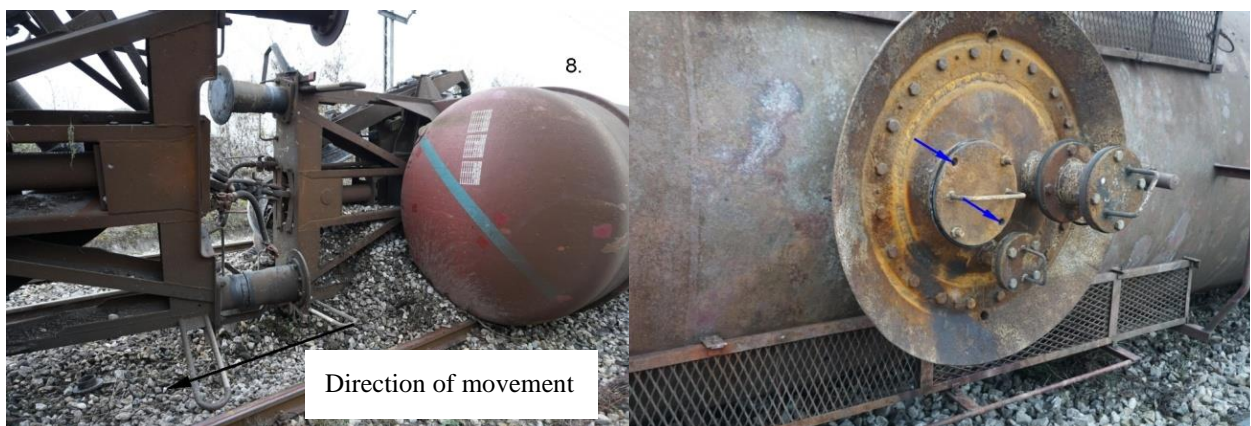
In the zone of overturning of the eighth wagon, the complete track was deformed to the left, obviously under the influence of large lateral forces while overturning the seventh and eighth wagons to the left in the direction of movement (Figure 4.2.1.5). The first three axle assemblies of the seventh wagon were separated from the frames of the bogies. One axle assembly flew over the seventh wagon and stopped on the adjacent track (Figure 4.2.1.1). Several concrete sleepers at that place were cut in the zone between the rails.

**Figure 4.2.1.4:** Derailed eighth wagon No. 33 72 7867 853-3 and sulfuric acid leakage on the lid

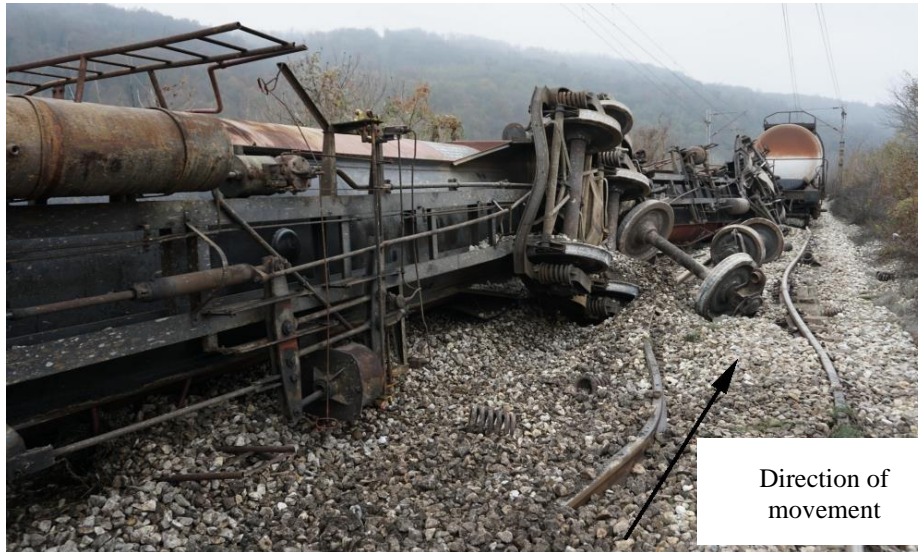
**Figure 4.2.1.5:** Deformed left track

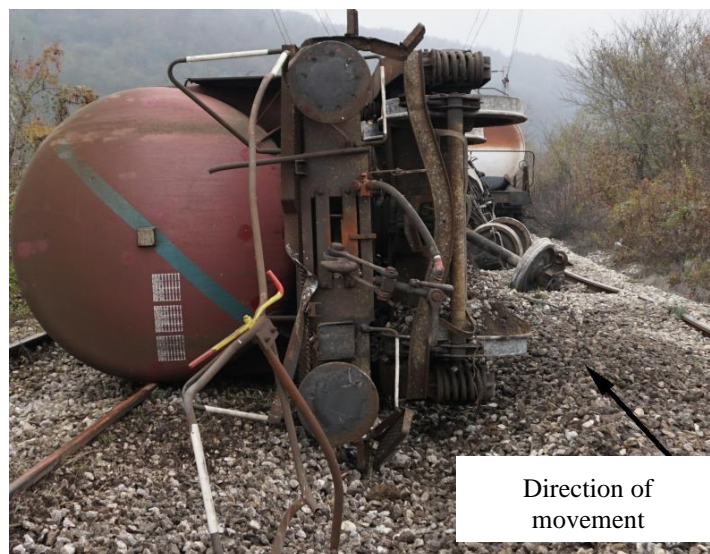
The first part of the train ends with the eighth wagon, which was separated from the second part of the train by approximately 27 m. All traction devices of the front part of the train were found in a tense state after the accident, which means that the seventh and eighth wagon have, after derailment and sinking into the superstructure of the railway, additionally braked that part of the train.

**Figure 4.2.1.6:** Undamaged traction devices at the end of the eighth wagon

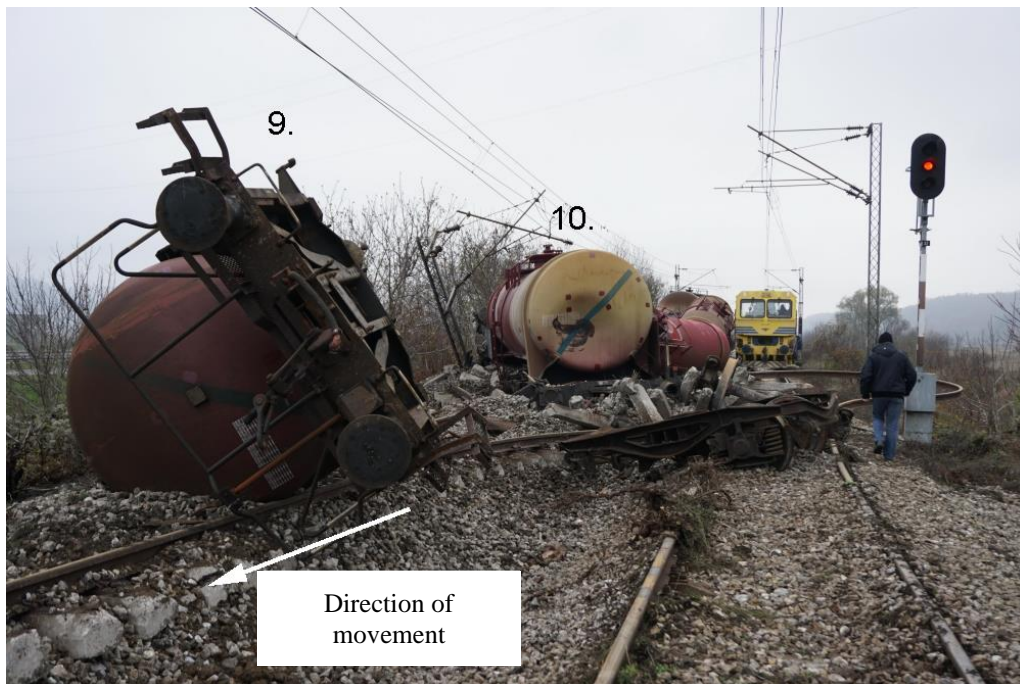
the bridge of the eighth wagon can be seen, which most likely originates from the left buffer of the ninth wagon.

**Figure 4.2.1.7:** Overturned ninth wagon with undamaged traction devices

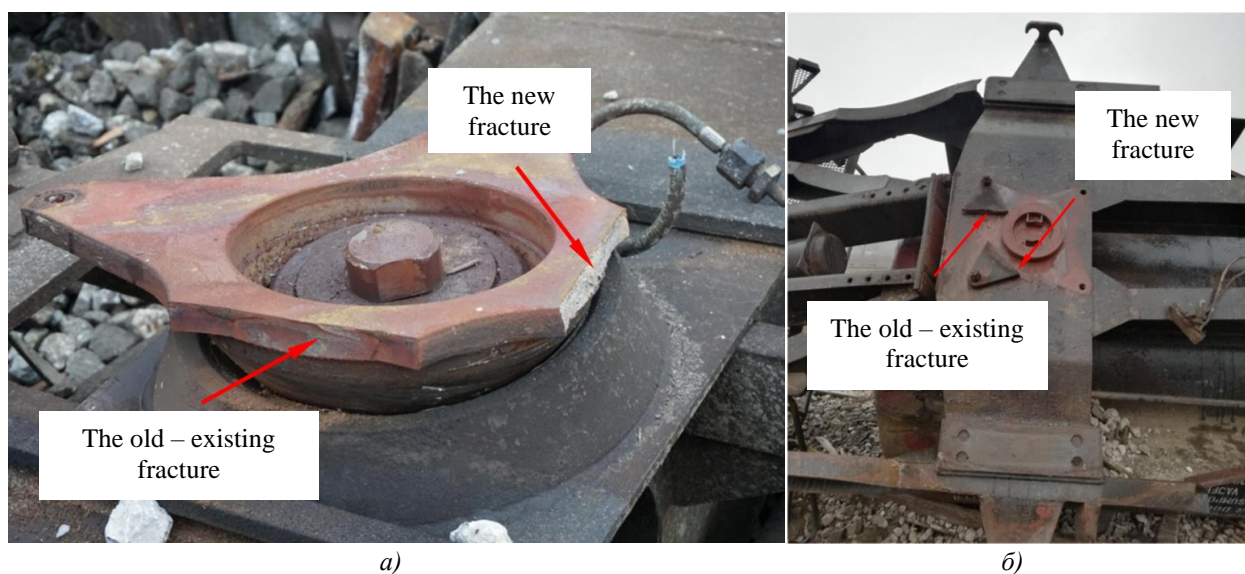
The front bogie of the ninth wagon detached from the wagon box during the derailment due to the cracking of the fastening screws and the fastening plate of the bogie's upper part. One axle detached from the frame of the bogie.

**Figure 4.2.1.8:** Front flange center bowl fracture of the ninth wagon's front bogie No. 33 72 7867 846-7

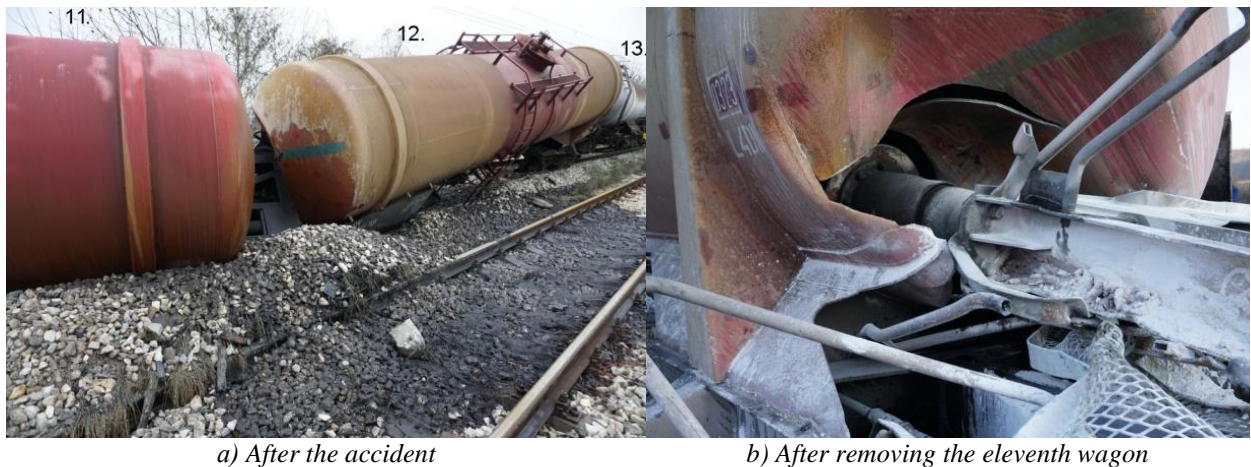
The front parts of the bogie between the tenth and eleventh wagon are completely compressed and deformed. The eleventh wagon overturned on the left side in the direction of movement (Figure 4.2.1.10. a).

**Figure 4.2.1.10:** Twelfth wagon with a punctured tank

The twelfth wagon with a head of the tank collided against the buffer of the eleventh wagon, thus breaking the tank (Figure 4.2.1.10. b). The entire content of 51.7 t of sulfuric acid leaked from this tank.

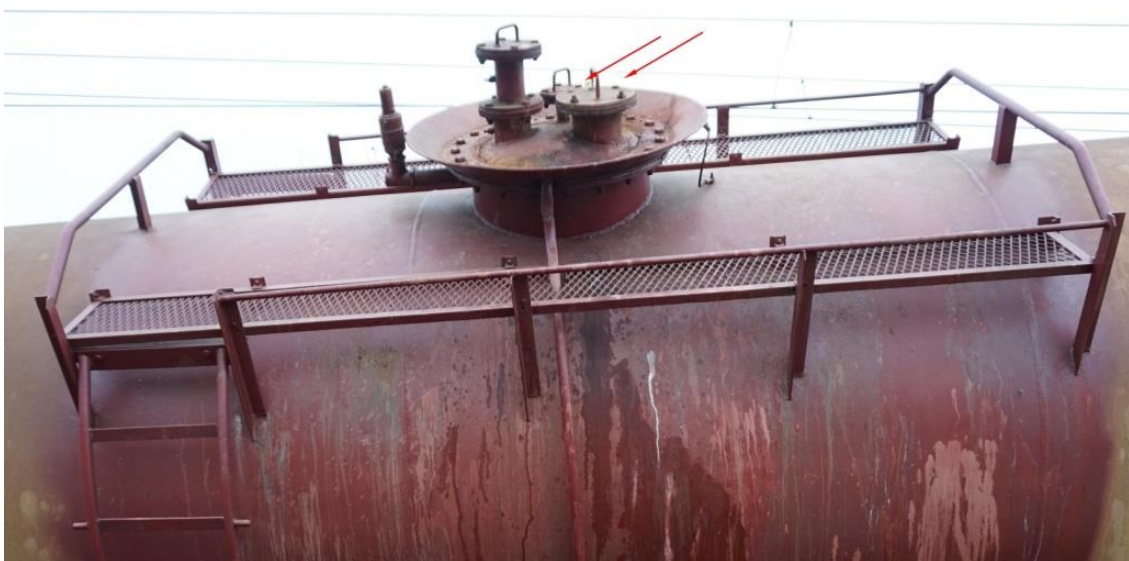
**Figure 4.2.1.11:** Lack of screws on the lid of the twelfth wagon No. 31 72 7865 010-4

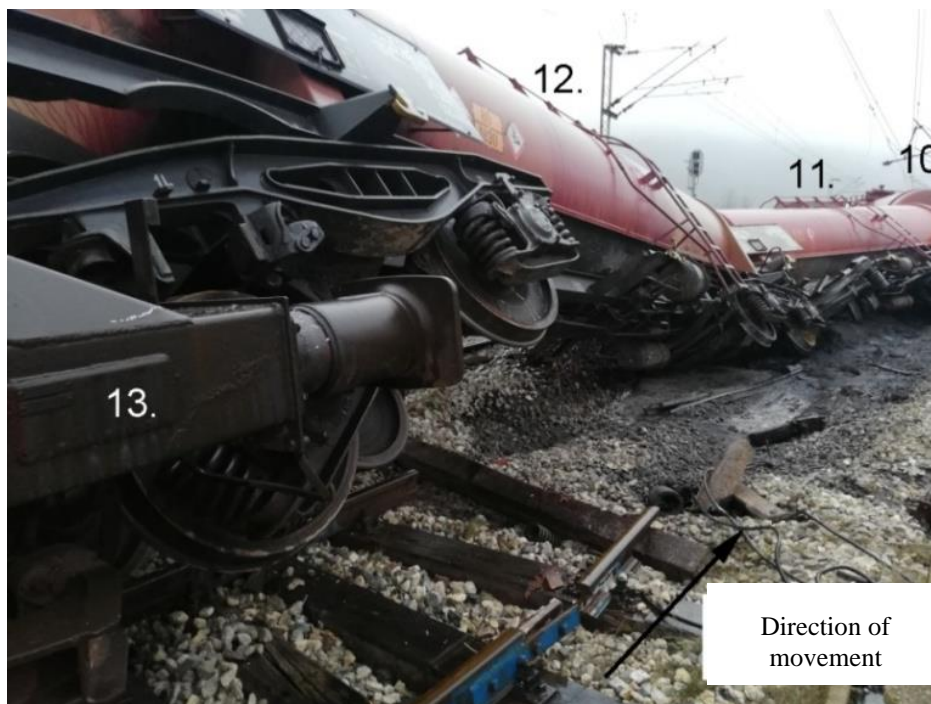
In Figure 4.2.1.12. the beginning of the destroyed part of the track with an insulated joint is shown, seen in the direction of train movement. Thirteenth wagon collided with the buffer of twelfth wagon with the front of the tank (Figure 4.2.1.13. c). The left wheels of the front bogie in the direction of movement remained on the unbroken part of the track directly in front of the insulated joint. The right wheels of the front bogie were found to be up off the track (Figure 4.2.1.13. a), and the rear bogie derailed to the right in the direction of movement (Figure 4.2.1.13. b). The left wheels of the rear bogie had fallen on the inside of the track next to the rail, and the right ones remained next to the right rail in the air. Apparently, this happened under the influence of a collision on the twelfth wagon that overturned on the left side.

**Figure 4.2.1.12:** The beginning of the destroyed track at the insulated joint at km 123+660.80 and the zone of greatest acid leakage

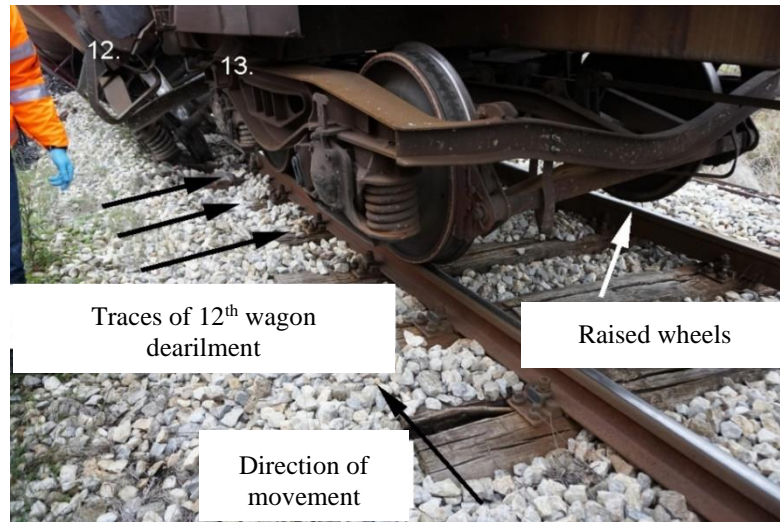
*a) Front bogie of the 13<sup>th</sup> and rear bogie of the 12<sup>th</sup> wagon*

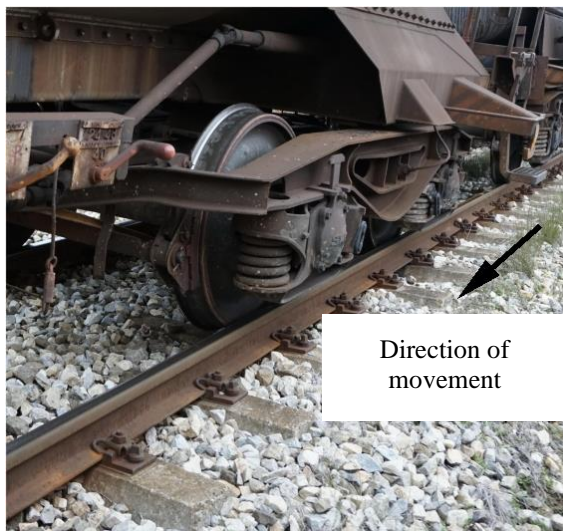
*b) The rear derailed bogie of the 13<sup>th</sup> wagon*

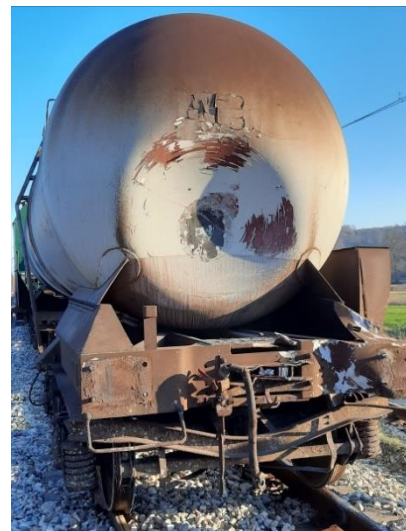
*c) Damage to the 13<sup>th</sup> wagon  
(recorded upon removal of the 12<sup>th</sup> wagon)*

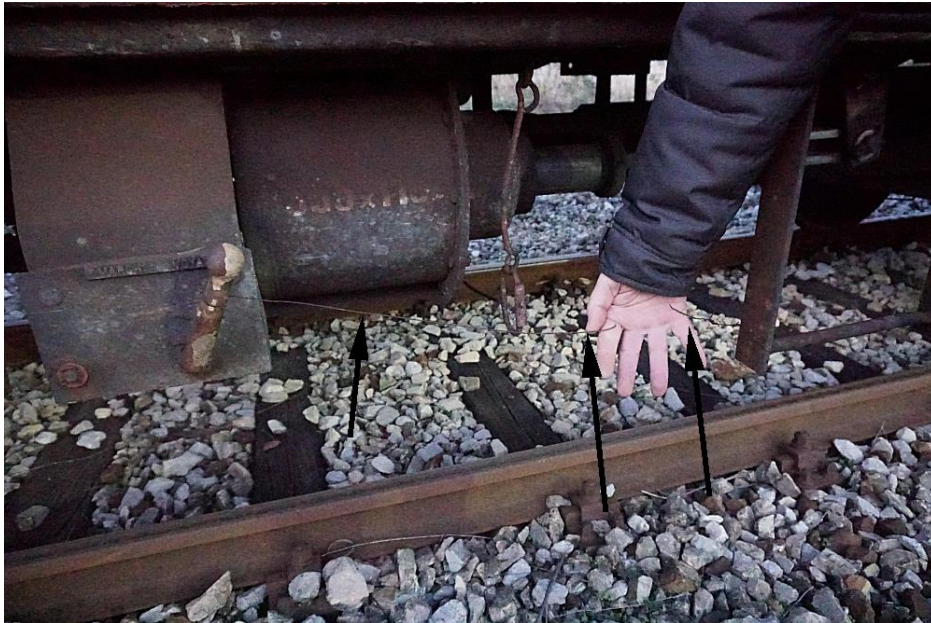
whether any malfunction of the brake of these wagons could have had an impact on the occurrence of the accident, the wagons were sent to a repair workshop to check the correctness of the brake.

**Figure 4.2.2.1:** The wire that fixed the G-P gear handle

**SR\_21/21** “Srbija Kargo” a.d., to train the staff that wagons due to defects (as stated in item 4.2.2.3, in one tank it was determined that the GP gearbox was defective when the handle could turn without resistance and without arrest in the end positions and said gearbox has been fixed with wire in position P) must be labelled and sent for repair (see item 4.2.6.).

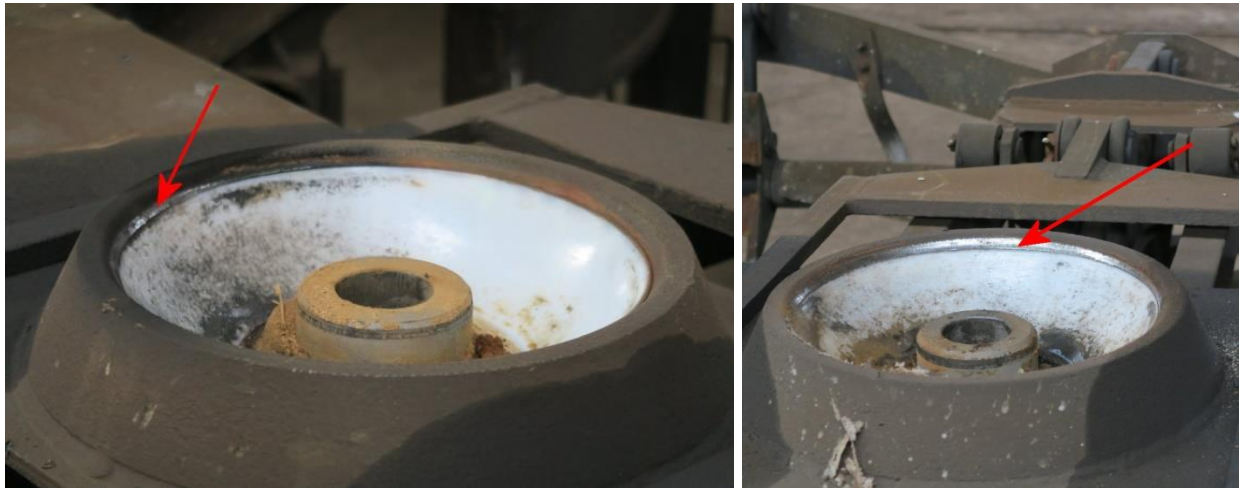
According to the data from the Instructions for operation and maintenance of bogies type Y25 and type Y27 adopted on the Yugoslav Railways ("Official Gazette of ZJŽ" No. 2/87), the average wear of the insert is 0.1 mm per 200,000 km travelled. Based on that, it is clear that the inserts should have been replaced in the previous revision, but that this was not done.

**Figure 4.2.2.1.2:** Center bowls of bogies from the wagon No. 33 72 7867 810-3

**SR\_25/21** Atir-Rail SA, to prescribe in maintenance procedures the control of the condition and wear of wearing inserts of center bowls and side bearers (see item 4.2.2.1.) as well as other elements that can reach the limit measures between the two repairs and define the documentation of buffer characteristics after repair and comparison with the characteristic given by the manufacturer (see item 4.2.2.2.).

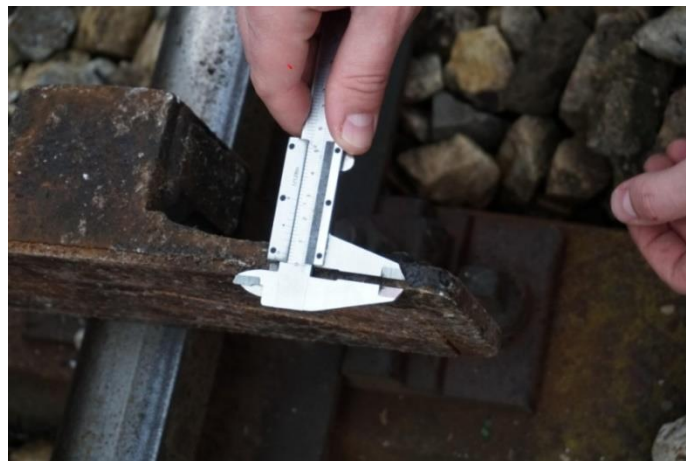
Figure 4.2.2.1.3. shows the worn insert of the side bearer from the wagon' bogie No. 33 72 7867 810-3, which was found at the place of derailment.

**Figure 4.2.2.1.3:** Non-metallic insert of the lower side bearer of the wagon No. 33 72 7867 846-7 bogie worn to the metal support

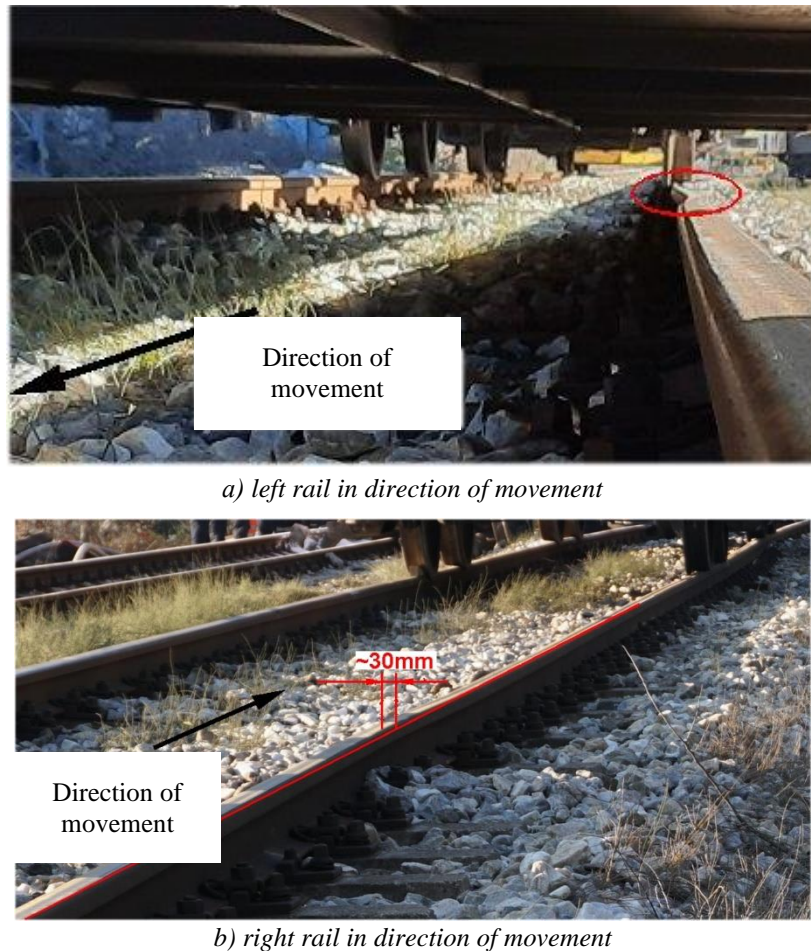
at a length of 10 sleepers (approximately 6 m). According to standard EN 13848-5: 2017, the directional deviation limit that requires immediate intervention, for a speed of 80 km/h is 22 mm.

**Figure 4.2.5.4:** Observed deformation of the left and right rail

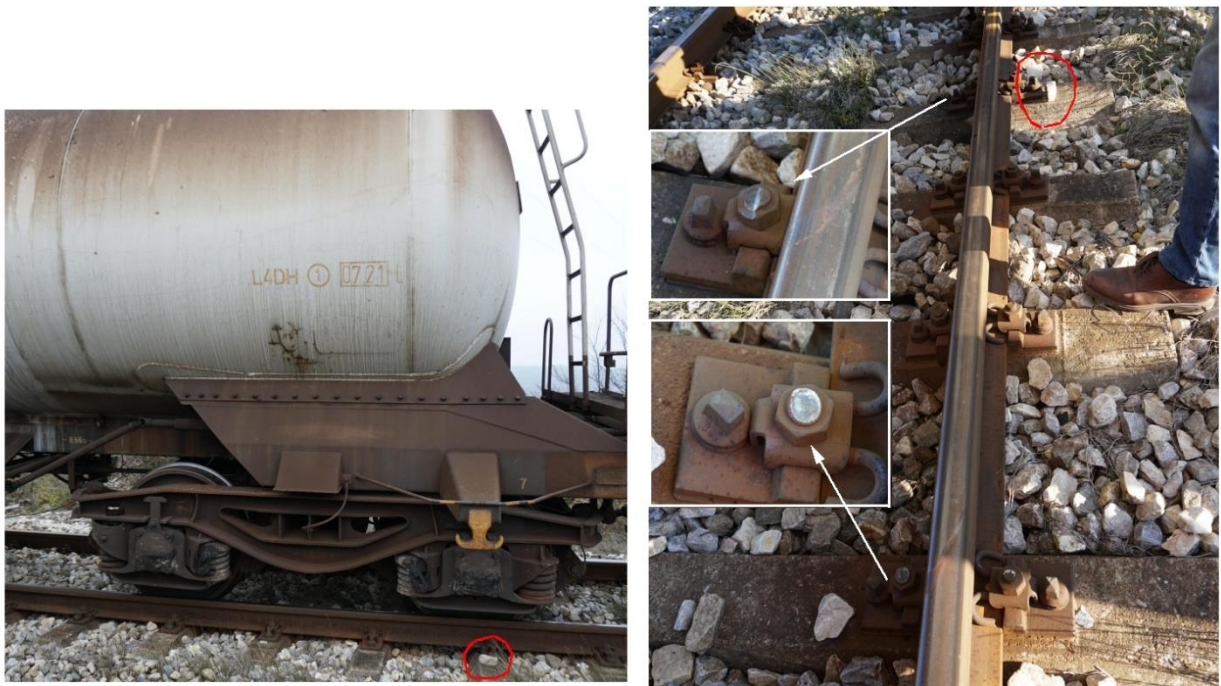
**Figure 4.2.5.5:** The first trace of derailment from the thirteen derailed wagons

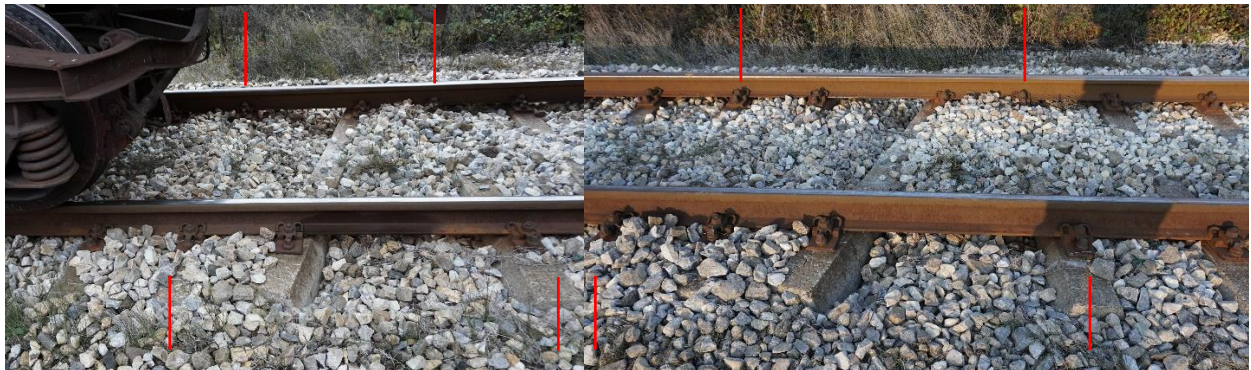
**Figure 4.2.9.5:** The view of sloping sleepers in the accident zone

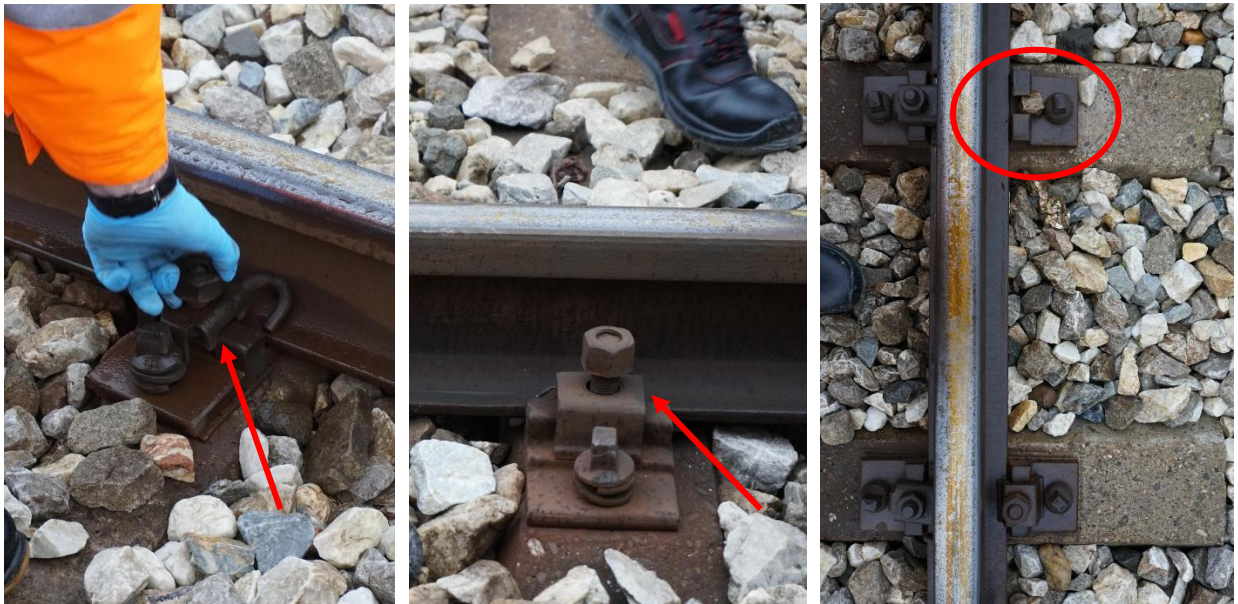
**Figure 4.2.9.6:** The view of the track accessories in the accident zone

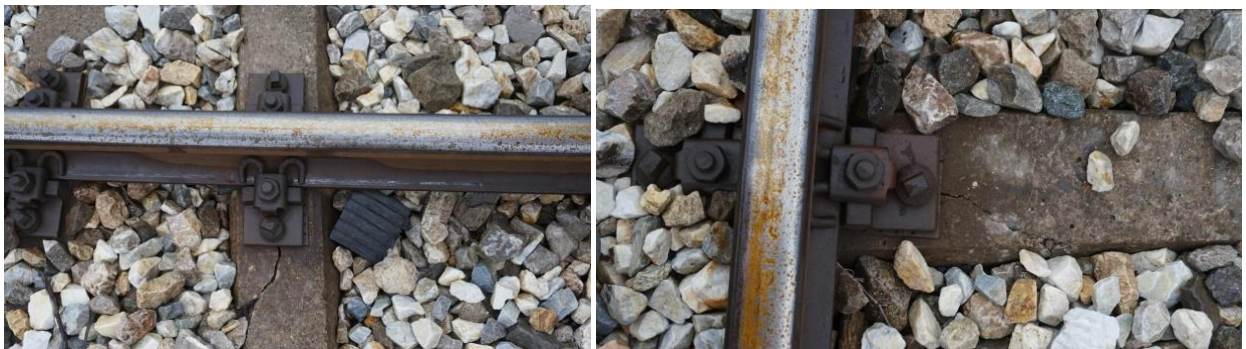
**Figure 4.2.9.7:** Sleeper rupture at the base board-sleeper connection point

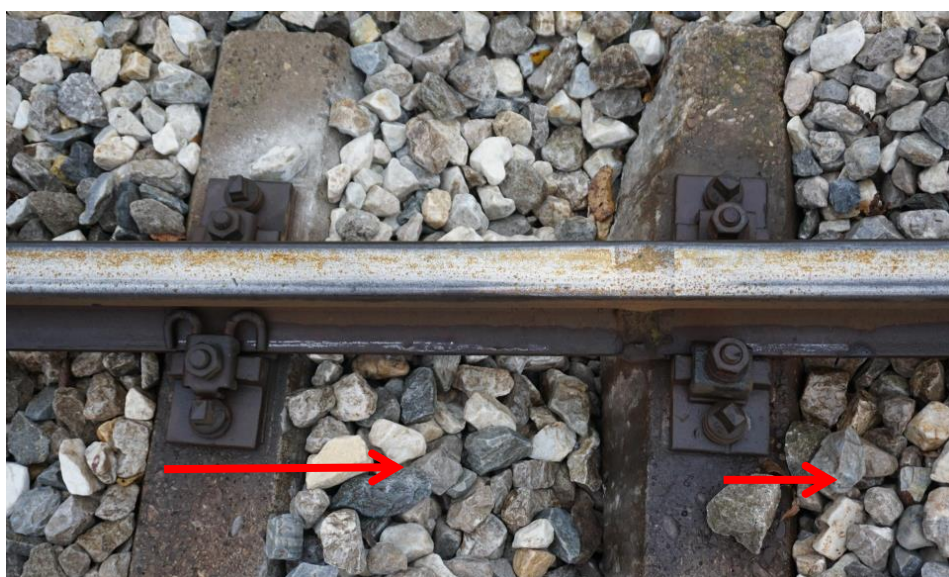
**Figure 4.2.9.8:** Longitudinal movement of the rail

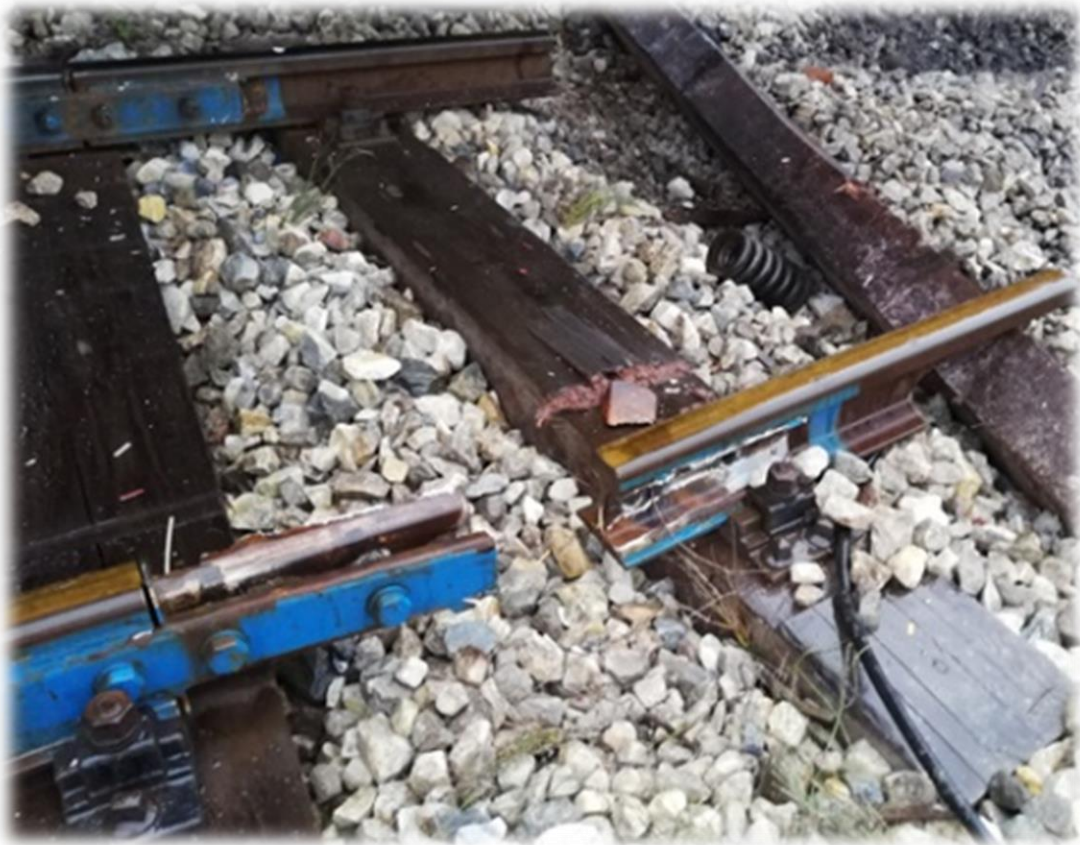
**Figure 4.2.10.1:** The view of the track rupture at the point of insulated joint at km 123+660.80

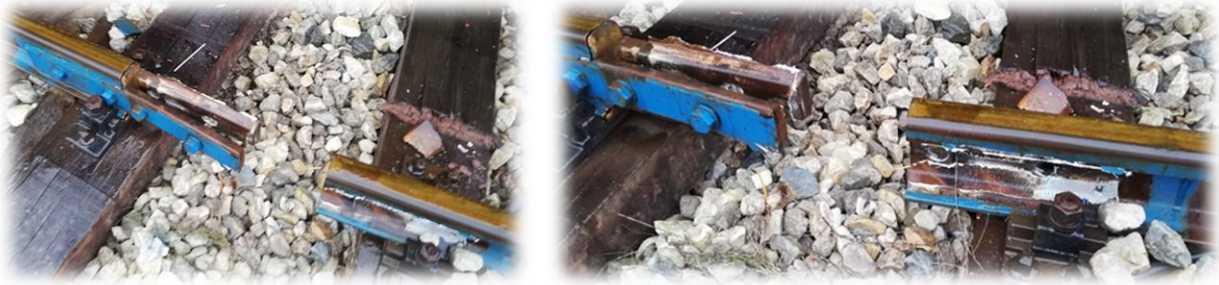
**Figure 4.2.10.2:** The view of rupture of the connecting screws in insulated joint at km 123+660.80  
(left rail in the direction of increasing stationing of the left track)

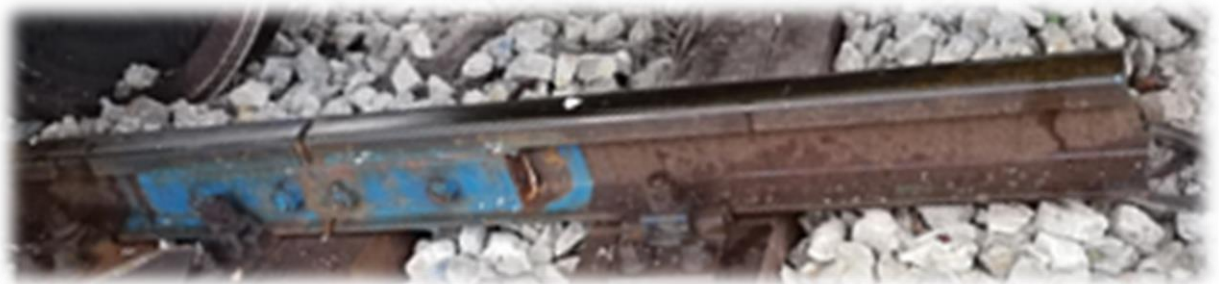
**Figure 4.2.10.3:** The view of the right rail rupture in the direction of increasing stationing of the left track at  
km 123+660.20
