**REPUBLIC OF SERBIA**  
**CENTER FOR INVESTIGATION OF ACCIDENTS IN TRANSPORT**  
**SECTOR FOR INVESTIGATION OF ACCIDENTS IN RAILWAY TRAFFIC**  
**NEMANJINA 11, 11000 BELGRADE**

## **FINAL REPORT ON SERIOUS ACCIDENT INVESTIGATION**

Accident type:	Serious accident on the level crossing
Train No.:	Train No. 6431
Accident location:	City of Subotica, Municipality of Bajmok, distance between the stations Bajmok - Aleksa Šantić
Date:	02.12.2020.
Time:	08:15

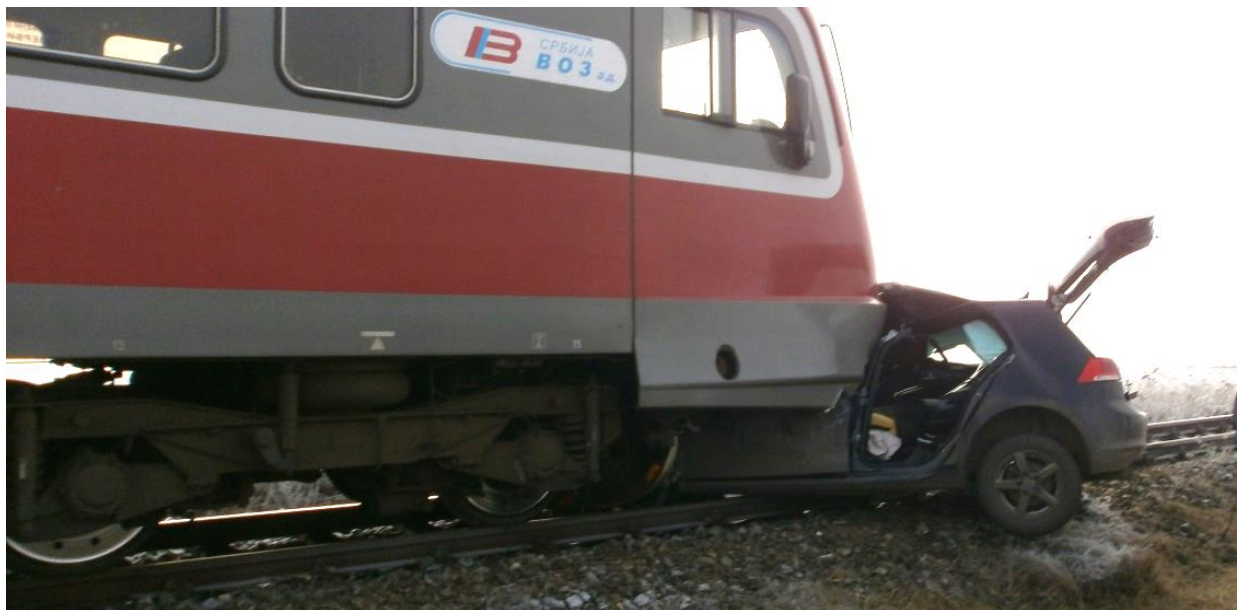
After overtaking, train No. 6431 continued its movement in the length of 165 m, after which it stopped. Due to the force of the impact, the road passenger vehicle crawled under the DMV 711-034 head (driver's cab), ie it remained stuck in the part between the DMV buffer and the track. On that occasion, the entire front part of the road passenger vehicle was significantly damaged.

**Figure 2.1.2.1:** Appearance of DMV 711-033/034 from the train No. 6431 and the road passenger vehicle after the serious accident (view from the free space between the railway line and the road, source: "IŽS" a.d.)

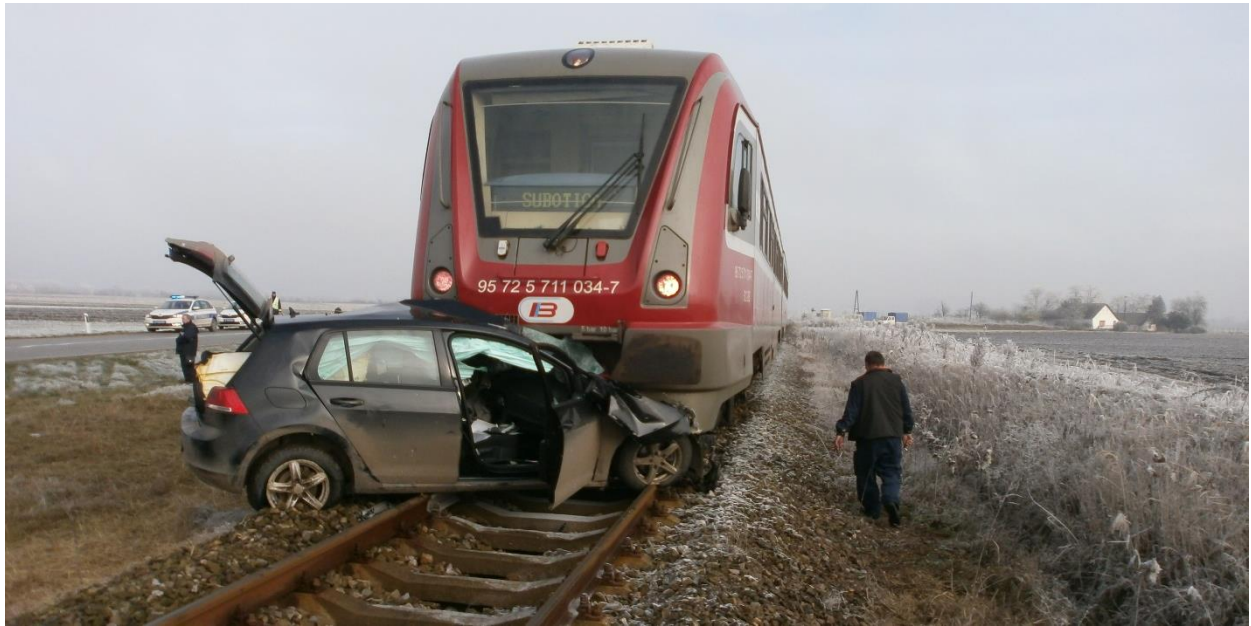
**Figure 2.1.2.2:** Appearance of the road passenger vehicle after the serious accident (view from the railway line, in the direction opposite from the direction of train movement, source:“IŽS”a.d.)

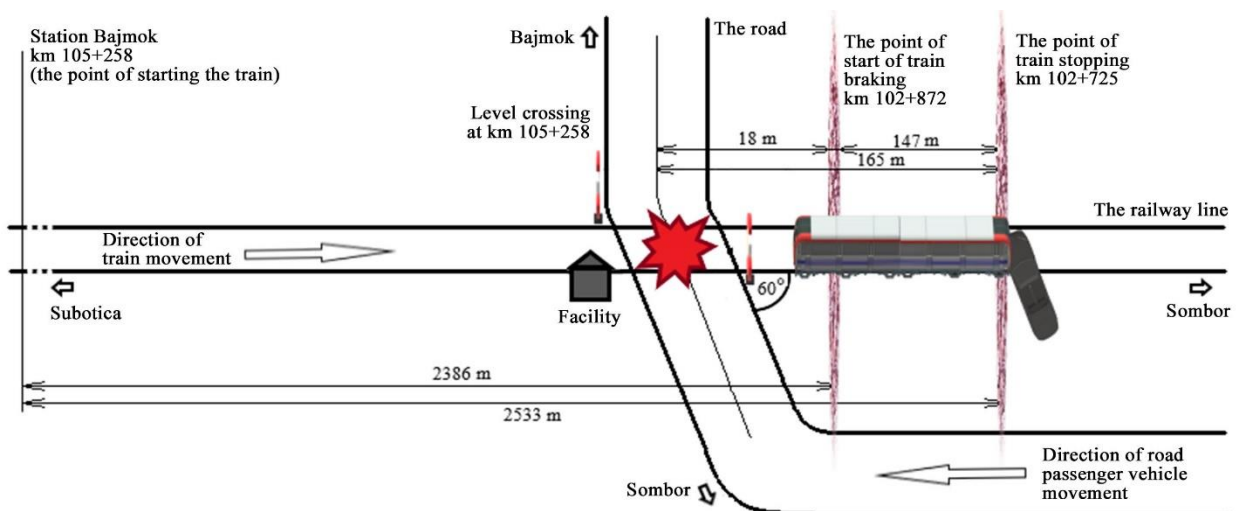
**Figure 2.2.3.3:** Serious accident sketch

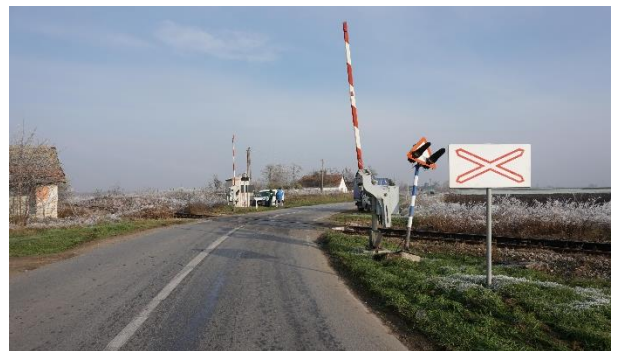
On the state road in question, before encountering the level crossing from the direction of Sombor to the settlement of Bajmok, on the supporters located on the left and right side of the road next to the roadway and from the level crossing are approximately 240 m away, the following traffic signs are placed: I-32: “Crossing of a road with a railway with barriers or half-barriers” and I-35: “Approaching the place of crossing of the road and the railway” (Figure 2.2.3.4.). On the supporters, located on the left and right side of the road next to the roadway and from the level crossing are approximately 160 m away, the following traffic signs are placed: I-35: “Approaching the place of crossing of the road and the railway” (Figure 2.2.3.5.) On the supporters, located on the left and right side of the road next to the roadway and from the level crossing are approximately 80 m away, the traffic signs are placed: I-35: “Approaching the place of crossing of the road and the railway” (Figure 2.2.3.6.). On the supporter, located on the right side of the road next to the roadway and is 8.2 m away from the level crossing (start of the rubber panel), the traffic sign: “Saltire” is placed, on the supporter located on the right side of the road, next to the roadway and is 5.3. m away from the level crossing (start of the rubber panel), the traffic lights IV-9, regulating the crossing of the road over the railway line at the same level, are placed (serving for announcing the train approaching and announcing of the half-barrier lowering), while the half-barrier supporter is placed on the right side of the road next to the roadway and is 4 m away from the level crossing (Figure 2.2.3.7.)

**Figure 2.2.3.7:** The view of traffic signalization (view from direction of Sombor)

An on-site inspection conducted by the CINS investigative team determined that the traffic signals at the road crossing at km 102+890 were not installed in accordance with the Rulebook on Traffic Signals (“Official Gazette of RS” No. 85/17). Traffic signs I-34: “Saltire” are not placed on a common supporter above the traffic lights: IV-9 which regulates the crossing of the road over the railway at the same level as defined in Article 23, paragraph 1, under 6) Rulebook on traffic signalization (“Official Gazette RS” No. 85/17), are already placed on special supporters located in front of the supporter on which the traffic lights are placed IV-9 (seen for the respective direction of movement of road vehicles), at a distance of 2.9 m, seen from the direction of Sombor in the direction of Bajmok, ie at a distance of 1.7 m, seen from the direction of Bajmok in the direction of Sombor (see point 2.2.3).

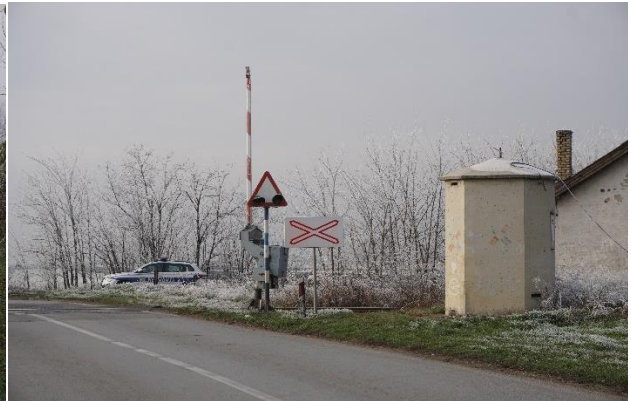
On the state road in question, before encountering the level crossing from the direction of the settlement Bajmok, towards Sombor, on the supporters, located on the left and the right side of the road next to the roadway, on the supporters located on the left and right side of the road next to the roadway and from the level crossing are approximately 240 m away, the following traffic signs are placed: I-32: “Crossing of a road with a railway with barriers or half-barriers” and I-35: “Approaching the place of crossing of the road and the railway” (Figure 2.2.3.9.). On the supporters, located on the left and right side of the road next to the roadway and from the level crossing are approximately 160 m away, the following identical traffic signs are placed: I-35: “Approaching the place of crossing of the road and the railway” (Figure 2.2.3.10.) On the supporters, located on the left and right side of the road next to the roadway and from the level crossing are approximately 80 m away, the identical traffic signs are placed: I-35: “Approaching the place of crossing of the road and the railway” (Figure 2.2.3.11.). On the supporter, located on the right side of the road next to the roadway and is 5.5 m away from the level crossing (start of the rubber panel), the traffic sign: “Saltire” is placed, on the supporter located on the right side of the road, next to the roadway and is 3.8 m away from the level crossing (start of the rubber panel), the traffic lights IV-9, regulating the crossing of the road over the railway line at the same level, are placed (serving for announcing the train approaching and announcing of the half-barrier lowering), while the half-barrier supporter is placed on the right side of the road next to the roadway and is 2.4 m away from the level crossing (Figure 2.2.3.12.)

**Figure 2.2.3.12:** The view of traffic signalization (view from direction of Bajmok)

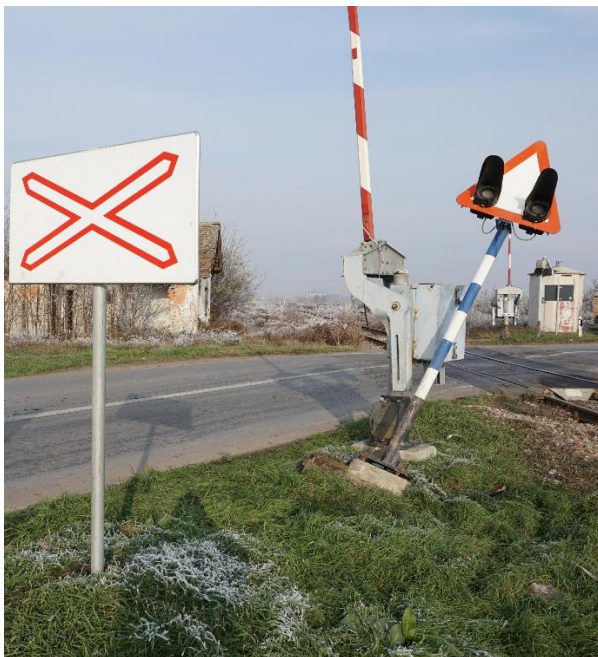
An on-site inspection carried out by the CINS investigative team established that the supporter on which the IV-9 traffic light was placed, which is located in front of the road crossing from the direction of Sombor, does not stand vertically ( $90^\circ$ ) in relation to the roadway, but at an angle of approximately  $70^\circ$ , inclined forwards, in the direction of the road towards Bajmok and slightly to the right. There is damage on the supporter and the foundation on which the supporter is placed, most likely caused by the impact of the road vehicle, while no damage was noticed on the traffic light itself. A certain amount of small broken safety (tempered) glass used on road vehicles was observed on the half-barrier supporter (Figures 3.4.2.1 and 3.4.2.2). The shape and location of the observed damages to the supporter and the base of the traffic light supporter and the shape, size and position of the broken glass indicate that the damages did not occur in the serious accident in question.

**Figure 3.4.2.1:** Appearance of the traffic lights  
(view from direction of Sombor)

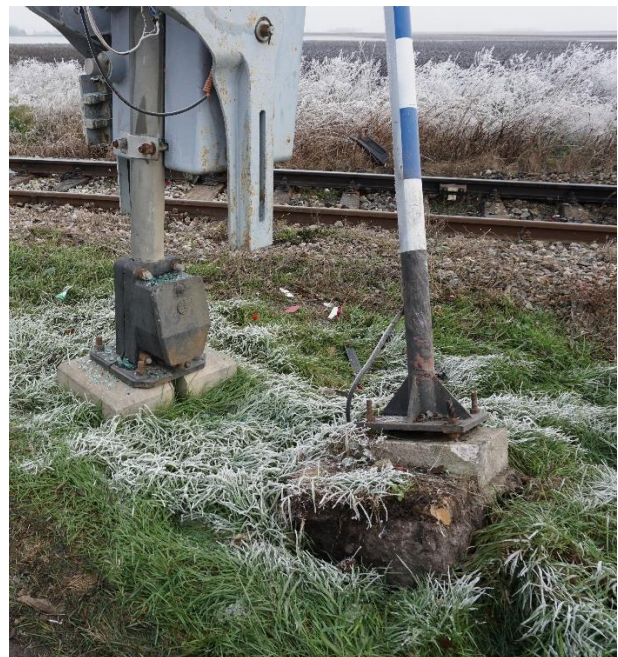
**Figure 3.4.2.2:** Appearance of traffic light details  
(view from direction of Sombor)

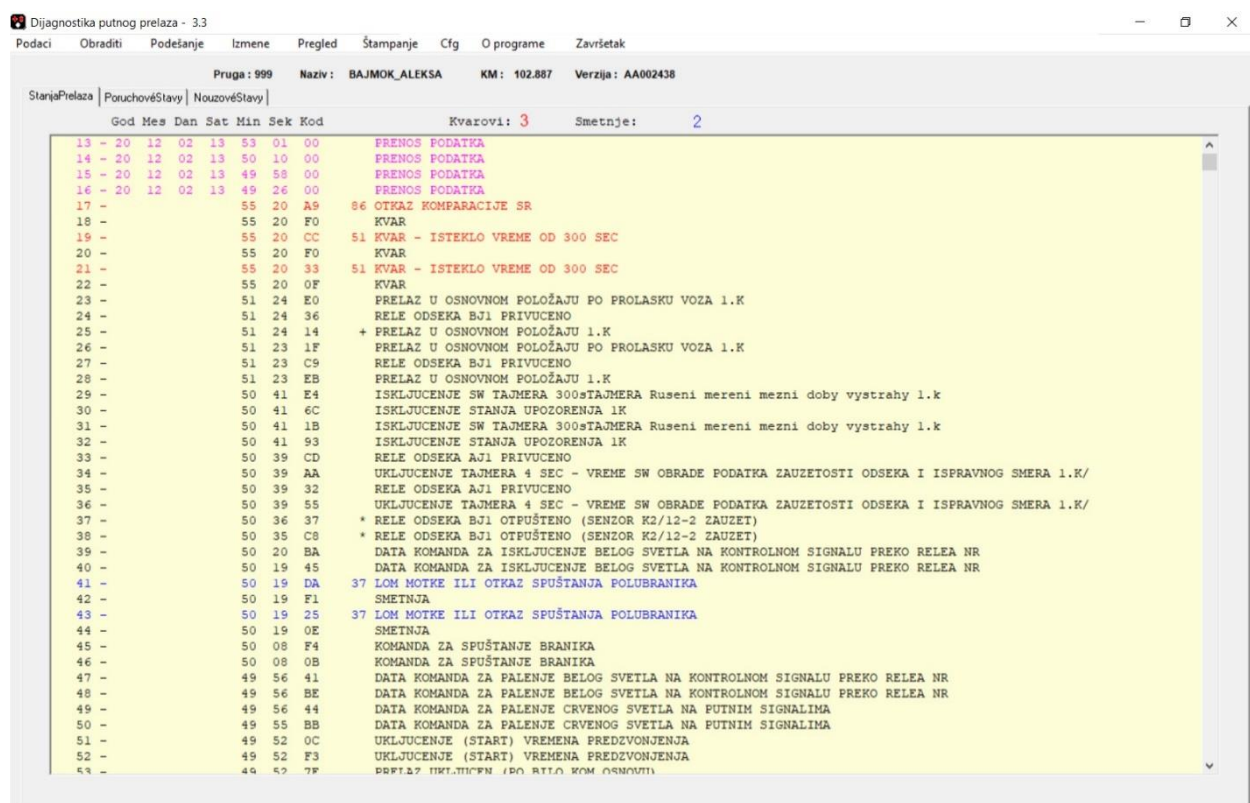
With the help of the submitted application, the analysis of the operation of the level crossing device in the period from 22.1.1.020 was performed. from 12:03 until the moment of taking over the record after the occurrence of a serious accident. This file contains 5251 records. As an illustration, Figure 4.2.1.1.1 shows the appearance of the work window of the application for data processing of the diagnostic record of the PZZ-EA road crossing device.

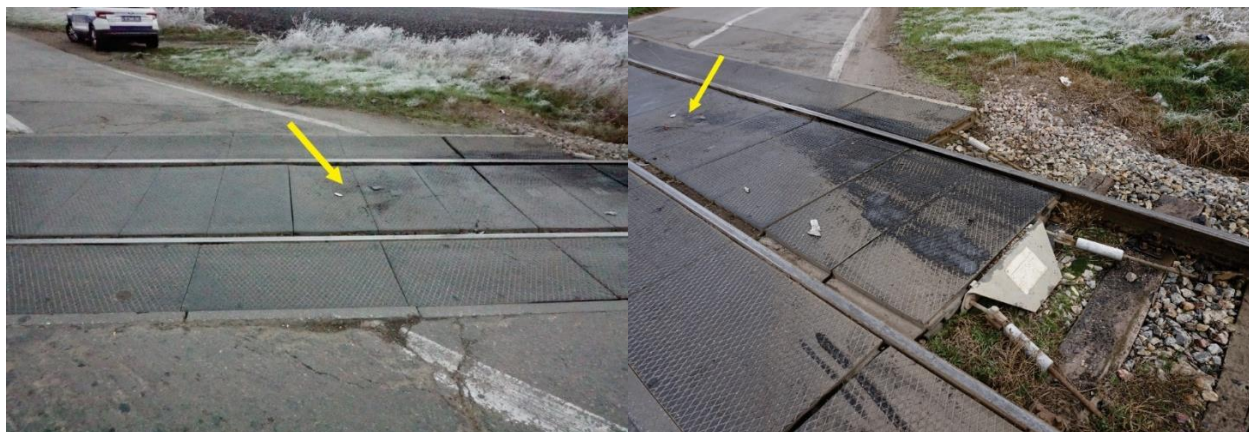
CINS does not have data on the speed of the road passenger vehicle that participated in this serious accident, just before its occurrence. Based on the photographs taken immediately after the occurrence of the serious accident in question and which are part of the investigative documentation, it can be seen that there are no traces of braking of the passenger vehicle before the occurrence of the serious accident. However, in Figure 4.2.4.1. it can be seen that the traces that have been made immediately after the train hit the passenger vehicle, and which originate from the liquid from the passenger vehicle caused by the force of the impact, begin in the roadway lane of the 1B rank road of the marking 12, for the direction towards Bajmok. This fact indicates that the passenger vehicle was in the correct lane at the time of the serious accident in question and that the barriers of the automatic device of the road crossing in question were raised at the time of the collision between the train and the passenger vehicle. This fact indicates that the passenger vehicle was in the correct lane at the time of occurrence of the serious accident in question and that the automatic device barriers of the level crossing in question were raised at the time of the collision between the train and the passenger vehicle.

**Figure 4.2.4.1:** The position of the serious accident site and the traces in relation to the roadway
